Motorola Solutions Technical Notification (MTN)

TITLE: BMC AppSight Black Box service running on A7.14 and earlier dispatch operator positions needs to be stopped before installing McAfee Virus Scan Engine 8.8 Patch 7 and above. (2016.Q4) The service must remain in the stopped state for McAfee VSE to function properly during and after install.

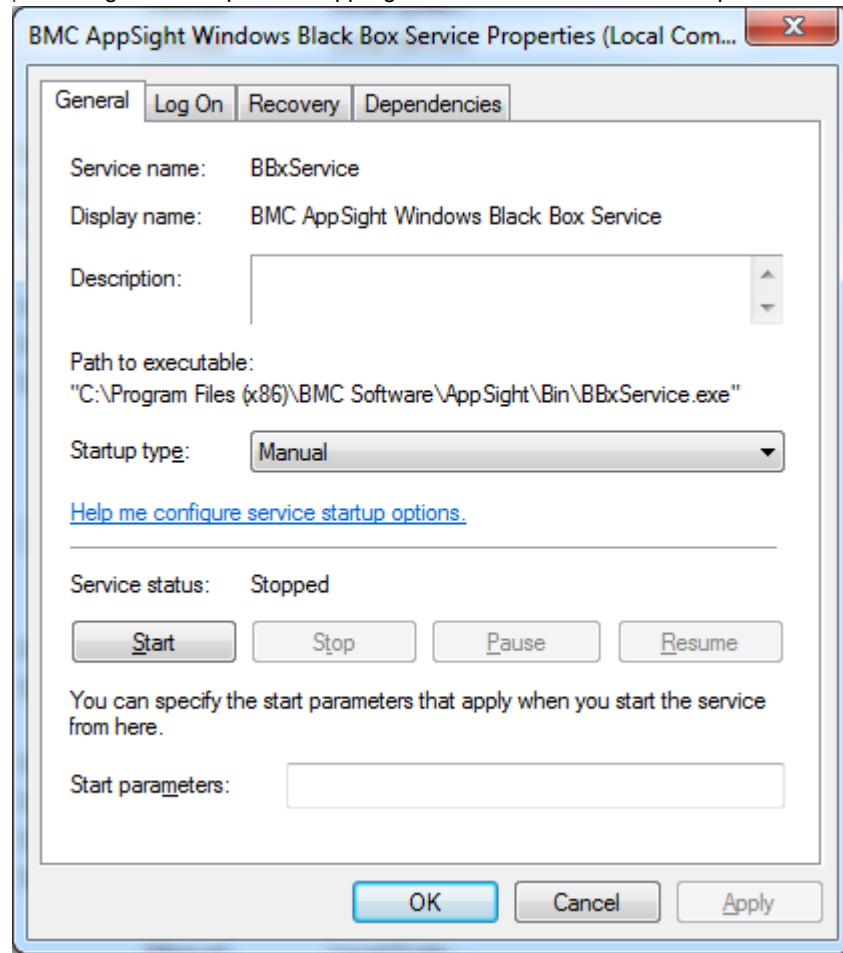
(Following is the snapshot of AppSight Black Box Service after the procedure is applied)

1. Open the "Services" management console as an administrator.
2. Scroll to the service name "BMC AppSight Windows Black Box Service".
3. Right-click Properties (or double-click)
4. Change the Startup Type to "Manual".
5. Click "Apply"
6. Click "Stop"
7. Service status should appear as "Stopped"
8. Click "OK"
