Motorola Solutions Technical Notification (MTN)

TITLE: Audio Loss and Network Outage of Up To 10 Seconds on Audio Processing Windows Products After Install/Upgrade/Uninstall of McAfee Antivirus (ENS)

TECHNOLOGY: ASTRO25

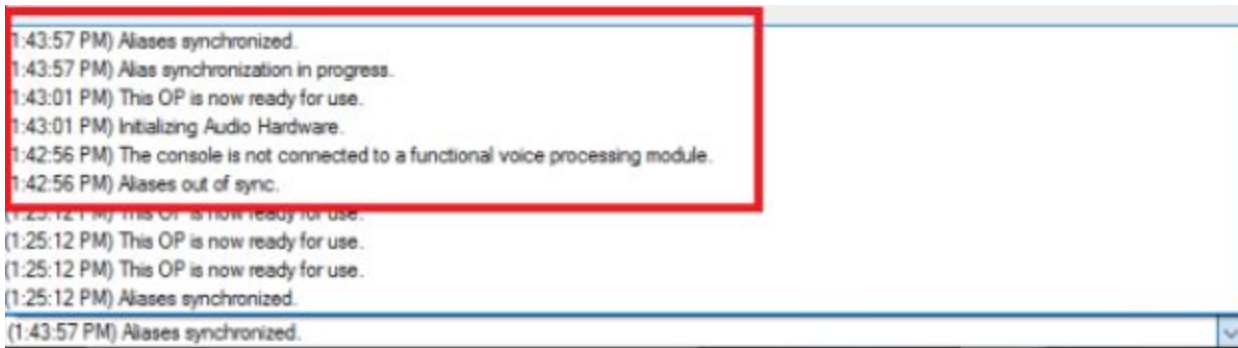
Audio loss and/or VPM link drops (as seen in image) lasting up to 10 seconds occur and automatically recover in these conditions:

1. Within 3 hours after initial McAfee ENS deployment to the device.
2. Upon uninstall of McAfee ENS from the device.
3. When a specific McAfee ENS update occurs. A “McAfee ENS update” can occur upon clicking the “Update Now” button locally from the device within the McAfee ENS console interface or after applying specific McAfee ENS Motopatches.

The root cause is a specific driver that McAfee ENS installs/updates that causes the network stack to initialize, resulting in the Windows device losing network connectivity for a short period.

1. Schedule maintenance window prior to deploying ENS and ensure the product in the *Audio Processing Applications (Windows-based) Impacted* list will not be in use any time within the next 3 hours. The Install/Upgrade/Uninstall of ENS can be aligned with other maintenance windows (e.g. Windows Motopatch, MCC7500 Application Upgrade, etc.) to avoid multiple downtimes for a given Windows device.
 - a. Trigger an "Update Now" for the endpoint to further shrink the 3 hour period to something more manageable, closer to 1 hour.
 - i. Login to the Windows device that has just had ENS deployed
 - ii. Click the **Start Menu** and begin typing `endpoint security`
 - iii. Click the **McAfee Endpoint Security** application
