DOCUMENT NUMBER:	MTN-0166-24
ISSUE DATE:	2024-12

MOTOROLA SOLUTIONS TECHNICAL NOTIFICATION (MTN)

Alarms from SDM3000 RTU and MC-EDGE NFM devices are classified incorrectly in the UEM.

ASTRO® 25

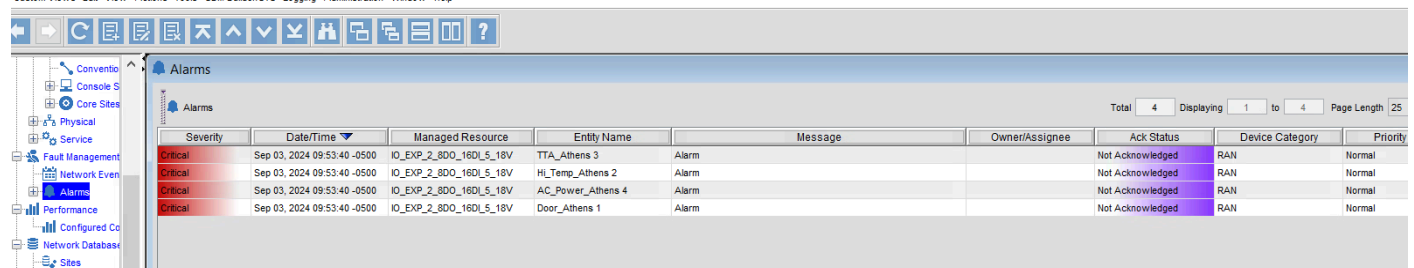
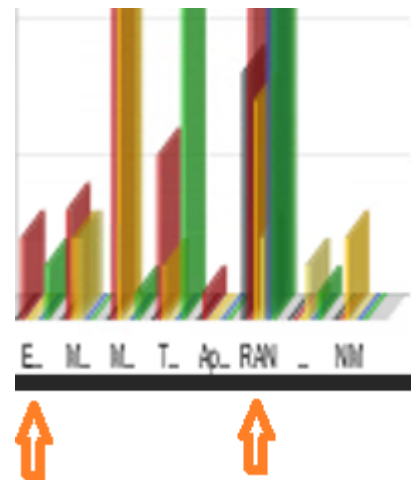
Alarms reported for *Environmental Mixed* entities of SDM3000 RTU and MC-EDGE NFM devices are classified in the wrong device category in the UEM (*RAN* instead of *Environmental*). As a result, the statistics related to these alarms are displayed in an incorrect section of the *Alarm Summary View* bar graph (see the screenshots below).

Upgrade to the appropriate version as listed in the "Software/Hardware Parts Required" section below, based on the model.
