DOCUMENT NUMBER:	MTN-0167-24
ISSUE DATE:	2024-12

MOTOROLA SOLUTIONS TECHNICAL NOTIFICATION (MTN)

MOSCAD "IP Management" setting does not work

ASTRO® 25

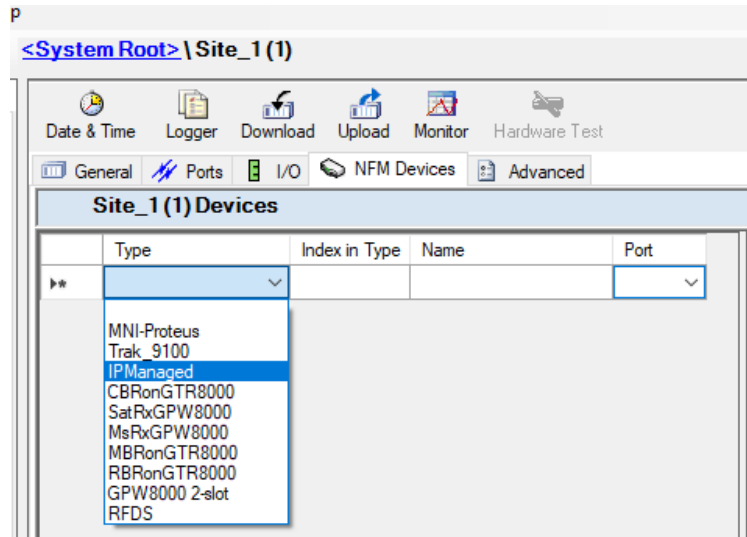
STS/MC-EDGE "IPManaged" setting

When "IPManaged" is selected and configured in the STS or SDM Builder menu selection, the NFM RTU does not report the associated IP device status to the UEM and the device up/down status is not displayed at the UEM. Selection and reporting of other than "IPManaged" SDM 3000 IP managed device types (such as Firewall, GGSN, ConvPDR, NiceLogRepStn, etc) works as expected.

The NFM RTU "IP managed" functionality will be deprecated. There is no need for the NFM RTU to proxy this information to the UEM as the UEM can IP ping manage IP devices directly. "IP managed" was useful with the MOSCAD GWS and GMC fault management solution which was used with ASTRO 7.15 and earlier systems. "IP managed" was also useful with the 3rd party fault manager solution for K-Core systems.
