DOCUMENT NUMBER:	MTN-0176-24
ISSUE DATE:	2024-12

MOTOROLA SOLUTIONS TECHNICAL NOTIFICATION (MTN)

Customers upgrading a DSC 8000 site from version 9.3.xx to 9.5.xx or later, may see an upgrade failure causing the site to go off the air for 10 minutes.

ASTRO® 25

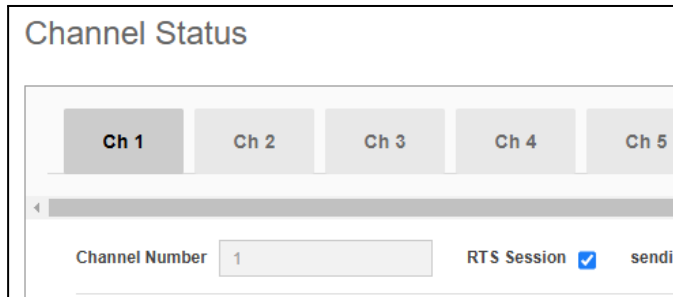
The upgrade failure is a result of an Real Time Session(RTS) being enabled prior to the upgrade. To prevent the failure from occurring, disable all of the 'RTS Sessions' of the channels via PCA (Provisioning and Configuration Agent) before performing the upgrade.

- Navigate to the **Services->Channel Status** screen
- For each **Channel** tab, uncheck the 'RTS Session' checkbox and click **Apply**

After the upgrade, the 'RTS Sessions' can be re-enabled with no future impact to upgrades.
