DOCUMENT NUMBER:	MTN-0003-25
ISSUE DATE:	2025-03

MOTOROLA SOLUTIONS TECHNICAL NOTIFICATION (MTN)

IMW 5.2.5 reports statuses of unknown for 4 Objects in UEM after discovery

ASTRO® 25, DIMETRA™

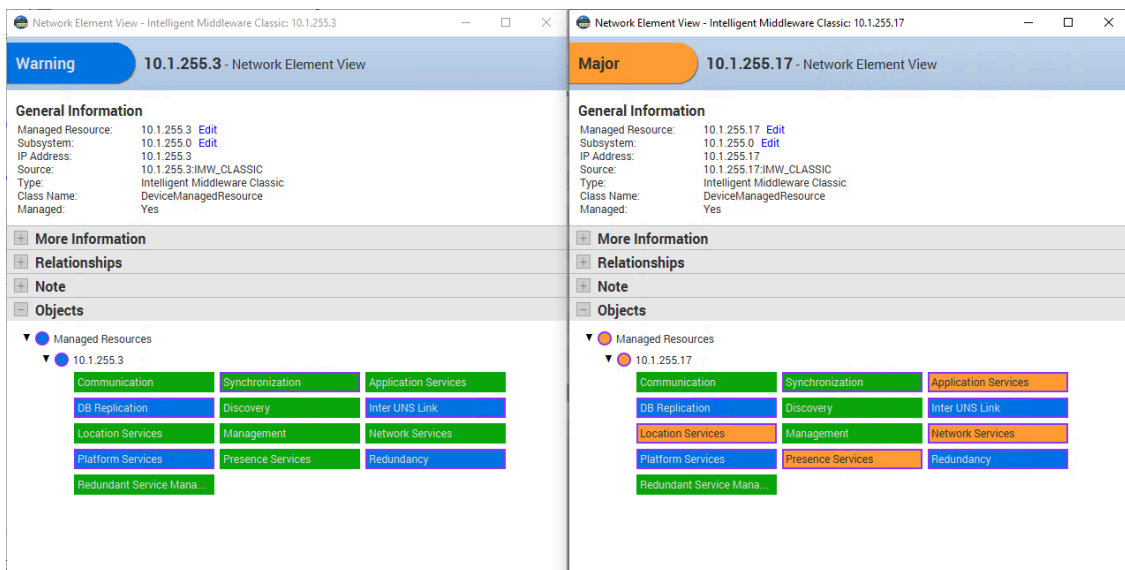
UEM is receiving "Unknown" status from IMW 5.2.5 and blue severity (i.e., Warning) for DB Replication, Inter UNS Link, Platform Services, and Redundancy in the UEM Network Element View.

Additionally, in case of Redundant Server configuration, the Standby IMW shows the same state for those components and also the "Disabled" state rather than "Disabled Standby" for the Network Services, Application Services, Presence Services and Location Services components in the UEM Network Element View.

See screenshots below:

Until further notice from MSI, MSI recommends the admin to check the status of IMW Services via IMW Administrative Client Following the instruction below.
