DOCUMENT NUMBER:	MTN-0054-24
ISSUE DATE:	2024-4

MOTOROLA SOLUTIONS TECHNICAL NOTIFICATION (MTN)

Thumbscrew detached from Accessory GCAI Connector

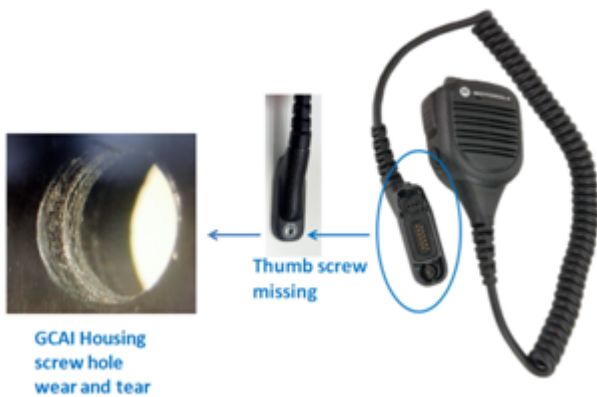
GCAI Thumbscrew detached or missing from the GCAI Connector. GCAI Thumbscrew is being removed from the GCAI Connector by excessive force / unintentional removal. The thumbscrew is not meant to be removed from the accessory GCAI Connector.

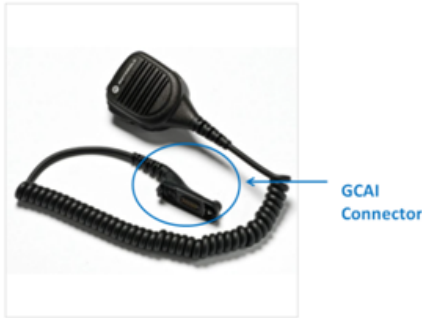
An accessory with GCAI Connector (see image)

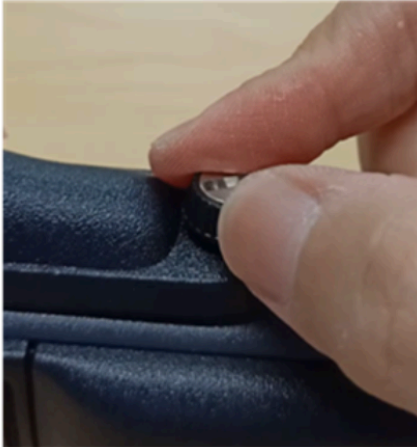
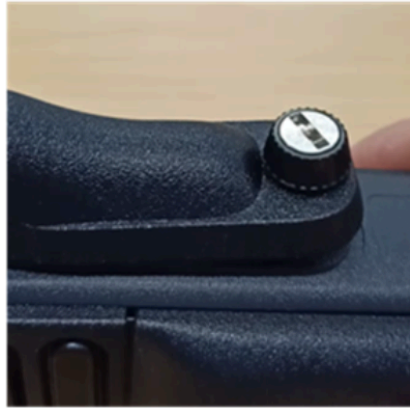
- **Removal from radio/host devices**

Please note that the thumbscrew should not be removed from the accessory connector.

Removal of the thumbscrew from the connector will damage the connector.

Unscrew the thumbscrew with fingers and turn it counterclockwise to unlock the screw, approximately 3 turns. If the screw is too tight to be unscrewed by fingers, use a coin to loosen the screw.

The connector can be detached from the radio once the screw is already released from the radio insert nut.

The "slot" in the Thumbscrew is designed to be curved and is meant for tightening the screw lightly using a coin. **DO NOT use any screw-driver, power driver or any other tool to tighten the screw.**
