APPARATUS AFFECTED: DATASPEED 40AB101/AA Answer-Back.

PART AFFECTED: TP410722 Answer-Back Circuit Card  
Assembly (MC722).  
TP305821 Capacitor

Attached Sheet 1

NEW-STYLE TP410722 CIRCUIT CARD ASSEMBLY  
(CUSTOMER IDENTIFICATION ISSUE 8A)

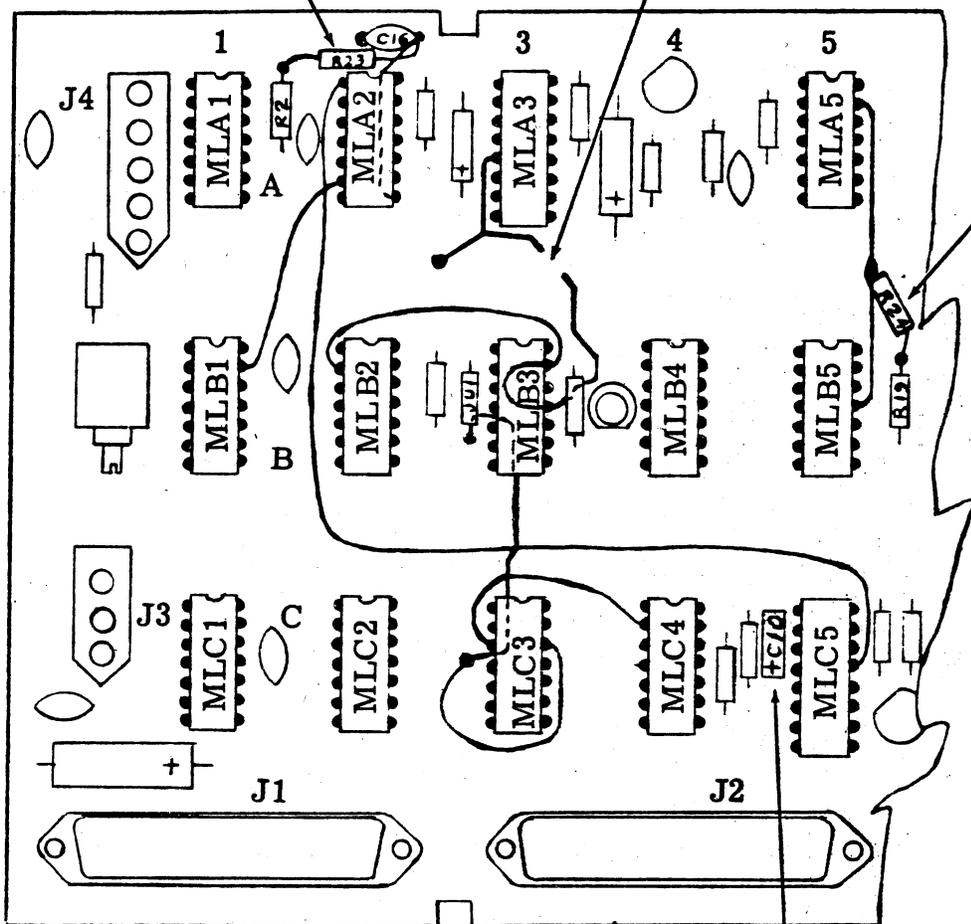
REASON: (1) To prevent false character printout on the receive unit upon answer-back detection of ENQ (enquiry) character.

(2) To assure generation of "answer-back start" upon detection of ENQ (enquiry) character.

(3) To prevent the "send data" output staying in the "space" condition after a power on sequence.

R23 (TP315971 - 680 OHM) ADDED FROM LAND FOR UPPER LEAD OF R2 TO LAND FOR RIGHT LEAD OF C16. LEADS OF R23 COVERED WITH SLEEVING.

ETCHING TO MLB3-11 CUT.

R24 (TP321213 - 1K OHM) ADDED (FROM LAND FOR UPPER LEAD OF R19 TO PLATED THRU HOLE).

C10 CAPACITOR (0.1 MFD) REPLACED BY TP336948 (1.0 MFD). POSITIVE (+) END OF TP336948 TO LOWER LAND.

INSULATED STRAPS ADDED  
(See above)

FROM MLB3-11 TO MLB3-13.  
FROM MLC3-12 TO PLATED THRU HOLE (TO JU1 STRAP).

(1A) On the noncomponent side of the board, the etched circuit path to MLC3-9 from the plated thru hole (to JU1 strap) is cut.

(1B) On the component side of the board, the etched circuit path to MLB3-11 (from MLA3-5) is cut.

(1C) Two insulated straps are added on the component side of the board, connected as follows:  
From MLB3-11 to MLB3-13.  
From MLC3-12 to plated thru hole (to JU1 strap).

(2) A TP315971 resistor (R23 - 680 ohm - 1/4 W) is added, connected from land for upper lead of the R2 resistor (+ 5V) to land for right lead of the C16 capacitor (gate output MLA2-8). The leads of the R23 resistor are covered with insulating sleeving.

(3A) The C10 capacitor (TP305821 - 0.1 mfd) is replaced by a TP336948 capacitor (1.0 mfd). The positive (+) end of TP336948 capacitor is connected to the lower land (to MLC5-2).

(3B) A TP321213 resistor (R24 - 1K ohm - 1/4 W) is added, connected from land for upper lead of the R19 resistor (+ 5V) to plated thru hole (gate output MLB5-11).

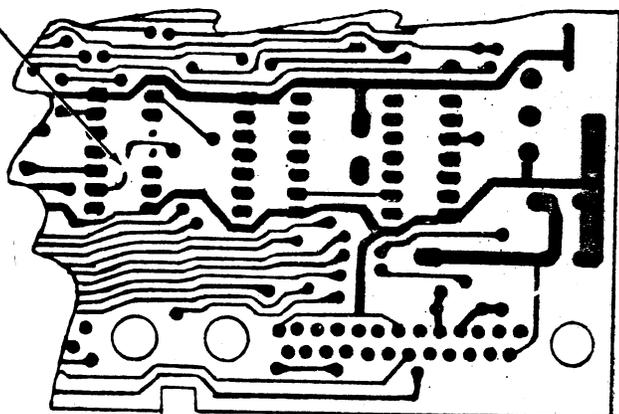
(NONCOMPONENT SIDE)

ETCHING TO MLC3-9 CUT.
