Technical Note TN-3448c-SR

This Software Release note applies to DMR cadence releases of v3.x software.

21 June 2024

DMR Cadence v3.04 (R24.1)

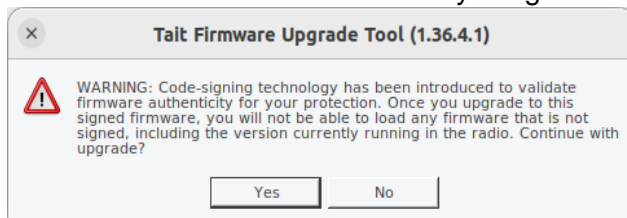
The release of the color control heads requires the TM9300 and TM9700 bodies using (or intending to use) these to upgrade to match the control head's firmware.

If not done so the head will display 'Firmware Mismatch'.

If the mobile firmware is not already a signed version, this pop-up may also appear:

See further details in TN-3397c-AN.

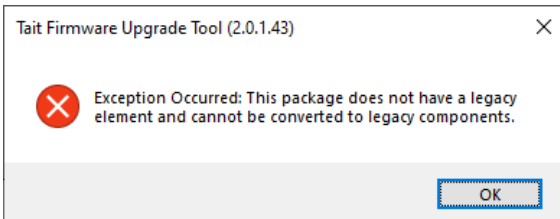
TP9300 and TM9300's that are operating with firmware v2.xx cannot be upgraded directly to firmware v3.03 or later. Attempting to do so will display this pop-up:

They must first be upgraded to firmware v3.01-**signed**.

From v3.01(signed) the radios are able to upgrade to v3.03 or later and can also downgrade later to v3.01 (signed) if required.

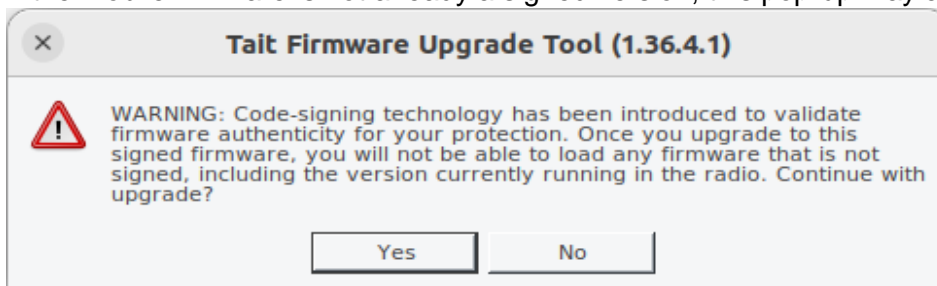
If not done so the head will display 'Firmware Mismatch'.

If the mobile firmware is not already a signed version, this pop-up may also appear:

See further details in TN-3397c-AN.

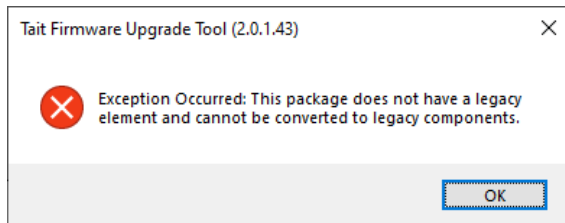
TP9300 and TM9300's that are operating with firmware v2.xx cannot be upgraded directly to firmware v3.03 or later. Attempting to do so will display this pop-up:

They must first be upgraded to firmware v3.01-**signed**.

From v3.01(signed) the radios are able to upgrade to v3.03 or later and can also downgrade later to v3.01 (signed) if required.
