**CROSSES OR FALSE GROUNDS ON
SUBSCRIBER LINE LINK FRAME
LR RELAY
NO. 1 CROSSBAR OFFICES**

SECTION 216-603-301

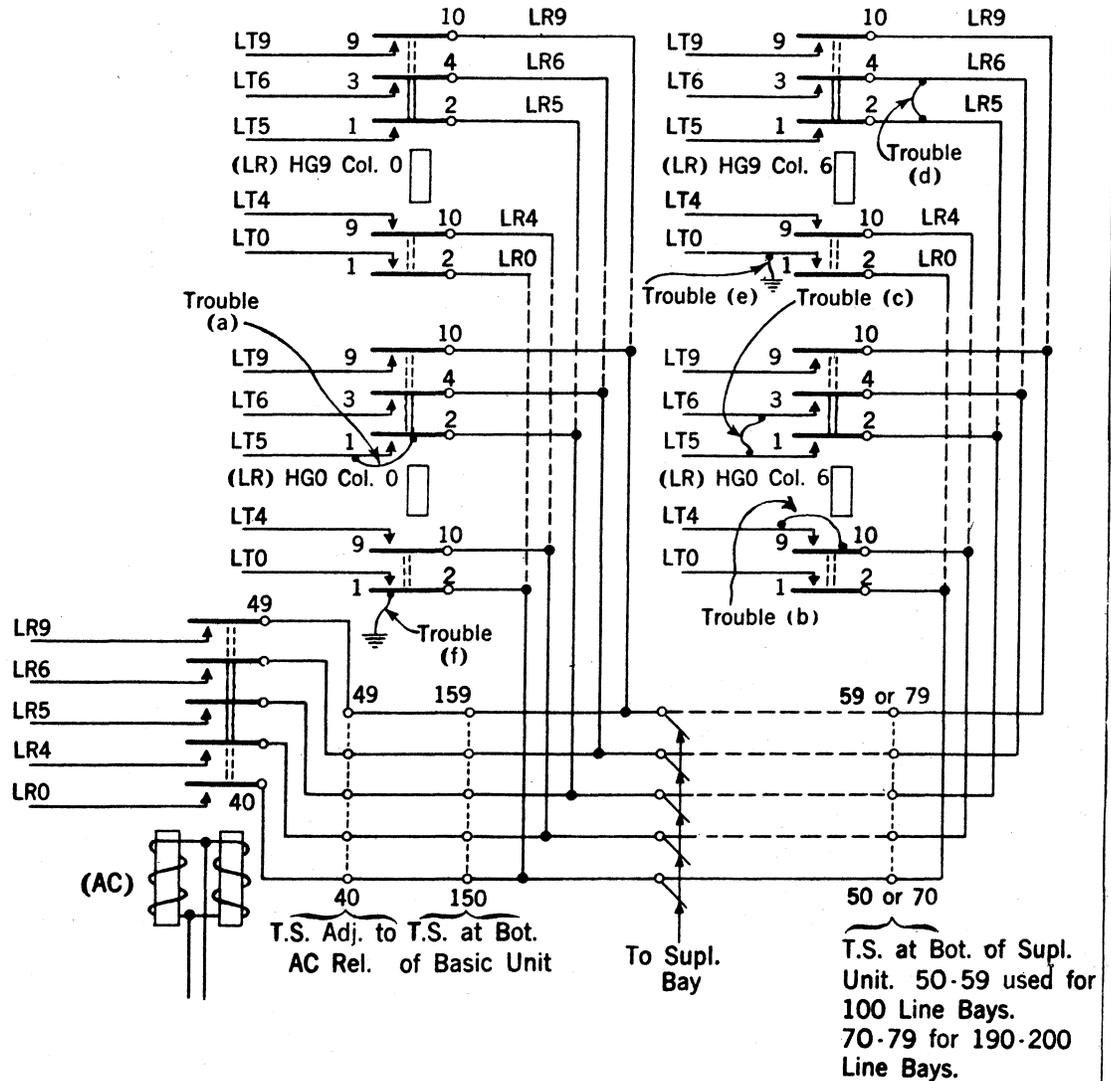
Fig. 1

5.01 Trouble conditions caused by crosses or false grounds on the subscriber line link LR relay contacts affect the controller circuit sequence of operation in various ways depending upon the nature of the particular trouble. To aid in analyzing a particular trouble appearance this section treats trouble conditions due to crosses or false grounds on the LR relay contacts under the six following classifications illustrated in Fig. 1:

LR RELAY CONTACTS AND ASSOCIATED LT LEADS

SKETCH OF LT AND LR LEADS
