Part No. 317177-A Rev 00  
May 2004

# **Release Notes for the Passport 8000 Series Switch Software Release 3.7**

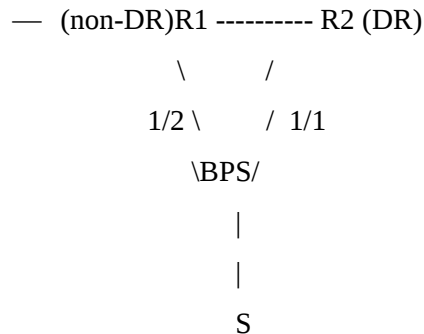
- Non-DR switch receives double traffic when a receiver is connected to a non-DR switch and the unicast route (shortest path) towards the source is not through a DR switch. Both non-DR and DR switches create (\*,G) and (S,G) records. (Q0086744)
- On a VLAN spanning more than 2 switches, SPT path joins are received on one port of the spanning VLAN. The messages on the VLAN port on which RP-to-source prune messages are received will not be properly pruned and will stay in a prune pending state (because of overriding joins received on the port in the SPT path). (Q00421566)
- The PIM MRtable incorrectly shows incoming traffic port when there is an SMLT fail over. (Q00664751)
- R1 and R2 are running PIM:

This issue happens with the BPS at the edge. The BPS always chooses to forward on the lowest link of the MLT. If we reboot the DR switch (traffic was flowing through 1/1), traffic recovers through 1/2.

On R1, since it is getting data locally through 1/2, the source->upstream becomes NULL. When R2 comes back up, traffic starts flowing on 1/1 to R2. However, if the unicast route to the source subnet still lies through R1 (since R2 rebooted), joins to the source will go to R1 instead of R2. Now R1 has to send a join to R2 to receive traffic, but it will not do so since its source->upstream is NULL (it thinks that the source is local).
