**TROUBLE LOCATION TESTS
USING VOICE-FREQUENCY SWEEP TEST SETS
DETAILED ANALYSES**

**ANALYSIS OF
OPEN-CIRCUIT IMPEDANCE CURVES
WITH VOICE-FREQUENCY SWEEP TEST SETS
H88 LOADING PLAN**

**ANALYSIS OF OPEN-
CIRCUIT IMPEDANCE CURVES
WITH VOICE-FREQUENCY SWEEP TEST SETS
H44 LOADING PLAN**

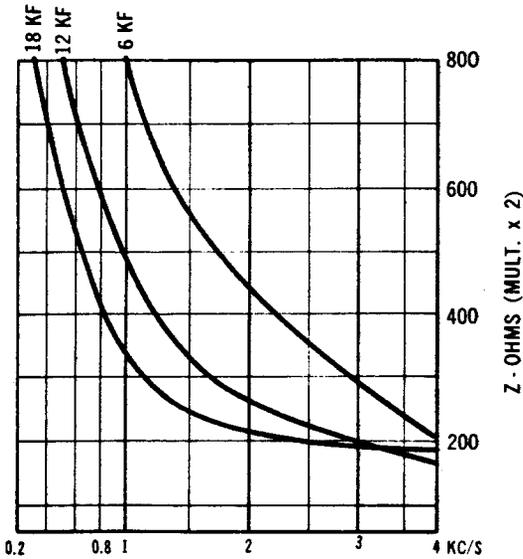
2.01 When the pair is in the test condition, operate the TEST PAIR key of the accessory arrangement as furnished per Section 330-450-102, Fig. 1-3. The pair is then connected to the sweep test set. With the set arranged for impedance measurement, examine the shape of the impedance curve. If it is similar to those shown in Fig. 1, the pair is nonloaded. The impedance magnitude will decrease as the length of the pair plus bridged tap increases.

Fig. 1 - Open-Circuit Impedance Curves for Various Nonloaded Pairs

3.02 Fig. 3 shows the effect of a short circuit at the distant end of the pairs shown in Fig. 1. Notice that the impedance approaches the DC resistance of the loop between the Central Office and the short at low frequency.

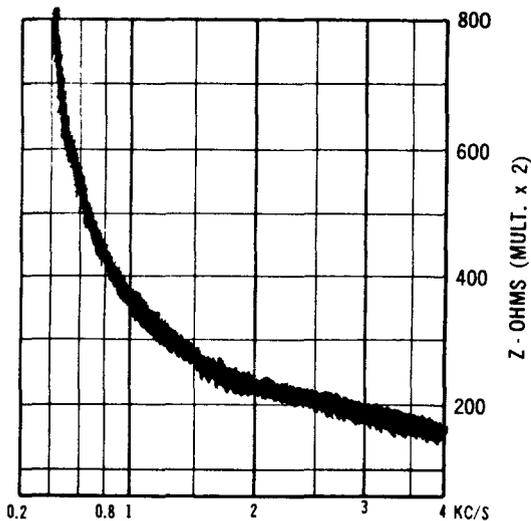
3.07 An unbalanced cable pair will often be encountered. It will usually be indicated by a widening of the trace due to noise. A typical display for a 15 KF nonloaded cable pair is shown in Fig. 7. In this case, an unbalance exists 9 KF from the Central Office.

Fig. 7 - Noise on Open-Circuit Impedance Curve for a Nonloaded Cable Pair

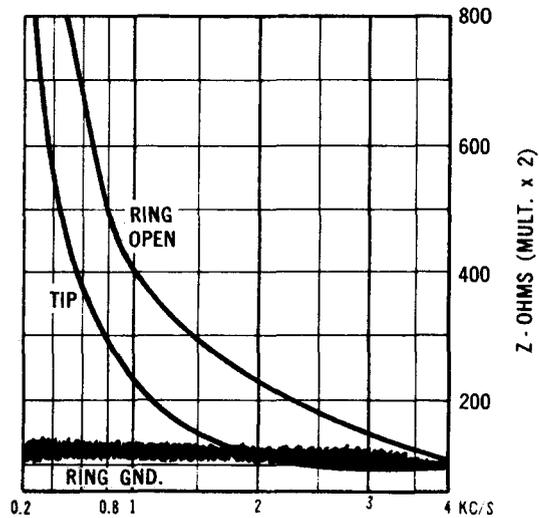
3.09 Fig. 8 shows some typical displays for a 15 KF nonloaded pair with a fault on the ring side 9 KF from the office. When the ring side is open, its impedance is higher than the tip side. When the ring side is grounded, its impedance is much lower.

Fig. 8 - Tip and Ring Impedance Curves for a Nonloaded Cable Pair with Fault in Ring Side

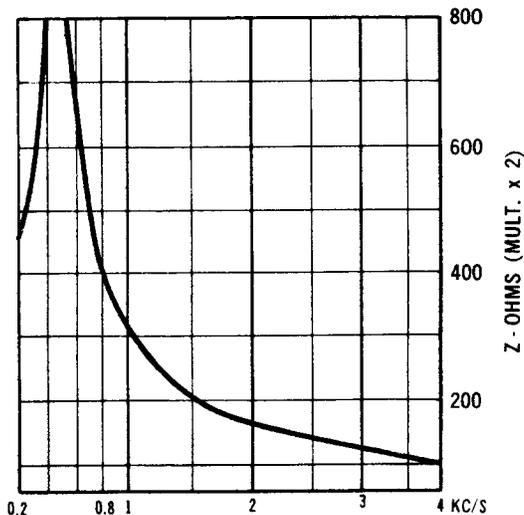
4.05 An exception will be found on nonloaded pairs terminated at 155G coin telephone sets. An example is shown in Fig. 10. The low impedance at low frequency is caused by the subset. These stations are being replaced.

Fig. 10 – Open-Circuit Impedance Curve for Nonloaded Cable Pair Terminated at 155G Coin Telephone Set

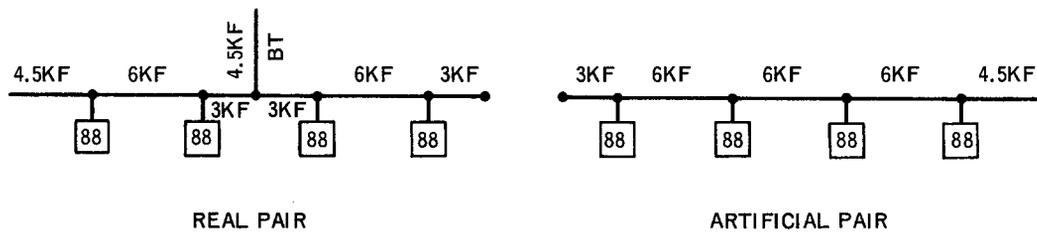
Fig. 14 – An Arrangement for an Impedance Comparison Test

4.14 Fig. 14 illustrates an arrangement that might be found in actual practice. The real pair has an irregularity, and the artificial pair is constructed in accordance with the cable record. Most irregularities, such as missing or doubled loading coils, can be identified by impedance matching.

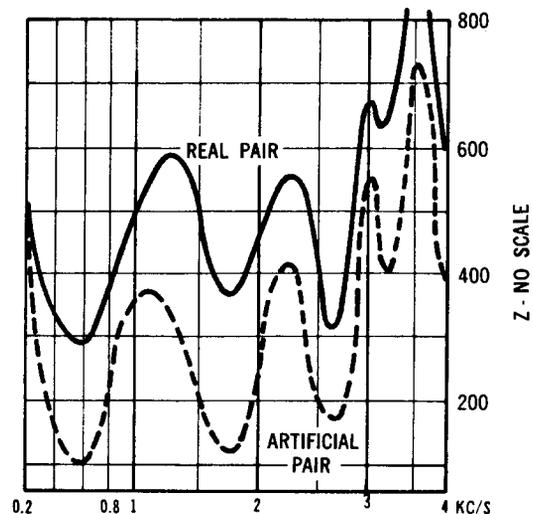
4.15 Fig. 15 shows the results of the test above. The two impedance curves have been displaced vertically for easier comparison. Inspection shows that the irregularity is not due to a missing coil, because the peaks occur at the same frequencies. The impedance curves can be made

to match by introducing bridged tap in the second loading section of the artificial pair or by lengthening the section. The correct interpretation can be selected by inspection of the cable schematic or by measuring loop resistance to any terminal beyond the irregularity. Most irregularities, such as missing or doubled loading coils, can be positively identified.

Fig. 15 – Comparison of Impedance of Irregular Pair with Impedance of Correct Artificial Pair

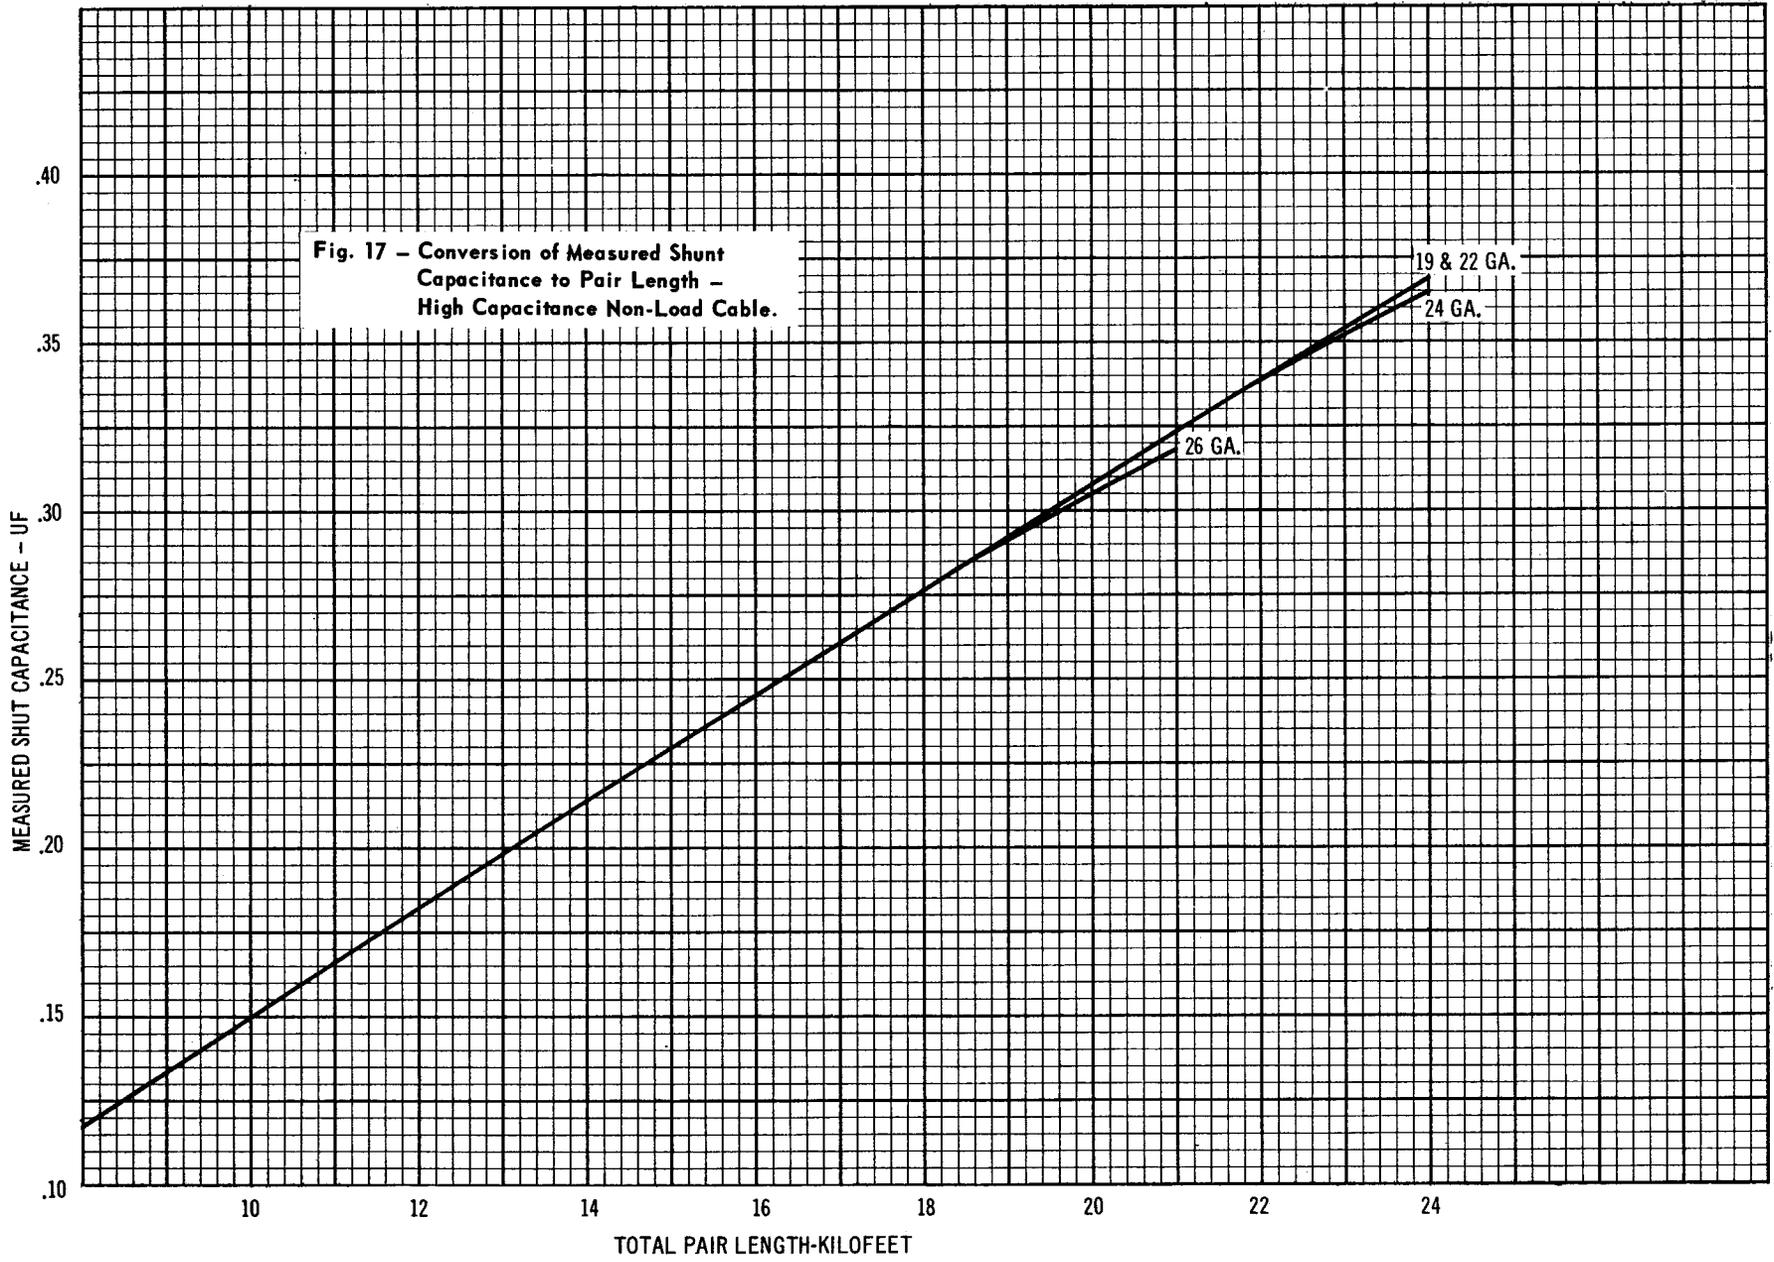
6.03 Measured shunt capacitance of nonloaded high capacitance cable pairs can be converted to pair length using the curves of Fig. 17. For loaded high capacitance cable pairs, use Fig. 18. If older low capacitance cables are en-

Fig. 17 - Conversion of Measured Shunt Capacitance to Pair Length - High Capacitance Non-Load Cable.
