Fisher and Paykel Aquasmart Washing Machine Suspension Rods Replacement

Kept getting an overbalance fault. Very heavy knocking sound during the rinse cycle.

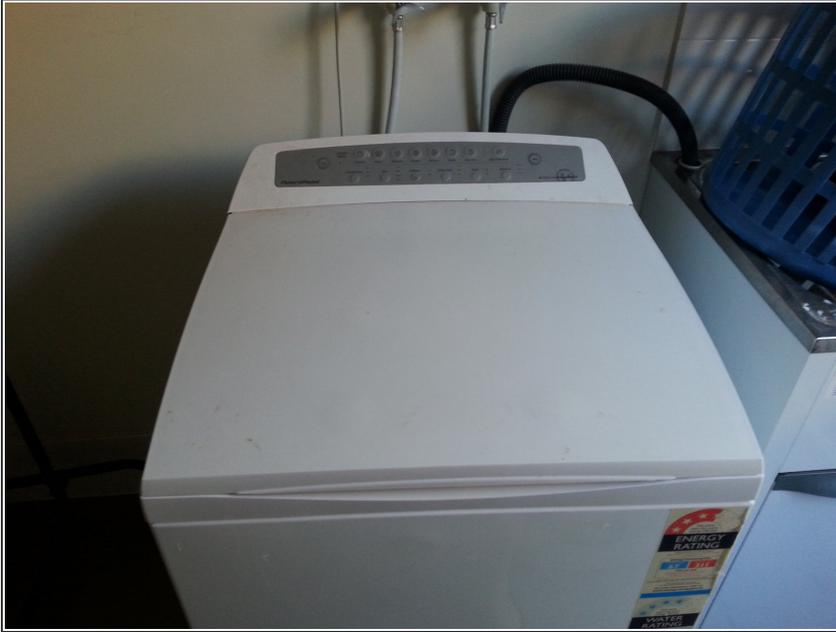
Step 1 — Getting Started

- First step is to disconnect power.
- Then disconnect all the hoses at the back and move the machine to a place where you have some room to work.

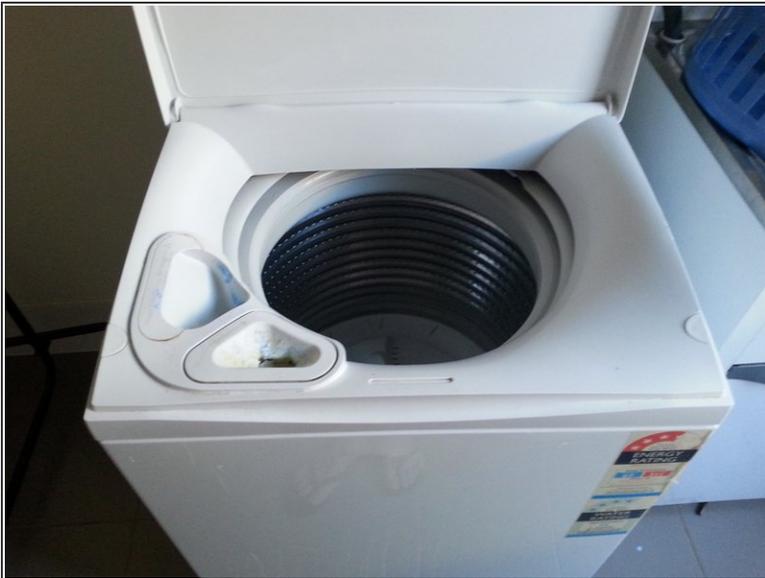
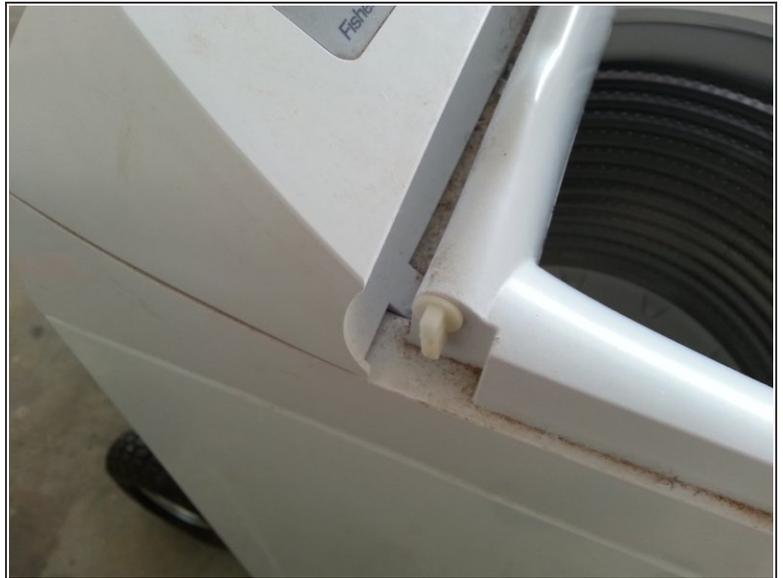
Step 2 — Remove the lid

- Removing the lid is the easiest part. Just push back until the lid is perpendicular with the top of the machine, then lift upwards and it will release.

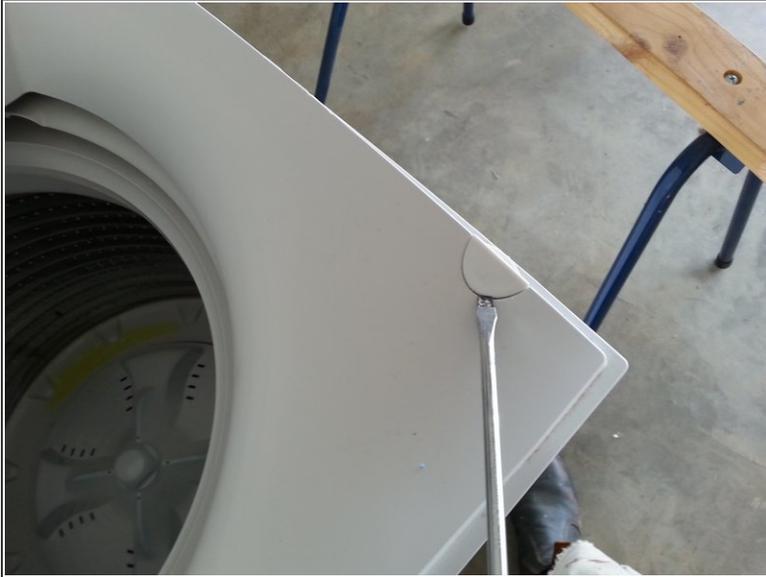
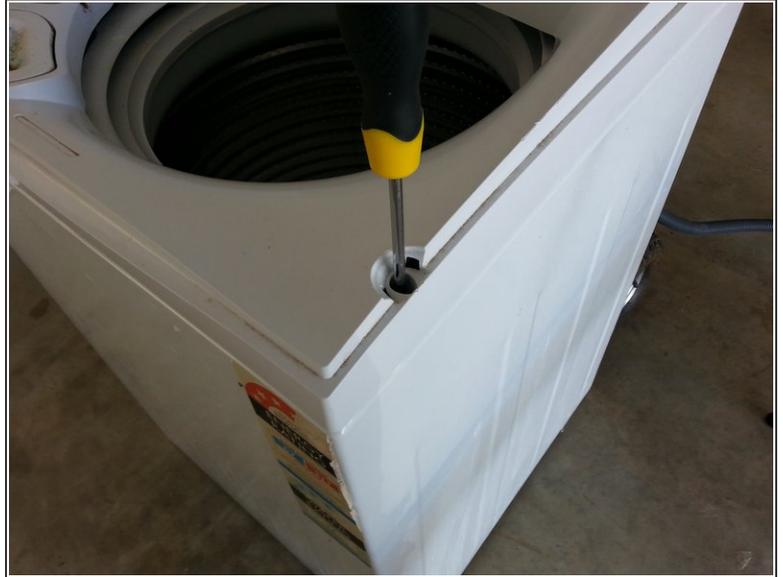
Step 3 — Unfasten the plastic cover

- Simply pry off the plastic screw covers then unscrew the two forward screws. Note there is no need to remove the cover, just tilt it backwards on its hinge to gain access. Be careful with hoses and electrical wires at the back of the cover.

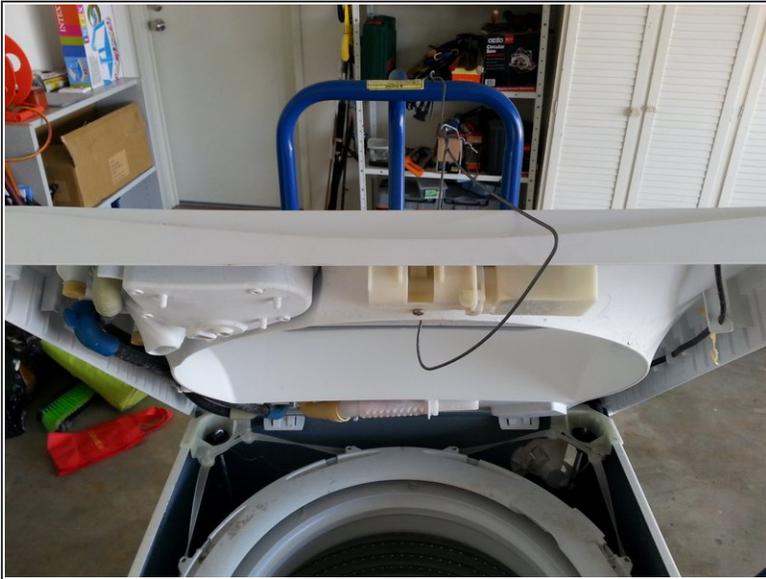
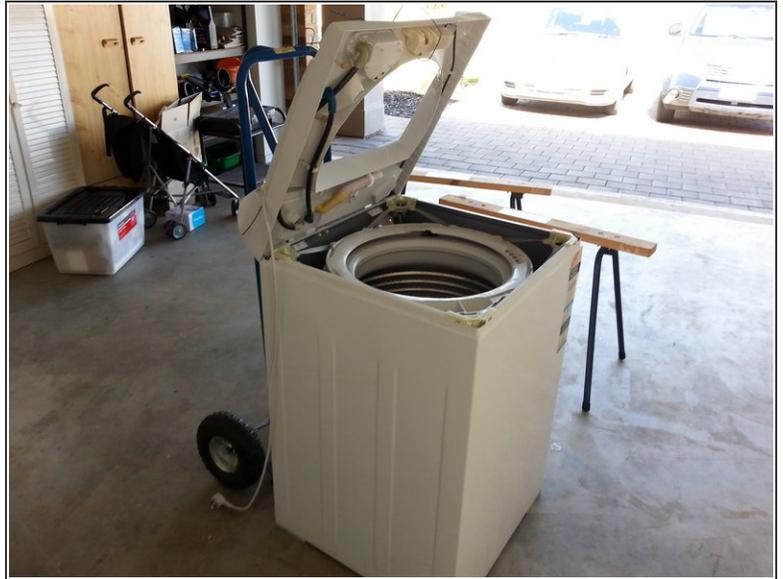
Step 4 — Suspend the cover out of the way

- I used an old coat hanger to suspend the plastic cover out of the way by hooking it onto the trolley that I used to move the washing machine. This gives you access to the 4 rubber straps and 4 suspension rods.

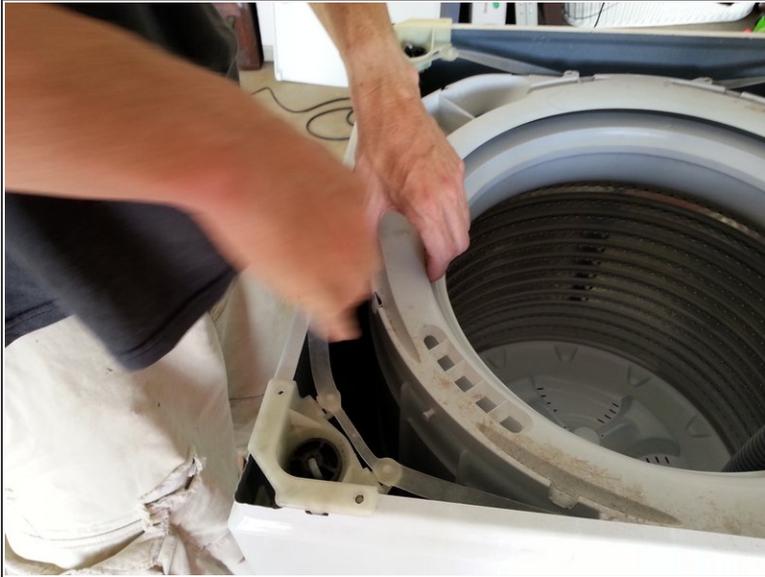
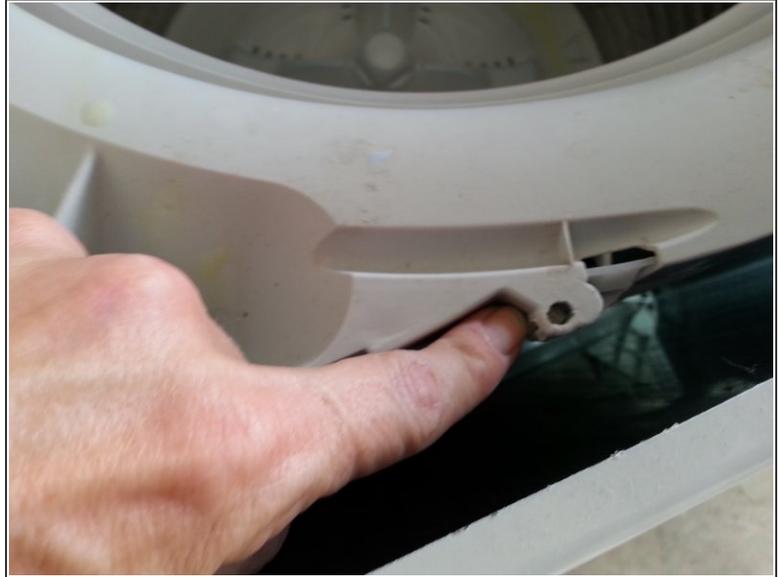
Step 5 — Replace th Rubber Hanger Straps

- You will see there are four rubber straps, one in each corner. I decided to replace these as well just to be on the safe side. When the old and new rubber straps were placed next to each other there was a significant difference in length. Just pull them straight off.

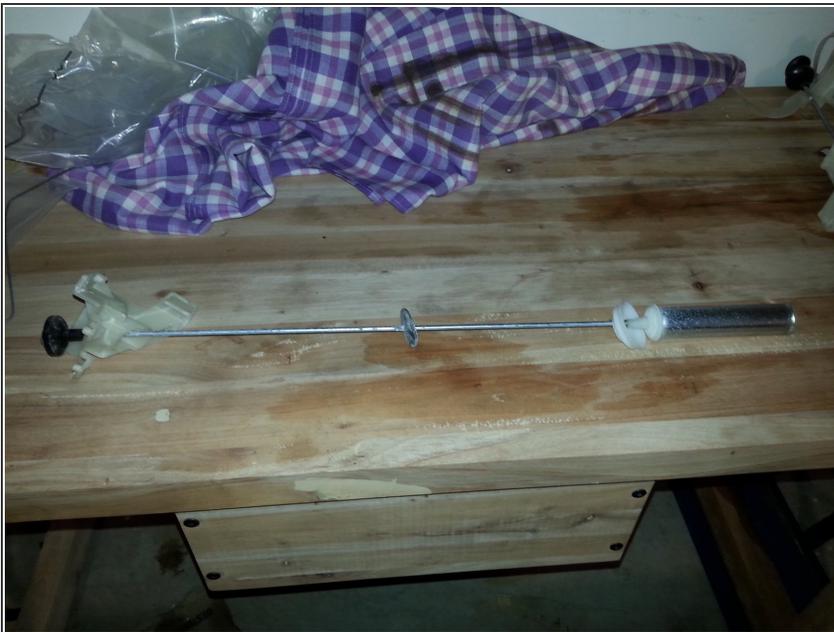
Step 6 — Removing the Suspension Rod

- The metal cylinder down the end is full of oil which leaks out over time. When I removed this one it was very greasy. Note: Im not sure if it was a defect or not, but my rear right rod appeared to have a bend in it and was unique to the other three.

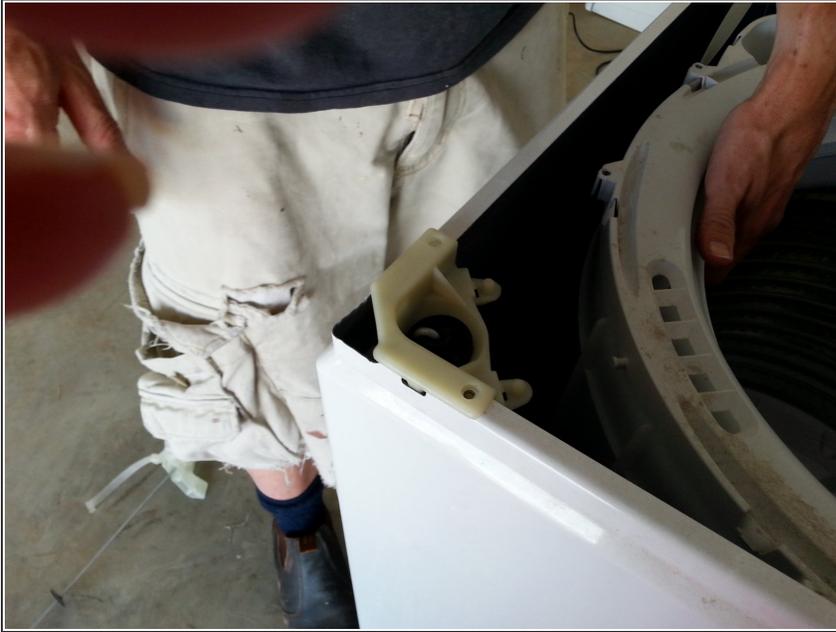
Step 7 — Lift out the Suspension Rods

- Place your left hand under the drum rim and support it. Remove and replace one rod at a time. You don't want the weight of the drum on the motor and pump below as you may break something underneath. By replacing them one at a time, the other three can help support the weight of the drum.

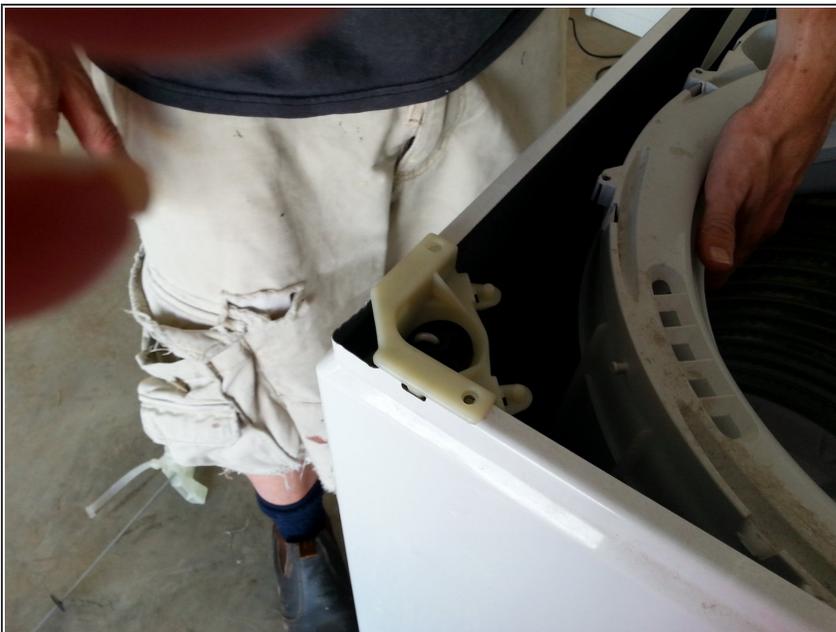
Step 8 — Removing the Suspension Rods

- To remove the rods lift the plastic hanger off the chassis and then jiggle the bottom part of the rod out of the slotted holder. There are no fasteners holding the rods in place. Its just the weight of the drum holding them in place.

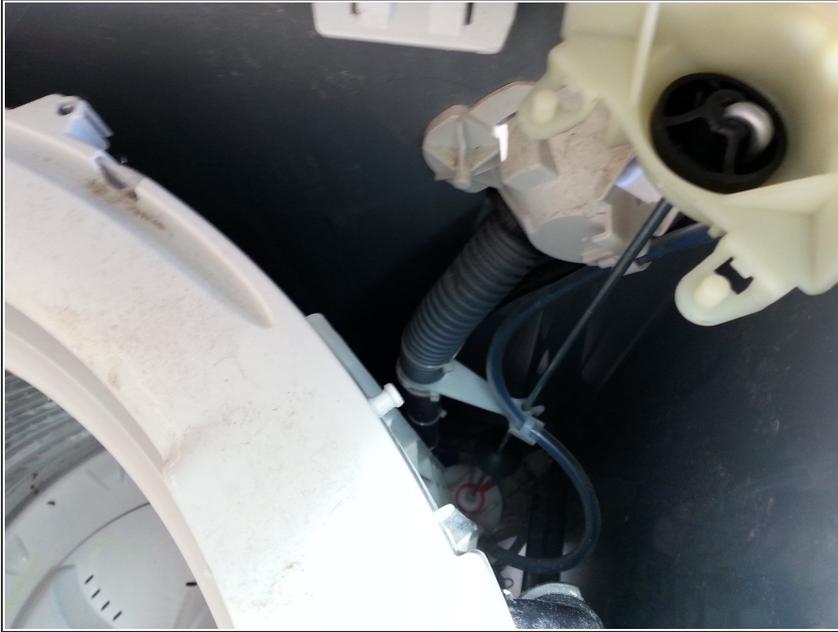
Step 9 — The Rear Right Rod is Different to the Others

- There is a clip half way down the rear right rod that needs to be undone. You also need to move the hoses and electrical looms out from under the plastic hanger prior to removing the rod. To remove the rods lift the plastic hanger off the chassis and then jiggle the bottom part of the rod out of the slotted holder.

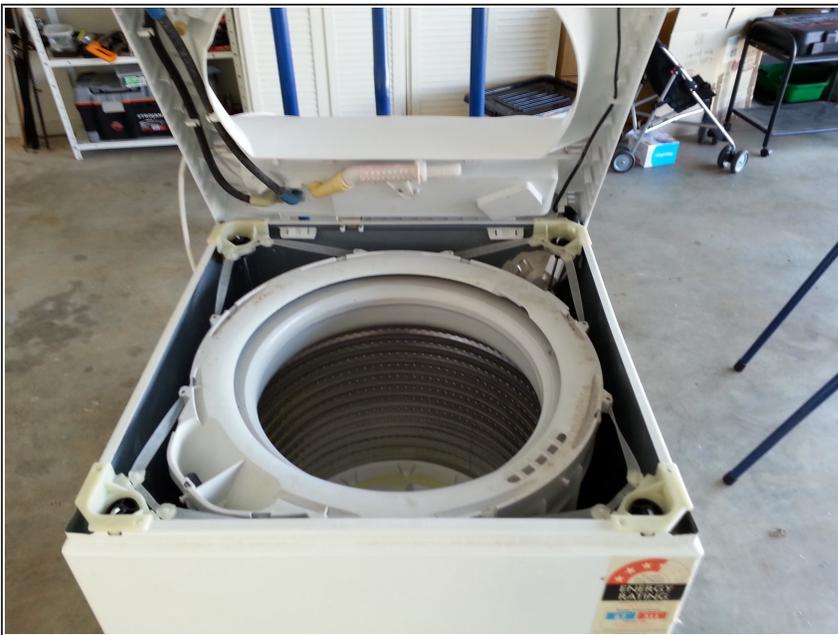
Step 10 — Reassembly

- Once you have replaced all of the suspension rods and rubber straps you can reassemble the washing machine cover and lid. Then you are finished. My washing machine ran beautifully after I completed this repair. Best of luck to you.
