HP EliteBook x360 830 G5 Repairability Assessment

Written By: iRobot

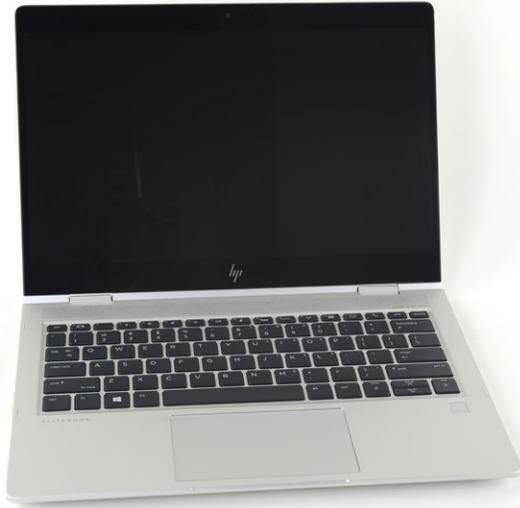
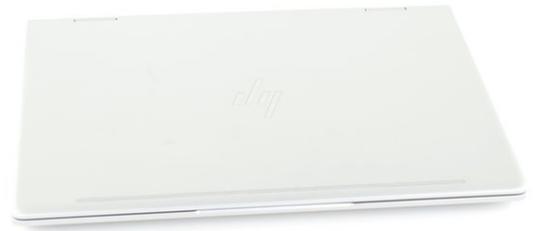
Step 1 — HP EliteBook x360 830 G5 Repairability Assessment

- Exterior reference photos.
- The laptop isn't ingress-proofed, so many gaps in the keyboard and lower case, including ports, vents, speaker grilles etc. may allow water damage or particle buildup.

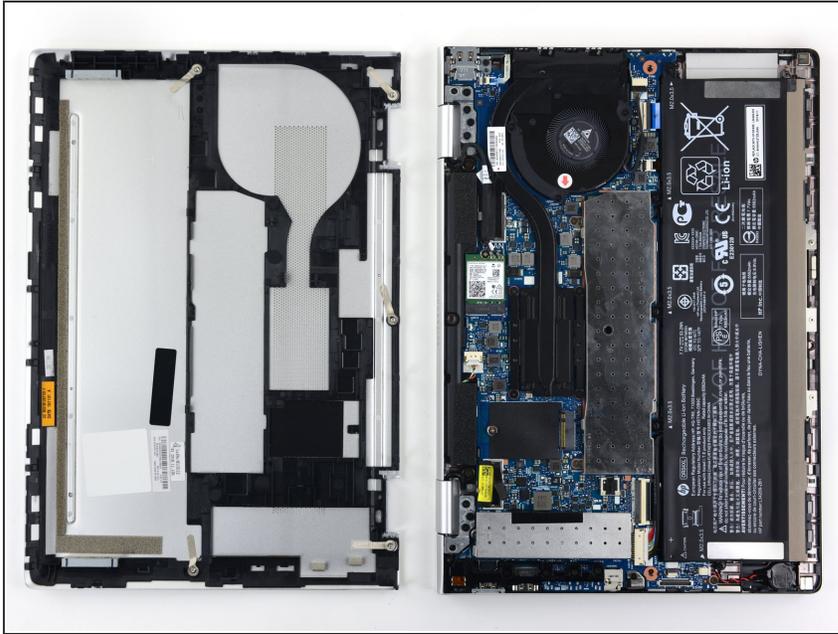
Step 2

- The lower case is secured by a few captive Torx screws. Torx isn't as common as Phillips, but should better withstand repeated removal, captive screws will also be hard to lose.
- The case is fairly well secured and requires a thin plastic prying tool to gain access; fingernails won't be strong enough and metal tools will likely scratch the laptop surface.
- Unfortunately, the bottom of the case is additionally secured with several plastic clips that can be damaged during opening. The bottom needs to slide rather than be pried open.
- The bottom case contains no major components, making for easy replacement, and the laptop itself has a flat construction that allows access to most components at this stage.

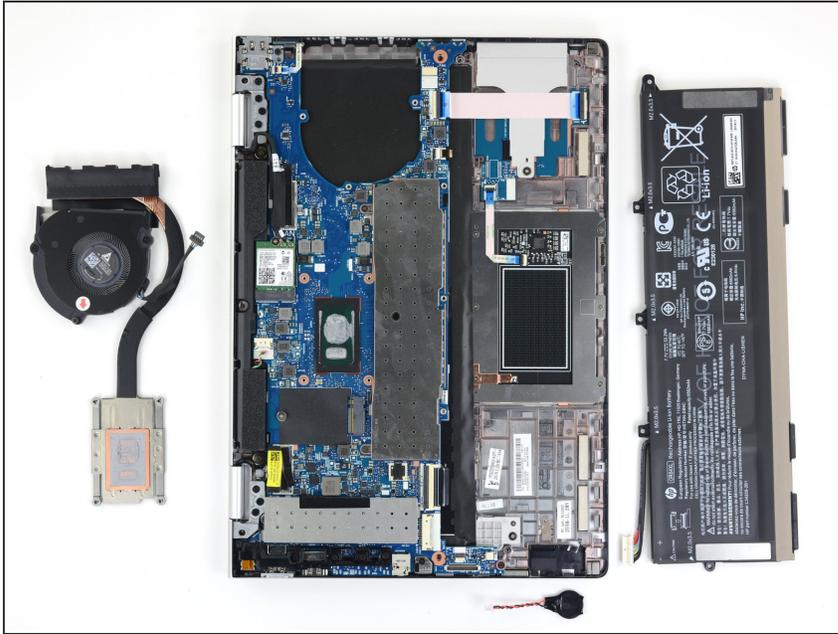
Step 3

- The battery is immediately accessible after removing a couple standard screws. No adhesive holds it down.
- A laptop battery is consumable—even if it's kept in mint condition, the battery will wear down and need replacing. An easily accessible battery is very important for the life of the device, as well as its end-of-life recycling.
- The heat sink and fan are modular. They're immediately and easily removed by loosening captive Phillips screws. Access to these components is desirable for maintenance and cleaning.
- The BIOS/CMOS battery is also immediately accessible. While these batteries are very low power and often last a long time, they will eventually need replacing, so easy access is appreciated.

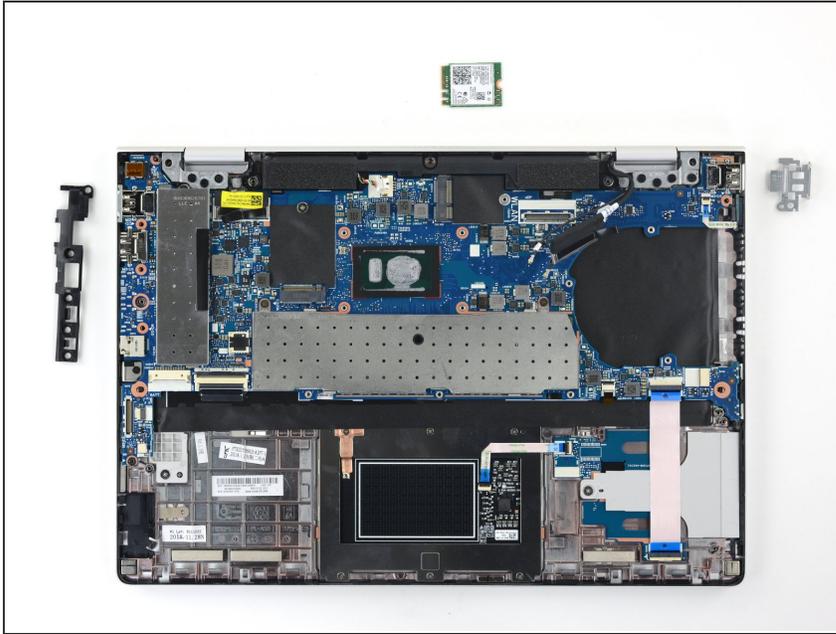
Step 4

- Also immediately accessible is the modular wireless card and a couple non-essential port cover/stabilizers.
- The ports are unfortunately soldered to the mainboard meaning that failure will be costly to repair. Brackets to support the ports are welcome reinforcement, hopefully postponing an expensive repair, if not preventing it entirely.

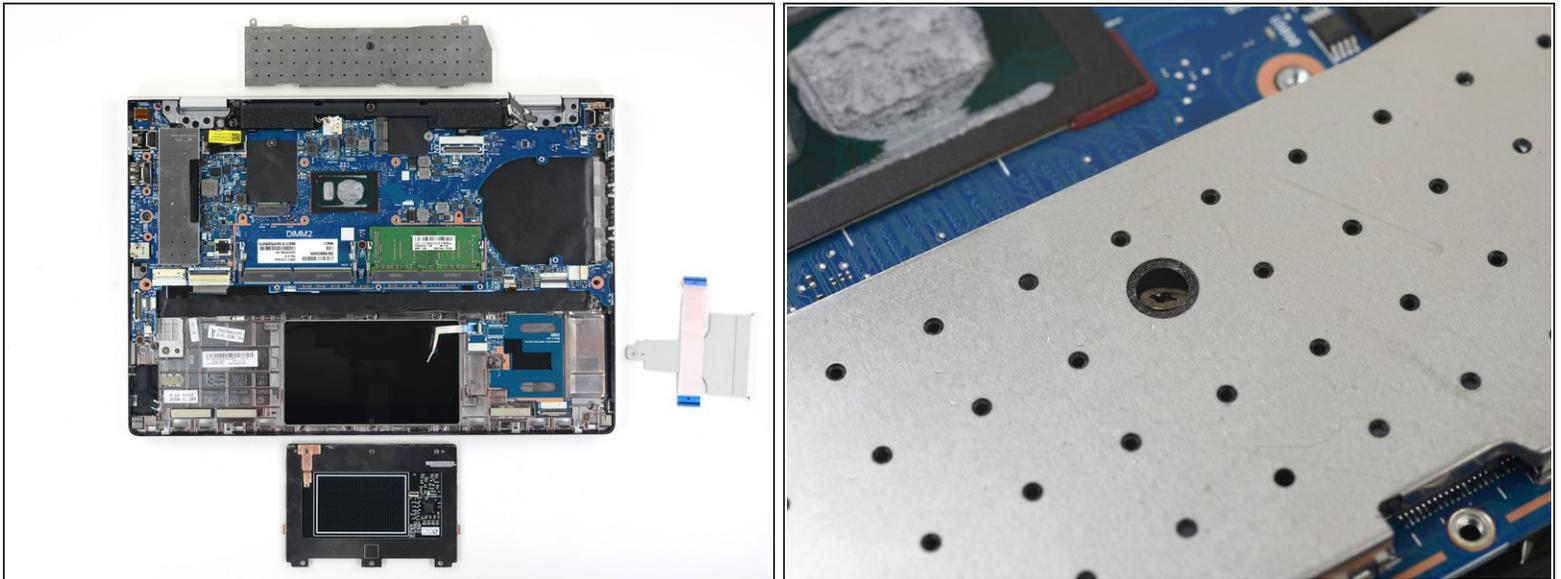
Step 5

- With the battery removed, the following components are accessible:
 - The trackpad assembly, which is secured with standard screws and no glue.
 - The peripheral port, or in this case, spaceholder plug with an interconnect cable adhered to it.
- The EMI shields on the motherboard are also immediately accessible, although the average user would never know it.
 - In addition to the exterior screws, the shield is secured with clips. There is also a screw hidden in the center that is hard to access, but not necessary to remove at this stage.

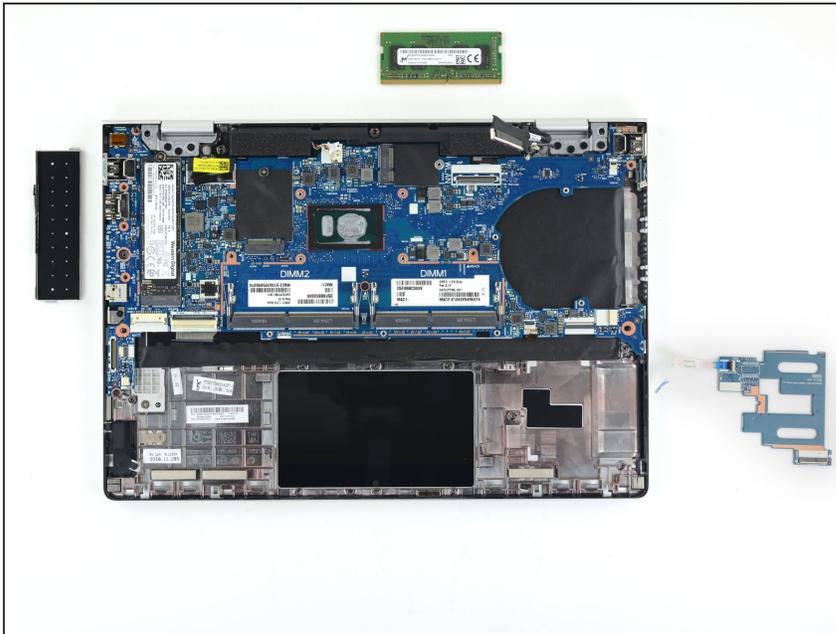
Step 6

- Once the shields are removed, the SSD and RAM can be replaced, with no other disassembly needed. Their modularity is highly desirable—both for protecting user data and for prolonging device life by allowing upgrades.
- That said, hiding the components under shields is a barrier to repair. If this is the only EMI solution available, a label alerting users to the presence and upgradability of the underlying components would be ideal.
- With the peripheral plug out of the way, the associated PCB can now be removed. The modularity seen here is nice, making for less expensive replacements.

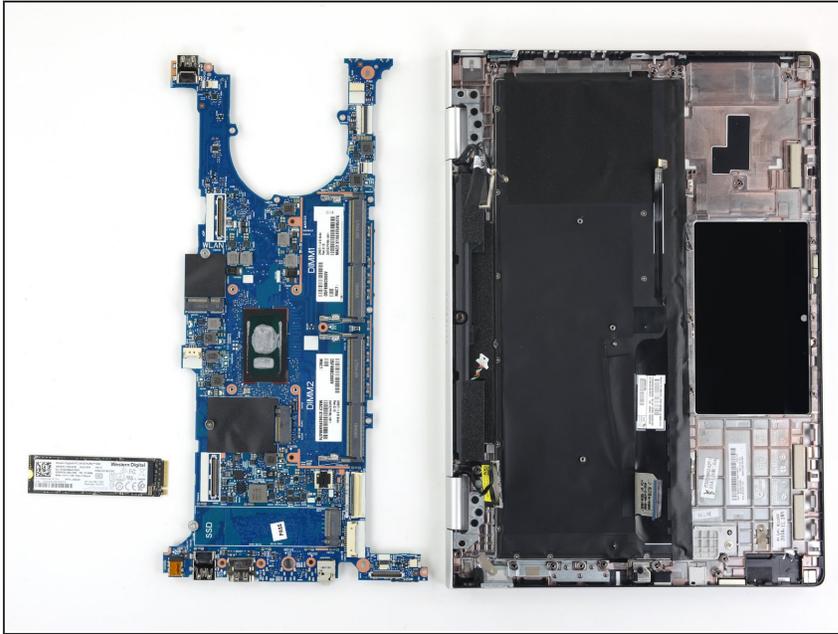
Step 7

- The motherboard is removable after the heat sink assembly, and after some (mostly labeled) connectors are disconnected.
- The motherboard contains the CPU, volume buttons, and ports.
- High-wear components like ports and buttons make for very expensive replacement when they're soldered to the motherboard.
- The modularity of the memory and standard PCIe SSD are welcome.

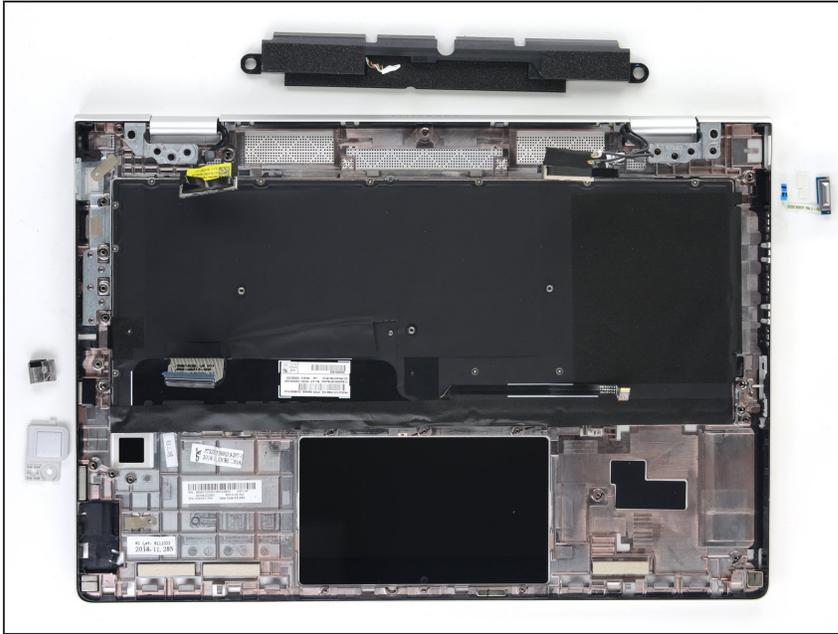
Step 8

- The motherboard blocks easy access to the speakers and fingerprint sensor (a placeholder in this case), so these components are best accessed after the board is removed.
- The fingerprint sensor is unlikely to need replacing, but better access to the speakers would be appreciated considering their proximity to the grille where there's increased risk of water damage.
- The power button is not easy to pry out of its recess even with the motherboard removed, and could likely be removed earlier. The modularity of this button is appreciated considering the number of components soldered on the main board.

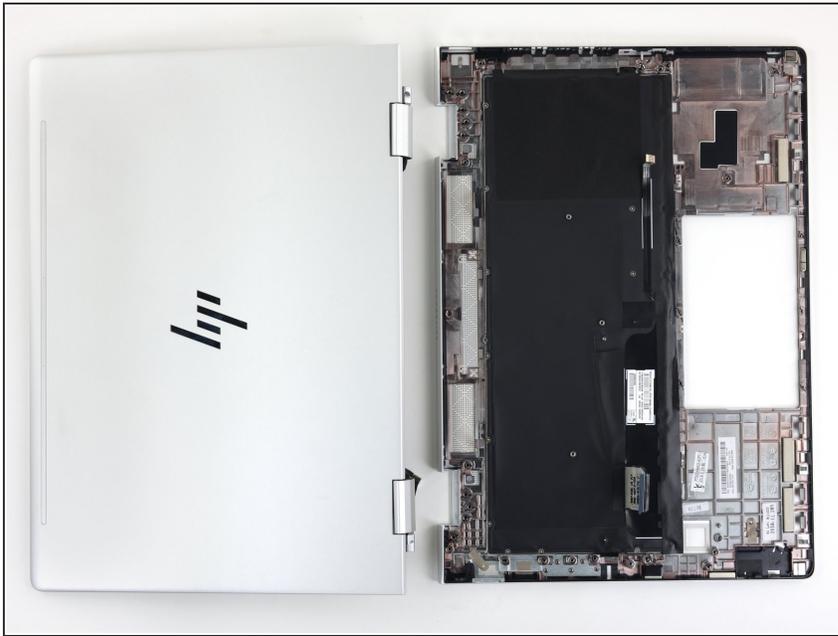
Step 9

- The display is actually removable upon opening the bottom case, which is great for repairability.
- That said, the cables are tough to wrangle, making hinge removal a little tricky.

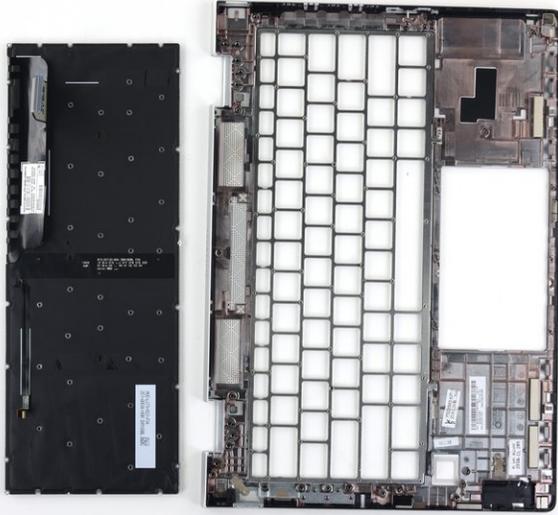
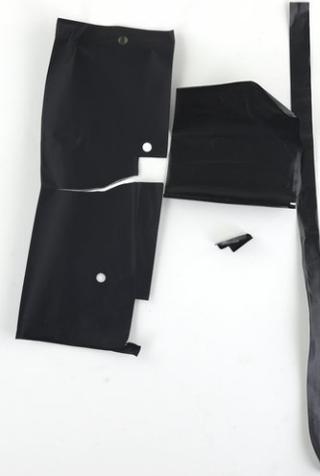
Step 10

- The keyboard assembly can be removed intact after some large stickers and a few dozen screws are removed.
- This procedure is not ideal, but not terrible—lengthy, but not especially challenging. Presumably the stickers are fulfilling an EMI need and should be replaced, but doing so without damage will be a challenge. Removing and replacing the many small screws will also be a marathon.
- The only components left in the upper case are some magnets, conductive foam, volume rocker cover, and a light guide.

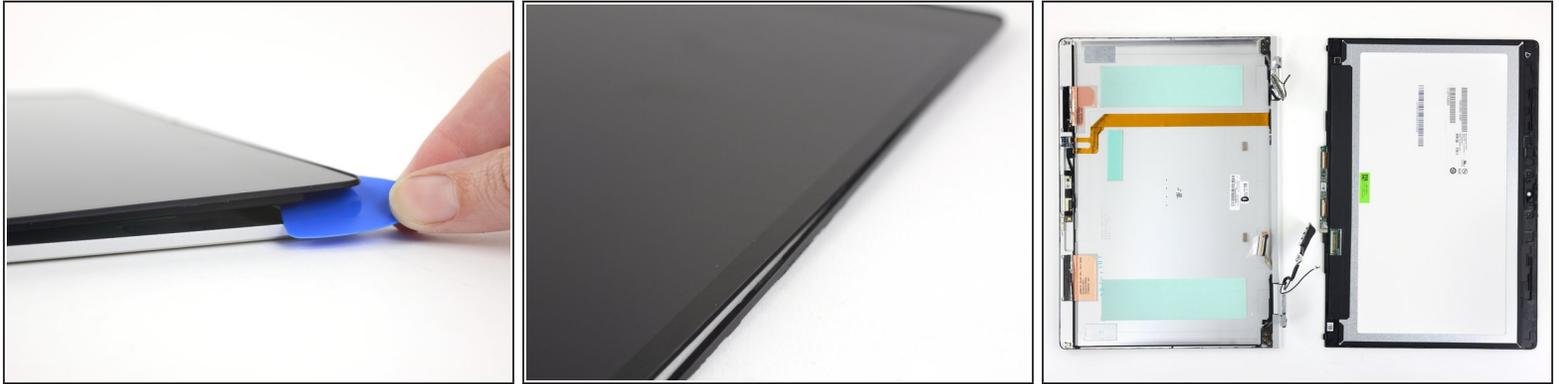
Step 11

- Prying the display out of its housing is somewhat difficult to begin (especially without heat), but overall it's quite simple and an improvement on past displays.
- The webcam slider provides a fairly safe access point, the thin adhesive is easy to slice through, and the lack of breakable plastic clips makes removal and reassembly much easier.
 - The display must be opened from the top so that the bottom end can slide out. Starting from the base will likely break clips and maybe a board.
 - Another potential failure point is the thin plastic bezel, seen separating in the second image. Ideally this will not need to be transferred to a new part as it may be damaged in the process.
- The display is quite easy to disconnect, and no cables or components are in danger during the prying procedure.
- The display houses no additional components, allowing for quicker replacement.

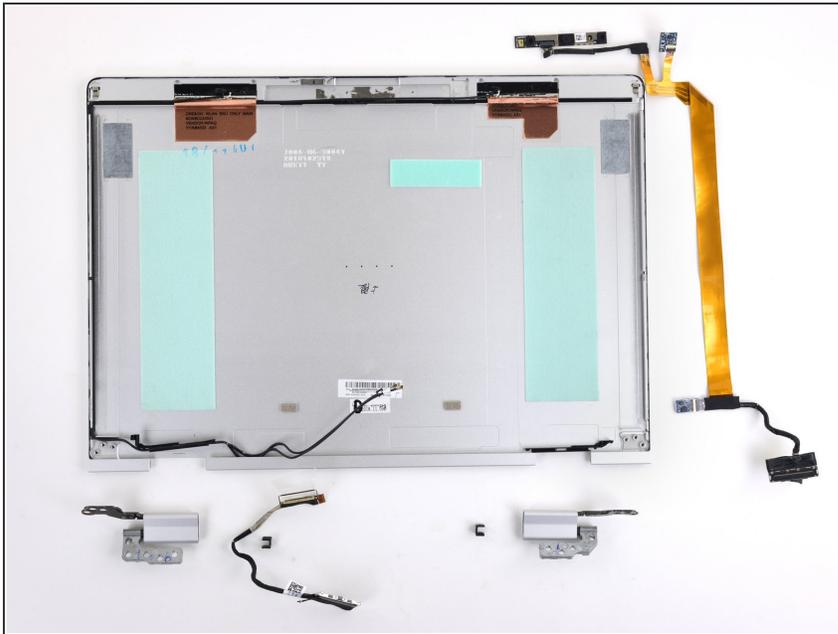
Step 12

- After removing the display you can replace:
 - Upper sensor assembly, on a shorter, more robust board than seen in the 1040 G5
 - Several antennas secured by copper tape, which may be a challenge to remove and replace intact
 - And the labeled hinges, with labeled plastic cable securers.
- Ideally the antennas won't fail, but their cables run through the hinges, which means some stress over time. The copper tape will complicate replacement.

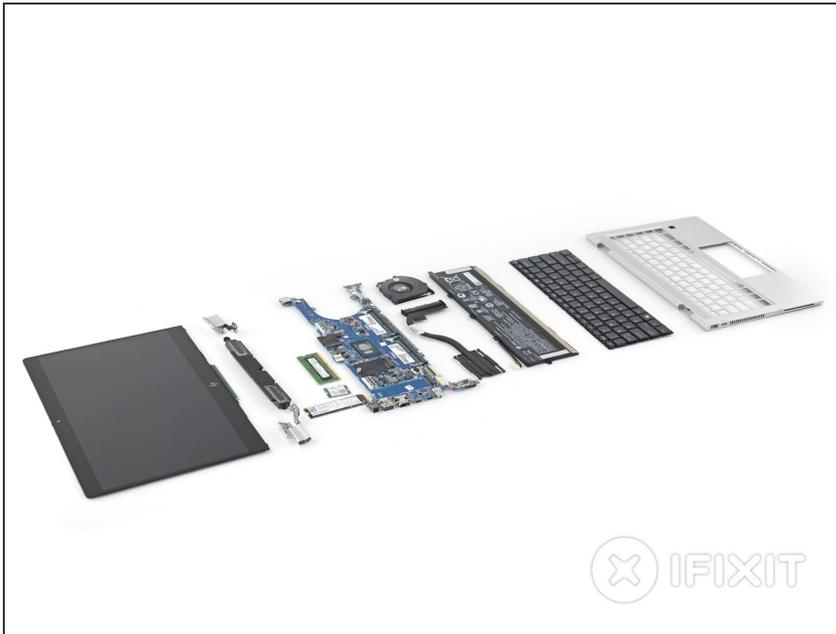
Step 13

- The HP EliteBook x360 830 G5 earns a **9 out of 10** on our repairability scale (10 is the easiest to repair):
 - SSD, RAM, and battery are accessible and removable.
 - Manufacturer provides free user-accessible repair documentation.
 - All screws are standard Phillips and Torx.
 - Overall mostly modular, but the motherboard contains both ports and CPU making for expensive repairs.
