HP Pavilion 11 x360 Fan Replacement

Fix overheating issues by replacing your fan.

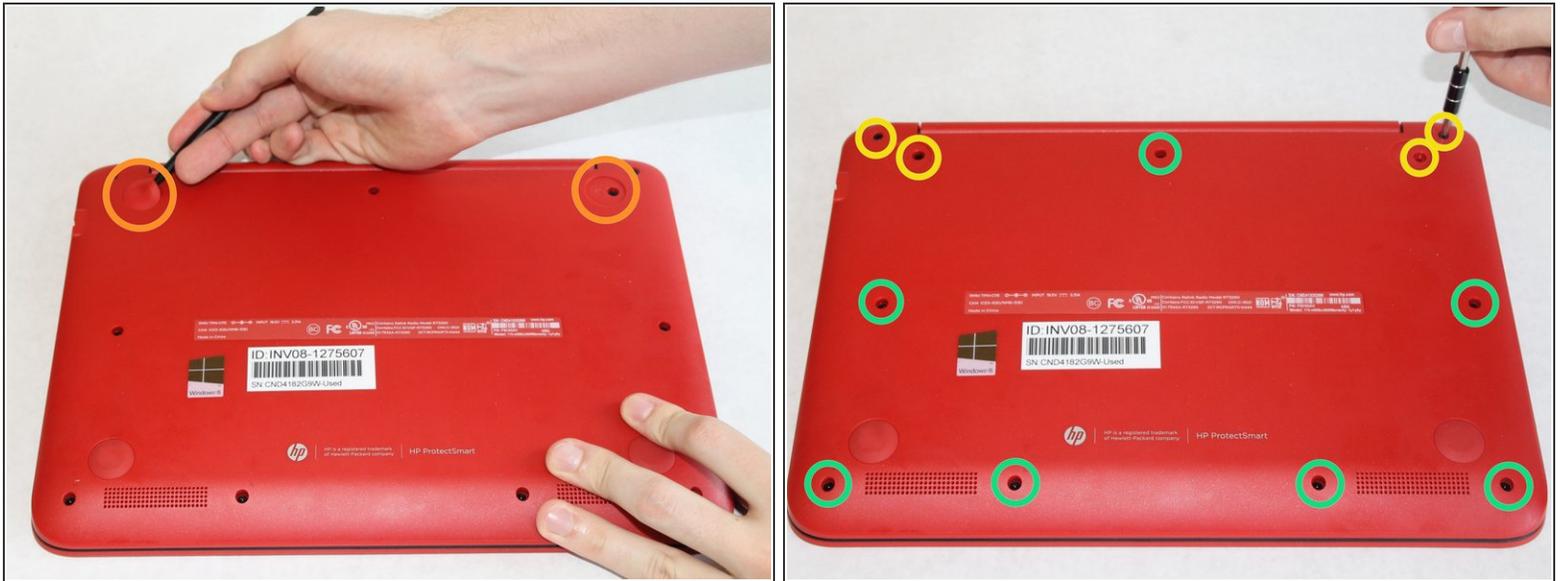
Step 1 — Remove Screws

- Use the spudger to pry off the two rubber feet near the hinge of the laptop. This will reveal two hidden 9mm screws.
- You must remove eleven screws.
 - Four 9mm screws with the PH0 screwdriver.
 - Seven 6mm screws with the PH0 screwdriver.

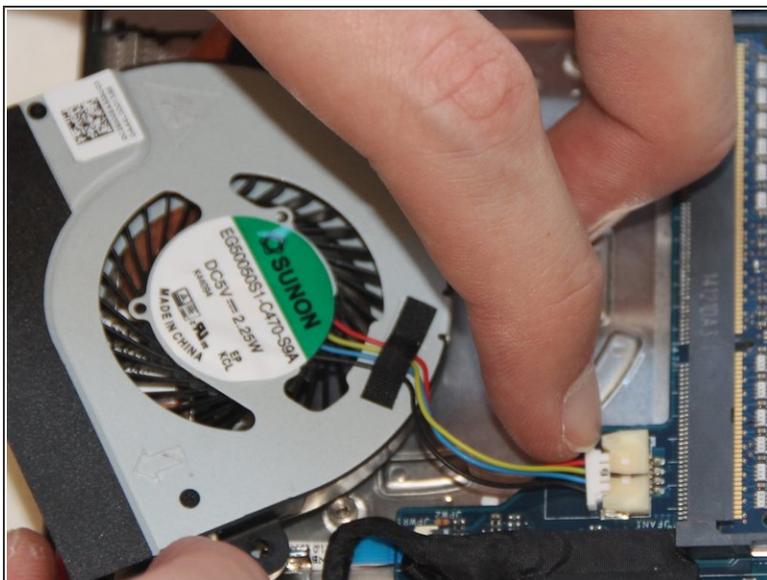
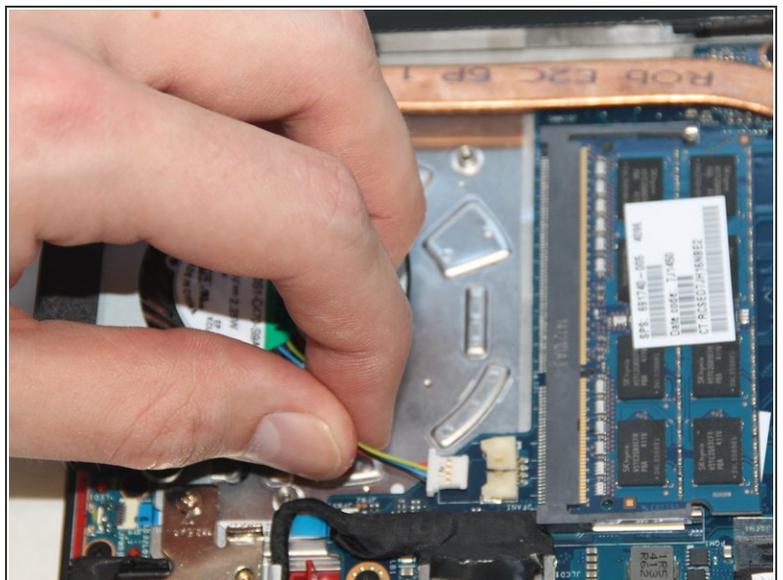
Step 5 — Disconnect Cable

- Use your fingernails to slowly loosen the fan connection cable.
- After the cable is slightly pulled from the connection, grab the cable and pull it outwards.
