Kenmore 400 Washer clutch band Replacement

Written By: oldturkey03

Here is a Kenmore 400 model 11029422801 with a clutch that was slipping. The washer went through all the programs but left the laundry soaking wet after the spin cycle. It sounded like it was spinning, but when we checked the drum while spinning, we noticed that it was not achieving full spinning speed. This was most evident on heavy loads.

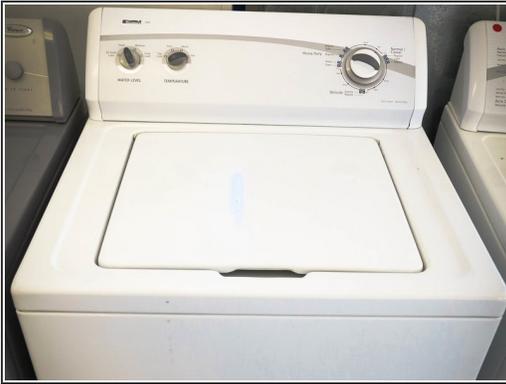
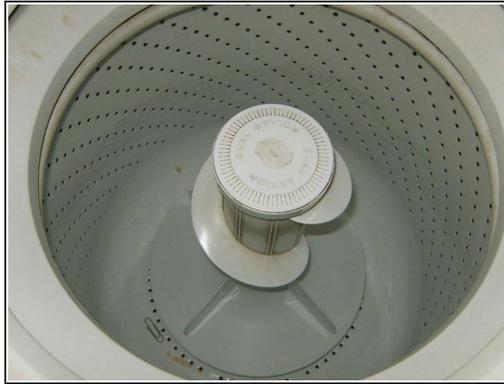
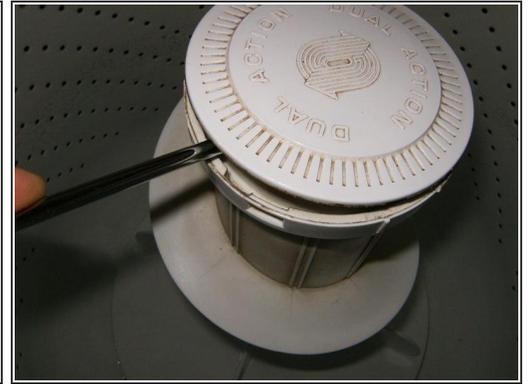
Step 1 — Clutch band

- Kenmore 400 washer that has difficulty spinning. It runs through the cycle but does not spin properly.
- Open the lid
- Remove cap from the agitator by using a flat tip screwdriver or similar.

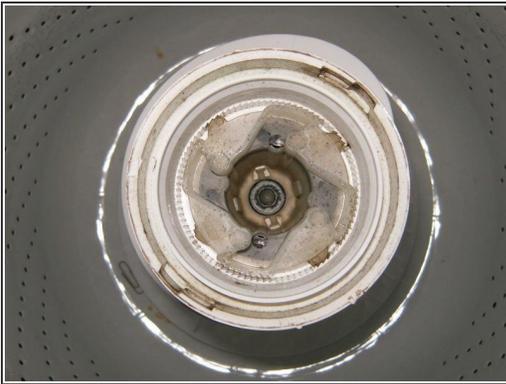
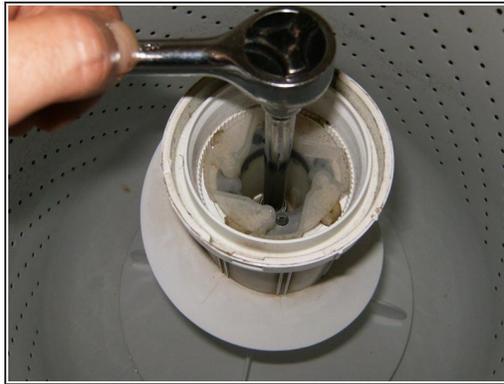
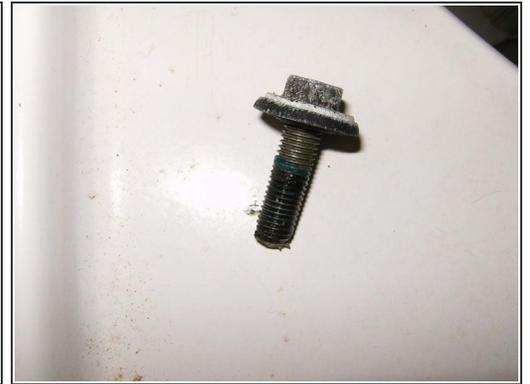
Step 2

- With the cap removed, a 7/16 hex bolt becomes visible.
- Use a socket wrench with 4 inch extension to remove the bolt.
- The agitator bolt measures 5/16 X 1 inches, 24 thread size

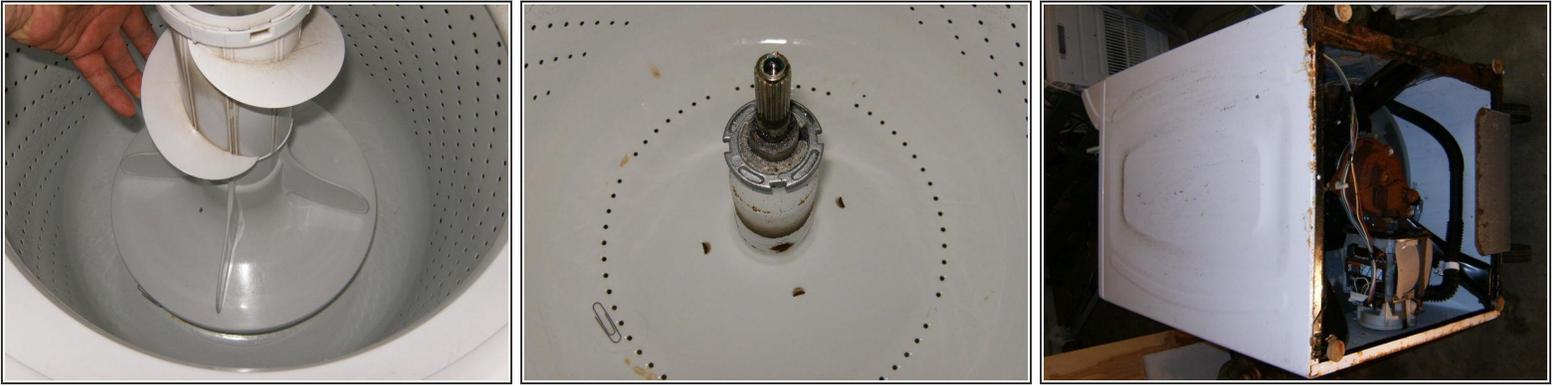
Step 3

- With the bolt removed, pull the agitator of the shaft.
- View of the drum with agitator removed
- For ease of working on the bottom parts, lay the washer on its side.

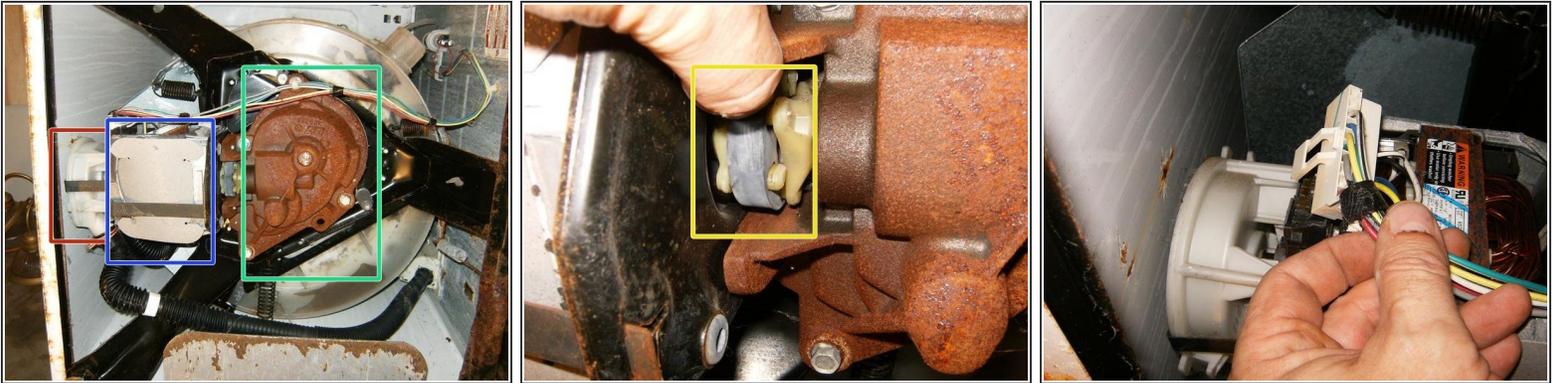
Step 4

- Main parts of the assembly include
 - Drain pump
 - Motor
 - Transmission
- This is a direct drive model. No belts but a motor coupler connects the motor to transmission. Check for any cracks etc.
- Remove the wiring harness from the motor

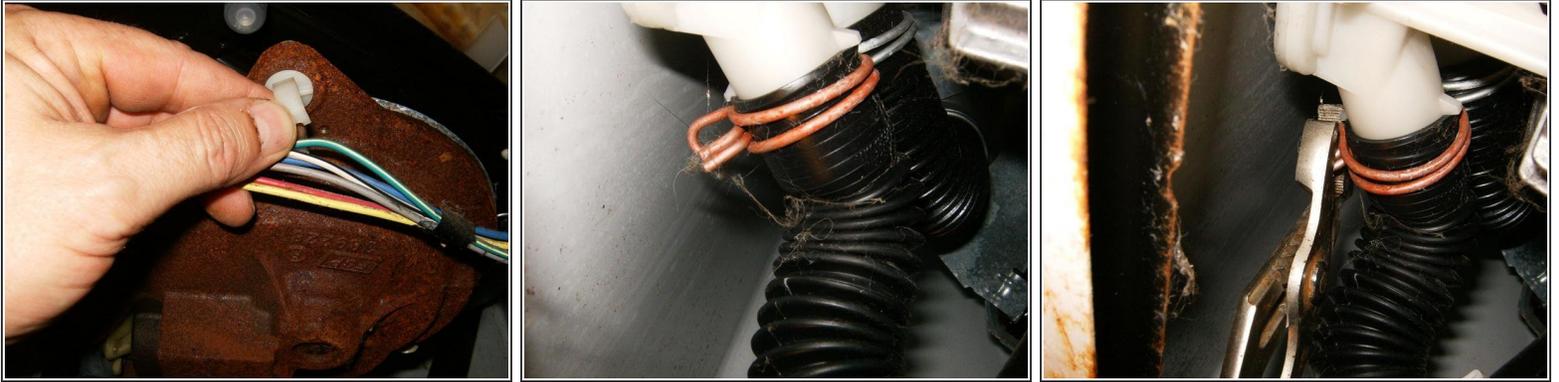
Step 5

- Remove the wiring harness from the clip on the transmission
- Drain lines from the drum and drain hose are connected to the pump with spring clamps.
- Using a pair of pliers and squeezing the opposite ends of the clamps together will loosen the clamp.

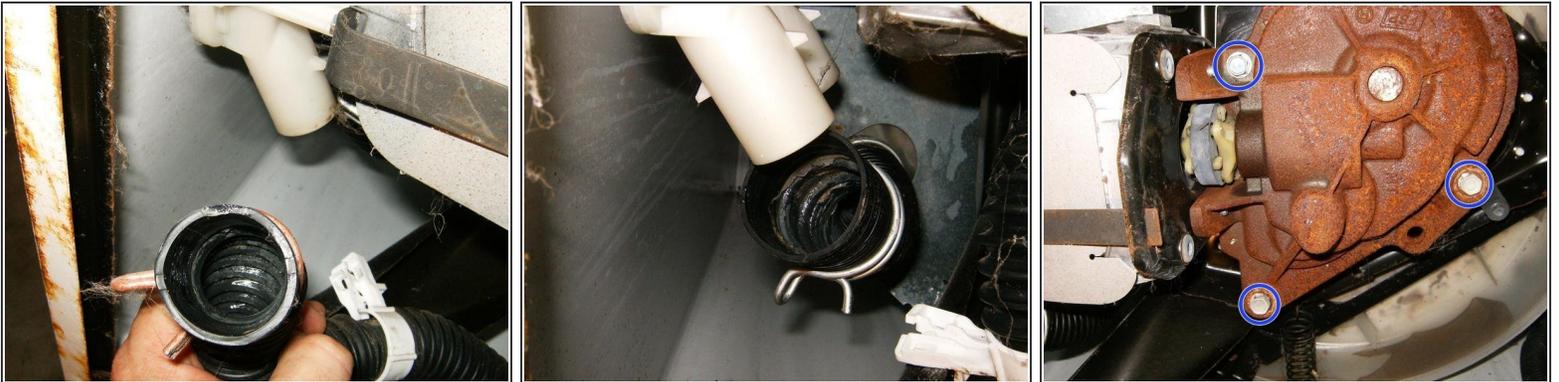
Step 6

- Pull the drain hose of the pump
- Remove the tub-to-pump hose the same way
- Remove the three 1/2inch bolts.

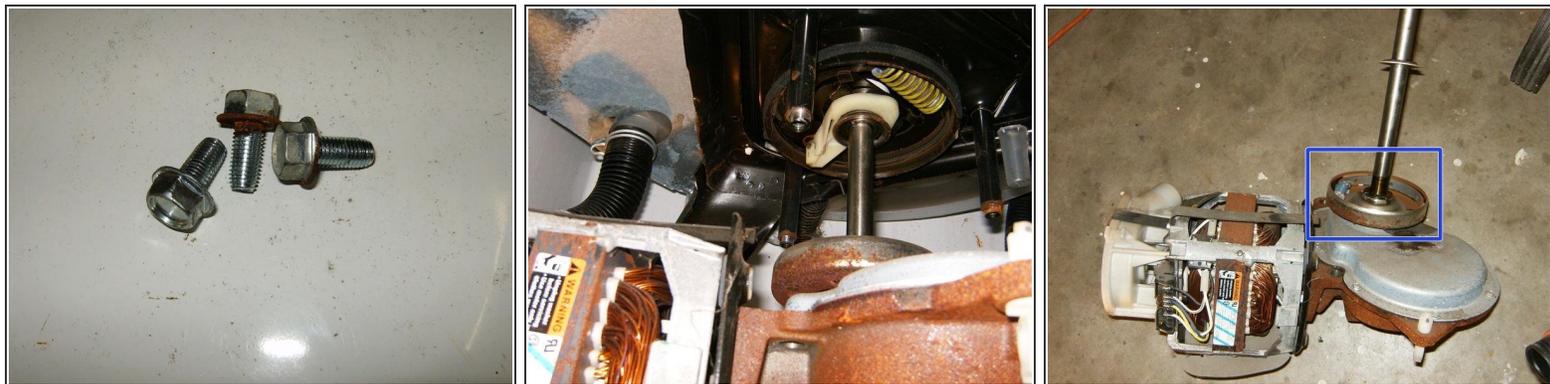
Step 7

- Here are the three bolts. They are 5/16 by 11/16 with a 1/2 inch hex head.
- With the three bolts removed, pull the complete assembly out of the drum
- With the assembly removed, the clutch is now completely visible.

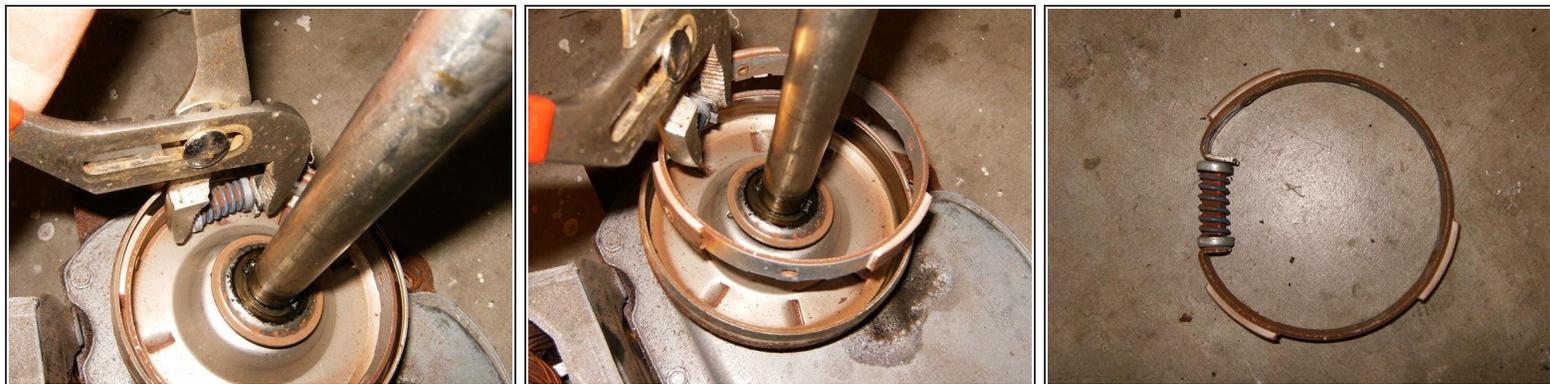
Step 8

- It is not necessary to replace the whole clutch. For this repair only the clutch band needs to be replaced
- Using a pair of pliers to compress the spring will loosen the clutch band.
- Lift the clutch band out of the clutch housing
- Clutch band removed. Replace with model specific part.

To reassemble your device, follow these instructions in reverse order.
