Lazy boy chair powered lift mechanism

Replacing a broken connector piece made of metal with one made out of nylon.

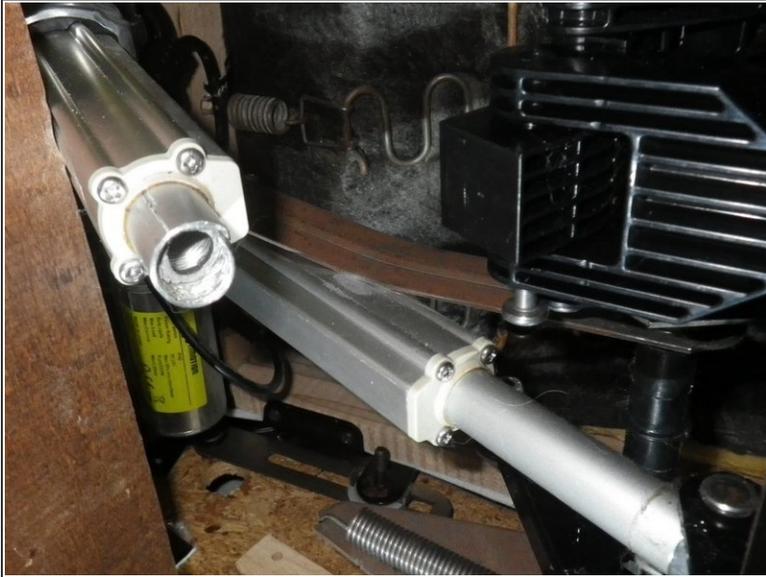
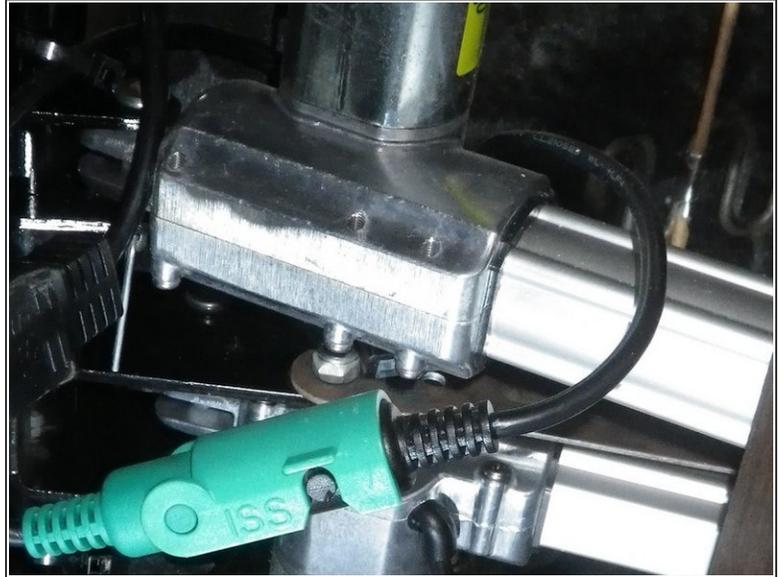
Step 1 — the piece that connects from the linear actuator to the lifting part for the leg lift

- Pictured the broken connector inside the linear actuator. To the right is the lifting part it was connected to.
- Next picture is the linear actuator and where it is connected at the other end.

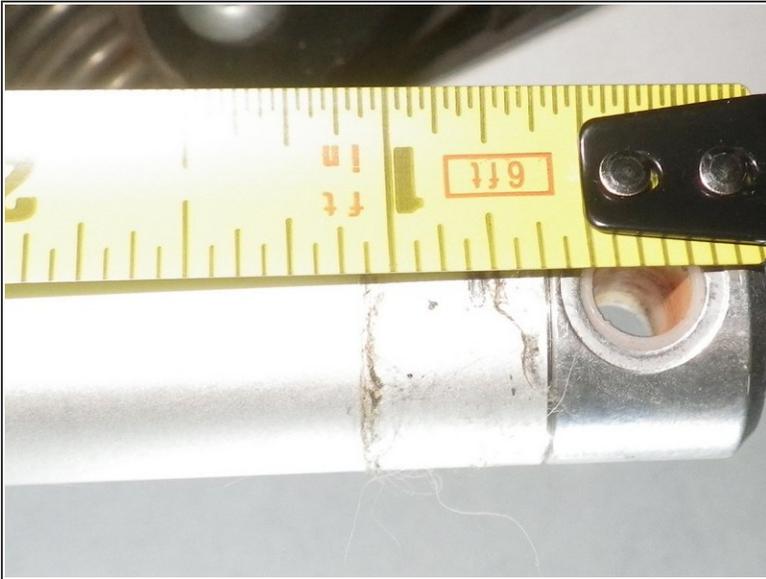
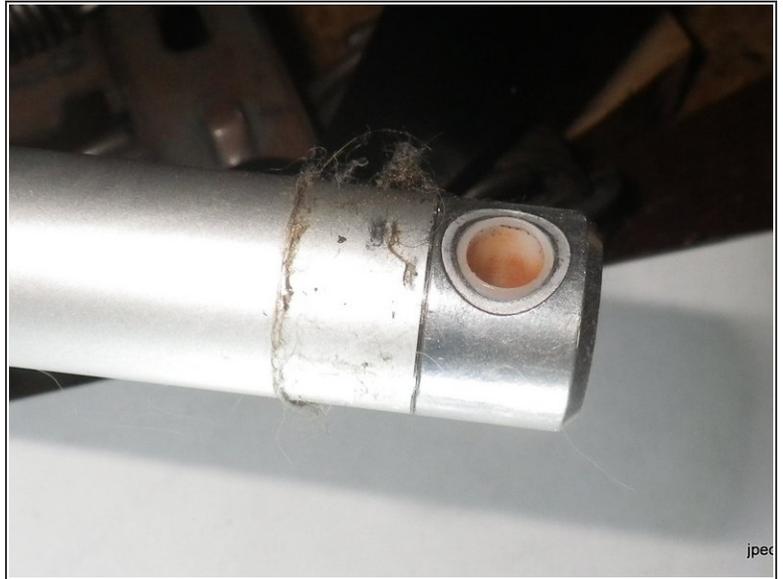
Step 3 — Measuring for a replacement part.

- This is what the manufactured part looks like, it is made of metal, it is threaded and has a 1/4 inch bushing at the other end for the locking pin.
