Mercedes W123 Fuel Filler Neck Seal Replacement

The fuel neck of the tank on your W123 passes through the rear fender in to the fuel filler opening. There is a rubber seal around the fuel neck to prevent water, dirt, and fuel drips from entering the trunk. Learn to replace it.

Written By: Nicolas Siemsen

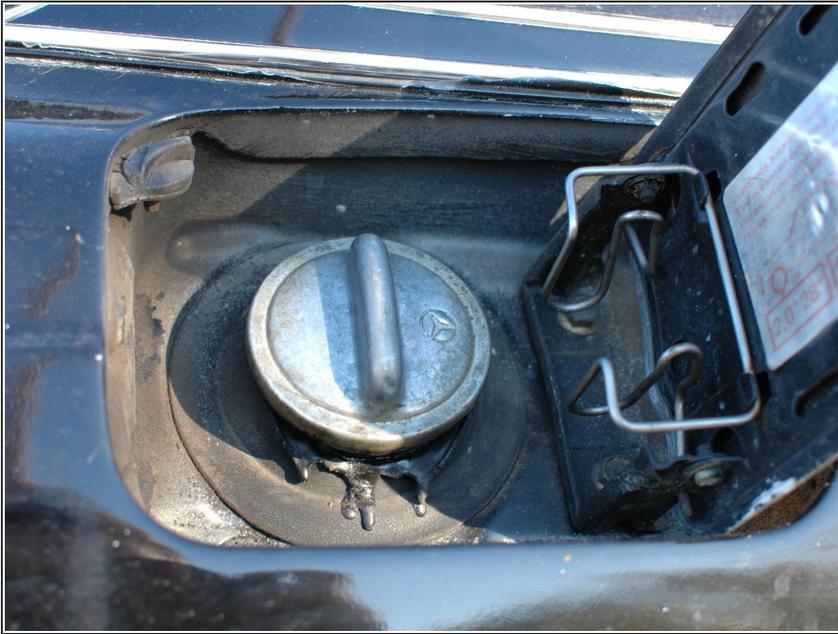
Step 1 — Fuel Filler Neck Seal

- When inspecting your fuel filler neck seal look for dryness, brittleness, or like on this particular diesel W123 obvious damage. This was caused by drips of B99 biodiesel on the already aged rubber seal.

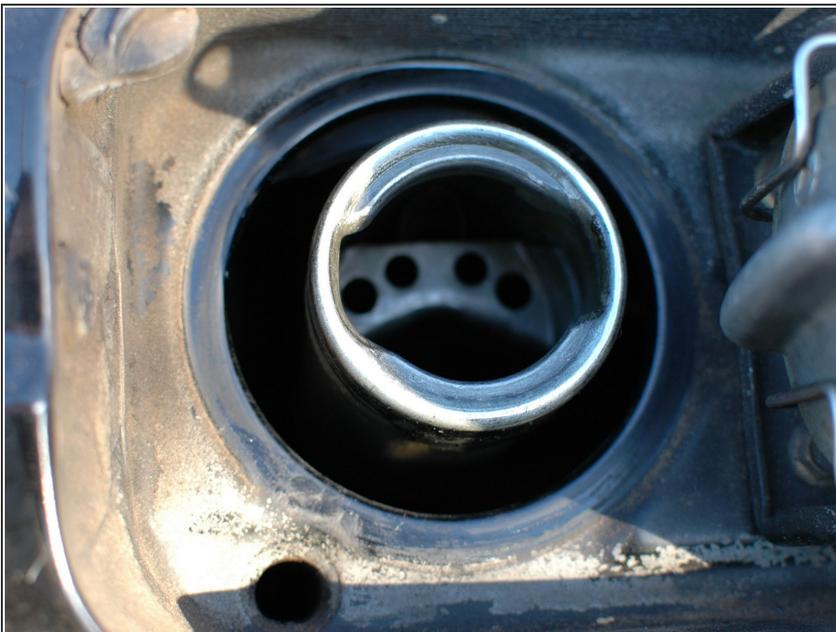
Step 3

- Pull the seal off of the fuel filler neck. It will look like this once the seal is off.

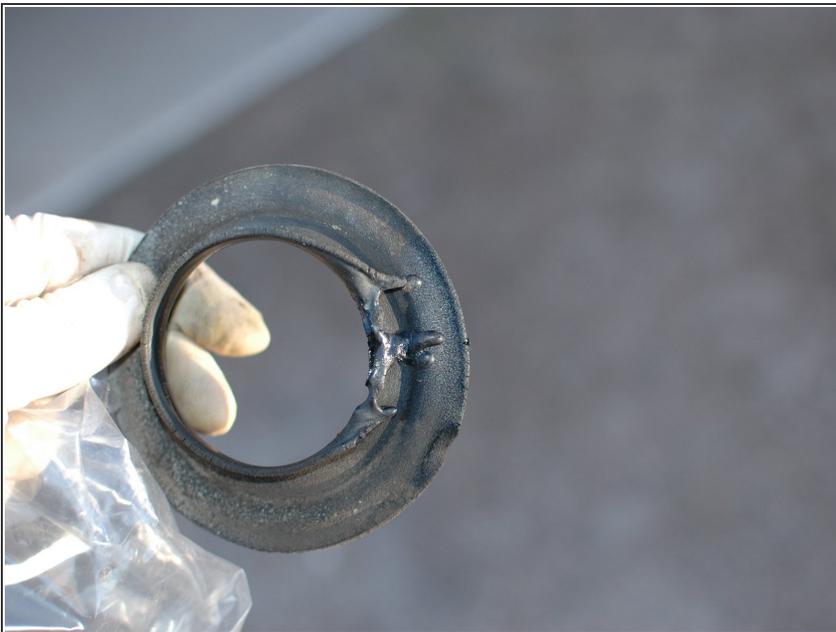
Step 5

- Here's one last look at the damage done by the biodiesel. The owner of this W123 will be more careful in the future not to drip fuel on the filler neck seal when filling with B99; at that concentration, biodiesel is very caustic to rubber. Lesson learned!

Once finished, consider covering the rubber seal in a light coating of silicone grease to help preserve it.
