Razer Naga Trinity LED Light Ribbon Cable Replacement

Written By: Alexandros Andreou

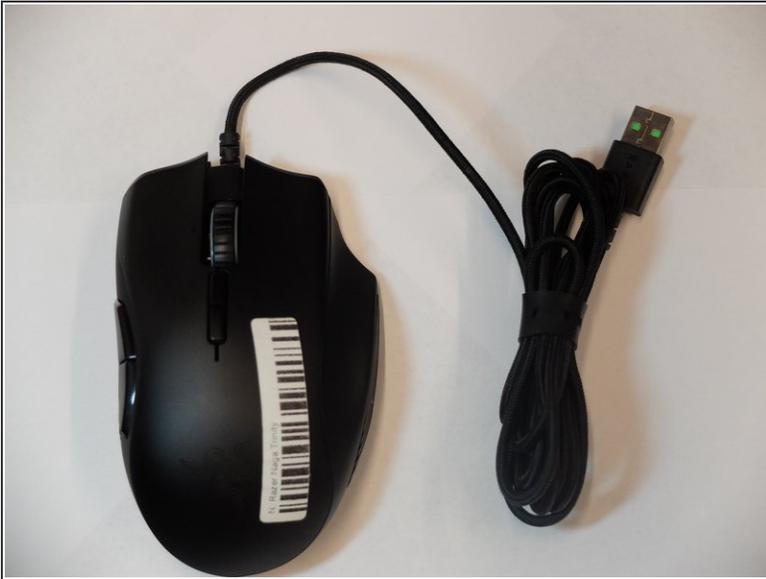
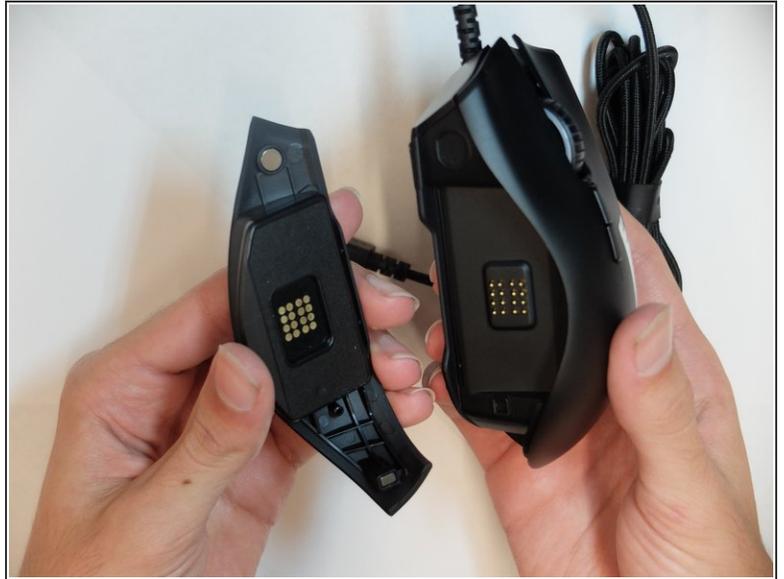
Step 1 — Razer Naga Trinity Disassembly

- Remove the interchangeable side plate.

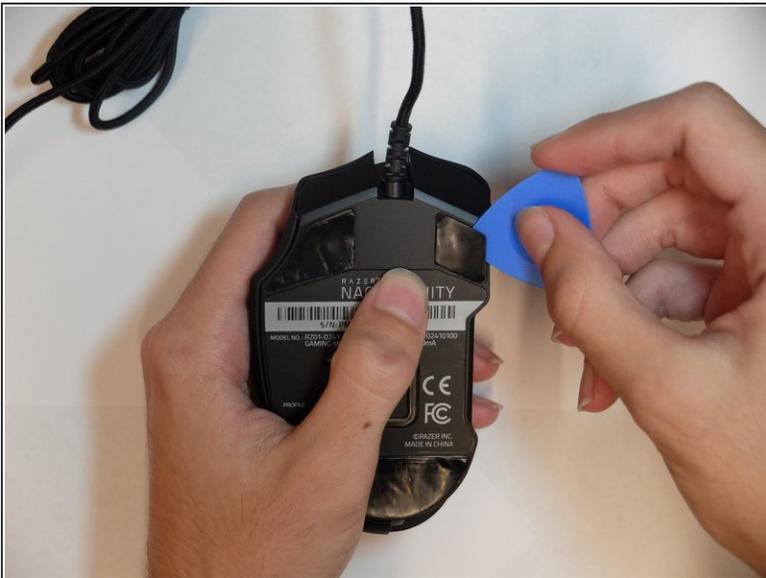
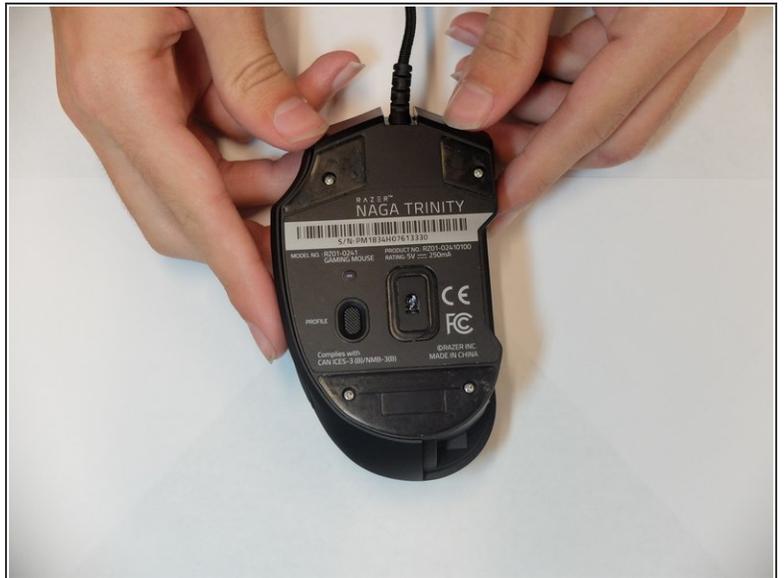
Step 2

- Remove the mouse's feet using the opening pick.

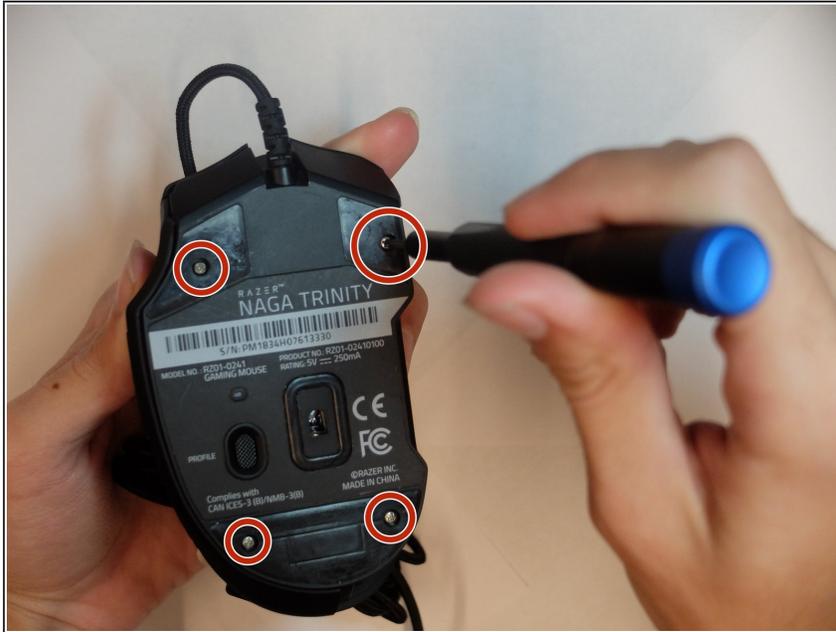
Step 3

- Remove the four 6mm screws by using a JIS #1 screwdriver.

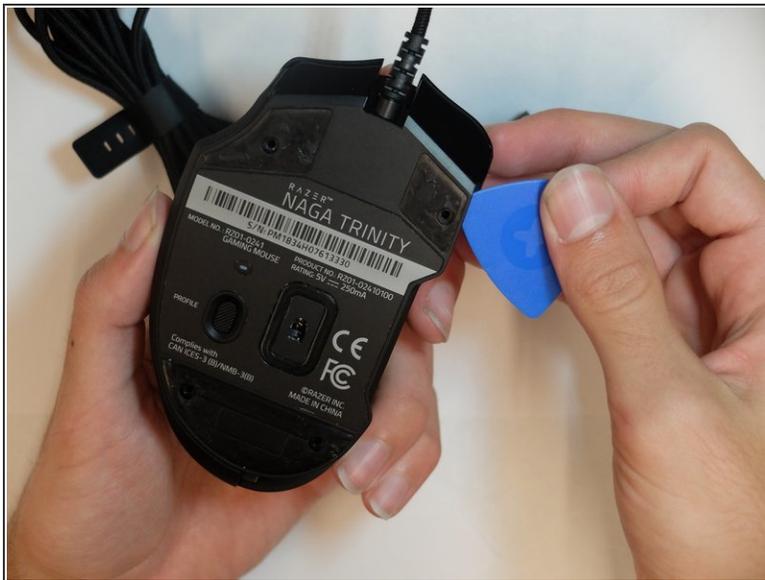
Step 4

- Separate the top mouse housing from the bottom mouse housing using the opening pick.

Be careful not to tug too hard on the ribbon connector.

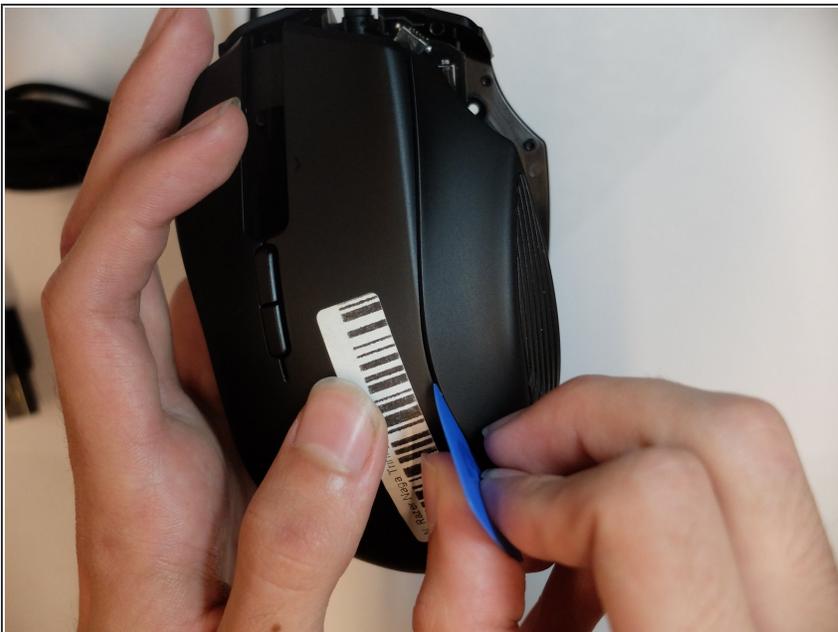
Step 6

- Remove the side housing using the opening pick.

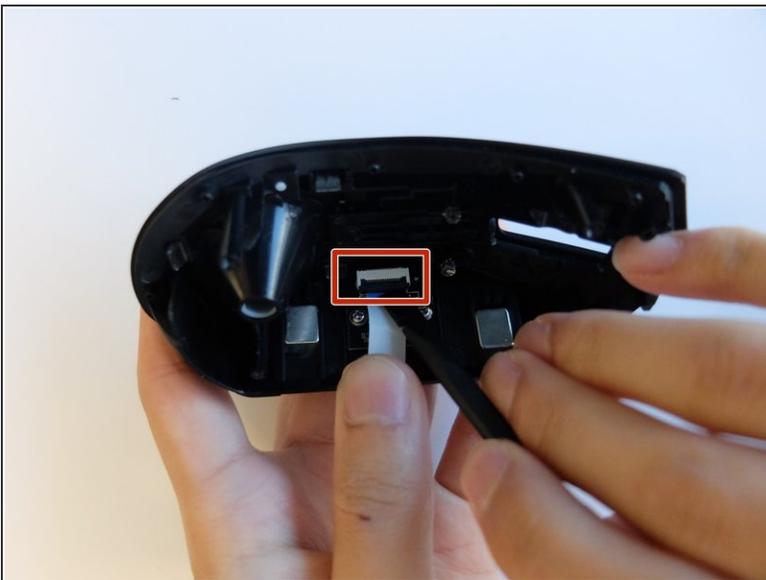
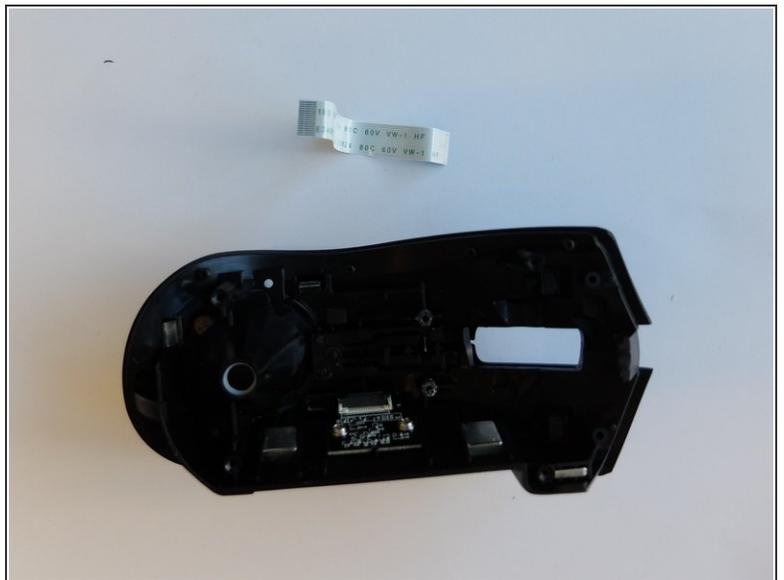
Step 8 — LED Light Ribbon Cable

- Using the flat end of a spudger, unlock the ribbon cable holding the clips.
- Remove the ribbon cable.

To reassemble your device, follow these instructions in reverse order.
