# Replacing Coffee Spout Manifold on Nivona Caferomatica 770

Replacement of the Coffee Spout Manifold on the Nivona Caferomatica 770

When the Coffee Spout Manifold is clogged with f. E. coffee fat, then the coffee only comes out in spurts, often out of only one of the two jets. The Spout Manifold is a sealed-off compartment with venting valves, which doesn't open and is hard to clean. The replacement part doesn't cost much and the replacement is fairly easy.

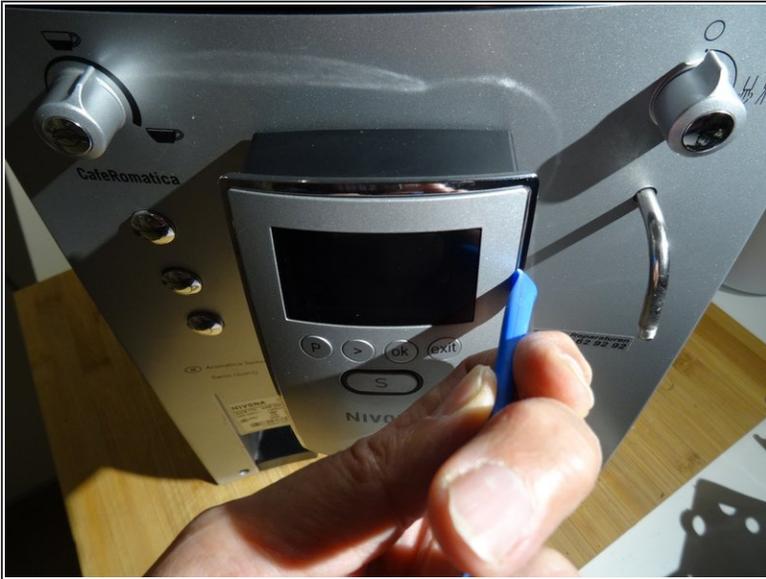
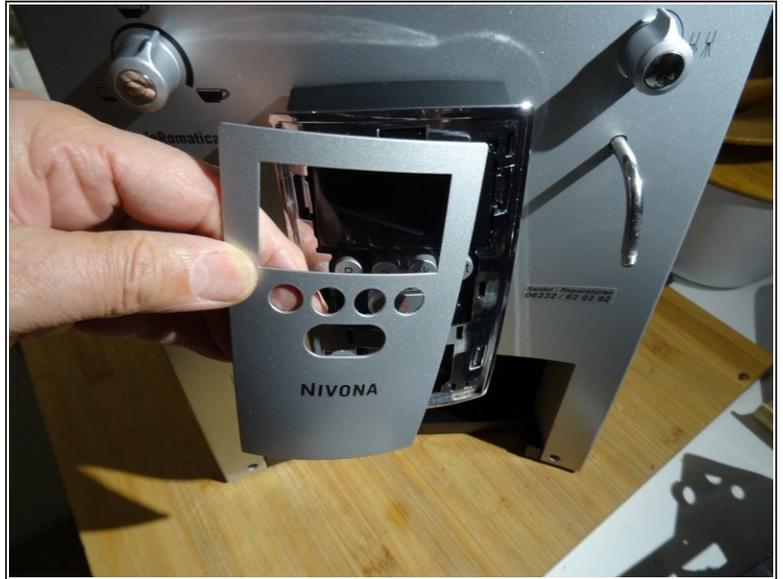
## Step 1 — Coffee Spout Manifold

- Remove the plastic plate with the 'Nivona' label carefully with a plastic opening tool.

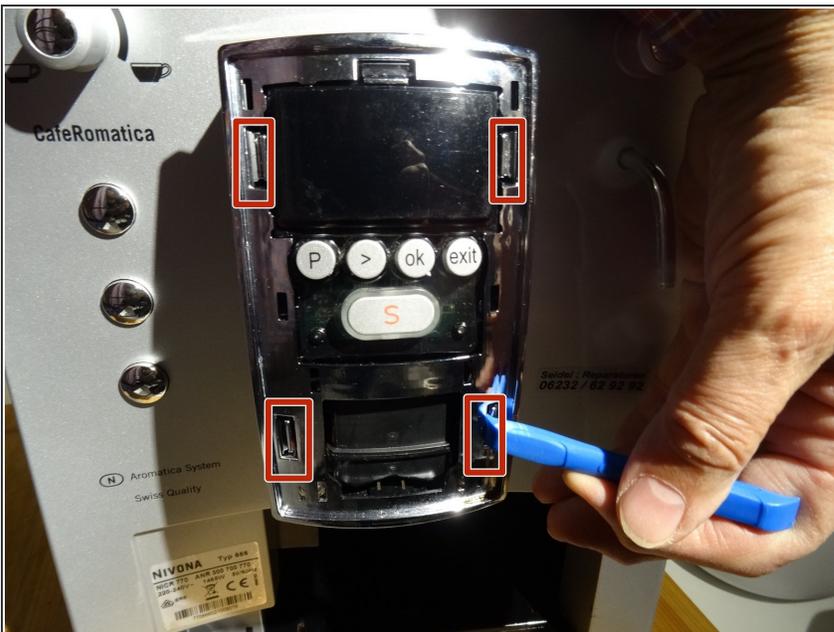
## Step 2

- Behind it, you'll find a chrome cover. It is mounted at the marked spots.
- Push the mounting points with a plastic opening tool to the side and remove the cover carefully.

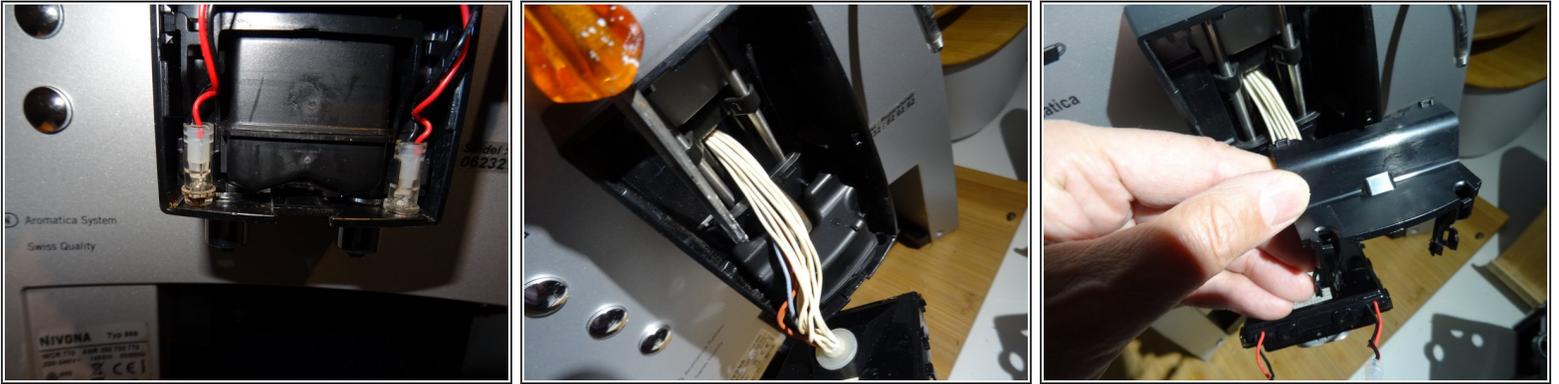
### Step 3

- Remove the LEDs of the cup lighting from their holding clips and bend them aside.
- Leverage the holder of the lighting element off and remove it.

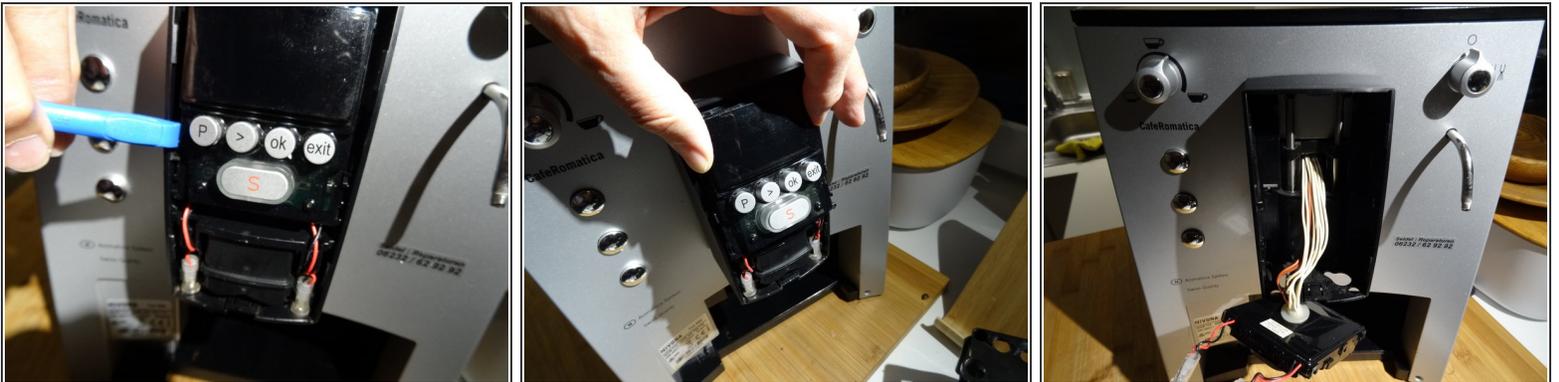
### Step 4

- Now it is possible to remove the keypad with the display, it is only held by clips. Remove it carefully by hand.
- ⓘ The keypad is connected by a large wire harness to the machine. The wire harness won't be removed, the keypad will only be pushed out of the way.

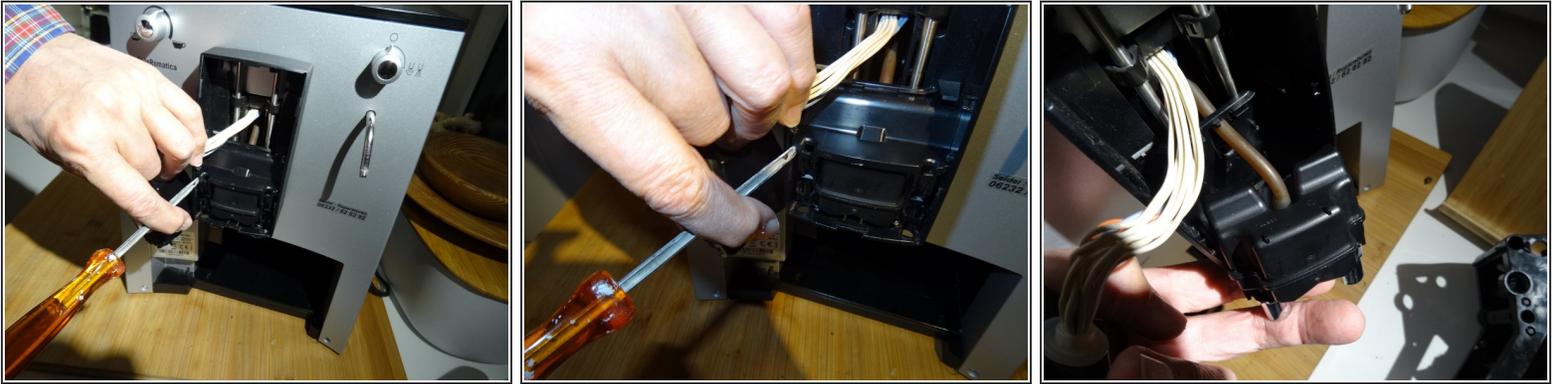
## Step 5

- Now the spout is easily accessible. It is only fixed in place by clips and can be removed via a flat screwdriver or spatula.

**i** The spout is now only connected to the coffee hose made of silicone.

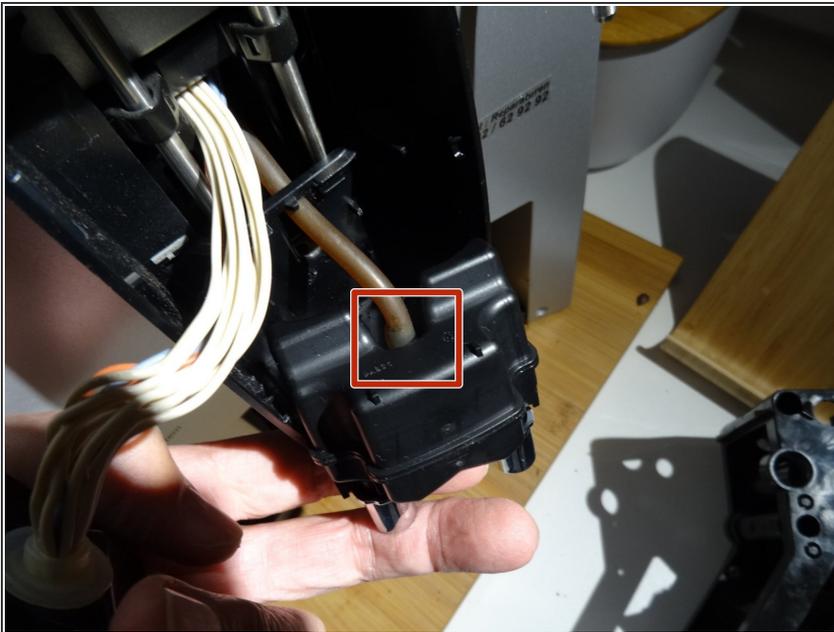
## Step 6

- Pull the silicone hose off the coffee spout.
- The coffee spout is disconnected.

Repeat the steps in reverse order to reassemble the device.
