Sony Vaio PCG-81114L Disk Drive Replacement

Follow this guide to replace a Sony Vaio PCG -81114L disk drive.

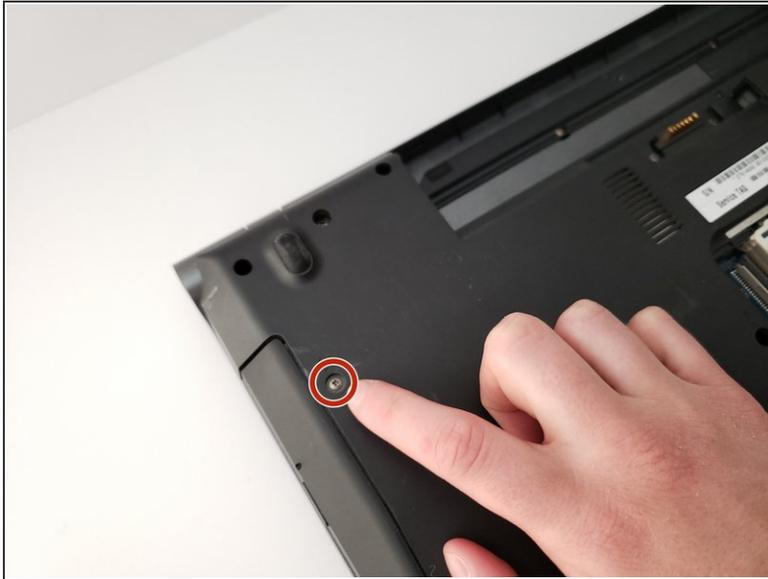
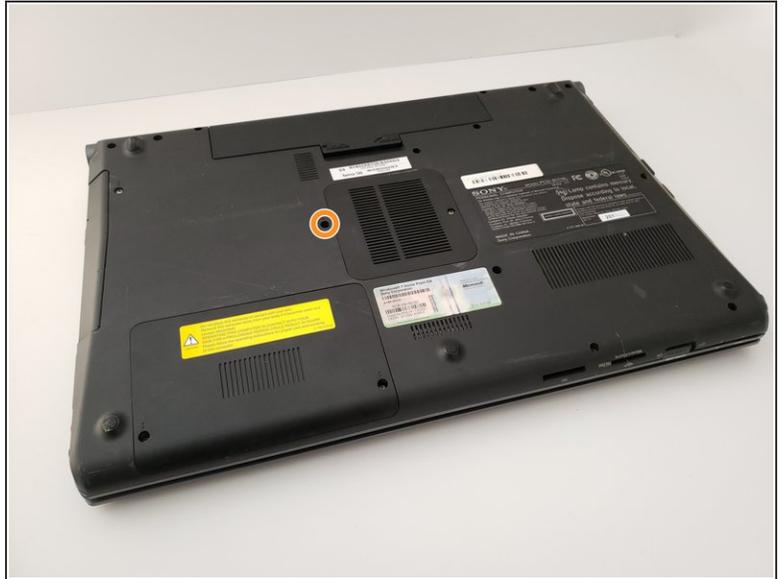
Step 1 — Disk Drive

- Remove the 9mm Phillips #1 screw holding the disk drive in place.
- Remove the 9mm screw near the memory stick.

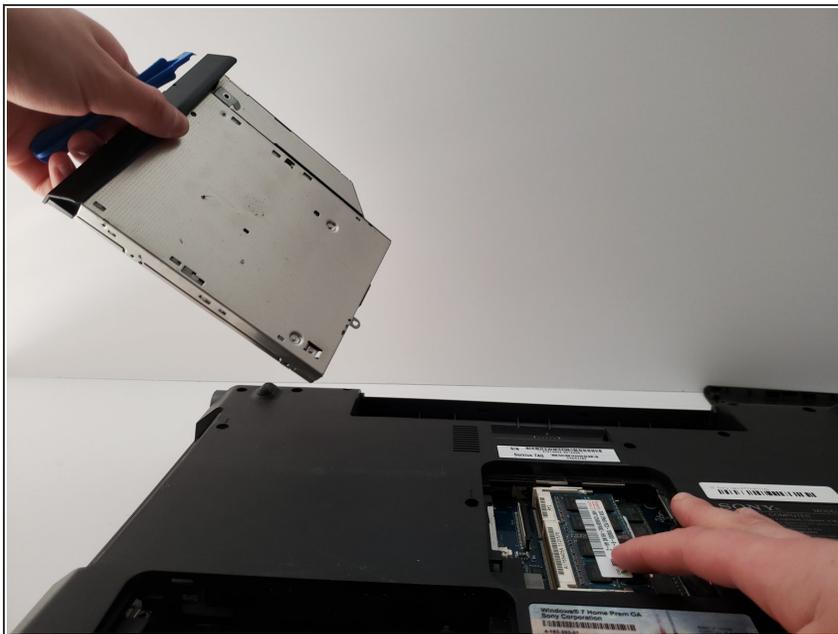
Step 2

- Using an iFixit opening tool, carefully pry the disk drive away from the device.

To reassemble your device, follow these instructions in reverse order.
