**Generic Software
Release Notes
V5.1 FSR00 PUN23**

61220300051-04P

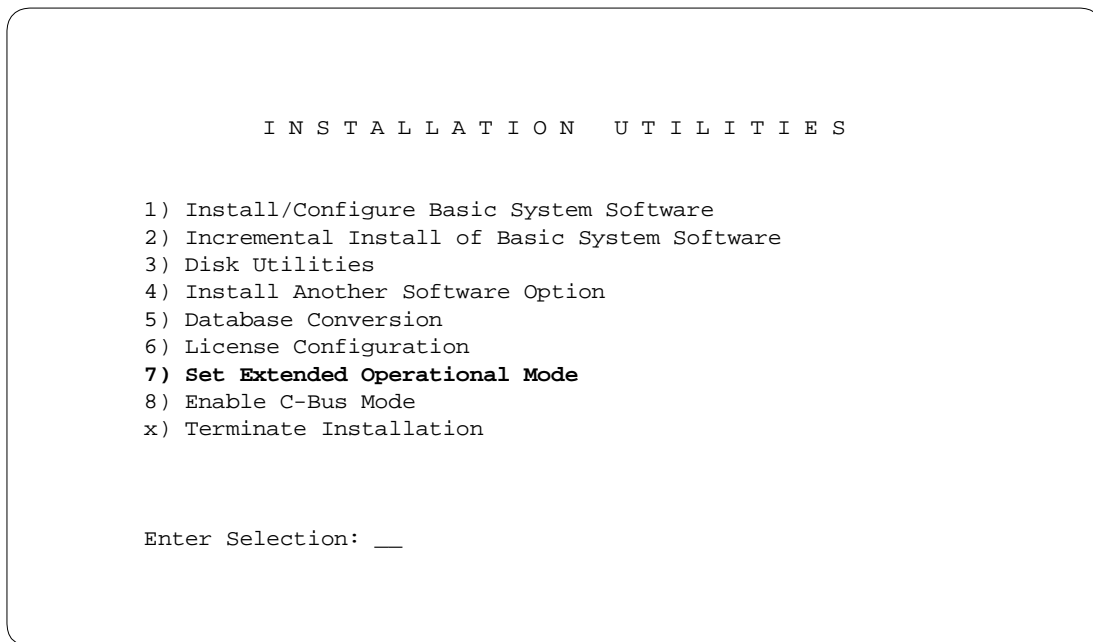
TP000005

Extended Operational Mode requires an addition to the Installation Utilities screen as shown in *Figure 2.1*. Select **7** for the new Set Extended Operational Mode option.

Figure 2.1: Installation Utilities Screen

To take advantage of the increased system limits, a menu option, Set Extended Operational Mode, has been added to the Installation Utilities screen. This screen, shown in *Figure 2.1*, appears during the installation process.

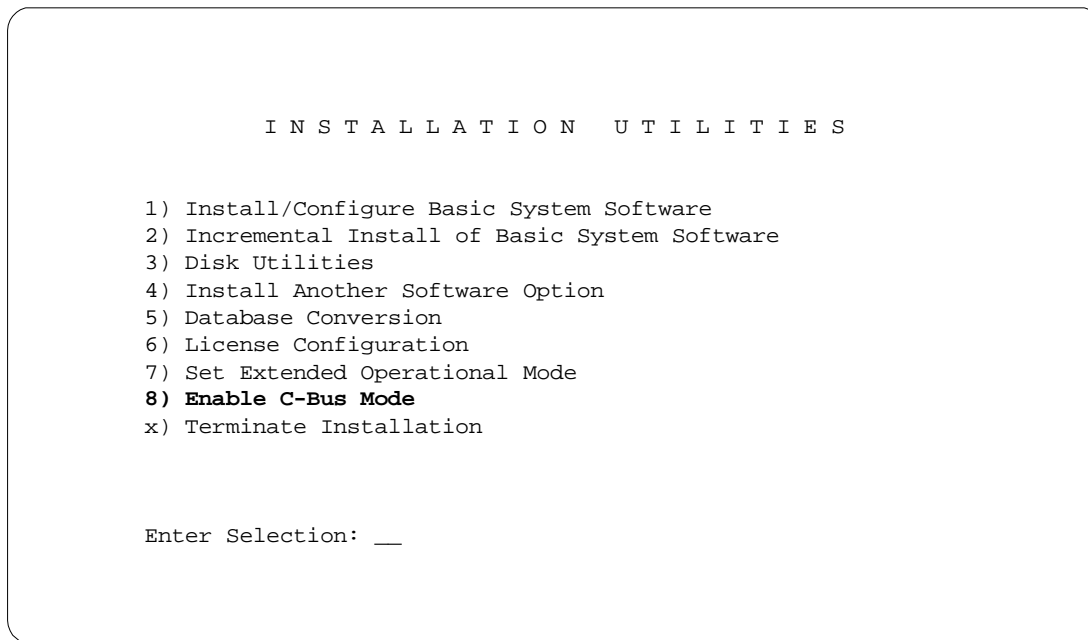
TP000006

C-bus operational mode requires an addition to the Installation Utilities menu as shown in *Figure 2.3*. Select **8** for the new Enable C-Bus Mode option.

Figure 2.3: Installation Utilities Screen

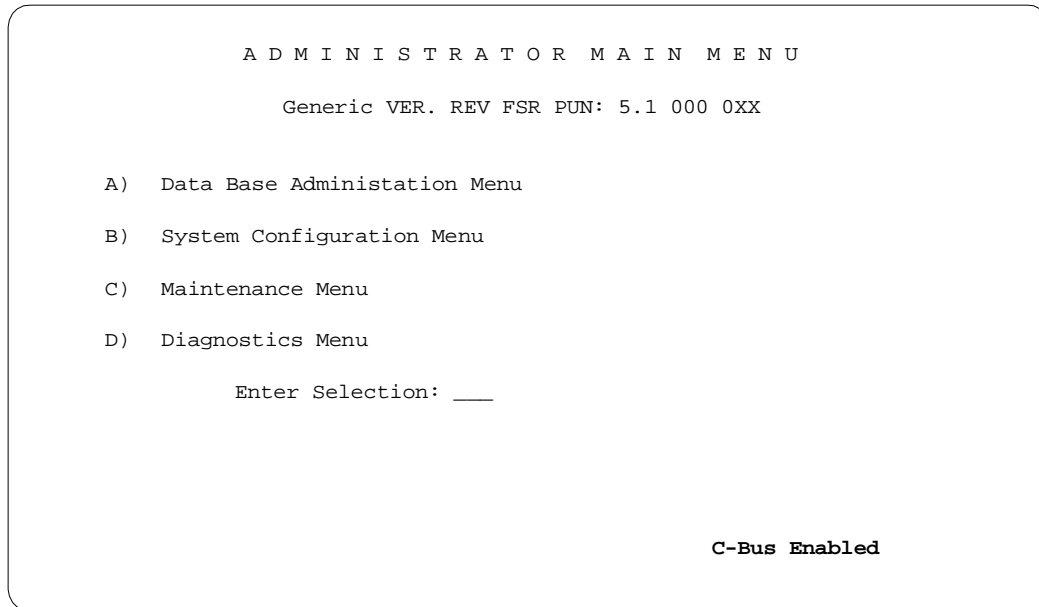
TP000209

The Administrator Main Menu screen, shown in *Figure 2.4*, displays a message if C-bus is enabled. If C-bus is installed and the hardware is detected, a C-Bus Enabled message appears on the lower right corner of the screen. However, in the unusual event that the hardware is not detected, an Error: C-Bus is not installed message displays.

Figure 2.4: Administrator Main Menu Screen

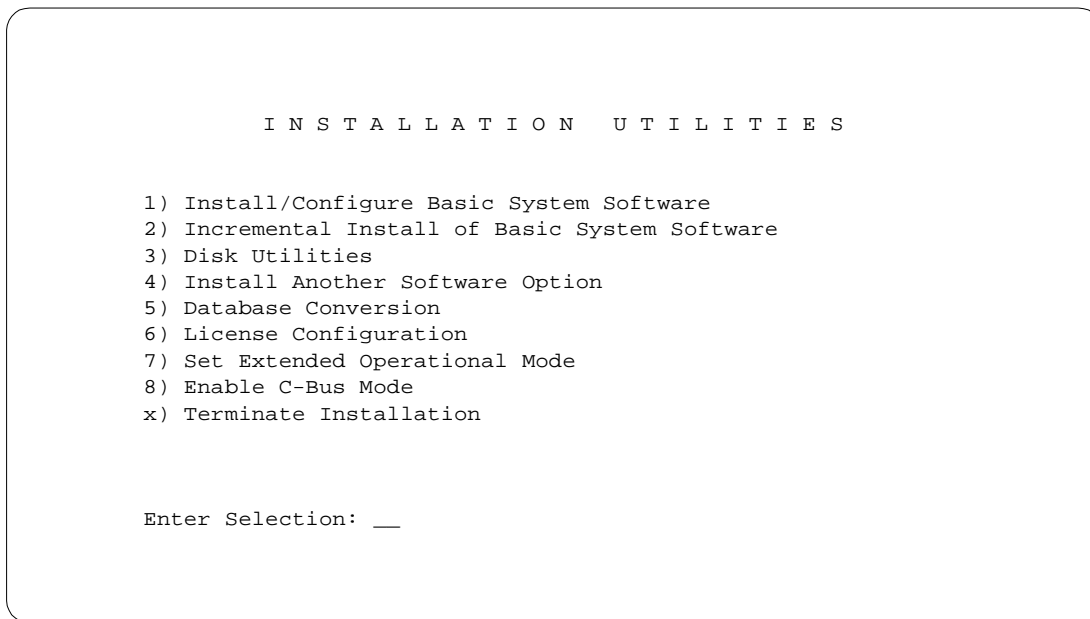
TP000004

Do You Wish To Back-Up The System Data Base? (Y/N) =N?_

Figure 4.1: Installation Utilities Menu

When the installation is complete, the Installation Utilities menu appears again (Figure 4.1).

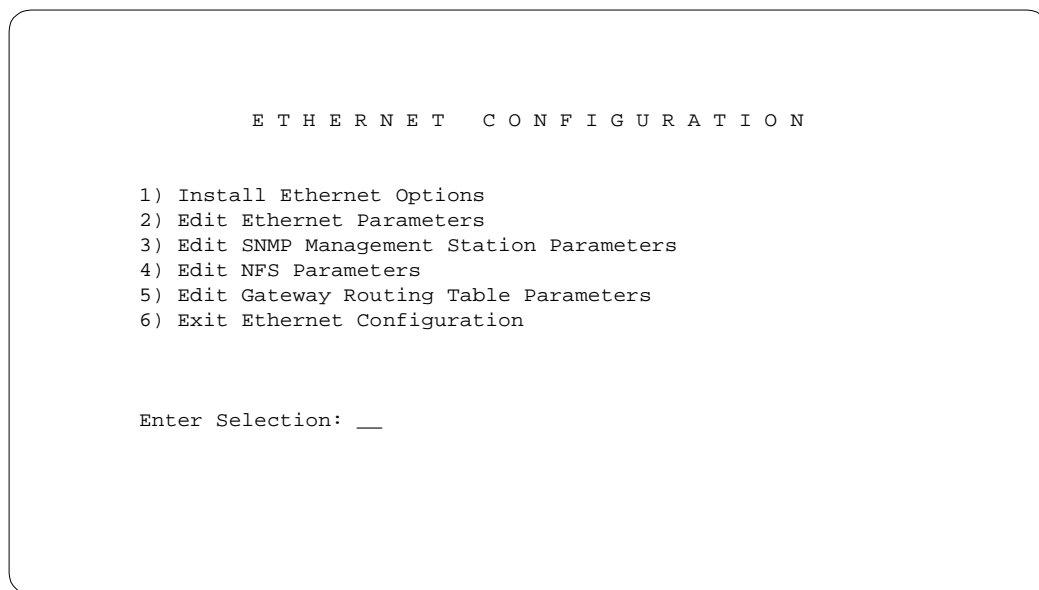
TP000019

The Ethernet Configuration menu appears (see *Figure 4.3*).

Figure 4.3: Ethernet Configuration Menu

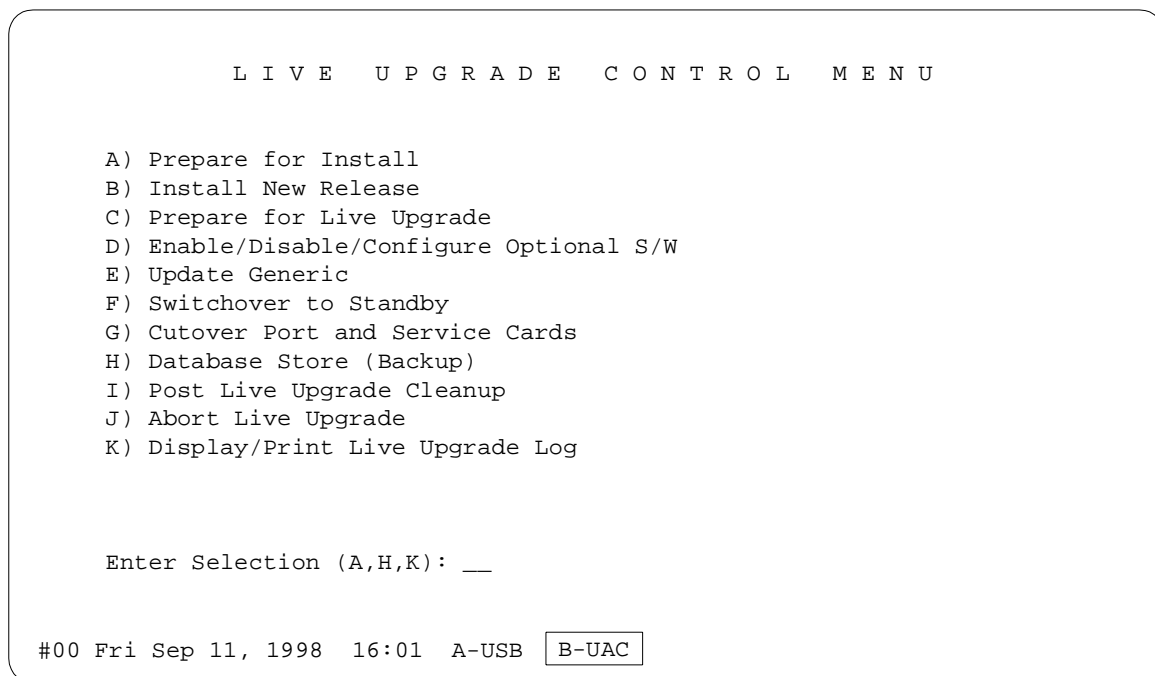
TP000112

To access the Live Upgrade Control Menu screen, as shown in *Figure 5.1*, from the Maintenance menu, press L. The cursor is located at the Enter Selection field.

Figure 5.1: Live Upgrade Control Menu

Screen selections are limited to the appropriate letter for the current step as indicated as part of the Enter Selection prompt. In *Figure 5.1*, valid selections are A, H, and K.

The system lets you know that a live upgrade is in progress by displaying UAC or USB at the bottom of the screen; UAC indicates Upgrade Active mode and USB indicates Upgrade Standby mode. As shown in *Figure 5.1*, side A is in standby mode and side B is active.

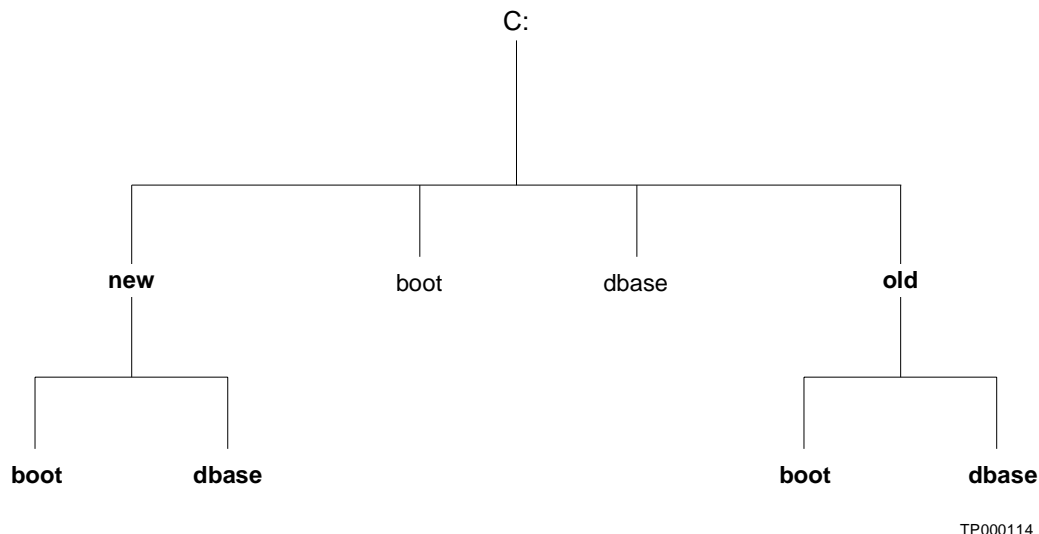
The directory structure that is required by the upgrade process is shown in *Figure 5.2*. The directories created for the upgrade procedure are shown in bold; they are automatically created by the generic software when you select the Prepare for Install option. If they already exist, any existing files are removed from the directories. The directories themselves are maintained, and are used during the upgrade process.

Figure 5.2: Upgrade Process Directory Structure

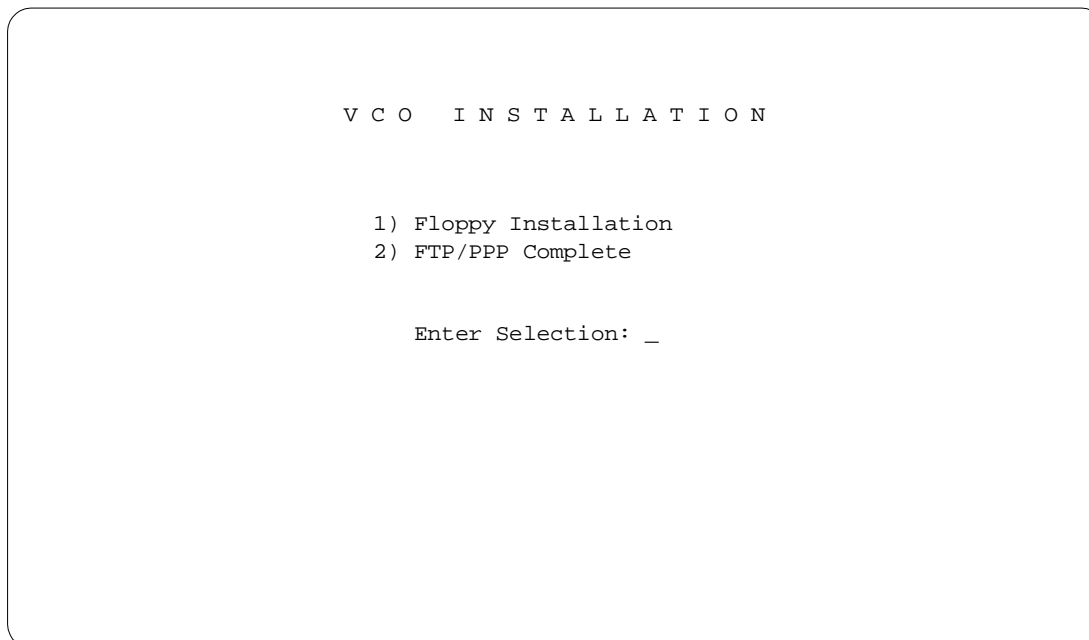
TP000115

When you select the Install New Release option from the Live Upgrade Control Menu, the VCO Installation screen is displayed as shown in *Figure 5.3*.

Figure 5.3: VCO Installation Screen

When the FTP transfer of the new generic software to the hard disk is complete, you must indicate that the transfer is complete by selecting Option 2 in the VCO Installation screen; refer to *Figure 5.3* on page 8. The generic software then verifies that the transfer is complete. Successful transfer is indicated by the Check for all Files Successful message.

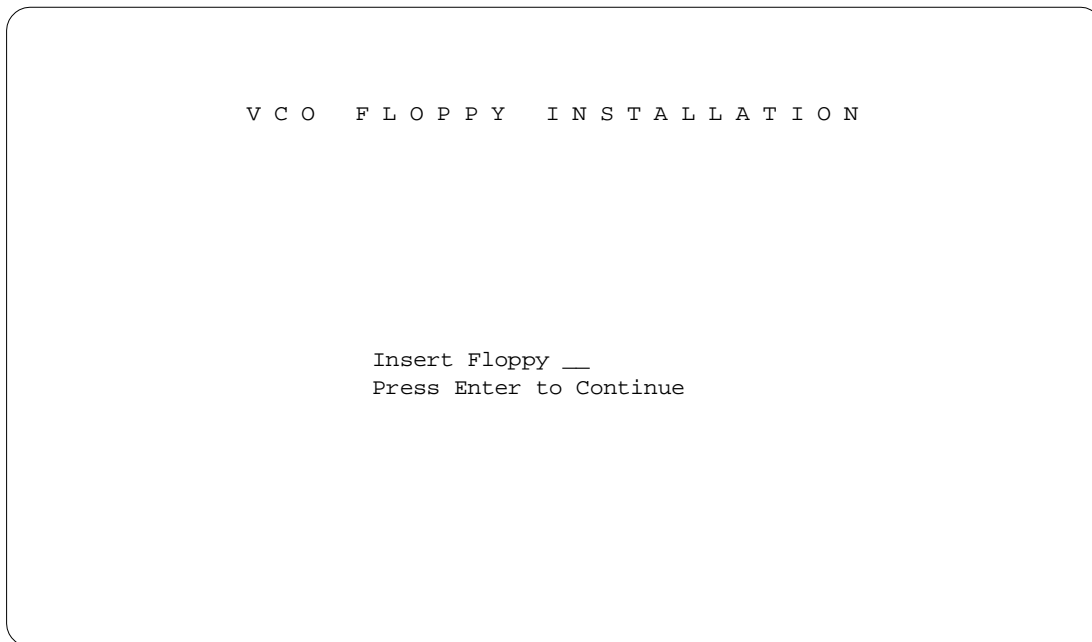
TP000116

To install from floppy diskettes, type **1**, then press **Enter**. The VCO Floppy Installation screen is displayed, as shown in *Figure 5.4*.

Figure 5.4: VCO Floppy Installation Screen

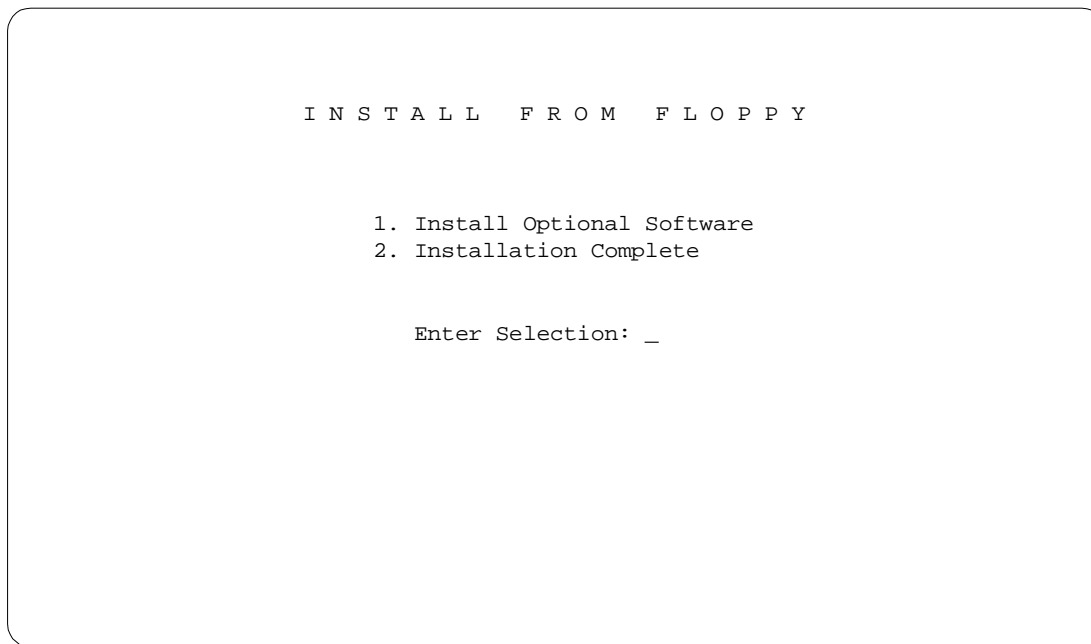
TP000117

After all software diskettes have been installed, you are prompted to install optional software as shown in *Figure 5.5*. If no other software is to be installed, select option 2: Installation Complete, shown in *Figure 5.5*, and press **Enter** to exit the installation.

Figure 5.5: Install from Floppy Screen

After the generic software is installed, you can install optional software package files; refer to *Figure 5.5*.

After completing the installation of an option, the menu in *Figure 5.5* appears again. Select Option 1 again to install another software package, or select Option 2: Installation Complete, to terminate the installation.

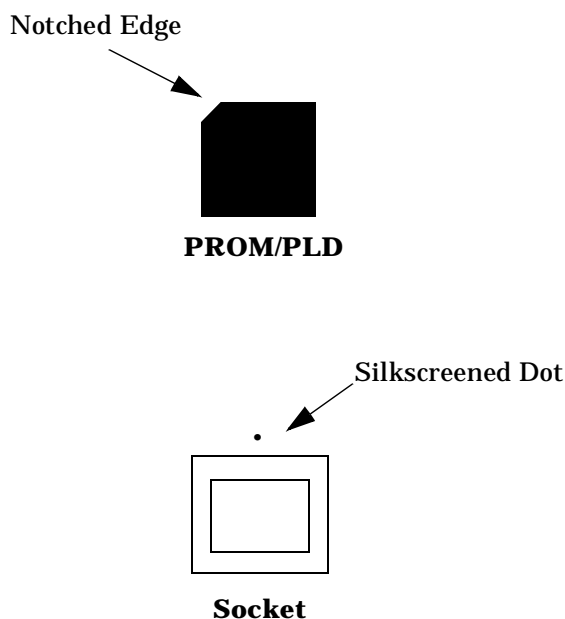
1. Before installing the new PROM or PLD, verify that the pins are all evenly spaced and properly aligned. If necessary, use tweezers to carefully align the IC pins prior to installation.
2. Align the notched edge on the PROM/PLD to the silkscreened dot on the circuit card, as shown in *Figure A.5*.

Figure A.5: PROM/PLD Alignment
