Installation Instructions
Field Feature Bill of Material (FFBM)
For Installing Feature Code 1450 (Multi-Path
Feature)
in a IBM 3583 Model L18/L36/L72

Document Number 18P8592 EC H80336A

This FFBM affects an IBM 3583 Model L18/L36/L72 enabling the Multi-Path feature in an Ultrium 1 tape library.

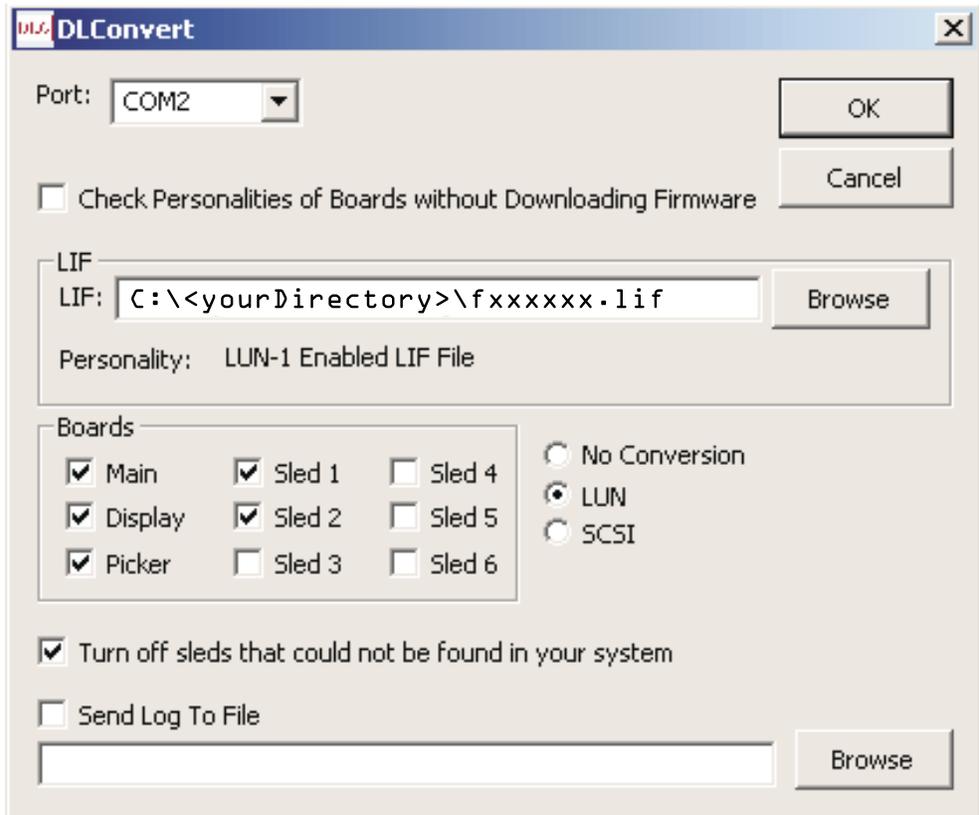
Figure 1. GUI Interface for DLConvert

- ___ 5. For assistance with the next steps, refer to Figure 1 on page 6.
- ___ 6. Use the Port pull-down menu to select the communication port to match the port selected on the laptop.
- ___ 7. Verify the **Personalities Check** box is not selected.
- ___ 8. At the **LIF** box, press type in the location and firmware filename or press Browse to locate the firmware V5_xx_xxxx.lif file downloaded earlier.
- ___ 9. Click **LUN** to convert the library from SCSI-based firmware to LUN-based firmware.

- ___ 10. Place a check mark in the **Turn off sleds that could not be found in your system** box.
- ___ 11. Leave the **Send Log To File** box blank.
- ___ 12. Click **OK** to execute the conversion and the firmware download.
- ___ 13. The Processing Download dialog will display the status of the download and indicate when the download is complete.
