Nokia Siemens Networks GSM/EDGE BSS, rel. RG10(BSS), operating documentation, issue 03

Troubleshoot

Trouble Management of UltraSite EDGE BTS

DN05168243

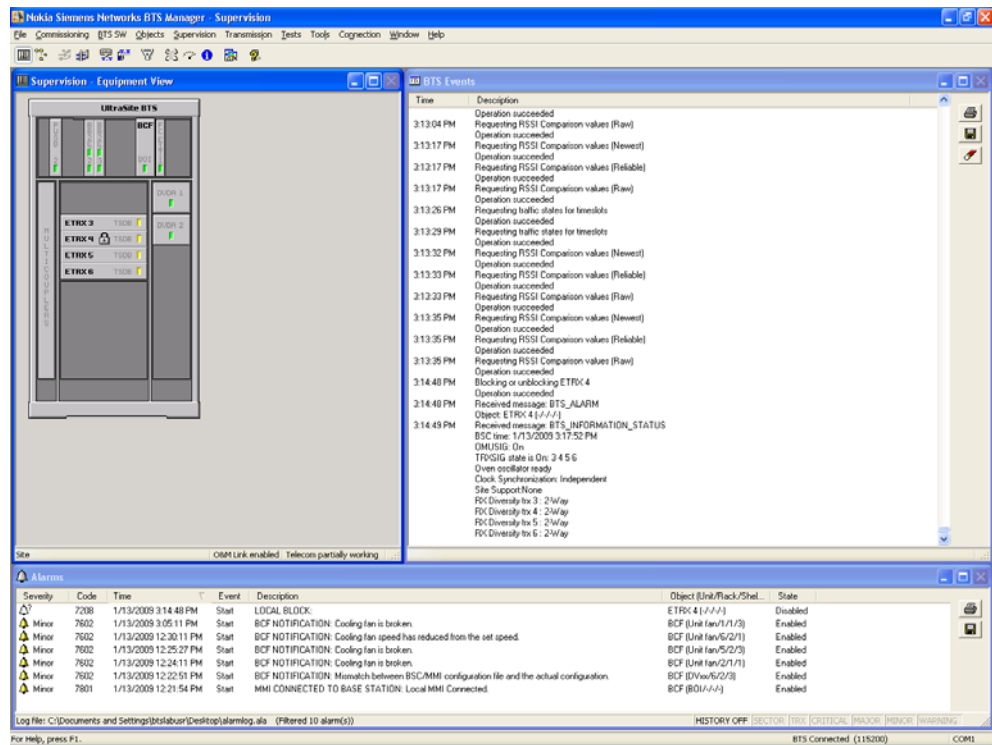
Figure 4 BTS Manager desktop showing the alarms in the Alarms window

The figure below shows how alarms (number, name, and fault reason) are seen in the Alarms window on BTS Manager desktop. See for example BB2's location (location number 2/1/1) in rack 2, shelf 1, slot 1.

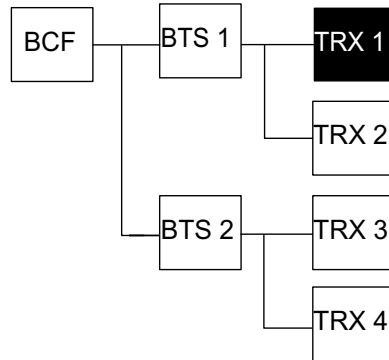
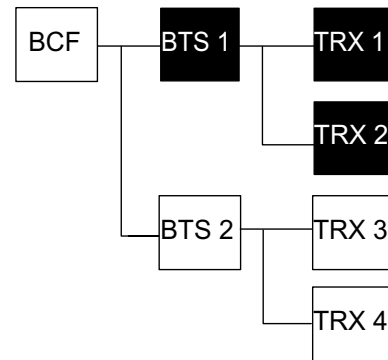
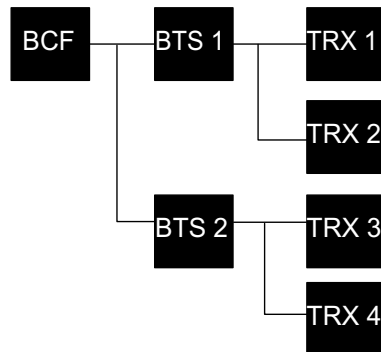
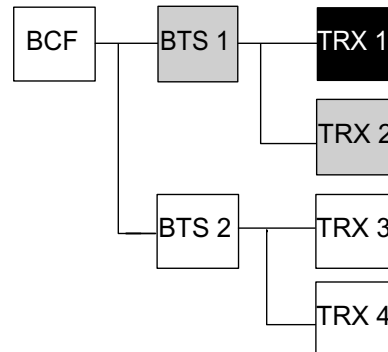
Figure 5 Faulty and degraded object alarm reclassification

① Alarm Output:

7606 TRX FAULTY (TRX 1)

② Alarm Output, in this order:

7606 TRX FAULTY (TRX 1)
7606 TRX FAULTY (TRX 2)
7603 BTS FAULTY (BTS 1)

③ Alarm Output, in this order:

7606 TRX FAULTY (TRX 1)
7606 TRX FAULTY (TRX 2)
7603 BTS FAULTY (BTS 1)
7606 TRX FAULTY (TRX 3)
7606 TRX FAULTY (TRX 4)
7600 BCF FAULTY (BCF)

④ Alarm Output, in this order:

7606 TRX FAULTY (TRX 1)
7607 TRX DEGRADED (TRX 2)
7604 BTS OPERATION DEGRADED (BTS 1)

- Functioning object
- Degraded object
- Faulty object

3. Now both TRXs are not operating, which causes BTS 1 cease to operate. A BTS alarm, 7603 BTS FAULTY, is issued.

1. TRX 1 becomes faulty and ceases to operate. 7606 TRX FAULTY alarm is issued.
2. TRX 2 becomes faulty and ceases to operate. 7606 TRX FAULTY alarm is issued.
3. Now both TRXs are not operating, which causes BTS 1 cease to operate. A BTS alarm, 7603 BTS FAULTY, is issued.
4. TRX 3 becomes faulty, and another 7606 TRX FAULTY alarm is issued.
5. TRX 4 becomes faulty, and another 7606 TRX FAULTY alarm is issued. BTS 2 ceases to operate.
6. Now both sectors in the BCF are not operating, and a BCF alarm, 7600 BCF FAULTY, is issued.

1. TRX 1 becomes faulty and ceases to operate. 7606 TRX FAULTY alarm is issued.
2. TRX 2 becomes partially faulty but calls are getting through. 7607 TRX DEGRADED alarm is issued.
3. Now the sector is partially faulty, and a BTS alarm, 7604 BTS OPERATION DEGRADED, is issued.

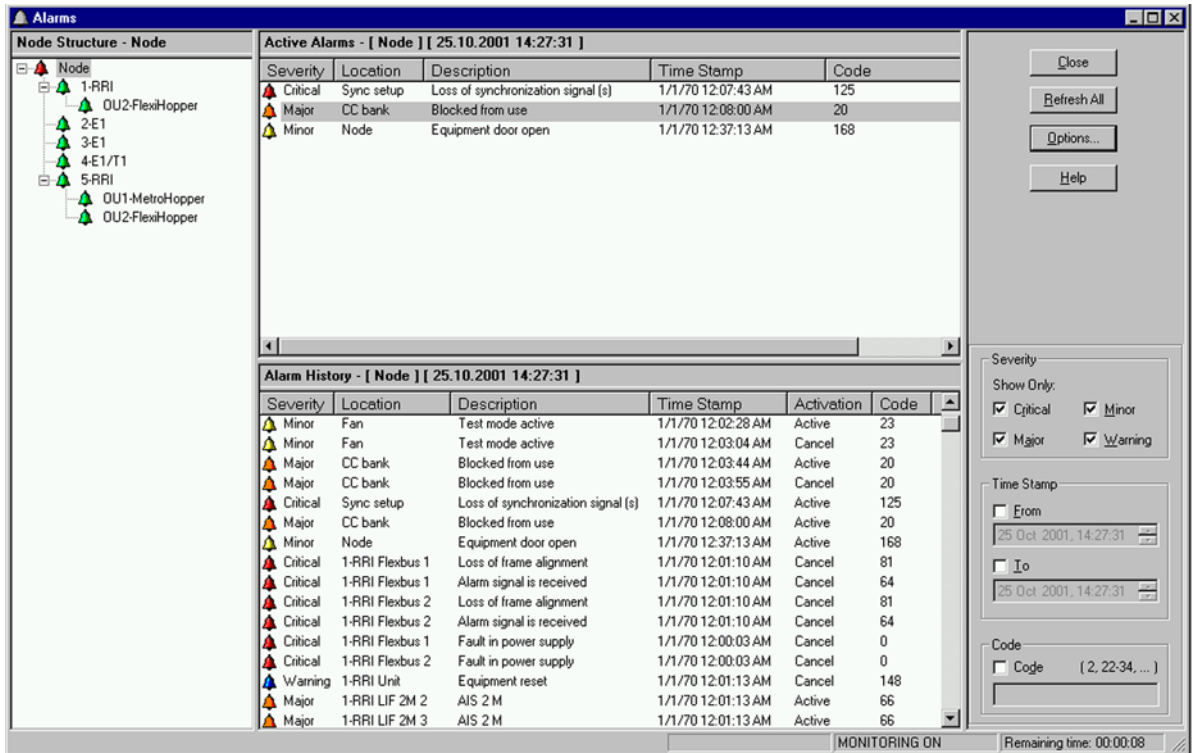
Figure 6 Alarms window

- **Severity** - severity class of the alarm
- **Location** - unit the alarm is located in
- **Description** - brief description of the alarm
- **Time stamp** - date and time when the alarm was detected
- **Code** - fault code of the alarm
- **Activation** (in the alarm history view) – indicates if an alarm is active or cancelled

The unit alarm status in **Equipment View** is visible only when the **Alarms** window is open and the alarm polling is on.

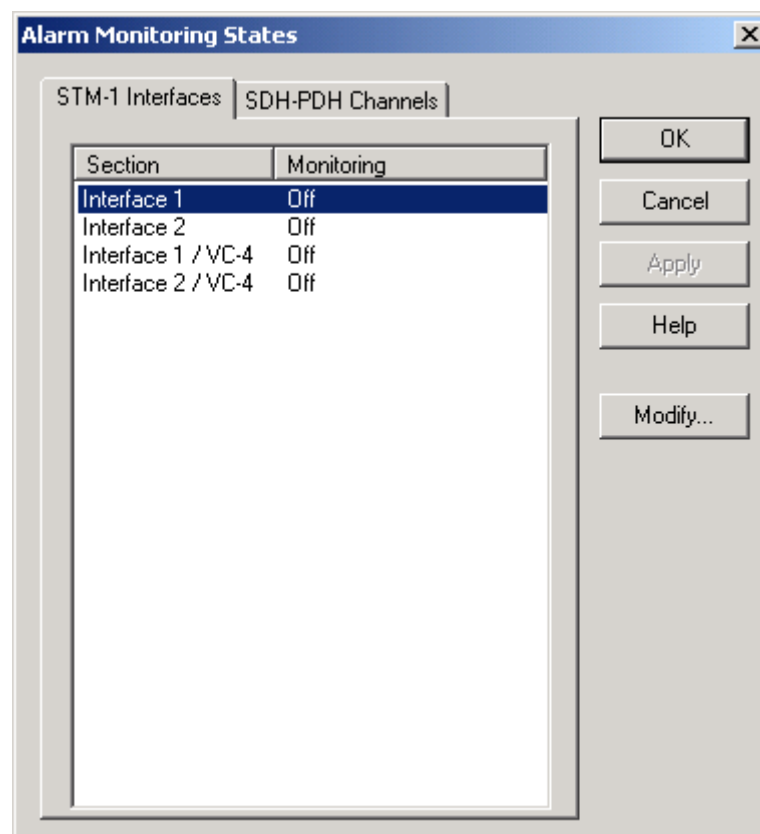
Figure 9 FXC STM-1 Alarm Monitoring States, STM-1 Interfaces

- 1 Click **FXC STM-1 → Alarm Monitoring States** to open the window (see the following figure).

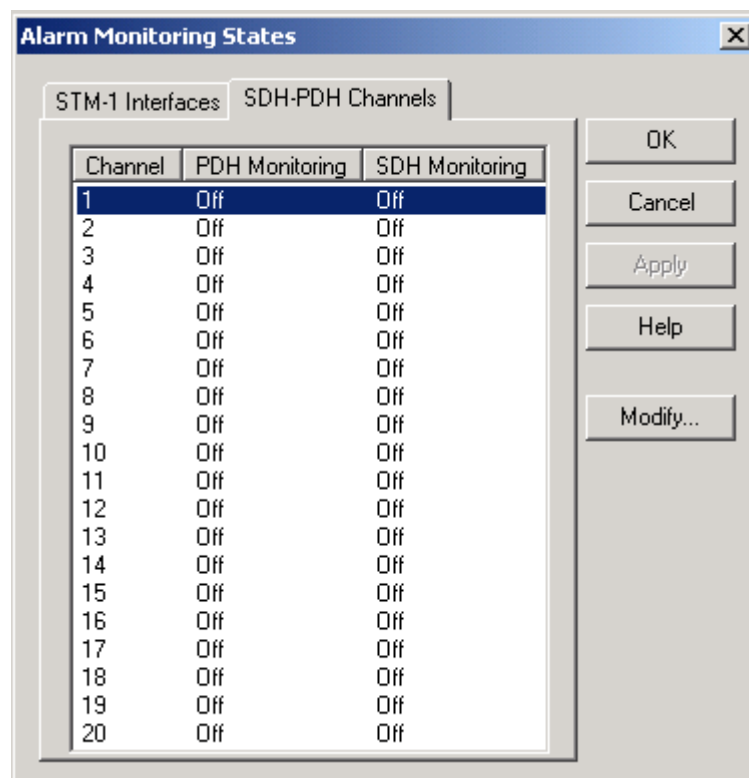
Figure 10 STM-1 Alarm Monitoring States, SDH-PDH Channels

- 3 **On the STM-1 Interfaces page, select the section you want to modify by clicking it.**
Select the section/sections you want to modify by clicking. To select multiple sections, hold down the Ctrl key or the Shift key on your PC keyboard while clicking.
- 4 **Click Modify to open the dialogue box.**
- 5 **Switch alarm monitoring on/off by selecting/clearing the Monitoring box.**
- 6 **Click OK.**
- 7 **Send the changes to the node by clicking Apply in the Alarm Monitoring States window.**
- 8 **In the SDH-PDH Channels page, select the channel/s to be modified by clicking them.**

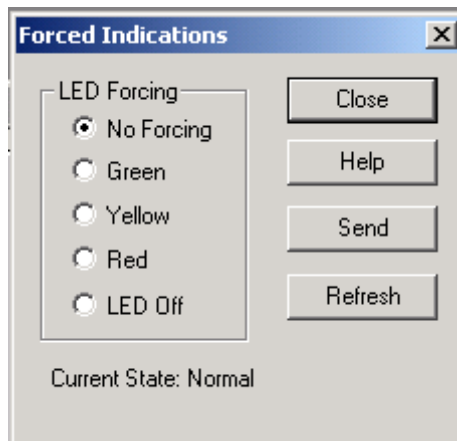
Figure 11 FXC STM-1 or FXC Bridge Forced Indications

- 2 View the **Current State of the LED**. Usually, this is **Normal** or **No Forcing**.
- 3 Select the state you want to force the LED to (**No Forcing**, **Green**, **Yellow**, **Red**, or **LED Off**).
- 4 Click **Send**.
- 5 Click **Refresh** to read the current state of the LED from the unit.

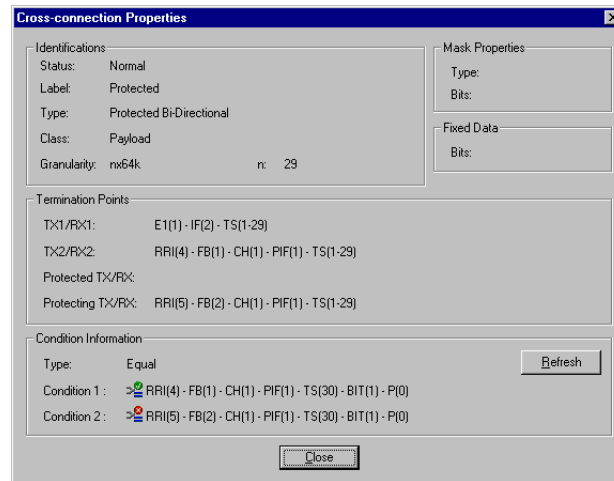
Figure 15 Condition information in the Cross-connection Properties dialogue box

7 Assess if the connection is faulty by viewing the condition bits of the protected cross-connections, in the Condition Information frame.

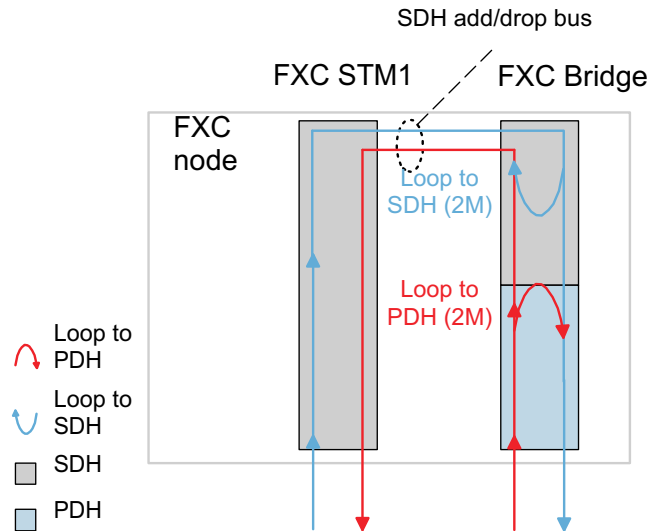
Figure 21 FXC STM node 2M loops

You can set interface loops manually to test the FXC STM node interface loops. These are 2M loops to SDH or PDH.

Through the **Loops** window, you can view and modify the FXC STM node interface loops for the SDH-PDH channels. You can modify one or several channels at a time.
