DOCUMENT NUMBER:	MTN-0013-24
ISSUE DATE:	2024-08

MOTOROLA SOLUTIONS TECHNICAL NOTIFICATION (MTN)

UNC failing local backups due to not enough space in /var/opt/perstore.

ASTRO® 25

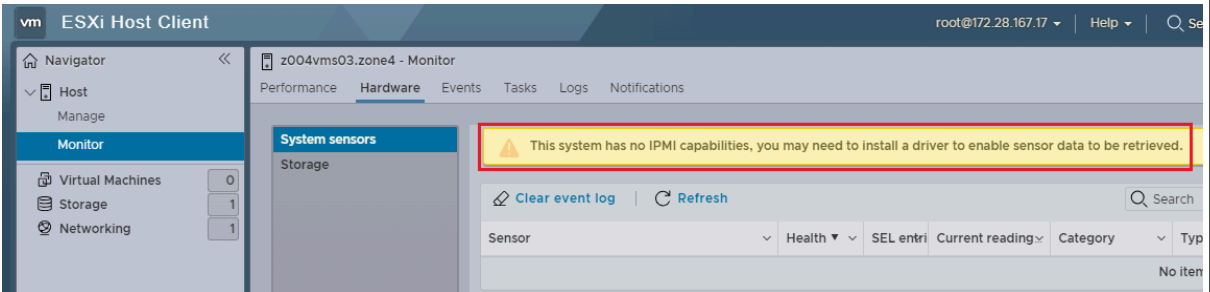
3.	<p>Check whether Redfish® is already applied by performing the following actions:</p> <ol style="list-style-type: none"> 1) Login to the ESXi host client. 2) In the left side pane, select Navigator → Monitor. 3) Select the Hardware tab. 4) From the list on the left, select System sensors and verify if there is a warning message above the list, indicating that <i>'this system has no IPMI capabilities'</i> and that <i>'you may need to install a driver to enable sensor data to be retrieved'</i>. See the screenshot below.

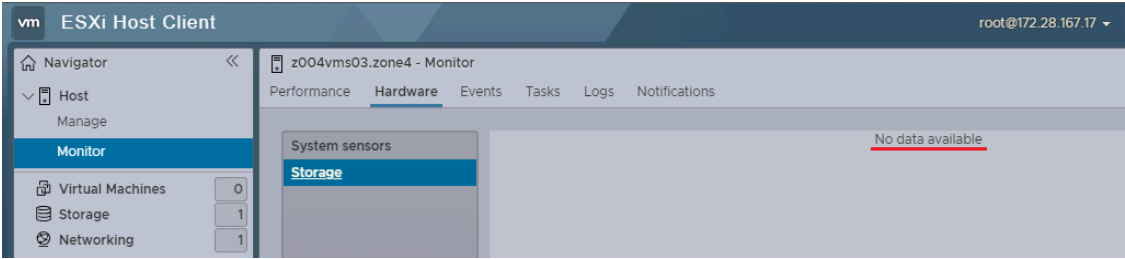
<ol style="list-style-type: none"> 5) From the list on the left, select Storage and check whether the list on the right is empty. See the screenshot below.

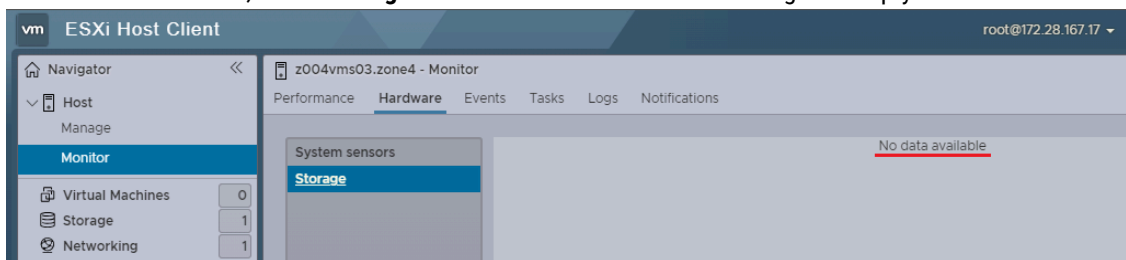
9) From the list on the left, select **Storage** and check whether the list on the right is empty. See the screenshot below

IF	There is a warning message indicating that <i>'this system has no IPMI capabilities you may need to install a driver to enable sensor data to be retrieved'</i> and the storage list is empty
THEN	Order and use for this procedure mot-csr-vsphere-cfg-07.03.08-01 or later (KC877C0B1000210110 or later)
ELSE	Order and use for this procedure mot-csr-vsphere-cfg-07.02.40-01 or later (KC877C0B1001210109 or later)
