Motorola Solutions Technical Notification (MTN)

TITLE: MCC7500 with VPM and MCC 7500E Dispatch Position software version update resolves multiple issues listed in the SYMPTOMS section

TECHNOLOGY: ASTRO 25

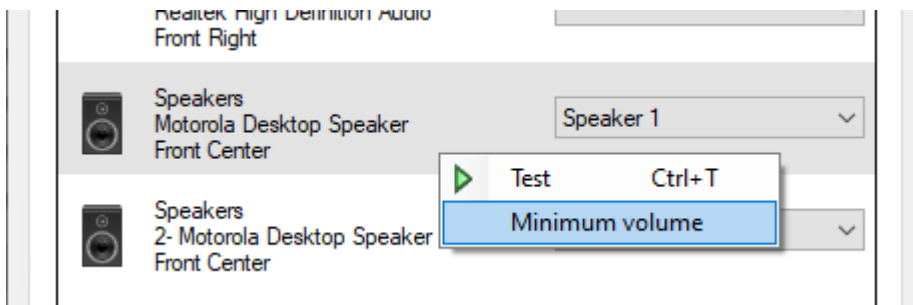
Minimum volume

1. Open the Peripheral Configuration Tool.
2. Select the Audio Outputs tab. The list of speaker devices configured in the Windows operating system appears.
3. In the **Audio Outputs** tab, right-click the Motorola Desktop Speaker device (B1952) that you want to configure minimum volume. Click **Minimum volume**.

4. Save the profile:
 - a. To save the changes to the existing profile, select **Apply**.
 - b. To save the changes as a new profile, select **Save As**.
5. Close the Peripheral Configuration Tool by clicking **OK**..
