**4ESS™ Switch  
3B20D Attached Processor  
System (APS) to 3B21D APS Conversion**

(Office With DLN00 5, DLN00  
10, DLN32 5, and DLN32 10)

234-353-400  
Issue 1  
December 8, 1998

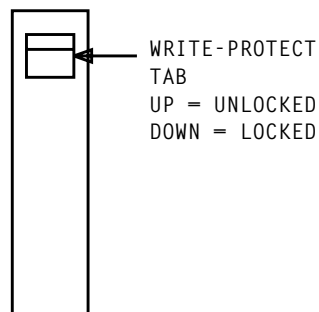
2. See Figure 1. Put write-protect tab in the up (unlocked) position.

**Figure 1. 4-mm Tape**

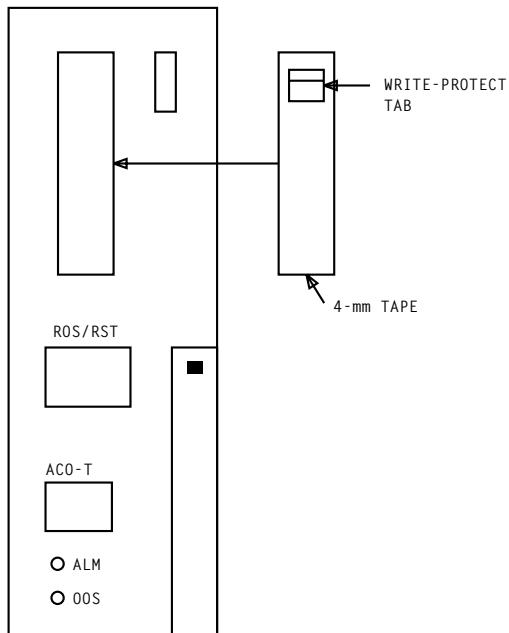
3. See Figure 2. At an available 3B21D APS DAT unit (EQL 11-124 or 62-124), insert blank or erasable 4-mm tape with write-protect tab in appropriate position.

Figure 2. DAT Unit with 4-mm Tape

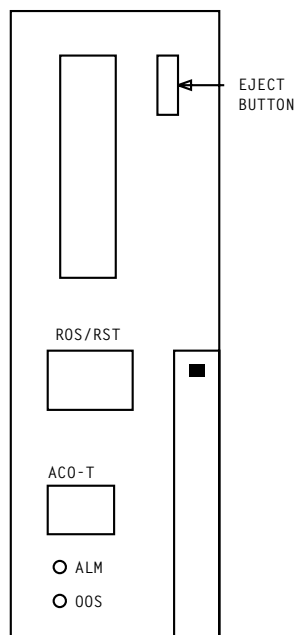
1. See Figure 1. At 3B21D APS DAT unit that contains tape to be removed, depress eject button.

**Figure 1. DAT Unit**

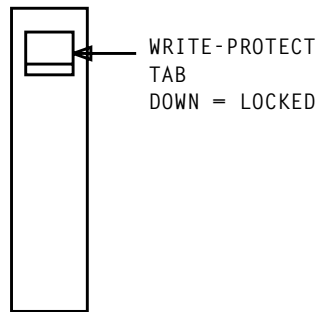
3. See Figure 2. Put write-protect tab in the down (locked) position.

**Figure 2. DAT Unit**
