SONET Products

# AccessNode

## Alarm and Trouble Clearing Procedures

Issue 4.0 January 2000

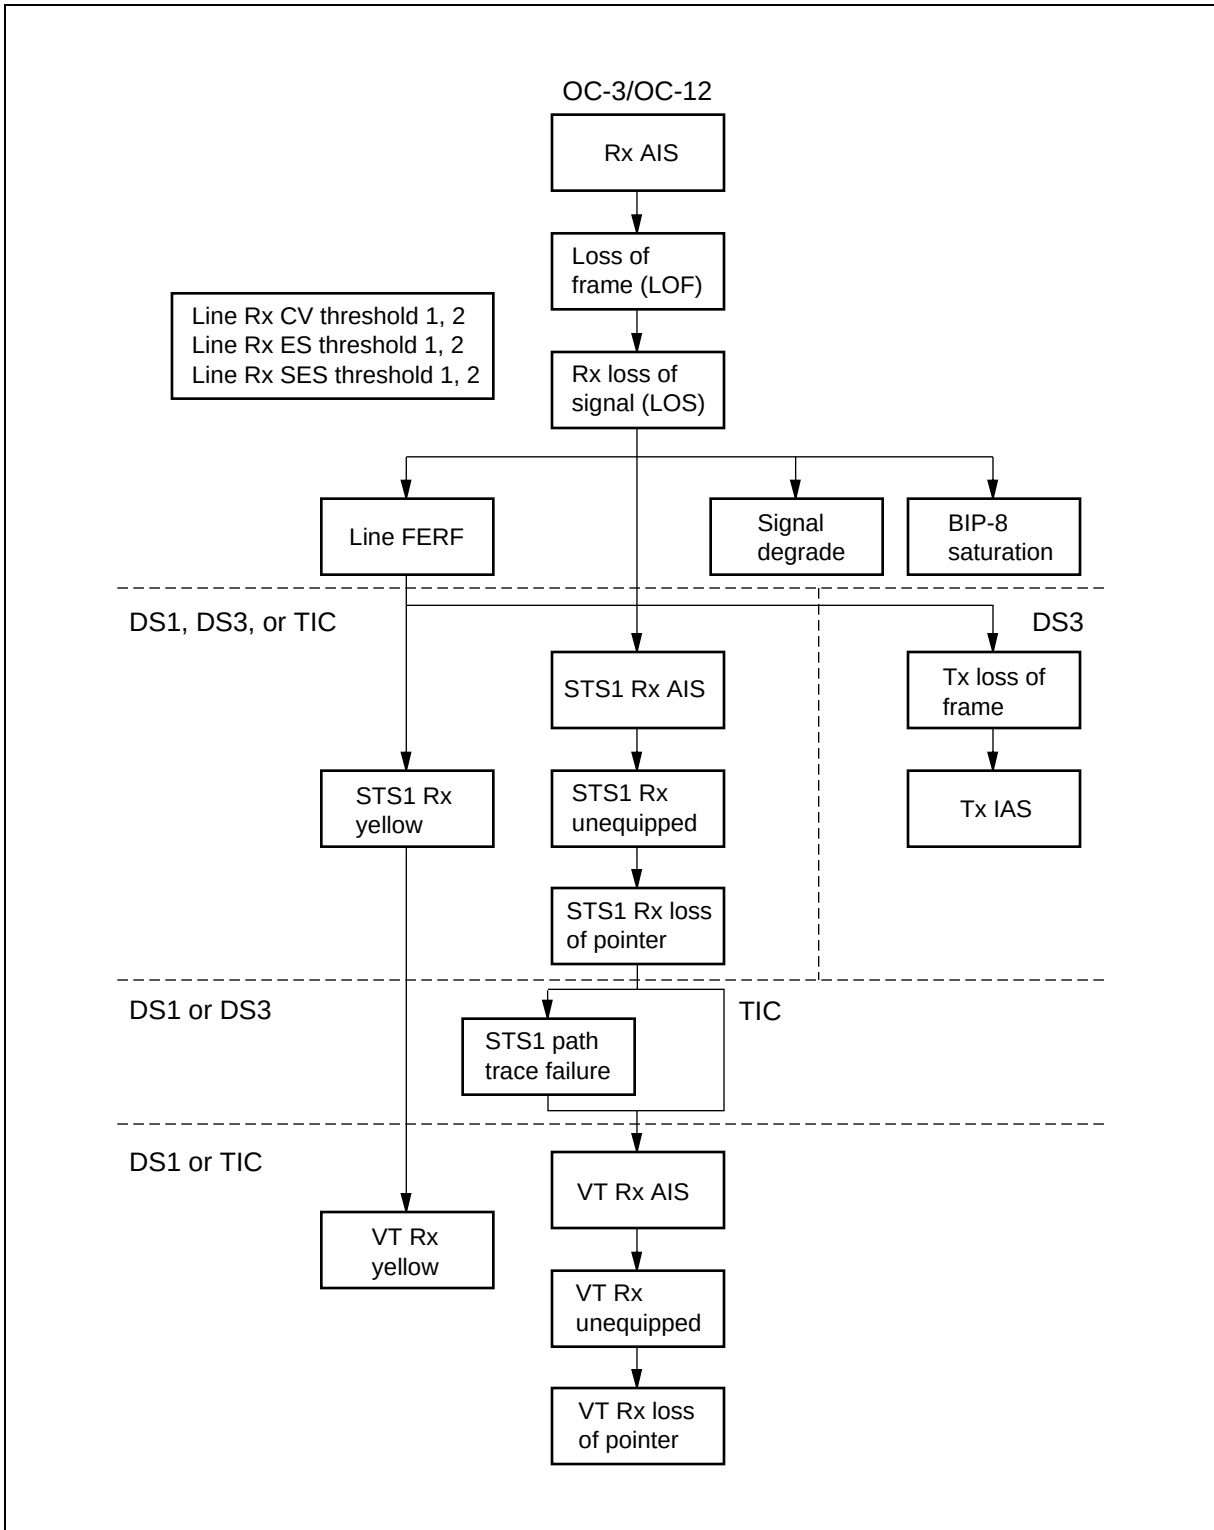
PC-11499

**Figure 2-1 (part 1 of 3)**  
**Facility alarm hierarchies**

Figures 2-1 through 2-3 show the complete hierarchy for facility alarms. The arrows represent a general relationship. Not every alarm lower in the hierarchy is masked, but in general, circuit pack failures mask intercard failures.

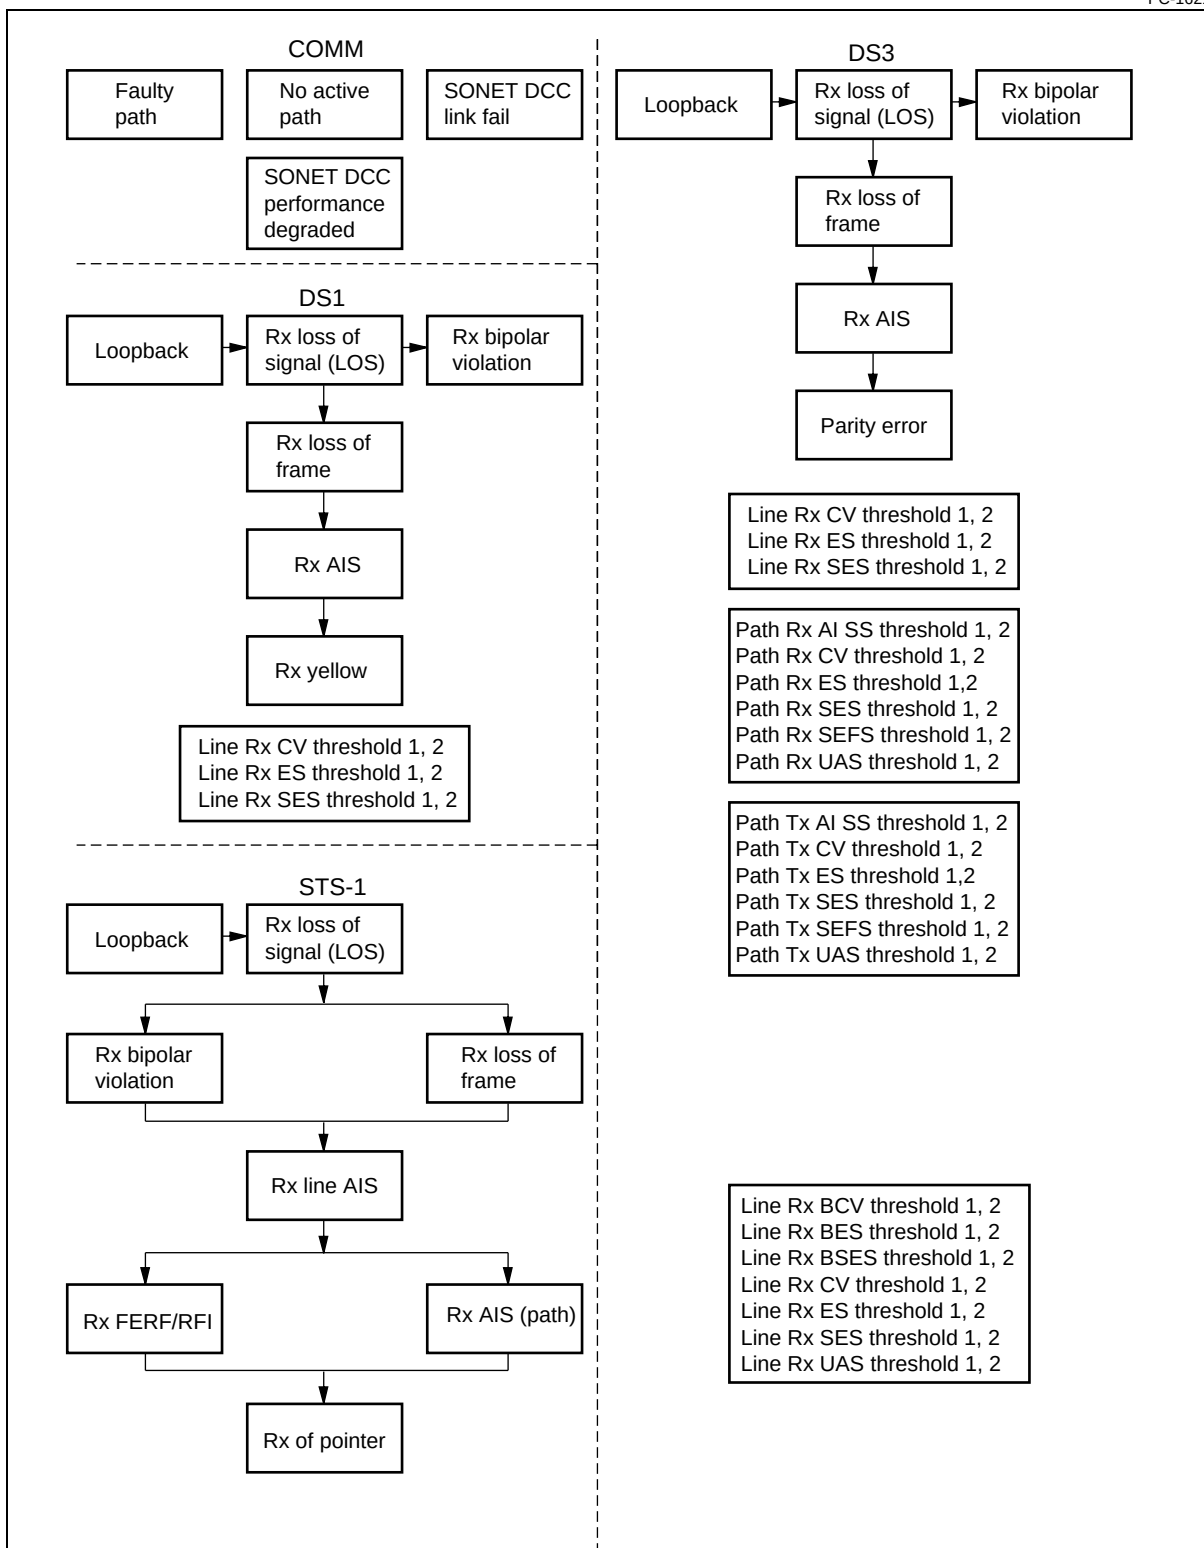
PC-16210

**Figure 2-2 (part 2 of 3)**  
**Facility alarm hierarchies**

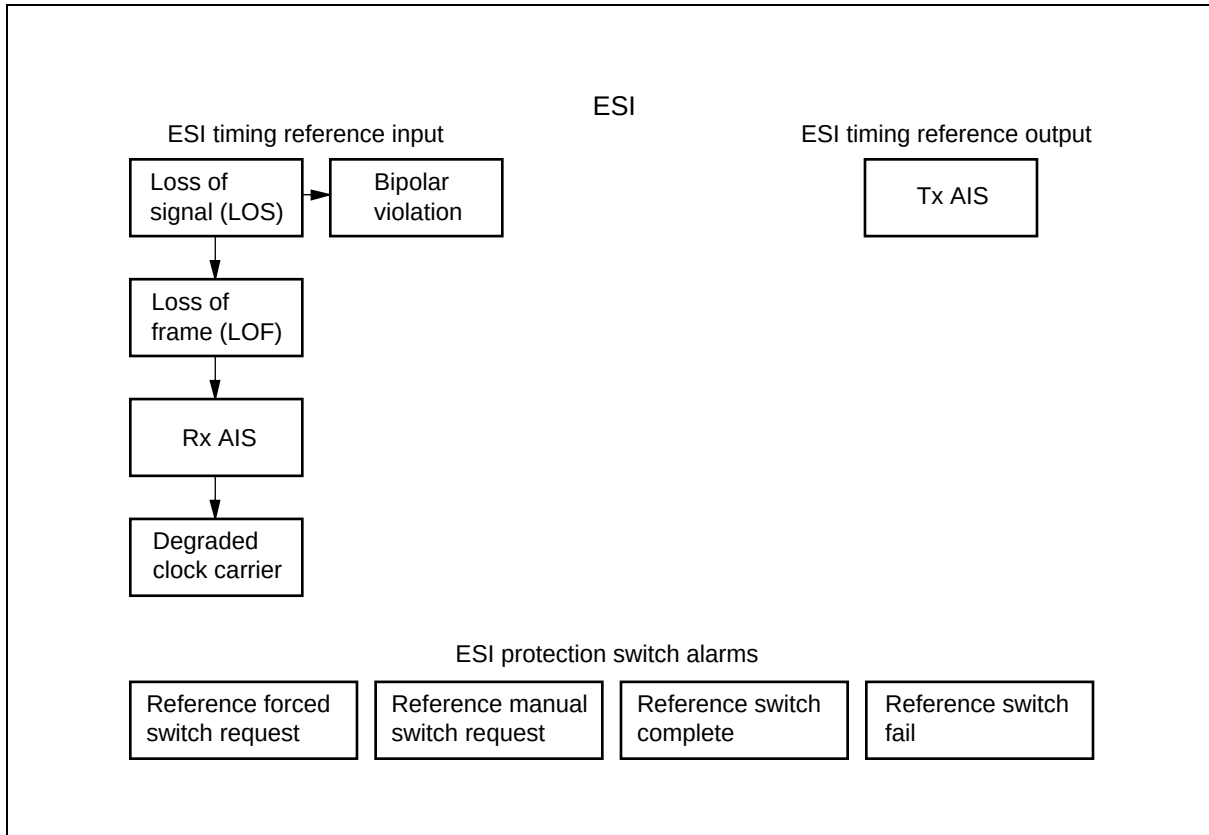
PC-11498

**Figure 2-3 (part 3 of 3)**  
**Facility alarm hierarchies**

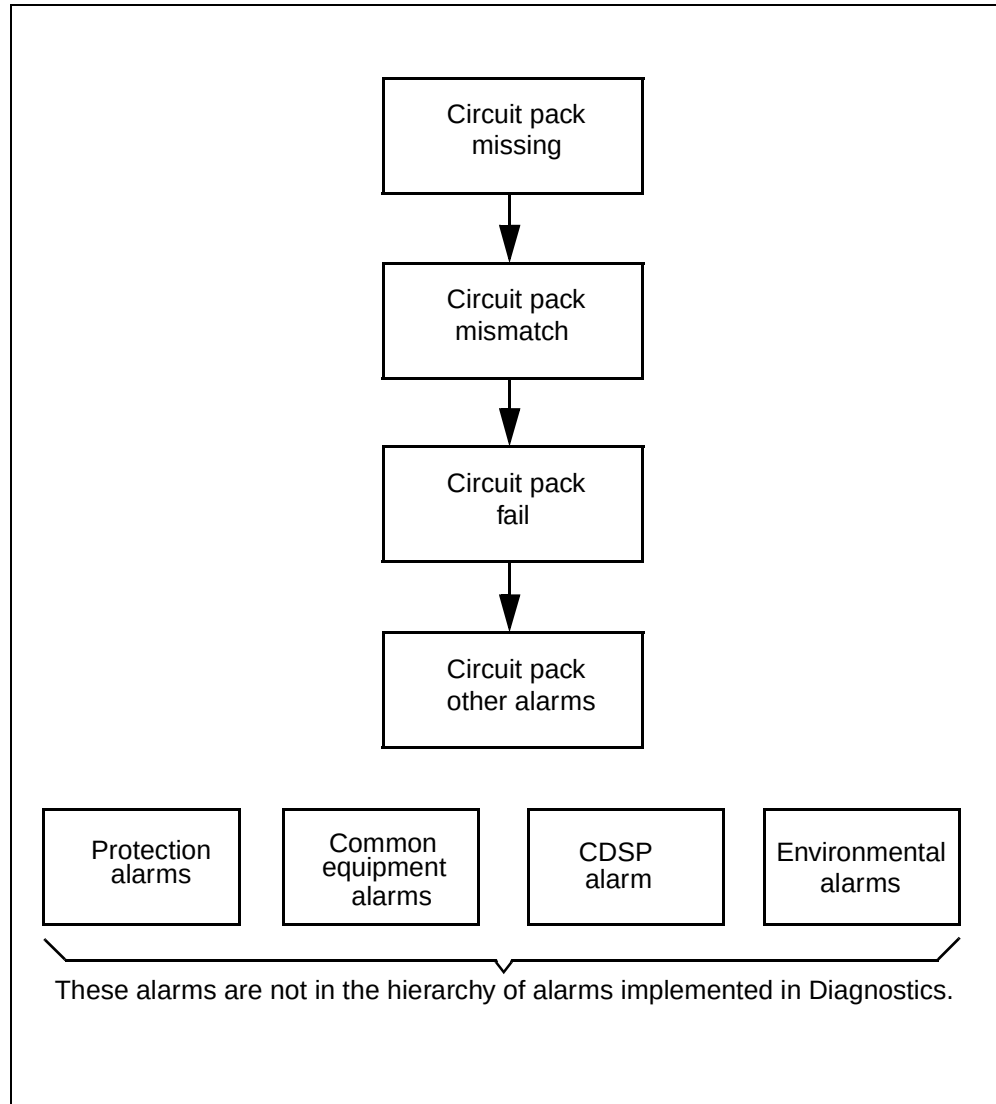
**Figure 2-4**  
**Equipment alarm hierarchy**

Equipment alarms identify the nature of a failure and the affected equipment. Figure 2-4 on page 2-6 shows the hierarchy of the three common alarms to all circuit packs (except the processor circuit pack).

Inserting a failed DS1/VT mapper circuit pack by mistake into a slot provisioned for a DS3/STS mapper raises a Circuit pack mismatch alarm. The Circuit pack failure alarm is not raised because it is lower in the hierarchy.

The OPC, MIC, and ESI common-equipment circuit packs also use the hierarchy shown in Figure 2-4 on page 2-6.

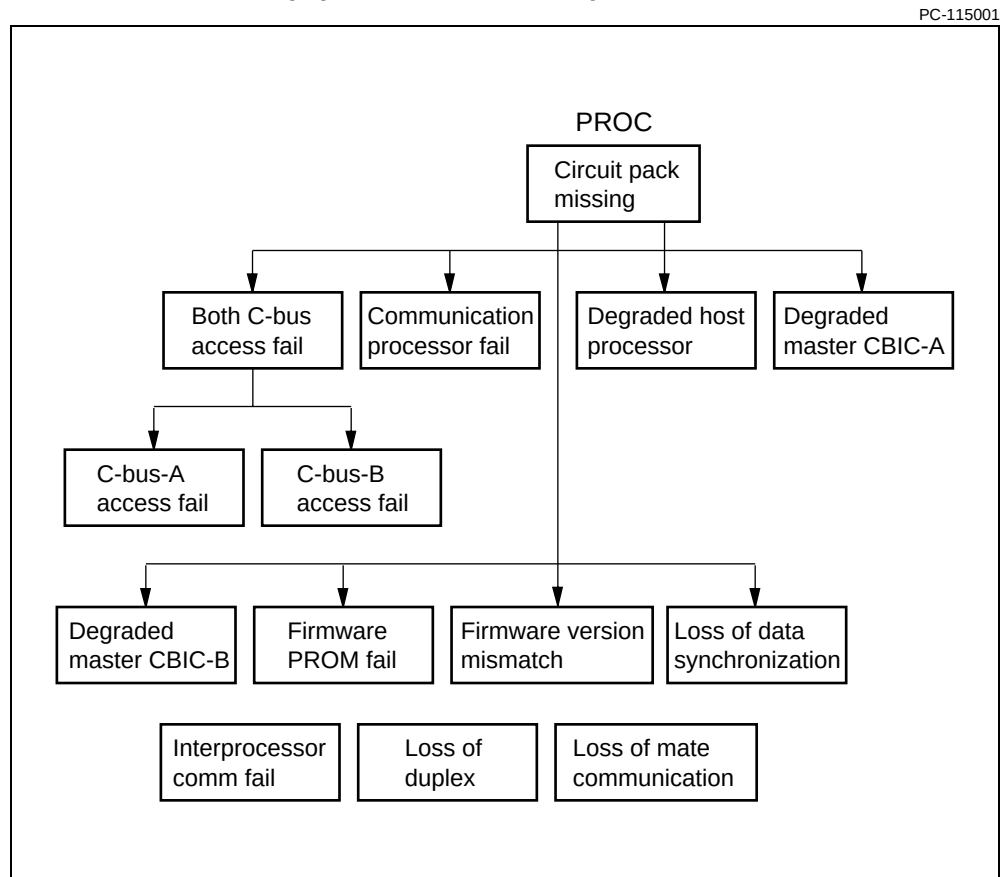
**Figure 2-5**  
Processor common-equipment alarm hierarchy

The processor common-equipment circuit pack (Proc) follows its own alarm hierarchy, which is shown in Figure 2-5.

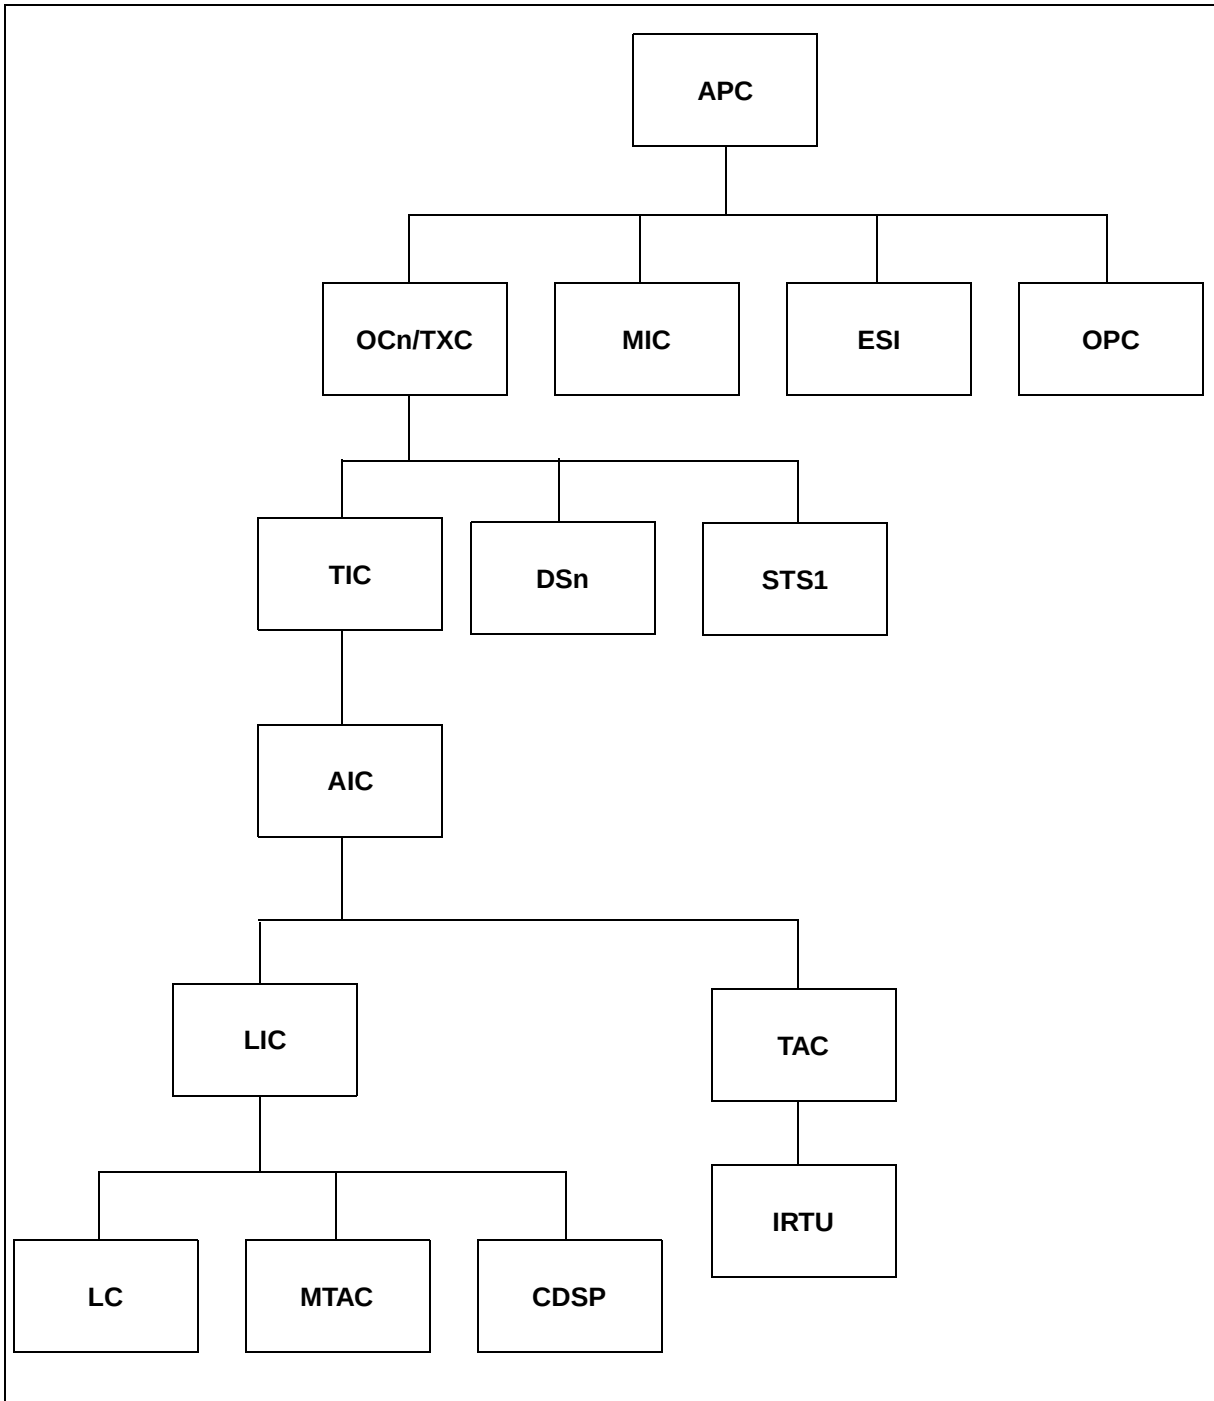
**Figure 2-6**  
**Parent equipment hierarchy**

Figure 2-6 on page 2-9 shows the parent equipment hierarchy for AccessNode circuit packs.

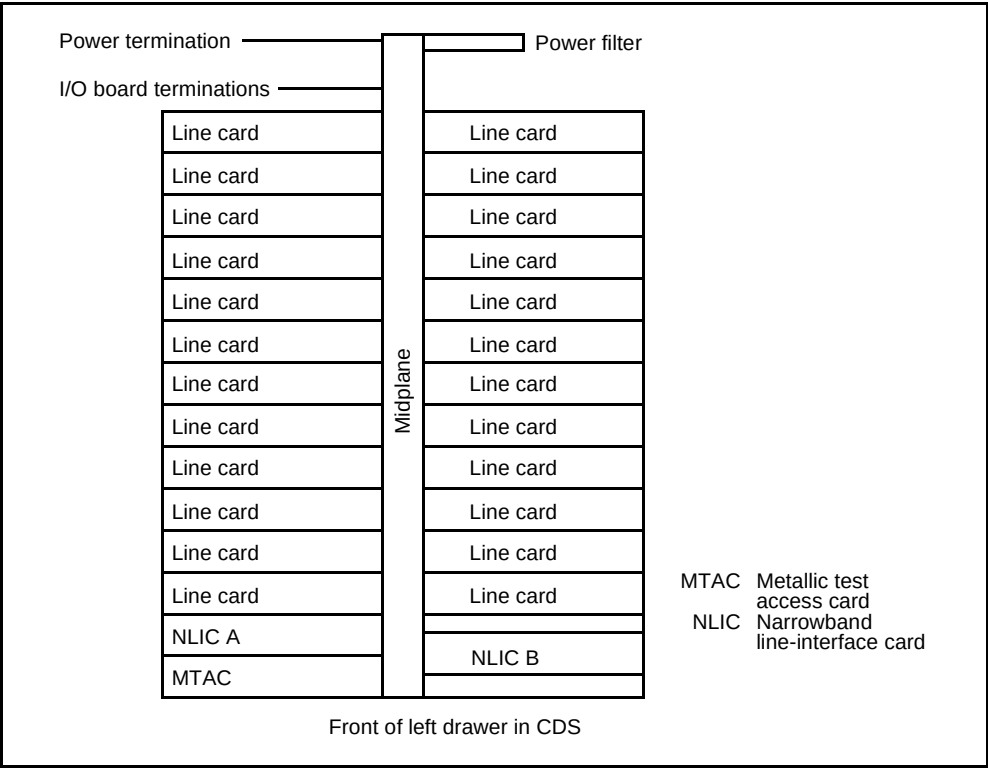
- 4      At the network element breaker interface panel (BIP), power down the affected copper-distribution shelf by turning off the CDS Power breaker and the Talk Battery breaker for the affected copper-distribution shelf.  
*Service is lost to all line cards housed in the affected copper-distribution shelf.*
- 5      Unlatch and open the left line card drawer.  
**Note:** Depress the catches on the top and bottom of the drawer so that it slides out far enough to give access to the power filter. The power filter plugs into the midplane at the back of the drawer (on the side of the drawer closest to the center of the shelf).

Figure 3-1  
Power filter (NT4K63) location in the left drawer of a CDS

| Step | Action |
|---|---|
| 6 | Insert an NT4K63AA power filter card into the rear most slot on the right side of the drawer as shown in Figure 3-1 on 3-34. |

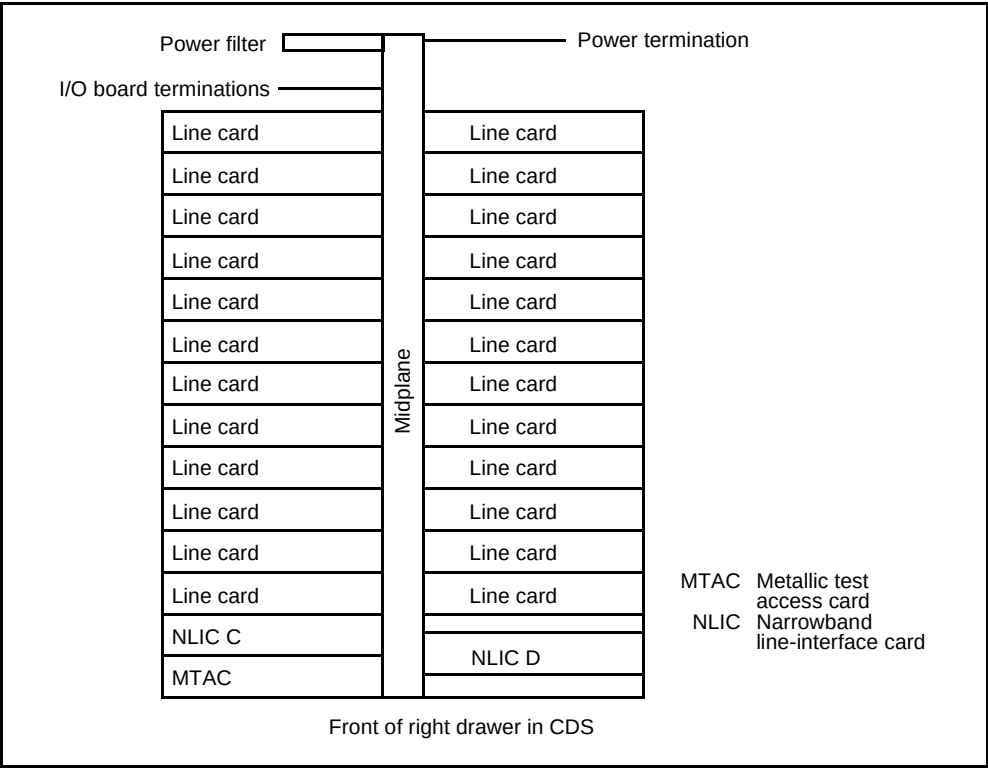
- 4    At the network element breaker interface panel (BIP), power down the affected copper-distribution shelf by turning off the CDS Power breaker and the Talk Battery breaker for the affected copper-distribution shelf.  
*Service is lost to all line cards housed in the affected copper-distribution shelf.*
- 5    Unlatch and open the left line card drawer.  
**Note:** Depress the catches on the top and bottom of the drawer so that it slides out far enough to give access to the power filter. The power filter plugs into the midplane at the back of the drawer (on the side of the drawer closest to the center of the shelf).

Figure 3-2  
Power filter (NT4K63) location in the right drawer of a CDS

| Step | Action |
|---|---|
| 6 | Insert an NT4K63AA power filter card into the rear most slot on the left side of the drawer as shown in Figure 3-2 on page 3-37. |

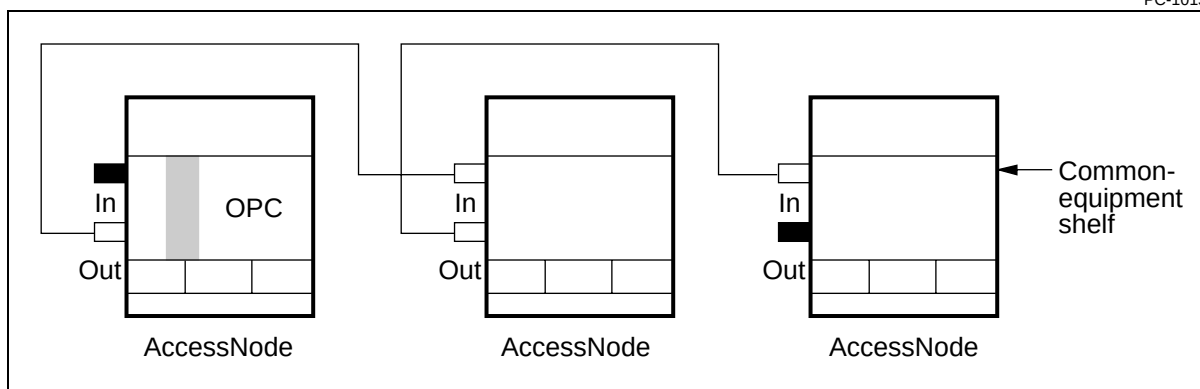
PC-10150

Defective cabling or termination plugs have been known to cause these alarms (link or performance degraded). If the alarm cannot be cleared after checking cable installation, try another cable/termination plug or verify the pin-outs listed in *Bay in Central Office Installation Manual for ABM*, 323-3001-201.

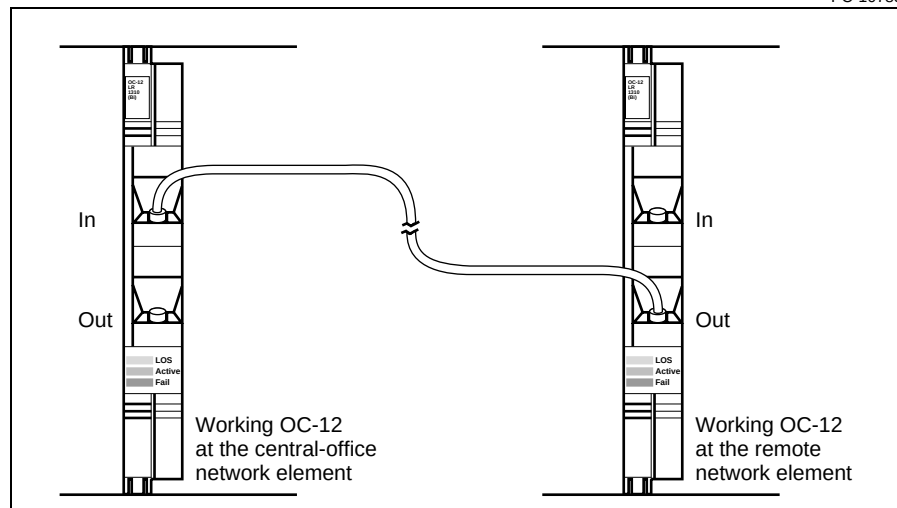
PC-10783

| If fiber-optic cables are | Then | not properly connected | go to step 2 | properly connected | go to step 3 |
| If fiber-optic cables are | Then | | | | | | |
| not properly connected | go to step 2 | | | | | | |
| properly connected | go to step 3 | | | | | | |
| 2 | <p>Connect fibers from the G1 (working) optics at the FCOT to the G1 (working) optics at the RFT. The following figure shows how the OC12 Rx at one end connects to the Tx at the other OC12 (same for OC3). Only one connection is shown for clarity. There is a corresponding Tx to Rx connection.</p> | | | | | | |

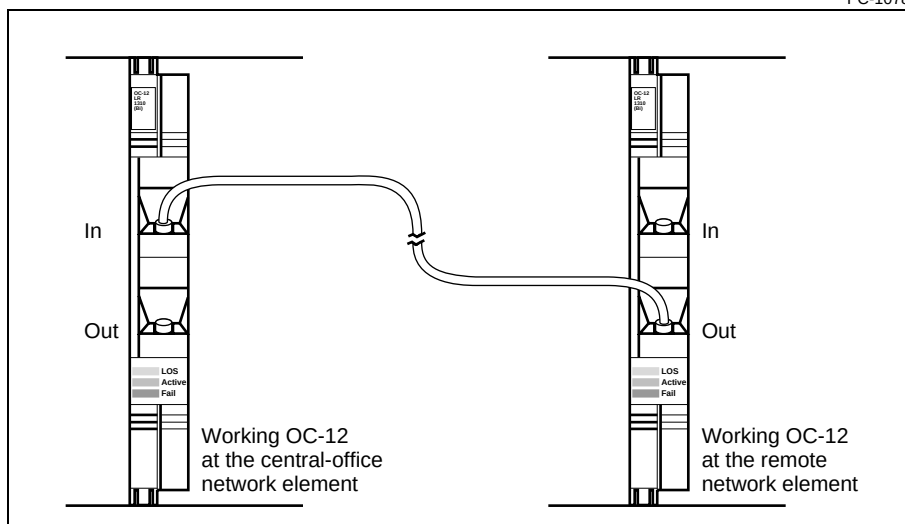
PC-10783

| Step | Action |
|---|---|
| 1 | <p>Verify all origination and termination points for the fiber-optic cables connected to the OC3 or OC-12 circuit packs. Fibers from the G1 (working) OC3 or OC-12 at the FCOT must connect to the G1 (working) OC3 or OC-12 at the RFT. The proper connection is from receiver (Rx) to transmitter (Tx).</p> <p>The following figure shows how the OC12 Rx at one end, connects to the Tx at the other. Only one connection is shown for clarity. There is a corresponding Tx to Rx connection.</p> |

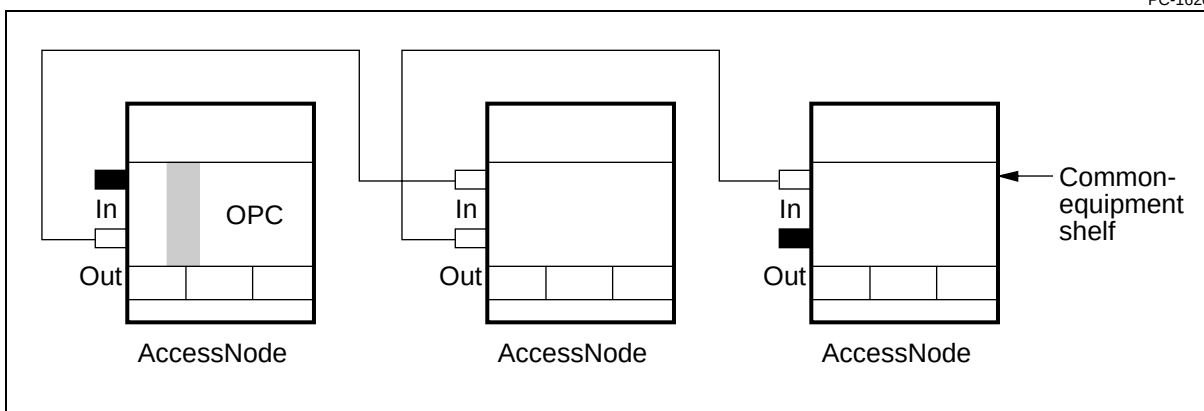
PC-16209

| Step | Action |
|---|---|
| 1 | <p>Verify the control network cabling at each connection point on each shelf. The following figure shows a block diagram of a typical CNET connection between three common-equipment shelves. The output of one shelf connects to the input of the next shelf. Unused CNET connectors must be terminated with an NT7E5072 termination plug.</p> <p>For ABM shelves: CNET in is J10, and CNET out is J09 on the side interconnect left</p> <p>For TBM shelves: CNET in is J11, and CNET out is J02 on the side interconnect left</p> |

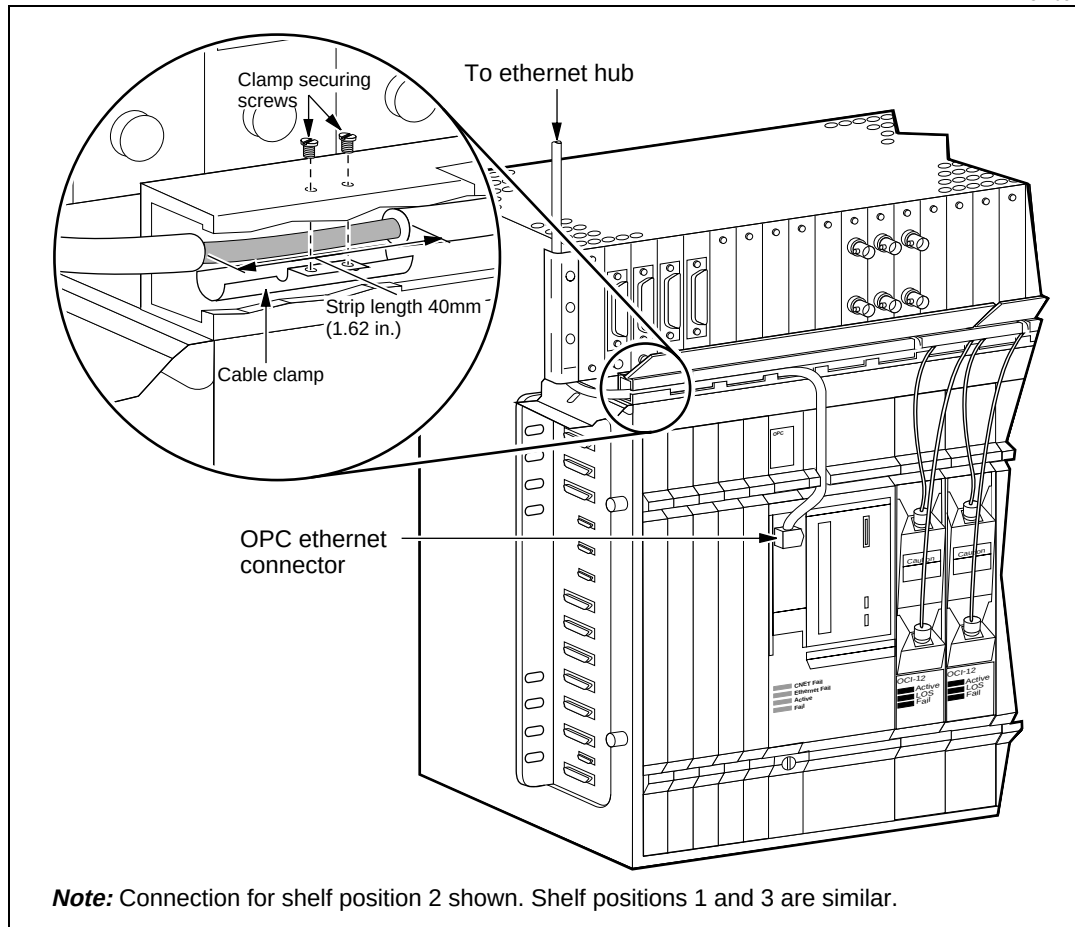
PC-10347

| 3 | Check the condition of the Ethernet cable and its connections to the OPC module and the X-terminal or workstation. The location of the Ethernet connector on the OPC module is shown in the following figure. |

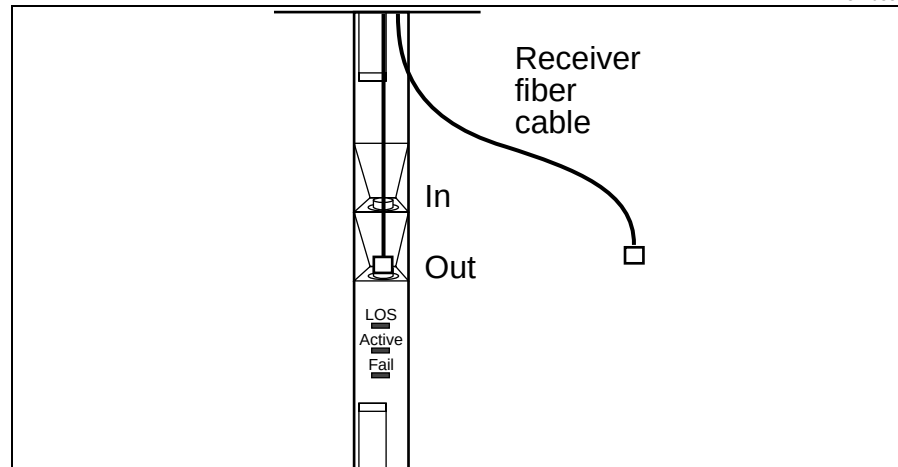
PC-10836

| 6 | Disconnect the receiver fiber cable from the Rx connector on the suspect optical interface (this is the optical interface that is no longer carrying traffic). |

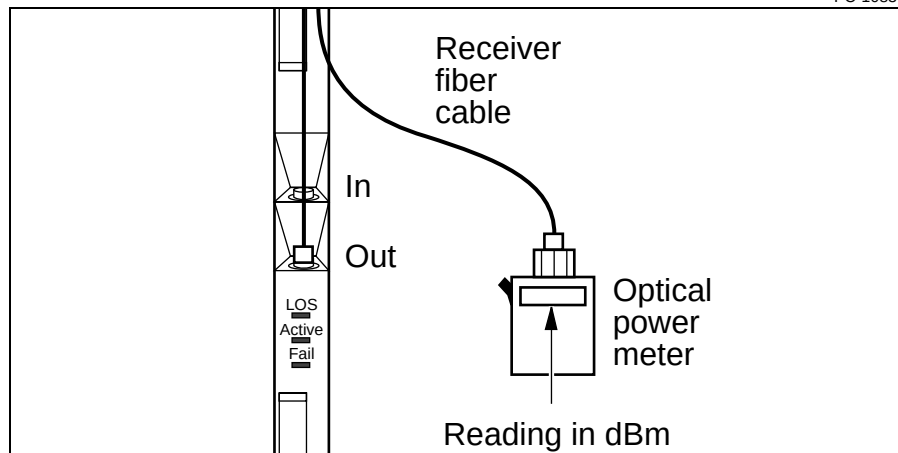
PC-10837

| 8 | <p>Connect the receiver fiber cable to an optical power meter and measure the receiver optical power level:</p> <p>For long reach OC-3 (NT7E01CA, CB, CC or CD): measure for a level greater than or equal to <math>-34.0</math> dBm (for example <math>-32.0</math> dBm).</p> <p>For intermediate reach OC-3 (NT7E01DA, DB, DC or DD) measure for a level greater than or equal to <math>-28.0</math> dBm (for example <math>-26.0</math> dBm).</p> <p>For long reach OC-12 (NT7E02KA, KB, KC, or KD): measure for a level greater than or equal to <math>-32.0</math> dBm (for example <math>-28.0</math> dBm).</p> <p>For intermediate reach OC-12 (NT7E02LA, LB, LC, or LD) measure for a level greater than or equal to <math>-24.5</math> dBm (for example <math>-23.0</math> dBm).</p> |

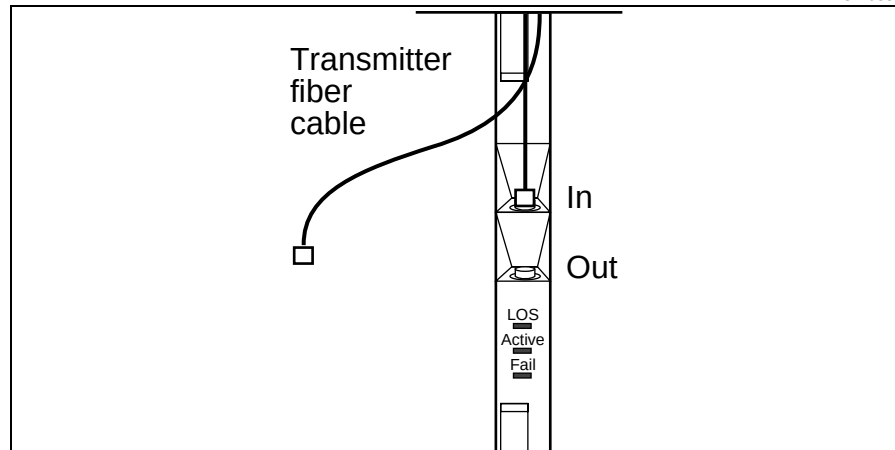
PC-10838

| 9 | At the far-end optical interface that is not carrying traffic, disconnect the transmitter fiber cable from the Tx connector on the circuit pack. |

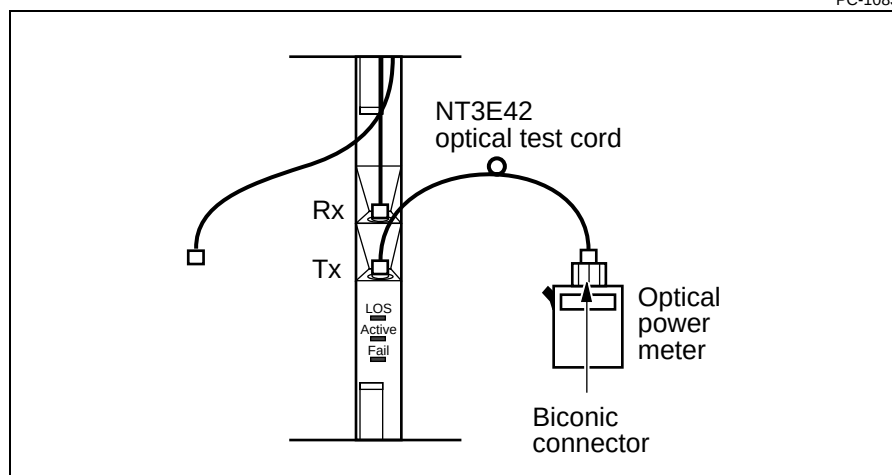
PC-10839

| 11 | <p>Connect one end of the optical test cord to the optical power meter through the 2017 biconic adapter, and connect the other end to the transmitter optical connector on the circuit pack. Measure the transmit optical level.</p> <p>For long reach OC-3 (NT7E01CA, CB, CC or CD): measure for a level greater than or equal to <math>-5.0</math> dBm (for example <math>-2.5</math> dBm).</p> <p>For intermediate reach OC-3 (NT7E01DA, DB, DC or DD) measure for a level greater than or equal to <math>-15.0</math> dBm (for example <math>-14.0</math> dBm).</p> <p>For long reach OC-12 (NT7E02KA, KB, KC, or KD): measure for a level greater than or equal to <math>-3.0</math> dBm (for example <math>-2.5</math> dBm).</p> <p>For intermediate reach OC-12 (NT7E02LA, LB, LC, or LD) measure for a level greater than or equal to <math>-4.5</math> dBm (for example <math>-4.0</math> dBm).</p> |

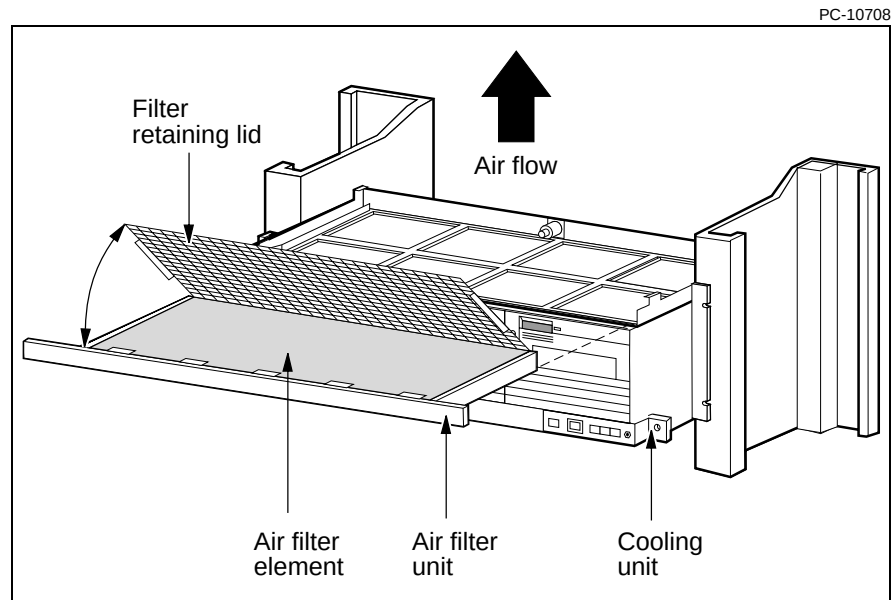
| Step | Action |
|---|---|
| 8 | Lift the filter retaining lid, and inspect the condition of the air filter, as shown following. |

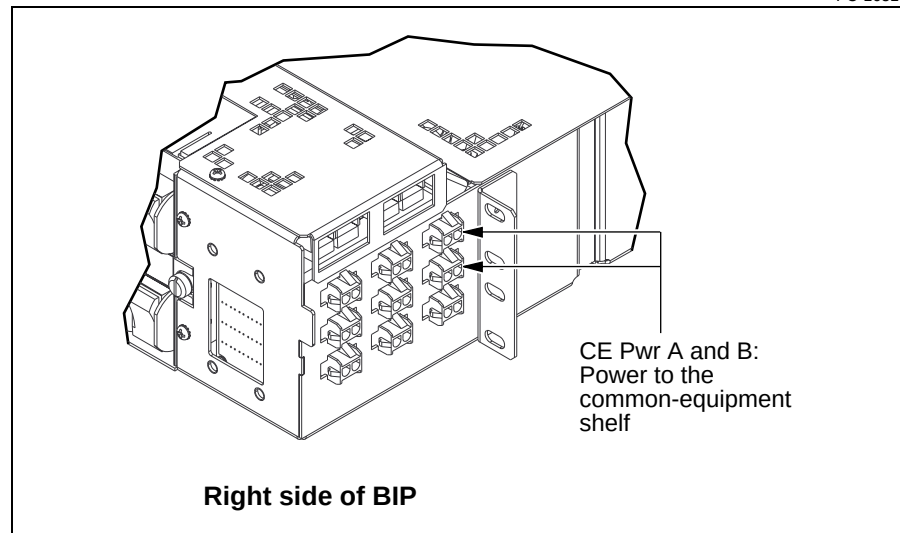
PC-16513

| 8 | Disconnect the common-equipment power cable from the side of the BIP. |

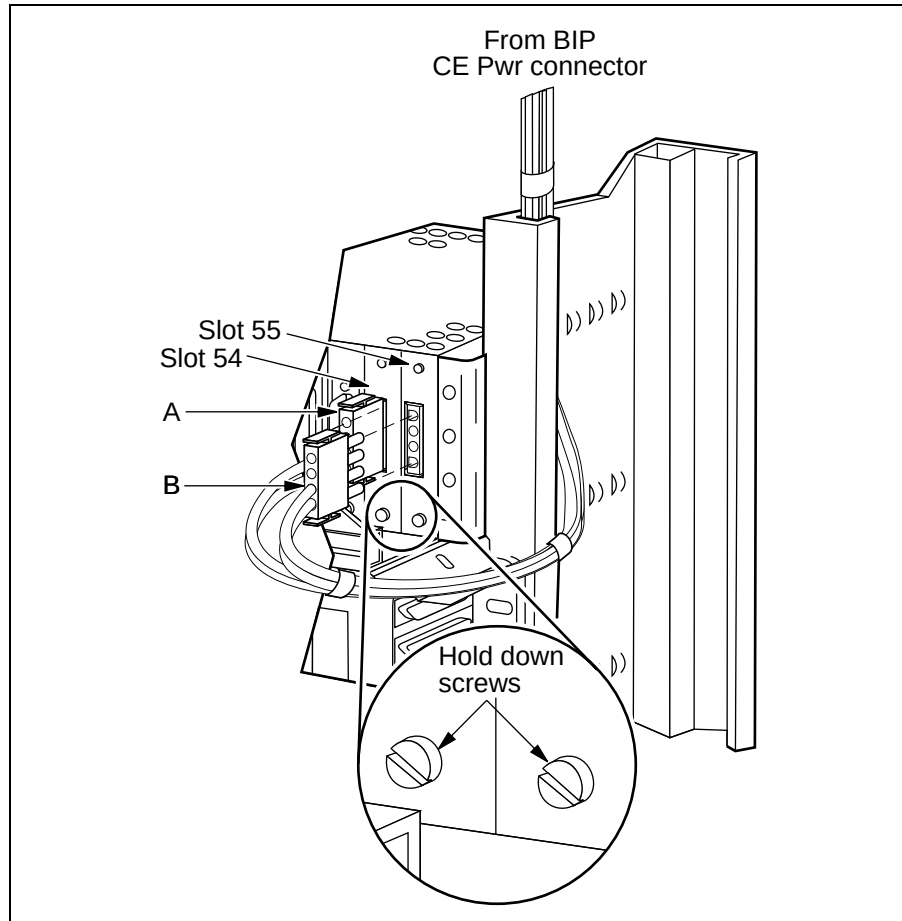
PC-11480

- 5** Connect a digital voltmeter across the power cable connector and measure the voltage.

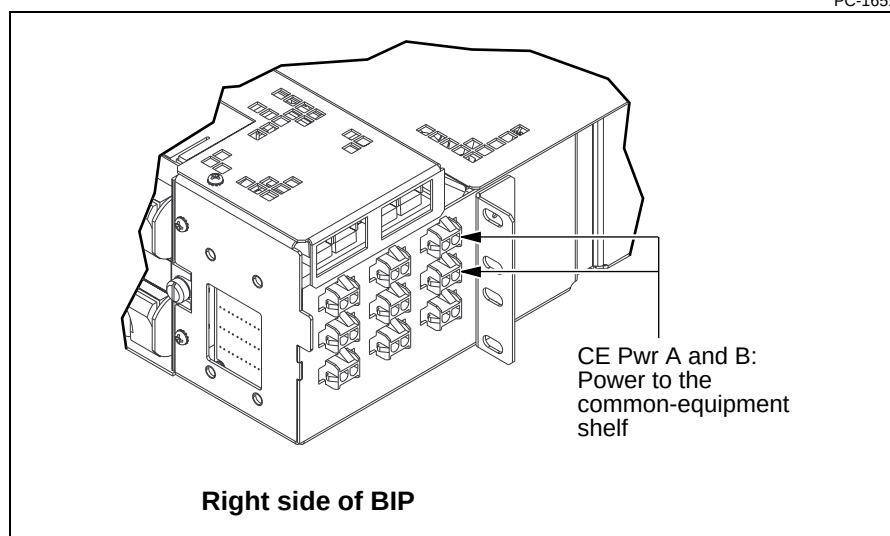
PC-16511

| 8 | <p>Disconnect the common-equipment power cable from the side of the BIP.</p> |

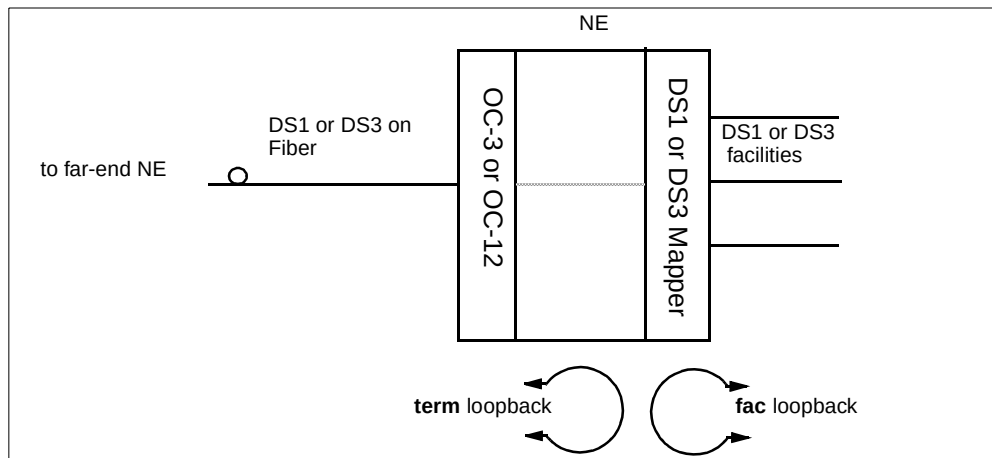
A facility loopback takes the incoming (copper) DS1 or DS3 and loops it back to the source, as shown following. A terminal loopback takes the incoming (optical) DS1 or DS3 and loops it back to the far-end network element.
