**OPERATION AND MAINTENANCE
HOT STANDBY
DR 6/11-135A AND 135EC
TWT AMPLIFIER
TRANSMITTER SUBROUTINES**

This section contains the subroutines (SR) referenced from the transmitter trouble-clearing main routines (MR), main subroutines (MSR), and transmitter test and adjustment subroutines (TASR).

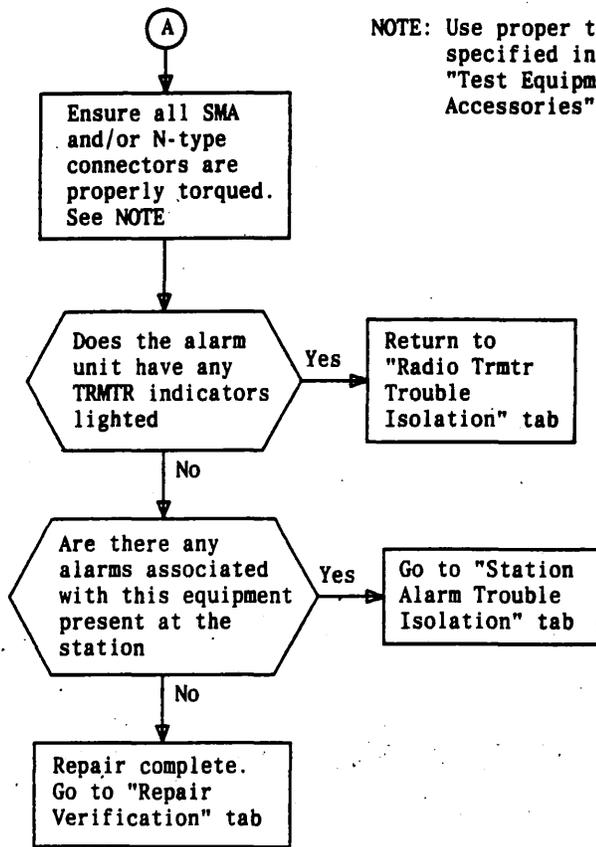
SR 1—Condition Transmitter for Repair Verification (Sheet 2 of 2)

NOTE: Use proper torque wrench specified in Table C of "Test Equipment and Accessories" tab.

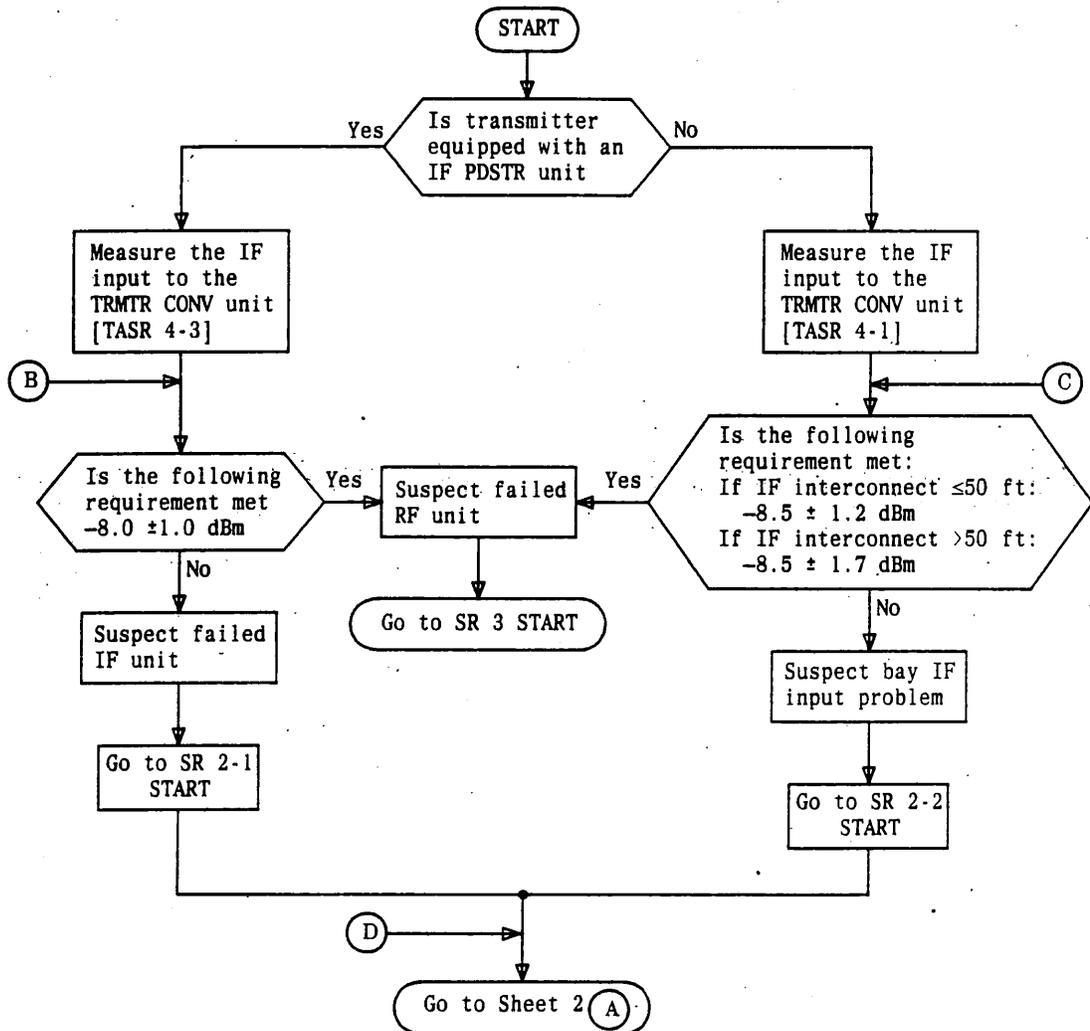
SR 2—Isolating Manual Gain Problems to Before or After TRMTR CONV Unit (Sheet 1 of 2)

CAUTION: THIS PROCEDURE IS SERVICE AFFECTING UNLESS THE PROPER MANUAL PROTECTION SWITCHING OPERATION HAS BEEN PERFORMED

PREREQUISITE: 1. PWR OUT OF RANGE indicator lighted.
2. RF MON power not adjustable to DATA CARD value.

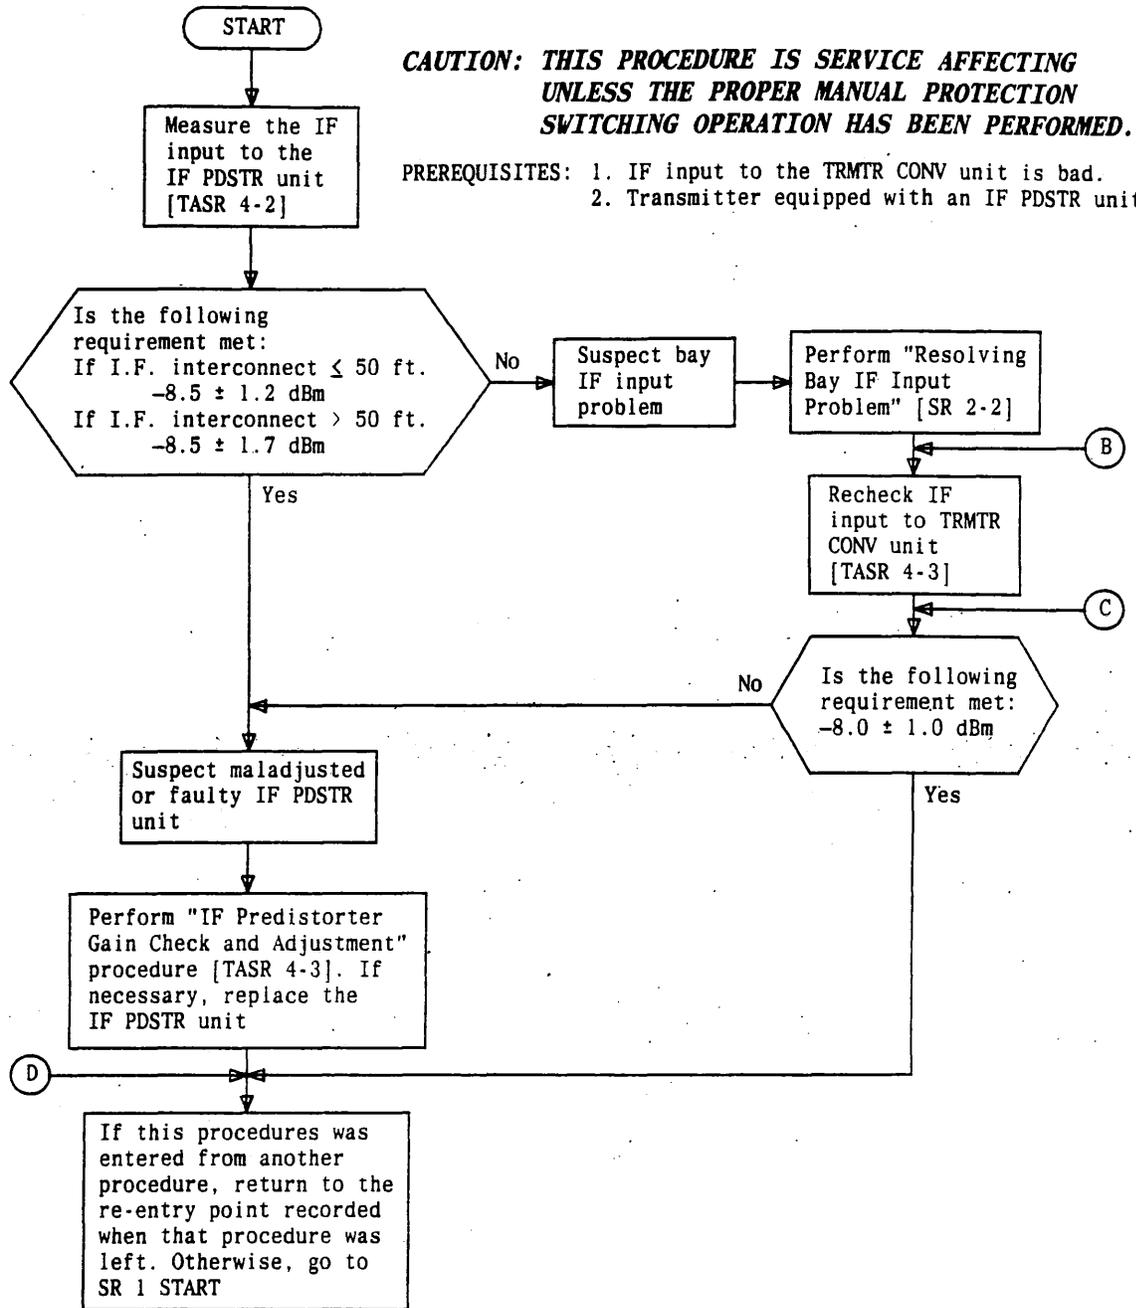
SR 2-1—Resolving Manual Gain Problems Before TRMTR CONV Unit

PREREQUISITES: 1. IF input to the TRMTR CONV unit is bad.
2. Transmitter equipped with an IF PDSTR unit.

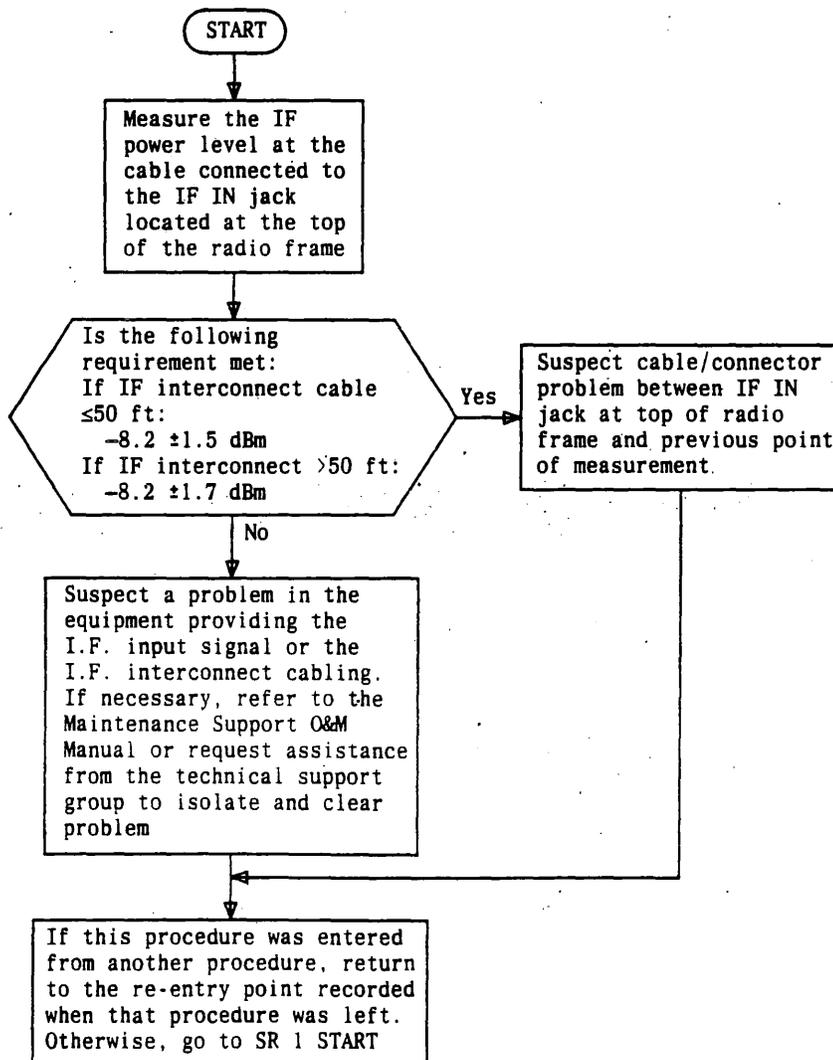
SR 2-2—Resolving Bay IF Input Level Problems

PREREQUISITE: I.F. input to the IF PDSTR unit is bad, or the I.F. input to the TRMTR CONV unit is bad when the I.F. PDSTR unit is not equipped.

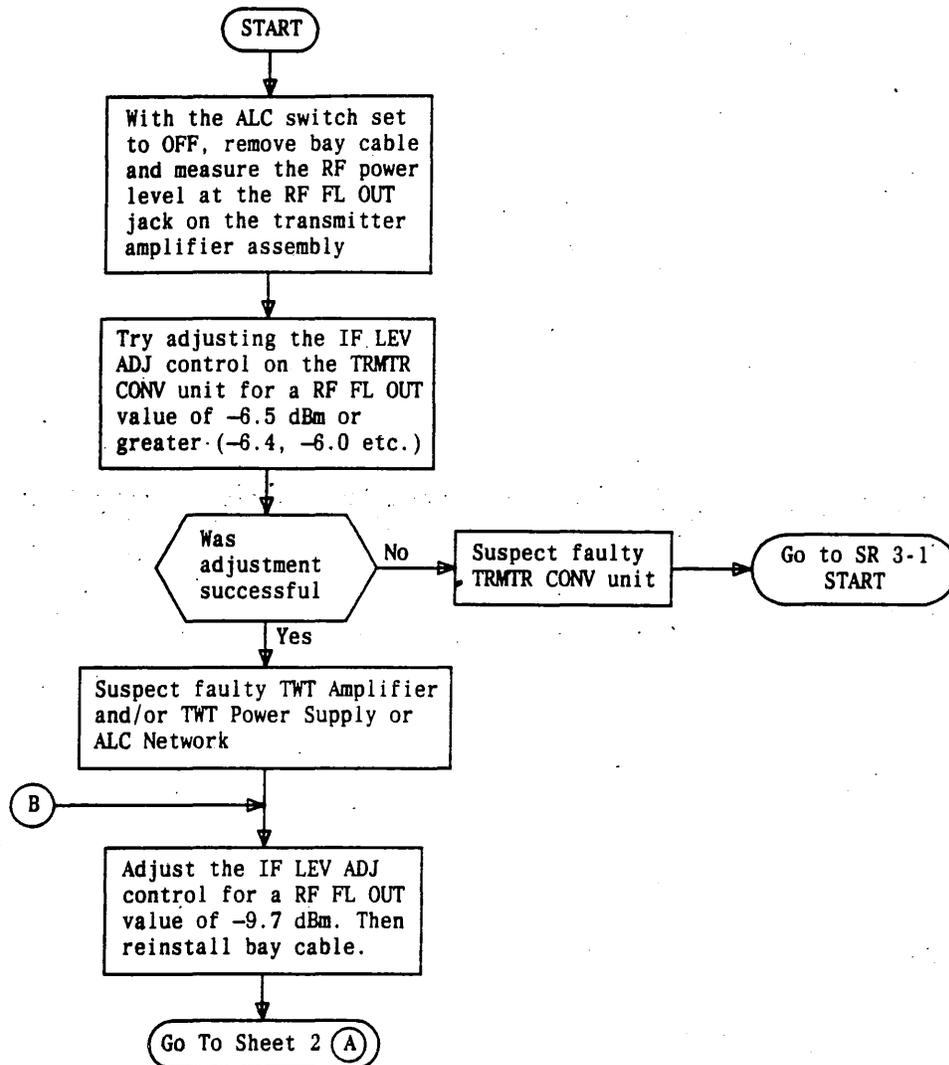
SR 3—Isolating Manual Gain Problems to Within or After TRMTR CONV Unit (Sheet 1 of 2)

PREREQUISITE: I.F. input to up-converter is good but
R.F. output at RF MON jack is bad.

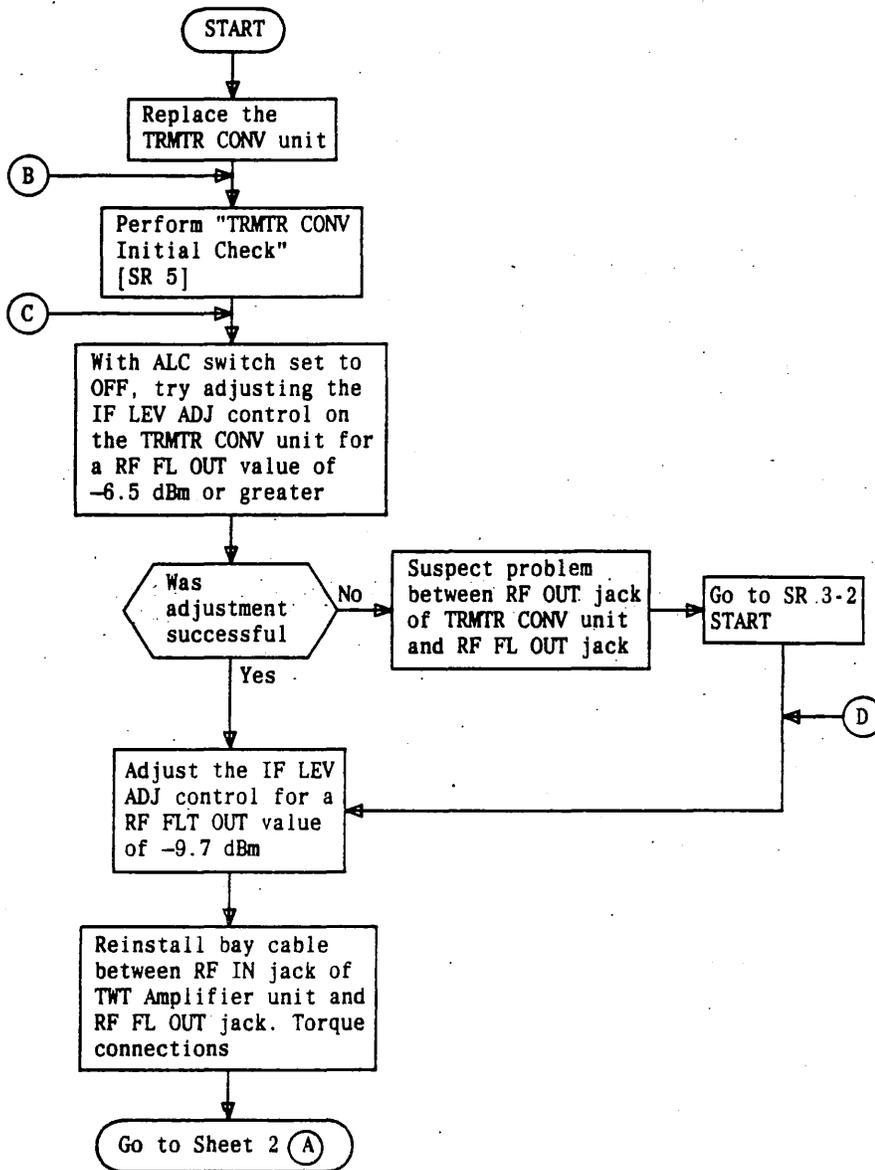
SR 3-1—Resolving Suspected TRMTR CONV Unit Manual Gain Problem (Sheet 1 of 2)

PREREQUISITE: I.F. input to up-converter is good but low or no output level at input to TWT Amplifier (RF FL OUT jack)

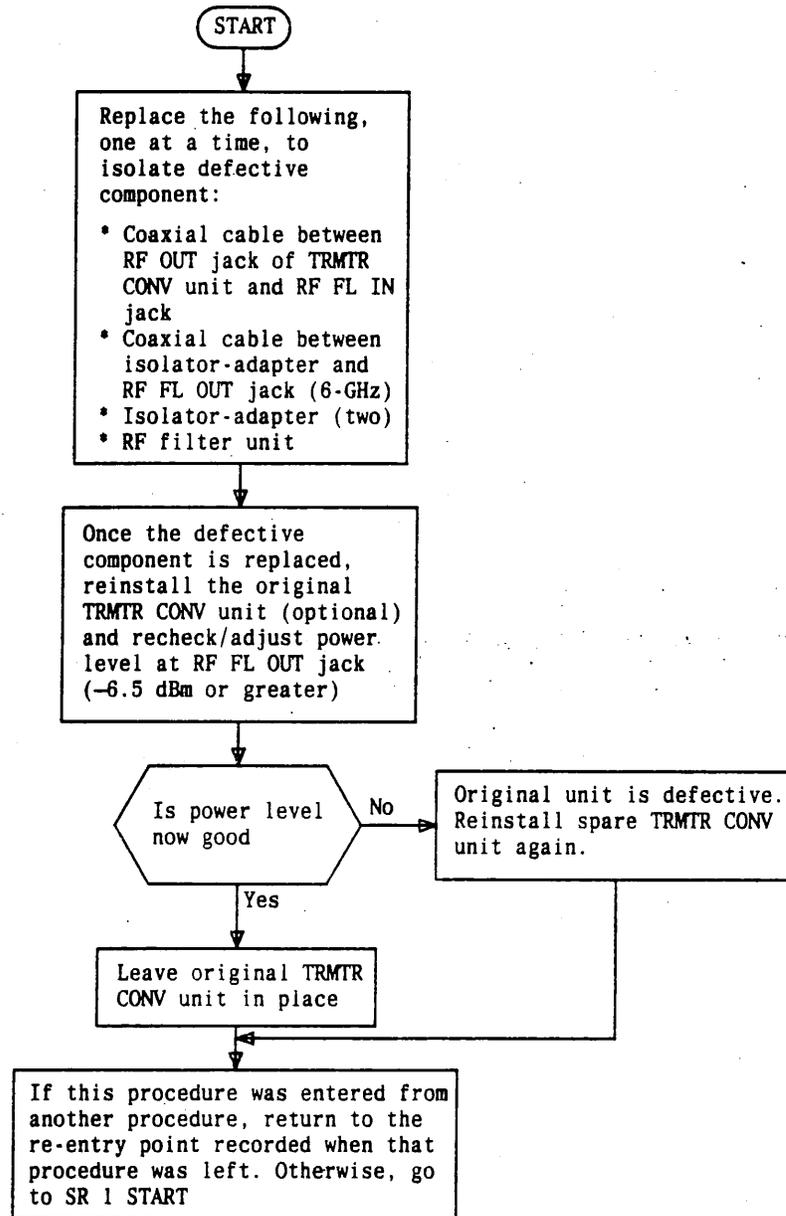
SR 3-2—Resolving Suspected Filter/Cable Problem Between Up-Converter Output and Amplifier Input

PREREQUISITE: Suspected problem between up-converter output and TWT Amplifier input

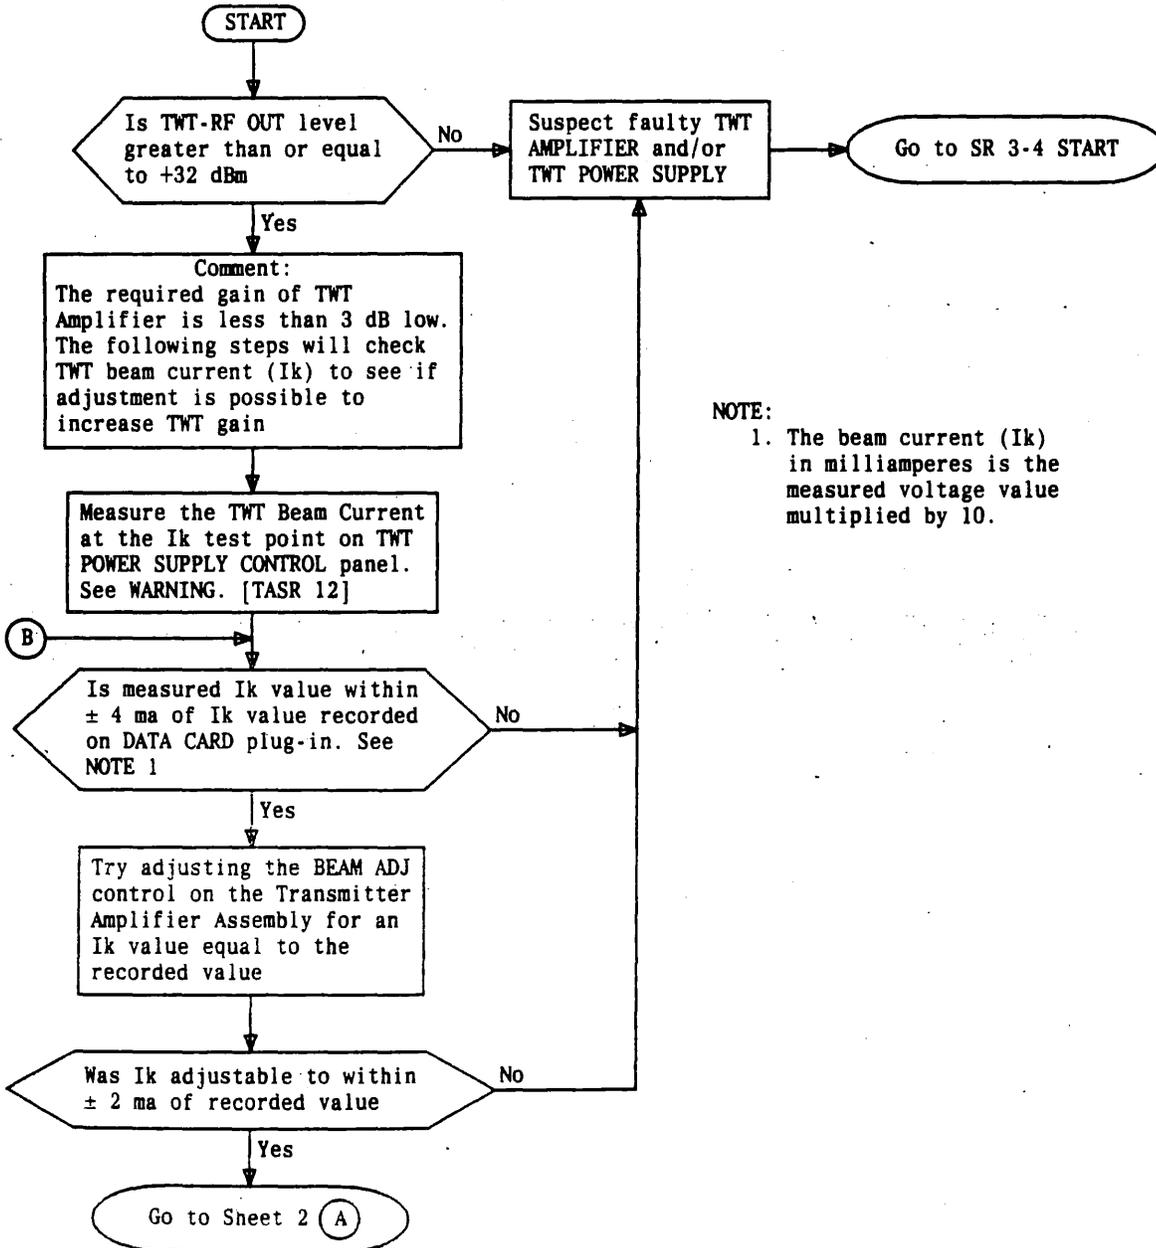
SR 3-3—Adjustment Attempt to Resolve Suspected TWT Amplifier Low Gain Problem (Sheet 1 of 3)

PREREQUISITE: RF input to TWT Amplifier is good but minimum gain of TWT Amplifier is low

NOTE:
1. The beam current (I_k) in milliamperes is the measured voltage value multiplied by 10.

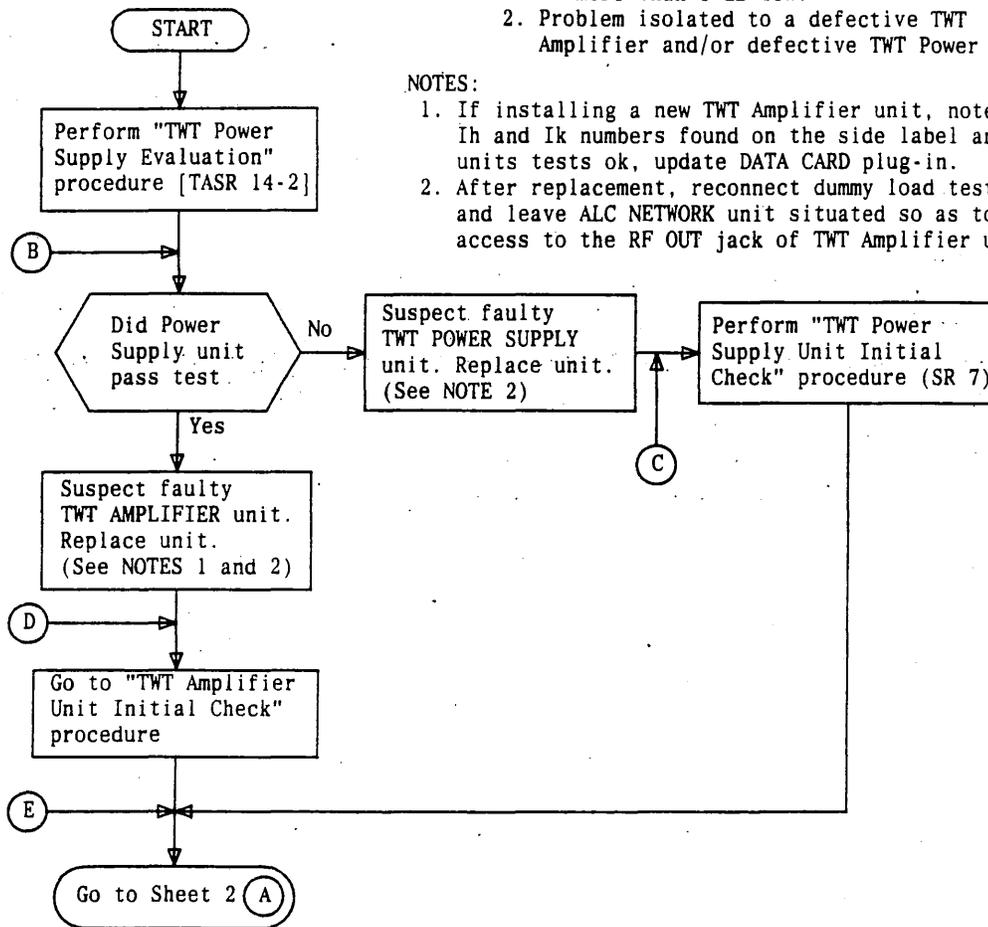
SR 3-4—Resolving Suspected TWT Amplifier Power Supply Unit Manual Gain Problems (Sheet 1 of 3)

- PREREQUISITES: 1. RF input to TWT Amplifier is good but required minimum gain of TWT Amplifier is more than 3 dB low.
 2. Problem isolated to a defective TWT Amplifier and/or defective TWT Power Supply.

1. If installing a new TWT Amplifier unit, note the I_h and I_k numbers found on the side label and if units tests ok, update DATA CARD plug-in.
2. After replacement, reconnect dummy load test cable and leave ALC NETWORK unit situated so as to allow access to the RF OUT jack of TWT Amplifier unit.

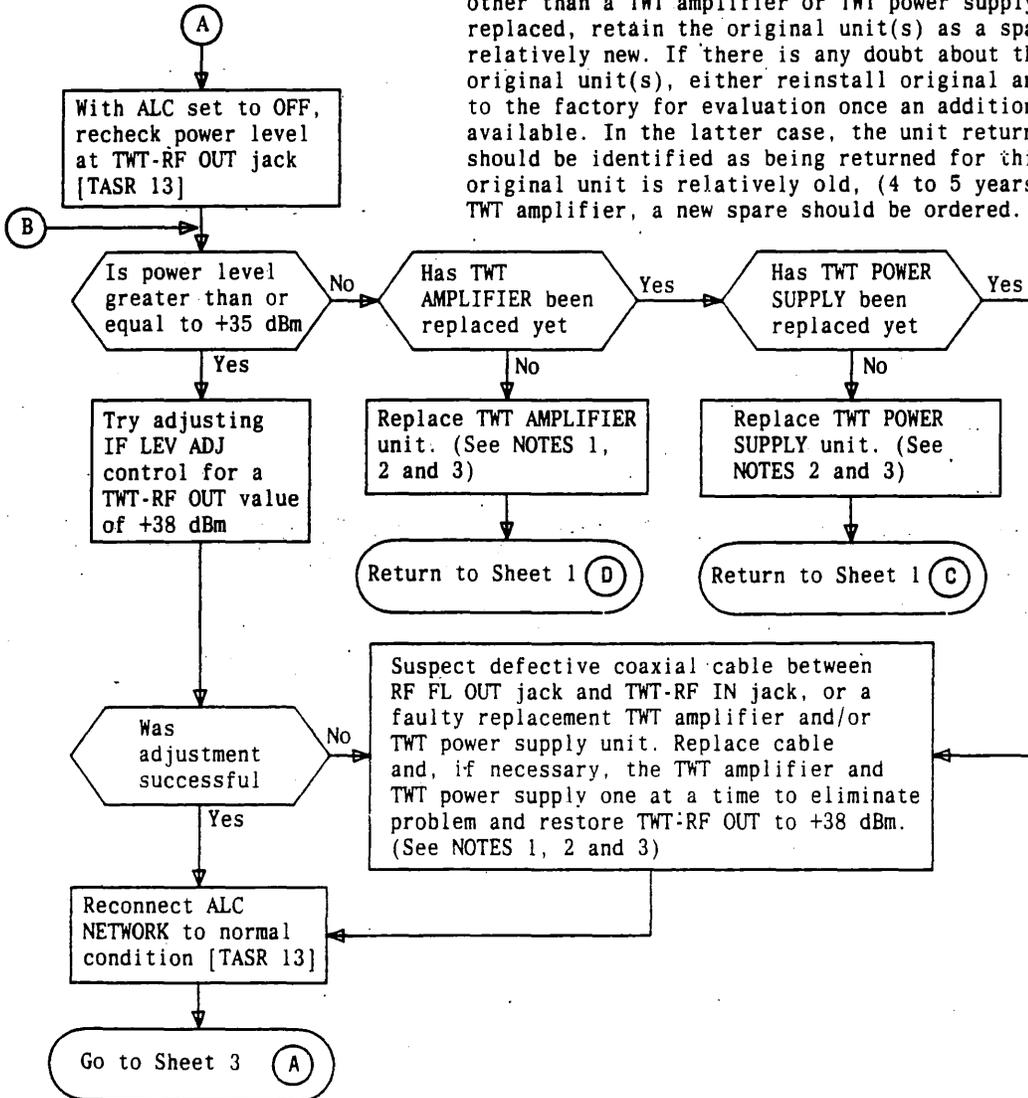
SR 3-4—Resolving Suspected TWT Amplifier Power Supply Unit Manual Gain Problems (Sheet 2 of 3)

1. If installing a new TWT Amplifier unit, note the I_h and I_k numbers found on the side label and if unit tests ok update DATA CARD plugin.
2. After replacement, reconnect dummy load test cable and leave ALC NETWORK unit situated so as to allow access to the RF OUT jack of TWT Amplifier unit.

3. If the ultimate source of the problem is found to be something other than a TWT amplifier or TWT power supply that has been replaced, retain the original unit(s) as a spare if it is relatively new. If there is any doubt about the quality of the original unit(s), either reinstall original and retest or return to the factory for evaluation once an additional spare is available. In the latter case, the unit returned to the factory should be identified as being returned for this purpose. If the original unit is relatively old, (4 to 5 years) especially the TWT amplifier, a new spare should be ordered.

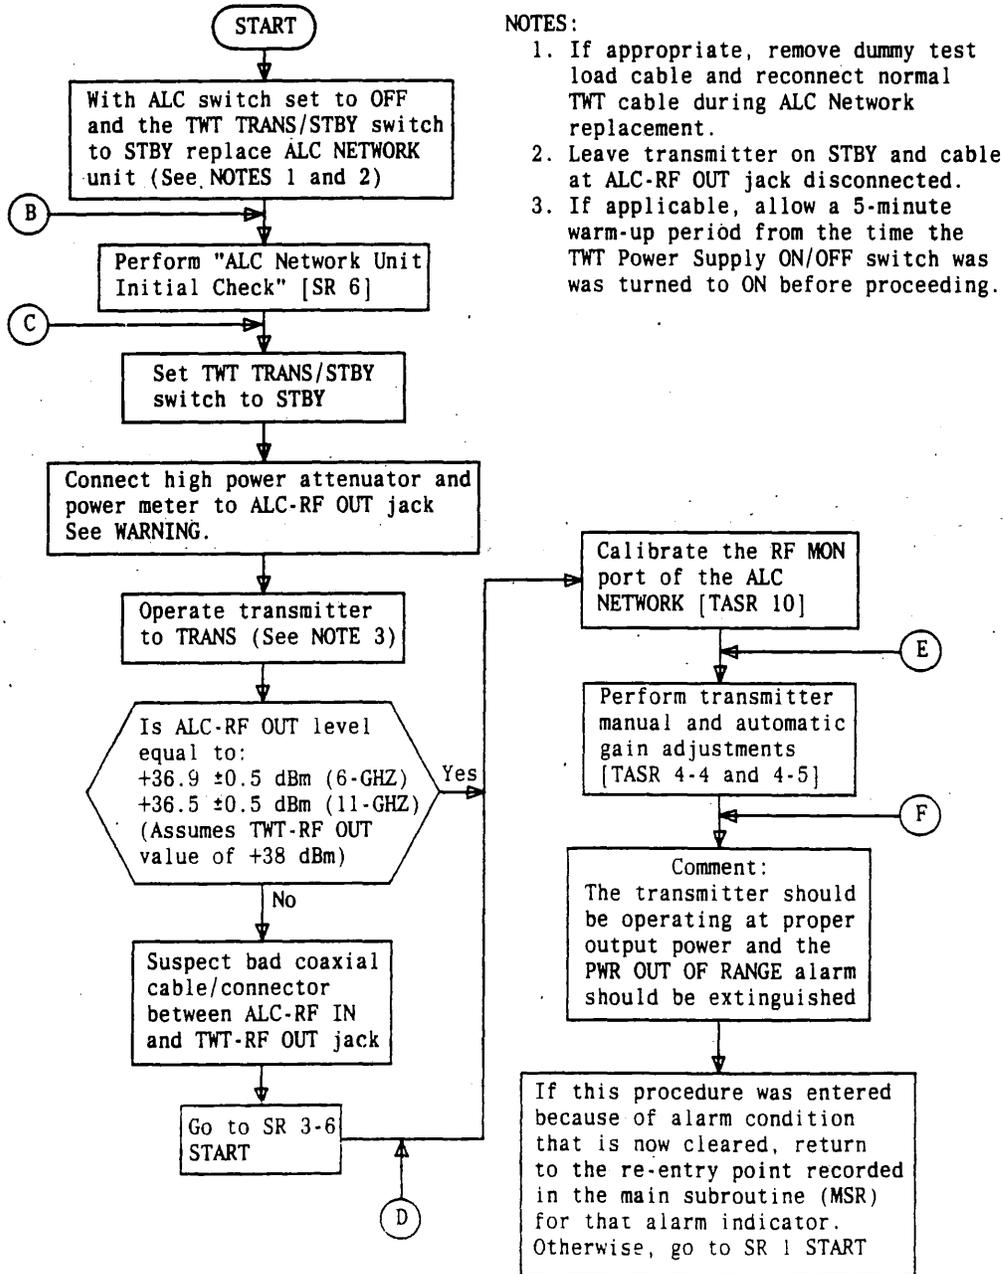
SR 3-5—Resolving Suspected ALC NETWORK Unit Manual Gain Problems

- PREREQUISITES:**
1. R.F. output of TWT Amplifier is good (+38 dBm) but low or no output level at ALC NETWORK unit RF MON/RF OUT jack
 2. Power problem isolated to a defective ALC NETWORK unit.

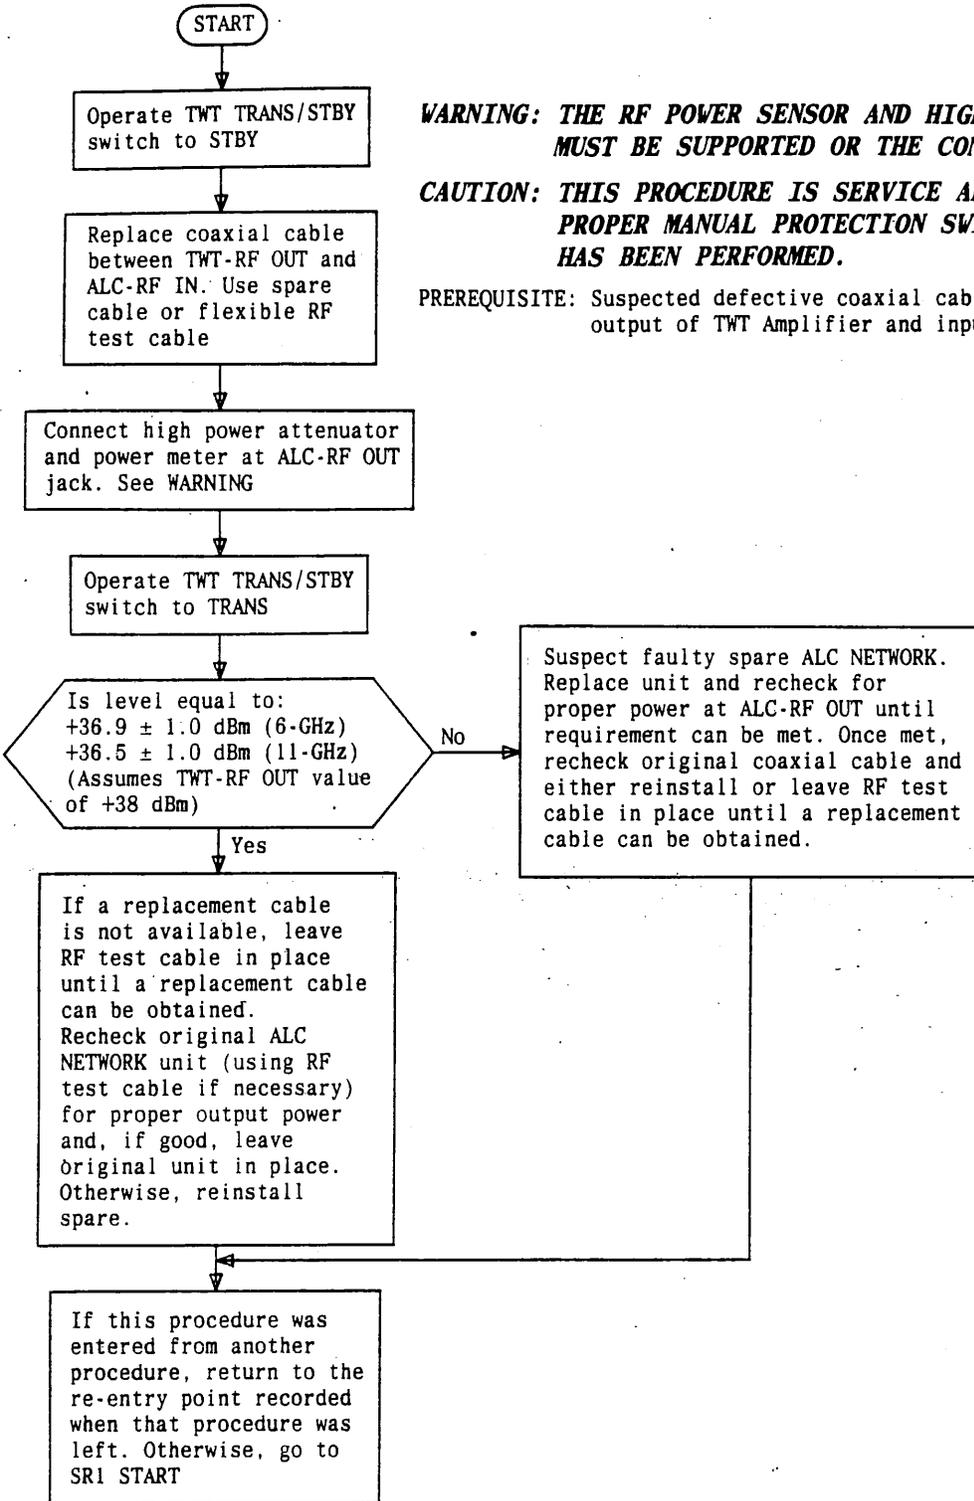
SR 3-6—Resolving Suspected Cable/Connector Problem Between Amplifier Output and ALC NETWORK Input

PREREQUISITE: Suspected defective coaxial cable/connector between output of TWT Amplifier and input to ALC Network

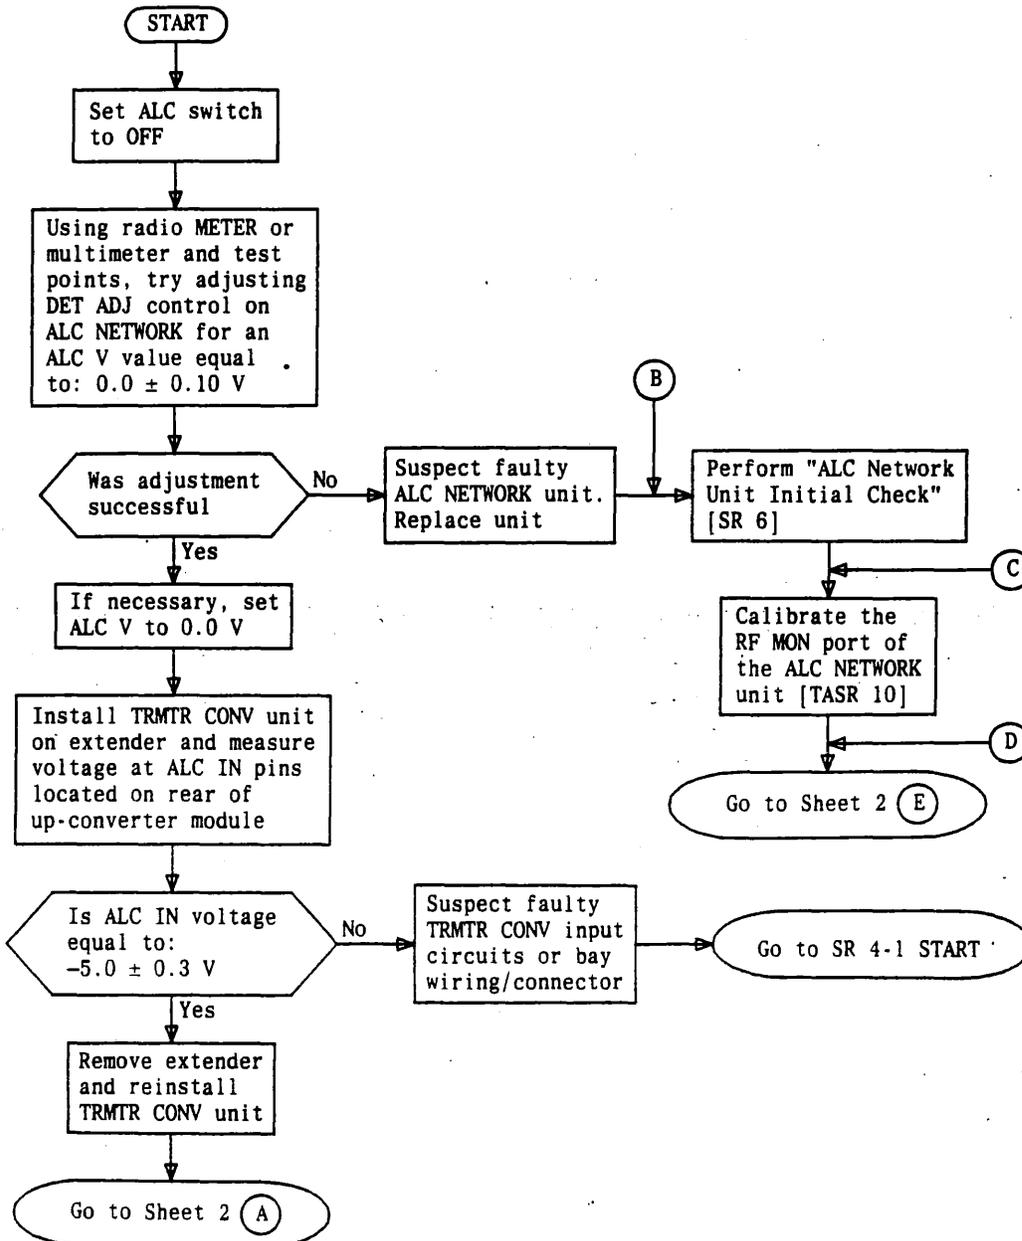
SR 4—Isolating Automatic Gain Problems (Sheet 1 of 2)

PREREQUISITE: Cannot adjust output level of transmitter in automatic mode (ALC switch set to ON) to within ± 0.1 dB of output level properly set with transmitter in manual mode (ALC switch set to OFF)

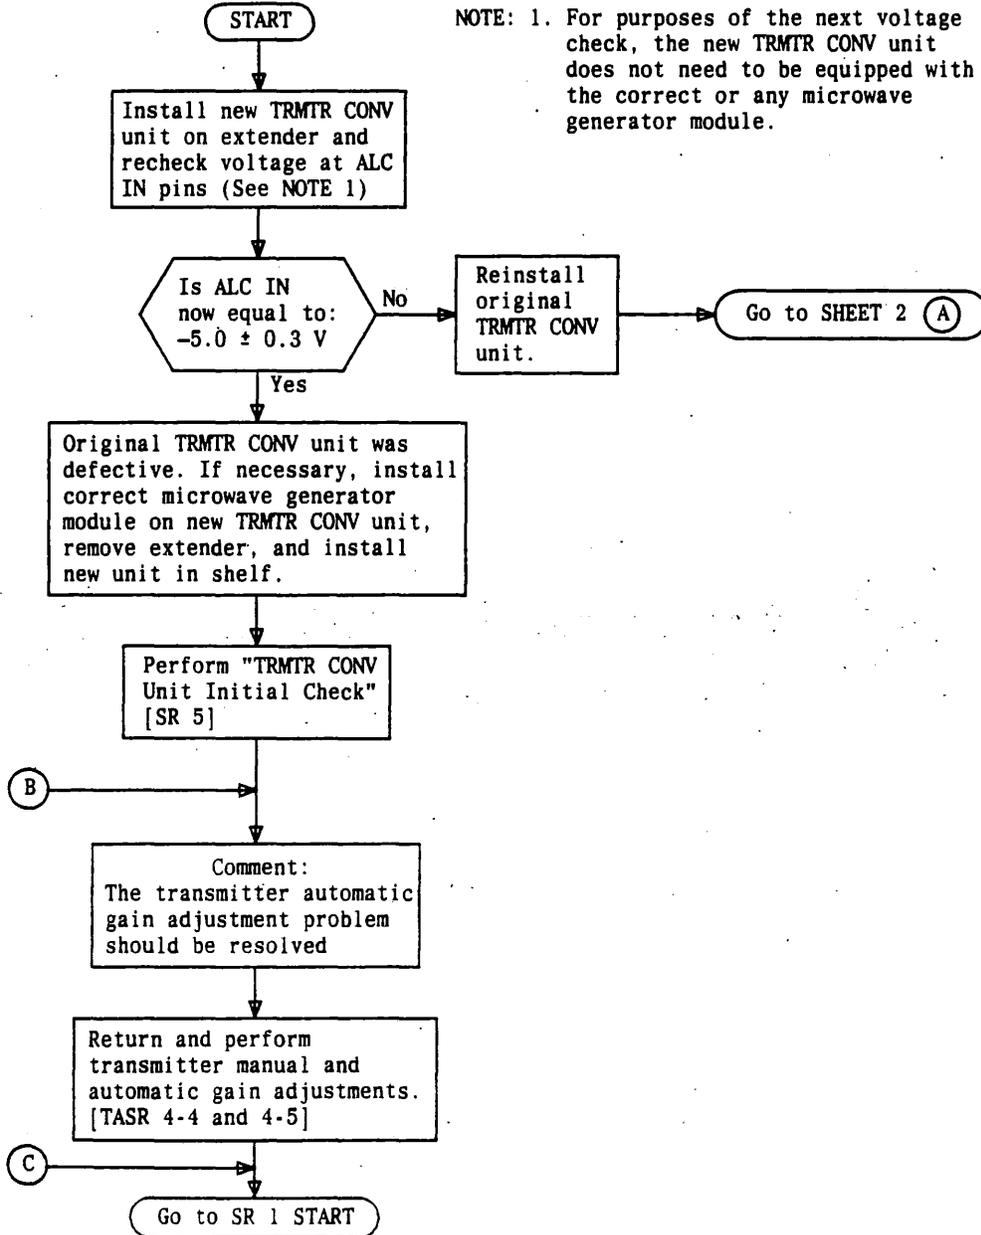
SR 4-1—Resolving Suspected TRMTR CONV Unit Automatic Gain Problem (Sheet 1 of 2)

PREREQUISITE: With ALC switch set to ALC OFF, the voltage measured at the ALC IN pins on the up-converter module is not within -5.0 ± 0.3 V

NOTE: 1. For purposes of the next voltage check, the new TRMTR CONV unit does not need to be equipped with the correct or any microwave generator module.

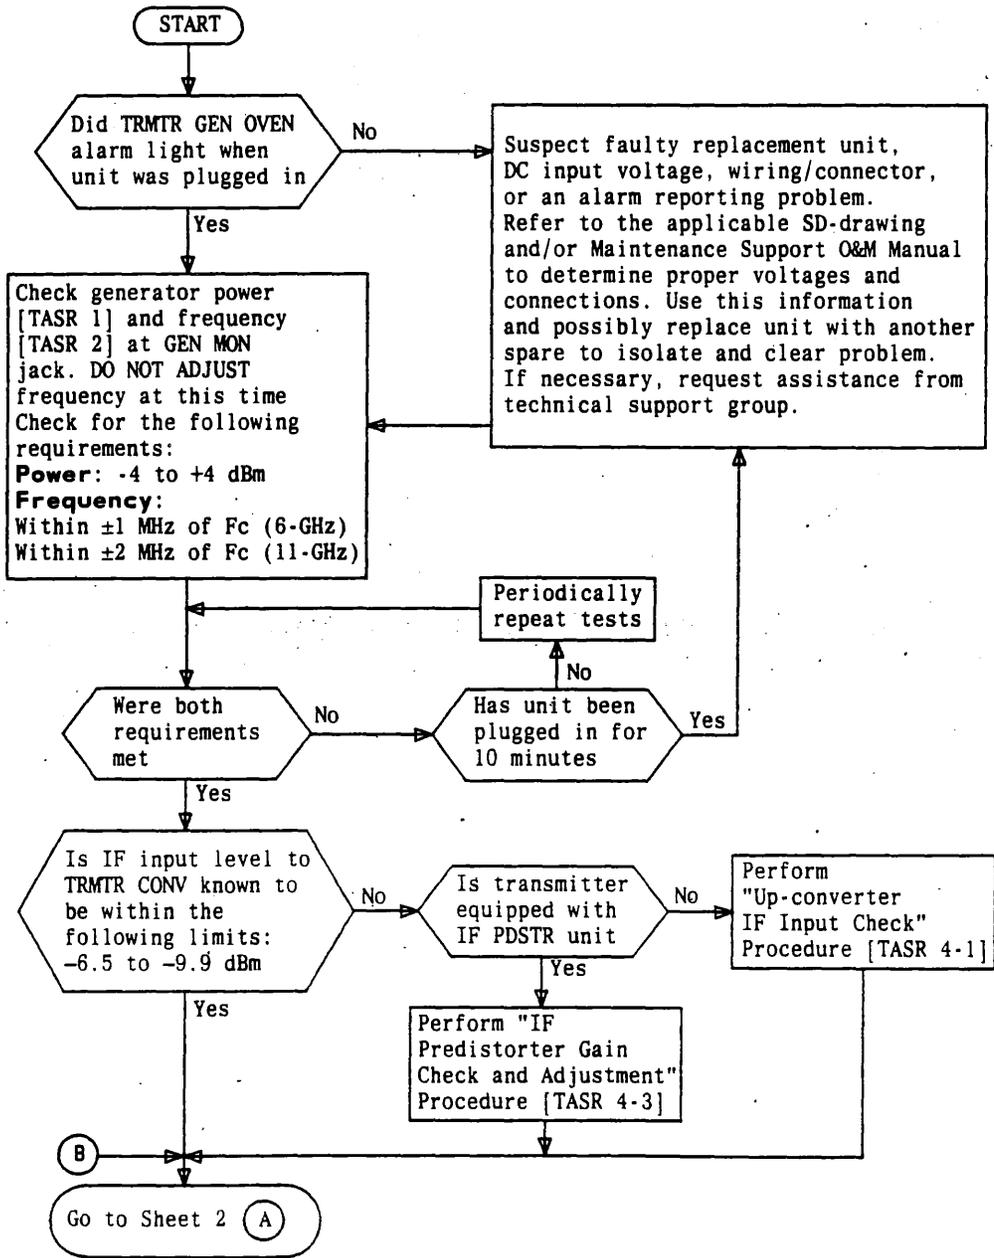
SR 5—TRMTR CONV Unit Initial Check (Sheet 1 of 2)

PREREQUISITE: TRMTR CONV unit just installed.

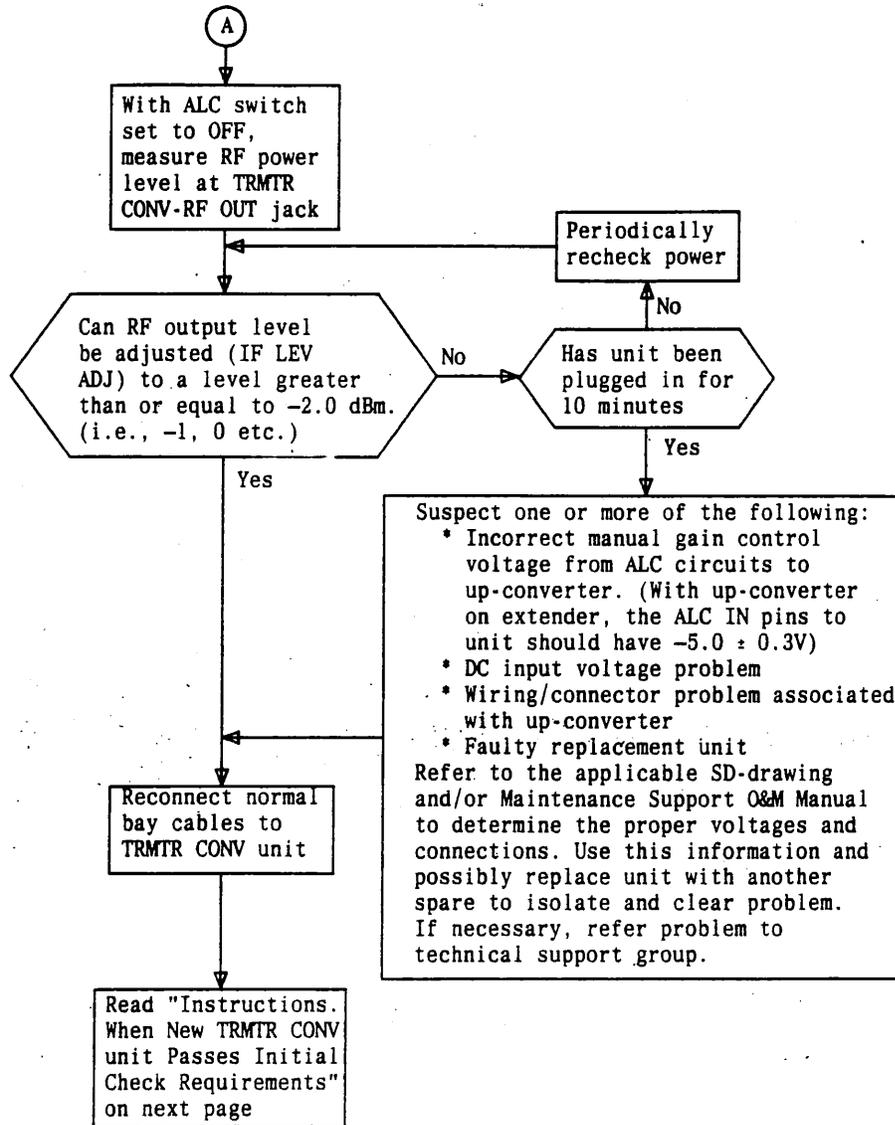
SR 5—TRMTR CONV Unit Initial Check (Sheet 2 of 2)

The status of the replaced unit at this point is usually adequate to continue most transmitter troubleshooting routines. This is especially true for those routines involving transmitter RF power or gain problems. Routines requiring temperature stabilization of the microwave generator oven of the TRMTR CONV unit (when the TRMTR GEN OVEN indicator is still lighted) should be delayed until the TRMTR GEN OVEN indicator goes off (see Final Generator Check). If this unit was replaced because of directions in another procedure, return to the instruction that called for the replacement (see *Note 1*). Generally, this will help to speed up troubleshooting transmitter alarms involving suspected TRMTR CONV problems (see Final Generator Check).

Note 1: Before returning to the referencing procedure, note the time that the TRMTR CONV unit was replaced and then periodically check the TRMTR GEN OVEN alarm indicator to ensure that it goes off within the normal time period (see *Note 2*). If the alarm indicator does not go off, dc voltage and/or wiring problems related to the TRMTR CONV unit may exist or the replacement unit is defective. Isolate and clear this problem before proceeding further with transmitter tests. Follow the instructions given in the Transmitter "GEN OVEN Alarm" tab.

Note 2: Normally, if the spare TRMTR CONV unit and microwave generator module were stored at room temperature, the TRMTR GEN OVEN indicator should go off within about 20 minutes. If the replacement units were stored in a cold environment, the time for the indicator to go off could be as long as 45 minutes.

Wait for the TRMTR GEN OVEN alarm to clear before proceeding further (see *Notes 1 and 2*). At that point, or any time after, when the generator frequency is within ± 350 kHz of the center frequency for 6-GHz systems or ± 700 kHz for 11-GHz systems, make the transmitter manual and automatic gain adjustments. Perform the Transmitter Alignment Check (TASR 5) also. If adjustments are necessary to meet alignment requirements, do the final frequency check of the microwave generator (see Final Generator Check) before making the adjustments.

For either of the above cases, the frequency (TASR 2) and power (TASR 1) of the microwave generator in the TRMTR CONV should be checked and, if necessary, adjusted about 1 hour after the TRMTR GEN OVEN alarm indicator goes off. Do not try this sooner than 1 hour since, in general, the oscillator should stabilize at its proper frequency with little or no adjustment. Go to MR 1(B) in the Transmitter "GEN OVEN Alarm" tab when this procedure is used without being directed from another routine.

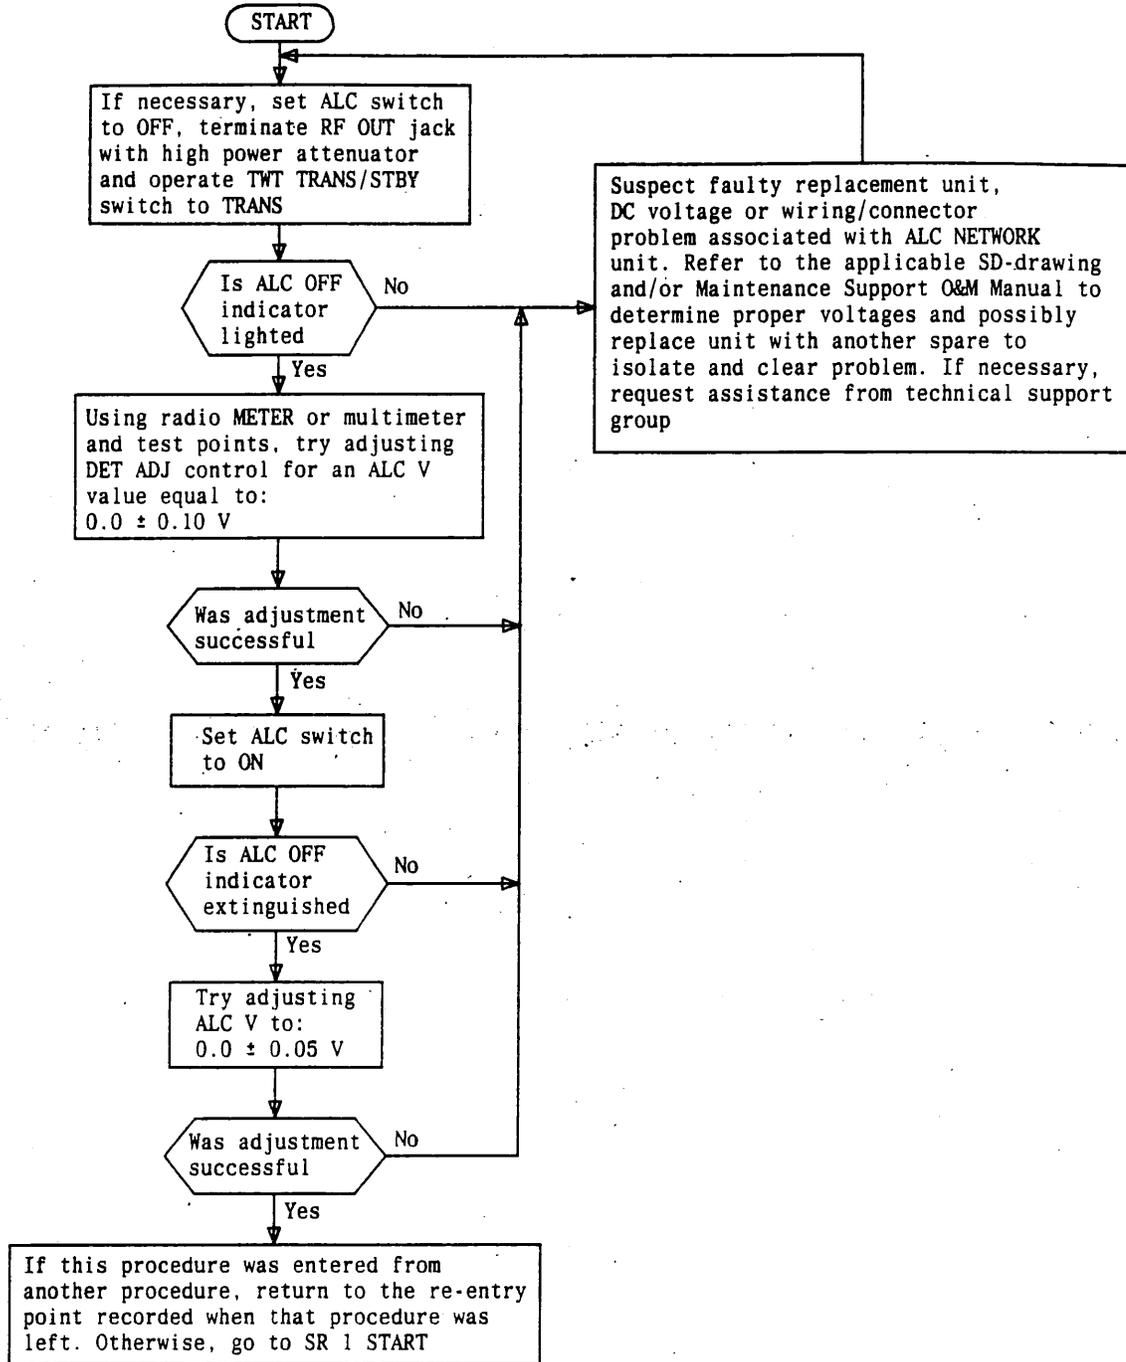
SR 6—ALC NETWORK Unit Initial Check

PREREQUISITE: ALC NETWORK unit just installed.

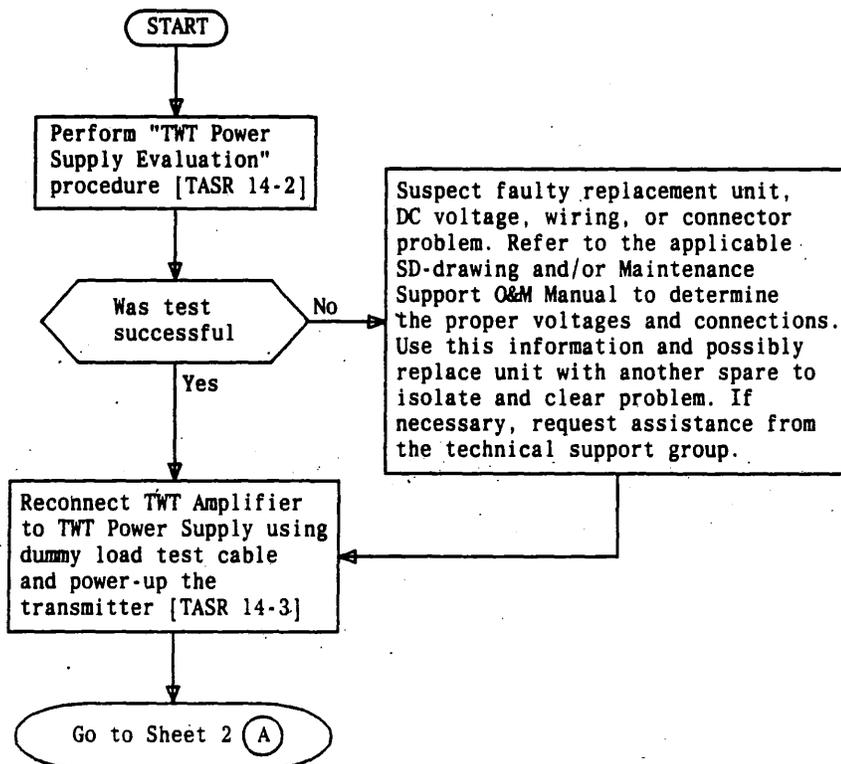
SR 7—TWT POWER SUPPLY Unit Initial Checks (Sheet 1 of 2)

PREREQUISITE: New TWT POWER SUPPLY AND CONTROL unit just installed.
