**OPERATION AND MAINTENANCE
HOT STANDBY
DR 6/11-135A AND 135EC
TWT AMPLIFIER
TRANSMITTER SUBROUTINES**

This section contains the subroutines (SR) referenced from the transmitter trouble-clearing main routines (MR), main subroutines (MSR), and transmitter test and adjustment subroutines (TASR).

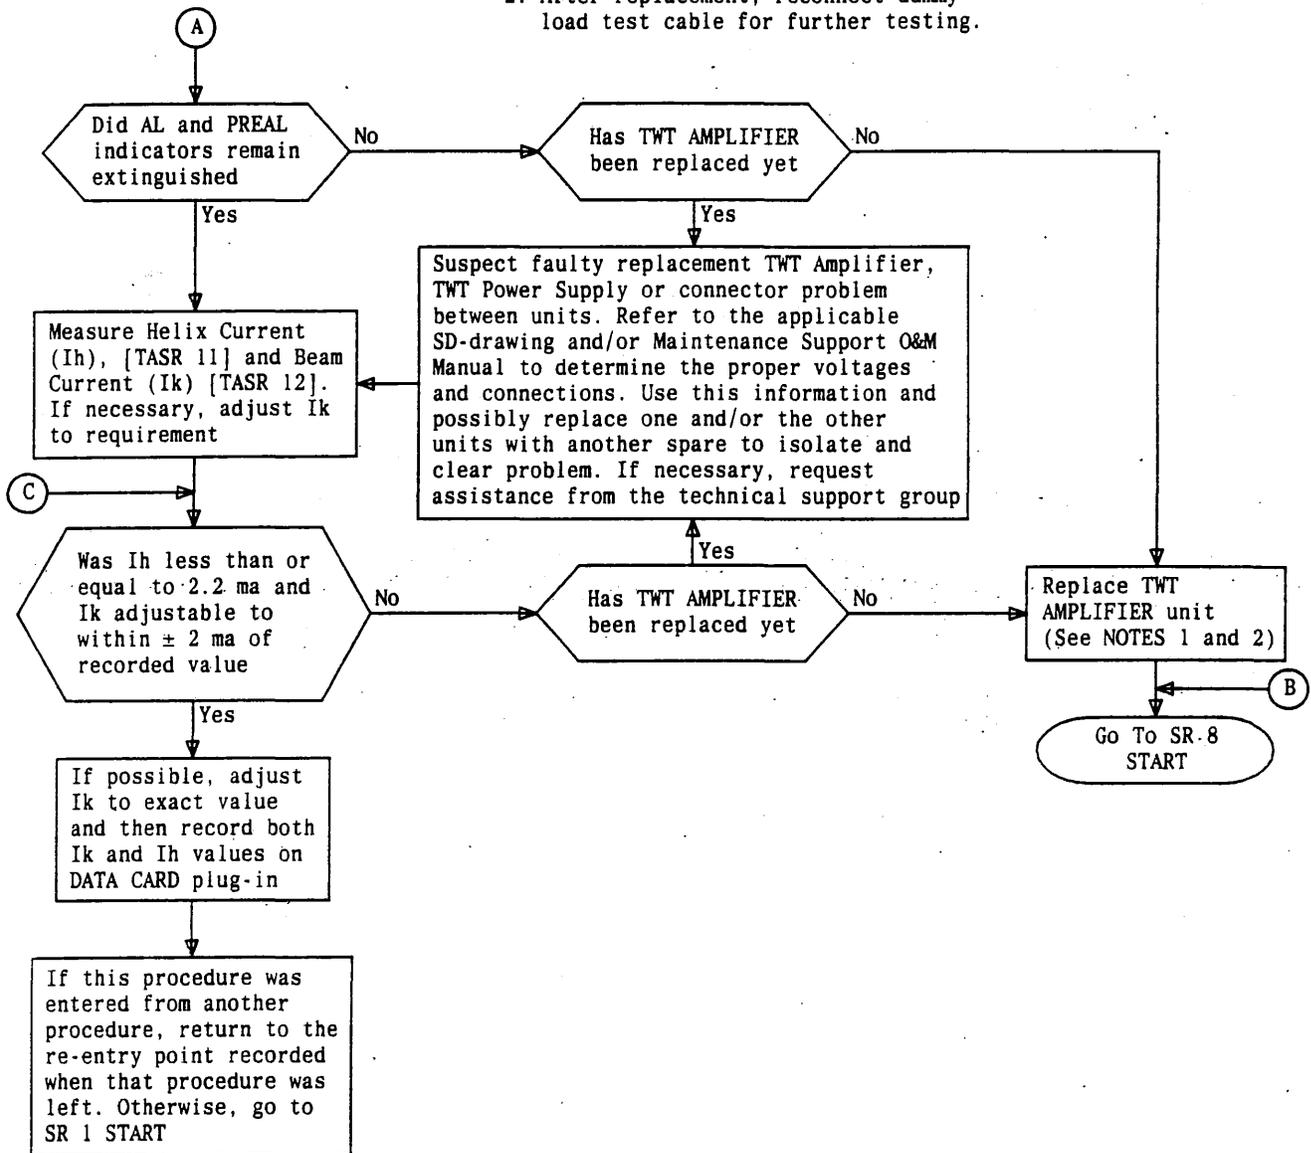
SR 7—TWT POWER SUPPLY Unit Initial Checks (Sheet 2 of 2)

1. Before installing new TWT Amplifier, note (for later use) the Beam Current (Ik) value recorded on the unit label.
2. After replacement, reconnect dummy load test cable for further testing.

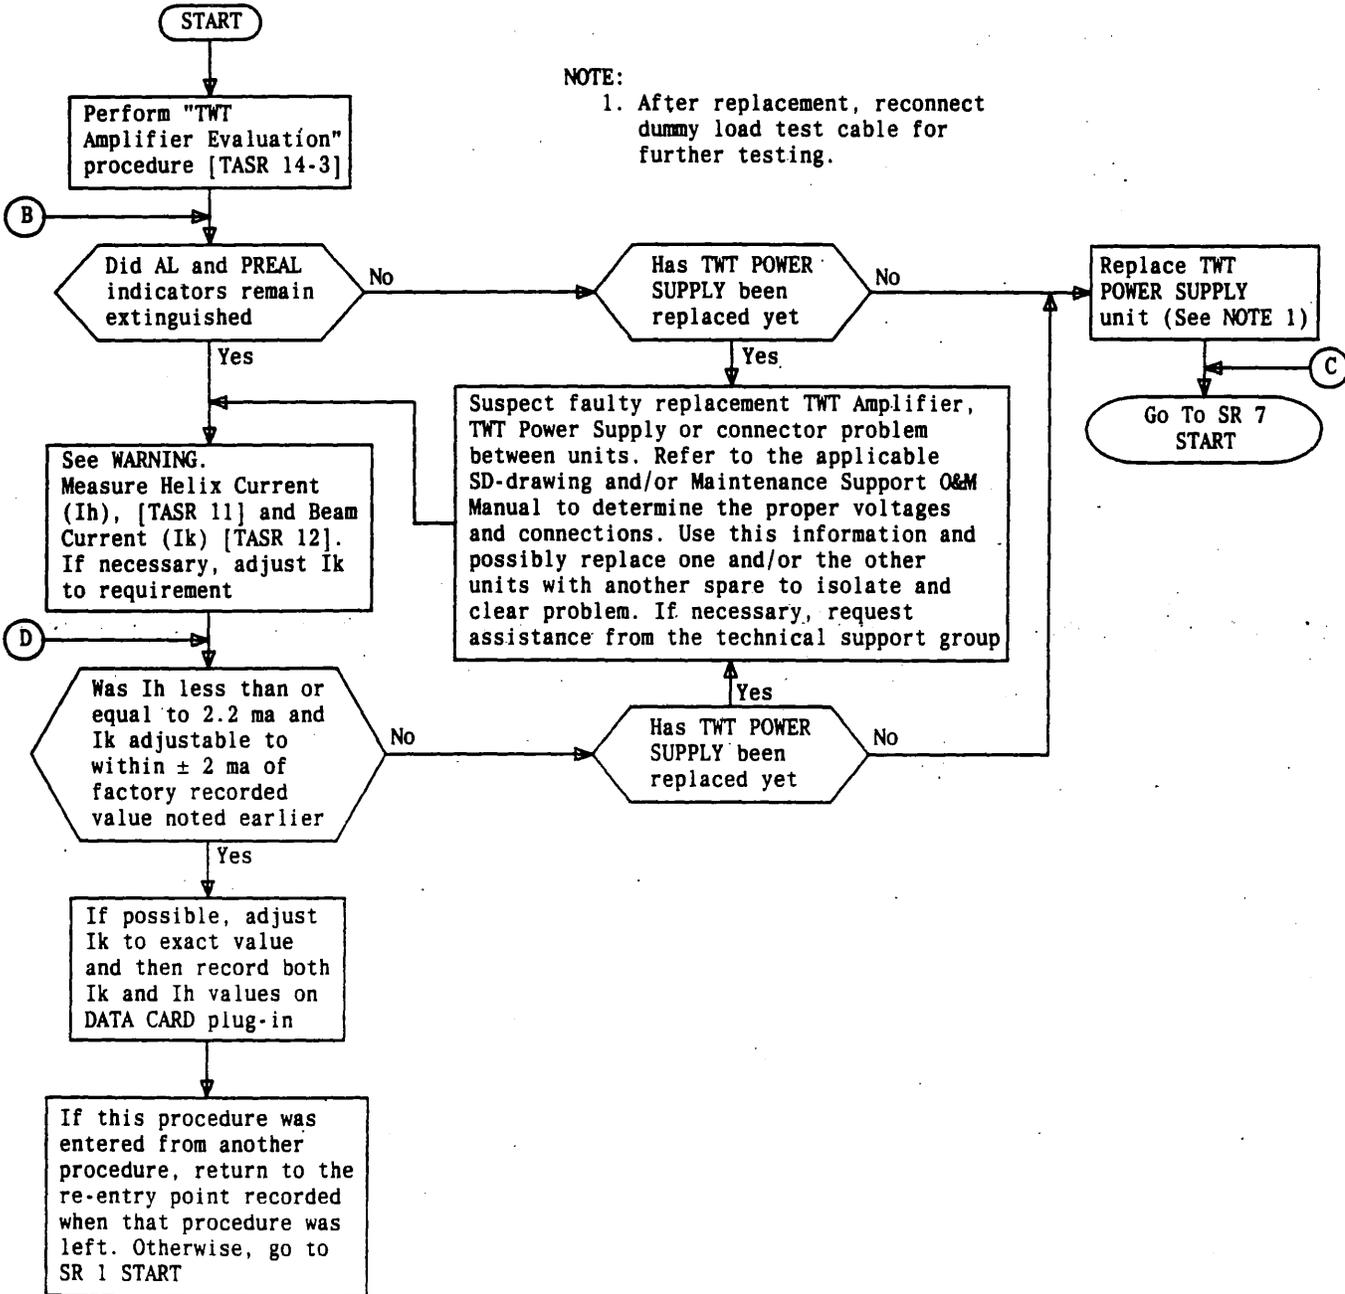
SR 8—TWT Amplifier Unit Initial Checks

PREREQUISITE: New TWT AMPLIFIER unit just installed.

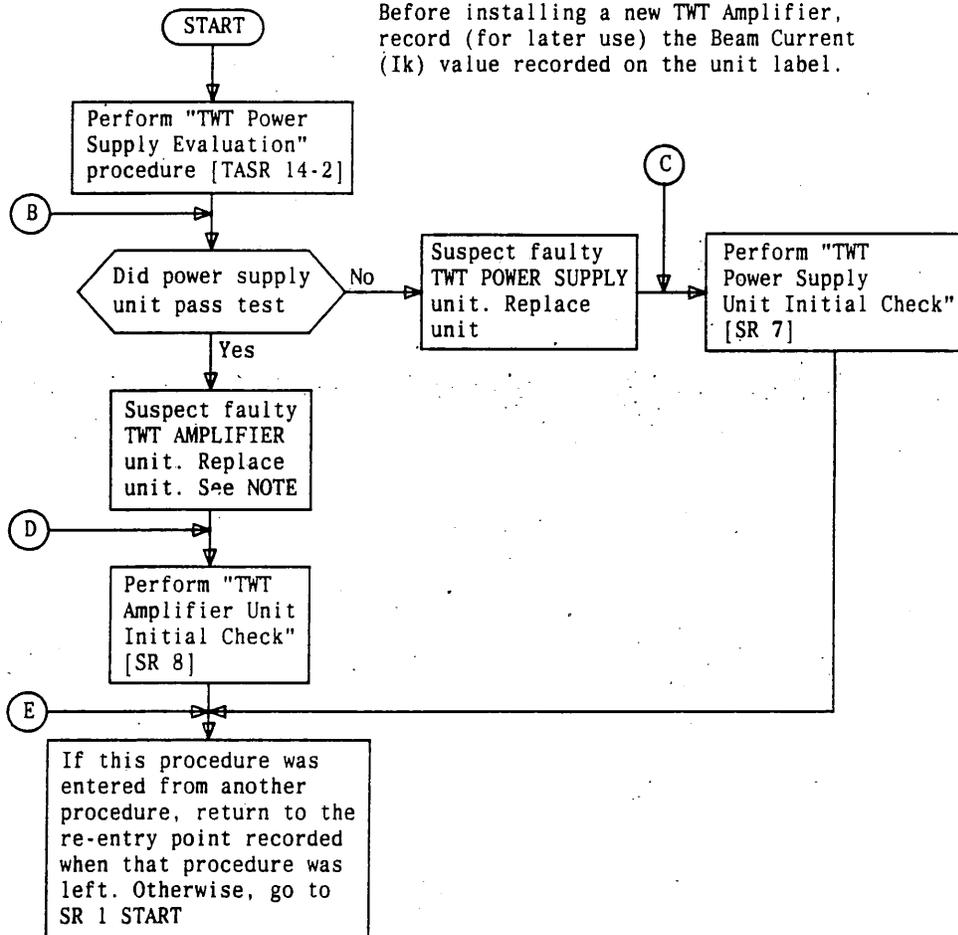
SR 9—Resolving Helix and/or Beam Current Out-of-Limits Problem

1. The helix (Ih) and/or beam (Ik) current measurements do not meet requirements.
2. The transmitter may or may not be reporting any alarms.

Before installing a new TWT Amplifier, record (for later use) the Beam Current (Ik) value recorded on the unit label.

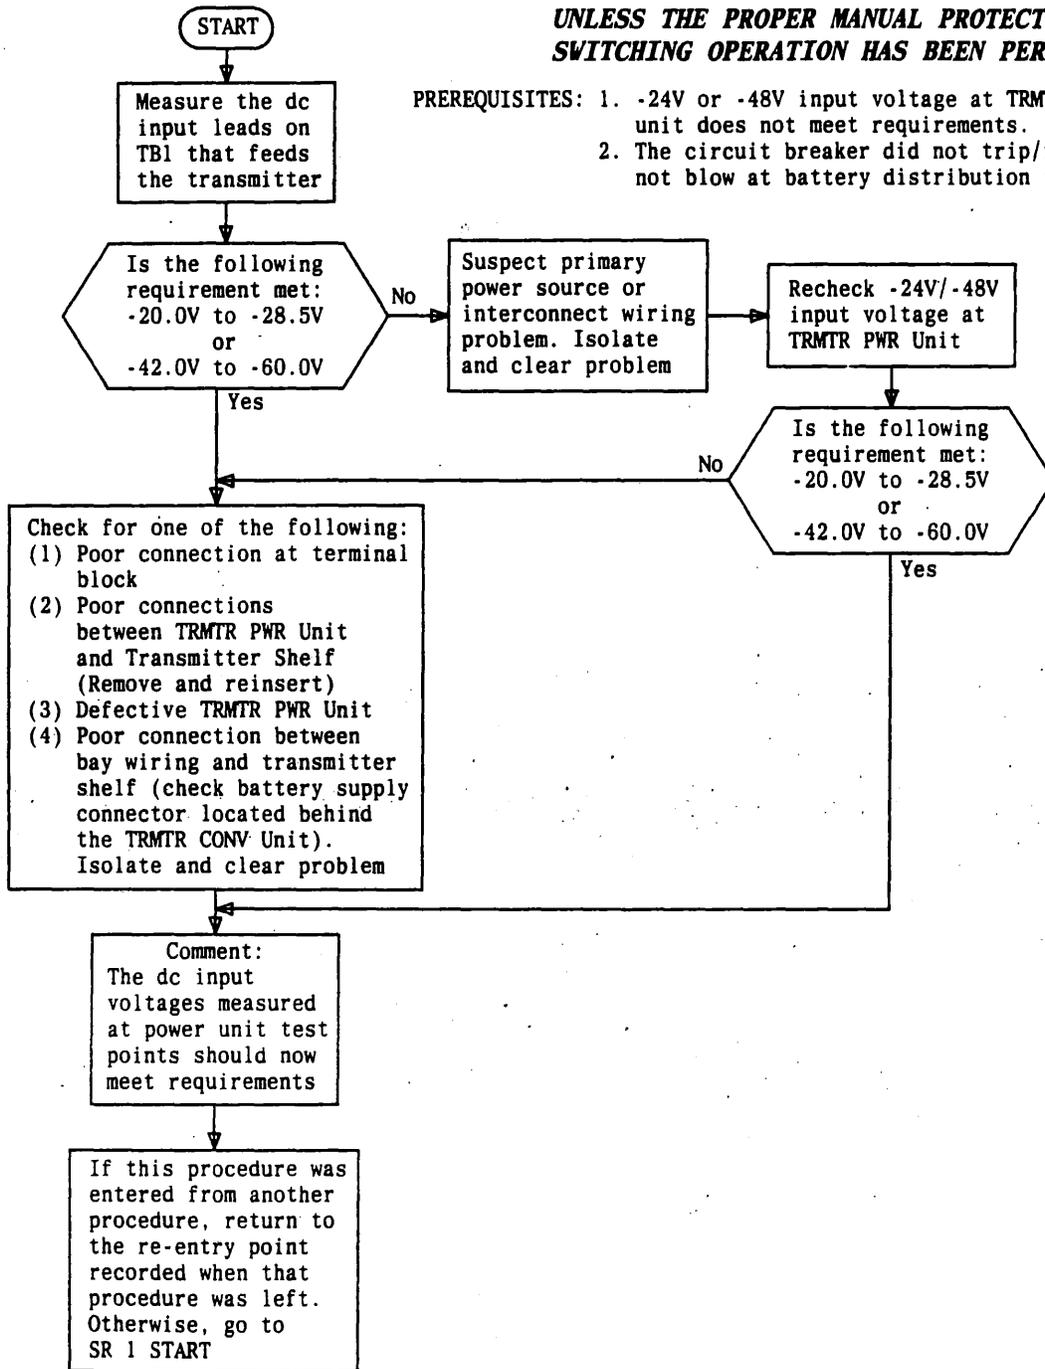
SR 10—Resolving DC Input Problems When Circuit Breaker Did Not Trip or Fuse Did Not Blow

PREREQUISITES: 1. -24V or -48V input voltage at TRMTR PWR unit does not meet requirements.
2. The circuit breaker did not trip/fuse did not blow at battery distribution fuse bay.

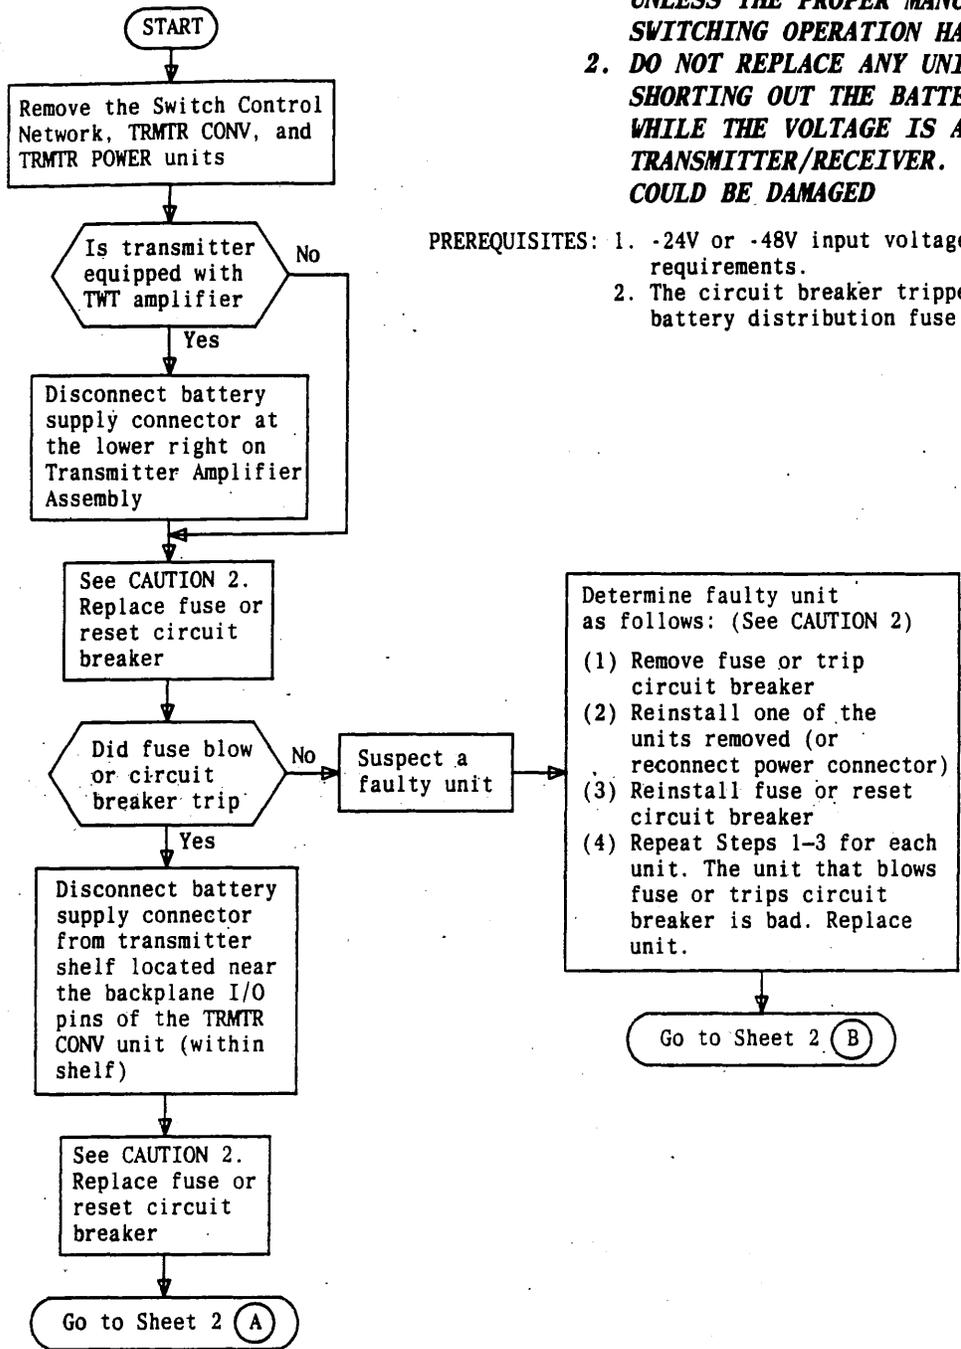
SR 11—Resolving Transmitter Shelf DC Input Problems (Sheet 1 of 2)

PREREQUISITES: 1. -24V or -48V input voltage does not meet requirements.
 2. The circuit breaker tripped/fuse blown at battery distribution fuse bay.

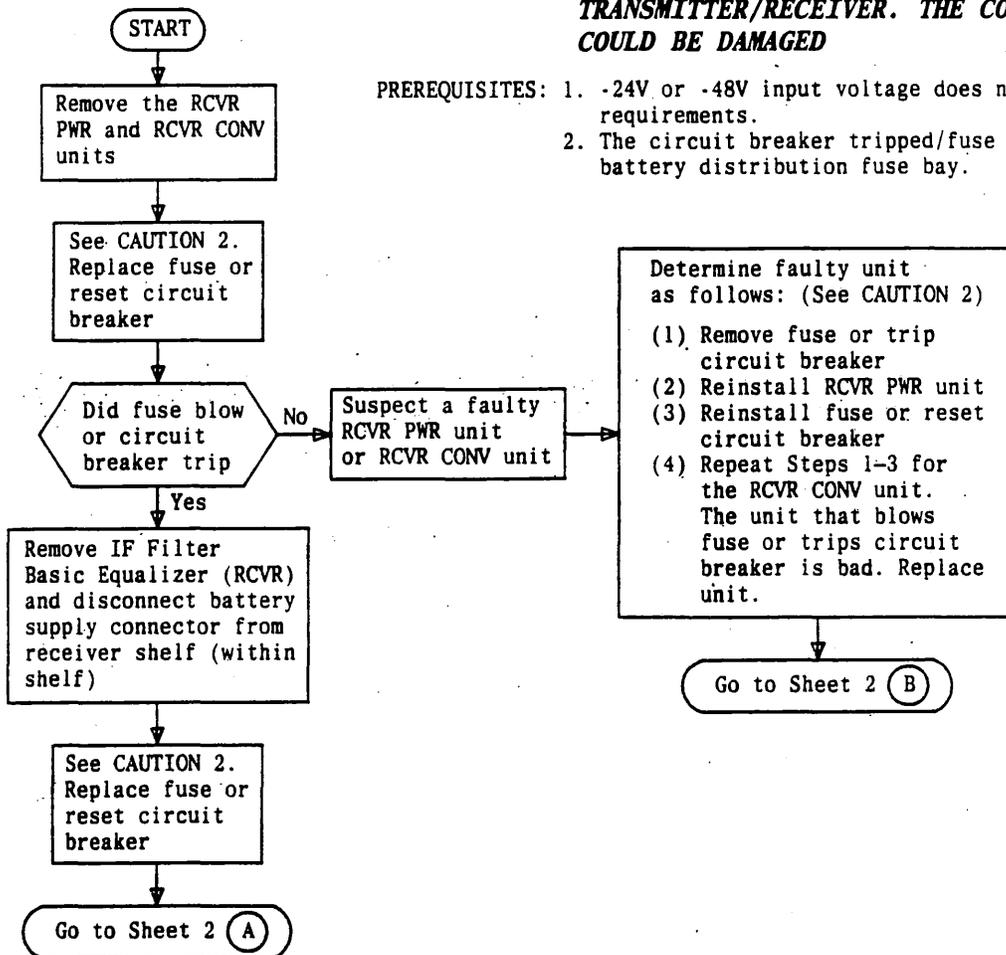
SR 12—Resolving Receiver Shelf DC Input Problems (Sheet 1 of 2)

- PREREQUISITES:**
1. -24V or -48V input voltage does not meet requirements.
 2. The circuit breaker tripped/fuse blown at battery distribution fuse bay.
