# **MultiPoint Conferencing Unit**

## **Release 7.2**

555-027-816  
Comcode 700217730  
Issue 1.0  
March 2002

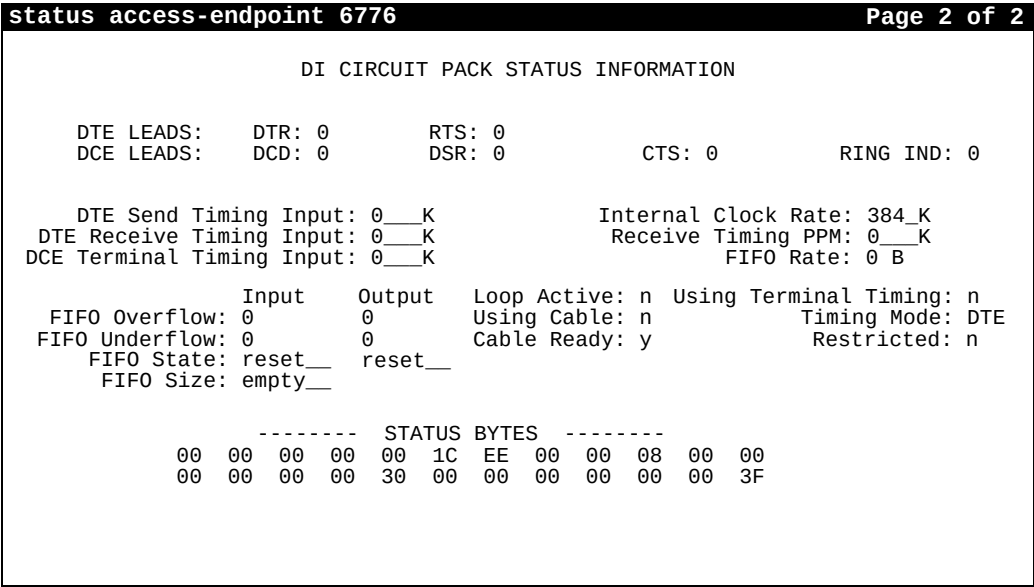
Figure 2-72. Access Endpoint Report (Page 2)

The following list shows the data collected for the report.

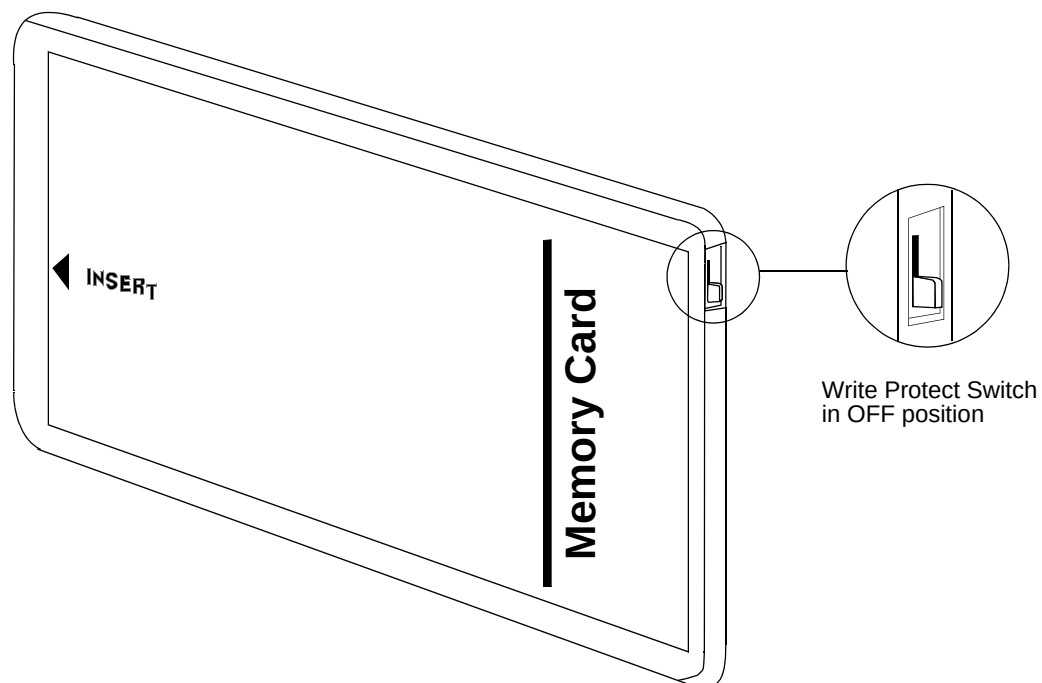
**Figure 2-73. Memory Card**

The **save translations** command copies the current system translations onto the memory card located on the Network Control circuit pack. One system memory card is included with the MCU. A backup memory card may be purchased optionally.

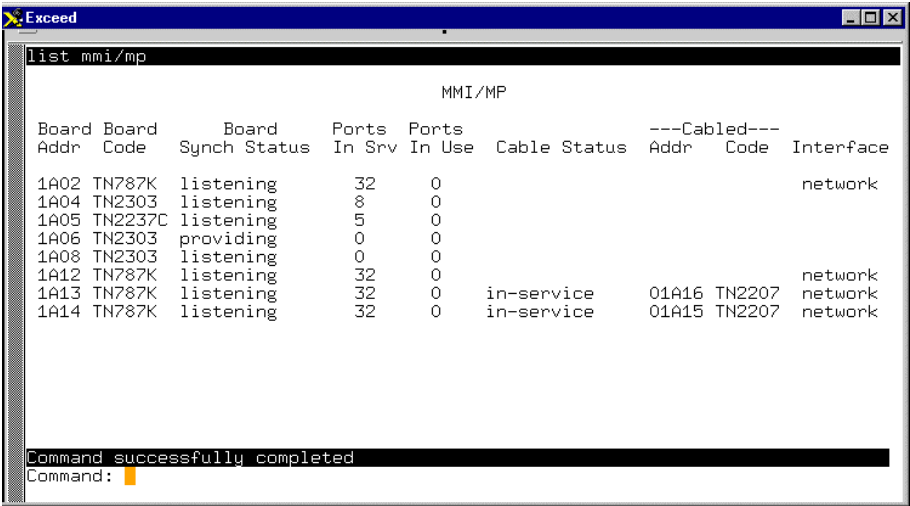
Figure 2-74. List MMI/MP screen

The List MMI/MP screen appears as follows:

The following describes fields on the List MMI/MP screen:

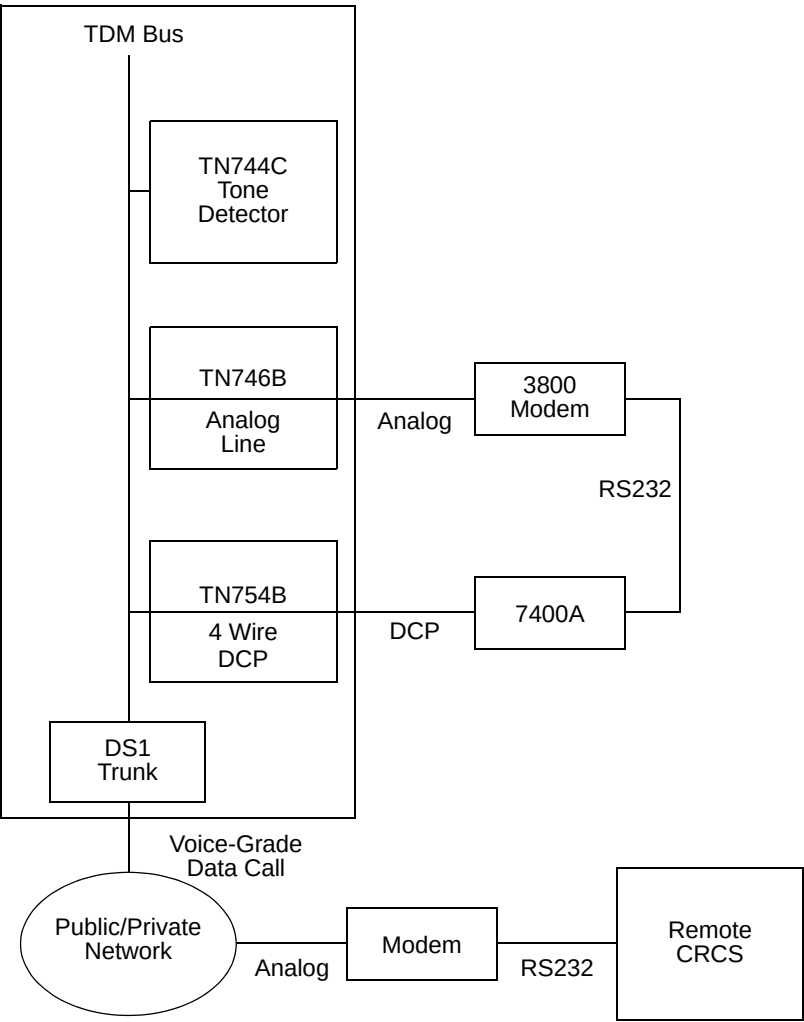
Figure 2-77. MCU/CRCS Combined Modem Pool Configuration

The MCU supports the Combined Modem Pooling solution. The required hardware is called a *combined conversion resource*. It includes a separate Trunk Data Module and modem administered as a unit. The Trunk Data Module component of the conversion resource is a 7400B Data Module. The module connects to a digital port using Digital Communications Protocol (DCP); the modem connects to an analog port. The MCU supports the Combined Modem Pooling Solution for use in remote connectivity between the MCU and the two CRCS modules, ResCenter and OpCenter, whenever all these components are not collocated.

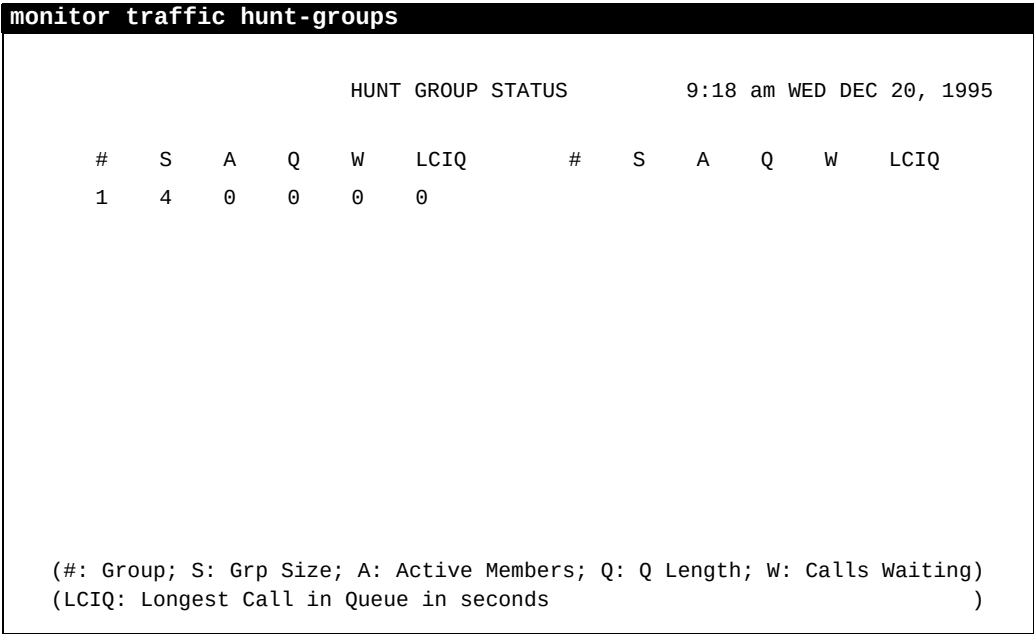
Figure 3-4. Hunt Group Status Report

The following list shows the data collected for the Hunt Group Status Report:

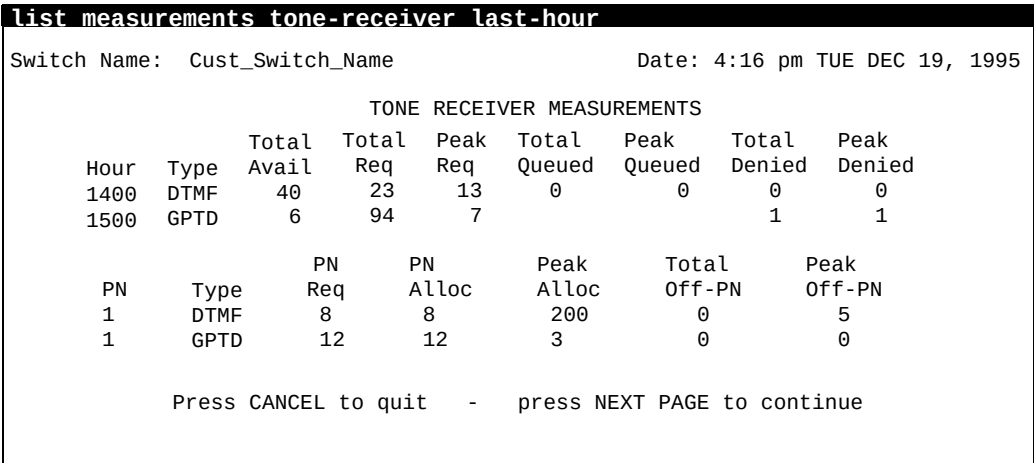
Figure 3-13. Tone Receiver Measurements Report

The following list shows the data collected for the Tone Receiver Measurements Report:

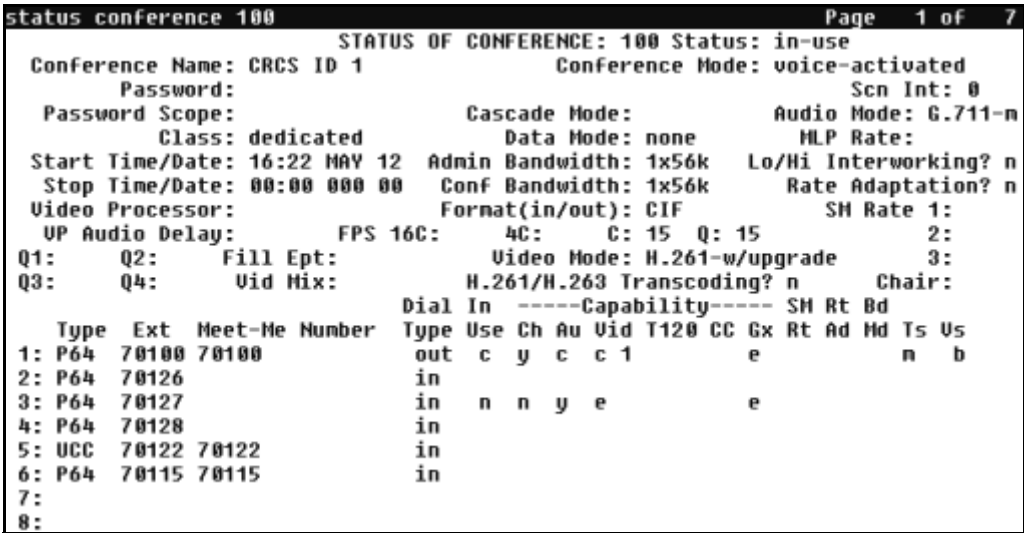
Figure 5-1. Sample Status of Conference Screen, Page 1

The first screen appears whenever you enter **status conference** and at least one valid conference is found. You can use the “Page” keys to browse through all the screens for a conference. The “Next Form” key enables you to move to the next conference (if any). To exit, press “Cancel.” Note that the data displayed is whatever the system had stored at the time the command was entered. To see the latest data, enter the command again. A repeat feature allows you to reissue the previously executed command. To do so, enter “R” followed by a return.

7. Enter **status conference conference-ID** where **conference-ID** is the *Conference-ID* number found in Step 3. The Status of Conference screen is displayed (refer to Figure 5-1 on page 5-3).

7. Enter **status conference conference-ID** where **conference-ID** is the *Conference ID* number found in Step 3. The Status of Conference screen is displayed (refer to Figure 5-1 on page 5-3).

7. Enter **status conference conference-ID** where **conference-ID** is the *Conference ID* number from Step 3. The Status of Conference screen is displayed (refer to Figure 5-1 on page 5-3).

6. Check the *Data Mode* field on the Conference Record. If the field does not contain **any-mlp**, the conference is not a data conference.
7. Enter **status conference conference-ID** where **conference-ID** is the *Conference ID* number from Step 3. The Status of Conference screen is displayed (refer to Figure 5-1 on page 5-3).

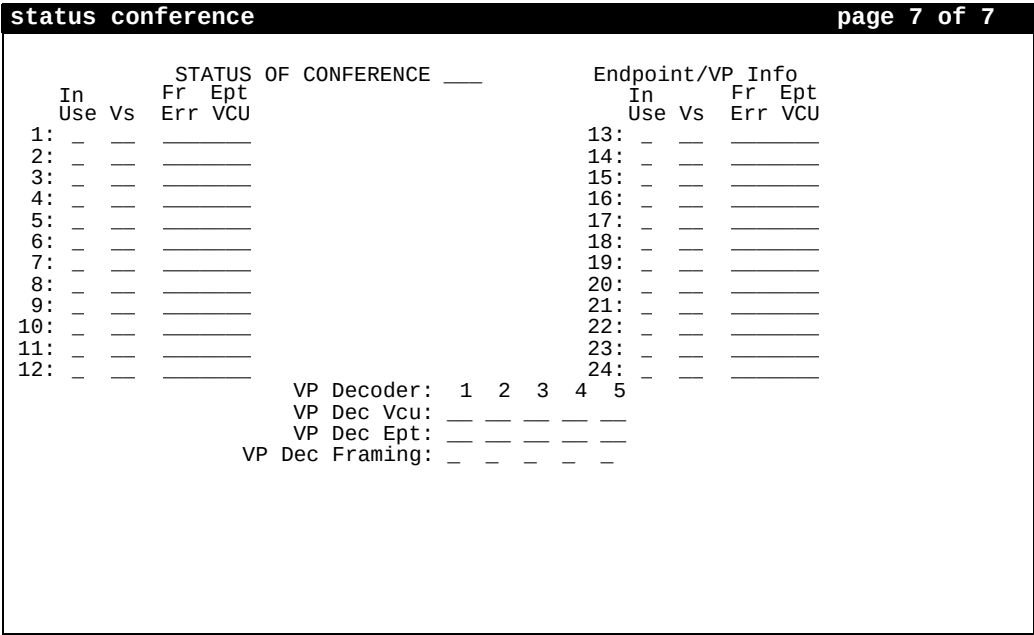
Figure 5-5. Sample Status of Conference Screen, Page 7

**NOTE:**  
Pages 4 through 6 of the Status of Conference screen display the same information as Page 3 when there are more than six MCU-extensions assigned to a conference.

The following list describes the fields in the screen:

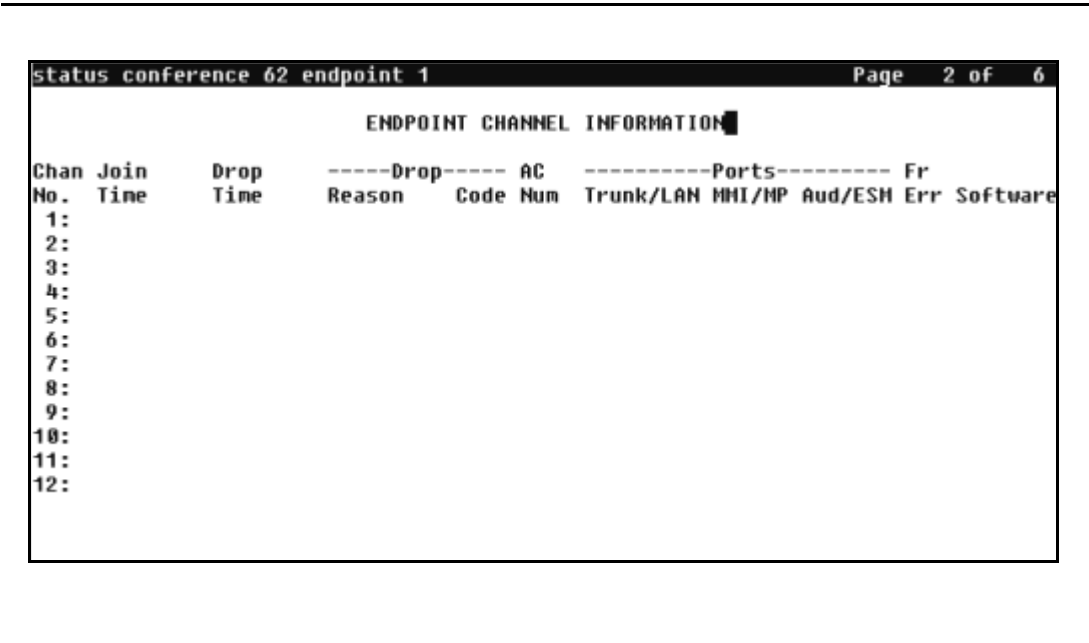
Figure 5-7. Status of Conference Endpoint—Page 2

Most of the fields in the screen are the same as the fields in the Status of Conference screen (discussed earlier in this chapter). Therefore, the following list describes only those fields that are specific to the endpoint level command output.

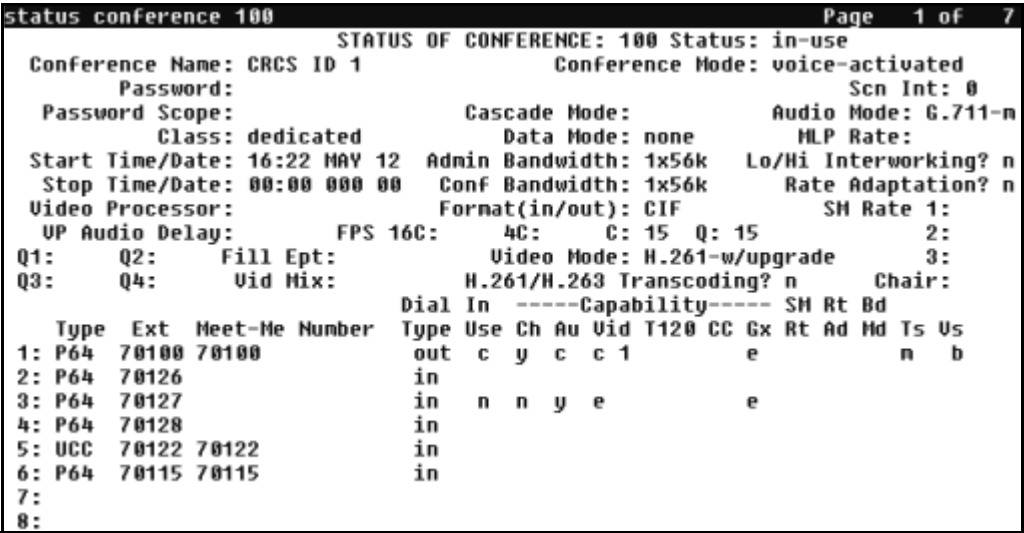
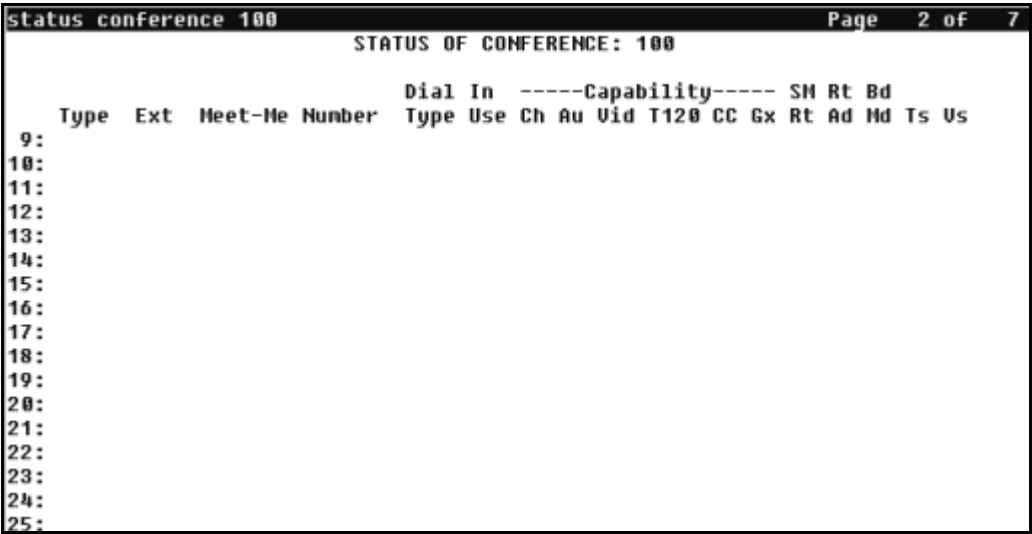
This section shows the status conference forms that help to troubleshoot conference problems. Information about the conference is displayed, including conference mode, start and stop times, conference bandwidth, features, video mode, and number, type and status of endpoints.

Figure 5-14. Sample Status Screen Used for Troubleshooting (1 of 7)

Figure 5-15. Sample Status Screen Used for Troubleshooting (2 of 7)

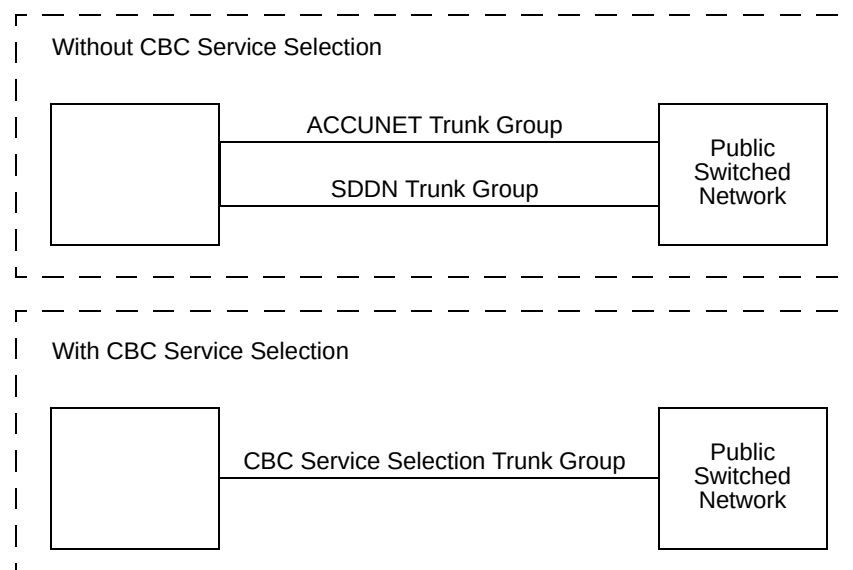
**Figure B-5. Call-By-Call Service Selection Example**

A Call-By-Call service selection example is shown in the following figure.

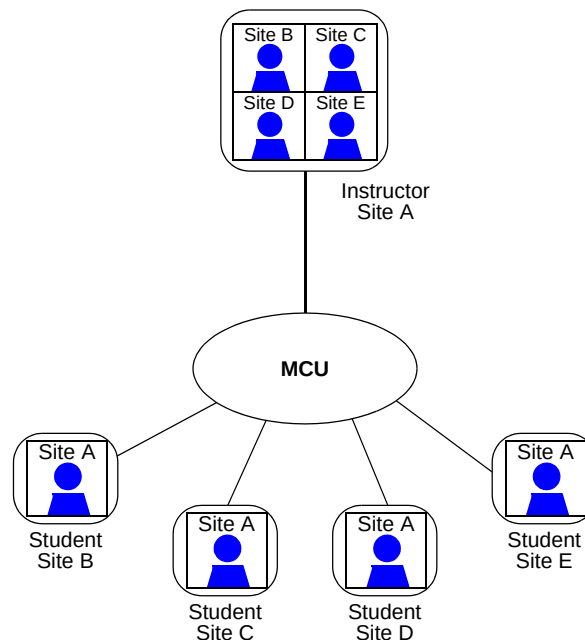
**Figure B-6. Continuous Presence *Plus* Quad-Image Scenario**

This feature is a customer option that enables a multipoint video conference to compose a picture consisting of the video from multiple (up to 16) sites participating in the conference. Each Continuous Presence *Plus* conference shows a Continuous Presence *Plus*-mixed (CPP-mixed) video to all “eligible” sites from the beginning of the conference. The user can transition from one video layout to another (including quad-image, dual-panoramic, lower-panoramic, upper-panoramic, as well as full screen) via administration, conference control commands, UCC, and CRCS.

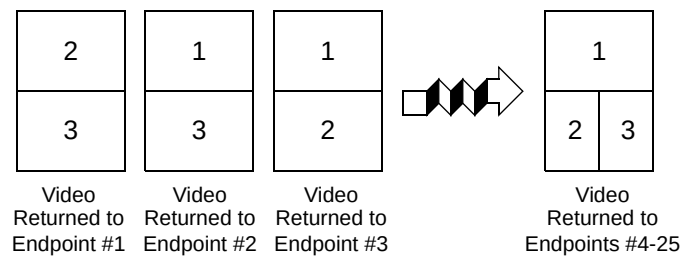
**Figure B-7. Executive Conferencing**

In this figure, sites #1, #2, and #3 are administered as the three eligible video sites (or broadcasters) for the conference. The remaining video sites (#4 through #25) in the conference can listen to return video but are not themselves eligible video sources for the conference.

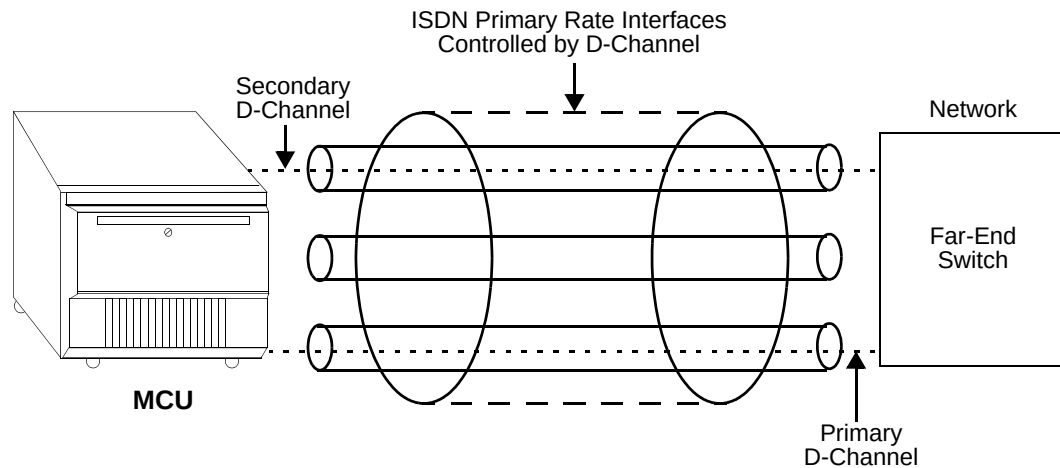
**Figure B-8. Example D-channel Backup with Three ISDN-PRIs**

Since the D-channels are signaling for more than one DS1/E1 facility, the D-channel Backup feature requires the use of the NFAS feature. At any given time, one of the two D-channels will be carrying layer 3 signaling messages, while the other D-channel will be active at layer 2, but in a standby mode only. Any layer 3 messages received over the standby D-channel will be ignored. The two D-channels can provide signaling for only a predefined set of B-channels and cannot dynamically back up other D-channels on other interfaces.

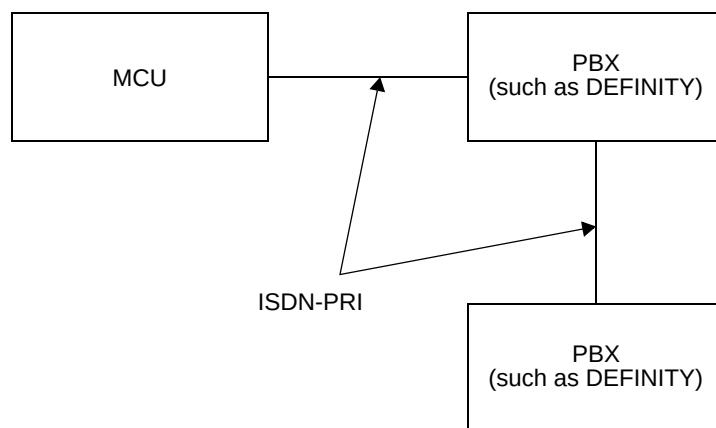
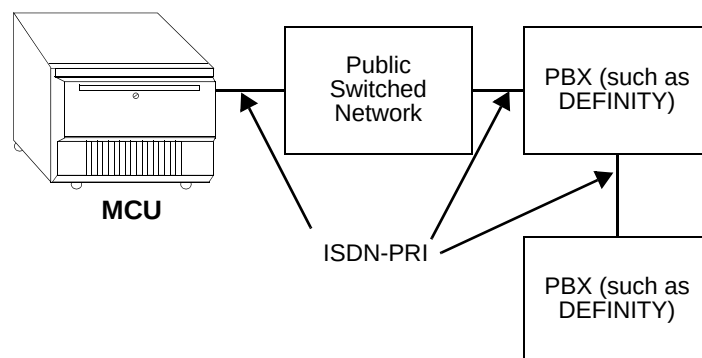
As an example of how the ISDN-PRI is used in private and public network configurations, refer to the following figures. As seen in these figures, the ISDN-PRI can be used to interface the MCU with a PBX.

**Figure B-9. ISDN-PRI Private Network Configuration**

**Figure B-10. ISDN-PRI Public Network Configuration****ISDN-PRI Services**

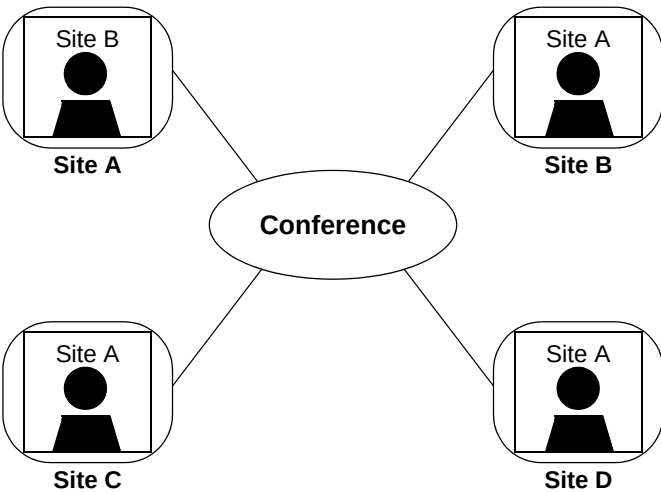
**Figure B-11. Previous Speaker=Site B**

A speaker's endpoint becomes the broadcasting endpoint. The broadcasting endpoint sees the last broadcaster. MCU software and hardware provides for suppression of a "ping-pong" effect to avoid excessive switching during a rapid conversation. As an example, imagine a four-party video conference between endpoints named Site A, Site B, Site C, and Site D. Site B is the first endpoint to speak. When Site B finishes speaking, Site A begins to speak. As Site A begins, the voice-activated switching function displays Site A to the other three endpoints, while Site B is still displayed on Site A's screen as depicted in the following figure.

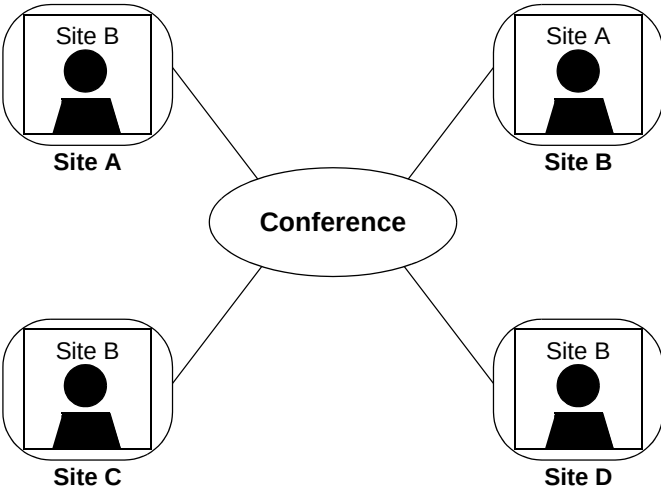
**Figure B-12. Previous Speaker=Site A**

The following figure illustrates the scenario when the speaker at Site A relinquishes to the speaker at Site B. In this setting, Site B sees Site A (the previous speaker), while all of the other endpoints see Site B (the current speaker).

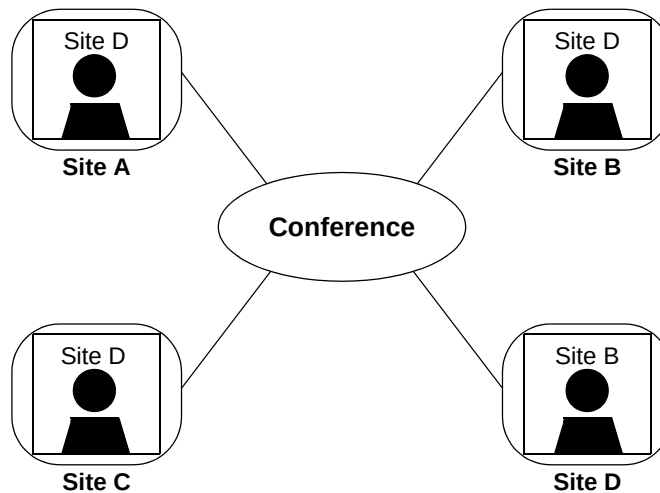
**Figure B-13. Previous Speaker=Site B**

In the final voice activated switching example, Site D begins to speak after Site B finishes, as shown in the following figure. Site D sees Site B on their screen while all other endpoints see Site D.

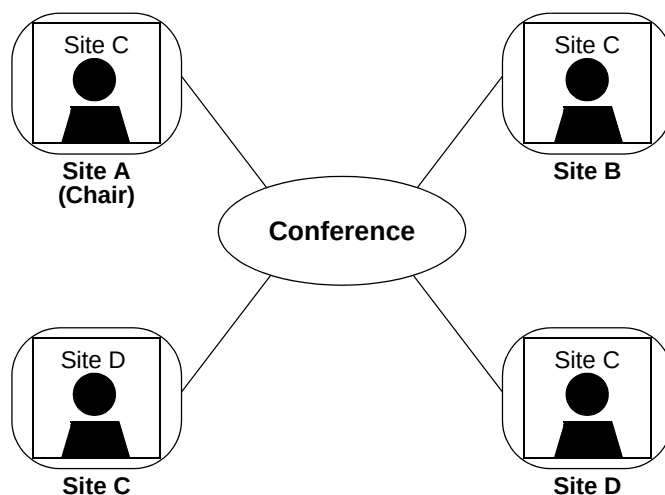
**Figure B-14. Broadcaster=Site C, Speaker=Site D**

This video function allows a conference chair to select which endpoint video is being broadcast to all the other endpoints. An endpoint with chair control can request and relinquish control and drop conferences. The endpoint that claims “chair control” is the chair endpoint. In the following figure, Site A has the chair token and has selected Site C as the broadcast source while Site D is speaking. In this example, Site C (the broadcaster) is displayed at all endpoints except Site C. Site C sees Site D (the speaker).

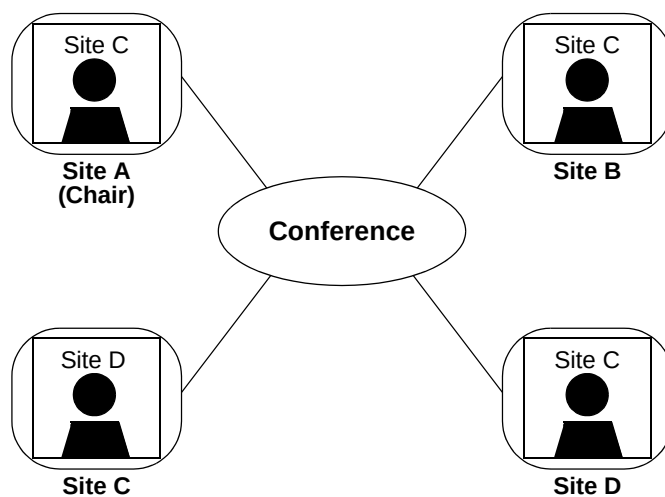
**Figure B-15. Broadcaster=Site C, Speaker=Site C**

After a time, Site D finishes talking and Site C resumes talking. No change occurs to the video streams as shown in the following figure.

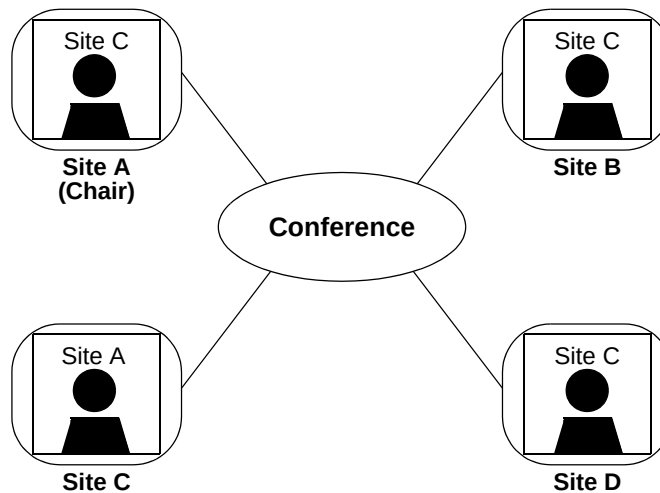
**Figure B-16. Broadcaster=Site C, Speaker=Site A**

Site A begins to talk when Site C asks for responses. Now, as shown in the following figure, Site C sees Site A (the speaker) on their screen while all other endpoints continue to see Site C (the broadcaster).

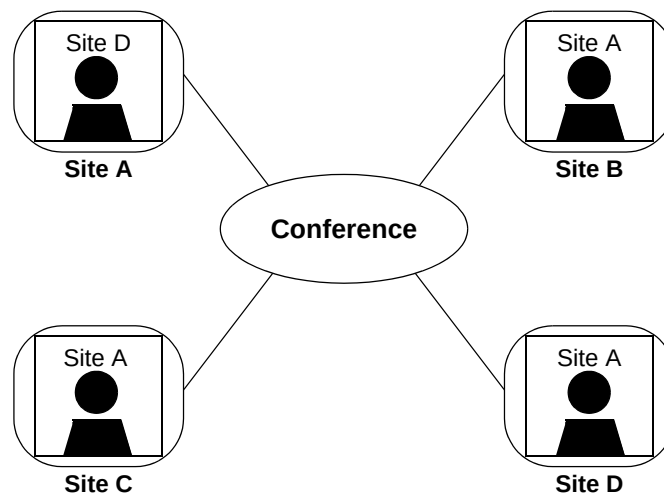
**Figure B-17. Speaker=Site D**

This function does not require special endpoint support. It is a standard feature on all MCU models. This function configures the system to broadcast a single endpoint (*presenter*) to all other endpoints. The receiving endpoints are set to *voice-activated switching* so the broadcaster sees the endpoint selected by that function while all other endpoints see the broadcaster. One endpoint is administered as the broadcaster on the MCU prior to the conference. In the following figure, Site A is administered as the broadcaster while Site D is speaking. In this case, Site A (the broadcaster) sees Site D (the speaker) while all other endpoints see Site A.

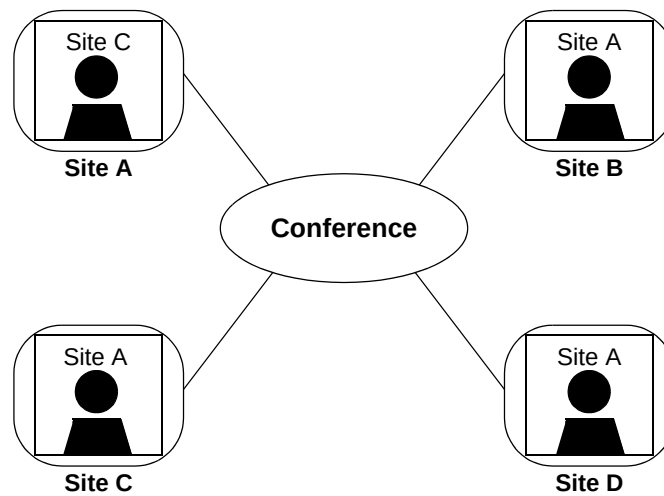
**Figure B-18. Speaker=Site C**

The following figure illustrates what happens when Site D stops speaking and Site C begins. Site A remains the broadcaster and sees Site C (the speaker) while all other endpoints still see Site A.

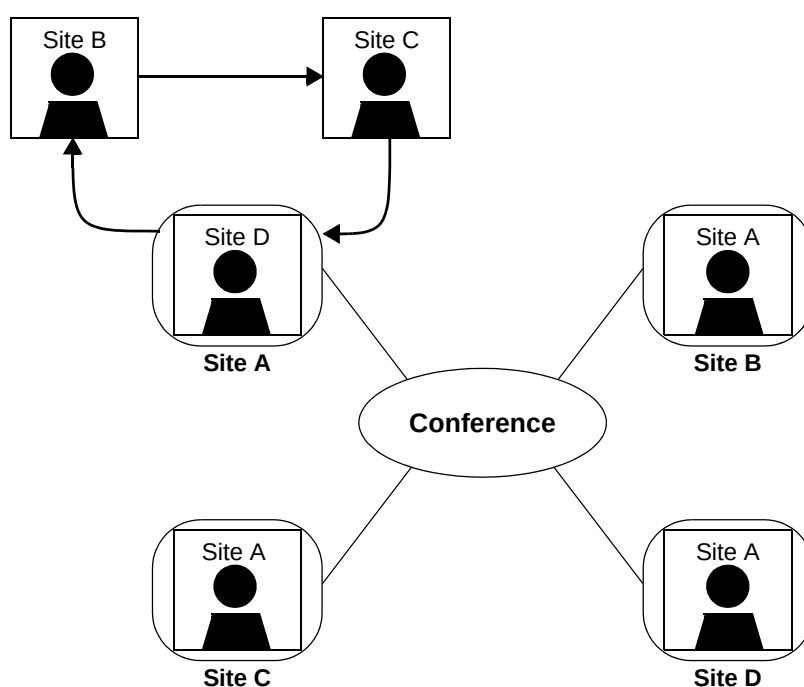
**Figure B-19. Broadcast with Autoscan**

This is a function that does not require special endpoint support. Broadcast with auto-scan provides for a single endpoint to broadcast audio and video to all other endpoints. The broadcasting endpoint does not receive audio but sees video from each of the endpoints one at a time. The interval each endpoint is displayed is administrable on the MCU. In the following figure, Site A was identified as the broadcast endpoint when the conference was scheduled. The scanning period was also set during conference reservation. Site A views each endpoint in turn for the scanning period one at a time until the conference ends. All other endpoints see and hear Site A the entire time.

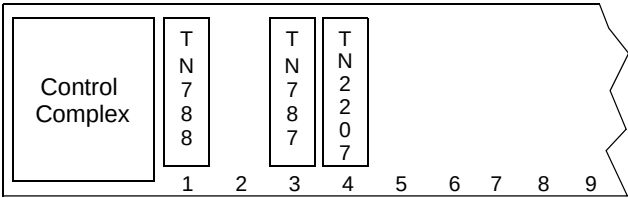
Figure 1-1. Basic Avaya MCU Configuration (4 Ports)

| Circuit Pack | Number | Function |
|---|---|---|
| Video Processor | TN2237C | Supports Continuous Presence <i>Plus</i> , Video Speed Match, and H.261/H.263 Transcoding |
| Voice Conditioner | TN788B | Provides audio-conferencing support including summing, gain control, and voice detection |

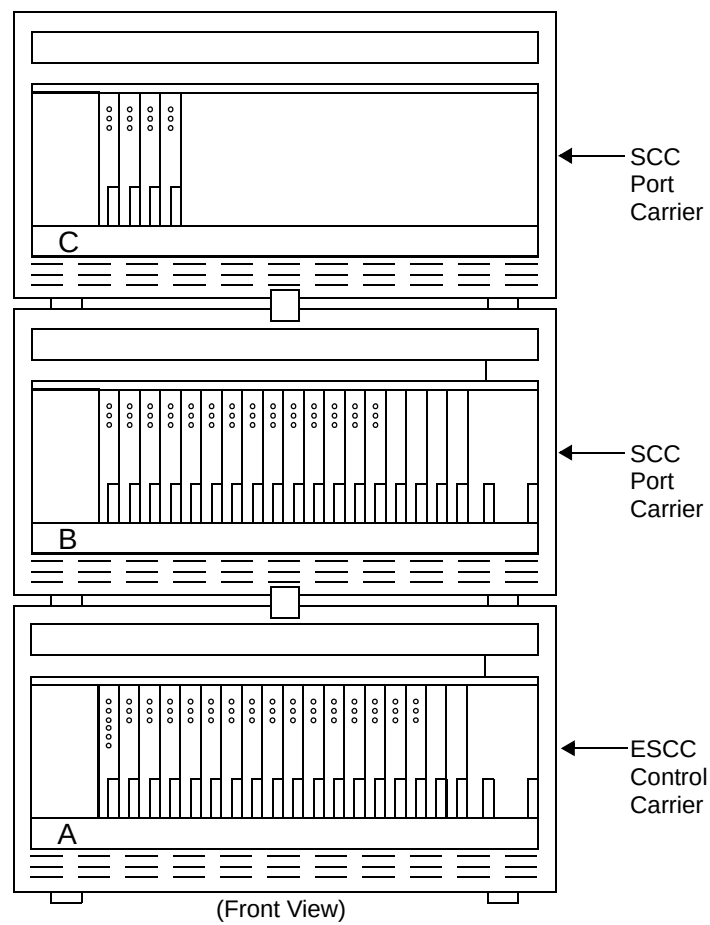
**Figure 1-2. Avaya MCU 64-Port Configuration**

For a three-cabinet system (required for 64-port configurations), the first Single-Carrier cabinet (SCC) is installed in position A, and the second and third SCCs are installed in positions B and C, respectively.

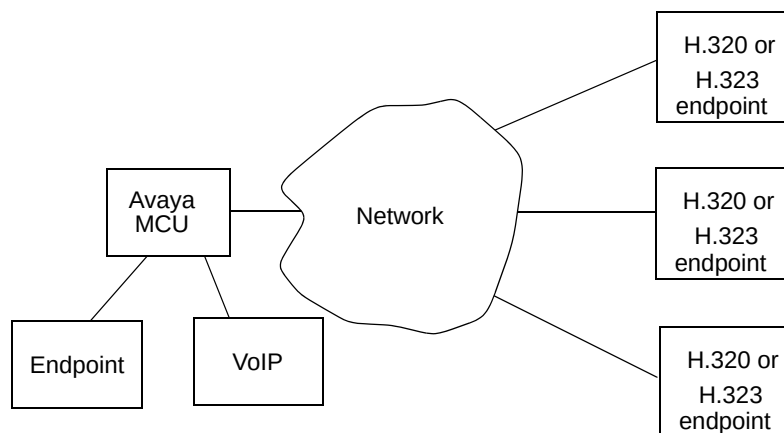
**Figure 1-3. Direct Network Connection**

However, the MCU can be connected to multiple network services. Therefore, if the MCU is connected to both AT&T and Sprint, for example, then any endpoint that is connected to either network can join an MCU video conference (provided all other criteria are met). Since the video endpoints view the connection to the MCU as a point-to-point call, the MCU accepts a call from an endpoint using the AT&T network and another endpoint using the Sprint network then places them in the same conference.

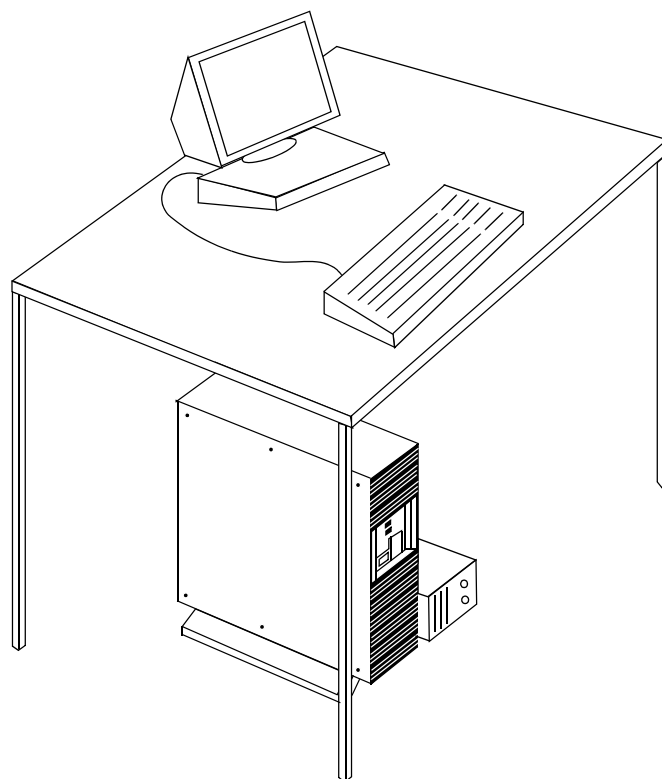
**Figure 2-1. Desk-Side ESM with UPS**

The desk-side unit is a tower configuration. The unit sits in a vertical position on a small support base. You must attach the support base to the unit. See the following figure. Also, see Chapter 3 for details on how to attach the base. Position the unit with approximately a 6-inch clearance on all sides of the equipment to provide for adequate air intake and exhaust. The Universal Power Supply (UPS) should sit on the floor alongside the tower unit.

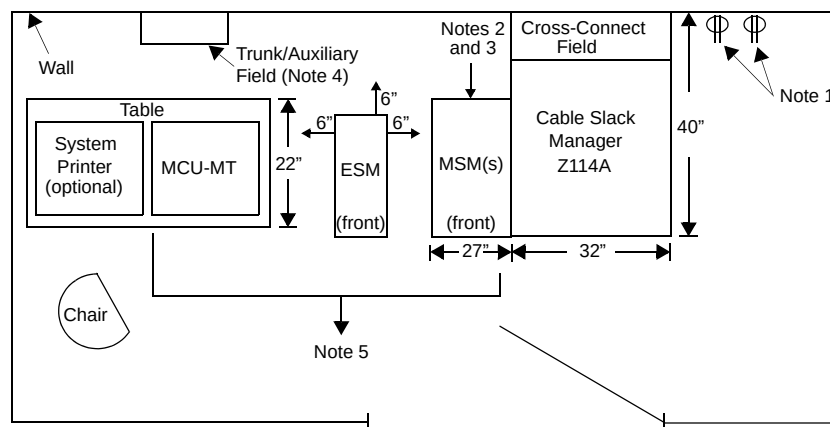
The figures in this section provide typical floor plans for various MCU systems.

1. AC receptacles must be separately fused and not under control of a wall switch. Receptacles must not be shared with other equipment, and should be located outside the cross-connect field area.
2. System must be grounded by one of the approved methods.
3. Earthquake protection may be required.
4. The trunk/auxiliary field may be located within the cross-connect field.
5. MCU-MT, MSM, and ESM must be within 50 feet of one another.

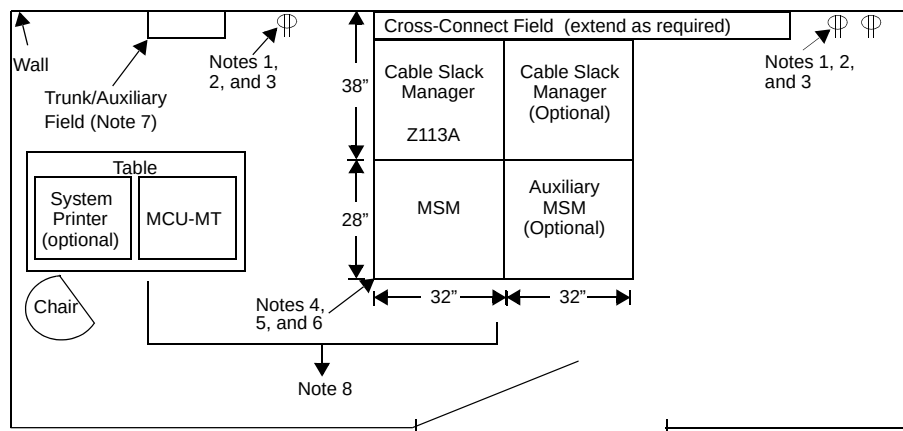
**Figure 2-3. Typical Floor Plan for DC-Powered MCU with Single-Carrier MSM**

1. AC receptacles must be separately fused and not under control of a wall switch. Receptacles must not be shared with other equipment, and should be located outside the cross-connect field area.
2. An MSM cabinet requires a special 120 volt, 60 Hz, 50 amp AC receptacle (NEMA 5-50R receptacle or equivalent) or 250 volt, 60 Hz, 30 amp AC receptacles (NEMA L14-30R receptacle or equivalent).
3. Auxiliary MSMs require a special 120 volt, 60 Hz, 20 amp AC receptacle (NEMA 5-20R receptacle or equivalent).
4. Allow at least 36 inches of space in front of MSM to let door swing open.
5. System must be grounded by one of the approved methods.
6. Earthquake protection may be required.
7. The trunk/auxiliary field may be located within the cross-connect field.
8. MCU-MT and MSM must be within 50 feet of one another.

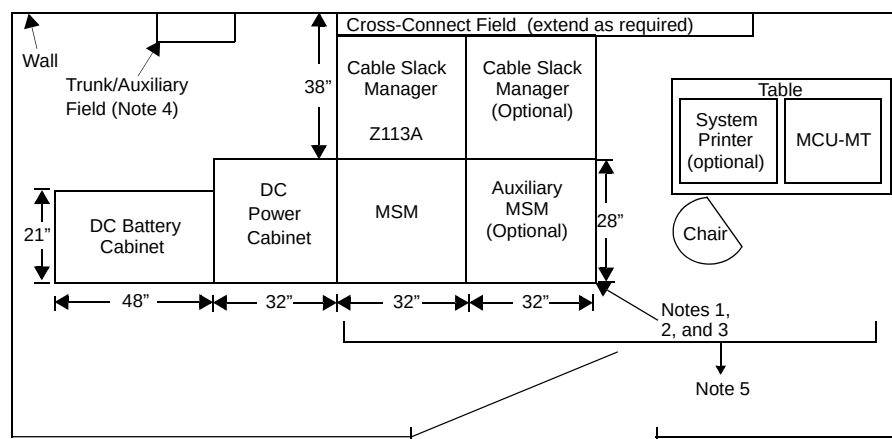
**Figure 2-4. Typical Floor Plan for AC-Powered MCU with Multicarrier MSM**

1. Allow at least 36 inches of space in front of MSM to let door swing open.
2. System must be grounded by one of the approved methods.
3. Earthquake protection may be required.
4. The trunk/auxiliary field may be located within the cross-connect field.
5. MCU-MT and MSM must be within 50 feet of one another.

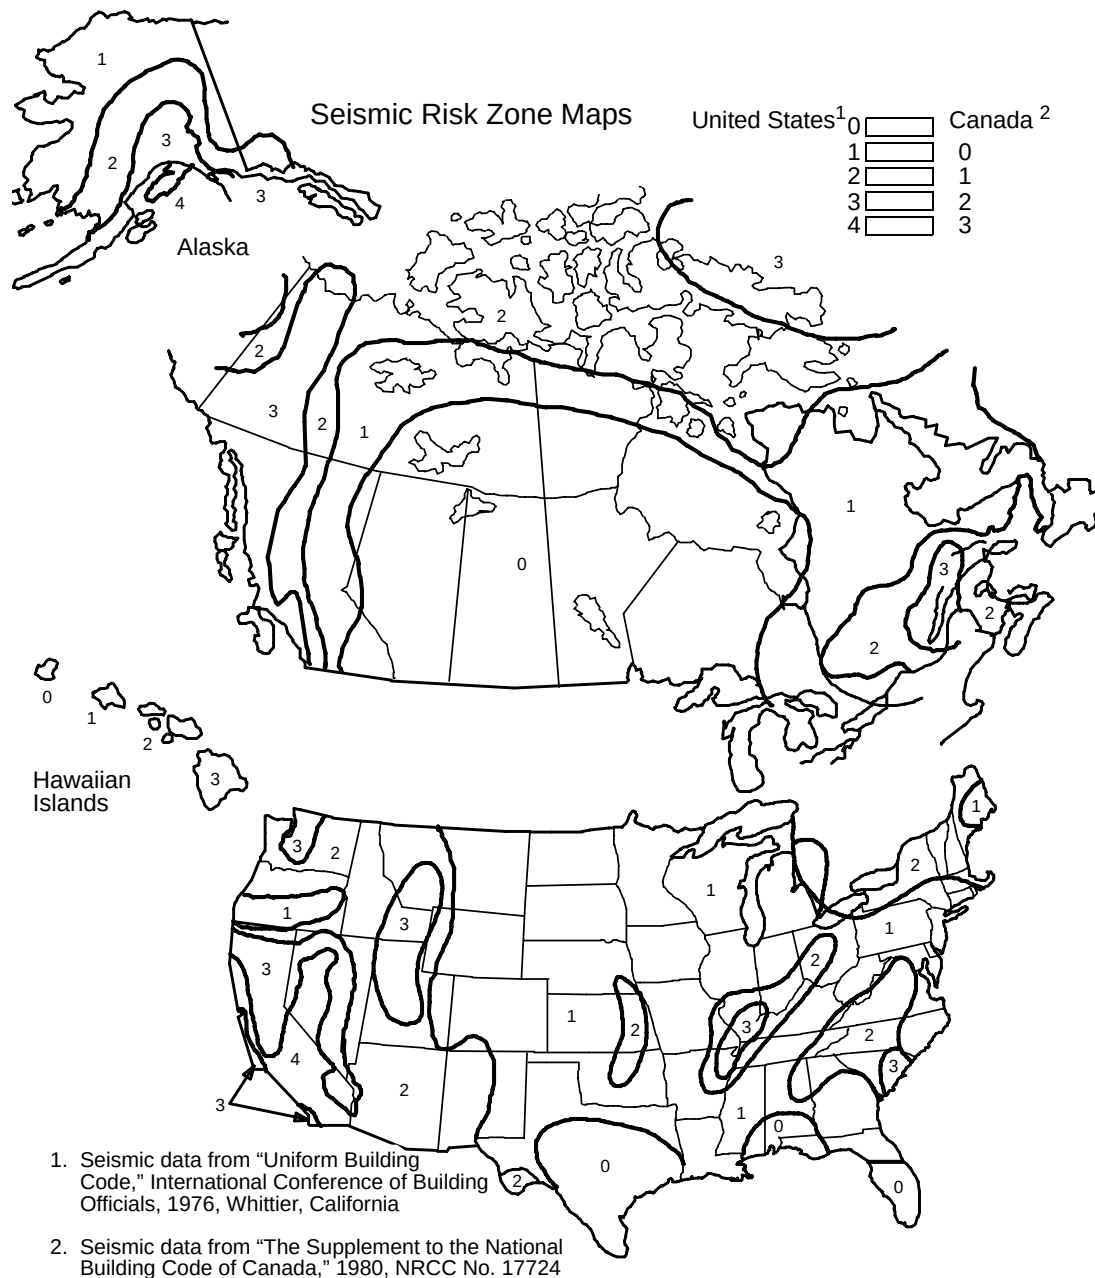
**Figure 3-1. North American Continent Earthquake Environment**

The following sections discuss how to add earthquake protection based on the floor type. The following figure shows the earthquake environment for North America.

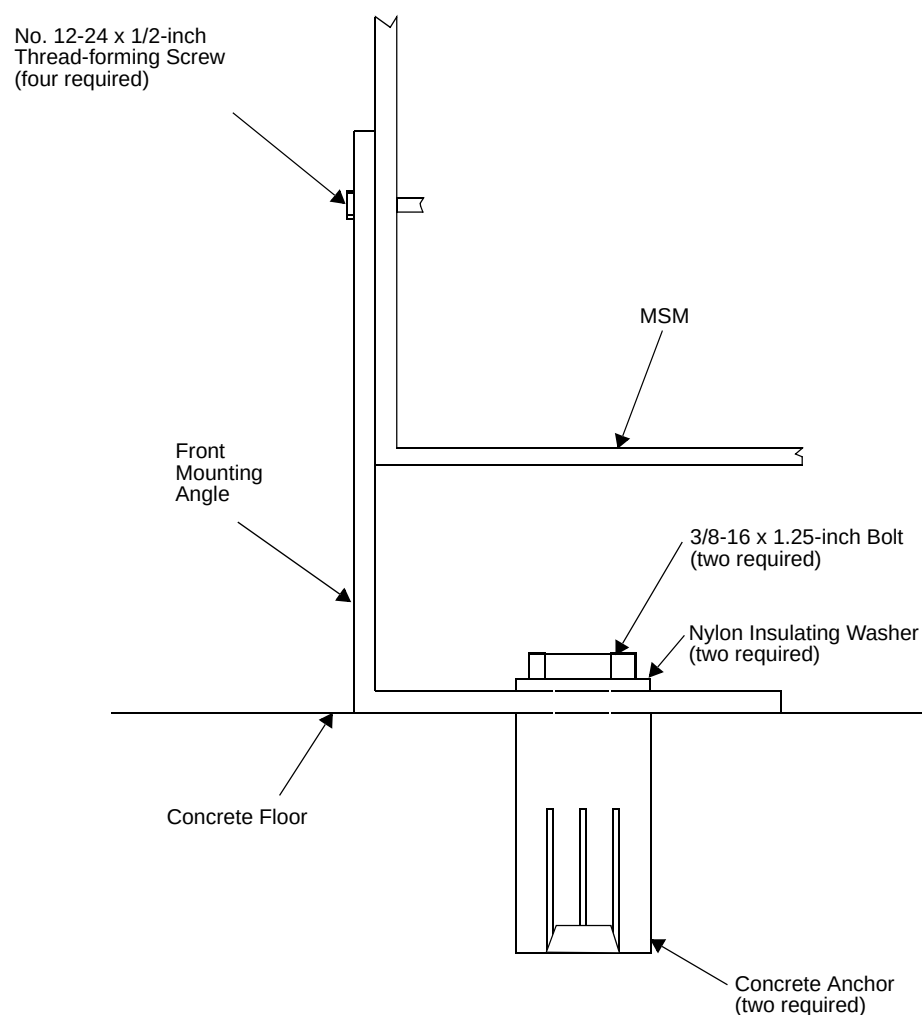
**Figure 3-2. Front Mounting Angle— Concrete Floor**

11. Move the SCC back into place.
12. Attach the SCC to the front mounting angle using four No. 12-24 x 1/2 inch thread-forming screws.
13. In the rear of the SCC, lay the stiffener on the bottom of the SCC, aligning the stiffener with the holes in the bottom of the SCC.
14. Fasten the SCC to the floor using the 3/8-16 x 3.25 hex bolt and nylon insulating washer.

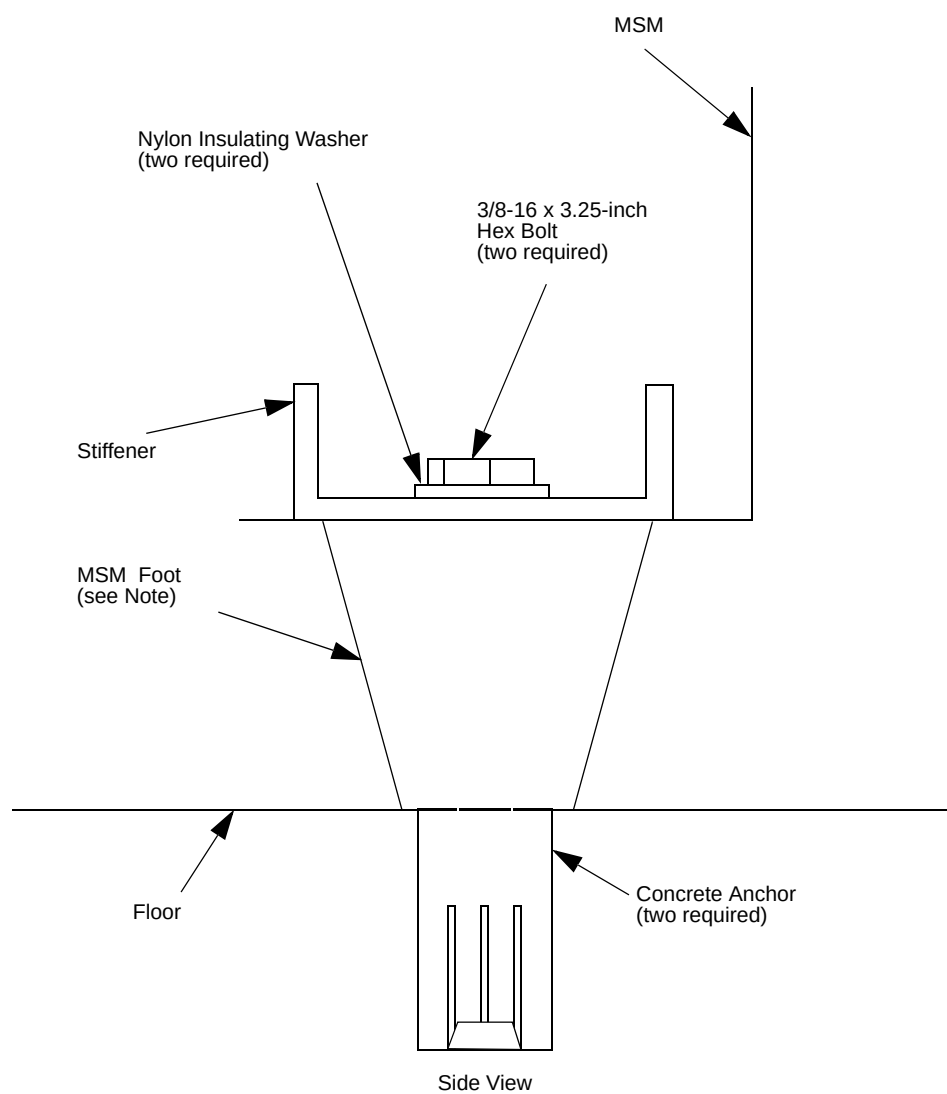
**Figure 3-3. MSM Earthquake Mounting—Concrete Floor**

NOTE: Bolt runs behind cabinet foot, not through it.

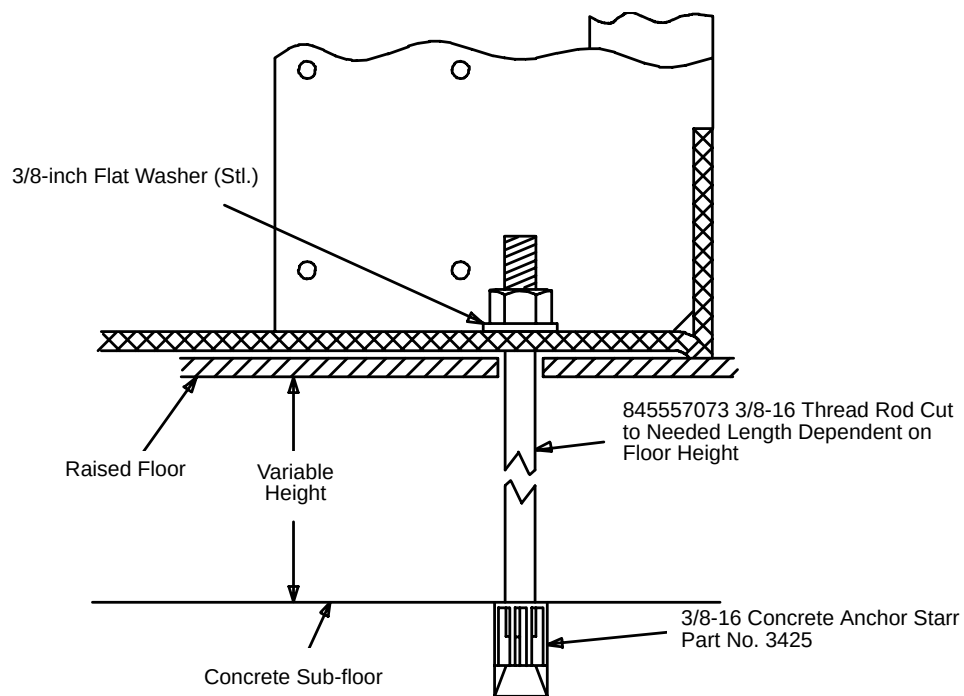
**Figure 3-4. Earthquake Mounting—Computer Raised Floor**

3. Insert a long punch through the holes drilled in step 2 and mark the concrete floor beneath the raised floor.
4. Remove the raised floor panel(s) in which the holes were drilled in step 2.
5. Using the supplied anchor bits, drill a hole at each of the locations marked in step 3. Stop drilling when the mark on the side of the bit reaches the floor level.
6. Insert a plug into the hole.
7. Drill the anchor into the hole until the mark on the bit reaches floor level again. Snap the top of the anchor bit off. Repeat for the other holes.
8. Replace the floor panel(s) removed in step 4.
9. Fasten the MSM to the floor (see the next figure).
