# **MultiPoint Conferencing Unit**

## **Release 7.2**

555-027-816  
Comcode 700217730  
Issue 1.0  
March 2002

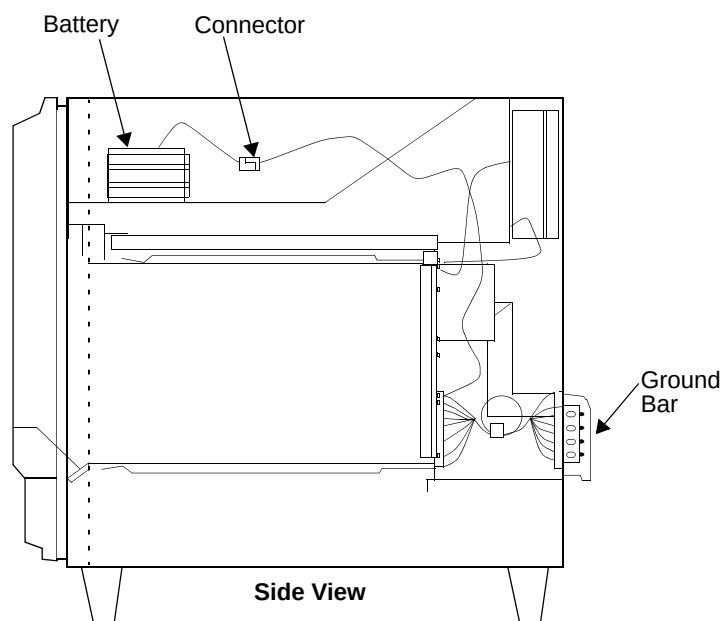
**Figure 3-5. Battery Location**

The battery is located inside the cabinet on the top of the carrier. The ESCC in position "A" is shipped with the battery lead disconnected to prevent the battery from discharging. Use the following steps to connect the battery:

1. Ensure that the circuit breaker is in the OFF position.
2. Remove the front panel. The battery lead is to the left of the battery. (You may need to reach inside to get to it.)
3. Connect the battery lead and push it back into the ESCC.
4. If additional SCCs are not being installed, skip to "Connecting AC Power to Single-Carrier MSMs" on page 3-17.

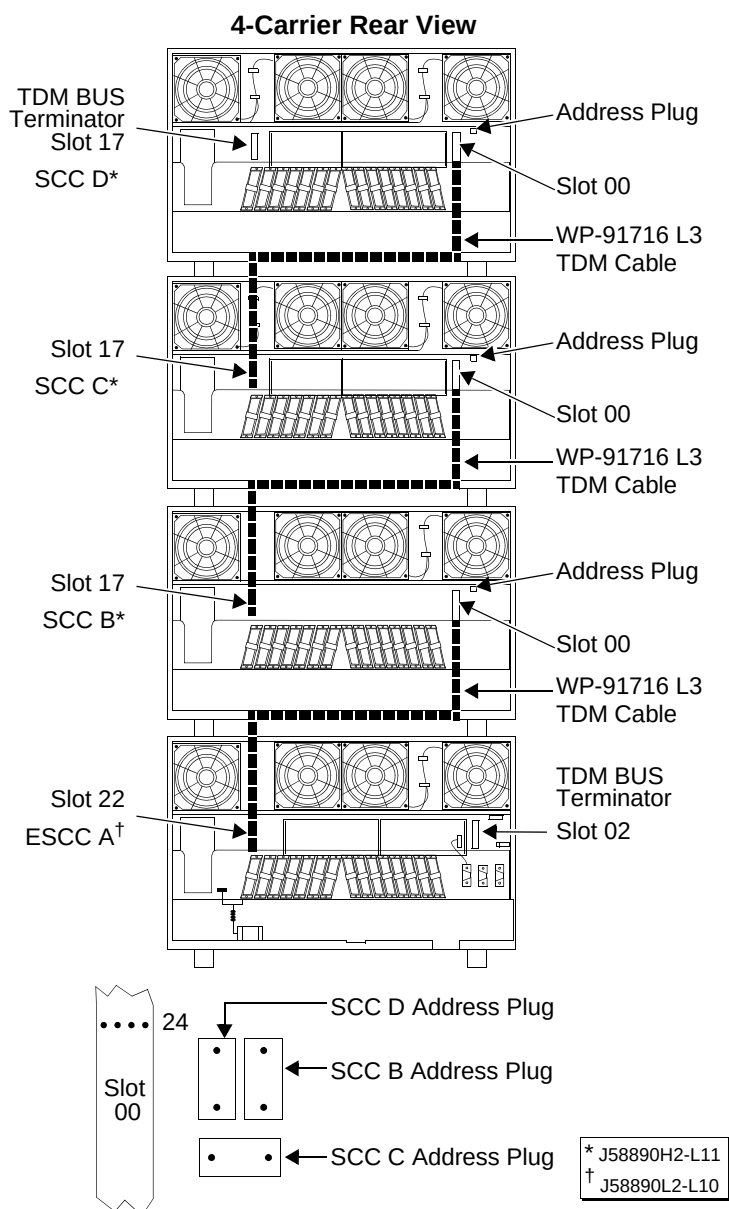
**Figure 3-7. TDM Bus Connections for the Single-Carrier MSM**

2. Remove the TDM Bus terminator in slot 22 of ESCC-A backplane and move it to slot 17 of the top SCC.
3. Connect TDM Bus cables as shown in the next figure. The TDM Bus cable is located behind the lower panel.
4. On the backplane of SCCs B, C, and D, to the right of slot 00, six pins are marked for the SCC address plug connections. Verify that the address plug for each SCC is in the right place, as shown in the next figure.

1. At the rear of the SCCs, replace the upper and lower panels (leave the screws loose). Refer to Figure 3-7 on page 3-12.
2. On SCC B, place the top of the ground plate over the bottom of the lower rear panel so the four No. 8-32 x 3/8 inch screws at the bottom of the lower rear panel go through the four ground plate keyhole slots.
3. Slide the ground plate down over the top of the upper rear SCC panel of SCC A so the four No. 8-32 x 3/8 inch screws that attach the upper rear panel go through the four lower ground plate slots.
4. Ensure that the exposed portion of the TDM Bus cable between the SCCs does not get pinched.
5. Tighten the screws. If earthquake protection is required, skip to "Installing Earthquake Plates" on page 3-14.

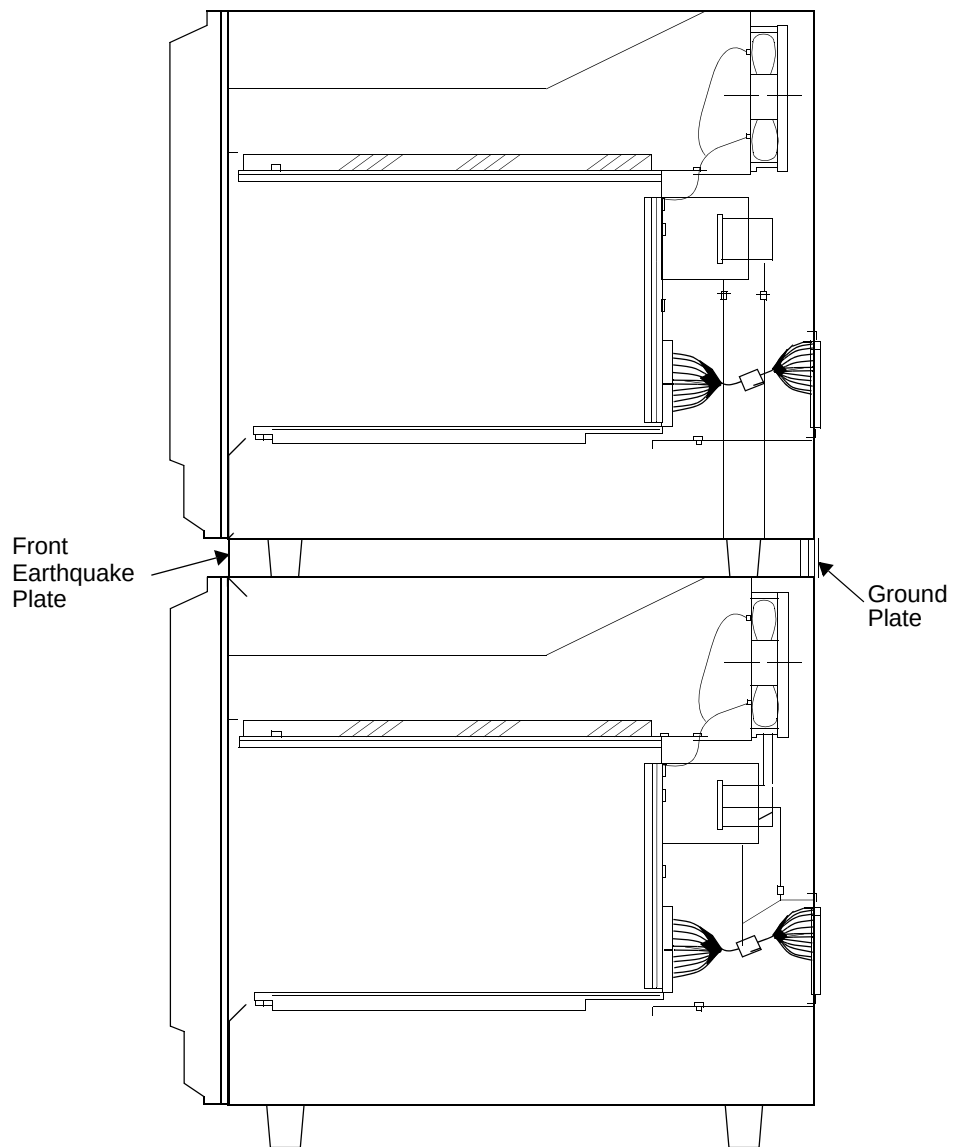
**Figure 3-9. Ground Plate and Earthquake Front Plate**

1. At the front of the SCCs, line up the holes in the top of the earthquake front plate with the holes at the bottom of SCC B and insert the four No. 8-32 x 3/8 inch screws. Do not tighten them yet.
2. At the front of the cabinets, line up the holes in the bottom of the earthquake front plate with the holes at the top of ESCC A and insert the four No. 12-24 x 1/2 inch thread-forming screws.
3. Tighten the earthquake plate screws.

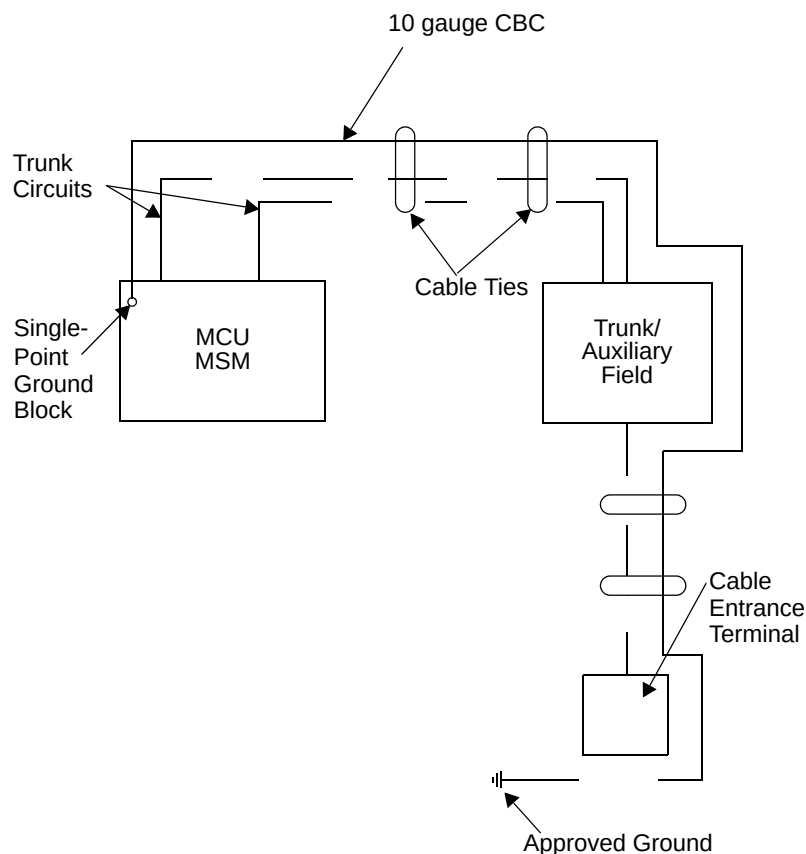
**Figure 3-10. Installing the Coupled Bonding Conductor**

The CBC is a conductor that is connected to ground and run adjacent to the pairs in an inside wiring cable. The mutual coupling between the bonding conductor and the cable pairs reduces potential differences in terminating equipment. The conductor consists of a 10-AWG wire that is tie-wrapped to the inside wiring cable.

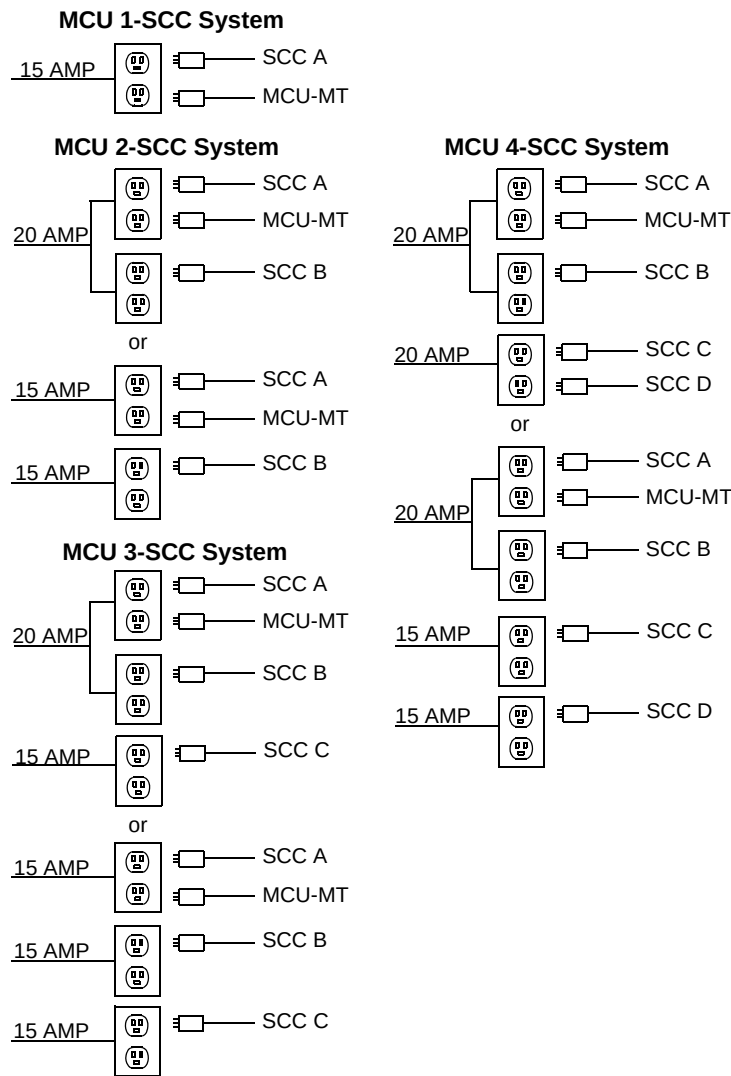
Figure 3-11. Typical AC Power Receptacle Requirements for SCC Systems

To confirm that an MCU is AC-powered, look at the front tab on the power supply (the hinge on the circuit board). The number "1271A" identifies the power supply as AC. The AC power is either 120v, 60 cycle or 240v, 50 cycle.

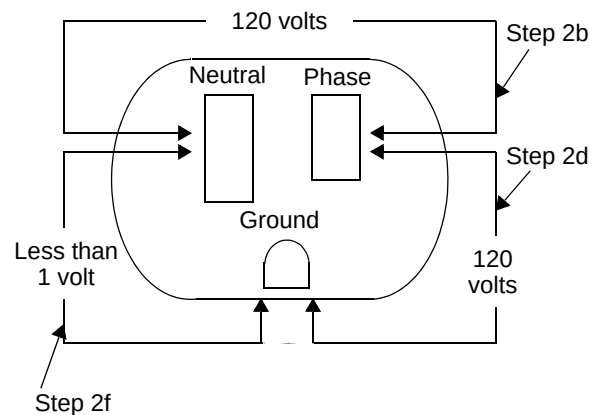
**Figure 3-12. Three-Prong 120 Volt AC Receptacle**

- a. Using a digital voltmeter (VM), set the AC voltage range scale to greater than 250 volts AC.
- b. Measure voltage between the hot side and the neutral side of the receptacle.
- c. Verify that the voltage measured from Phase to Neutral is 110 to 125 volts AC. Correct any power problem before proceeding.
- d. Measure voltage between the phase side of the receptacle and receptacle ground.
- e. Verify that the voltage between the phase side of the receptacle and the receptacle ground reads between 110 and 125 volts AC. Correct any power problem before proceeding.
- f. Measure voltage from Neutral to Ground.
- g. Verify that the meter reads less than 1 volt AC. Correct any grounding problem before proceeding.

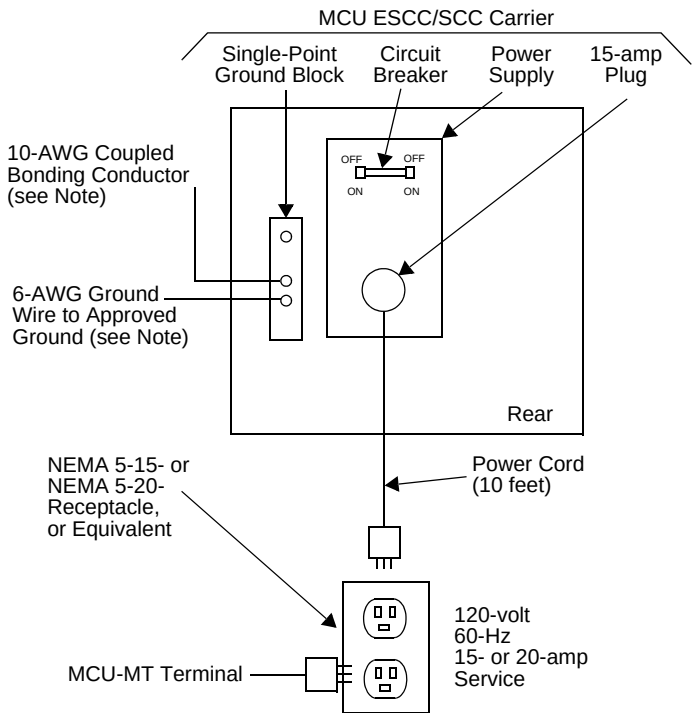
Figure 3-13. Typical Grounding and Power Arrangement

NOTE: To Coupled-Bonding Conductor-Terminal Bar at Cross-Connect Field

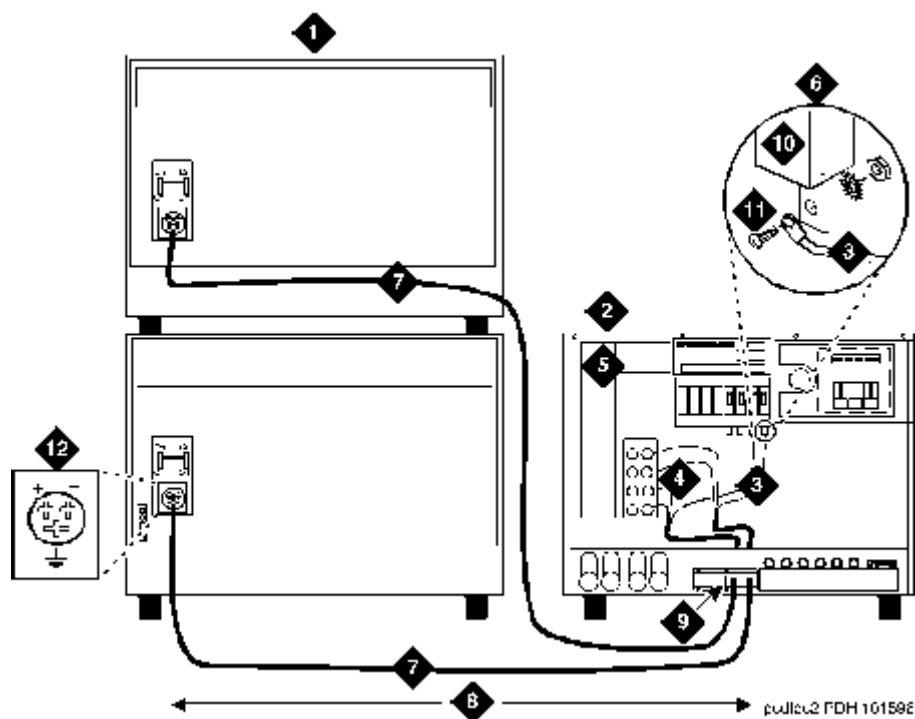
### Figure 3-14. Typical DC Power Connections

1. System MSM Stack
2. DC Power MSM
3. White Wires
4. Green Ground Wires and Black Wires Connect to the -48 VDC Return Bus
5. -48 VDC Bus
6. Connect White Wires to Circuit Breakers
7. DC Power Cable (H600-436, G1) to Power Connector on Each MSM. Cut to Length and Crimp a Ring Terminal Onto Each Wire
8. 30 Feet (9 m) Maximum
9. Route Cables Through Sliding Door
10. Circuit Breaker
11. Supplied #10-32 Screw, #10 Star Washer, and #10-32 Hex Nut
12. Inset Showing DC Power Connector (Male)

Figure 3-14 shows a typical power and ground layout for a DC-powered system without a J58890CG DC Power Distribution Unit. The J58890CG is required if the distance between the DC Power MSM(s) is greater than 30 feet (9 m). Figure 3-15 shows a typical power and ground layout for a DC-powered system containing a DC power distribution unit.

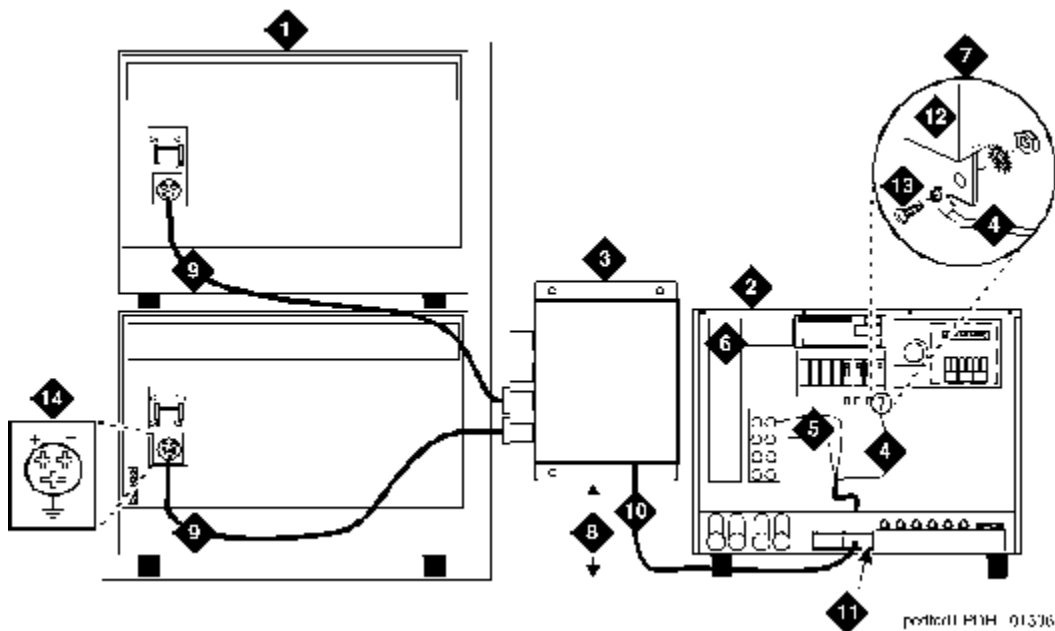
**Figure 3-15. Connections Using DC Power Distribution Unit**

A 10 foot (3 meter) power cord is equipped with the appropriate connectors. In the configuration shown in Figure 3-15, each cabinet stack has a DC Power Distribution Unit associated with it.

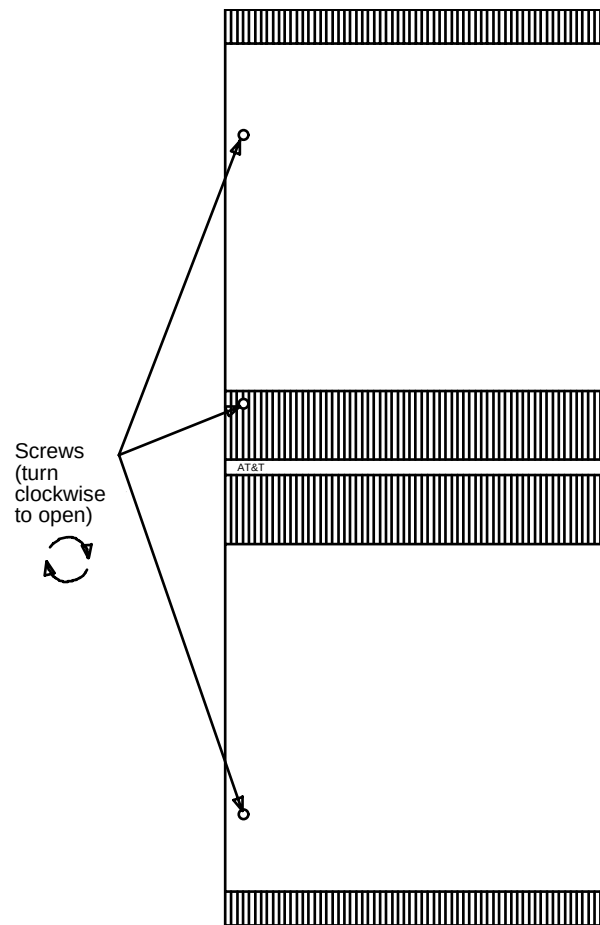
Figure 3-16. Location of MCC Door Latches (Front)

5. Remove all cardboard, tape, and plastic from the MCC.
6. To open the MCC doors, use a screwdriver to turn the screws clockwise. The screws are located on the front and rear doors to release the door latches (see the following figures).
7. Lift off the front and rear doors (do not remove the screws from the door hinges).

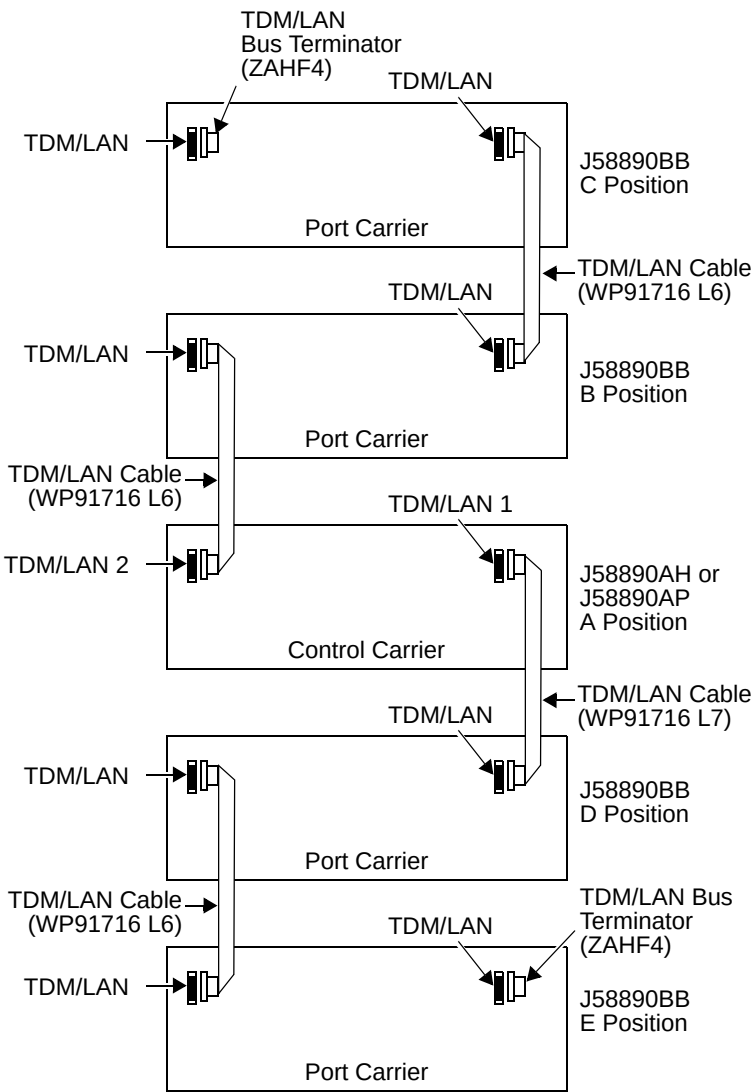
**Figure 3-18. TDM/LAN Bus Cabling — Rear View of a Fully Loaded Multicarrier MSM Configuration**

The following figure provides a rear view of the TDM/LAN bus cabling for a fully loaded multicarrier MSM configuration.

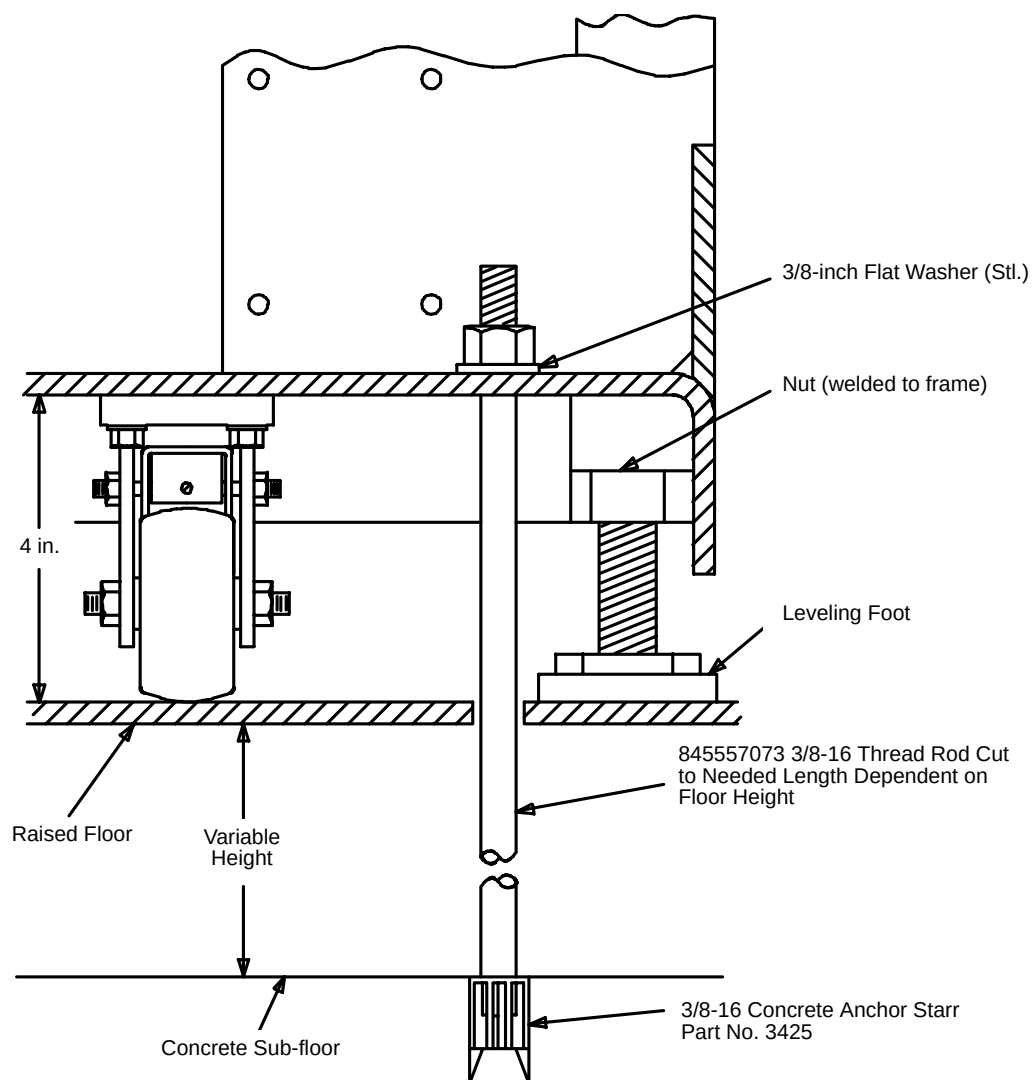
**Figure 3-19. Earthquake Mounting—Computer Raised Floor**

- j. Fasten the MSM to the floor.

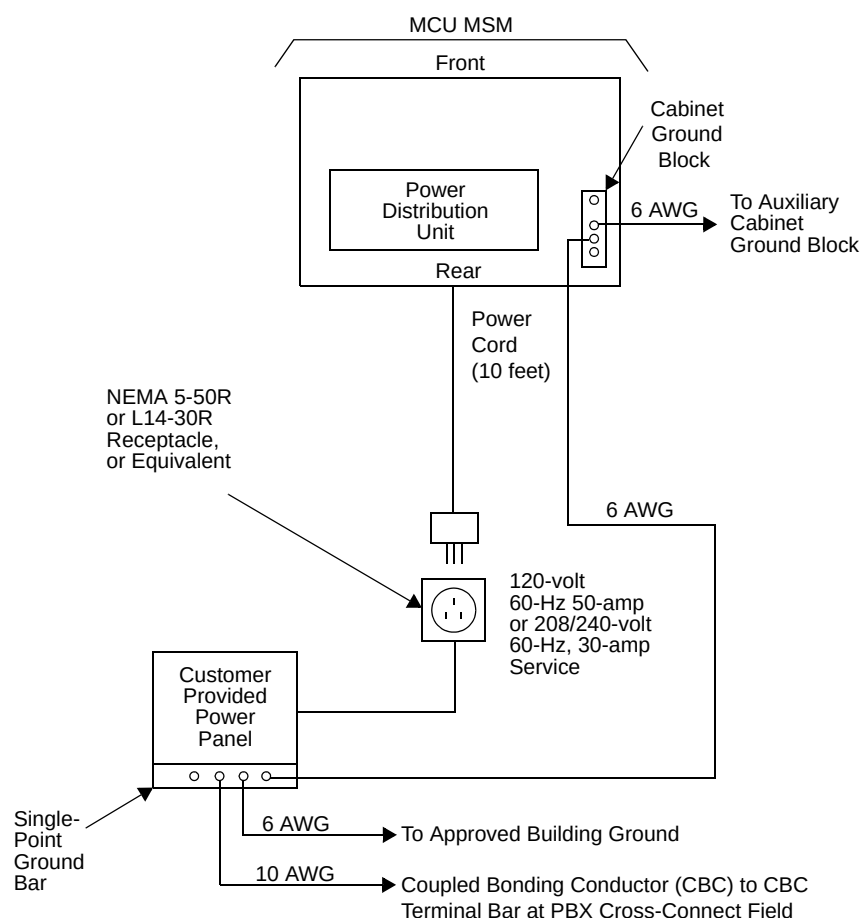
**Figure 3-20. Typical AC Power and Grounding Arrangement for a MCC-MSM**

The following figure shows a typical AC power and grounding layout. The switch may be powered by a 120 volt, a 220 volt, a 208 volt, or a 240 volt AC source, depending on which is required for the particular installation. The power circuit must be dedicated to the switch. It must not be shared with other equipment, and it **must not be** controlled by a wall switch. The AC receptacle should not be located under the cross-connect field. (The coupled bonding connector shown in the illustration is described later in this chapter.)

1. At lower right rear of the MSM, connect a 6-AWG ground wire to the MSM ground bar (Figure 3-20 on page 3-34). See the accompanying note.

2. Run the ground wire to the single-point ground-terminal bar at the AC load center (shown as “power panel” in Figure 3-20 on page 3-34).
3. Run the ground wire to the MSM, and connect it to the MSM ground bar (Figure 3-21 on page 3-35).
4. At the AC load center, connect a 10-AWG wire single-point ground-terminal bar. This ground wire (coupled bonding conductor) will later be tie-wrapped to the trunk cables and connected to the coupled bonding conductor ground bar at the cross-connect field and finally terminated at the customer-provided load center (Figure 3-21 on page 3-35).

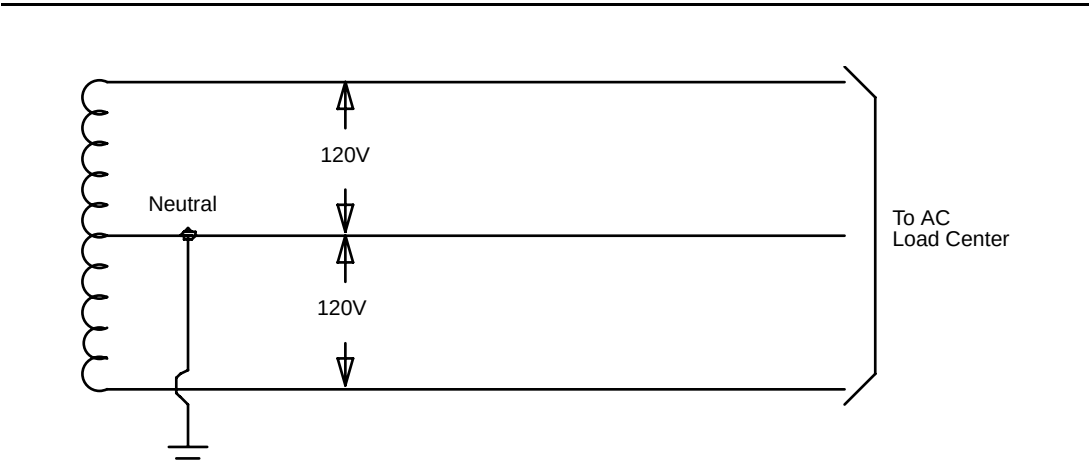
Figure 3-21. Single-Phase 3-Wire (220 to 240 VAC) System

It is necessary to note the difference between 208 volt and the other kinds of AC power. The most common power arrangements currently in use are single-phase 3-wire and three-phase 4-wire systems. Both arrangements are illustrated in the following figures. On a three-phase 4-wire Wye system, 208 volt can be obtained from any two phases of the three-phase system. Either method is satisfactory as long as 208 volt three-phase or 220 to 240 volt single-phase 50 to 60 Hz AC, centered around a neutral connection, is furnished at the correct amperage capacity and meets the national and local electrical codes.

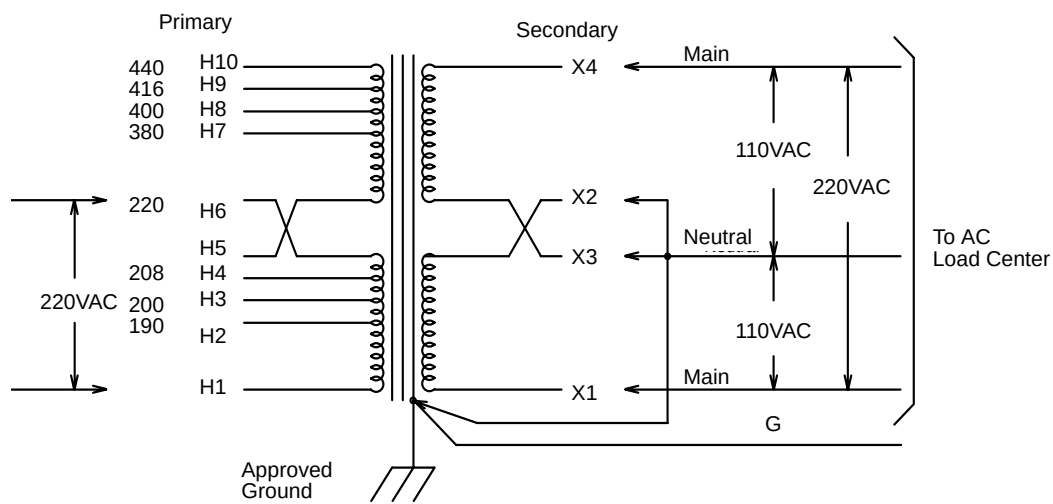
Figure 3-23. Typical Center-Tapped Isolation Transformer

International 50 Hz commercial power is often supplied without a centered neutral connection. In situations like this, the power must be transformed to work with the MCU. Use a transformer with a single-phase tapped primary and a center-tapped secondary to provide compatible power. The following illustration shows an example of a properly wired transformer.

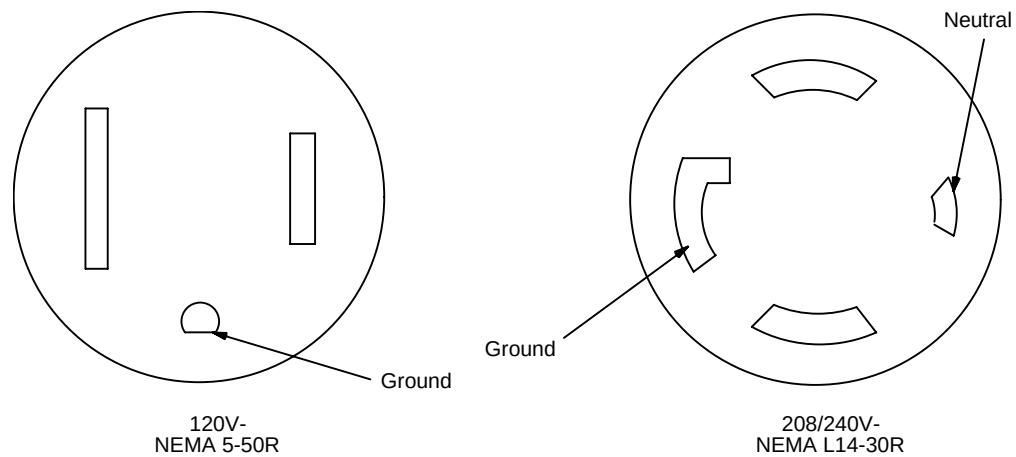
**Figure 3-24. AC Receptacle**

1. Set the DVM to the 250 volt range.
2. Carefully measure the voltage between the hot and the neutral side of the receptacle (see Figure 3-24). The neutral wire is white, the hot wire black.

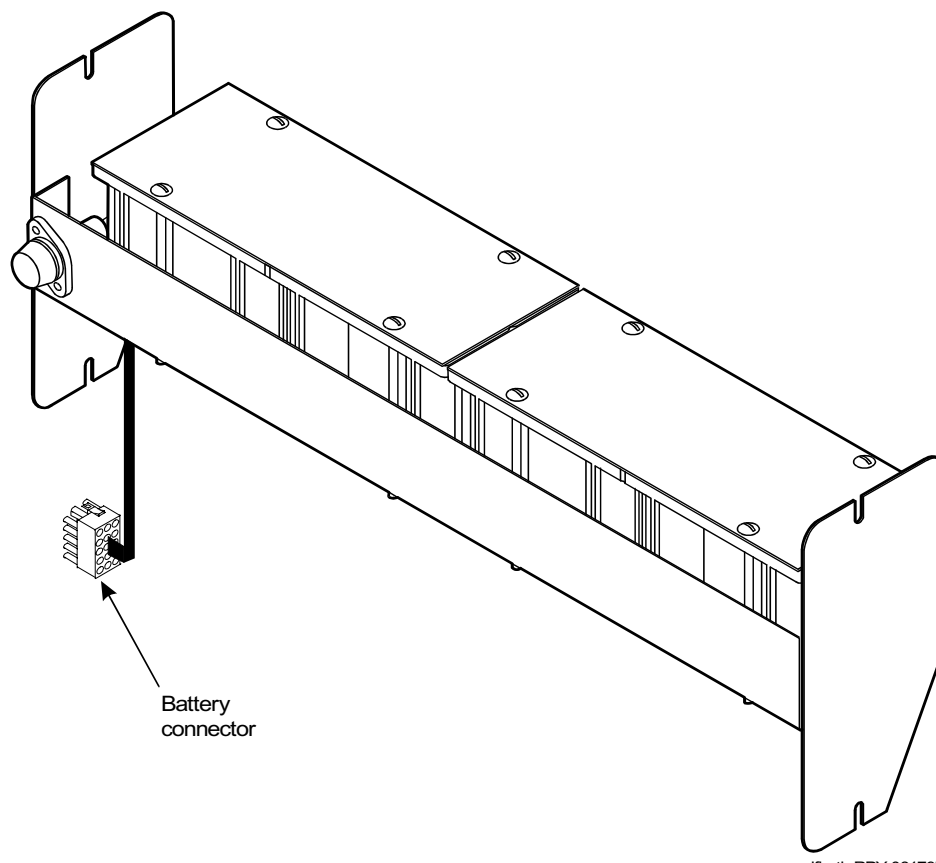
Figure 3-25. Typical Small Battery Assembly

Figure 3-25 shows a typical optional small battery holdover assembly. These assemblies may ship with the battery leads disconnected to prevent the batteries from discharging.

1. Plug the battery connector into the -48 VDC Batteries connector on the rear of the J58890CH-1 Power Distribution Unit.

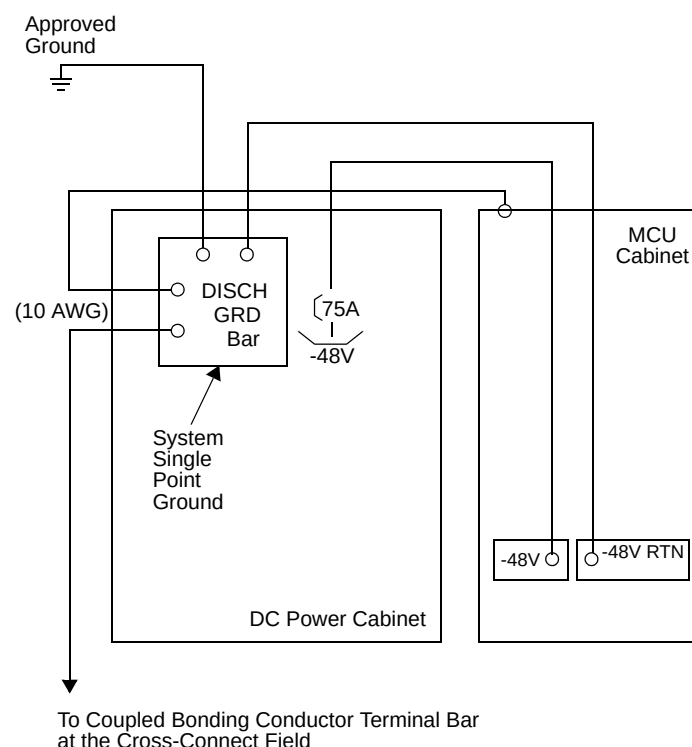
The following illustration shows a typical power and grounding layout for a DC-powered MCC-MSM. The size of the wire required for the -48 volt DC and -48 volt return must be engineered to ensure the **-48 volt DC supplied by the battery plant to the MSMs will be maintained between -42.5 and -52.5 volt DC at all times** to ensure proper operation and to prevent hardware damage.

**Figure 3-28. Power and Grounding Arrangement for DC-Powered MCC-MSM**

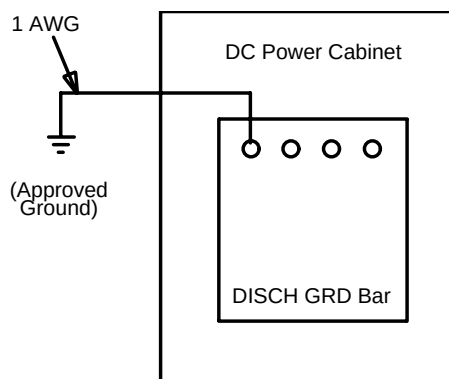
1. At the DC power cabinet, connect a 1-AWG ground wire to the **DISCH GRD** bar.
2. Route the ground wire out of the cabinet and terminate it on the approved ground, as shown in the following figure. The approved ground must be identified with an Avaya-supplied grounding tag (FORM 15657NR or equivalent).

**Figure 3-29. Power Plant Grounding**

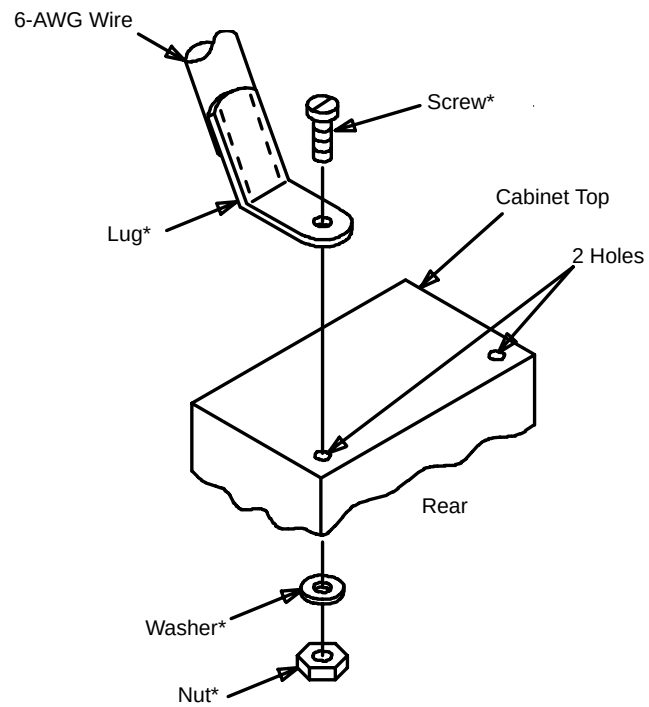
3. At the DC power cabinet, connect wire to the **DISCH GRD** bar. Route wire out of DC power cabinet and up to the top rear corner of the MSM.
4. On top of the MSM, terminate the 6-AWG ground wire, as shown in the following figure.

\* Included in D-181895, Kit of Parts (Comcode 105434559)

**Figure 3-30. MSM Frame Ground Connections**

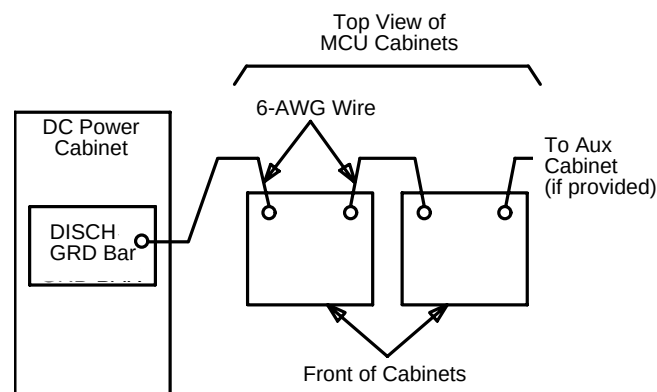
**Figure 3-31. Frame Ground Attachment**

1. Set the main circuit breaker to OFF.
2. At the MSM:
  - a. Using a 3/8-inch allen wrench, connect the -48 volt DC lead as shown in Figure 3-31 on page 3-48.
  - b. Using a 3/16-inch allen wrench, connect the -48 volt RTN lead as shown in Figure 3-31 on page 3-48.
3. Route the leads out of the MSM through the mouse hole in the lower rear cover and over to the DC power cabinet.
4. At the DC power cabinet:
  - a. Terminate the -48VDC lead on a **DC OUTPUT** circuit breaker.
  - b. Terminate the -48V RTN lead on the **DISCH GRD** bar.
5. Repeat the procedure for each MSM.

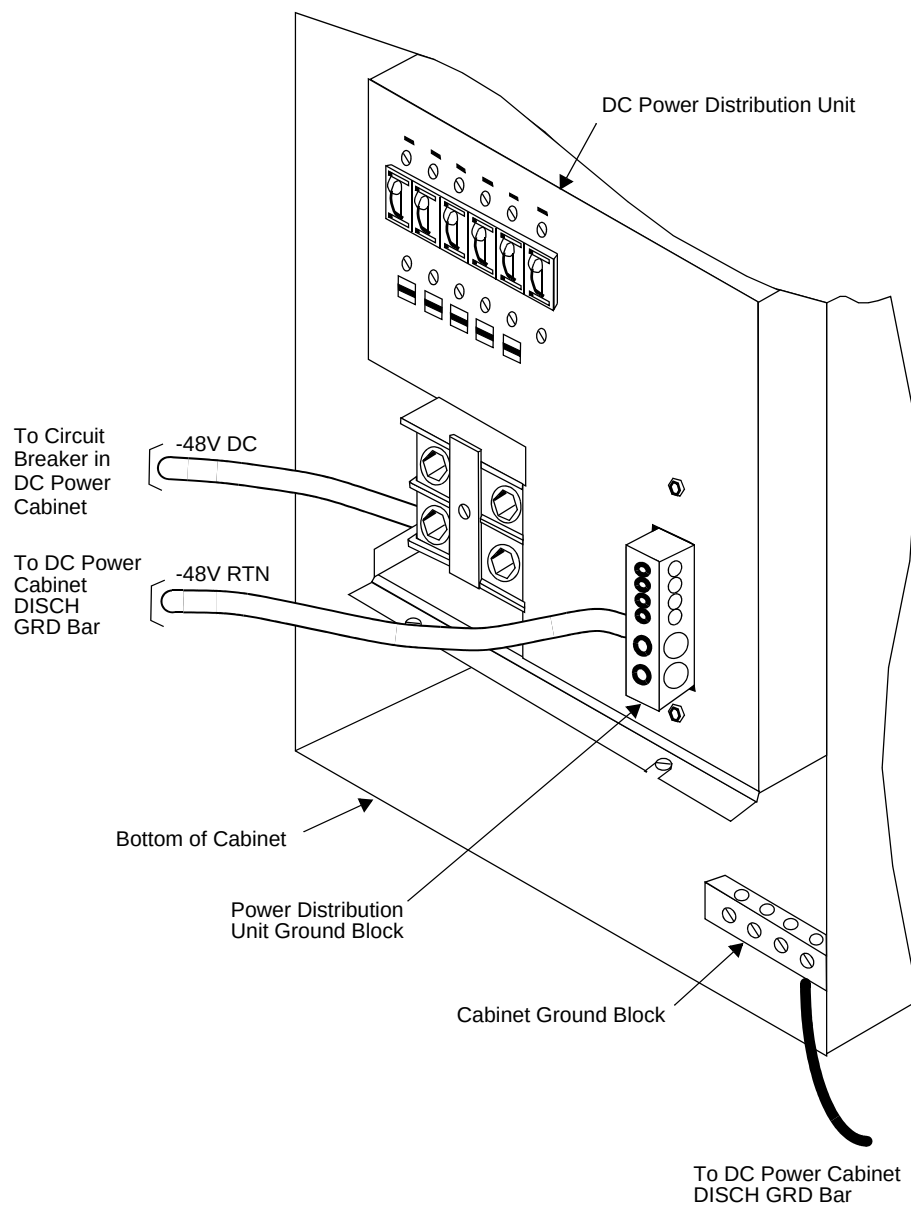
**Figure 3-32. Power and Ground Connections for a DC-Powered MCC-MSM**

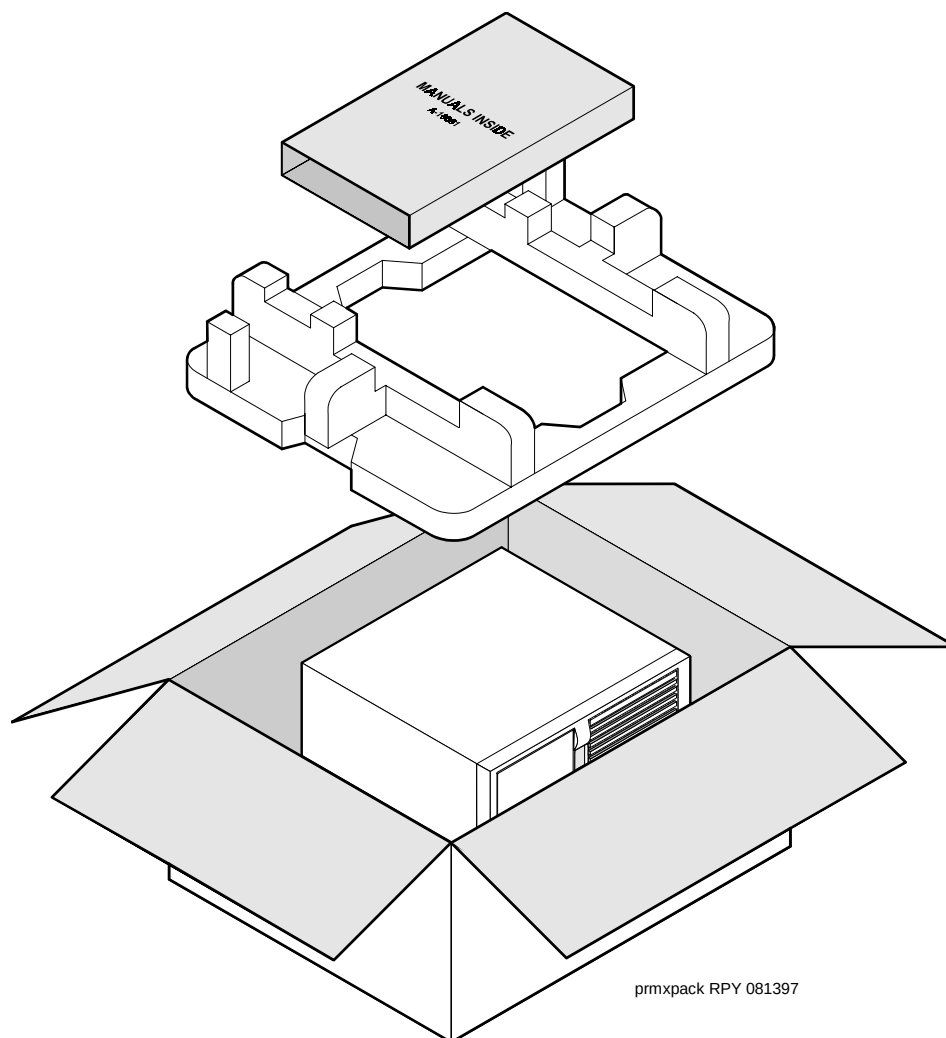
**Figure 3-33. Unpacking the MAP/40P**

To unpack the MAP/40P, see Figure 3-33 and complete the following procedure:

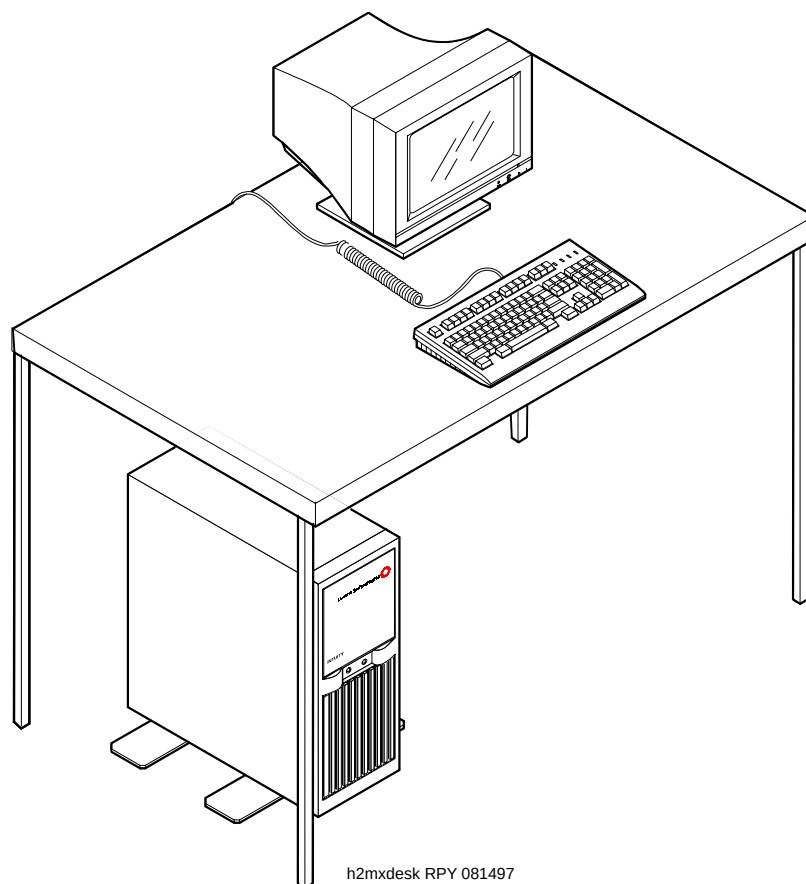
The MAP/40P is a desk side unit in a tower configuration (Figure 3-34). It sits vertically on stabilizing feet, which you will install as described in the following "Attaching the Stabilizing Feet" section.

**Figure 3-34. MAP/40P Deskside Unit**

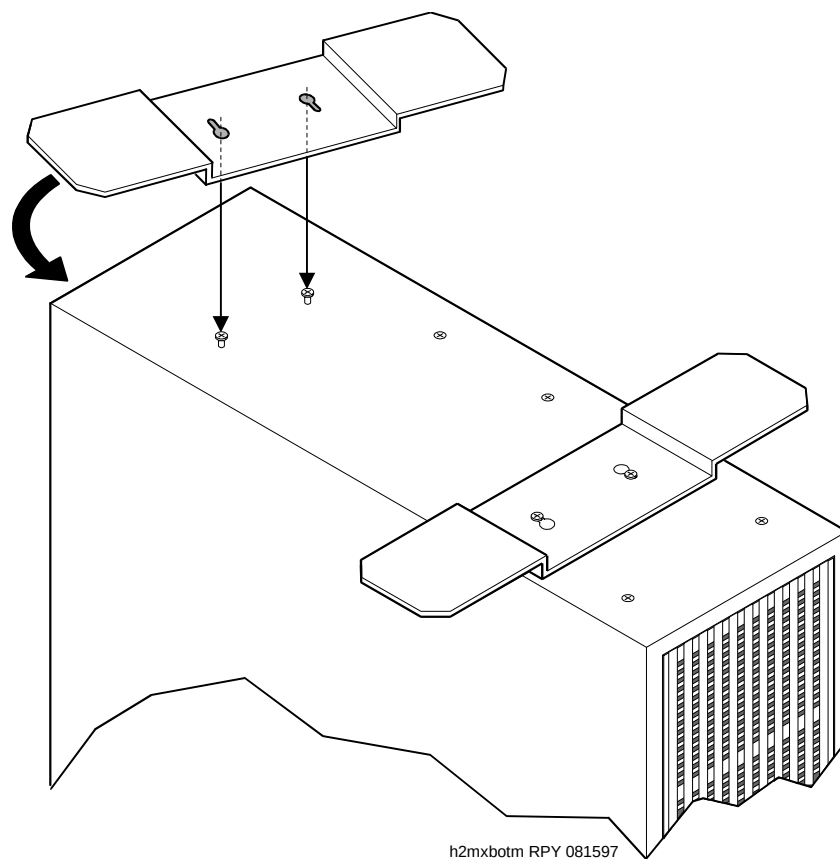
**Figure 3-35. Attaching the Stabilizing Feet**

The manufacturer attaches four screws to the bottom of the MAP/40P to use with the stabilizing feet. See Figure 3-35 for a view of the stabilizing feet.

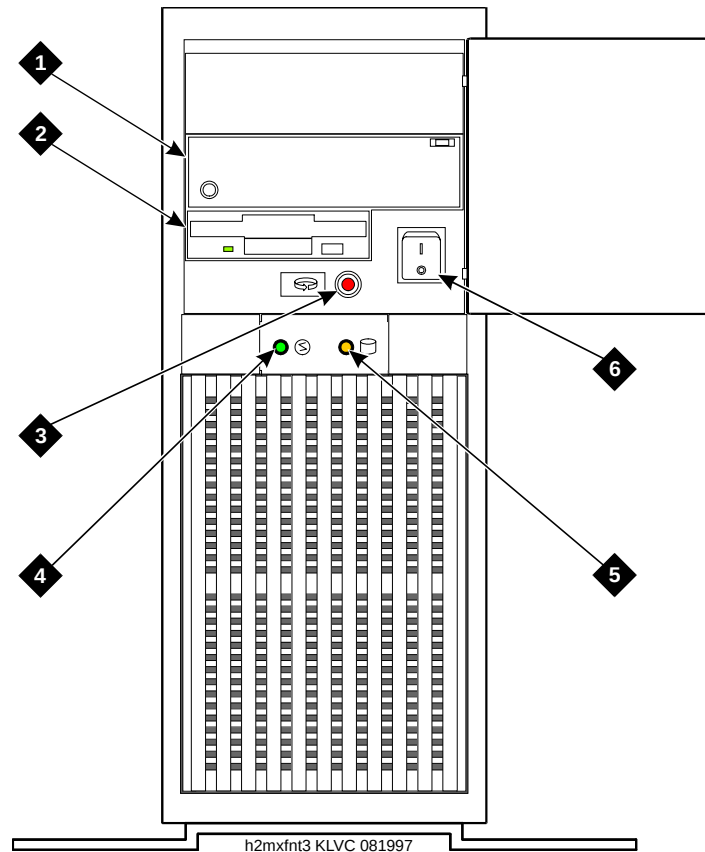
1. Cartridge tape drive
2. Diskette drive
3. Reset switch
4. Power indicator LED
5. Disk activity indicator LED
6. Power switch

**Figure 3-36. Front View of the MAP/40P**

Figure 3-36 shows the front view of the MAP/40P. The following components are accessible on the front of the MAP/40P:

Figure 3-36 shows the front view of the MAP/40P.

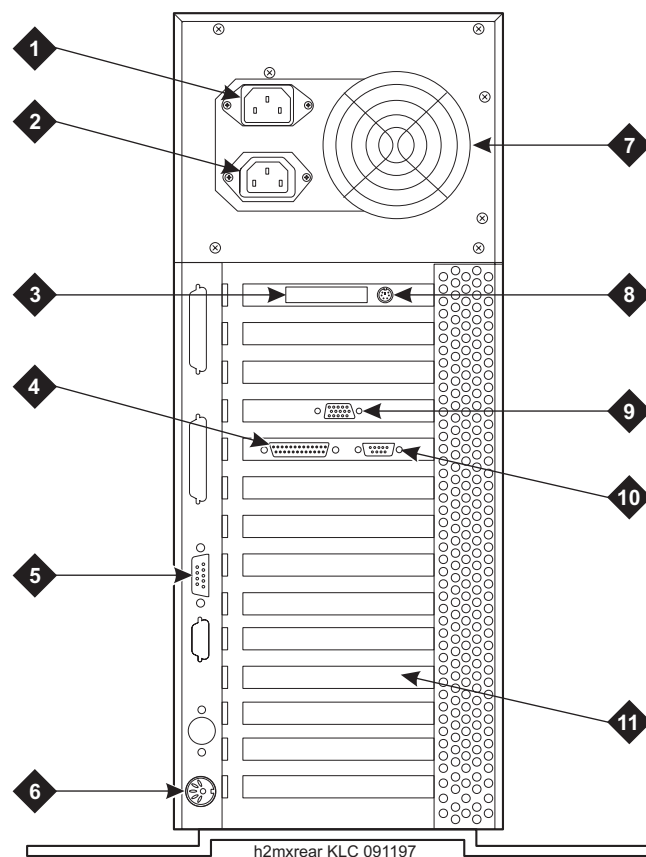
1. AC power inlet receptacle
2. AC power supply outlet
3. External SCSI I/O connector
4. Parallel port
5. COM2
6. Keyboard connector
7. Power supply fan exhaust
8. Mouse connector
9. Video connector
10. COM1
11. MSM interface card

**Figure 3-37. Back View of the MAP/40P**

See Figure 3-37 for the locations of these components on the MAP/40P.

The external SCSI I/O connector provides an external SCSI connector and an active termination for the SCSI bus. No terminating resistor is shown in Figure 3-37.

Figure 3-37 shows the back view of the MAP/40P.

1. Plug the video cable connector from the monitor directly into the video connector located on the back of the MAP/40P. See Figure 3-37 for the location of the video connector.
2. Tighten the thumbscrews on the video cable connector with your fingers or with a small flat-blade screwdriver.
3. Plug the female end of the power cable into the monitor.
4. Plug the male end of the power cable into a grounded outlet.

A 6-pin female DIN receptacle is located in the back of the MAP/40P. The mating male plug is provided with the keyboard. Both of the connector assemblies are keyed to provide proper alignment. See Figure 3-37 for the location of the keyboard connector.

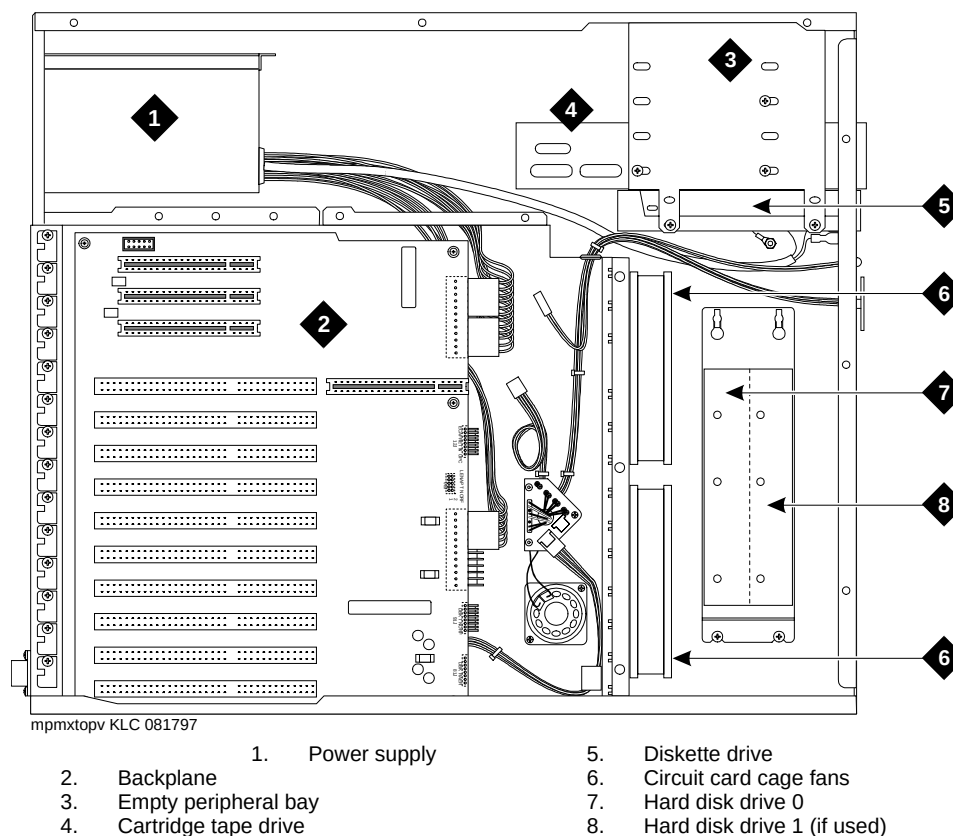
Figure 3-38 includes a side view of the MAP/40P peripheral drive device locations.

**Figure 3-38. Side View of MAP/40P Including Locations of Peripheral Drive Devices**

See Figure 3-38 for the location of peripheral drive devices.

**Hard Disk 1.** Hard disk drive 1 may or may not be present in your system. If it is installed, it is located in the front slot of the hard disk drive support box, toward the lower front dress cover. Hard disk 1 can be used for mirroring.

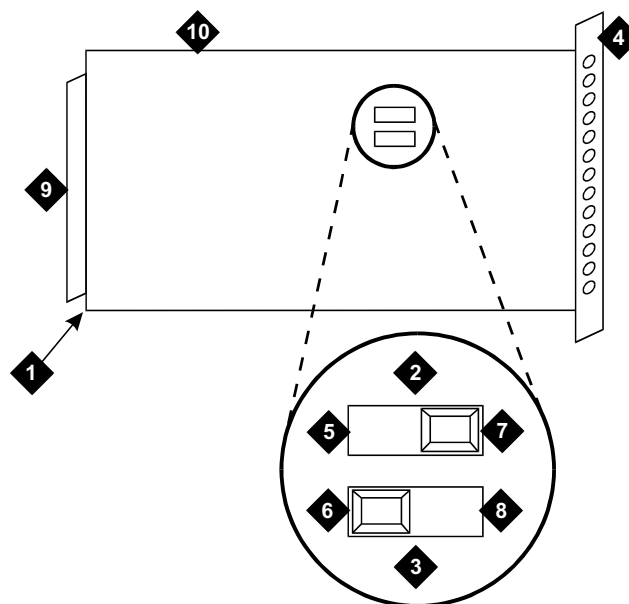
**Figure 3-39. TN2207 Option Settings****NOTE:**

The standard configuration for TN2207 circuit packs shipping from the factory is 24-channel DS1 service with a termination impedance of 120 ohms (24CH/120ohm). Therefore, the 24/32CH jumper/switch must be deliberately moved to the 32CH E1 position before installing the TN2207 circuit pack as an ESM-DS1 circuit pack. If this is not done, the ESM-MSM Link will never establish itself as in-service. The impedance can remain at the factory default setting.
