# **MultiPoint Conferencing Unit**

## **Release 7.2**

555-027-816  
Comcode 700217730  
Issue 1.0  
March 2002

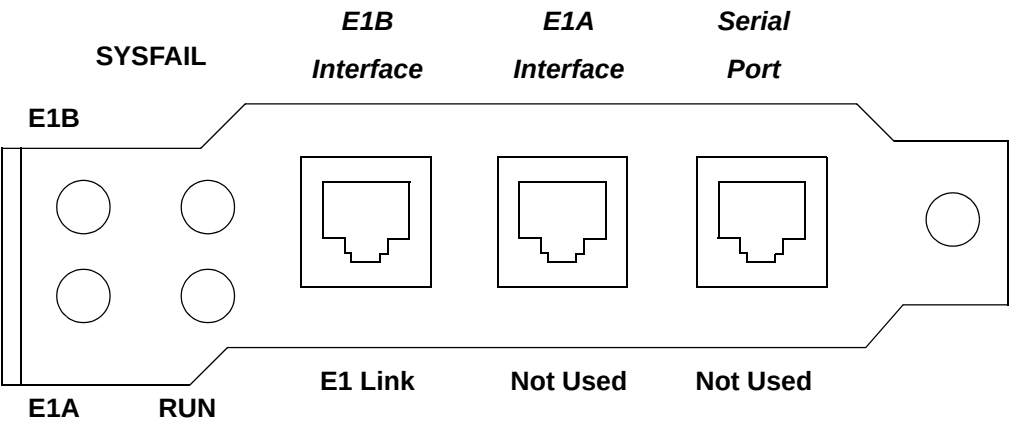
Figure 3-40. Rear Bracket of the MSM Interface Card

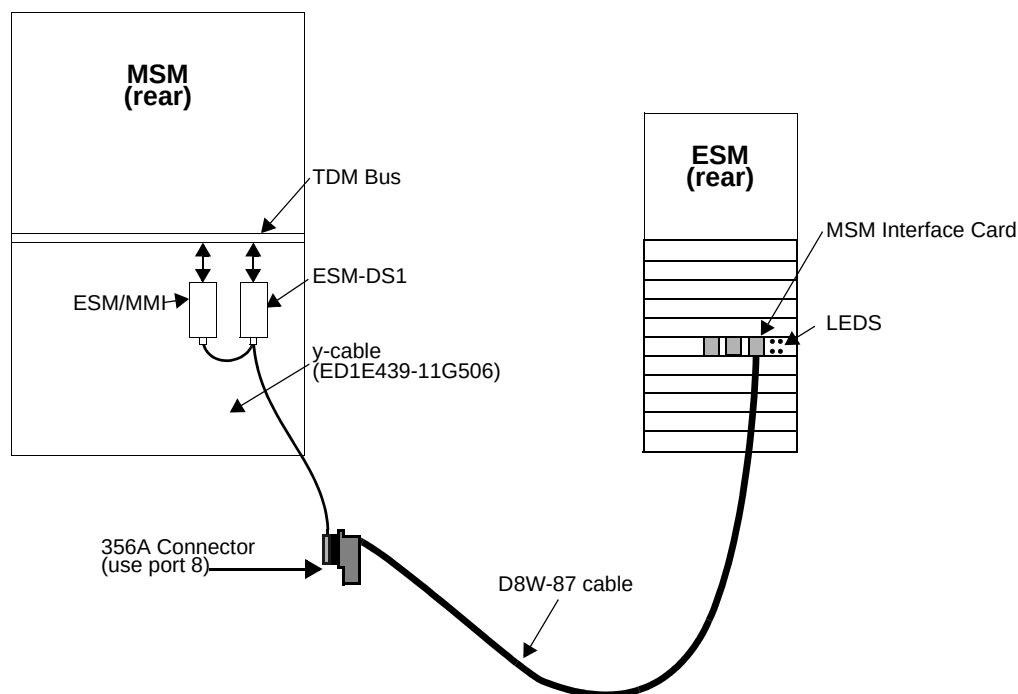
Use the following figure to connect the MSM to the ESM.

**Figure 3-41. Cabling the ESM / MSM Link**

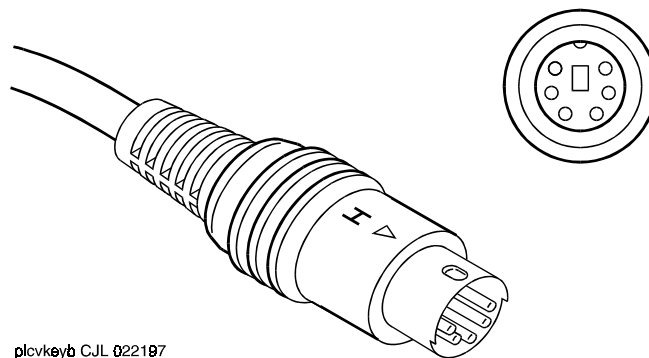
Figure 3-42 shows the receptacle and plug.

**Figure 3-42. Circular DIN 6-Pin Connector for the Keyboard**

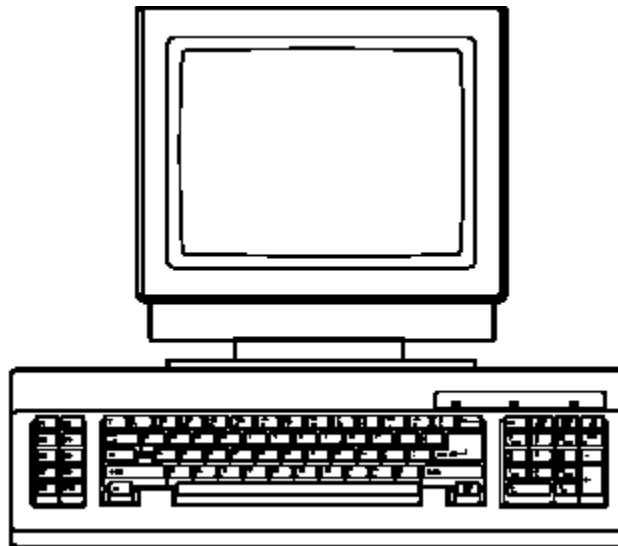
**Figure 3-43. Management Terminal and Keyboard**

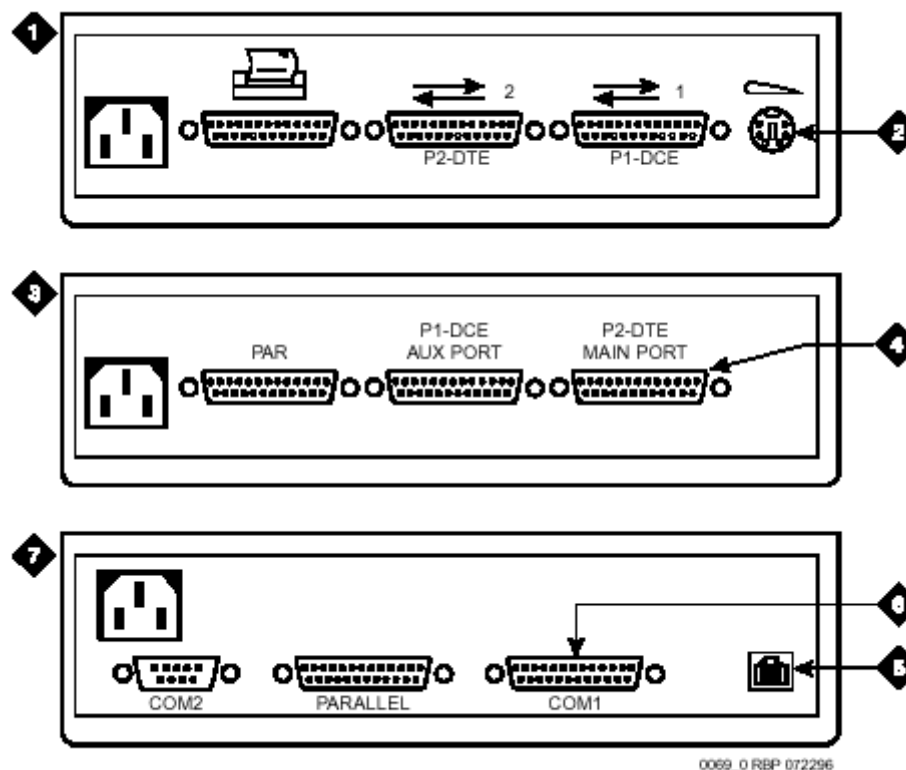
Figure 3-44. Rear Panels on Management Terminals

The management terminal in Figure 3-44 is shown for illustration purposes only and does not represent a specific terminal type.

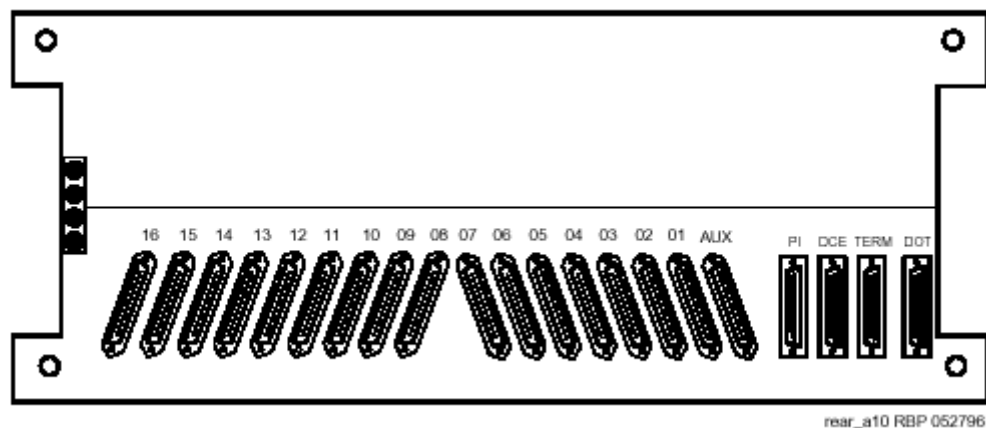
1. Route the 25-pin Data Terminal Equipment (DTE) cable (H600-426) from the terminal to the rear of the Control Cabinet.
2. For a standard reliability system, plug the cable into the **TERM** connector. See Figure 3-45. For a high or critical reliability system, plug the cable into the **DOT** (Duplication Option Terminal) connector.

**Figure 3-45. Typical Management Terminal Connections**

1. Plug the keyboard cable into the 6-pin mini-DIN jack on the rear of the terminal. See Callout 2 in Figure 3-45.
2. Plug the supplied 25-pin Data Terminal Equipment (DTE) cable into the P2 port (center connector) on the rear of the terminal.

1. Plug the keyboard cable into the 6-pin RJ-11 jack on the left side of the terminal. An adapter cable is available to convert a 6-pin mini DIN jack to an RJ-11 jack to allow a 715 BCS keyboard to be used (comcode 847489895 or 847489903).
2. Plug the supplied 25-pin Data Terminal Equipment (DTE) cable into the P2 port (right side connector). See Callout 4 in Figure 3-45.

1. Plug the keyboard cable into the modular keyboard jack on the rear of the terminal. See Callout 5 in Figure 3-45. This is a unique cable and must be connected to the 715 BCS-2 only.
2. Plug the supplied 25-pin Data Terminal Equipment (DTE) cable (H600-426) into the COM1 port (right side connector).

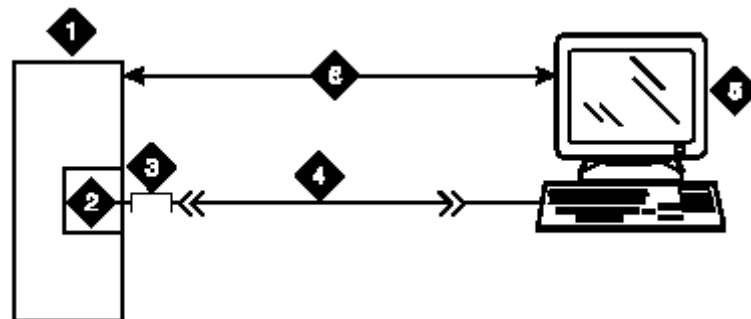
**Figure 3-46. Direct Connections to Management Terminal**

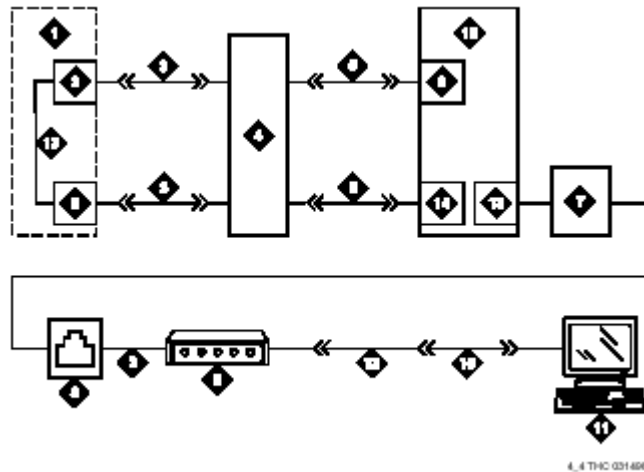
**Figure 3-47. Typical Connections to Remote Devices**

If the terminal is connected to a DC-powered system, a 116A Electronic Industries Association (EIA) Isolator (comcode 106005242) must be installed in series with the 25-pin Data Terminal Equipment (DTE) cable. See Figure 3-47

A management terminal can be installed at some distance from the system. Typical remote connections are shown in Figure 3-47.

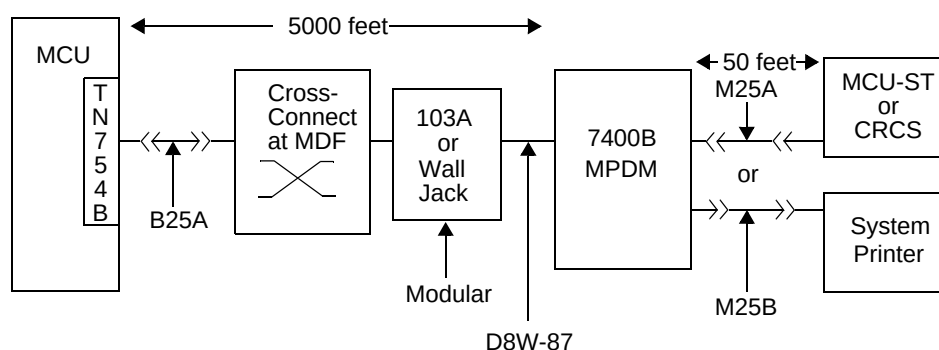
**Figure 3-48. Typical Remote Connection for MCU-ST, Avaya CRCS, or System Printer**

1. For a standard reliability configuration, plug the 116A isolator into the **Term** connector on the Control Carrier. See figure 3-48.
2. For a high and critical reliability configuration, plug the 116A isolator into the **DOT** (Duplication Option Terminal) connector on the Control Carrier. See figure 3-48.
3. Plug the 25-pin Data Terminal Equipment (DTE) cable (H600-426) from the terminal into the end of the 116A isolator.
4. Plug the terminal AC power cord into the AC receptacle on the terminal.
5. Plug the opposite end of the power cord into the AC power receptacle.

Typical remote connections are shown in Figure 3-48.

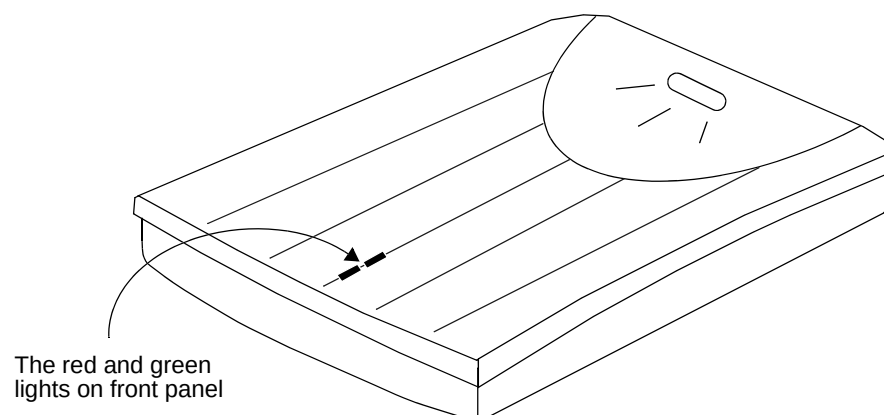
**Figure 3-49. 8400B Data Module**

Like the 7400B data module, the 8400B data module is a full-duplex asynchronous, data module that provides for simultaneous voice-data communications at the desktop over standard twisted pair wiring. However, it has been designed explicitly to work, in the linked mode, with 2-wire DCP circuits; that is, this data module is a data service link between a DTE device, a 2-wire voice terminal such as the 8400-Series voice terminals, and the MCU.

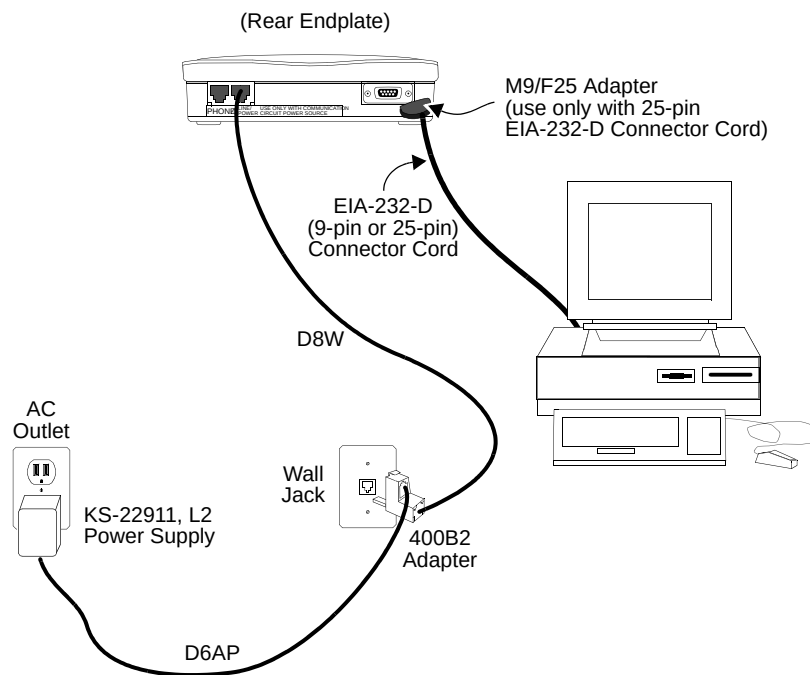
The following figure shows a standard configuration in the United States.

**Figure 3-50. Typical 8400B Data Module Configuration in the US**

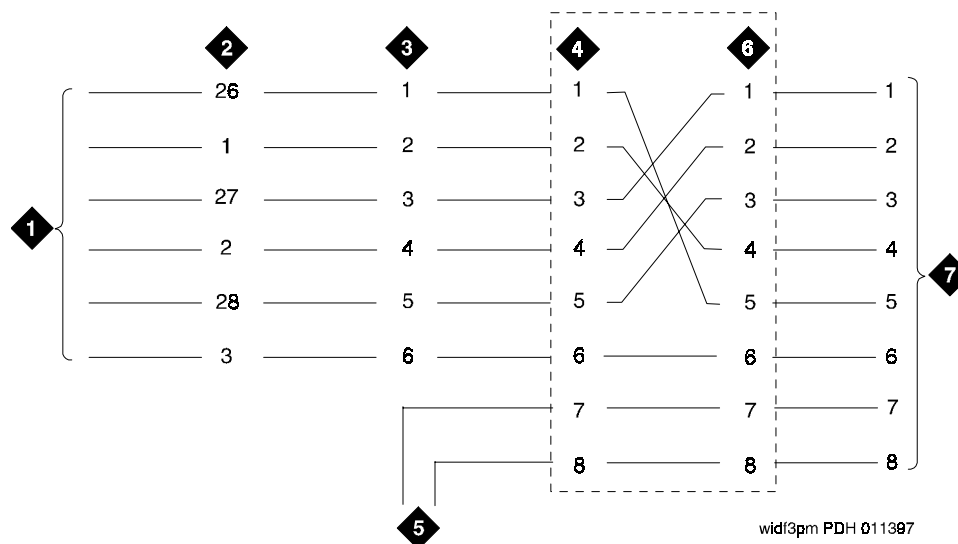
**Figure 3-52. 3-Pair and 4-Pair Modularity**

Figure 3-52 shows 3-pair and 4-pair modularity from the port circuit pack to the voice or data terminal.

Most terminals connect to an information outlet (modular jack) installed at the work location. Make the connections as shown in Figure 3-52.

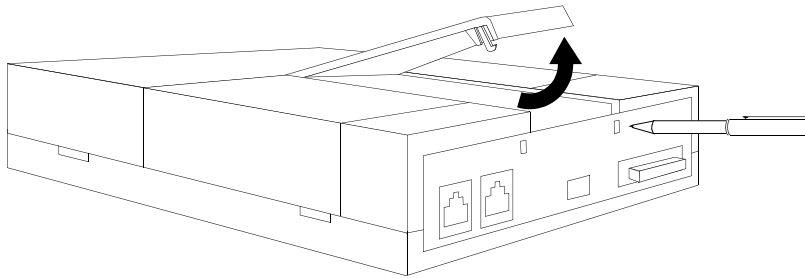
2. Refer to the following figure. Remove the top access panel of the data module:
  - a. Apply a gentle lifting pressure at the rear edge of the access panel, and insert the tip of a ballpoint pen or other suitable device into each of the two tab-lock holes in the rear panel to release the locking tabs.
  - b. Lift and remove the access panel.

**Figure 3-53. Removing the Top Access Panel**

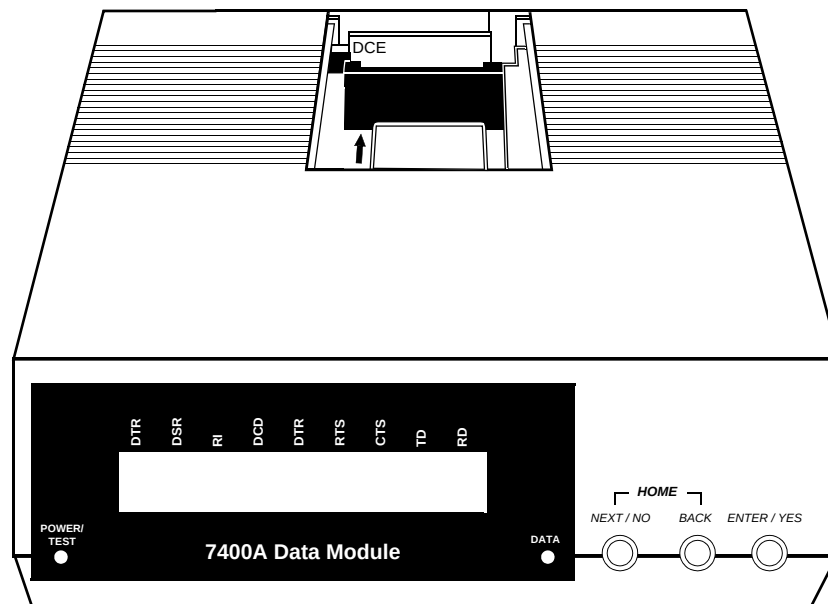
3. Turn the data module so that you are looking at it from the front.
4. Look down into the access opening of the data module. Then locate the large silver arrow pointing toward the back of the unit; the arrow points to the EIA Connector Board.
5. Look at the board from the front of the data module. Note that "DCE" is etched into the upper left corner of the board. This indicates that the board is oriented for a DCE operation. See the following figure.

Figure 3-54. EIA Connector Board Shown in DCE Position

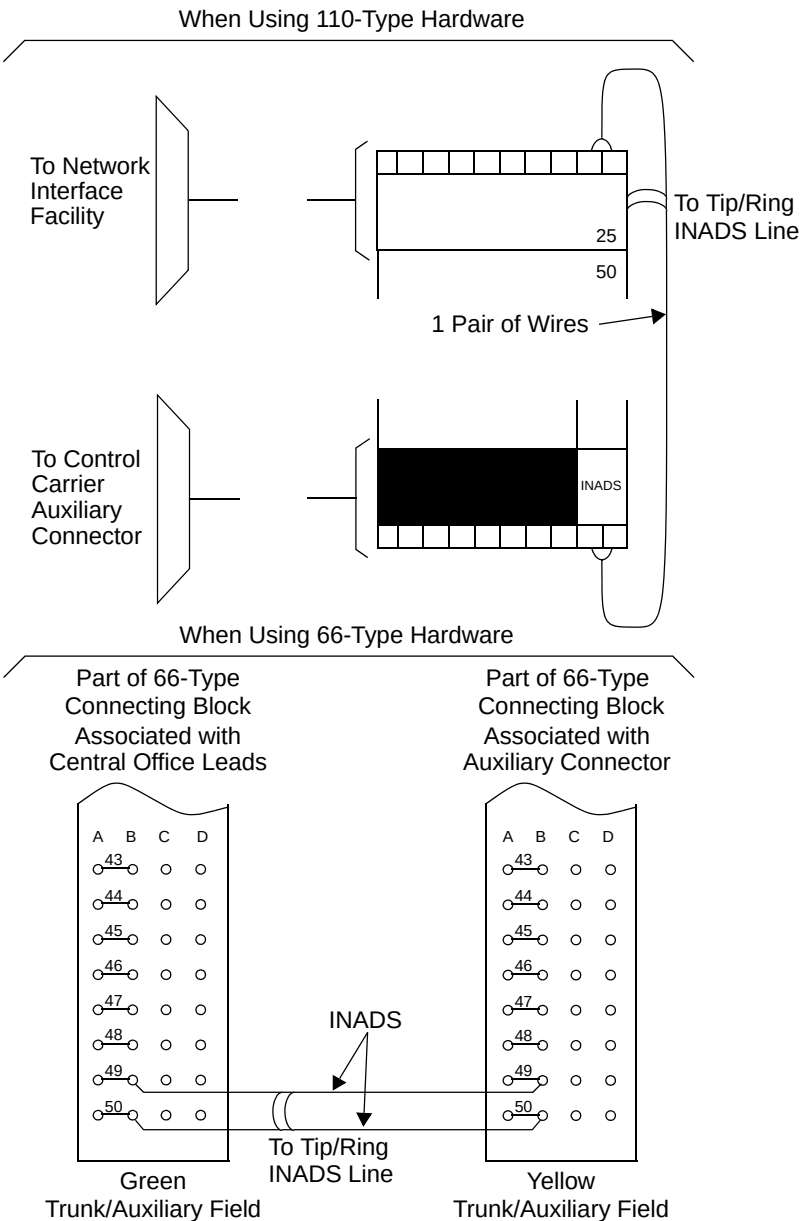
2. Label terminals for INADS trunk appearance (IN).
3. Install jumpers between INADS trunk appearance (IN) and INADS terminals.

Figure 3-55. Connections at Trunk/Auxiliary Field for INADS Trunk

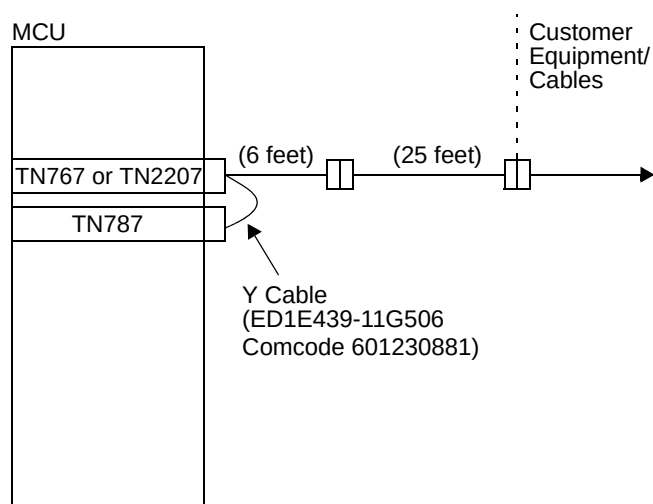
The following figure shows a typical DS1-MMI cable configuration.

**Figure 3-56. Typical DS1-MMI Cable Configuration**

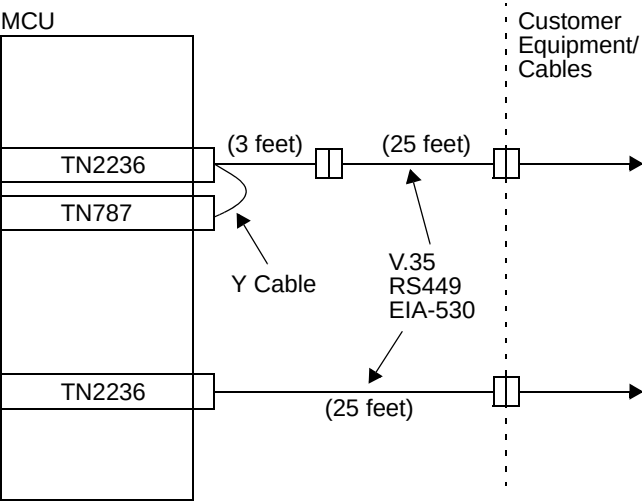
Figure 3-57. Typical Data Interface Cable Configurations

For one connection, the TN2236 DI circuit pack is cabled to the TN787 MMI circuit pack. This is done with a separate Y-cable with three 50-pin Amphenol connectors. For the other connection, a cable is connected directly to the TN2236 circuit pack.

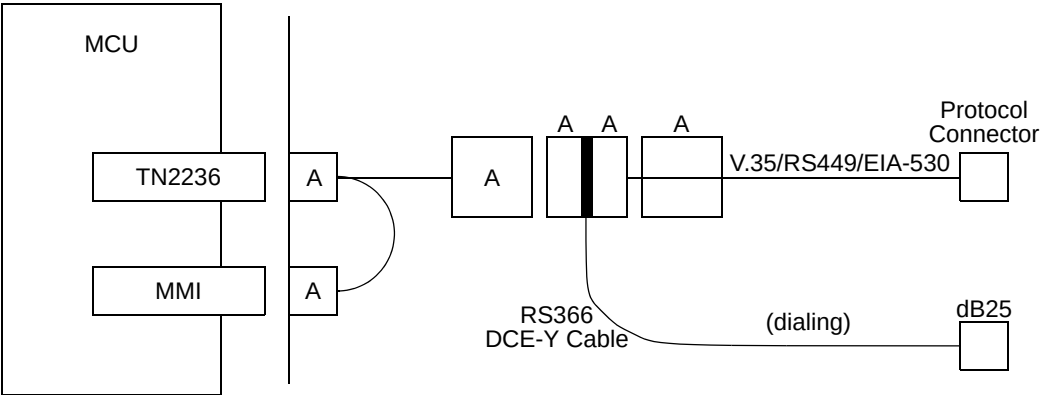
The following two figures show scenarios involving the RS366 DCE-Y cable, which is required to support customer equipment dialing into the MCU.

Figure 3-58. Data Interface Cable Configuration Including the RS366 DCE-Y Cable (Scenario 1)

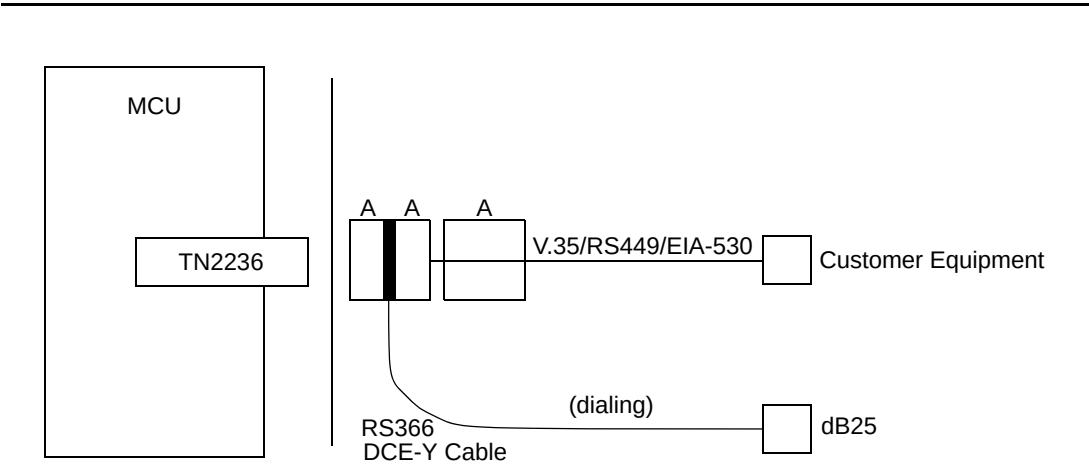
**Figure 3-59. Data Interface Cable Configuration Including the RS366 DCE-Y Cable (Scenario 2)**

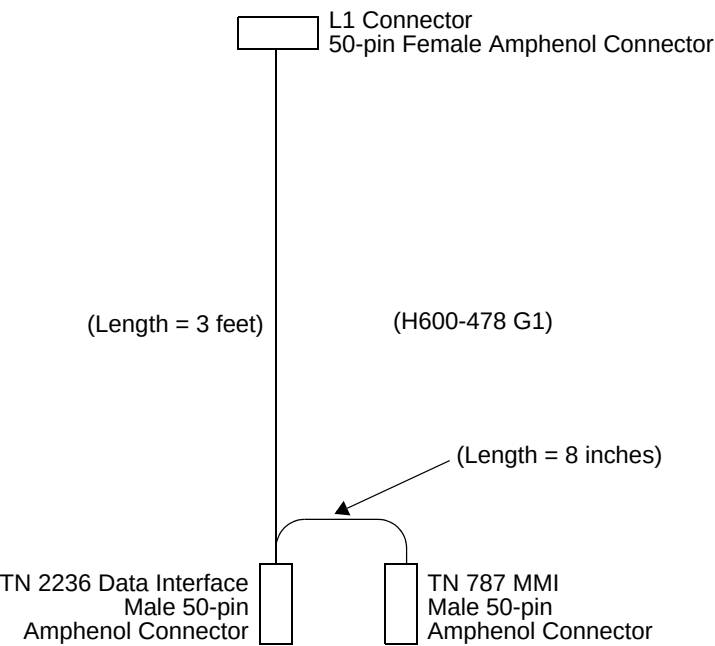
Whenever the DI-MMI-Y cable is used on the system, the L1 connector end is connected to the TN2236 DI Male Amphenol connector shown in the following sections, depending on the interface type. The TN2236 DI Amphenol is labeled “DI,” the TN787MMI Amphenol is labeled “MMI,” and the L1 connector Amphenol is labeled “LI Conn.”

Figure 3-60. DI-MMI-Y Cable

The DI-MMI-Y cable uses the connections indicated in the previous table. All TN2236 circuit packs that support transfer rates in the range of 672k to 1920k are cabled to a TN787 MMI circuit pack via this cable. If a DI circuit pack is cabled to an MMI circuit pack, the system reserves the appropriate number of resources to ensure that the administered DI capacity can be used. Excess MMI capacity may be used by any other DS1 or DI circuit pack. Therefore, the cable shown in this section is not used whenever the transfer rate is less than 672k.

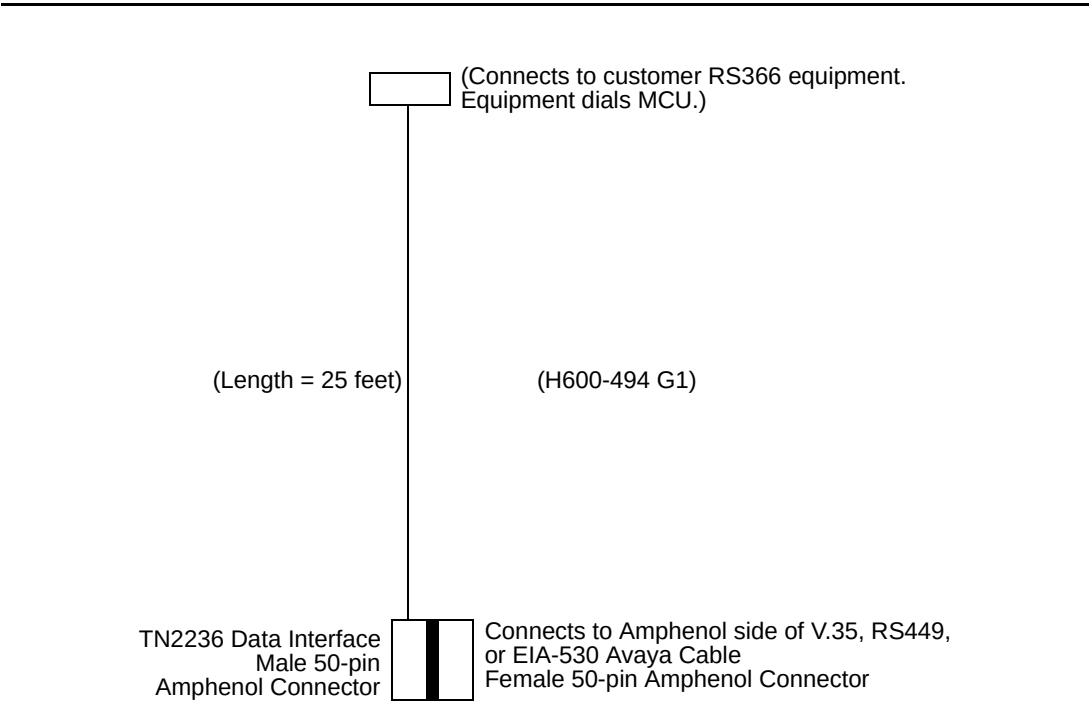
The RS366 DCE-Y cable is required to support customer equipment dialing into the MCU. The cable appears as follows:

Figure 3-61. RS366 DCE-Y Cable

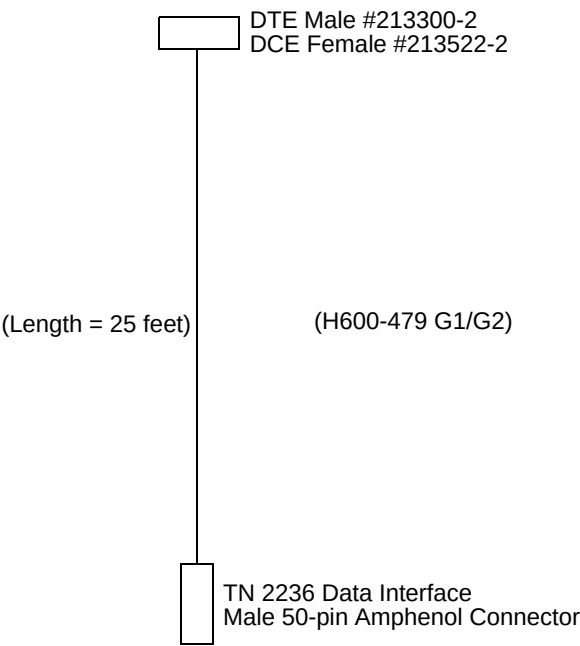
**Figure 3-62. V.35 Interface Cable**

The cable is available in two versions. The DCE V.35 version provides female 34-pin connections, and the DTE V.35 version provides male 34-pin connections. DTE-to-DCE conversions are done with the help of a 150 ohm resistor that is embedded within the cable. The maximum distance between the Avaya MCU and the V.35 endpoint is 50 ft when using the extension cable. This means that a 25 ft extension cable is added to the 25 ft Avaya cable.

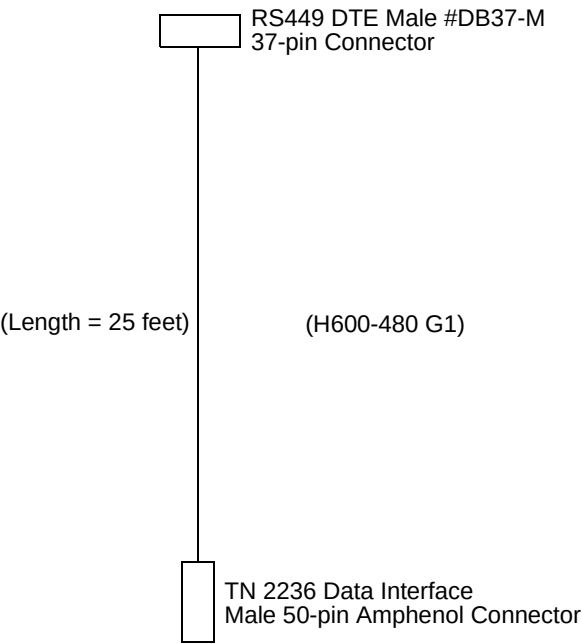
**Figure 3-63. RS449 Interface Cable**

Only the DTE version of this cable is available. For DCE versions, a female to female gender changer can be used to convert a male connection to a female connection. The maximum distance using the extension cable between the MCU and the RS449 endpoint is 50 ft. This means that a 25 ft extension cable is added to the 25 ft Avaya cable.

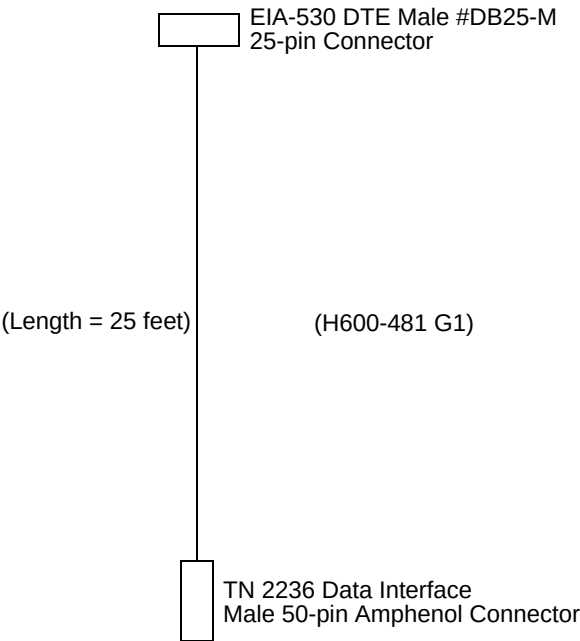
Figure 3-64. EIA-530 Cable

Only the DTE version of this cable is available. To convert a DTE interface to a DCE interface, a female-to-female gender changer is used. The maximum distance between the MCU and the EIA-530 endpoint is 50 ft. This means that a 25 ft extension cable is added to the 25 ft Avaya cable.

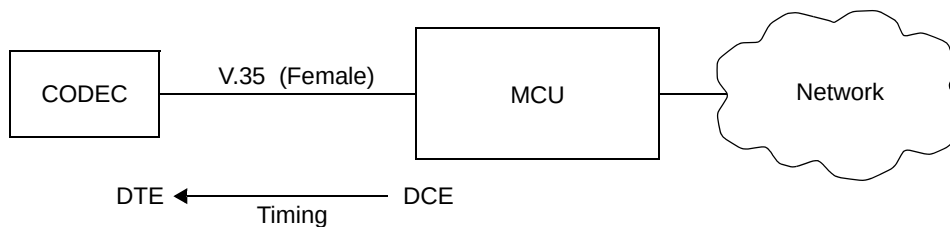
**Figure 3-65. V.35 Codec Directly Connected to the MCU**

The following figures show typical V.35, RS449, and EIA-530 connections to the Avaya MCU.

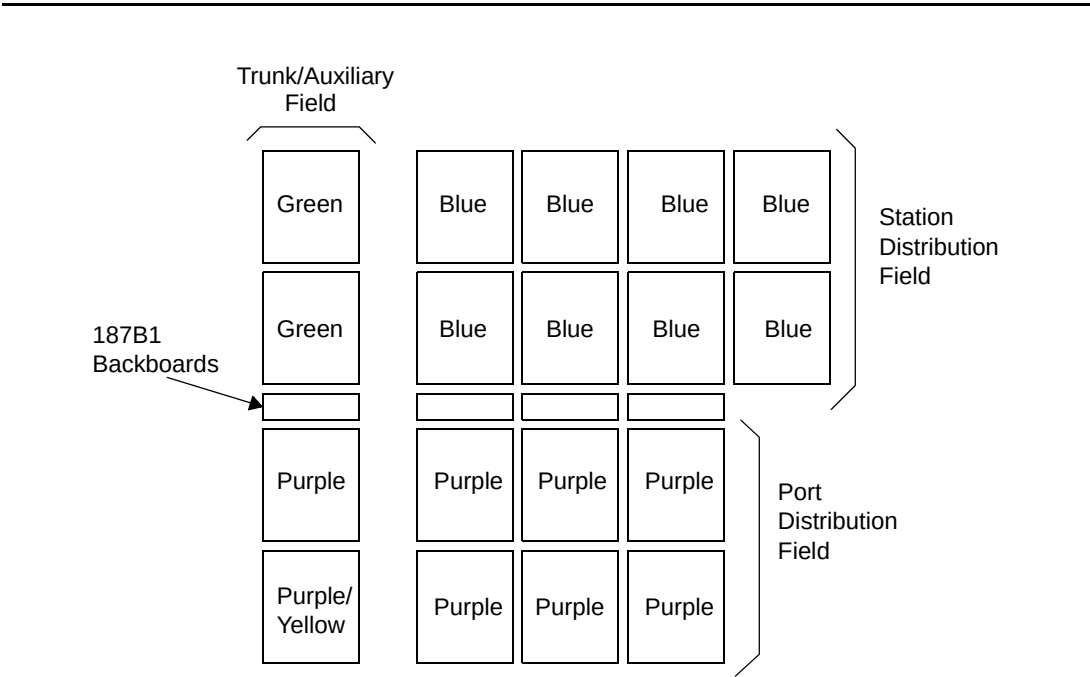
**Figure 4-1. Typical Cross-Connect Field Arrangement Using 66-Type Hardware**

The following figure shows a typical cross-connect field using 66-type hardware. It is possible that only a few 66-type connecting blocks will be required in the trunk/auxiliary field for the green and yellow fields. For this reason, if 157B connecting blocks mounted on a purple 183-type or 166-type backboard is used as the trunk/auxiliary field, then some of the extra connecting blocks in the purple field can be used as the green and yellow fields to avoid ordering extra backboards and connecting blocks.

When this is done, the green and yellow fields should be clearly identified to avoid confusion. When white backboards are required for cross-connections with a satellite closet, they must be ordered from an outside vendor. If a blue backboard is used for these cross-connections, the part of the blue field that is functionally used as the white field should be clearly identified.

The 66-type connecting blocks can be mounted directly onto the wall without using colored backboards. If this is the case, all the cross-connect field functional colors should be identified on the wall.

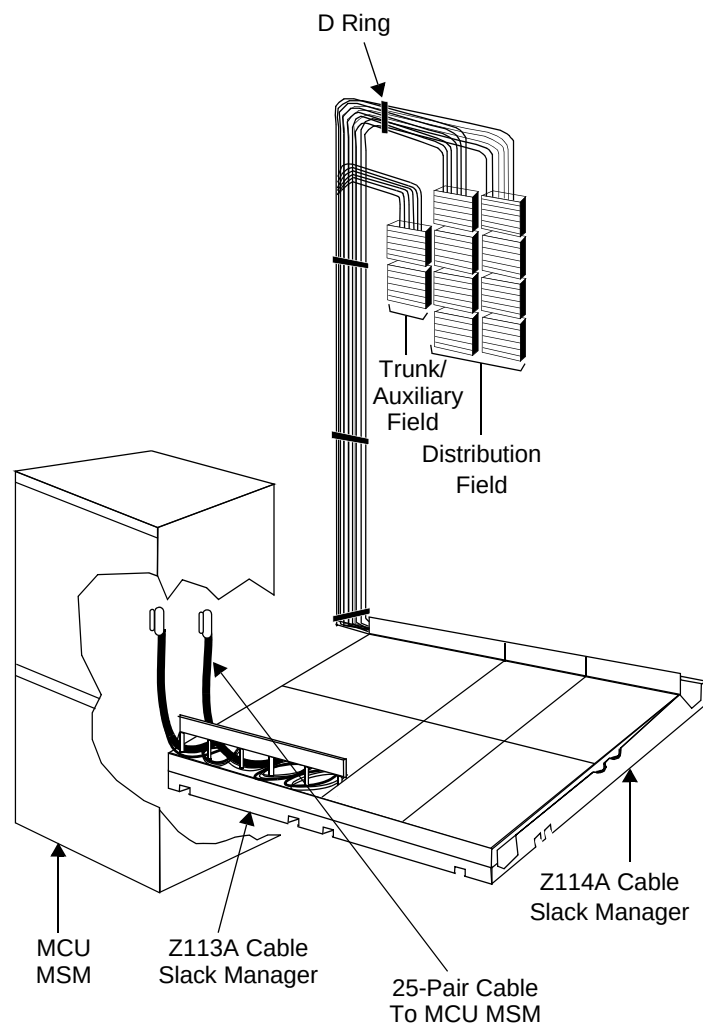
**Figure 4-2. Typical Cross-Connect Field Installation Using 110A-Type Hardware**

The cross-connect field is located directly behind the MSM. The following figure shows a typical cross-connect field installation using 110A-type terminal blocks.

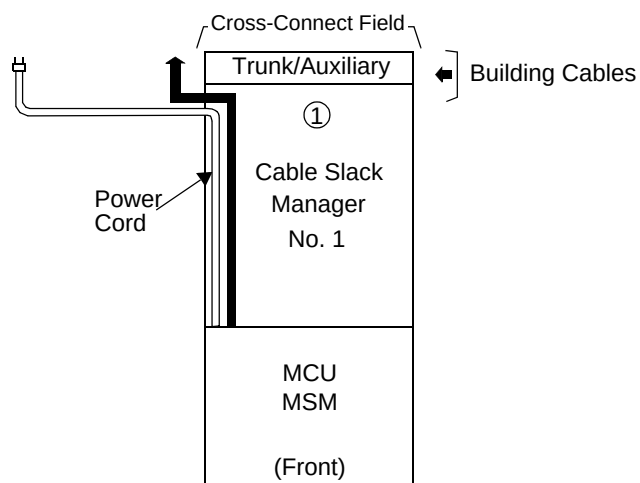
**Figure 4-6. Cable Routing from MSM to Cross-Connect Field (using top)**

The following two figures show typical cable routing from the MSM to the top and bottom of the cross-connect field, respectively.

① Cables Run from MSM to Trunk/Auxiliary

- When cable routing is to the top or bottom of the cross-connect field, each port cable is connected at the MSM and then routed along the front trough of the cable slack manager to the connecting/terminal block where the cable is to be terminated.

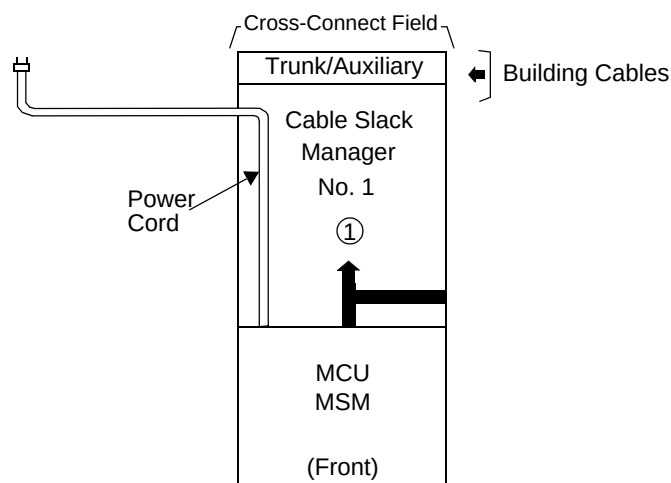
**Figure 4-7. Cable Routing from MSM to Cross-Connect Field (using bottom)**

① Cables Run from MSM to Trunk/Auxiliary Field

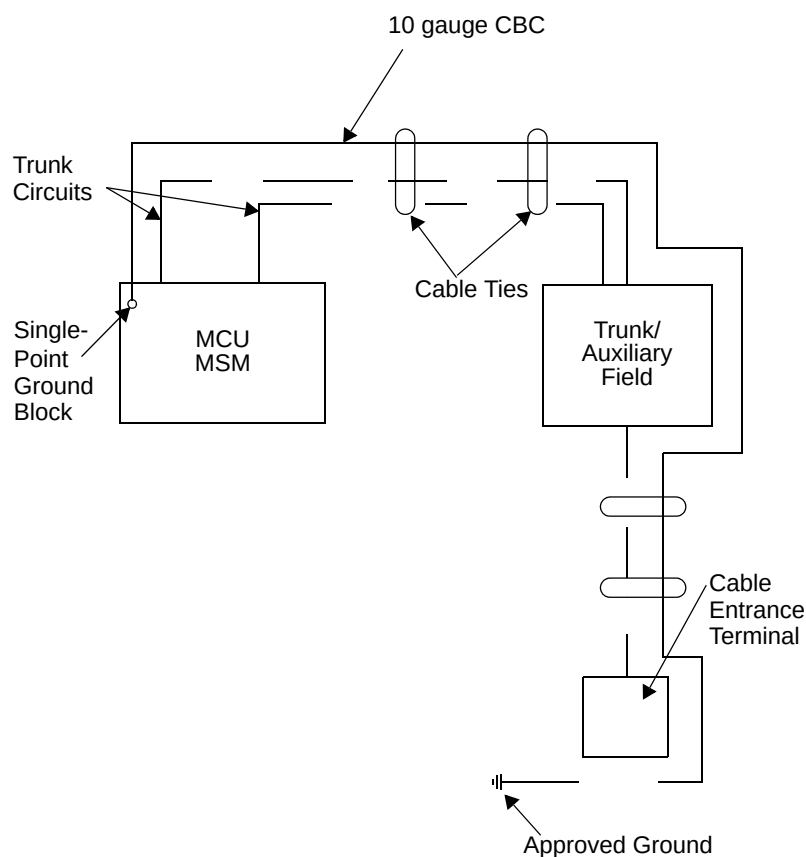
Figure 4-8. Installing the Coupled Bonding Conductor

The CBC is a conductor that is connected to ground and run adjacent to the pairs in an inside wiring cable. The mutual coupling between the bonding conductor and the cable pairs reduces potential differences in terminating equipment. The conductor consists of a 10-AWG wire that is tie-wrapped to the inside wiring cable.

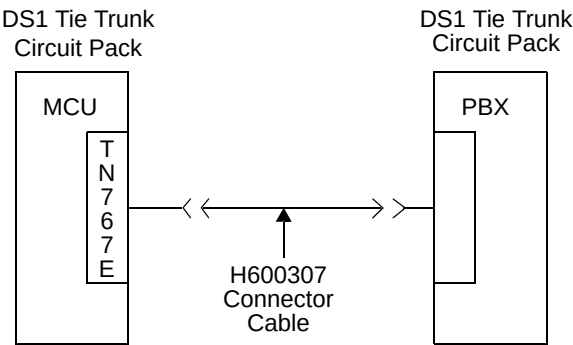
Figure 4-9. Connections for DS1 Trunks Between the MCU and PBX

The following figures show the connections between the MCU to a PBX and between the MCU and a CSU for a direct network connection. In this example, the DS1 circuit pack is used. For information on installing a CSU, see the documentation provided with the unit.

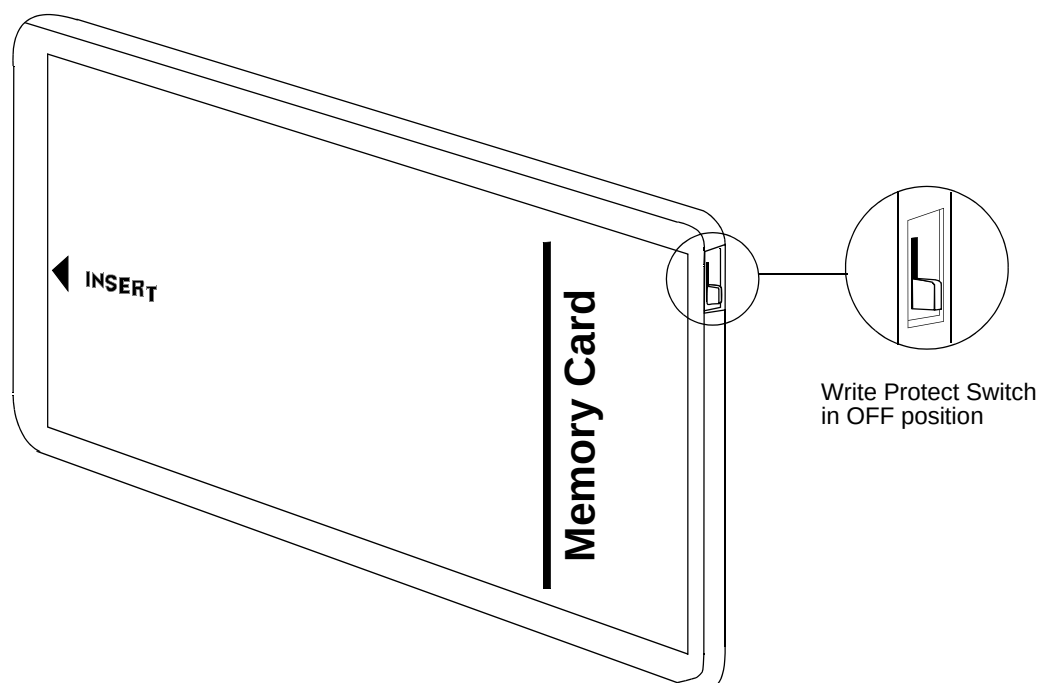
**Figure 5-1. Memory Card**

1. Verify that the slide on the memory card, shipped with the MCU, is not in the write-protect position as shown in Figure 5-1.
2. Insert the memory card into the TN794 NetPacket circuit pack in the direction indicated by the arrow on the label.

1. Verify that the slide on the memory card, shipped with the MCU, is not in the write-protect position as shown in Figure 5-1.
2. Insert the memory card into the TN794 NetPacket Control circuit pack in the direction indicated by the arrow on the label.
3. Verify that all cabinet power modules are OFF.
4. Plug the MSM power cable into the appropriate receptacle. For DC-powered systems, go to step 6.
5. For AC-powered systems, ensure that the associated circuit breakers at the AC power panel are in the ON position.
6. At the DC battery cabinet, set the circuit breaker to ON.
7. At the DC power cabinet, set the circuit breaker on associated rectifiers to ON.
8. In each MSM, in front of the power distribution unit, set the MAIN circuit breaker to ON.
9. In each MSM, at the rear of the power distribution unit, set each of the circuit breakers to ON.

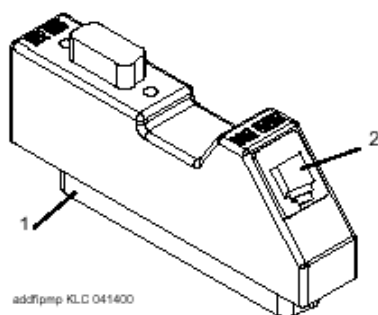
Figure A-1 shows the cable used for TN2303 Media Processor connectivity.

Adapter (for Series 3 CPs)

1. Amphenol connector to connector corresponding to TN2303 slot
2. To ethernet 10/100BaseT over Category 5 cabling

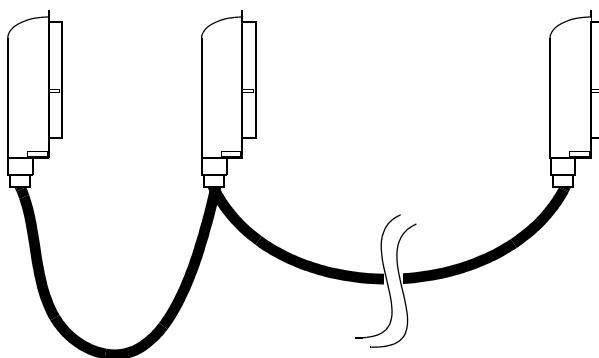
**Figure A-2. Y-Cable 25 Feet**

The DS1 Y-Cable has a length of 6 ft., while the DI Y-Cable has a length of three ft.

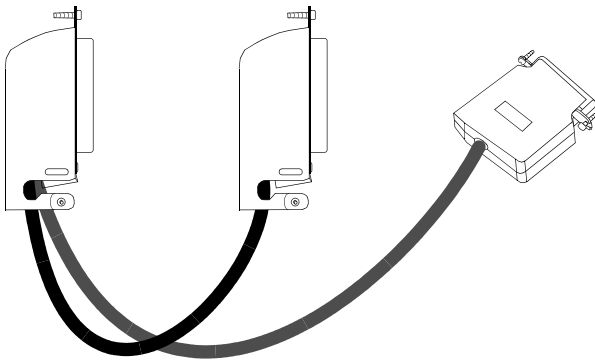
**Figure A-3. RS366 DCE-Y Cable**

The RS366 DCE Y-Cable is 25 ft.

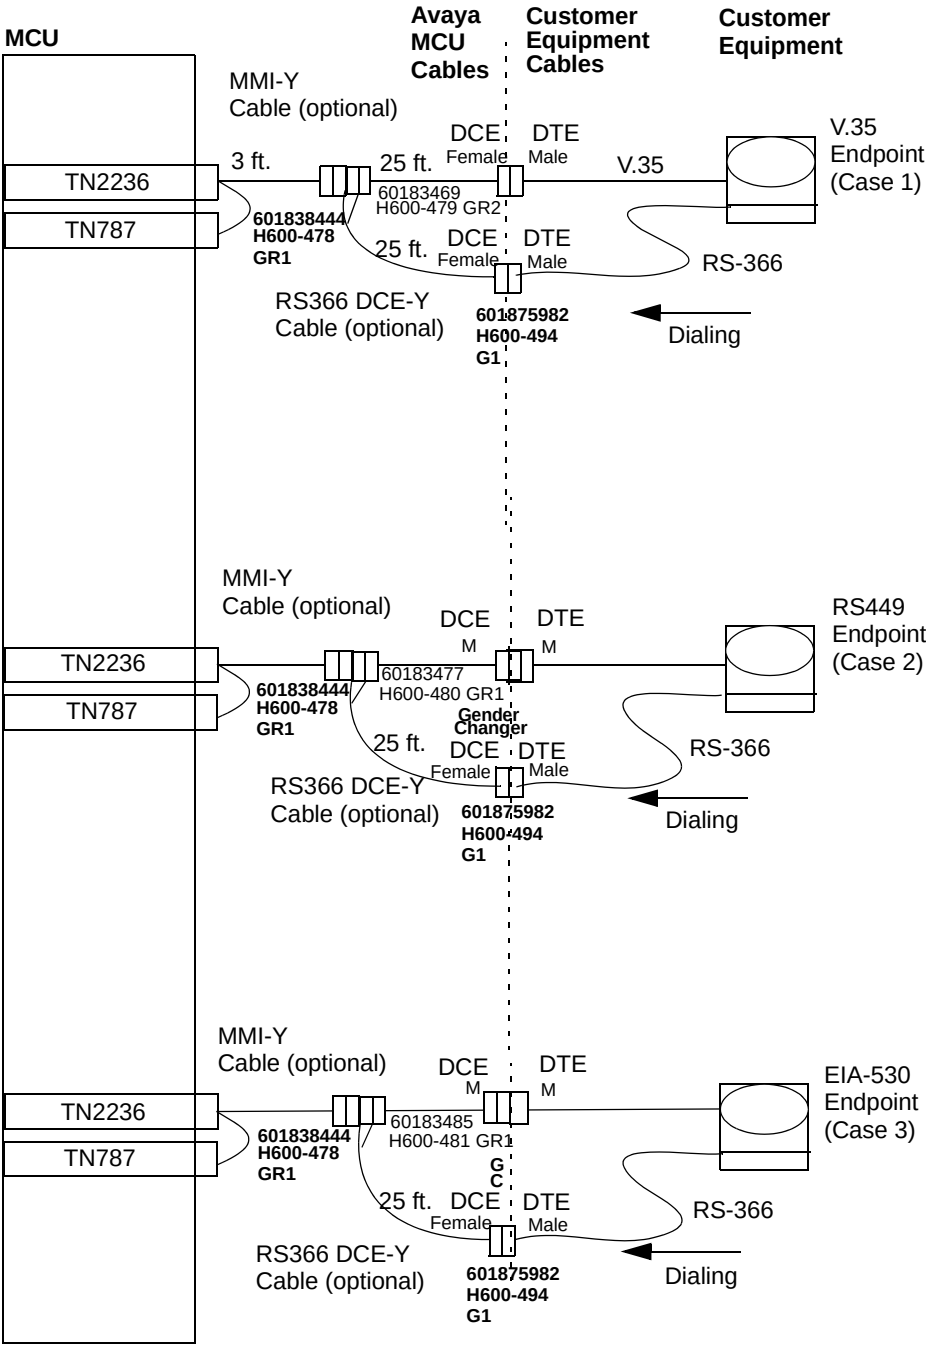
Figure A-10. Installation Example: MCU connected to customer endpoints

Following are several illustrations to assist customers and installers at sites equipped with the TN2236 Data Interface circuit packs.

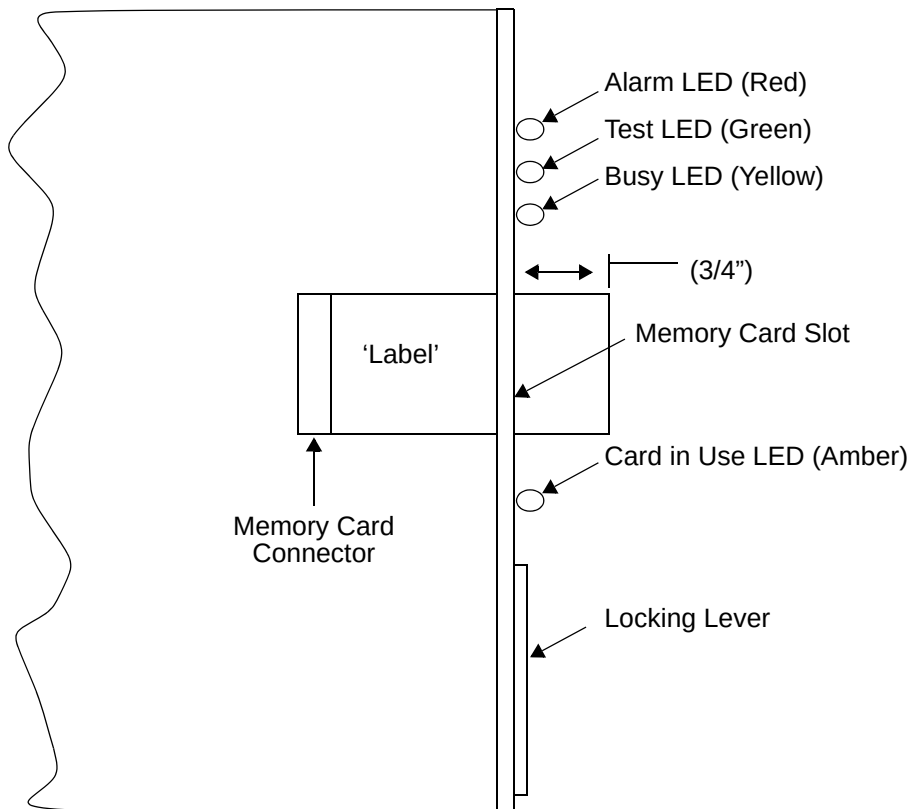
**Figure 5-6. Inserting a Memory Card**

1. Hold the memory card in front of you so the card's label is facing to your left.
2. With the memory card in this position, insert the shorter edge of the card into the mounting slot in the TN794 NetPkt Interface circuit pack.
3. Gently push the card forward until you feel some resistance at the opposite edge of the card.
4. When the card is fully inserted, about 3/4 inch of the card should still appear outside the memory card slot.
5. Confirm that as you are facing the circuit pack, the memory card label is facing to your left. If it is not, remove the card and start again.
6. Test the memory card by entering **test card-mem** (see CARD-MEM in Chapter 8, "Maintenance Object Repair Procedures").

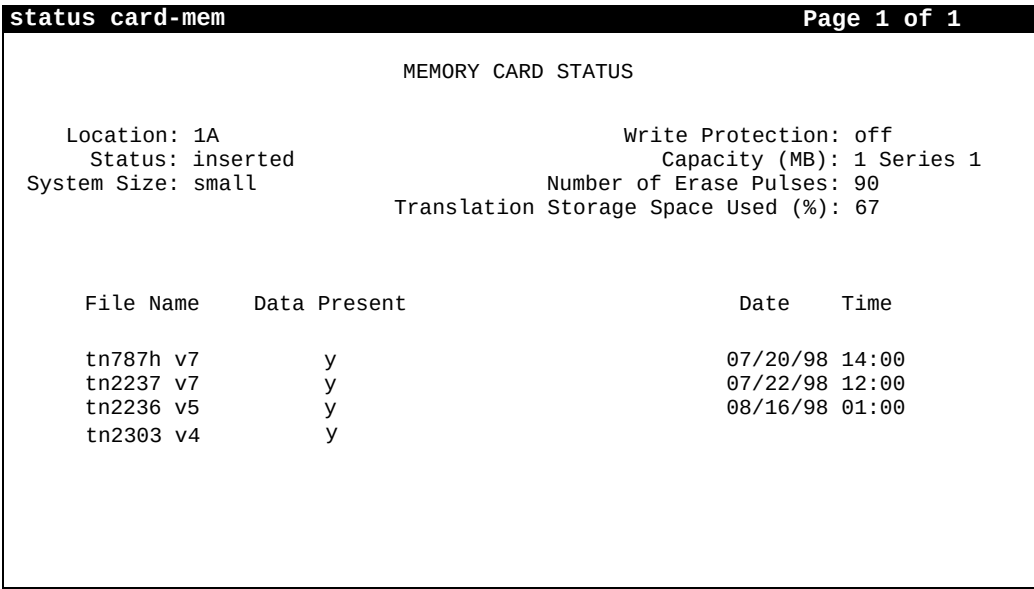
Figure 5-9. Memory Card Status Report

Firmware information is stored on a memory card inserted into the Net Packet circuit pack. To display firmware information, use the **status card-mem** command. This command produces the Memory Card Status report. The output from this report helps determine if it is necessary to proceed with the upgrade. (It is possible, for example, that the circuit packs already have the appropriate firmware or that the memory card, but not its label, was changed.) An example of the report appears as follows:

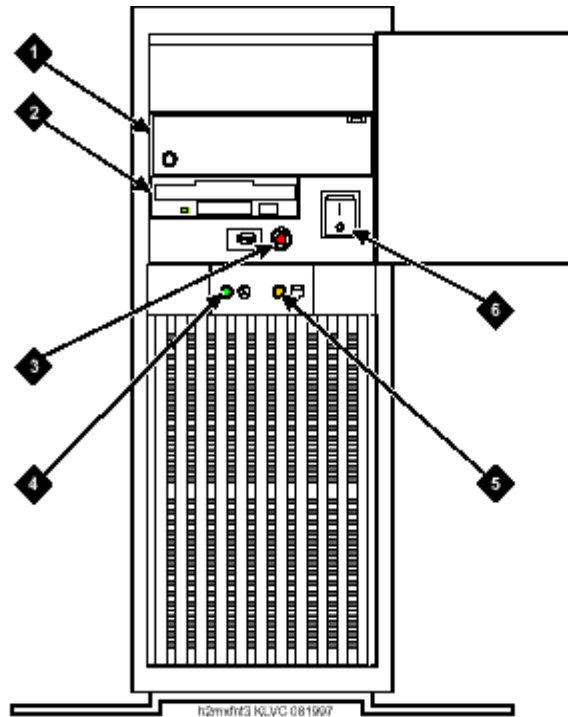
**Figure 5-15. Front View of the ESM**

1. Cartridge tape drive
2. Diskette drive
3. Reset switch
4. Power indicator LED
5. Disk activity indicator LED
6. Power switch

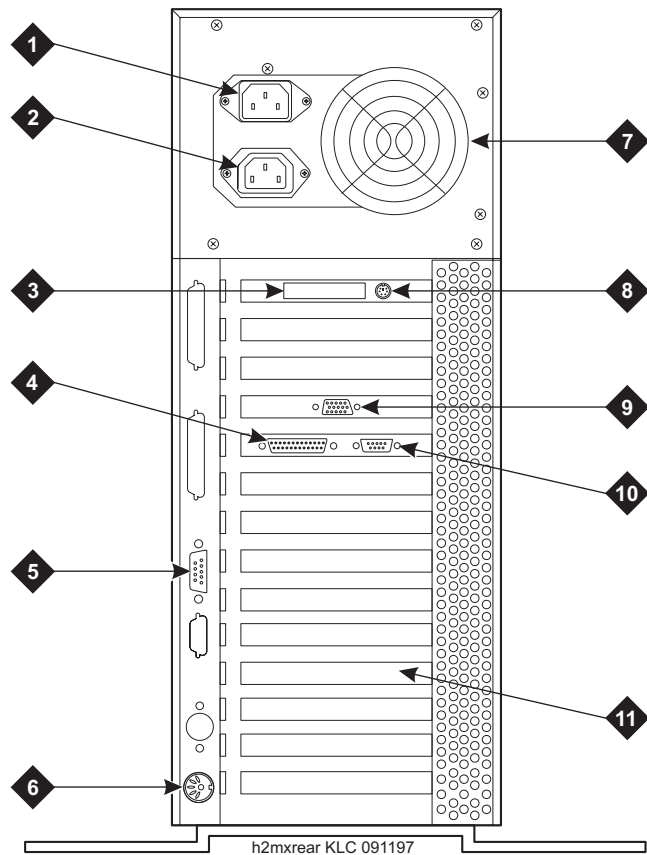
**Figure 5-16. Back View of an AC-Powered ESM**

1. AC power inlet receptacle
2. AC power supply outlet
3. External SCSI I/O connector
4. Parallel port
5. COM2
6. Keyboard connector
7. Power supply fan exhaust
8. Mouse connector
9. Video connector
10. COM1
11. MSM interface card
