# **MultiPoint Conferencing Unit**

## **Release 7.2**

555-027-816  
Comcode 700217730  
Issue 1.0  
March 2002

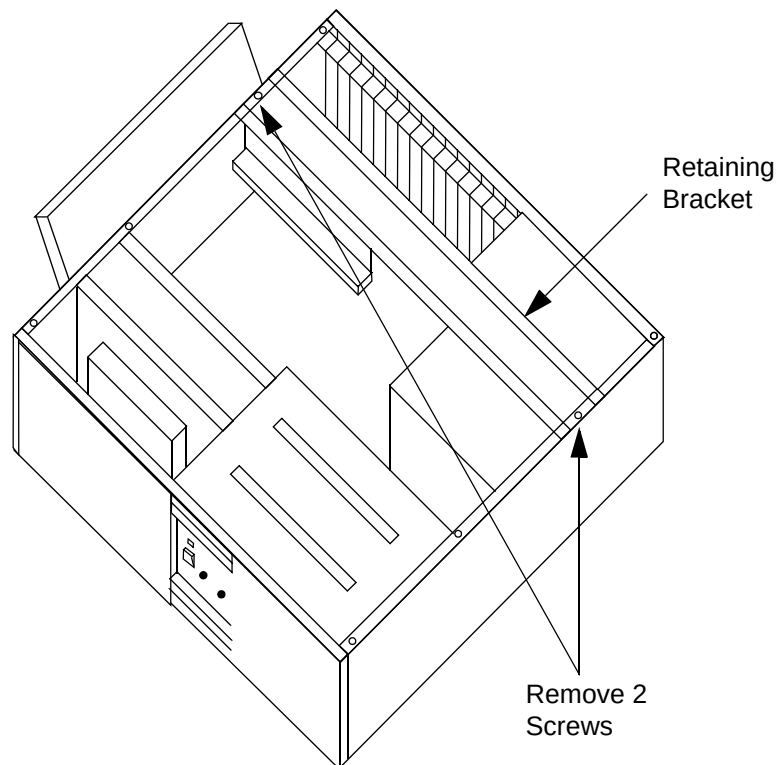
**Figure 5-20. Removing Screw in Retaining Bracket**

The manufacturer equips the ESM card cage with a retainer to reduce shipping and environmental vibrations that could damage the circuit cards. To remove the retaining bracket, use a #2 Phillips screwdriver to remove the two hold down screws in the retaining bracket. See the following figure.

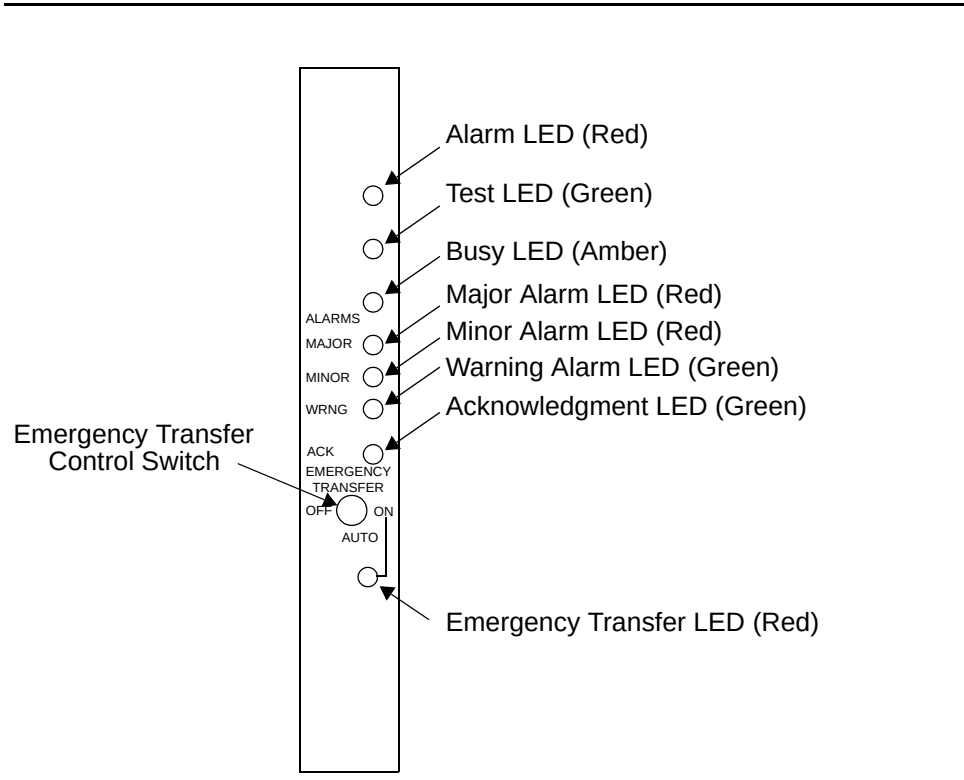
Alarms on the PROCR, MEMORY, and PR-MAINT MOs are indicated by the first red LED on the processor circuit pack.

Figure 7-1. LEDs on the Processor Circuit Pack

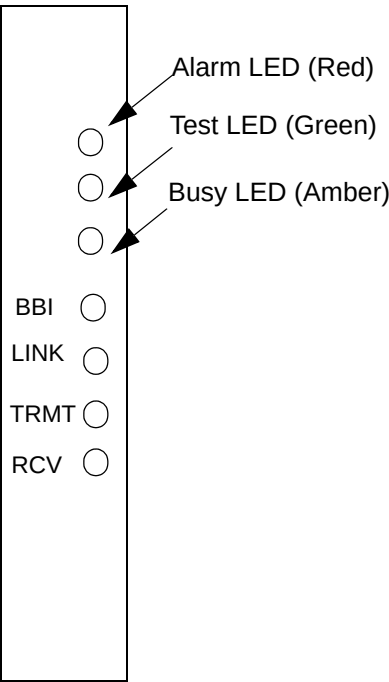
**Figure 7-2. LEDs on the TN799B and TN2303 Circuit Packs**

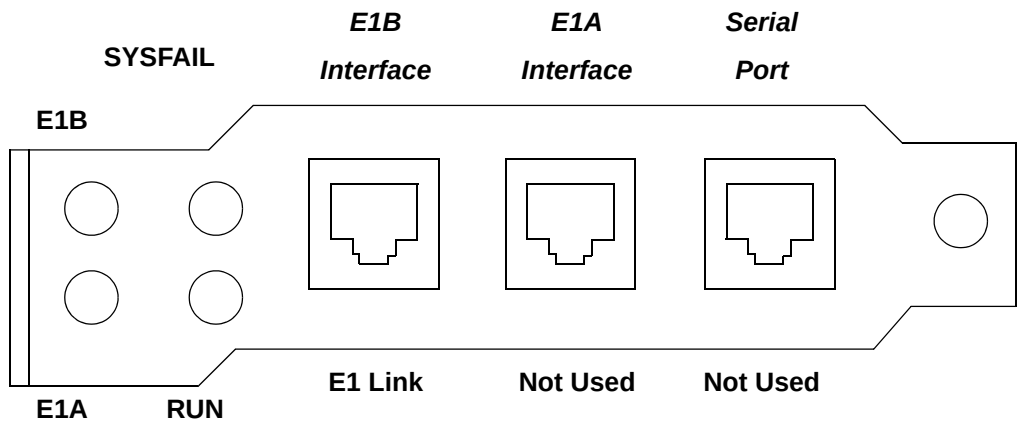
The following figure illustrates the LED arrangement on the back of the MSM Interface Card.

Figure 7-3. Rear Bracket of the MSM Interface Card

Normal operation is indicated by an unlit yellow LED on the **E1B** and **SYSFAIL** lamps and a lit yellow LED on the **E1A** lamp. Proper microprocessor activity is indicated by a lit green LED on the **RUN** lamp.

PRI-ISA64 board failures are indicated by a lit yellow LED on the SYSFAIL lamp or an unlit green LED on the **RUN** lamp. Failure on the E1B span is indicated by a lit yellow LED on the **E1B** lamp.

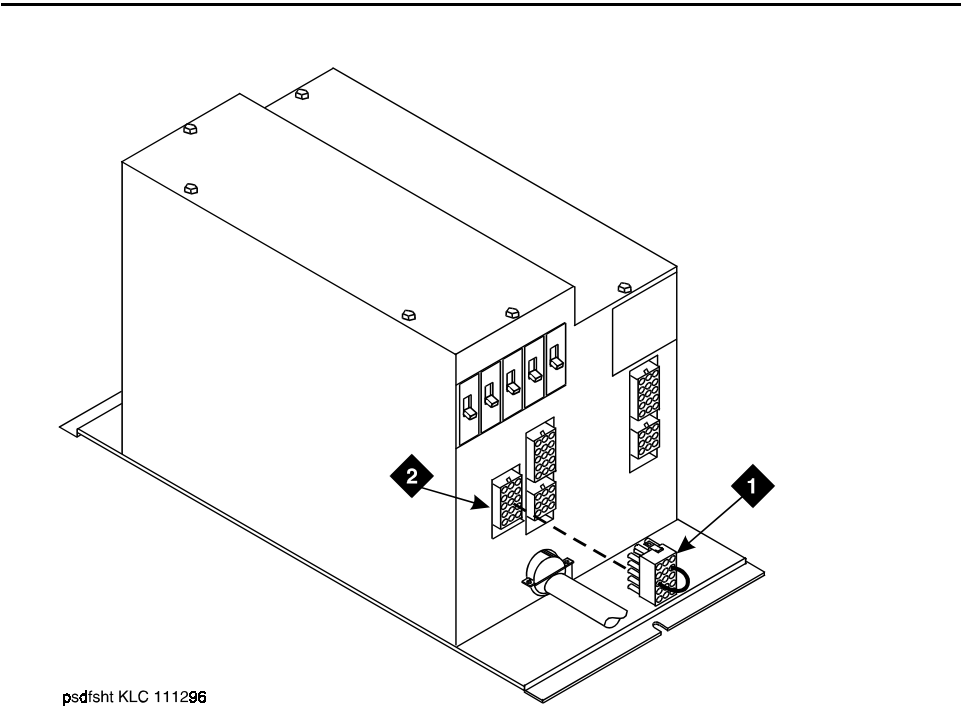
1. Shorting Cable (H600-442-G1) (If Battery
- Charger is Not Installed)
2. J11

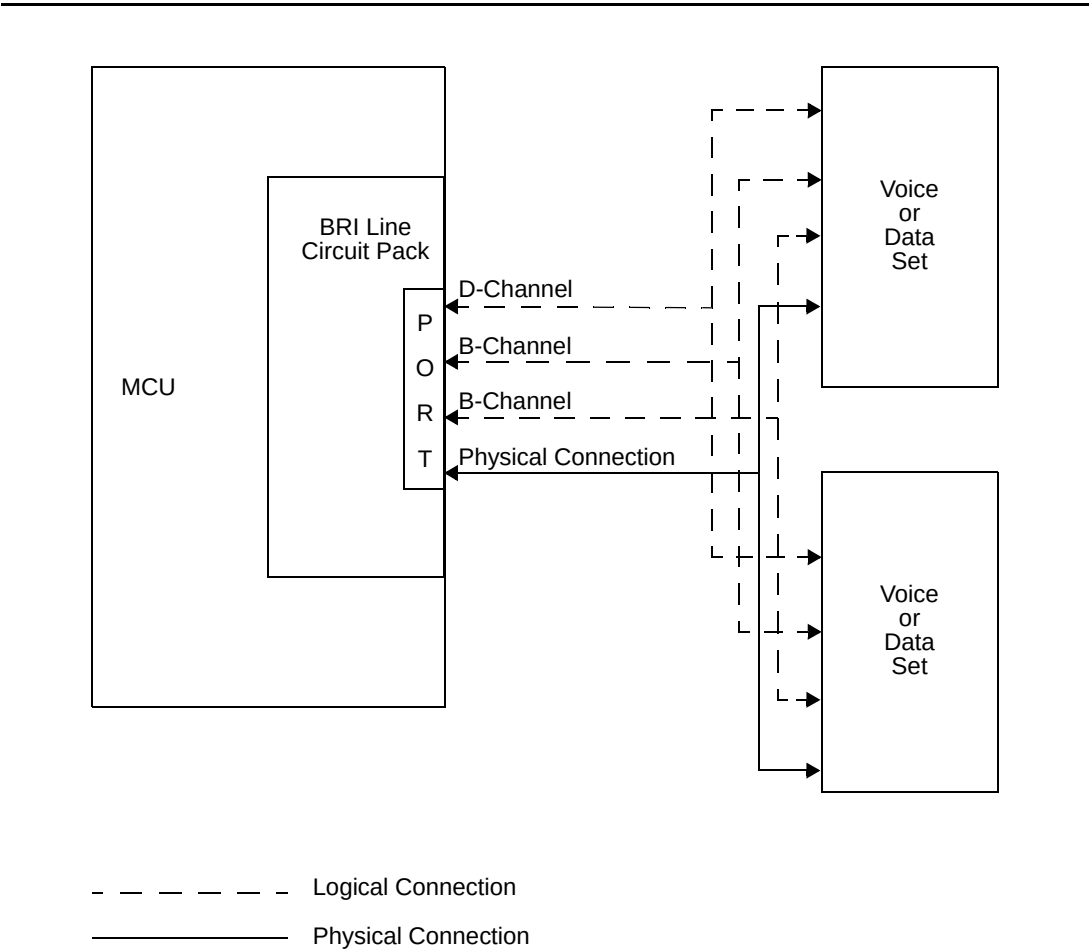
This section covers the maintenance documentation for ISDN-BRI ports. Some of the results of maintenance testing of ISDN-BRI ports may be affected by the health of the ISDN-BRI Line circuit pack (BRI-BD) or BRI endpoint (BRI-SET). These interactions should be kept in mind when investigating the cause of ISDN-BRI port problems. For more information on the circuit pack and endpoints, refer to the BRI-BD (ISDN-BRI Line Circuit Pack) Maintenance documentation and the BRI-SET (ISDN-BRI Endpoint) Maintenance documentation.

Figure 8-2. ISDN-BRI Port Interactions

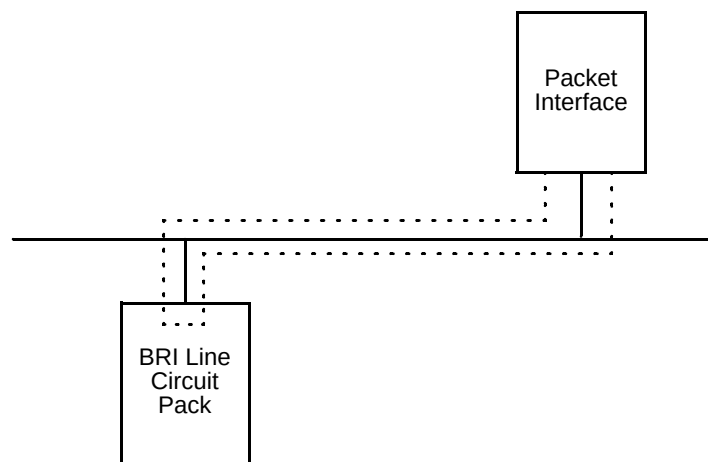
This test, which verifies the connectivity of a BRI port across the LAN Bus, executes only if the port is out-of-service. The test aborts if calls associated with the port are in-progress. Failures of this test indicate either on-board faults associated with the BRI-PORT hardware on the circuit pack, or problems with the LAN Bus, which is used to form connectivity between the switch and the BRI-PORT.

The dotted lines in the following figure show how a Loop-Around Test is performed across the Packet Bus for the D-channel.

**Figure 8-3. Path of the BRI Port LAN Loop-Around**

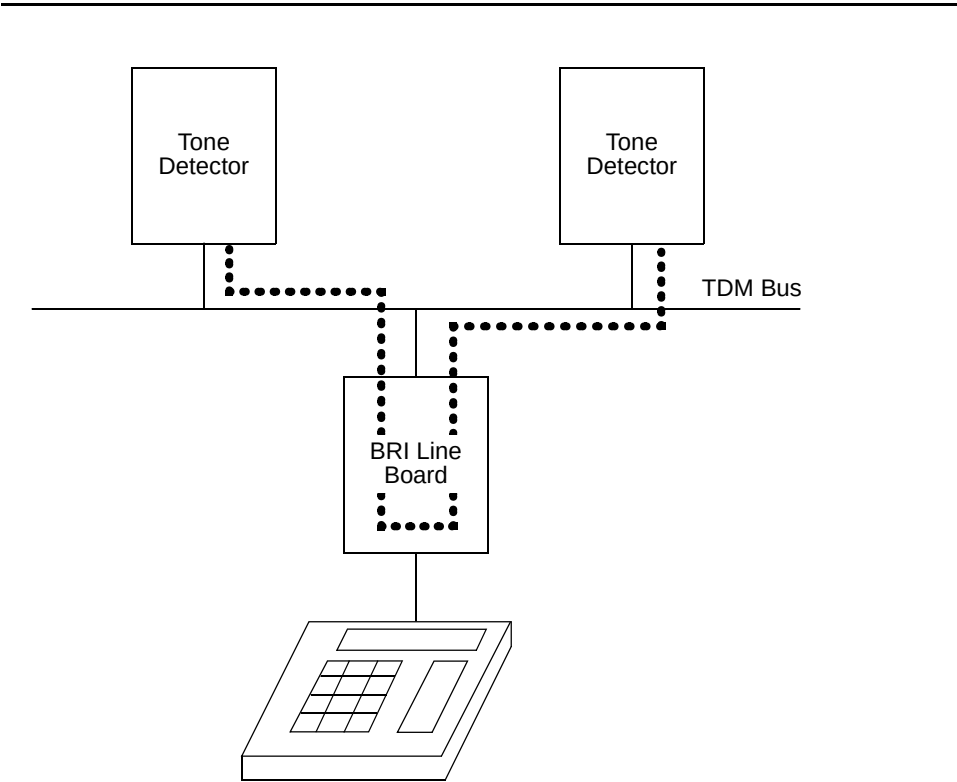
The dotted lines in the following figure show how a Loop-Around Test is performed for the B-channels.

Figure 8-4. Path of the BRI Port Local TDM Loop-Around

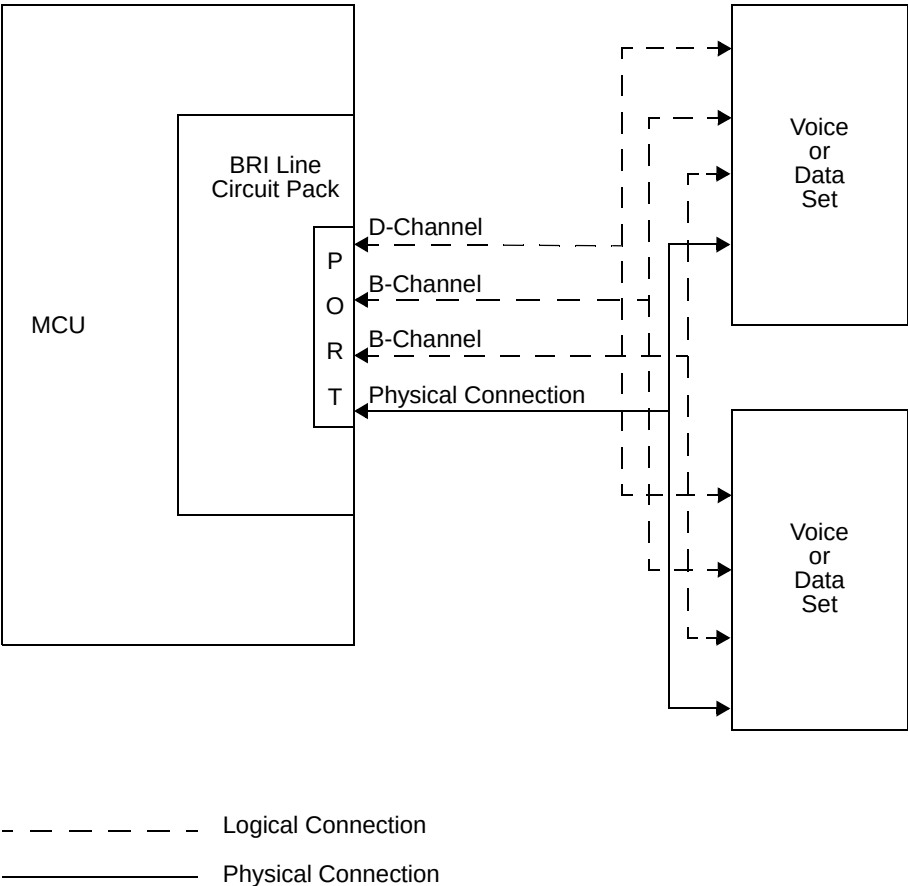
allows for two B-channels, as stated previously, plus one D-channel. Each ISDN-BRI circuit pack can support up to 12 of these physical connections to different voice and voice/data sets.

**Figure 8-5. ISDN-BRI Set Interactions**

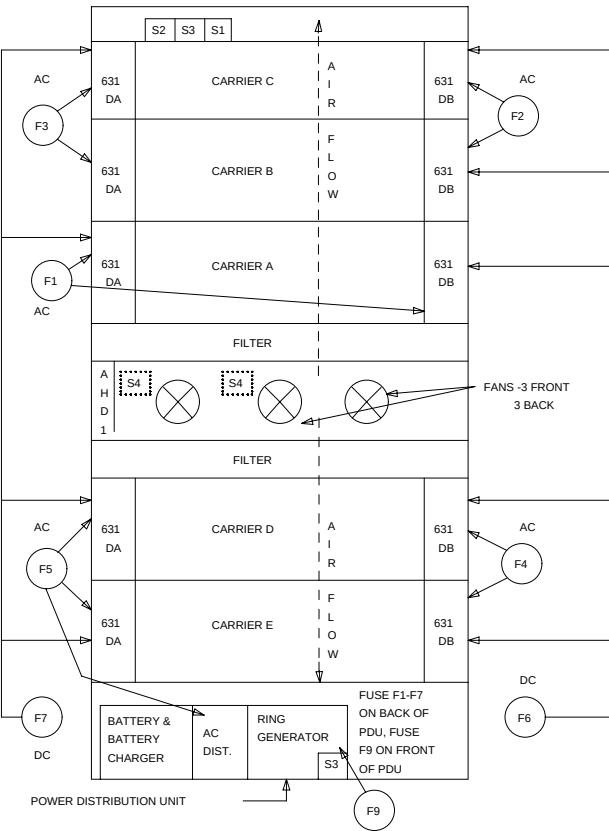
The following figure shows a multicarrier cabinet system and the location of the temperature sensors S1 through S4 (there are actually two S3 sensors and two S4 sensors) as well as the location of the fans, the AHD1 circuit pack, and the filters. The figure also shows other environment-related components of a multicarrier cabinet system and can be ignored for this section on Cabinet Sensors.

Figure 8-6. Multicarrier Cabinet Environment Components (CABINET) [Non-Variable Speed Fan Option]

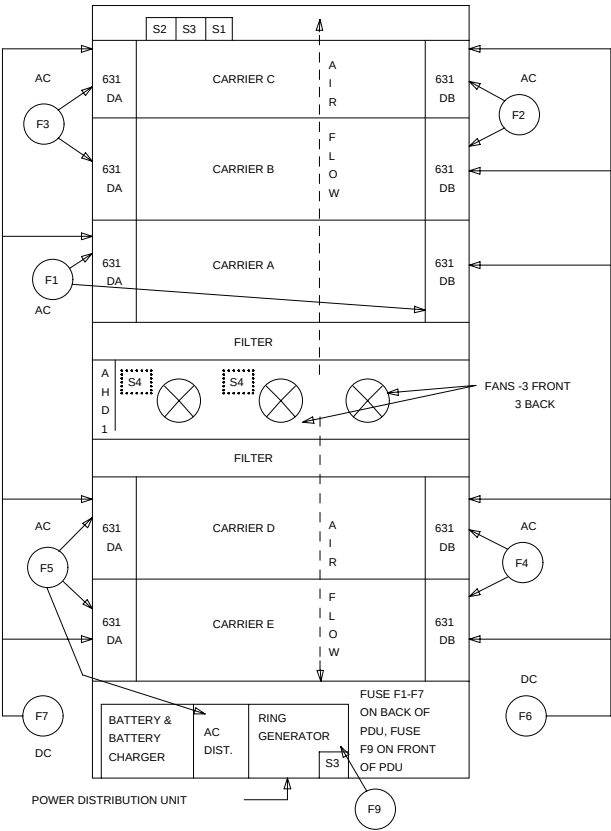
Figure 8-8. Multicarrier Cabinet Environment Components (CARR-POW)

| Error Code | Test Result | Description/ Recommendation |
|---|---|---|
| | FAIL | <p>There is a problem with one or both power units on the tested carrier.</p> <ol style="list-style-type: none"><li>1. For each power unit that has all status LEDs OFF, check the AC input to the power unit at the power unit outlet (see Figure 8-8 and Figure 8-9). If there is no AC, then check the appropriate fuses (see Figure 8-10) for the affected power unit. If the fuses are blown out, replace the fuses. If the fuses blow out again or AC does not show up at the power unit outlet, then there is probably a power wiring problem in the cabinet. Follow normal escalation procedures.</li><li>2. At this point AC should be present at the power unit outlet. If the carrier being tested is the 1A or 2A carrier, refer to "Troubleshooting Control Carrier Power Units" in Chapter 5, "Routine Maintenance Procedures". Otherwise, use the <b>recycle carrier PC</b> command (where PC is the appropriate port network and carrier) in an attempt to bring back the power units for this carrier.</li></ol> <p>If the test passes, the trouble is cleared. If the test does not pass, one power unit, or both, in the tested carrier is defective.</p> <p>If only one power unit is defective, the status LEDs on the healthy power unit light green for a moment. When the recycle test determines that both power units are defective, the software turns off power to both the good and defective power units. This causes the status LED(s) on the good power unit to light red.</p> <ol style="list-style-type: none"><li>3. Unplug both power units, and wait about one minute to allow the power units to cool down. Plug in the power units. If either power unit is operating properly (that is, the status LEDs show green), then replace the defective power unit(s). See "Power Unit Replacement Procedures" in this section.</li></ol> |

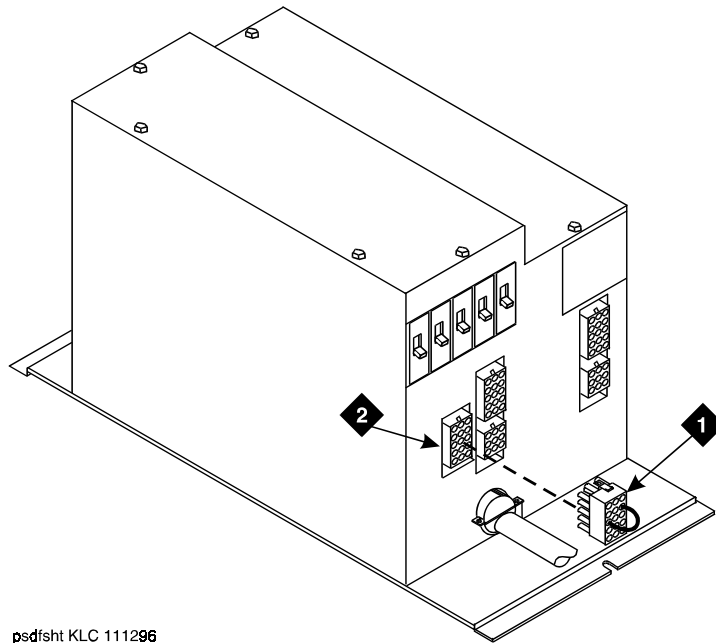
1. Shorting Cable (H600-442-G1) (If Battery Charger is Not Installed)
2. J11

**Figure 8-9. Small Cabinet Environment Components (CARR-POW)**

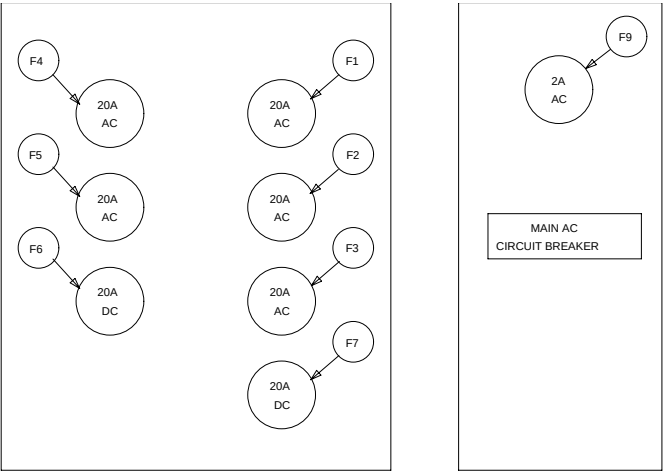
BACK OF POWER DISTRIBUTION UNIT

FRONT OF POWER DISTRIBUTION UNIT

Figure 8-10. Multicarrier Cabinet Fuse Location and Replacement

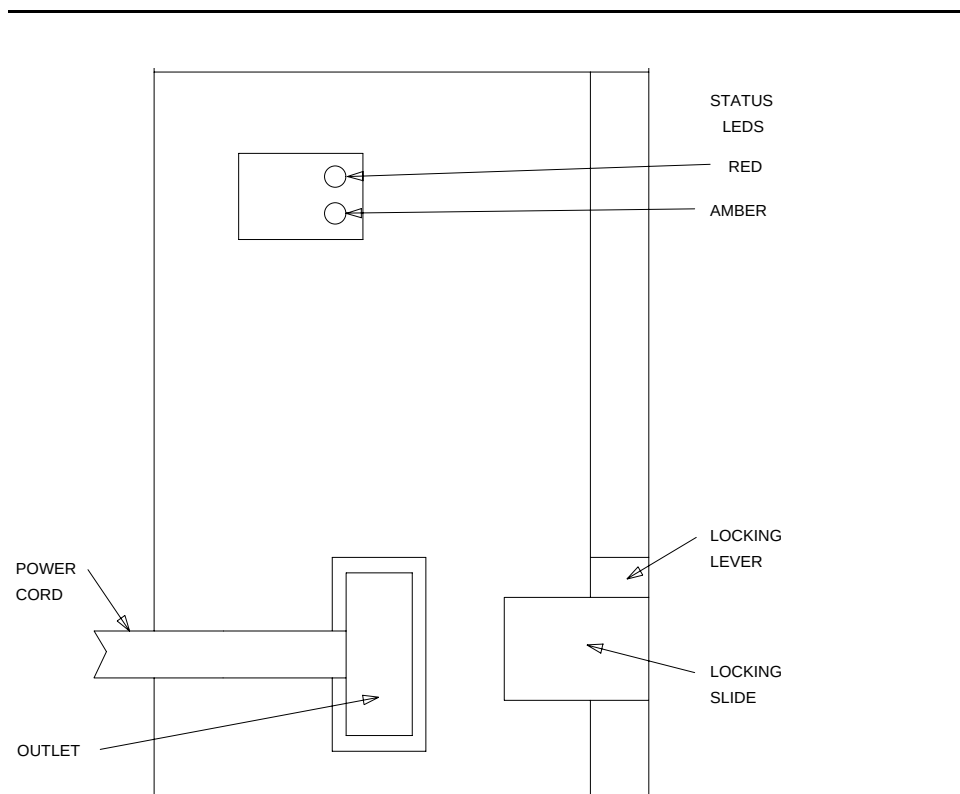
**Figure 8-11. 631WA or 631WB AC Power Unit**

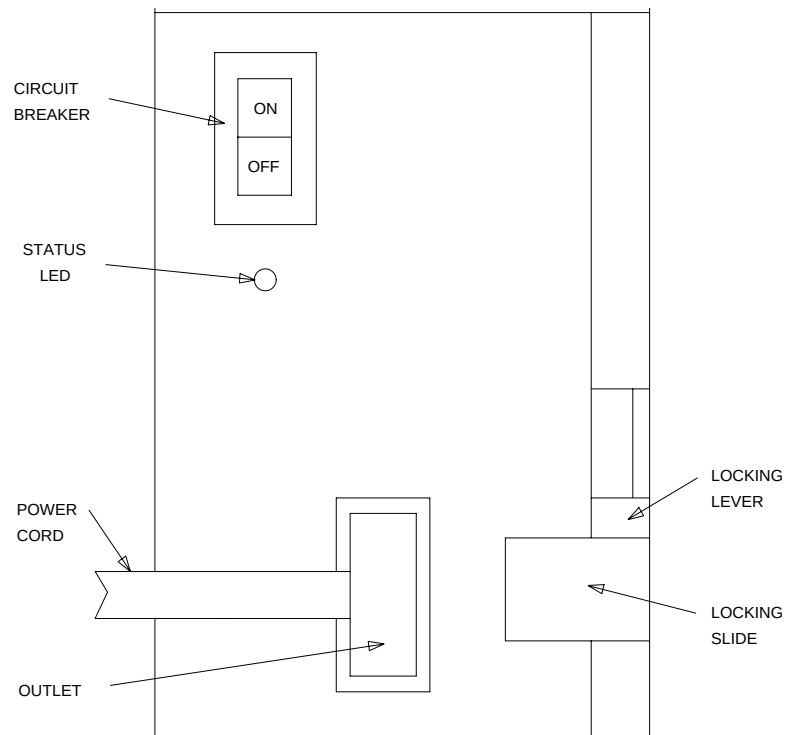
**Figure 8-12. 631AR or 631BR AC Power Unit**

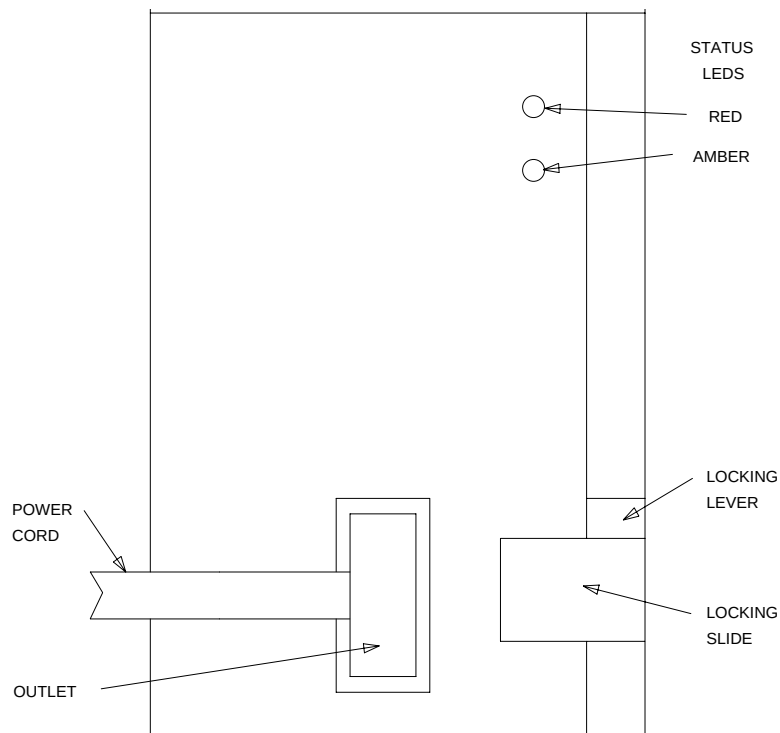
**Figure 8-13. 631DA or 631DB AC Power Unit**

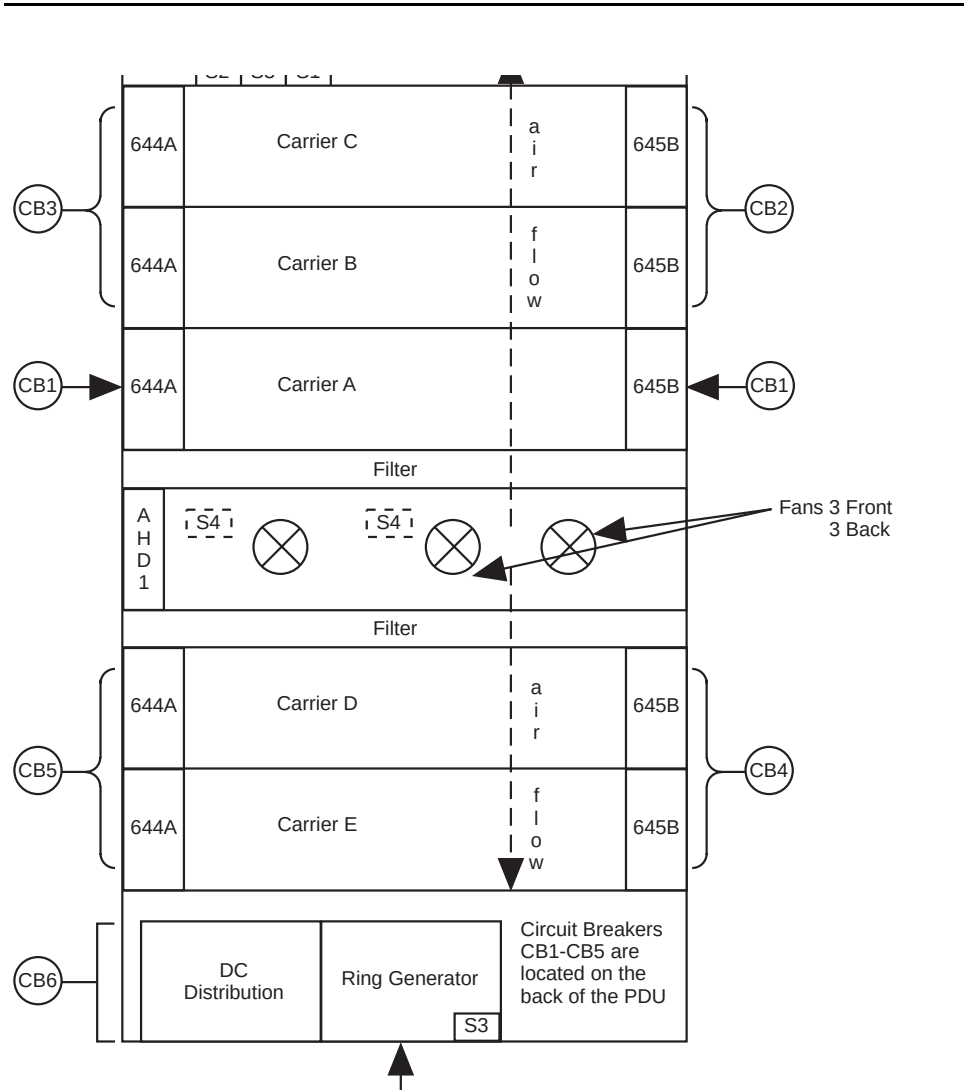
Figure 8-16. Power Distribution Unit for DC-Powered Systems (PDU8890CF-1)

Power Unit). Figure 8-15 shows the position of the circuit breakers on the PDU J58890CF. Figure 8-16 illustrates the position of the carrier power units and PDU J58890CF-1 and shows which power unit each circuit breaker controls (Figure 8-16 also shows other Environment maintenance-related items that can be ignored for this section on Carrier Port Power Unit). Figure 8-17 shows the position of the circuit breakers on the PDU J58890CF-1. The TN2036 Voltage Range circuit pack provides easy access for testing the various voltages on the backplane pins.

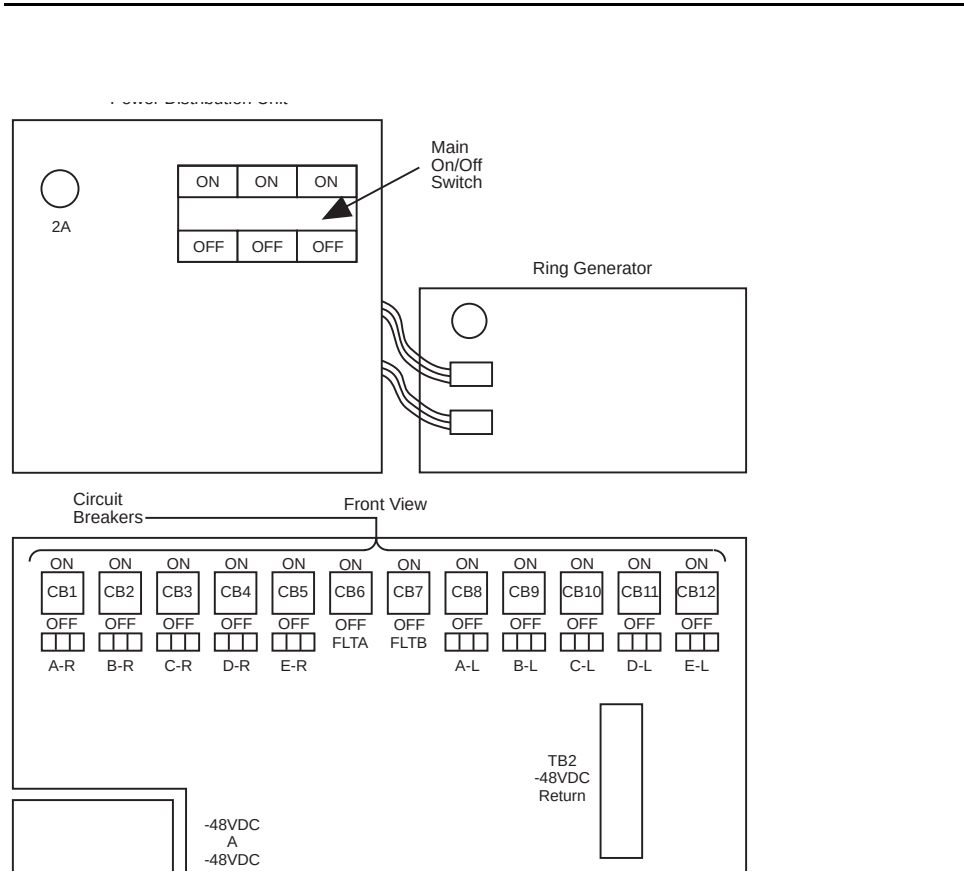
Figure 8-17. Power Distribution Unit for DC-Powered Systems (PDU 58890CF-1)

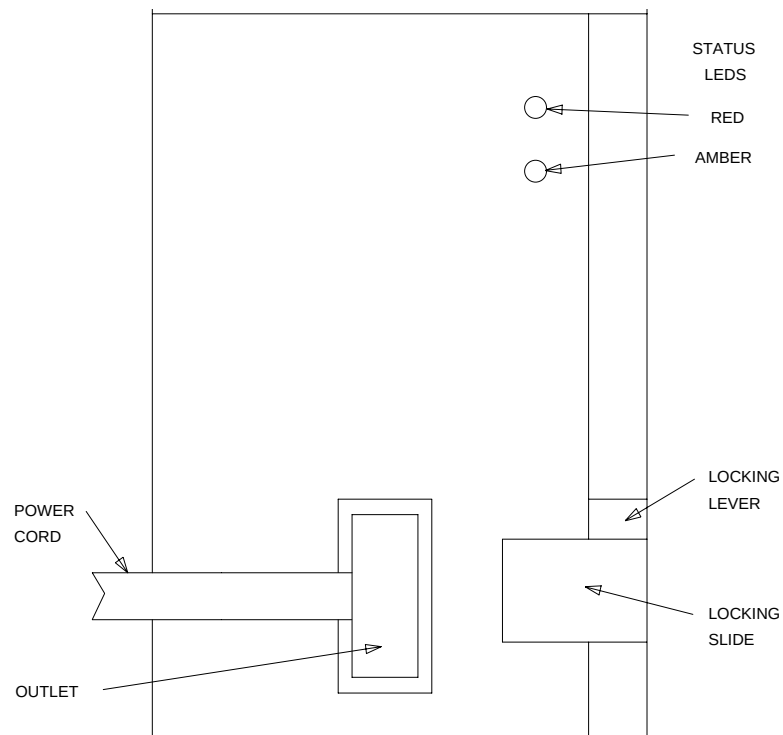
**Figure 8-18. 644A Port Carrier Power Unit for DC-Powered Systems**

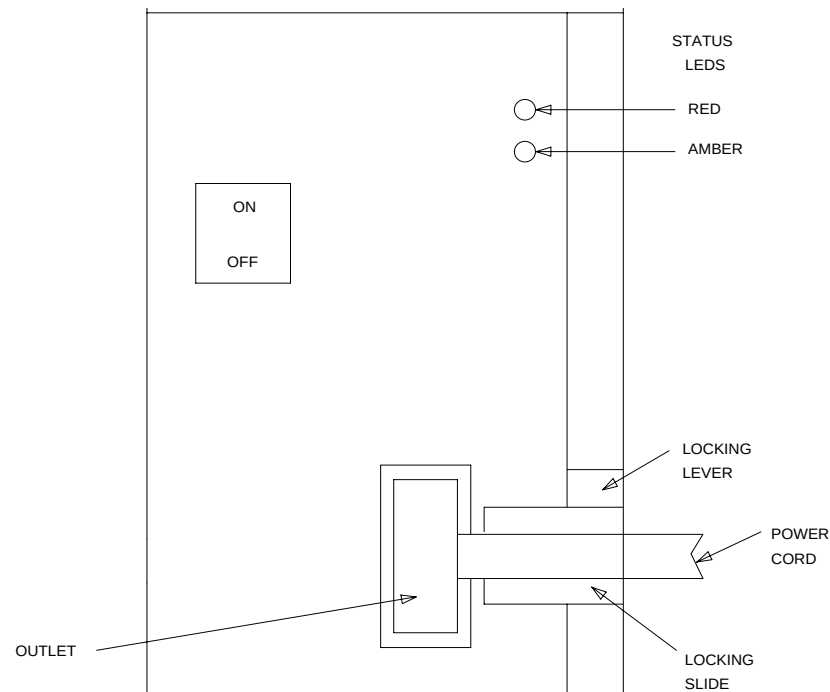
**Figure 8-19. 645B Port Carrier Power Unit for DC-Powered Systems**

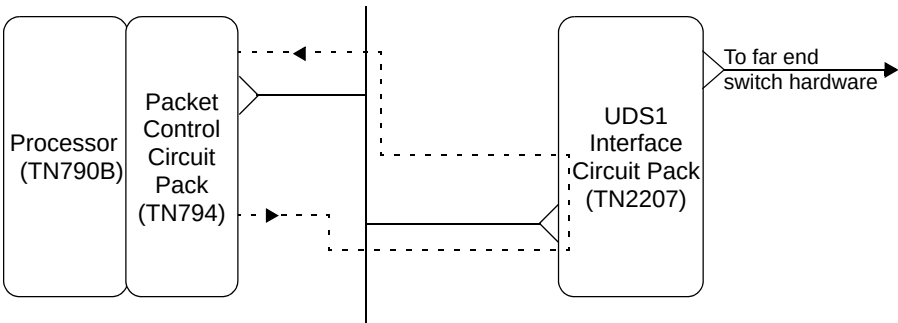
This test verifies the connectivity of an ISDN-PRI Signaling Port (D-channel) across the Packet Bus, also known as the LAN bus. It will execute only if the port is busied out. Failure of this test indicates a fault associated with the port hardware on the circuit pack.

Figure 8-21. Signaling Port Packet Bus (LAN) Loopback

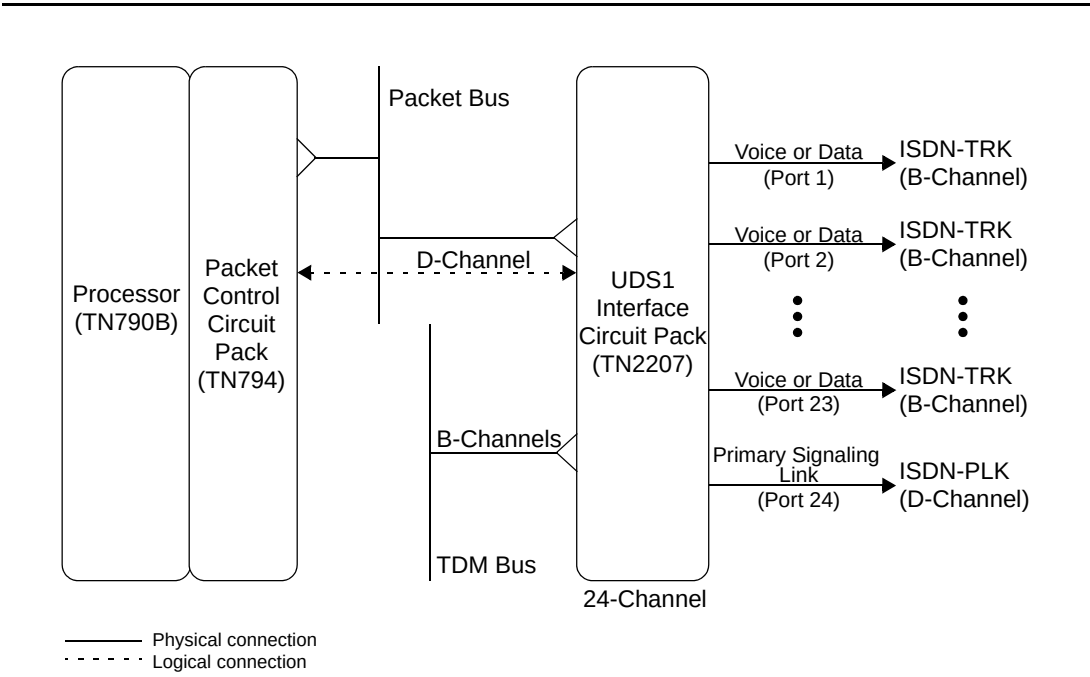
The ISDN-PRI Signaling Group itself depends on three other entities: the DS1 Interface circuit pack on which the D-channel(s) resides, the ISDN-PRI Signaling Link Port(s), and the interface link that provides connectivity to the processor (the Packet Control circuit pack). If there are any problems with the ISDN-PRI Signaling Group, also investigate the ISDN-PRI Signaling Link Port(s), the DS1 Interface circuit pack(s), and the Packet Control circuit pack.

Figure 8-22. FAS ISDN-PRI Over TN794 NetPacket Signaling Group (24 Channel)

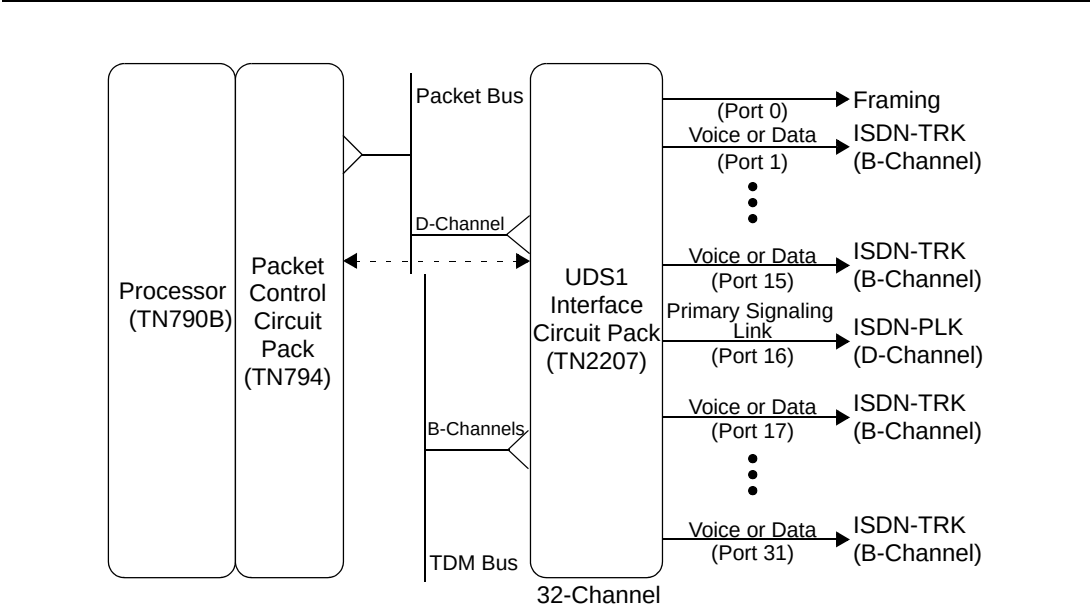
Figure 8-23. FAS ISDN-PRI Over TN794 NetPacket Signaling Group (32 Channel)

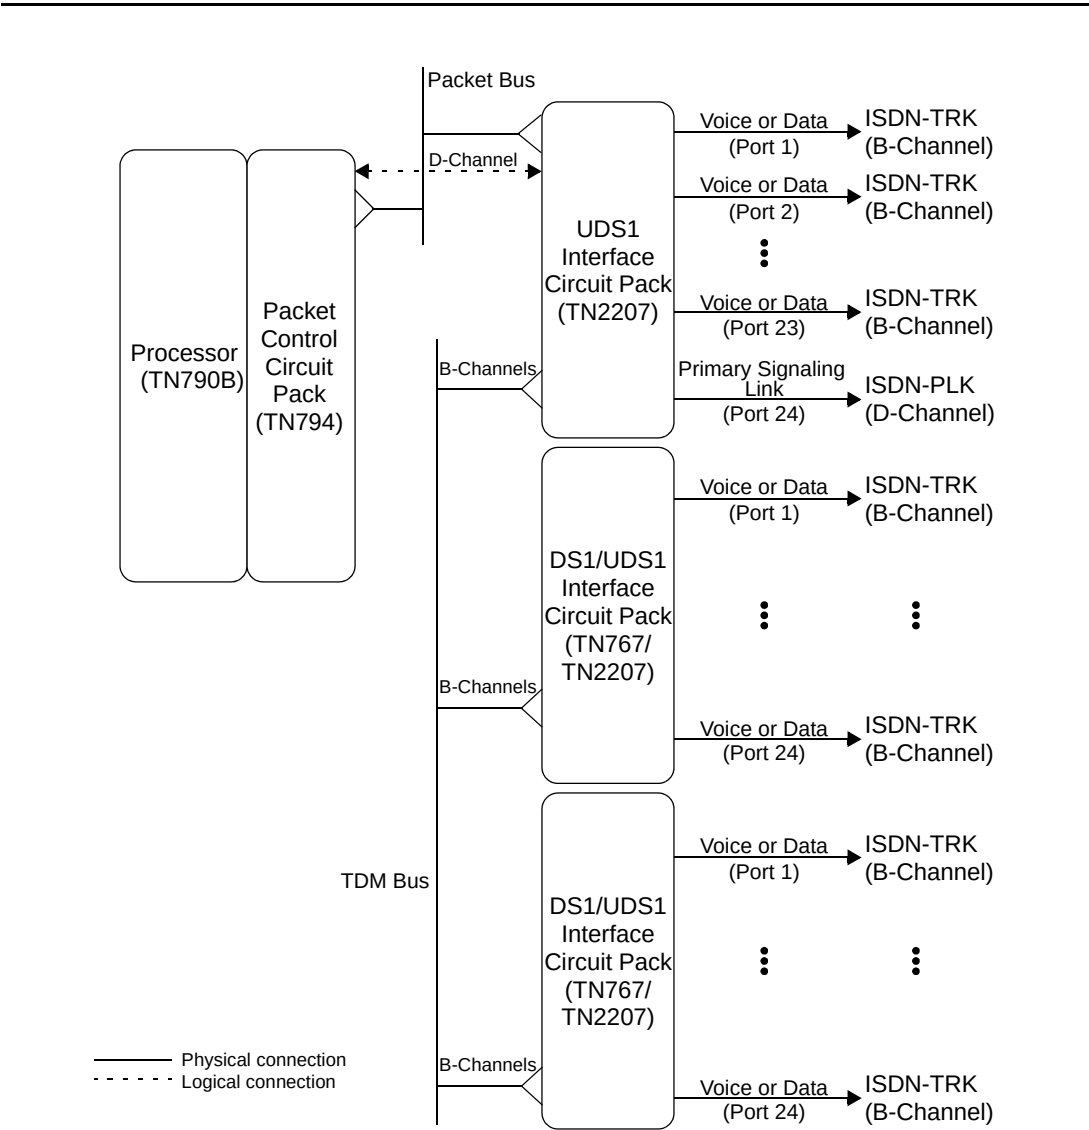
Figure 8-24. NFAS Simplex ISDN-PRI Over TN794 NetPacket Signaling Group (24 Channel)

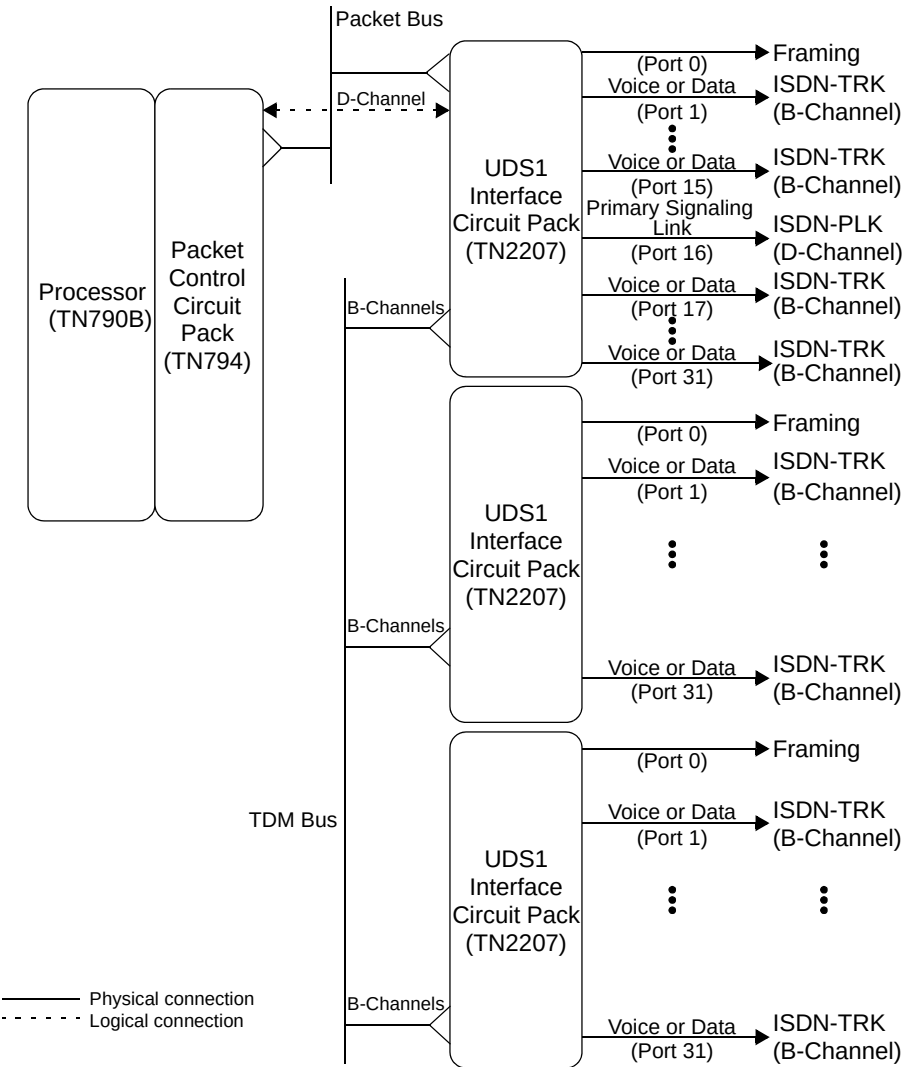
Figure 8-25. NFAS Simplex ISDN-PRI Over TN794 NetPacket Signaling Group (32 Channel)

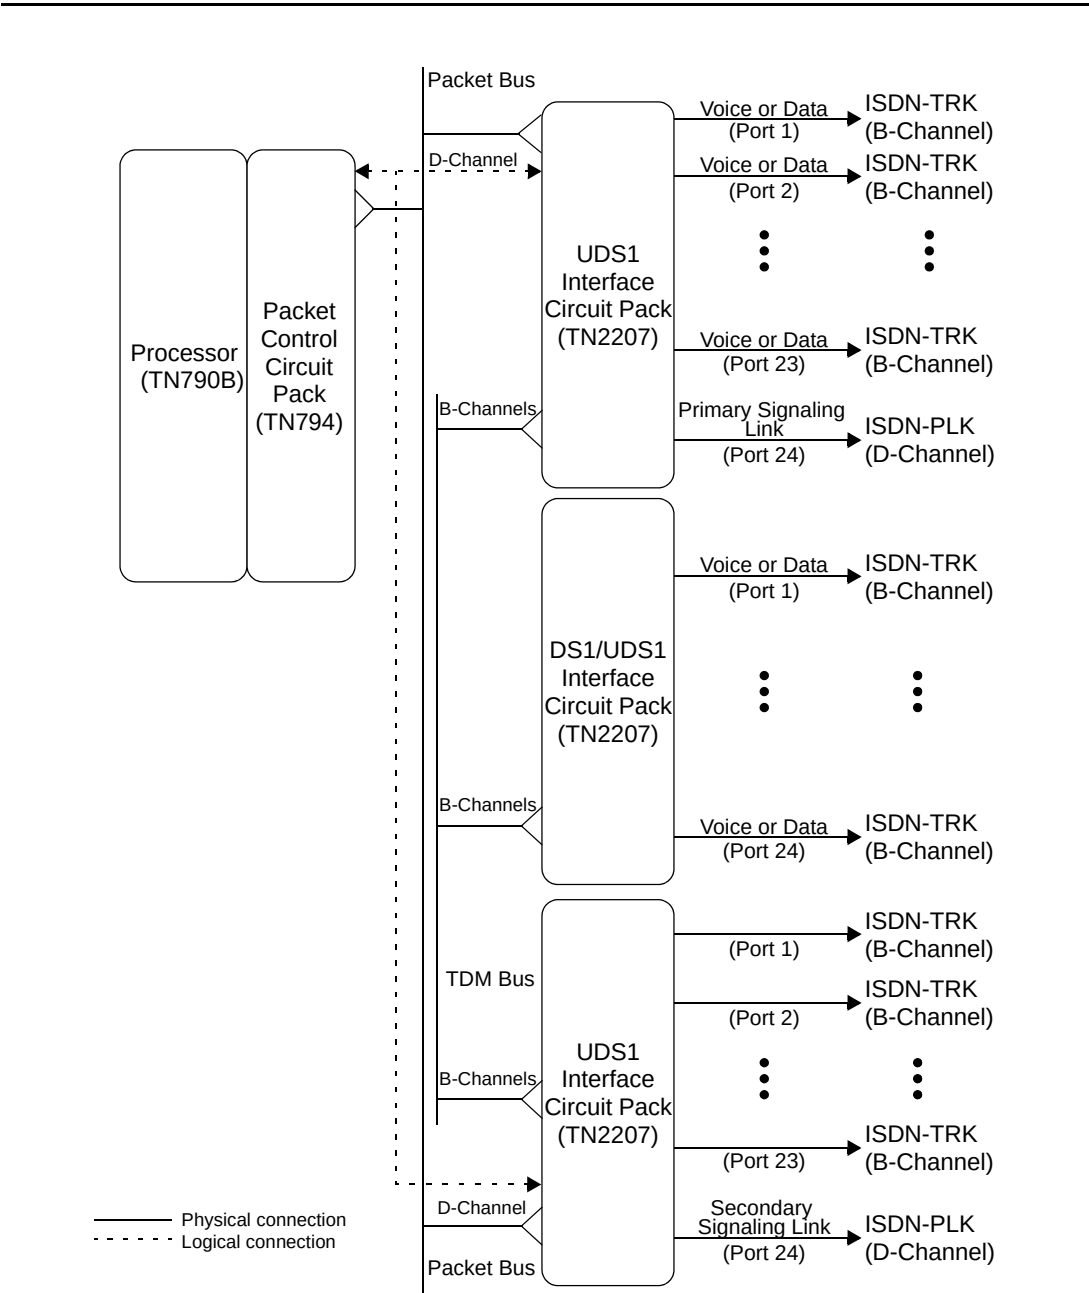
Figure 8-26. NFAS Duplex ISDN-PRI Over TN794 NetPacket Signaling Group (24 Channel)

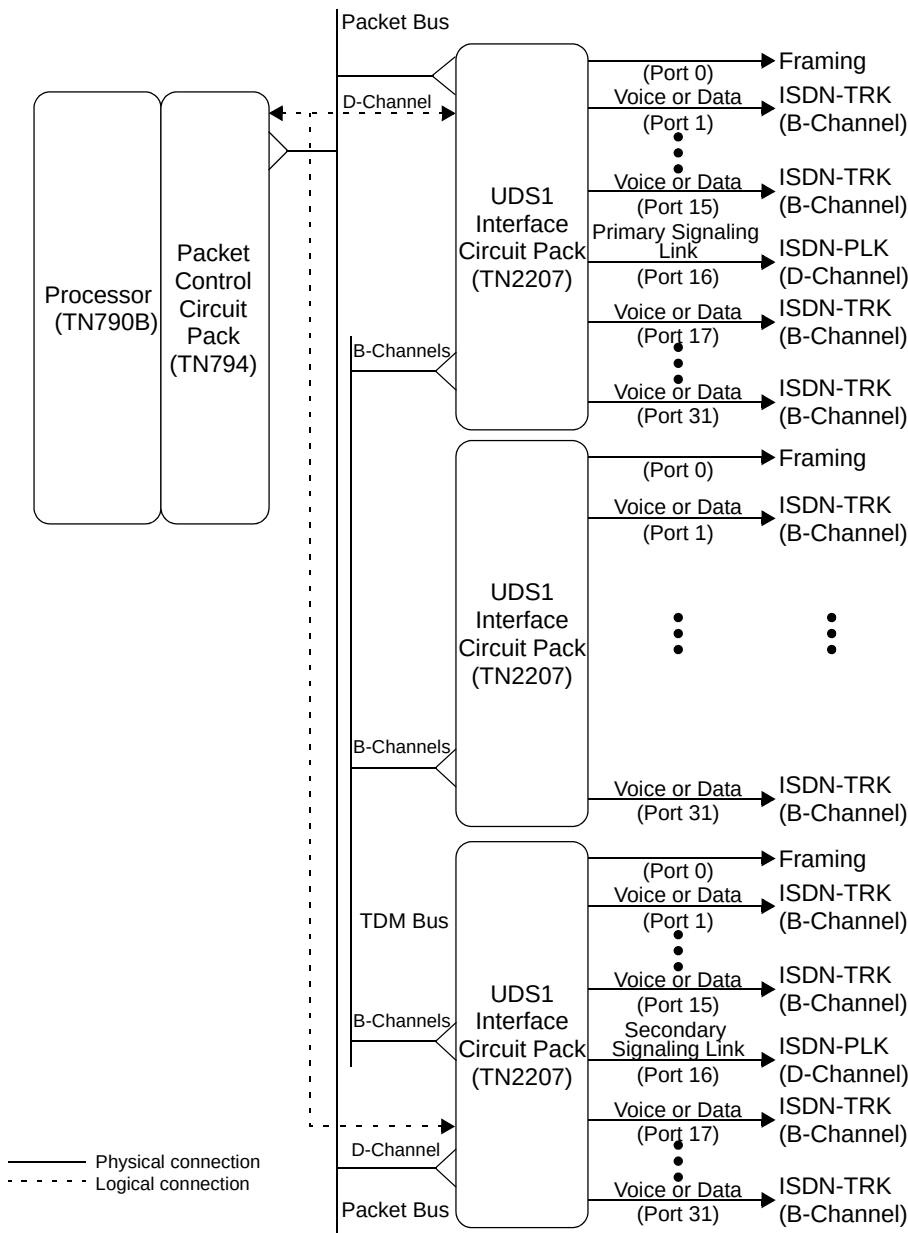
Figure 8-27. NFAS Duplex ISDN-PRI Over TN794 NetPacket Signaling Group (32 Channel)

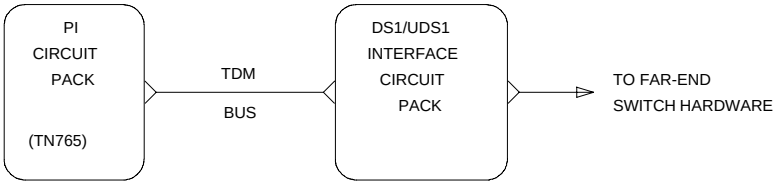
The ISDN-PRI Signaling Link Port itself depends on the health of the DS1/UDS1 Interface circuit pack on which it resides. This test will fail if there are problems with either the ISDN-PRI Primary D-channel port or the DS1/UDS1 circuit pack. The ISDN-PRI Primary D-channel also depends on the health of either the Processor Interface Link or the Processor Control circuit pack providing connectivity to the DS1/UDS1 circuit pack.

Figure 8-28. Primary Signaling Link Hardware Check (Test #636)

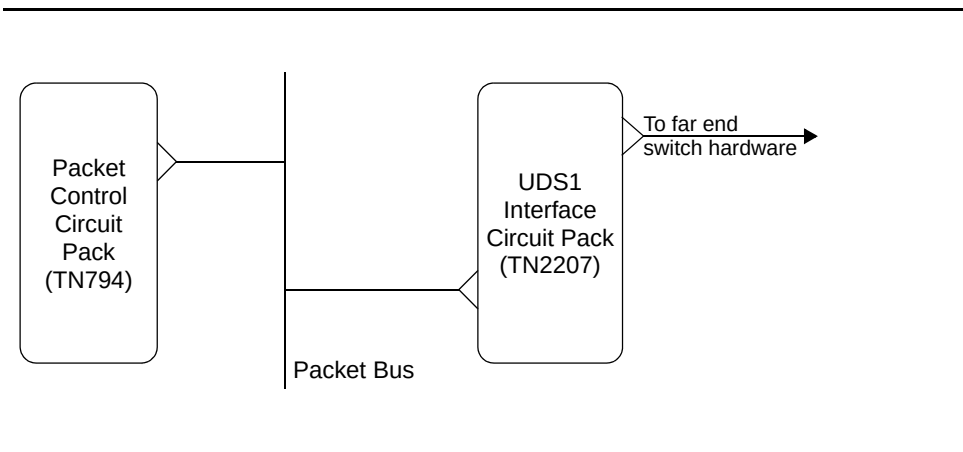
Figure 8-29. PRI over TN794 NetPacket Primary Signaling Link Hardware Check (Test #636)

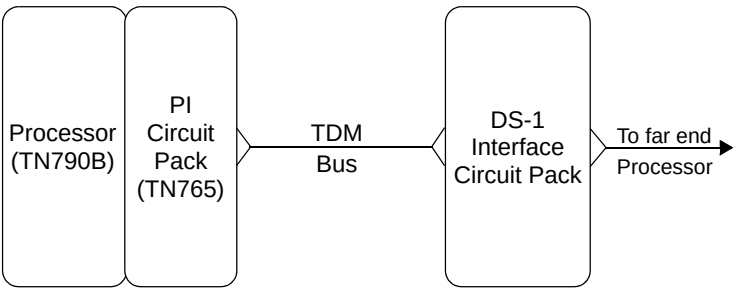
Figure 8-30. Remote Layer 3 Query (Test #637)

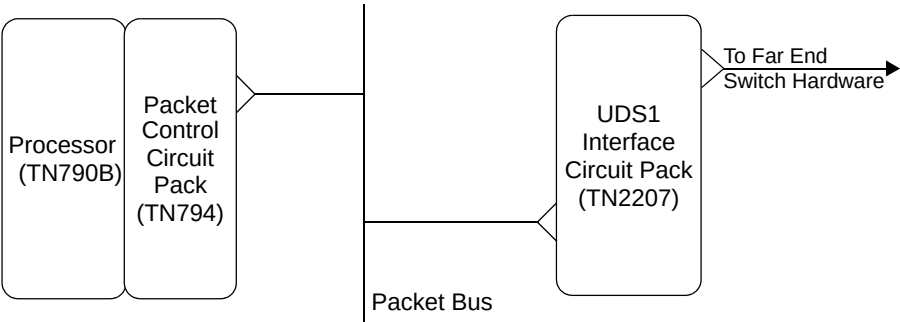
Figure 8-31. PRI Over PACON Remote Layer 3 Query (Test #637)

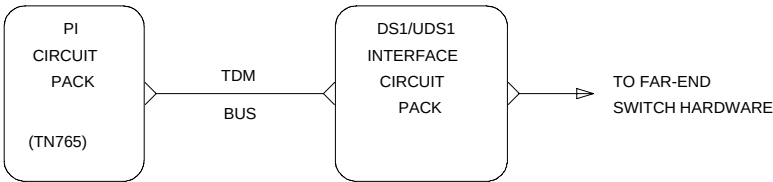
The ISDN-PRI Signaling Group D-Channel port depends on the health of the DS1/UDS1 Interface circuit pack on which it resides. This test will fail if there are problems with either the ISDN-PRI Primary D-channel port or the DS1/ UDS1 circuit pack. If there are problems with the ISDN-PRI Secondary Signaling Channel port (ISDN-LNK or ISDN-PLK), also investigate the DS1/UDS1 circuit pack.

Figure 8-32. Secondary Signaling Link Hardware Check for PRI over PI (Test #639)

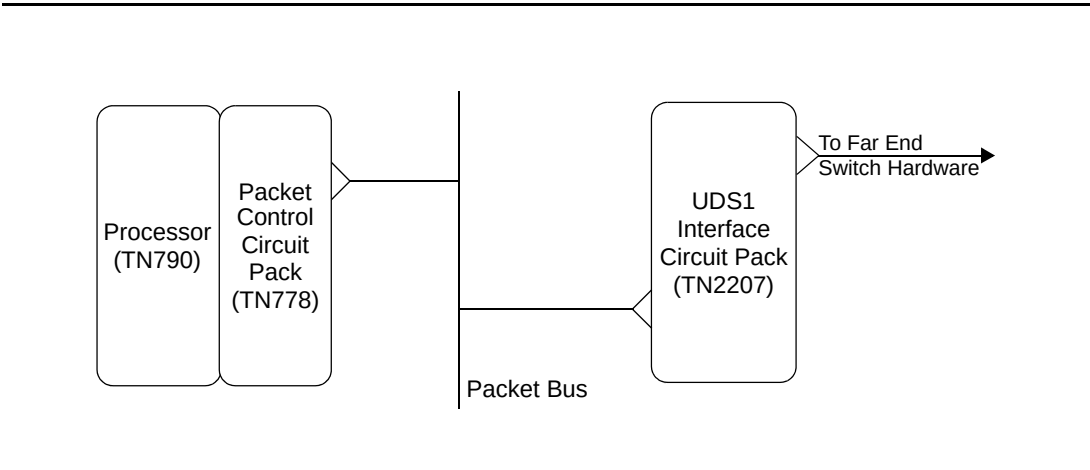
Figure 8-33. Secondary Signaling Link Hardware Check for PRI over TN794 NetPacket (Test #639)
