# **MultiPoint Conferencing Unit**

## **Release 7.2**

555-027-816  
Comcode 700217730  
Issue 1.0  
March 2002

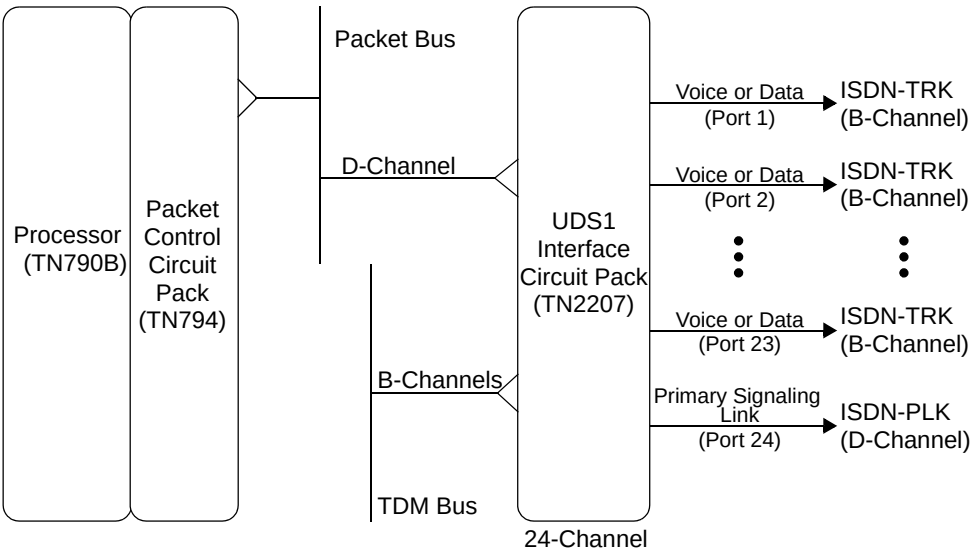
As a port on a DS1 circuit pack (DS1-BD or UDS1-BD), and as part of a signaling group dependent on a D-channel (ISDN-LNK/ISDN-PLK) for signaling, operation of the ISDN-TRK is dependent on the health of these other maintenance objects. The ISDN D-channel in turn depends on the Packet Bus (PKT-BUS)/Processor Interface Link (PI-LINK) (dependent on setup) for transmission through the system. Keep this hierarchy of dependencies in mind when diagnosing problems.

Figure 8-34. DS1 ISDN Trunk Interactions (24-channel interface)

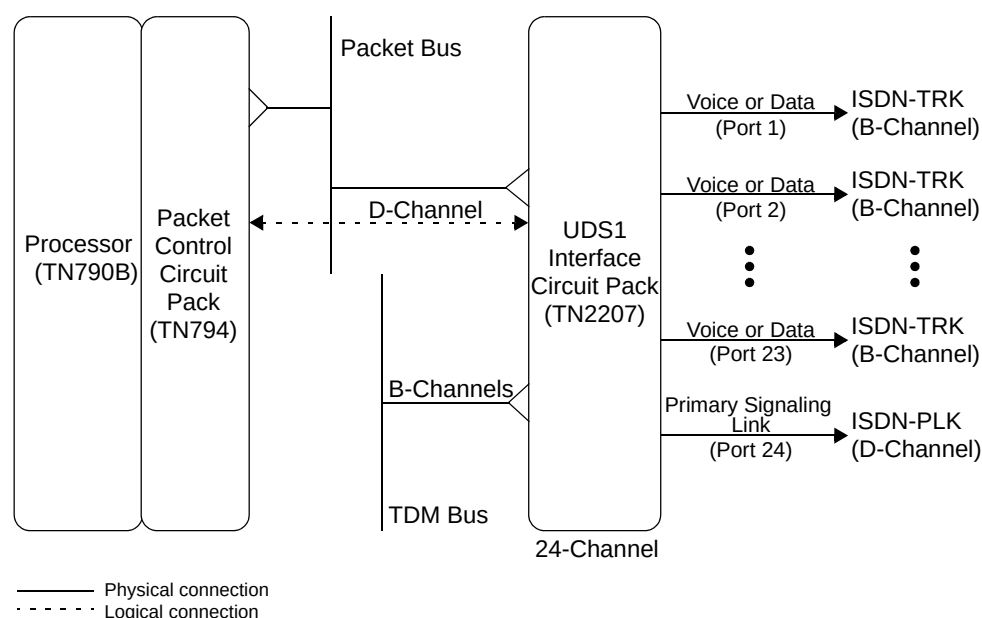
**Figure 8-35. PRI Over TN794 NetPacket DS1 ISDN Trunk Interactions (24-channel interface)**

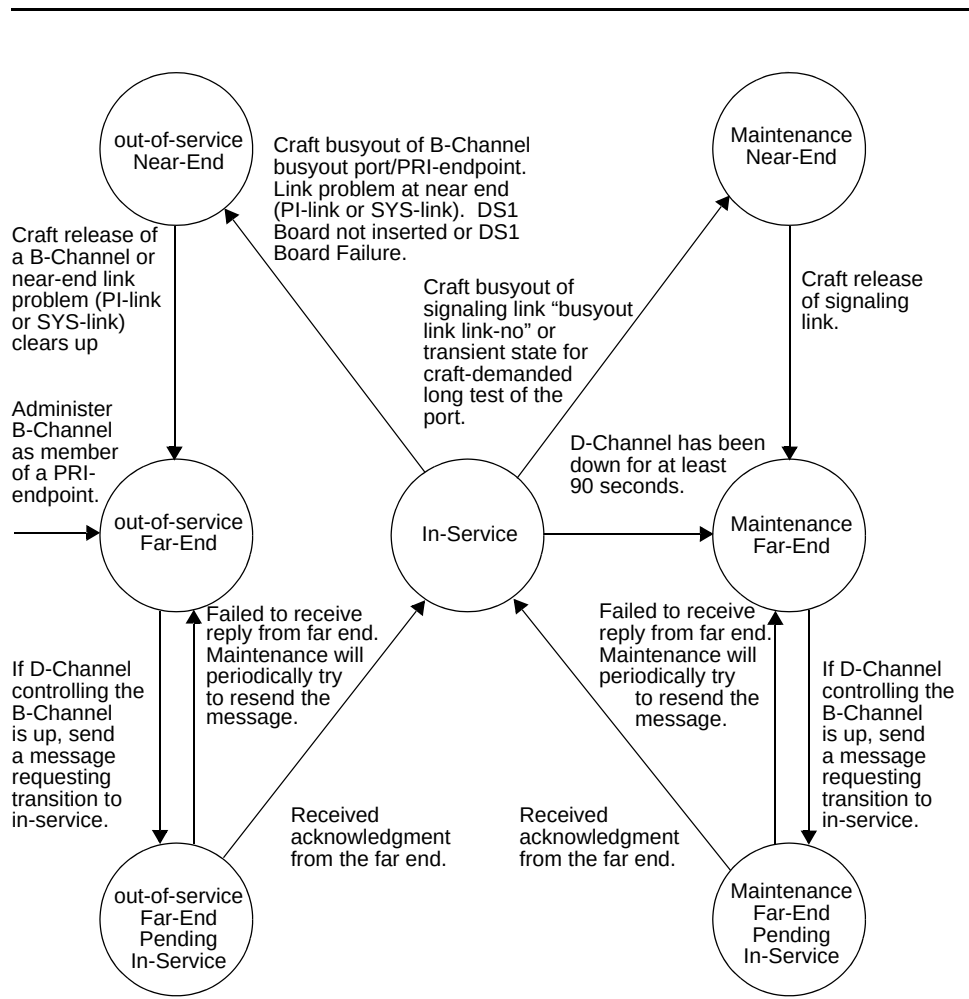
The following figure of the DS1 ISDN trunk service states shows the common progression from one service state to another and the event that caused the change of state.

Figure 8-36. Common Progressions in Service States

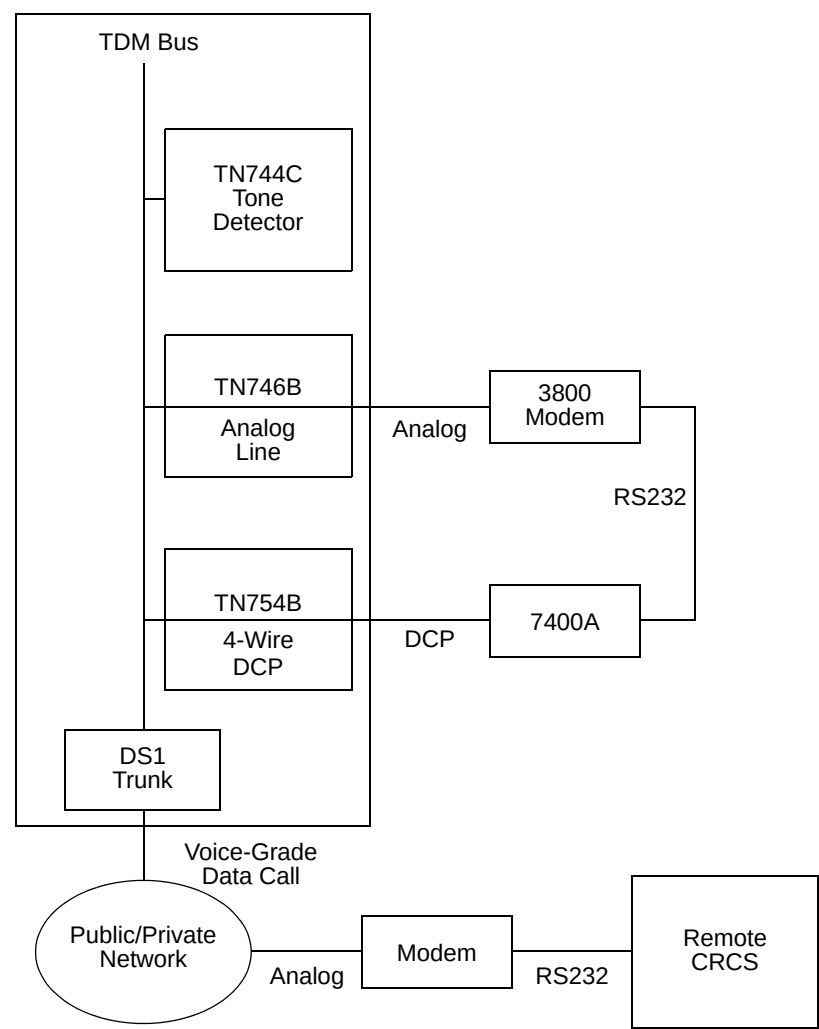
A number of modem pool conversion resources may be available in the MCU. Each such resource is assigned to one of five available Modem Pool Groups. Only one conversion resource is used per data connection. Whenever a local data call originates from an analog port normally used for voice service only and terminates on a digital port, a Data Origination access code must be dialed before the extension number for the Modem Pool conversion resource to be included in the connection.

Figure 8-37. MCU/CRCS Combined Modem Pool Configuration

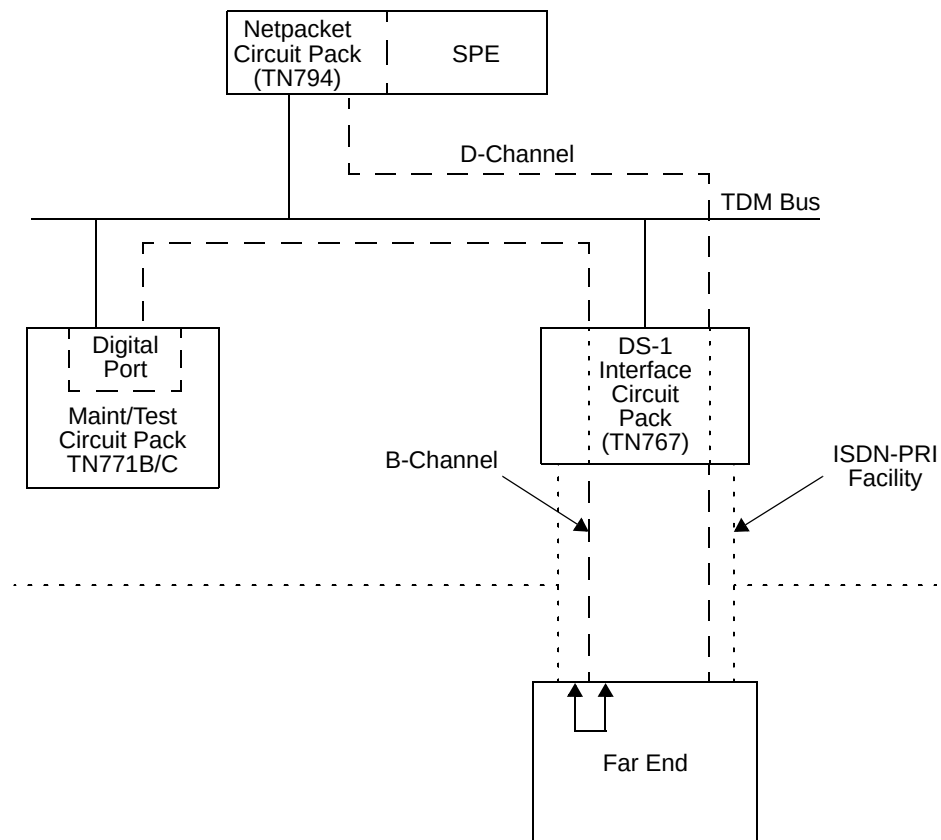
**Figure 8-38. ISDN-PRI Outgoing Test Call**

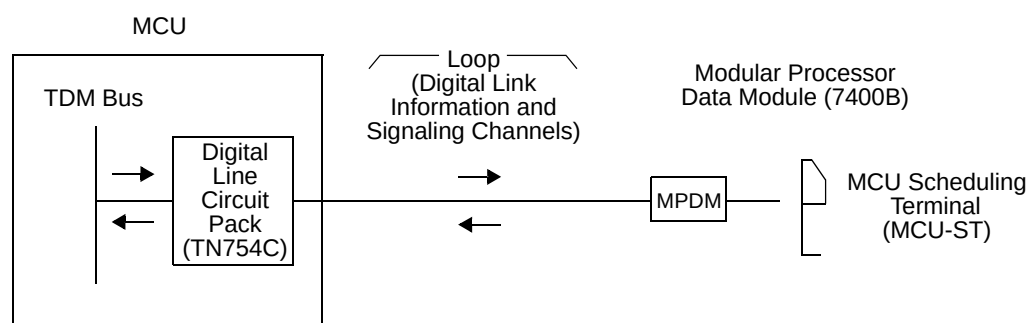
Data modules provide an interface between the system TN754C Digital Line circuit pack and data equipment, such as terminals, host computers, and modems. Data modules are used for both dial-up and permanent circuit-switched data calls.

**Figure 8-39. Typical Data Module Application**

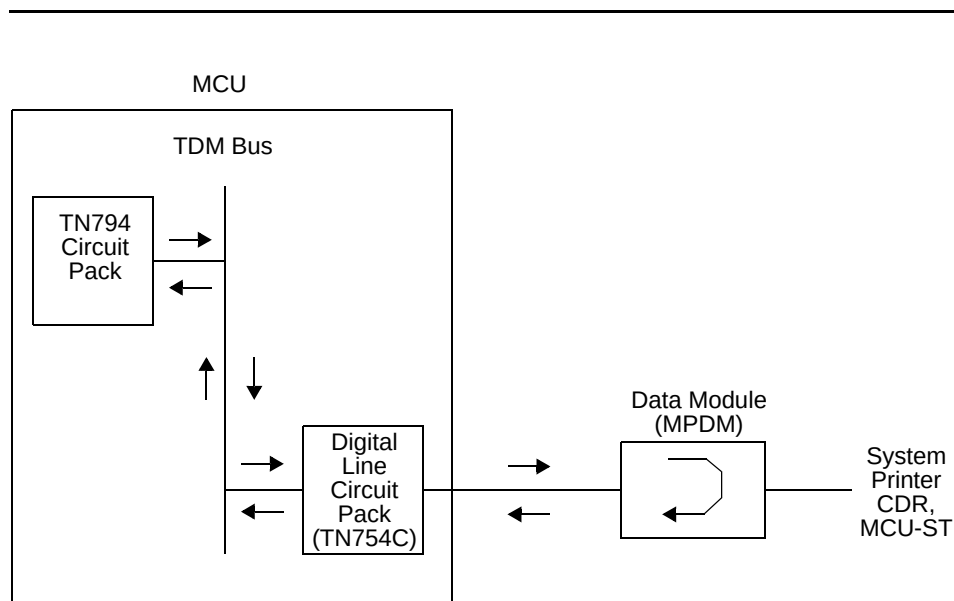
This test verifies that a data message can be sent from the MCU, through the building wiring, through an internal loop-around path in the data module under test, and back to the MCU. The following figure shows the hardware configuration used for this test.

**Figure 8-40. Internal Loop-Around Test**

A signaling message is sent through the Digital Line circuit pack to the data module under test to request it to enter loop-around mode. A test pattern is then sent from the SPE through the Netpkt Interface circuit pack (Netpkt Interface), over the TDM Bus, through the Digital Line circuit pack, to the data module where the message is looped around, and sent back through the Digital Line circuit pack, the TDM Bus, the Netpkt Interface circuit pack, and to the SPE where it is checked for consistency.

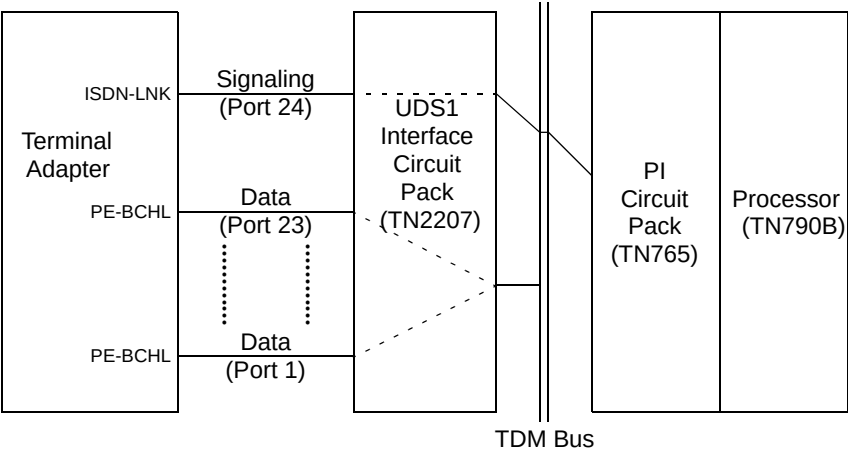
A PRI Endpoint Port is a port on a UDS1 interface circuit pack. Therefore, this port depends on the health of the UDS1 interface circuit pack for proper operation (see the following figure). As noted earlier, a PRI Endpoint Port B-channel also depends on an ISDN-PRI Signaling Link Port D-channel (ISDN-LNK) to carry the signaling traffic. If there is a problem with the ISDN-PRI Signaling Link Port, the PRI Endpoint Port is affected. The ISDN-PRI Signaling Link Port, in turn, depends on the PI-LINK (Processor Interface Link). Processor Interface Link problems affect the ISDN-PRI Signaling Link Port. Keep this hierarchy of dependencies in mind when diagnosing problems.

Figure 8-41. PRI Endpoint Port Interactions [INTEL]

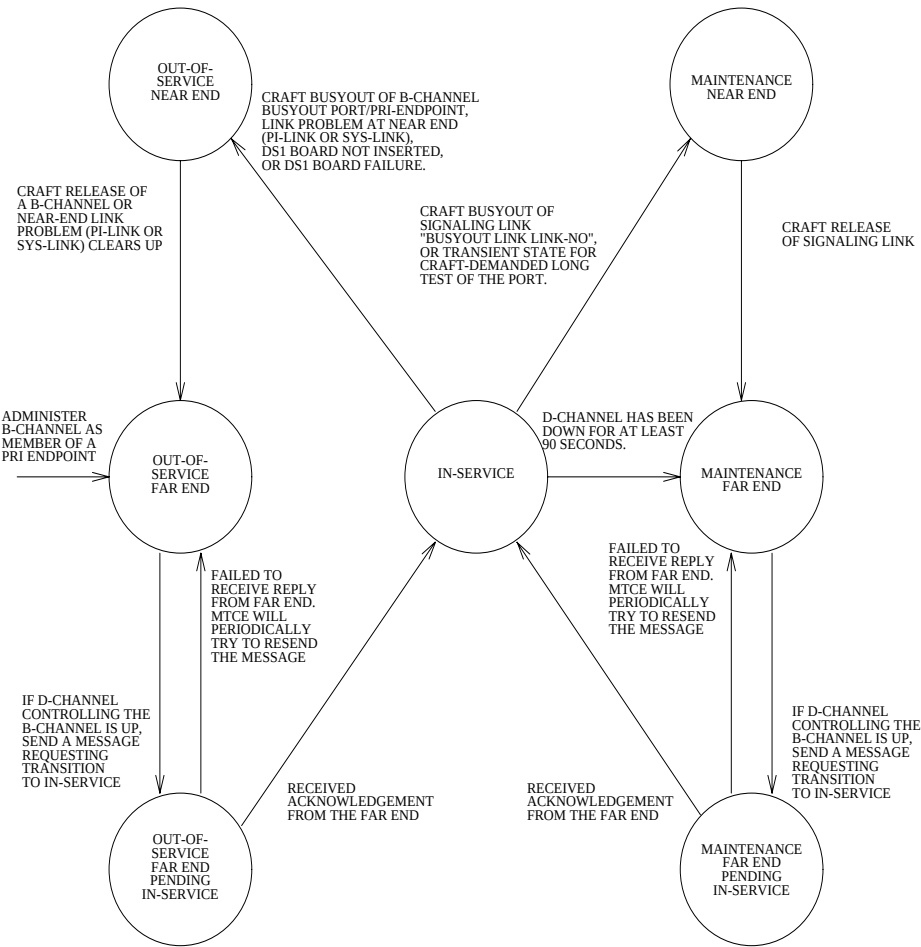
The following diagram of the PRI Endpoint Port service states shows the common progression from one service state to another and the event that caused the change of state.

Figure 8-42. Common Progressions in Service States

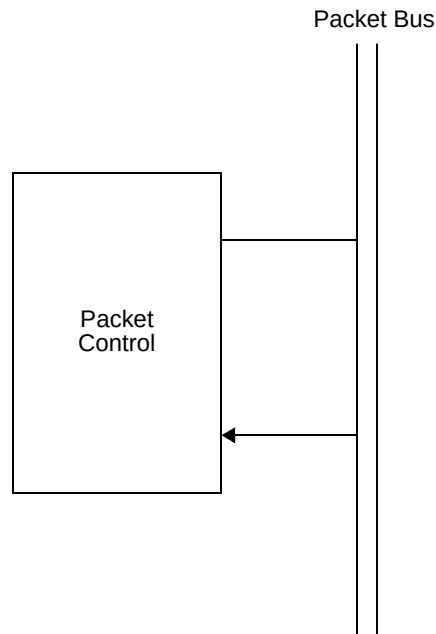
The TN794 Packet Control circuit pack is the hardware component that serves as the interface between the SPE and the Packet Bus. It terminates the Link Access Procedure D (LAPD) protocol and provides support for thousands of signaling links. As shown in the figure on the following page, a Packet Control link generally terminates on the Packet Control circuit pack and a packet endpoint that is connected to a Packet circuit pack. A TN556 circuit pack is an example of a Packet circuit pack. The following Packet circuit packs (packs that can connect to the Packet Bus) are available:

**Figure 8-43. Packet Hardware Configuration**

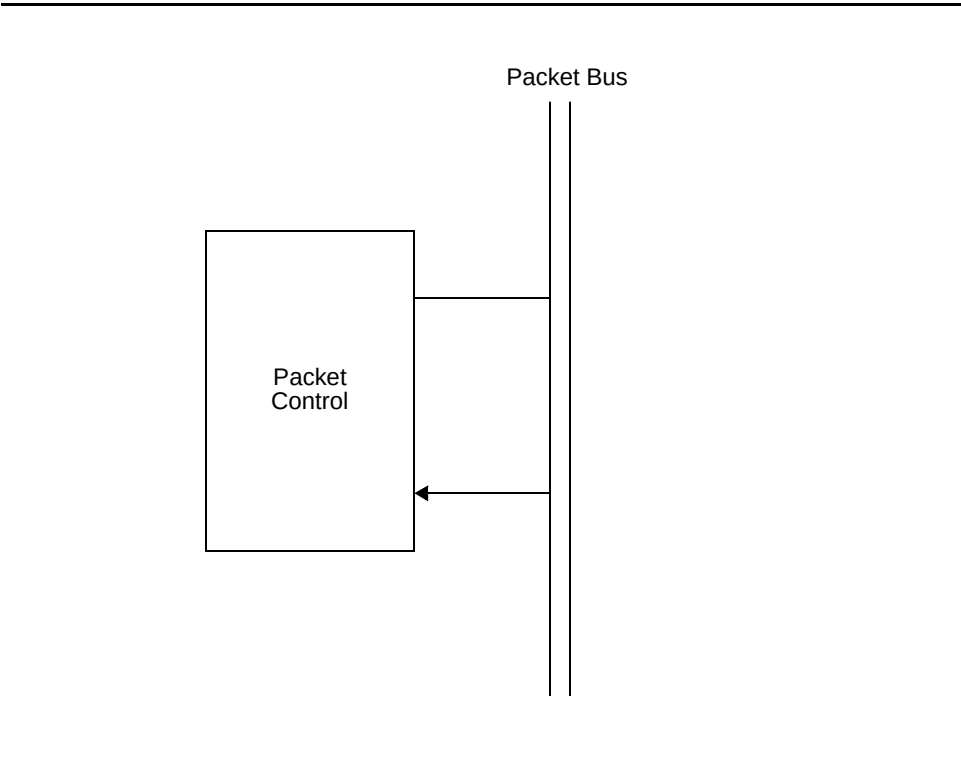
1. Establishes an LAPD link from the Packet Control circuit pack to itself (see the following figure).
2. Transmits and receives test data over the testing link.

Figure 8-44. Test Configuration

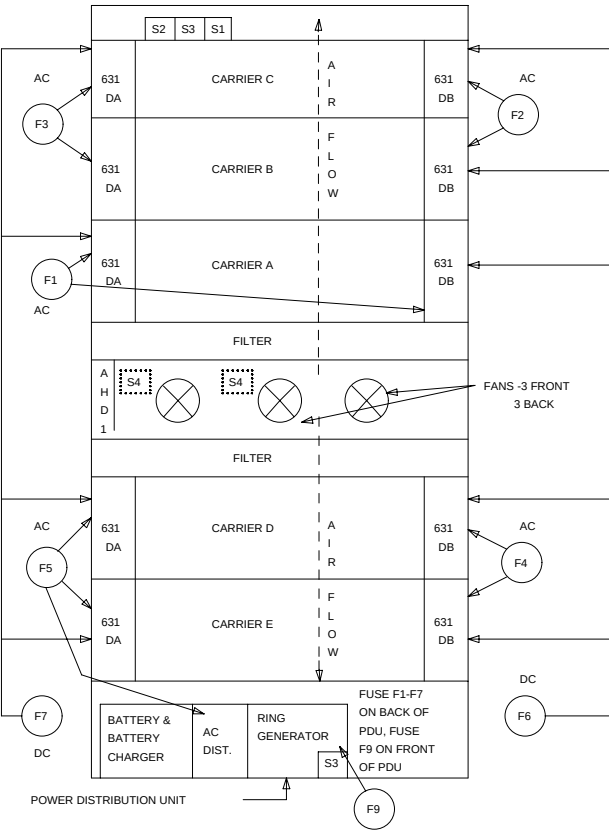
Figure 8-45. Multicarrier Cabinet Environment Components

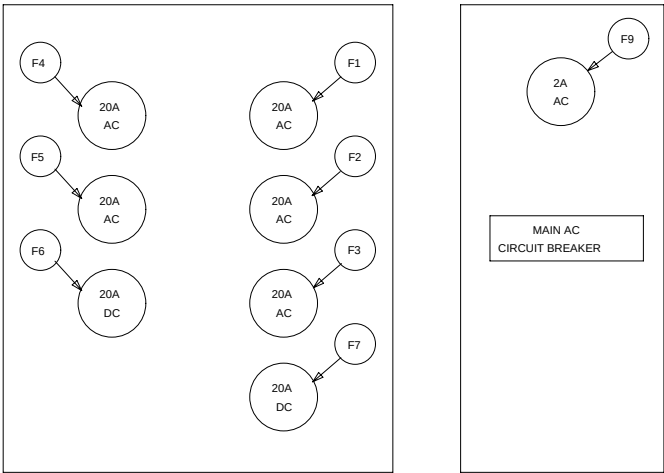
BACK OF POWER DISTRIBUTION UNIT

FRONT OF POWER DISTRIBUTION UNIT

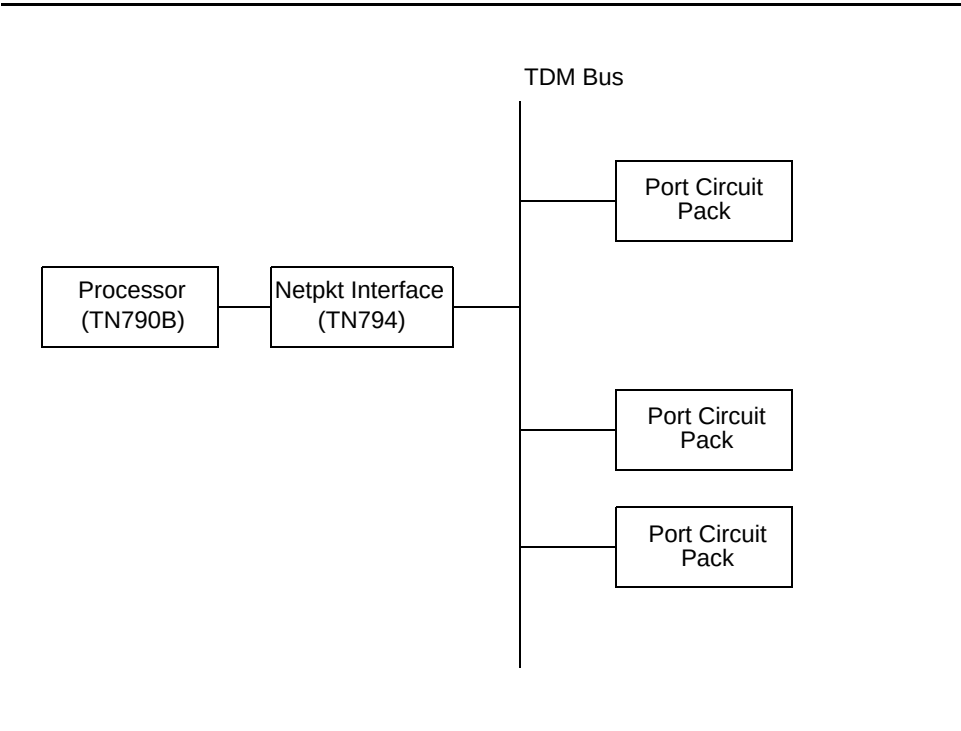
Switch Control contains the hardware time of Day (TIME-DAY) clock that the system uses for all its date and time information. In addition, Switch Control also contains hardware to monitor critical system timing signals and informs the processor when these signals fail. For example, if the timing signals from a Tone-Clock circuit pack in the cabinet fail, Switch Control informs the processor.

Figure 8-47. Switch Control Connectivity

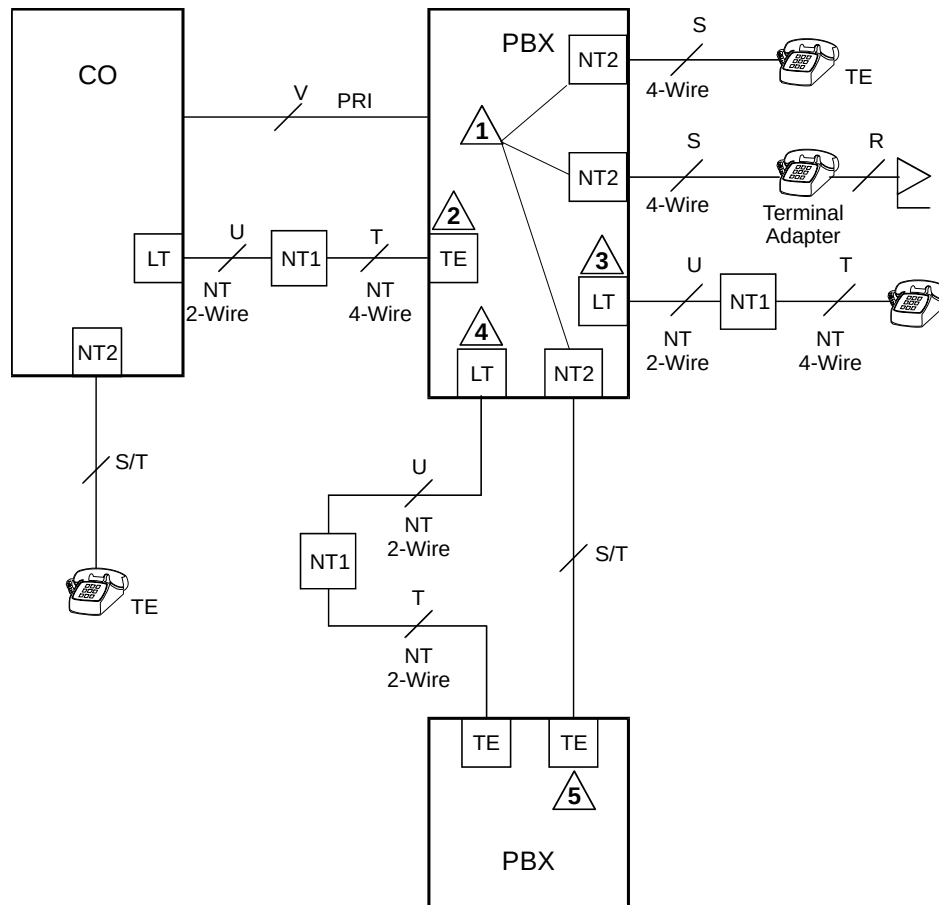
ISDN Interface Reference Points

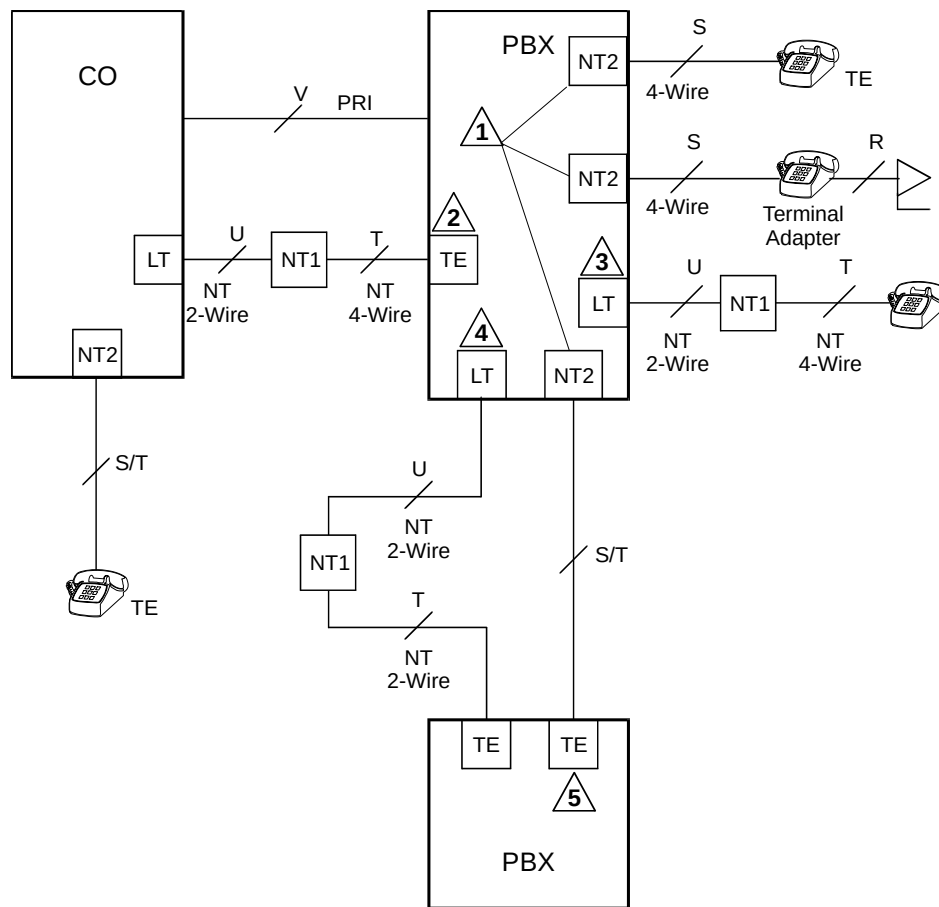
ISDN Interface Reference Points

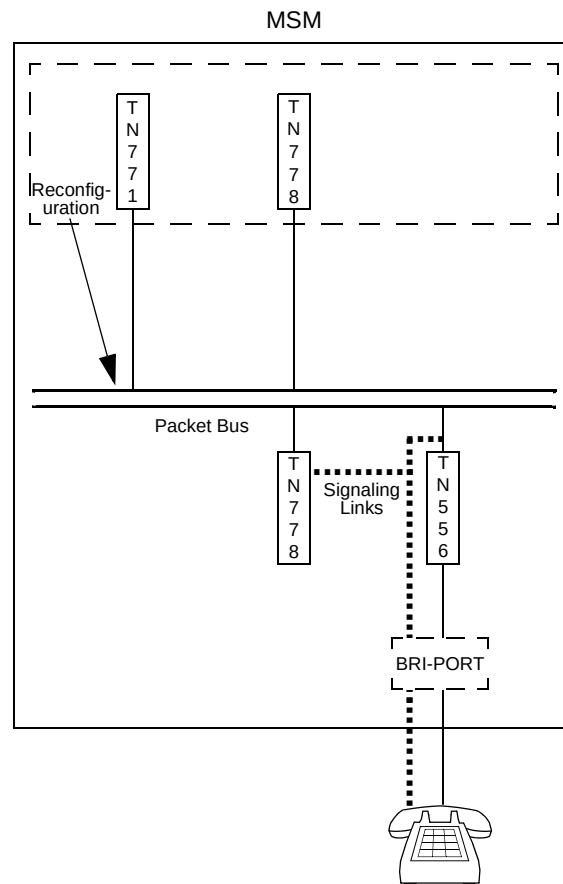
Figure 9-1 shows the various circuit packs that communicate on the Packet Bus. Logical and physical connections are illustrated. Connectivity with three port networks is similar.

**Figure 9-1. ISDN-BRI/Packet Bus Connectivity**

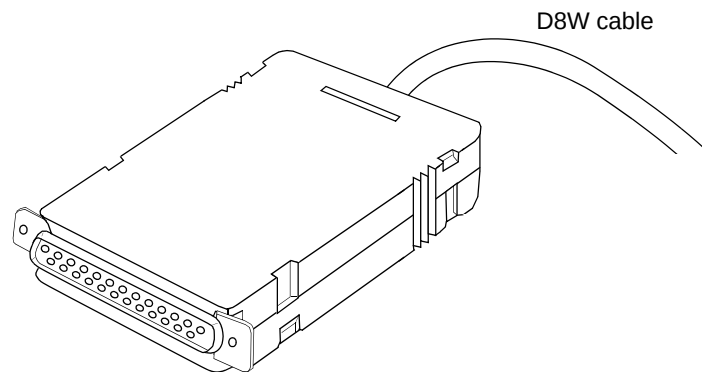
**Figure 9-2. 355A EIA-232 Adapter**

2. 355A EIA-232 Adapter (COMCODE 105 012 637). This adapter is illustrated in Figure 9-2.
3. 258B Six-Port Male Amphenol Adapter (COMCODE 103 923 025). This adapter is illustrated in Figure 9-3.

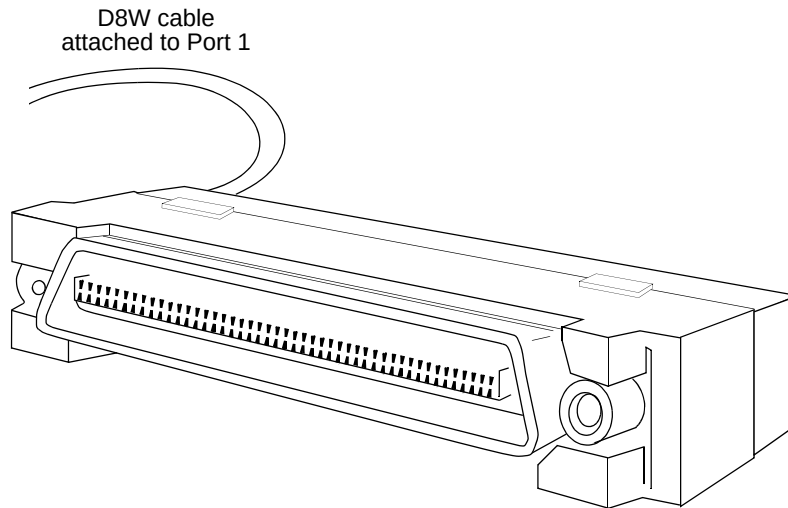
Figure 9-3. 258B Six-Port Male Amphenol Adapter

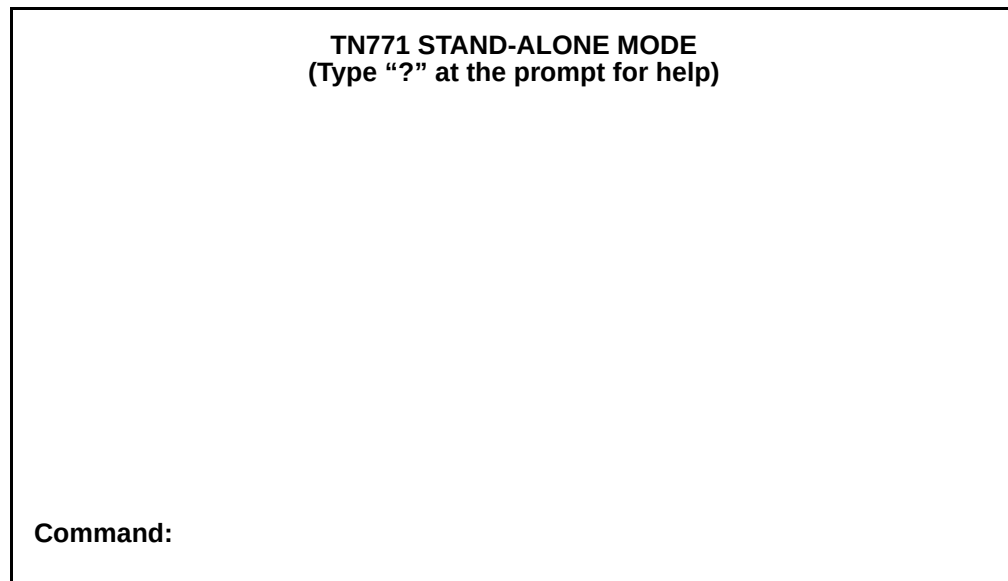
If the standalone mode is entered successfully, the following is displayed on the connected terminal:

**Figure 9-4. Normal Stand-Alone Mode Display**

*If the display in Figure 9-4 does not appear, be sure to check the wiring between the terminal and the TN771 circuit pack, and also the terminal parameters. If these are correct, the TN771 circuit pack may be defective. In such a case, follow the procedures to exit stand-alone mode (described in the next paragraph). Then test the Maintenance/Test circuit pack (refer to M/T-BD and M/T-PKT in Chapter 8, "Maintenance Object Repair Procedures").*

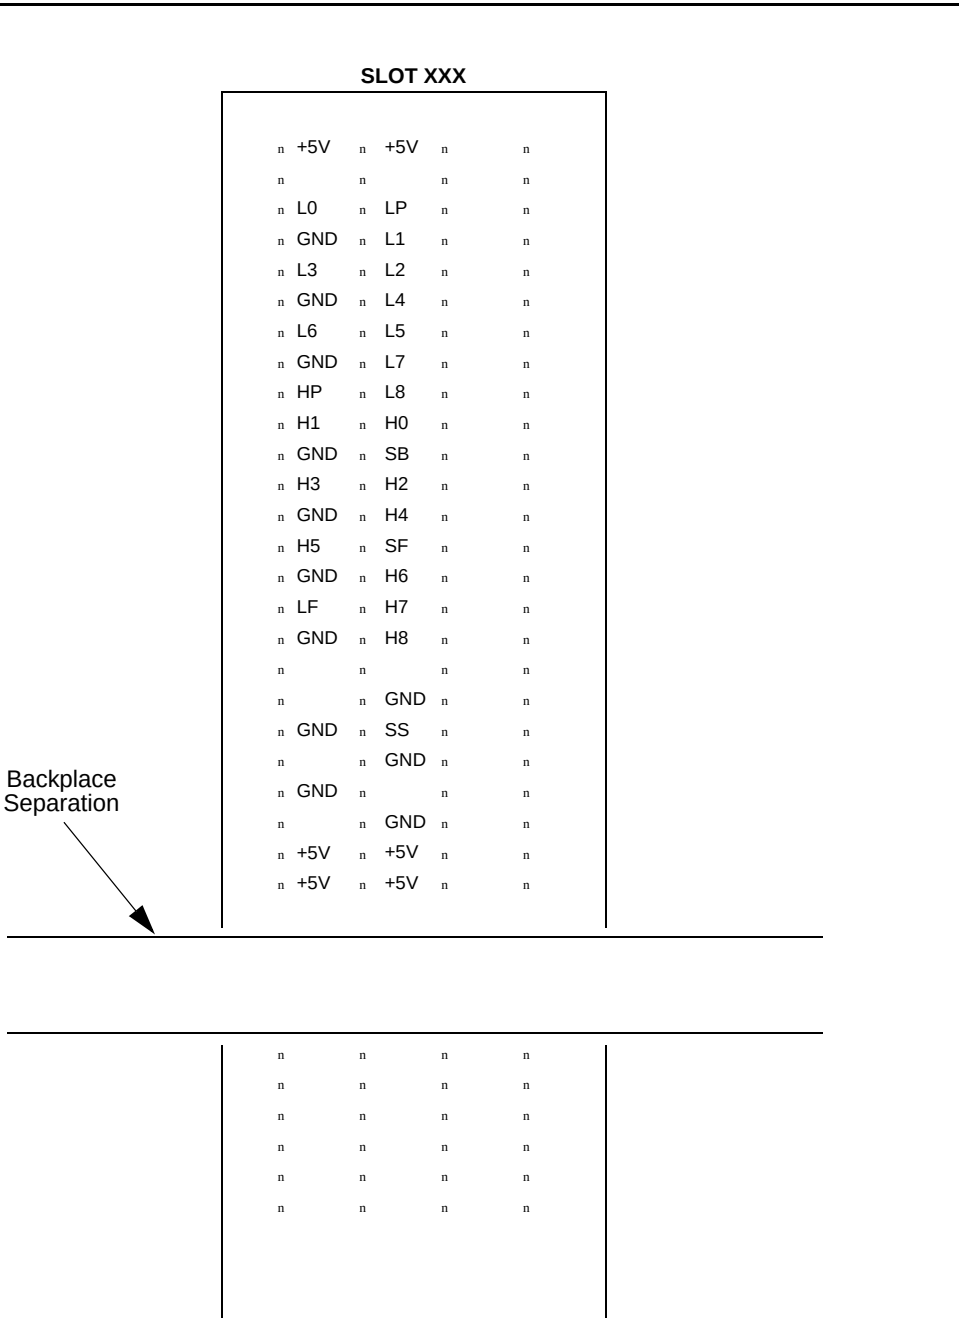
The information within a stand-alone mode display is used in the Packet Bus Fault Correction procedures that follow. The TN771 circuit pack display indicates the specific leads on the backplane to examine for bent or damaged pins. Figure 9-6 shows the location of the Packet Bus leads on the backplane as viewed from the front of the carrier, while Figure 9-7 shows the same slot as viewed from the back of the carrier.

Figure 9-6. Packet Bus Leads on the Backplane—Front View

2. Determine if the Packet Bus fault is still present.
3. If the Packet Bus fault is still present:
  - Determine if the backplane pins in the removed circuit pack's slot are bent. Use the output from the Maintenance/Test stand-alone mode and Figures 9-6 and 9-7.

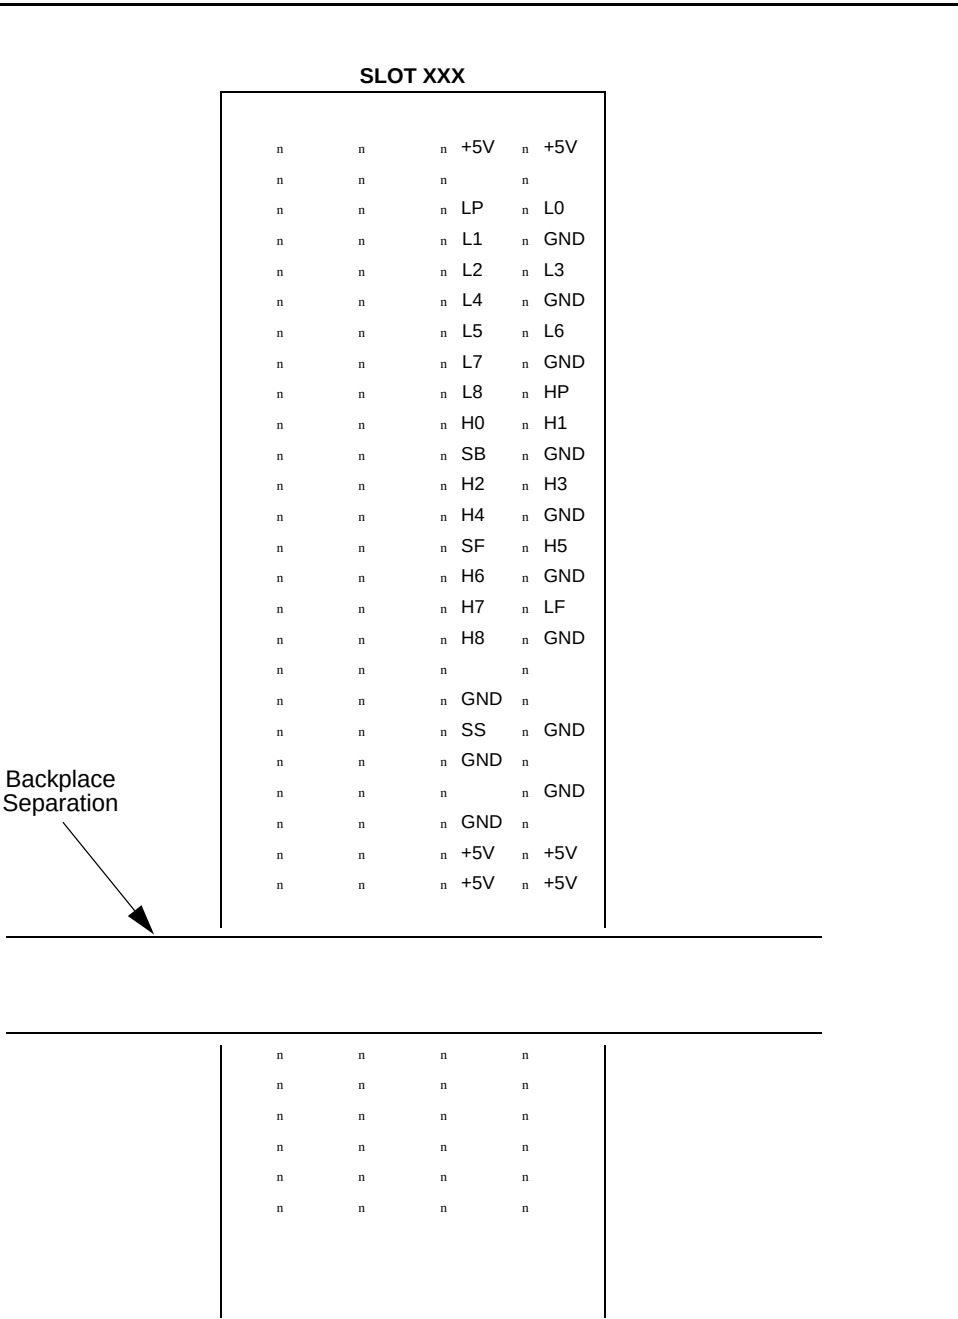
Figure 9-7. Packet Bus Leads on the Backplane—Back View

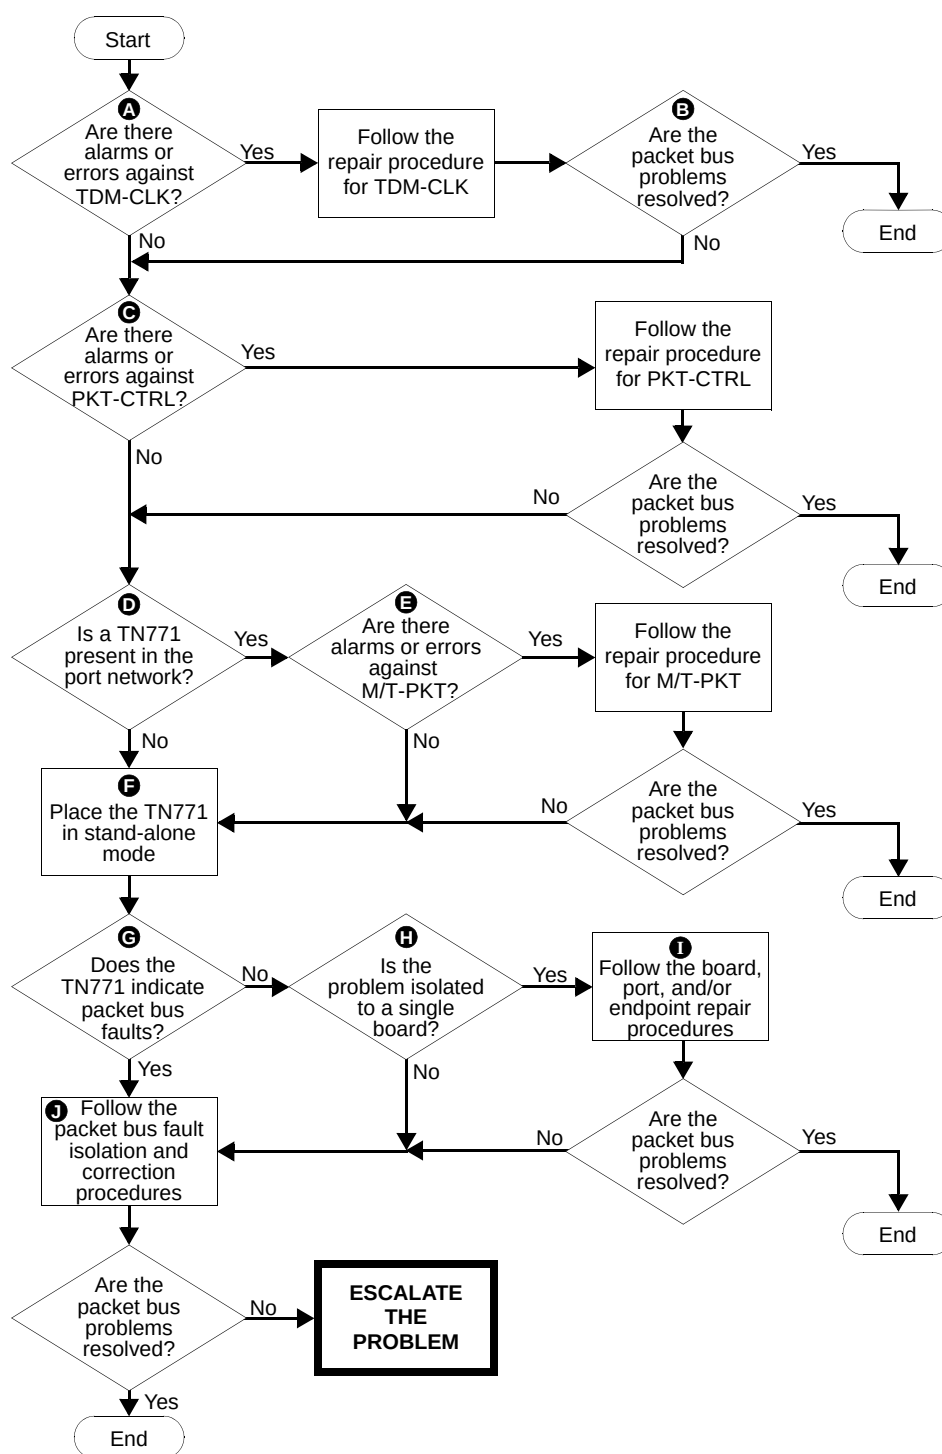
See the "Flowchart Description and Supplement" section following the flowchart for a description of the flowchart as well as for supplementary information, the availability of which is indicated by the uppercase letters in bold that appear within some of the boxes and diamonds in the flowchart.

Figure 9-8. Processing of Packet Bus Problems

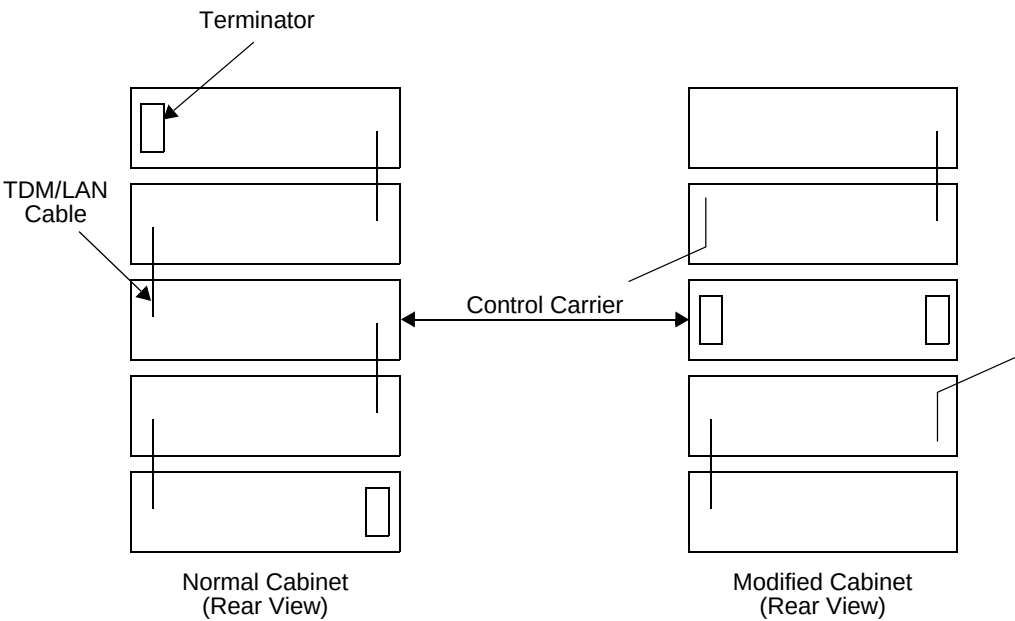
In Procedure 4, the TDM/LAN Cable Assemblies and TDM/LAN termination resistor packs are replaced. If this action does not resolve the Packet Bus fault, the carriers are reconfigured by moving the termination resistor packs in such a manner that certain carriers are disconnected from the bus. This is done by moving the termination resistors on the carrier backplanes. To terminate the Packet Bus at the end of a particular carrier, first unplug the cable that connects the carrier to the next carrier and then replace the cable with a termination resistor (see Figure 9-9). When the length of the Packet Bus is modified via this procedure, circuit packs that are essential to system operation (for example, Processor Complex, Tone-Clock) must still be connected to the new “shortened” Packet (and TDM) Bus. In addition, the Maintenance/Test circuit pack (in stand-alone mode) must be connected to the “shortened” bus.

Figure 9-9. Carrier Rewiring Example

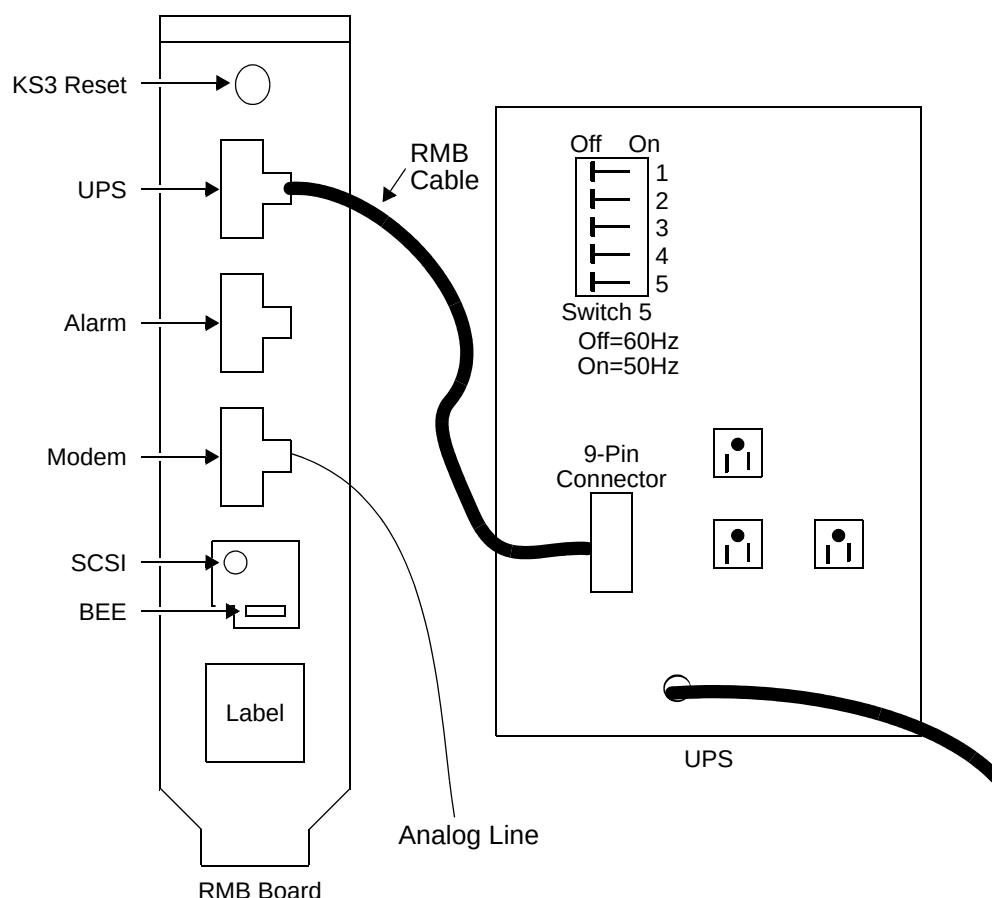
- If the ESM is powered up, follow the shutdown procedure described in the "Procedure Using the Esmhut Command" section earlier in this chapter.
- If there is a Remote Maintenance Board (RMB) installed in the system, ensure that the BEE switch on the board is NOT in the "on" position. See the following figure.

**Figure 10-1. RMB-UPS Connection and RMB Faceplate Description**

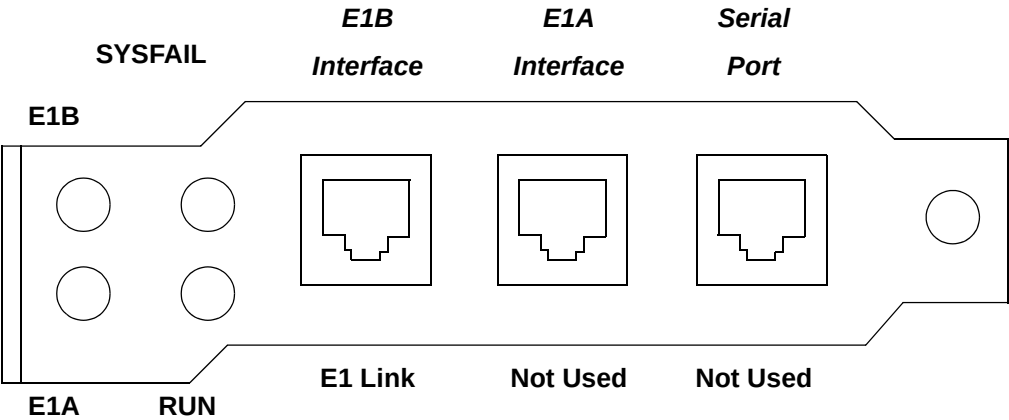
- 1. From the back of the ESM cabinet, verify that the D8W line is inserted into the E1B interface connector adjacent to the bank of LEDs on the board's rear bracket. Refer to the following figure.

Figure 10-2. Rear Bracket of MSM Interface Card

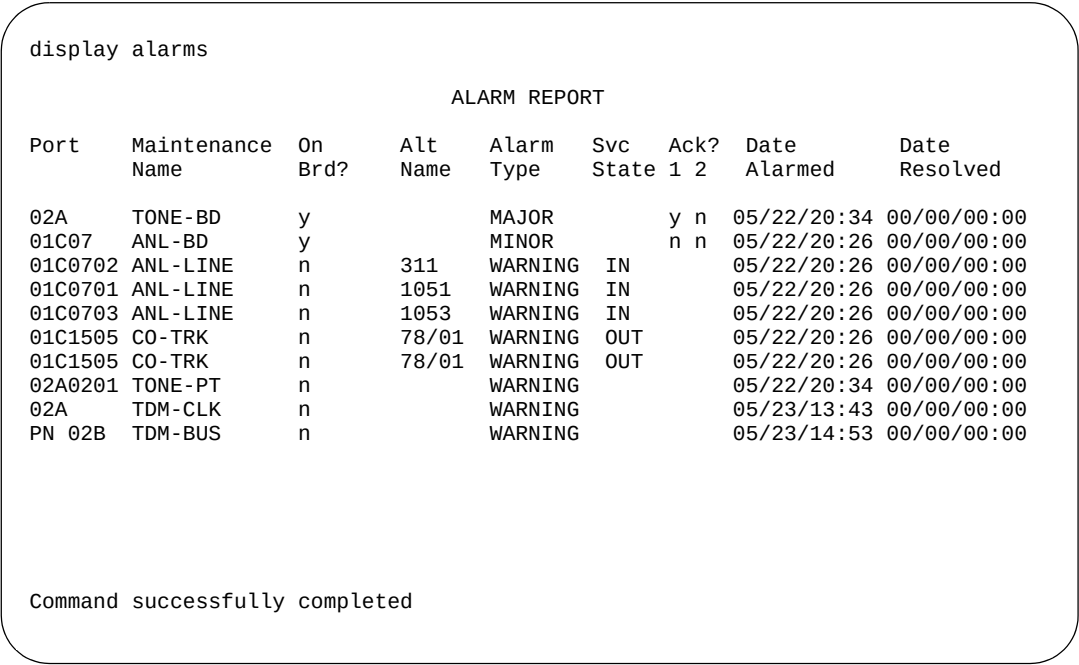
The following figure is an example of an Alarm Report.

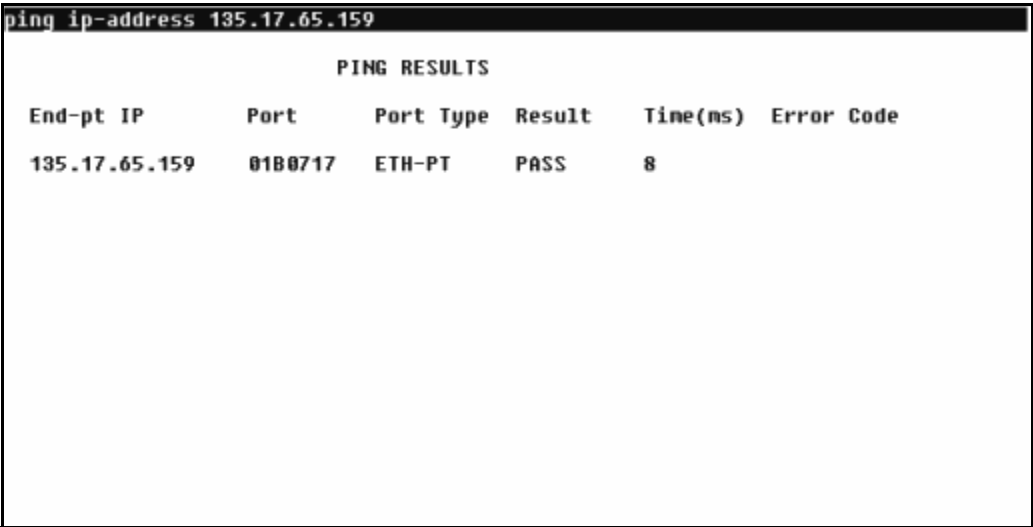
This command pings an administered node. Look the “**node-name**” up with the display node-names command).

Figure A-1. ping node-name report

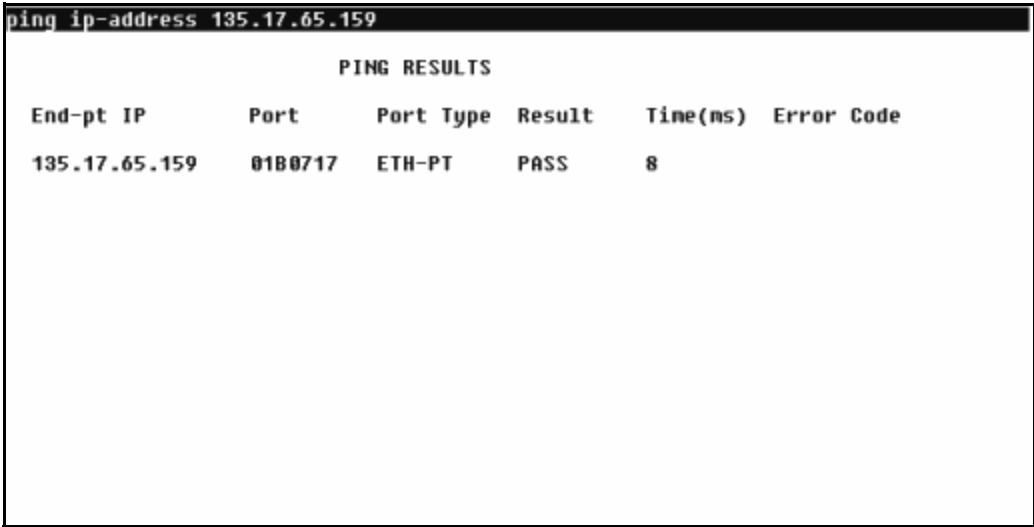
The following example shows the output from the **ping ip-address packet-length** command.

Figure A-2. ping ip-address report
