**DEFINITY<sup>®</sup>**  
**Enterprise Communications Server**  
Release 8  
Maintenance for R8csi  
Volumes 1 and 2

555-230-129  
Comcode 108596594  
Issue 5  
December 1999

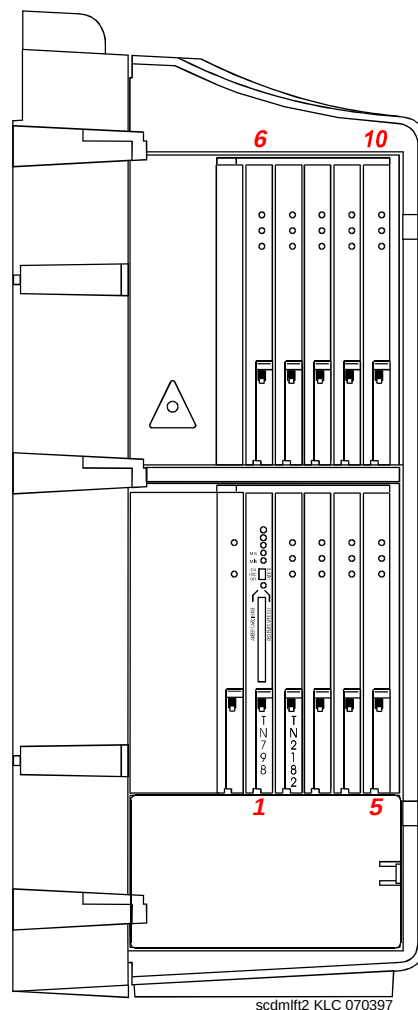
Figure 1-1. Compact Modular Cabinet (CMC) slot configuration

- The CMC cabinet has 2 shelves of 5 slots each (1-5, 6-10) as shown in [Figure 1-1](#). This means that slots 5 and 6 are not contiguous like they are in other DEFINITY cabinet types and that Multi-Function boards such as the TN566 and the MAPD boards (TN800, TN801, and TN802) must be installed in specific slots. For example:

- The TN798 Processor circuit pack incorporates the RISC processor complex, the TN777B NETCON (including PCM flash card interface), and TN765 Processor Interface functions and is always found in slot 1 of the A carrier. (See [Figure 1-1](#))

- The RISC-based TN798 Processor circuit pack must be located slot 1. [Figure 1-1](#) also shows the Flash Memory Card slot for translations.
- TN2182 Tone-Clock must be installed in slot 2. This is the only Tone-Clock circuit pack allowed in the CMC.
- Service circuit packs the only packs allowed in the CMC. These “universal” service packs can be located in any slot numbered 3-10.
- AUDIX, if present, requires 4 slots (slots 6-9 on the top row).
- MAPD requires 2 slots if administered in slot 7, otherwise, installation requires 3 slots.

All circuit pack slots in the Compact Modular Cabinet (CMC) are “universal slots.” That is, any slot can contain any type of circuit pack (port, control, or service), hence the absence of the purple and white slot coding found on other DEFINITY products. The only requirements for slot allocation are:

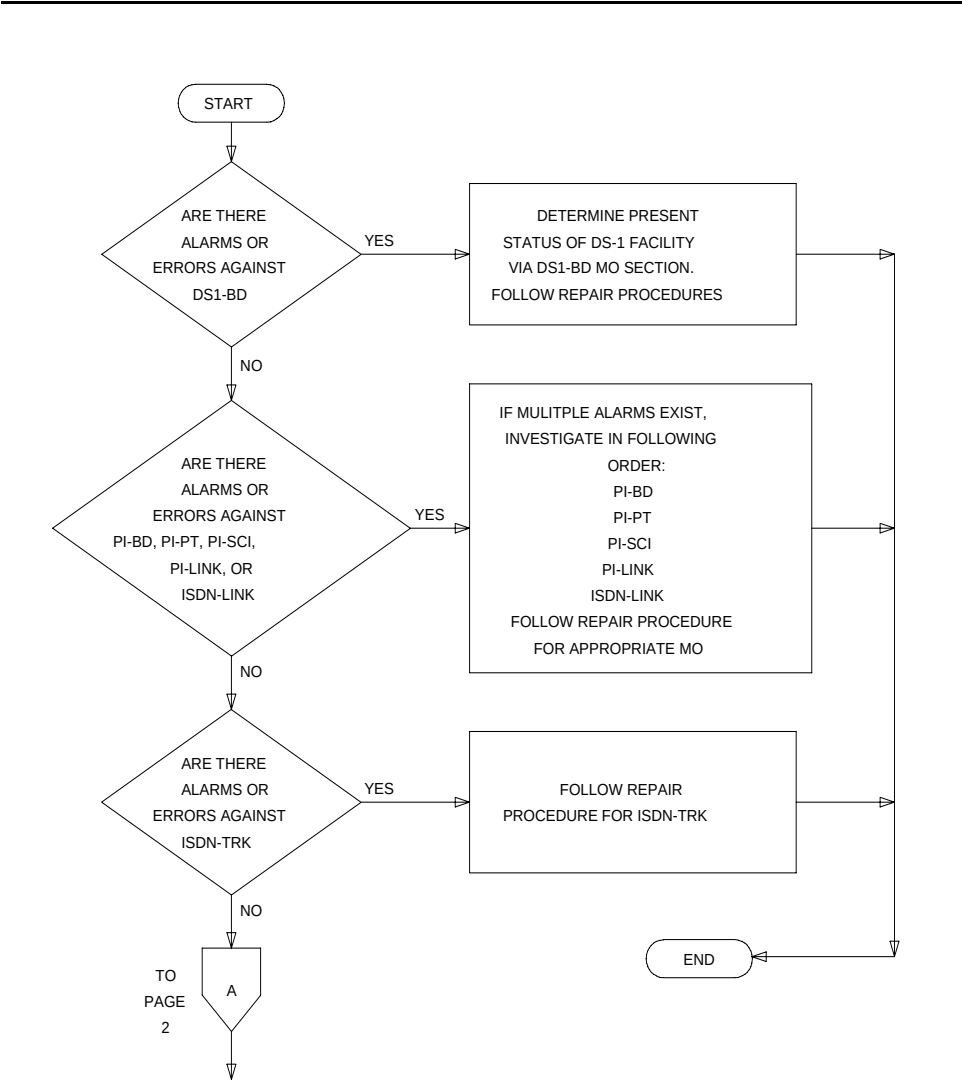
Figure 1-16. Processing of ISDN-PRI Problems (Page 1 of 2)

The following flowchart, [Figure 1-16](#) and [Figure 1-17](#), defines a layered approach when troubleshooting ISDN-PRI problems. Since a problem at a lower layer affects upper layers, layers are investigated from low to high. In the flowchart, the DS1 facility is layer 1, the TN765 Processor Interface is layer 2, and the ISDN trunks are layer 3. Transient problems are diagnosed on Page 2 of the flowchart, [Figure 1-17](#).

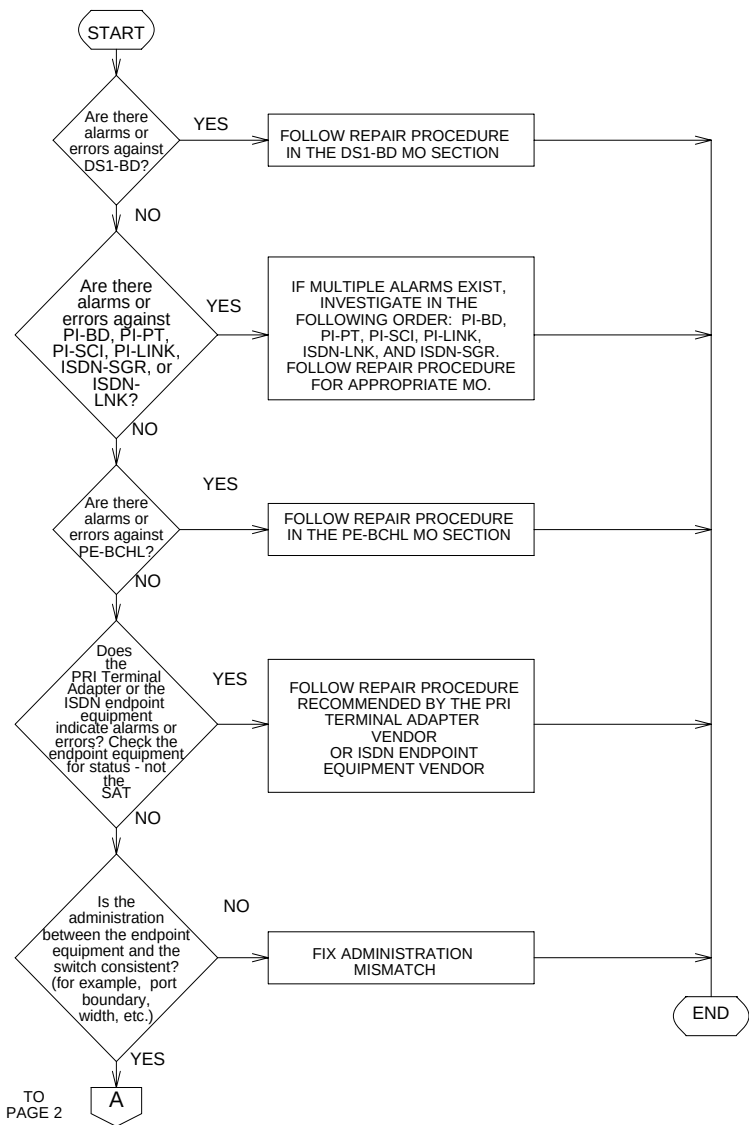
Figure 1-18. Processing of PRI Endpoint Problems (Page 1 of 2)

The following flowchart, [Figure 1-18](#) and [Figure 1-19](#), defines a layered approach when troubleshooting PRI endpoint problems. Since a problem at a lower layer affects upper layers, layers are investigated from low to high. In the flowchart, the DS1 facility is layer 1, the TN765 Processor Interface is layer 2, and the ISDN trunks are layer 3.

The troubleshooting procedure described here diagnoses faults between the switch and the line-side PRI terminal adapter/ISDN-PRI endpoint equipment. Problems encountered on the network-side of a wideband connection or problems with end-to-end equipment compatibility are outside the scope of this manual.

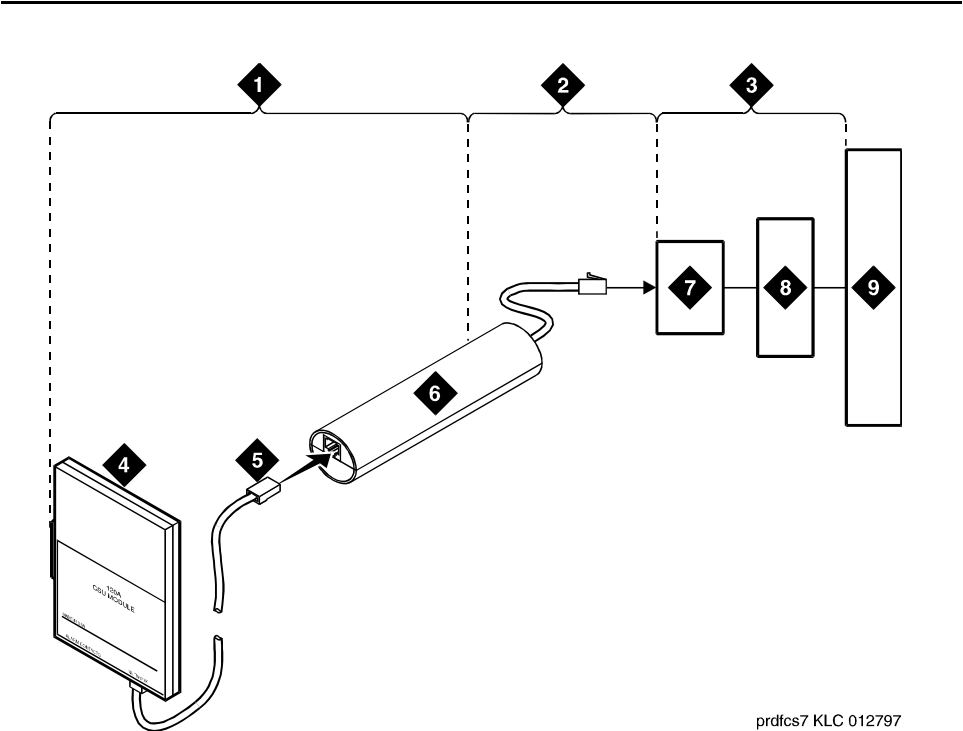
**Figure 1-21. Network Interface at Smart Jack**

1. If there is no extended demarcation point, install the loopback jack directly at the network interface point as shown in [Figure 1-21](#).
2. If there is an extended demarcation point and the Smart Jack is not accessible, install the loopback jack as shown in [Figure 1-22](#).
3. If there is an extended demarcation point, but the Smart Jack is accessible, install the loopback jack as shown in [Figure 1-23](#).

| 1. Span Section 1 | 5. RJ-48 to Network Interface (Up to 1000 Feet) (305 m) |

The addition of the loopback jack and the presence of a Smart Jack divides the DS1 span into 3 separate sections for fault isolation. These sections are shown in [Figure 1-21](#) through [Figure 1-23](#) for the different span configurations. They are:

- Test customer premises wiring (section 1 in the following 3 figures) from the ICSU to the loopback jack as described in "DS1 Span Test."
- Test the CO-to-network interface wiring (section 3 in [Figure 1-21](#)) using the Smart Jack loopback (CO responsibility). Coordinate this test with the DS1 provider.

Fiber MUXes can take the place of Interface termination feeds as shown in [Figure 1-21](#), [Figure 1-22](#), [Figure 1-23](#), and [Figure 1-24](#). Test these spans using the same procedures as metallic spans. Note the following points:

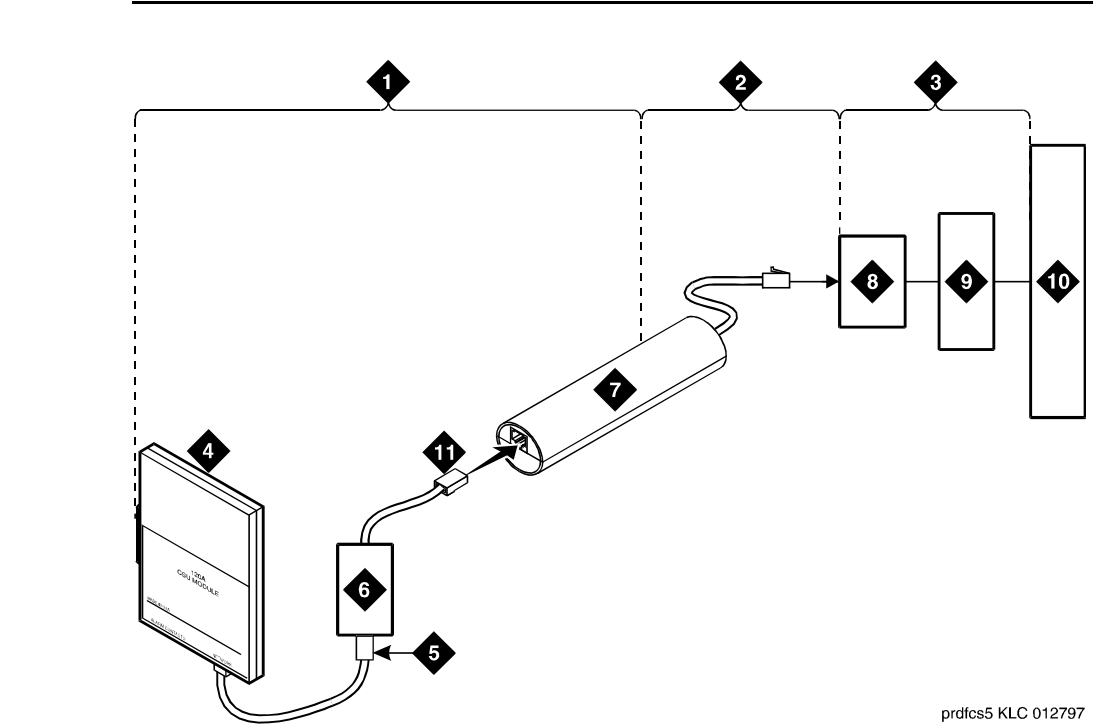
| 1. Span Section 1 | 6. “Dumb” Block (Extended Demarcation) |

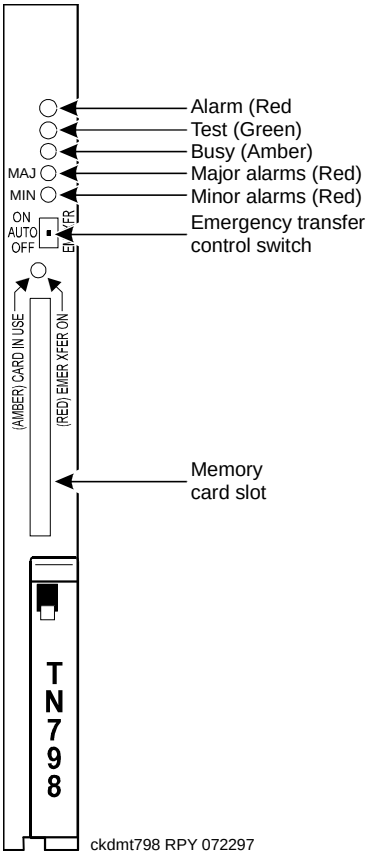
Figure 1-26. LED Indicators on the TN798 Processor Circuit Pack

The front panels of the Processor circuit pack and the Maintenance circuit pack are identical. Each has two groups of LEDs. One group indicates the status of the pack, and the other group (which includes the Major, Minor, and Warning alarms described in the [“Alarm and Error Reporting”](#) section) reflects maintenance conditions in the entire system. See [Figure 1-26](#).

**NOTE:**  
If the LED just above the Memory Card Slot is alternating red and amber, this indicates both card in use and emergency transfer.

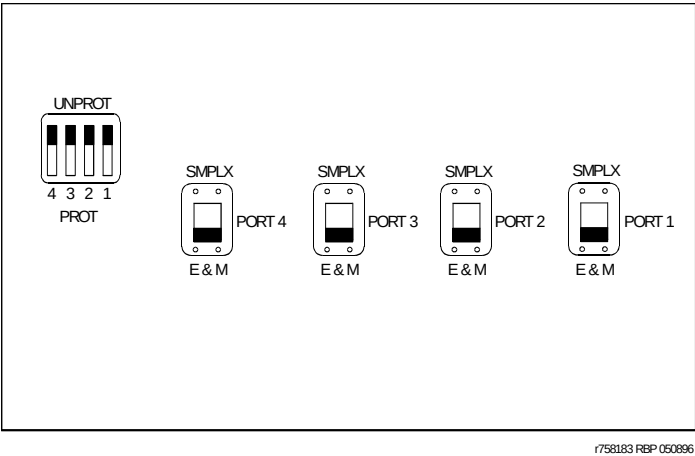
Figure 1-28. TN760D Tie Trunk Circuit Pack (Component Side)

To choose the preferred signaling format ([Table 1-10](#) and [Table 1-11](#)), set the switches on the TN760D and administer the port using [Figure 1-28](#) and [Table 1-12](#).

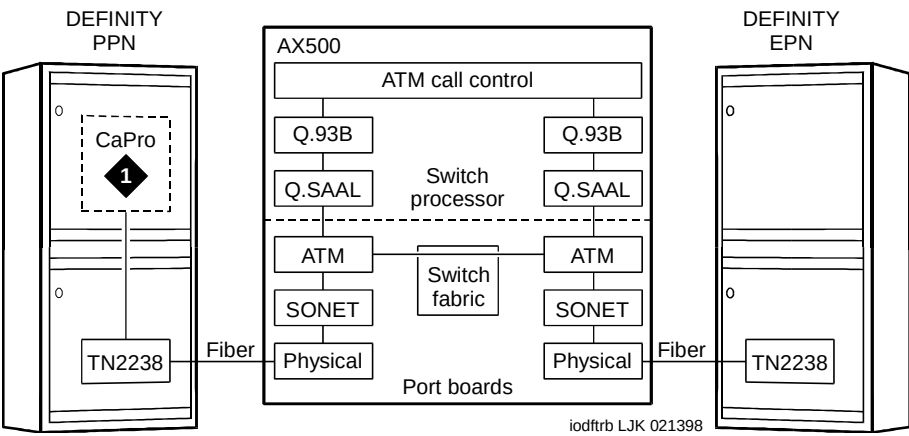
Figure 1-30. ATM troubleshooting schematic

This section provides tips for DEFINITY ATM PNC when interfacing with the Cajun Networks A500 ATM switch. Throughout this section, refer to [Figure 1-30](#), using *TN2238* for R6.3 systems, and *TN230X* for Release 7.

**NOTE:**  
The CaPro element (Note 1 in [Figure 1-30](#)) is a software module within the DEFINITY PPN.

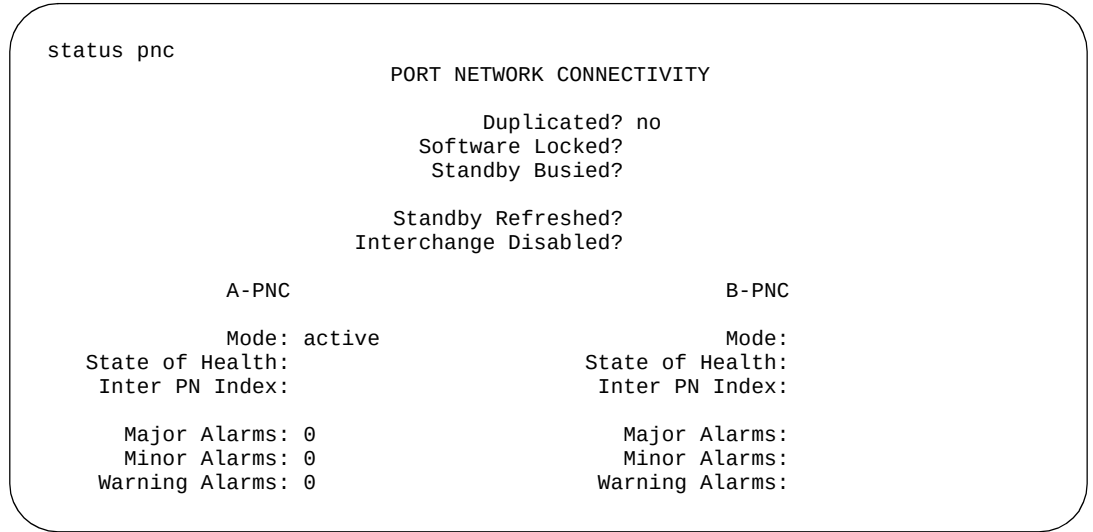
Figure 1-34. Screen output for status pnc command

2. Enter **status pnc** at the DEFINITY SAT. This display tells you which TN230X board is active in a duplicated system and how many alarms (if any) of each severity level have been logged for the board. [Figure 1-34](#) shows the output from this command.

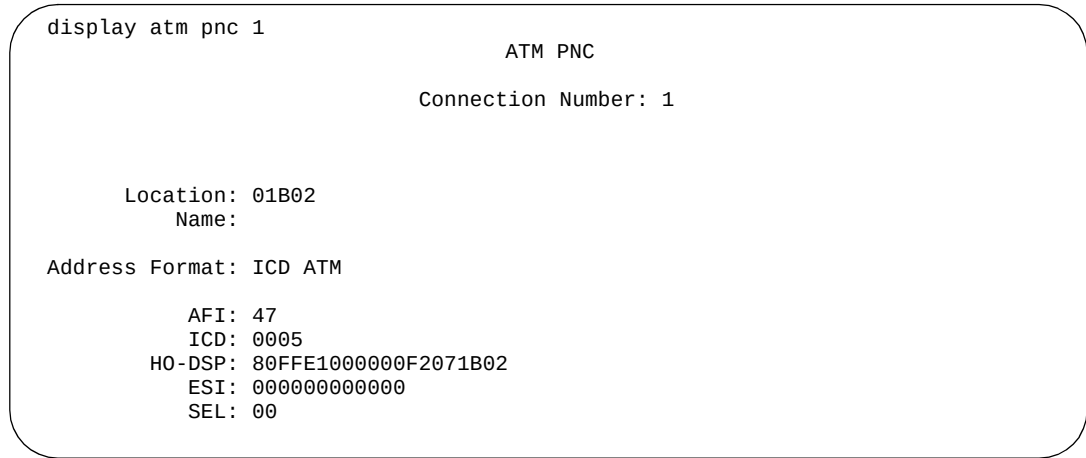
Figure 1-37. Screen output for display atm pnc 1

4. Enter **display atm pnc portnetwork** on the DEFINITY SAT.
- This display tells you the ATM addresses that have been administered for each TN230X. Verify that each ATM address (the concatenation of the five displayed hexadecimal fields) is correct and match those administered in the A500. See [“A500 Administration”](#) for more information.
- Administered with hard coded PNNI routes**
- If the port networks are addressed using *hard coded PNNI routes* in the A500, the display looks like [Figure 1-37](#) (pnc 1) and [Figure 1-38](#) (pnc 2).

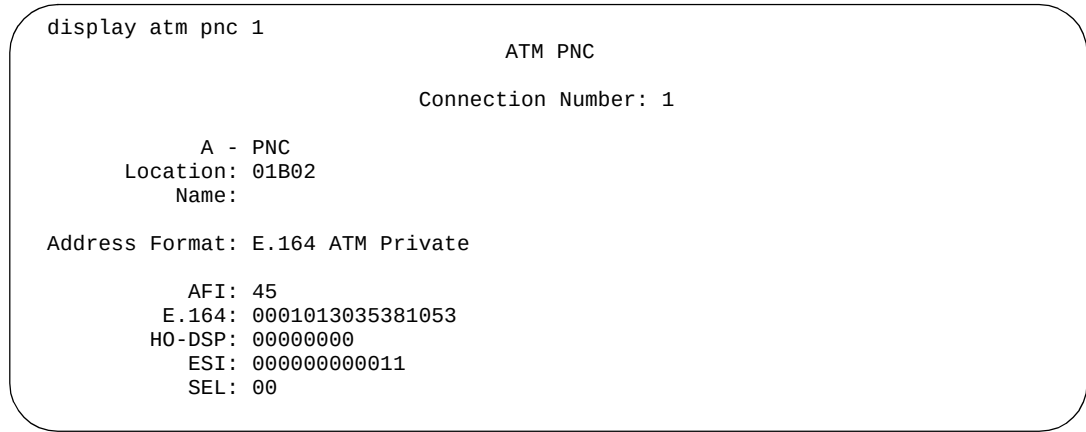
Figure 1-39. Screen output for display atm pnc 1 with End System Identifiers

If the port networks are addressed using End System Identifiers, the display looks like [Figure 1-39](#) (pnc 1) and [Figure 1-40](#) (pnc 2).

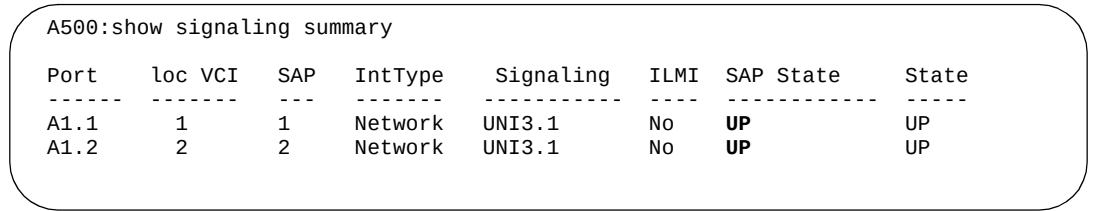
Figure 1-41. Screen output for the show signaling summary command

- 1. Enter **show signaling summary** on the A500 console. [Figure 1-41](#) shows the screen output.

- a. If an A500 port to which a DEFINITY port network is attached is not listed in this display, it is likely that the port was administered incorrectly as having no UNI signaling (**admin link** command).

| Field | Value |
|---|---|
| SAP State | May or may not be UP. Their values depend on more than just whether the port was marked as <b>UP</b> . (See highlighted data for SAP State in <a href="#">Figure 1-41</a> .) |

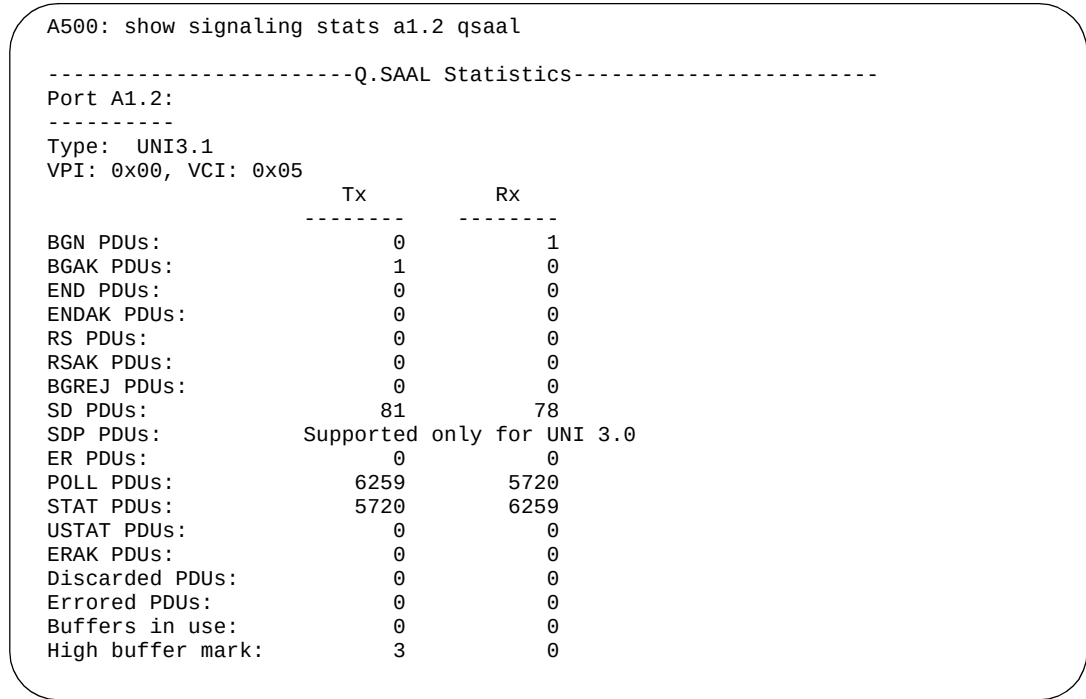
Figure 1-52. A500: show signaling stats a1.2 qsaal screen

1. Enter **show signaling stats port qsaal** on the A500 console. [Figure 1-52](#) shows the screen output.

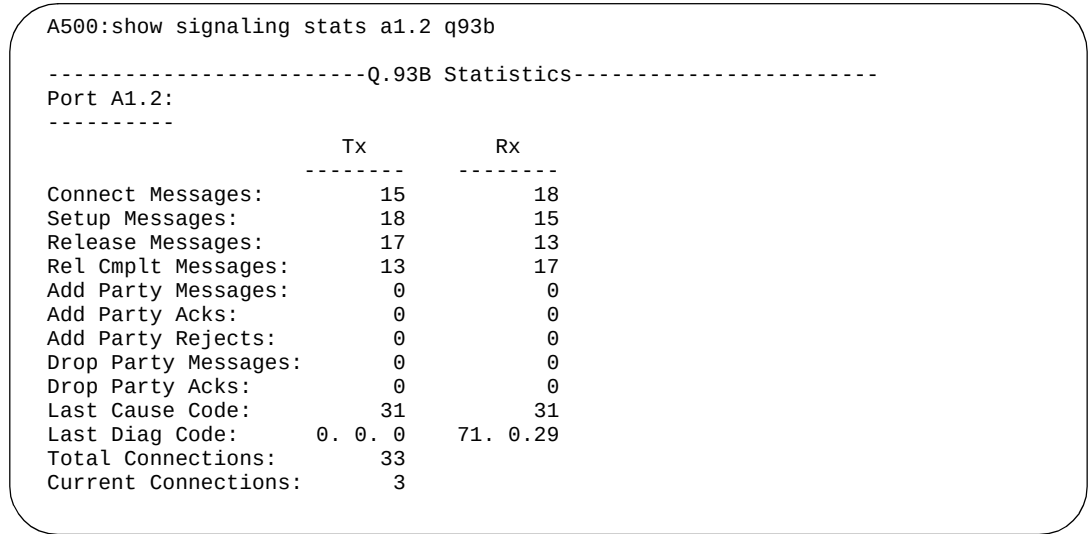
Figure 1-53. A500:show signaling stats A1.2 q93b

1. Enter **show signaling stats port q93b** (or the port of interest) on the A500 console. [Figure 1-53](#) shows the screen output.

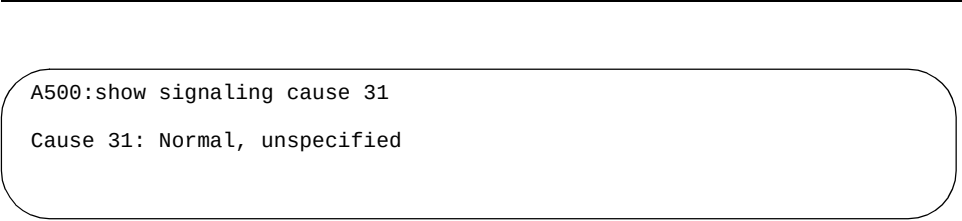
Figure 1-54. A500:show signaling cause 31

Enter **show signaling cause causecode** on the A500 console. [Figure 1-54](#) shows the screen output for this command.

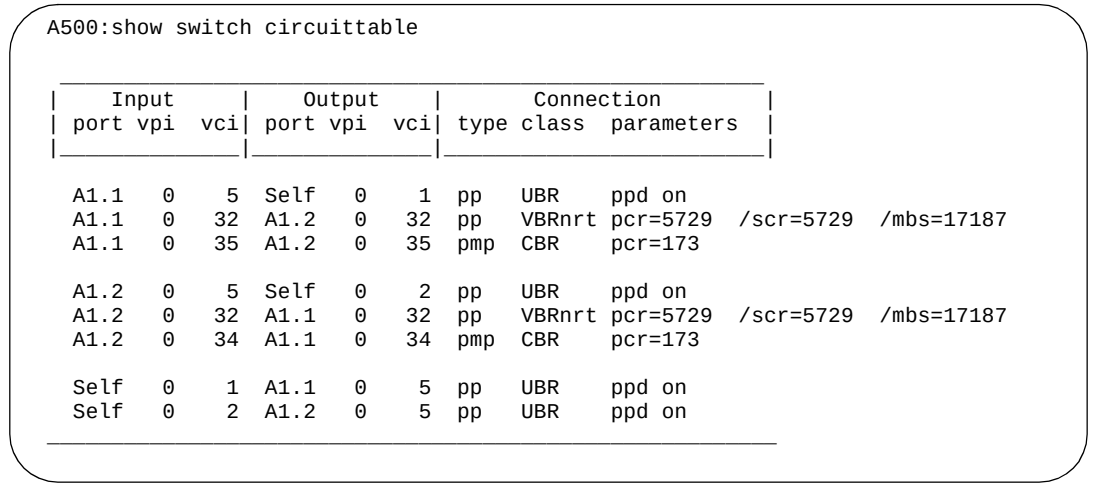
Figure 1-57. A500: show switch circuittable screen

1. Enter **show switch circuittable** on the A500 console. [Figure 1-57](#) shows the screen output.

- The pp UBR virtual circuits between A500 ports A1.1 (PPN) and Self (A500) and between A1.2 (EPN) and Self (A500) are ATM signaling channels between the port network and the A500.
- They are used to request connection setups and releases to other end points such as another port network.
- These are established by each TN230X when it comes up, independent of DEFINITY Call Processing.
- Other UBR virtual circuits may exist between A500 ports that are not associated with DEFINITY port networks and may be signaling channels for other applications (for example, data network traffic).

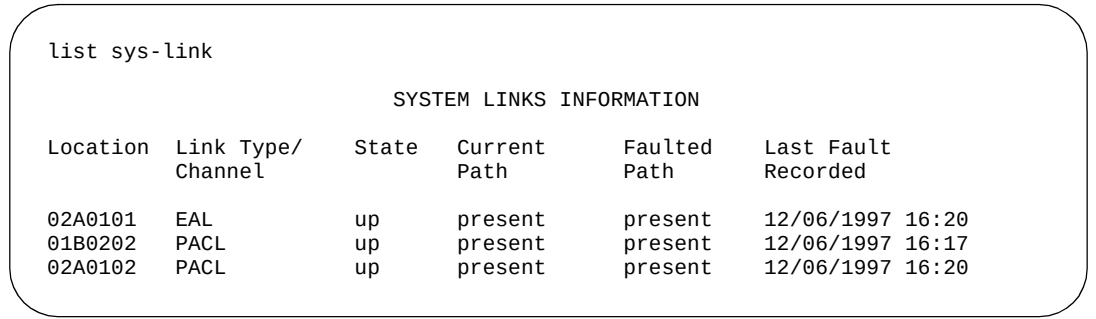
Figure 1-58. List sys-link screen

- Do you get a dial tone on a set on the port network in question?
  - Can you ring a set on the EPN dialing from the PPN and vice versa?
1. Enter **list sys-link** on the DEFINITY SAT. [Figure 1-58](#) shows the screen output.

Ensure that the fields have the values indicated below.

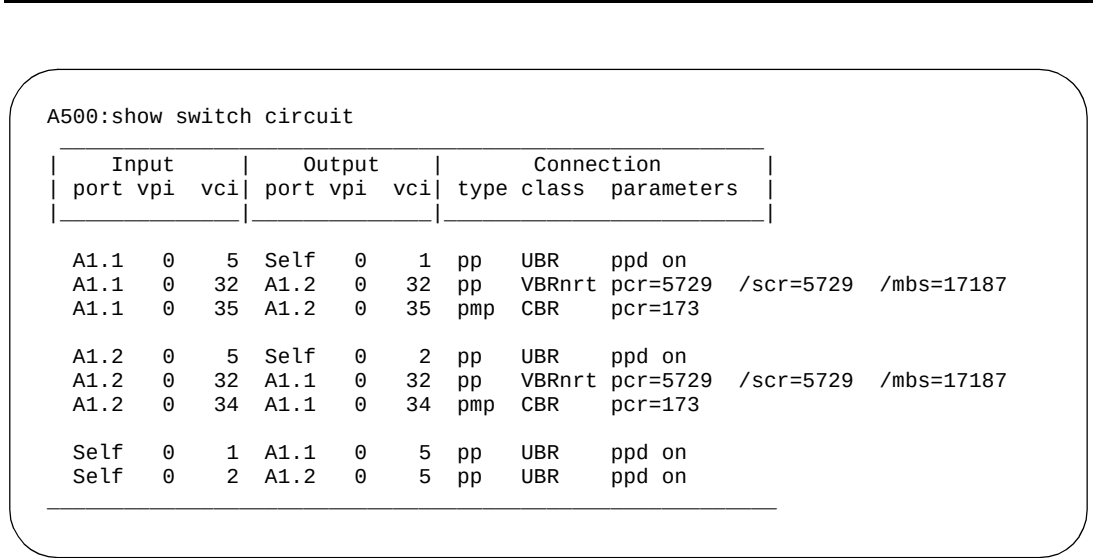
Figure 1-59. A500: show switch circuit screen

2. Enter **show switch circuittable** on the A500 console. [Figure 1-59](#) shows the screen output.

- The pp VBRnrt (Variable Bit Rate) virtual circuits between A500 ports A1.1 (PPN) and A1.2 (EPN) are used for signaling between the PPN and each EPN.
- These are established once upon initialization under control of DEFINITY Call Processing. They represent the ATM Control Link (ACL) and Expansion Archangel Link (EAL).
- VBRnrt virtual circuits are also be used for ISDN channels between Definity port networks.
- Other VBRnrt virtual circuits may exist between A500 ports that are not associated with DEFINITY port networks. A common use of VBRnrt circuits is multimedia and video-conferencing systems.

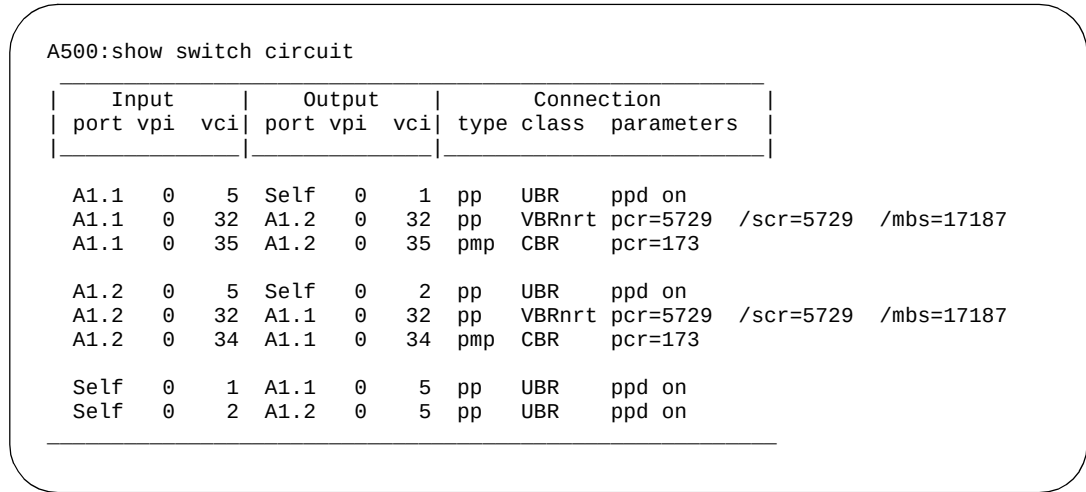
Figure 1-60. A500:show switch circuit screen

- Can you talk both ways on a set on one port network dialed from another port network and vice versa?
1. Enter **show switch circuit** on the A500 console. [Figure 1-60](#) shows the screen output.

- The pmp CBR (Constant Bit Rate) virtual circuits (VCs) between A500 port A1.1 (PPN) and A500 port A1.2 (EPN) are used for talk paths between port networks (PPN to EPN, EPN to PPN, or EPN to EPN).

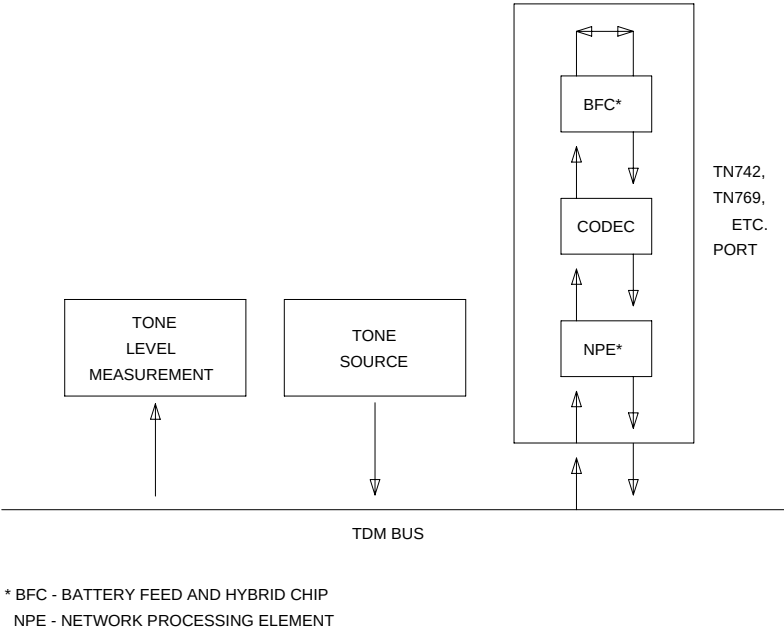
Figure 3-1. Analog Loop Around and Conference Test

This Loop Around Test is sensitive to the length of the loop, the equipment in the loop, or the equipment terminating the loop, such as off-premises stations. If this test is causing a false alarm, then disable the test by changing the Tests field to "no" using the **change station** command for this station.

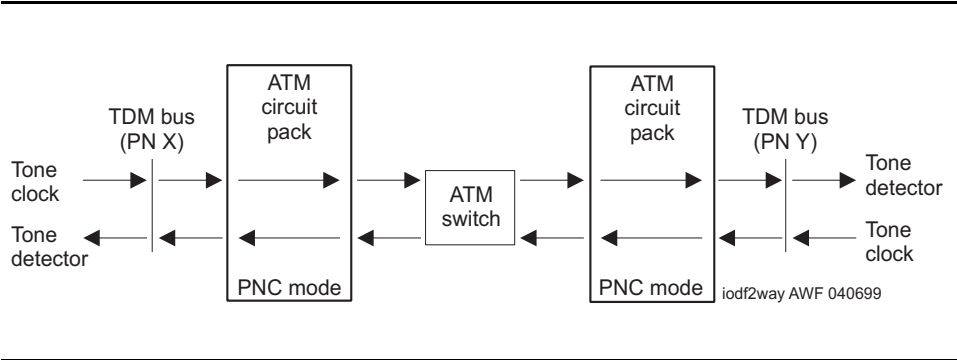
The test results indicate if the test failed in one or both directions. The test aborts if the ATM-EIs do not exist on both ends (for example, the EIs are not administered correctly). If the test passes, the TDM and ATM framer interfaces of both ATM-EIs are functioning properly. If the test fails, a series of tests are run on the board. [Figure 3-3](#) shows a schematic of this test.

**Figure 3-3. Expansion Interface 2-Way Transmit Test #241**  
PN X and PN Y represent any of 43 possible port networks.

In this test the second ATM-EI may be in any port network outside the port network of the ATM-EI under test. Therefore if the test should fail in any direction, the test is repeated with a different port network, if available, which aids the fault isolation procedure.

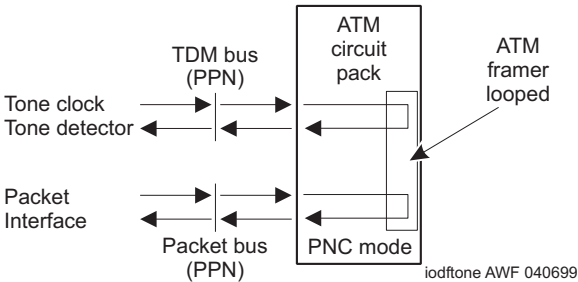
Figure 3-5. ATM Board Framer Looparound Test (#1260)

- **The circuit (TDM) path:** one of the tone generators sends a bit pattern is through a TDM bus time slot to the ATM framer. The pattern is converted into ATM cells and looped back to the ATM-EI board, which converts the cell back into the bit pattern and puts it on a pre-determined time slot. A tone detector tests for the bit pattern and reports the test result. This test verifies that a large portion of the ATM-EIs circuit paths are functioning correctly. [Figure 3-5](#) shows a diagram of the test.

This test places the ATM circuit pack in ATM framer looparound mode. Once the board receives this message, it creates a dummy virtual circuit that originates and ends on the same board, without leaving the board. This test verifies both the TDM path and the Packet Path. If the TDM test path passes, then the packet path is tested. Definitions of each test path are:

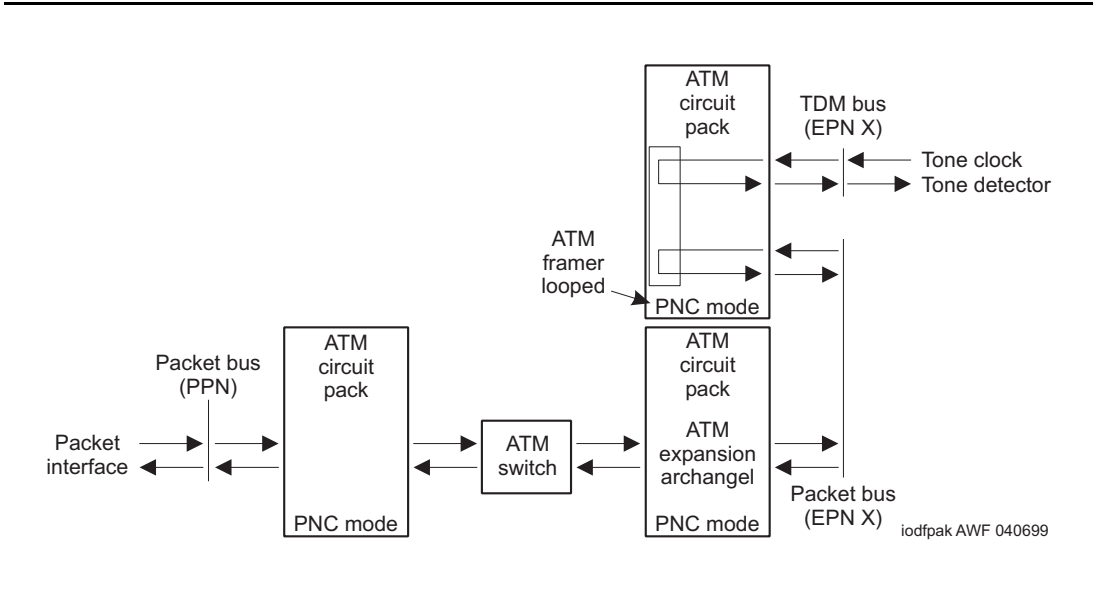
**Figure 3-6. ATM Board Framer Looparound Test (#1260)  
(non-EAA, Packet Path)**

- **Packet path:** the Packet Interface circuit pack sends packet data to the ATM framer interface, where it is mapped into ATM cells and then looped around internally. The cells are converted back to packet data after it has been looped. This portion of the test verifies correct operation of the ATM-EI's Packet bus interface and a large portion of the ATM-EI's packet paths. [Figure 3-6](#) shows the packet switched signal path for the ATM circuit pack.

This test verifies the operation of a large portion of the ATM-EI circuit and packet paths, but does not verify the optical portion of the lightwave transceiver. If this test passes, the ATM-EI circuit pack is functioning correctly, but faults may exist in the lightwave transceiver. If the test fails, the fault may lie on the board. After the test results are reported, the ATM framer is taken out of loopback.

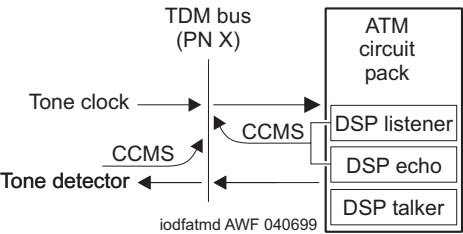
Figure 3-8. ATM Board DSP Test (#1293)

This test applies to TN2305 and TN2306 ATM-EIs, both active and standby, and is run as part of craft short and long testing, periodic, scheduled, initialization, and error analysis testing. Refer to [Figure 3-8](#) for a diagram of this looparound test.

If the test fails for all DSPs, a MAJOR alarm is raised against the board. If the test fails for one or more DSPs, a MINOR alarm is raised. If a DSP is “busy,” the test for that particular DSP is considered passed. The test aborts if the system resources (for example, the TDM time slots, tone generator, and others) are not available.

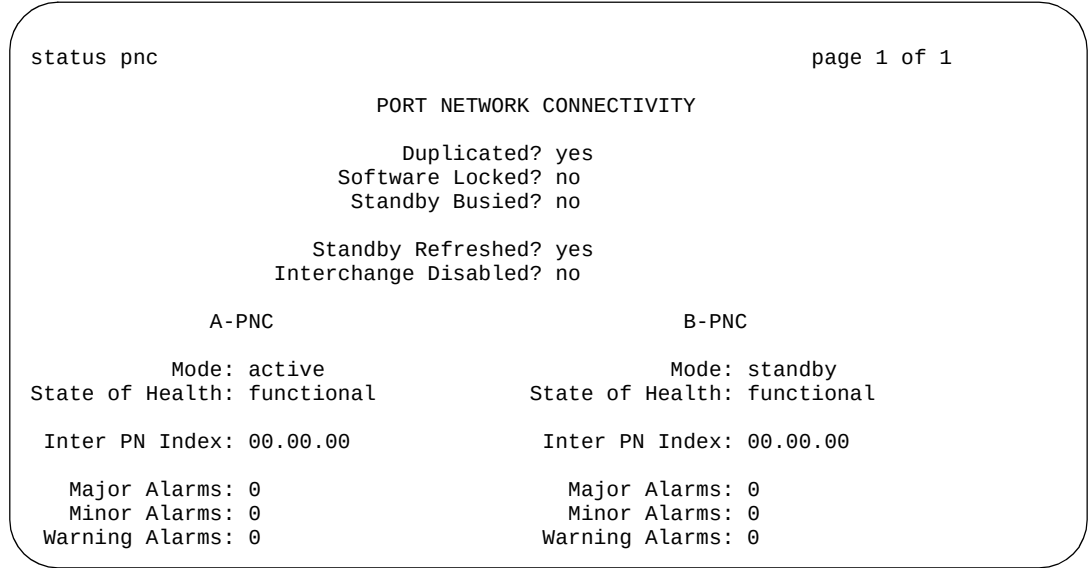
Figure 3-9. Status PNC screen with standby PNC fully In-Service

PNC-DUP software monitors the health of the two PNCs as determined by their state of health (SOH) vectors, and initiates an interchange when the health of the active falls below that of the standby (unless prevented from doing so by a PNC lock, busyout, or antithrashing mechanism). Potentially service-disrupting faults that occur in PNC components are reported to PNC-DUP and incorporated in the state of health for the affected PNC. The SOHs of both PNCs are displayed on the **status pnc** screen, as shown in [Figure 3-9](#).

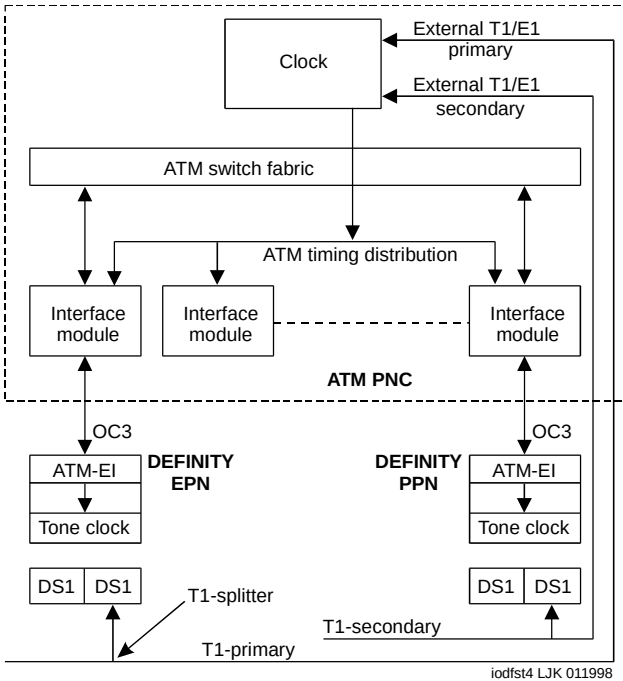
Figure 3-10. Stratum 4 synchronization with simplex ATM PNC

If the primary synchronization reference in [Figure 3-10](#) is providing a valid timing signal, then the flow of system synchronization would travel from the DS1 interface circuit pack in the EPN to the ATM switch. The primary DS1 interface circuit pack provides a timing signal for the ATM switch clock circuitry. This

[Figure 3-10](#) depicts a simplex ATM PNC with T1/OC3 synchronization reference into the ATM switch.

If the primary synchronization reference is not providing a valid timing signal, the system automatically switches to the secondary synchronization reference. If the primary synchronization reference is invalid, and if the secondary reference does not provide a valid timing signal or is not administered as a synchronization reference, the switch infers that the local oscillator of the ATM switch provides the system timing source. If the system is using the local oscillator of the ATM switch as the system timing source because the primary and secondary references are providing invalid timing signals, when either the primary or secondary reference becomes valid again, the system switches back to the primary or secondary source. When both the primary and secondary source become valid, the system switches to the primary source, since the primary source is always preferred over the secondary source when both sources are equally healthy.

**NOTE:**  
The TN722 DS1 Interface circuit pack does not provide a synchronization reference as reliably as the TN767 or TN464C circuit packs. Therefore, administer the TN767 or TN464C circuit packs as the primary or secondary sources.

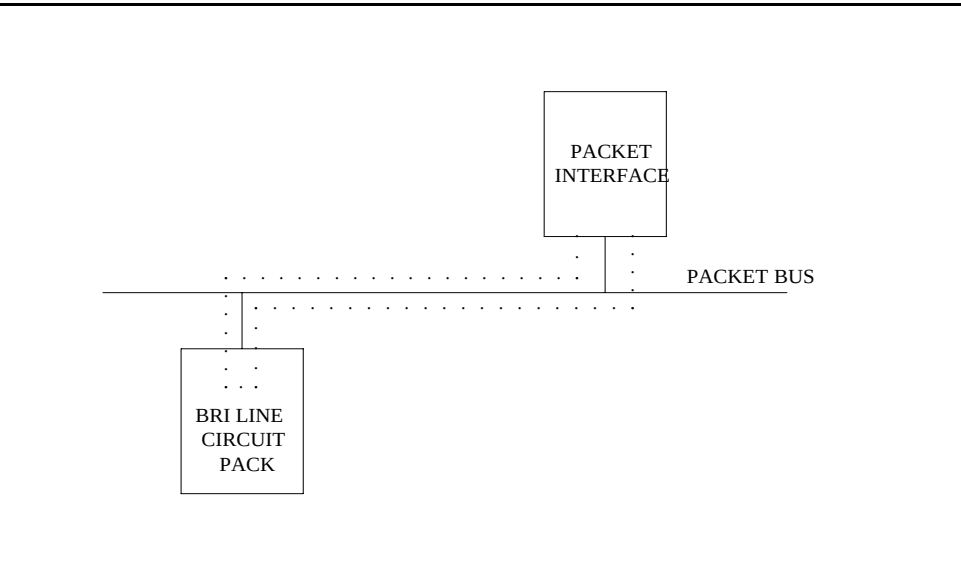
The dotted lines in [Figure 3-12](#) show how a Loop Around Test is performed across the Packet Bus for the D-channel.

Figure 3-12. Path of the BRI Port Local LAN Loop Around

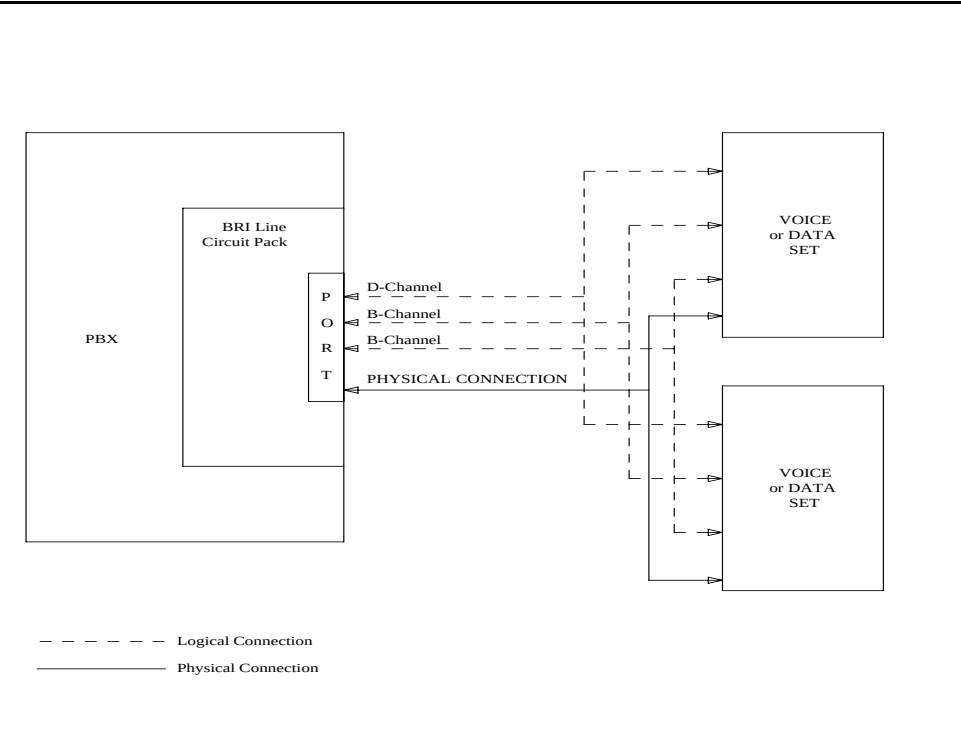
[Figure 3-14](#) illustrates the physical connection (solid line) between an ISDN-BRI Circuit Pack and a voice or voice/data set. Each physical connection allows for two B-channels, as stated above, plus one D-channel. Each ISDN-BRI circuit pack can support up to 12 of these PHYSICAL connections to different voice and voice/data sets or ASAI and Lucent adjuncts.

**Figure 3-14. ISDN-BRI Set Interactions**

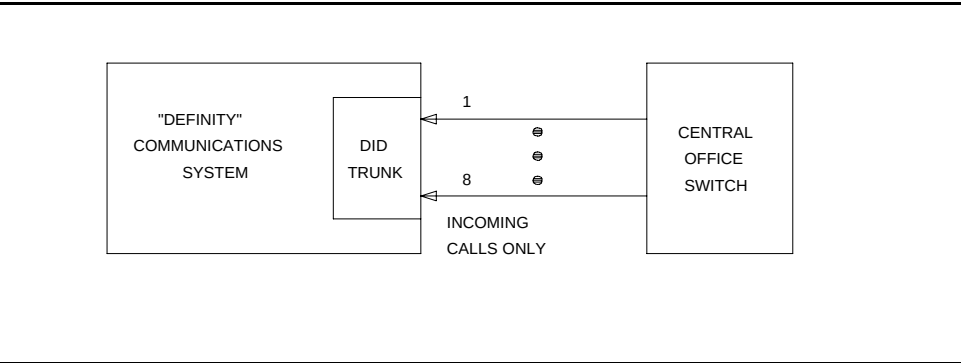
The DID Trunk circuit packs support eight, incoming-only, ports. Each port provides an interface between the 2-wire analog line from the CO and the DEFINITY system. The DID port receives 3 to 5 digits from the CO that is used to directly connect an outside caller to the called station without assistance from an attendant. See [Figure 3-16](#).

Figure 3-16. DID Trunk Interactions

For each call, the CO switch signals the system by opening and closing individual DID loops (one of the eight ports) and causing the starting or stopping of loop current.

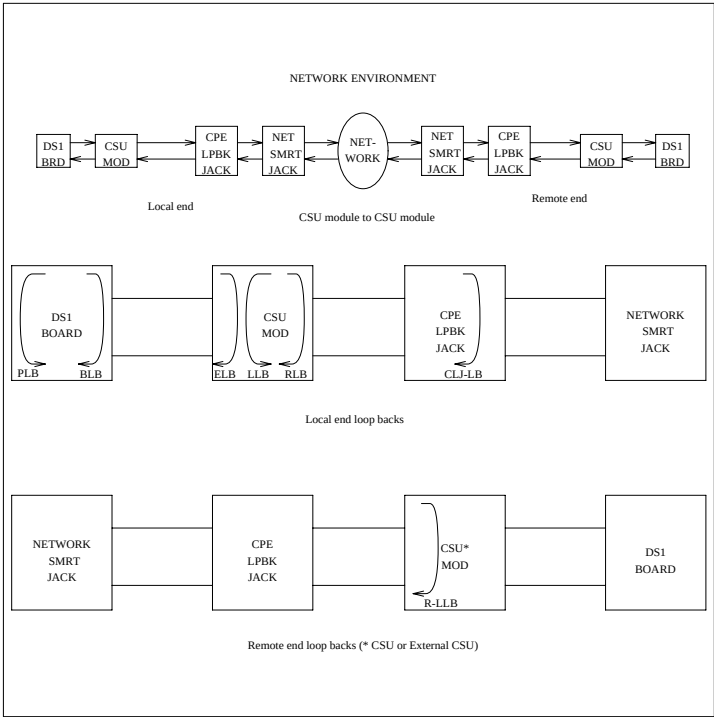
The TN767E and 120A CSU Module support on-demand loopback tests that assist in the detection of faults between the TN767E circuit pack and the CSU Module, between the Integrated CSU and the optional Customer Premises Loopback Jack, or between the Integrated CSU and remote CSU. These loopback tests are explained in detail later in this DS1-BD section, but [Figure 3-19](#) gives a high level overview of the loopback points.

- PLB = Payload Loopback
- BLB = Board Loopback
- ELB = Equipment Loopback
- LLB = Line Loopback
- RLB = Repeater Loopback
- CLJ = Loopback Jack Loopback
- R-LLB = Remote Line Loopback
- SMRT = Smart Jack
- LPBK = Loopback

Figure 3-19. High Level Overview Of Loopback Points

The following list of acronym definitions are for [Figure 3-19](#):

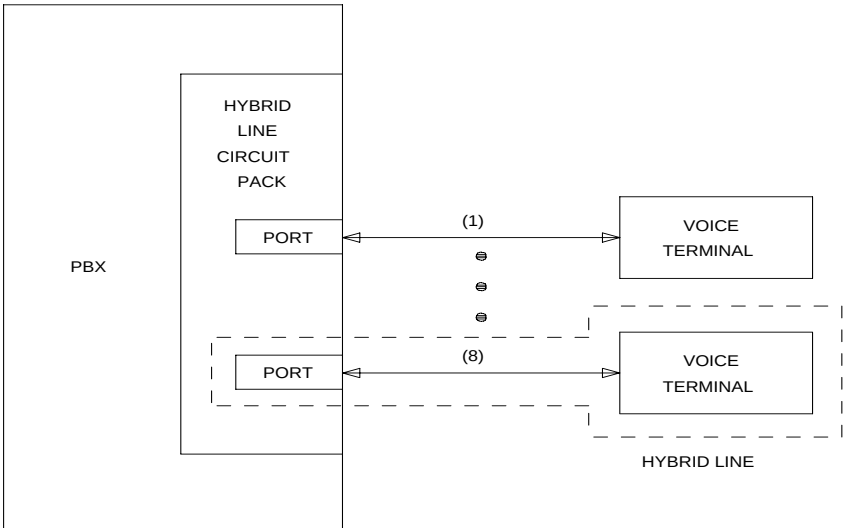
The TN762B Hybrid Line circuit pack supports eight of these multifunction analog telephone sets, as shown in the following figure. The Hybrid Line sets use three pairs of wires: an analog voice pair, a transmit/receive pair, and a power pair.

Figure 3-20. Hybrid Station Interactions

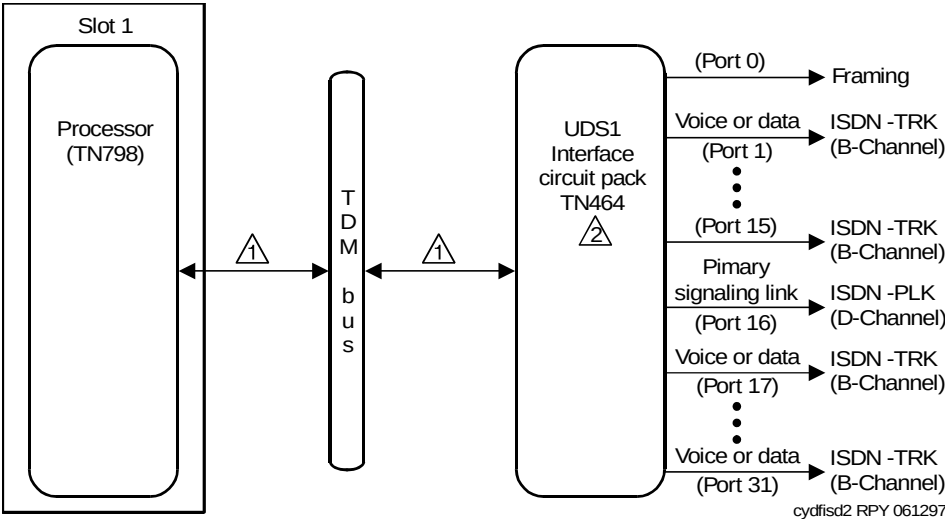
In a 32-channel system (see [Figure 3-21](#)), the DS1 ISDN Trunk or PRI endpoint port (B-channels) may use any of the ports 1-15 or 17-31, but the ISDN-PRI Signaling Link Port must be the 16th port on the TN464C (or higher) circuit pack. In certain configurations (NFAS), the 16th port may be used as a B-channel. Refer to the [“ISDN-SGR \(ISDN-PRI Signaling Group\)”](#) Maintenance documentation for further details.

1. B- and D-channel messages are routed over the TDM Bus. For additional reliability, a duplex D-channel can be administered for a signaling group and located on a different TN464C (or higher) circuit pack.
2. TN464C or higher

Figure 3-21. ISDN-PRI Signaling Link Port Interactions (32-Channel - TN464)

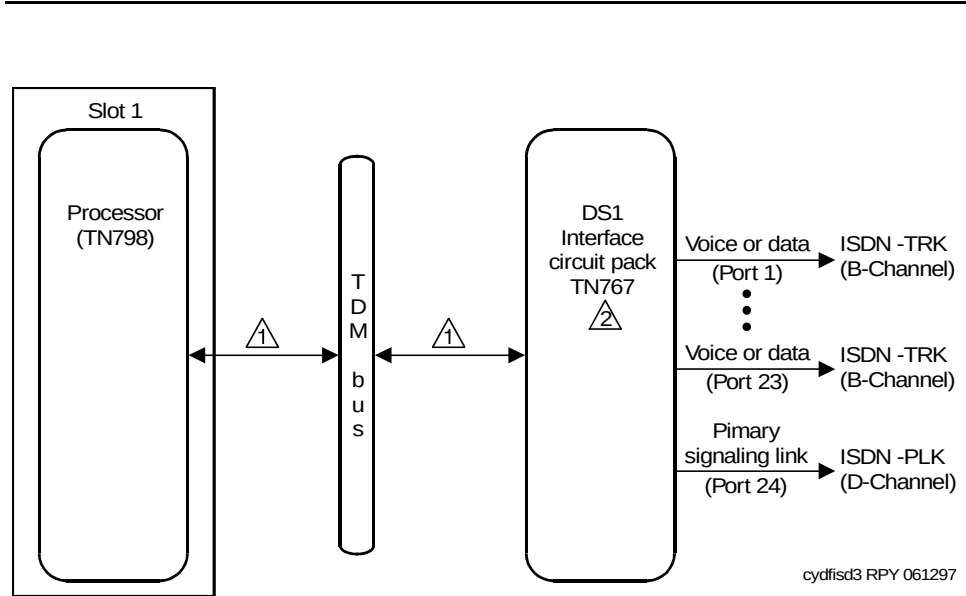
In a 24-channel system, the DS1 ISDN Trunk or PRI endpoint port (B-channels) may use any of the first 23 ports. The ISDN-PRI Signaling Link Port must be the 24th port (See [Figure 3-22](#)). In certain configurations (NFAS), the 24th port may be used as a B-channel. Refer to the ISDN-PRI Signaling Group (ISDN-SGR) Maintenance documentation for further details.

1. B- and D-channel messages are routed over the TDM Bus. For additional reliability, a duplex D-channel can be administered for a signaling group and located on a different TN464C (or higher) circuit pack.
2. TN767B (or higher) or TN464C (or higher)

Figure 3-22. ISDN-PRI Signaling Link Port Interactions (24 Channel - TN767/464C)
