**DEFINITY<sup>®</sup>**  
**Enterprise Communications Server**  
Release 8  
Maintenance for R8csi  
Volumes 1 and 2

555-230-129  
Comcode 108596594  
Issue 5  
December 1999

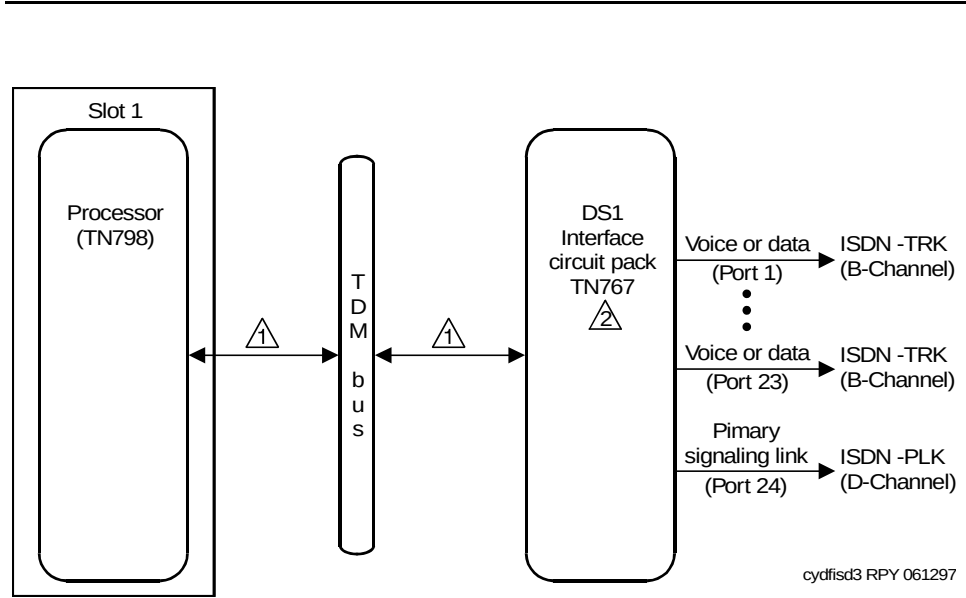
For 24-channel interfaces, the first 23 ports on the circuit pack are used as B-channels. The 24th port may be used as a B-channel or as a D-channel depending on the type of Signaling Group used (see [Figure 3-23](#)).

1. B- and D-channel messages are routed over the TDM Bus. For additional reliability, a duplex D-channel can be administered for a signaling group and located on a different TN464C (or higher) circuit pack.
2. TN767B (or higher) or TN464C (or higher)

Figure 3-23. ISDN-PRI Signaling Link Port Interactions (24 Channel - TN767/464C)

The ISDN-PRI Signaling Link Port itself depends on the health of the DS1/UDS1 Interface circuit pack on which it resides. This test will fail if there are problems with either the ISDN-PRI Primary D-channel port or the DS1/UDS1 circuit pack. See [Figure 3-23](#) for DS1 connections, [Figure 3-24](#) for UDS1 connections.

See [Figure 3-23](#) for DS1 connections, [Figure 3-24](#) for UDS1 connections.

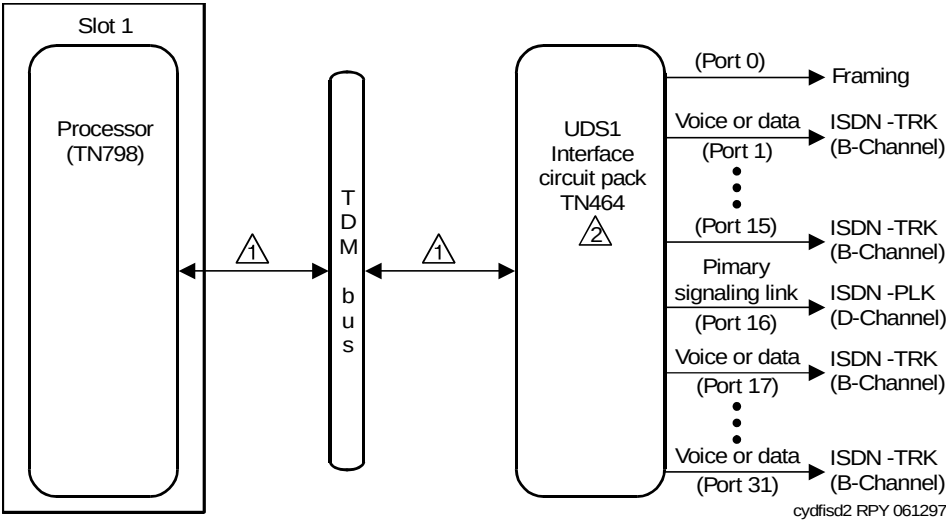
For 32-channel interfaces, ports 1-15 and 17-31 on the circuit pack are used as B-channels. The 16th port may be used as a B-channel or as a D-channel depending on the type of Signaling Group used (see [Figure 3-24](#)).

1. B- and D-channel messages are routed over the TDM Bus. For additional reliability, a duplex D-channel can be administered for a signaling group and located on a different TN464C (or higher) circuit pack.
2. TN464C or higher

Figure 3-24. ISDN-PRI Signaling Link Port Interactions (32-Channel - TN464)

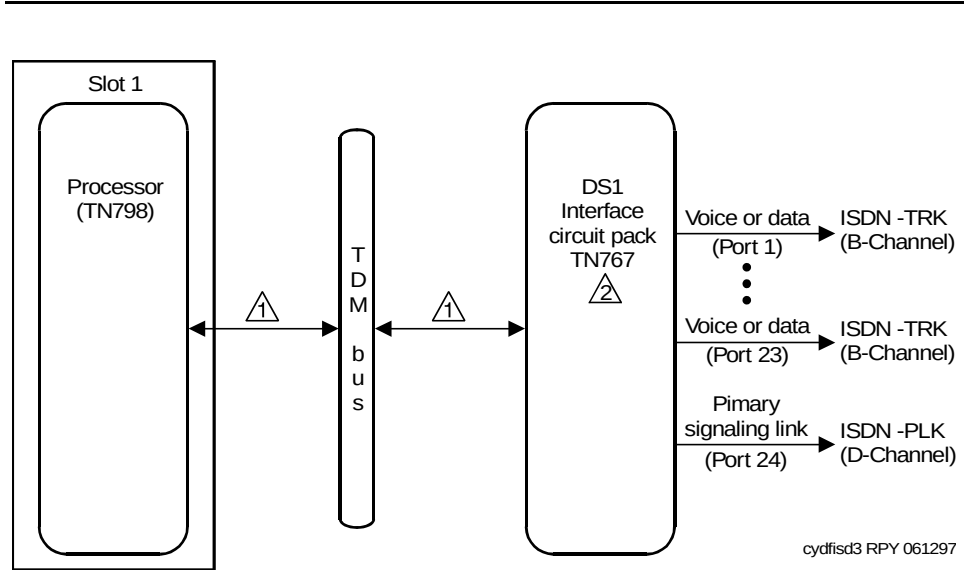
On 24-channel interfaces, any of the first 23 ports on the DS1/UDS1 interface circuit pack can be a B-channel. The 24th port may be used as a B-channel or as a D-channel depending on the type of ISDN-PRI Signaling Group (ISDN-SGR) to which it belongs.

1. B- and D-channel messages are routed over the TDM Bus. For additional reliability, a duplex D-channel can be administered for a signaling group and located on a different TN464C (or higher) circuit pack.
2. TN767B (or higher) for DS1; TN464C (or higher) for UDS1

Figure 3-25. DS1 ISDN Trunk Interactions (24 Channel - TN767/464C)

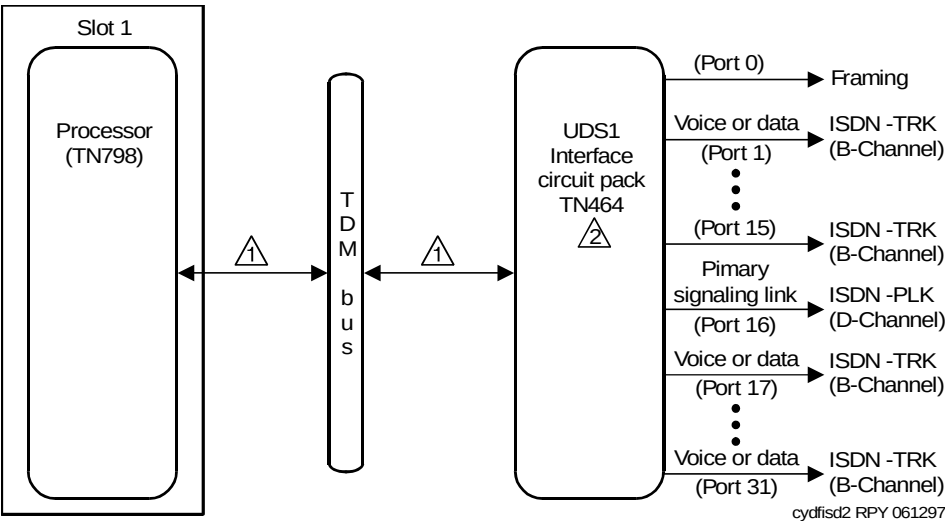
On 32 channel interfaces, any of ports 1-15 and 17-31 on the DS1 interface circuit pack can be a B-channel. The 16th port may be used as a B-channel or as a D-channel depending on the type of ISDN-PRI Signaling Group (ISDN-SGR) to which it belongs. For more details, refer to the ISDN-SGR and DS1-BD/UDS1-BD Maintenance documentation.

1. B- and D-channel messages are routed over the TDM Bus. For additional reliability, a duplex D-channel can be administered for a signaling group and located on a different TN464C (or higher) circuit pack.
2. TN464C or higher

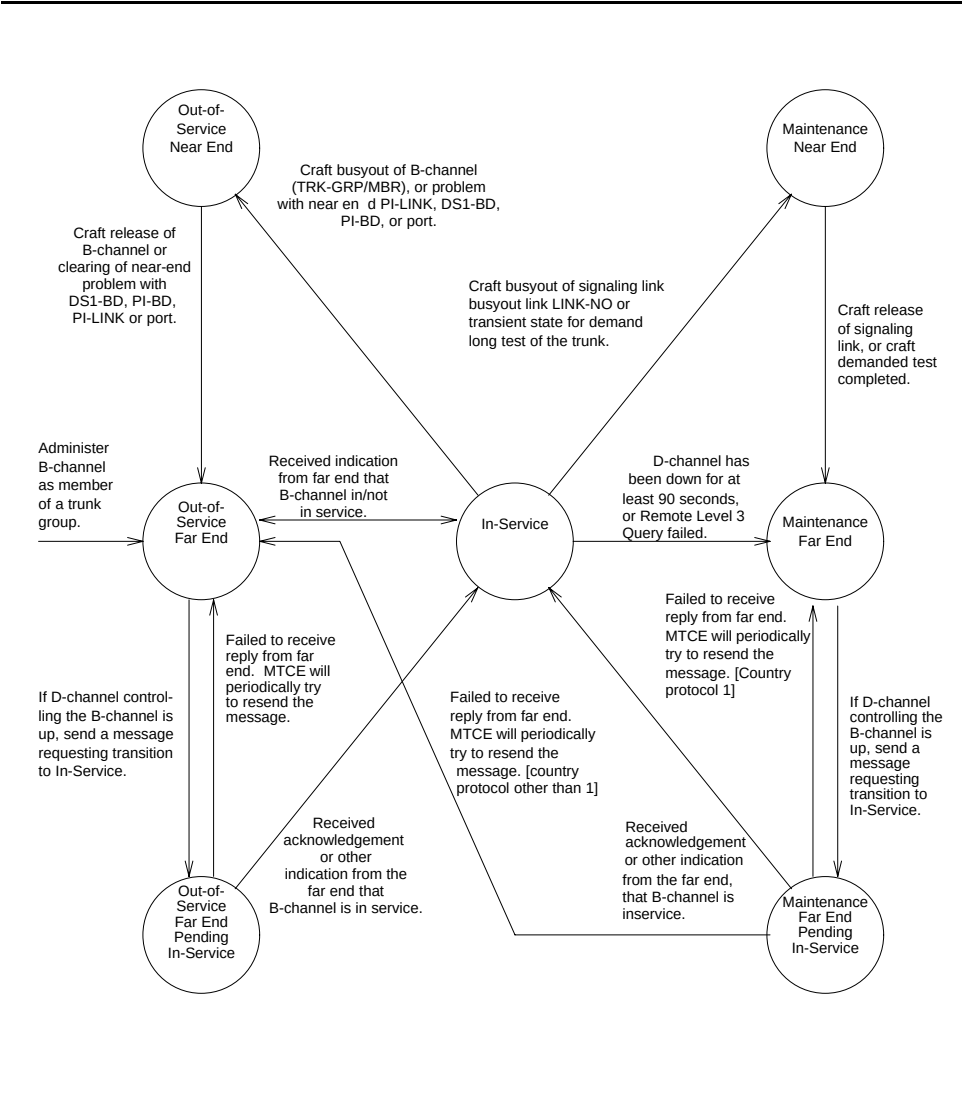
The following diagram of the DS1 ISDN Trunk service states shows the common progression from one service state to another and the event that caused the change of state.

Figure 3-27. Common Progressions in Service States

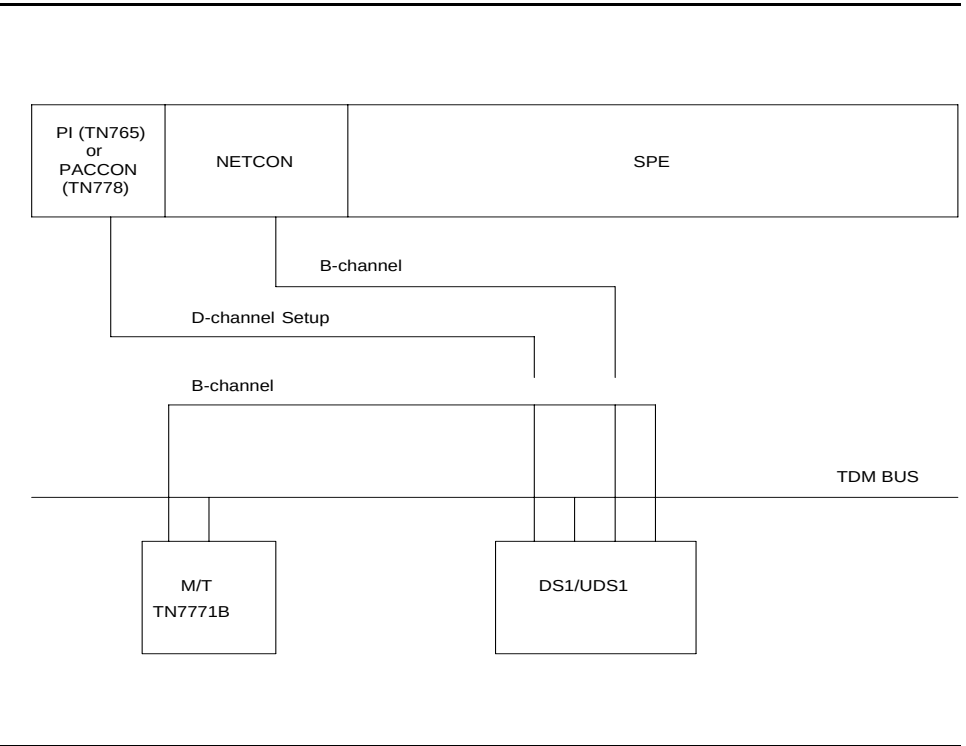
In the second method, the test call connection is established over the TDM Bus of the transmit and receive sides of the ISDN-PRI trunk to a digital trunk testing port on the Maintenance/Test circuit pack. The Maintenance/Test Digital Port generates a pseudo bit stream. A pictorial description of the outgoing ISDN-PRI test call connectivity is contained in [Figure 3-28](#).

Figure 3-28. ISDN-PRI Outgoing Test Call

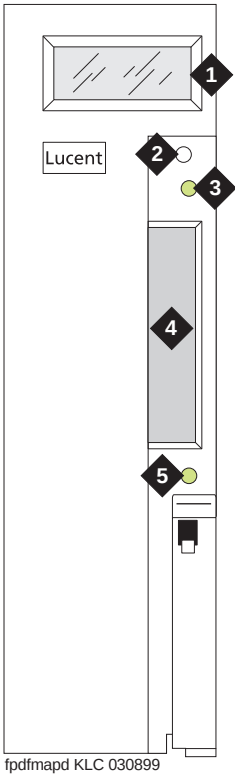
[Figure 3-29](#) shows the TN802 faceplate.

1. LCD display (see [Table 3-301](#))
2. Reset button (recessed)
3. Red board status LED
4. PCMCIA card slot
5. Yellow PCMCIA disk-in-use LED

Figure 3-29. TN802 faceplate

| Step | Description | Comments |
|---|---|---|
| 4. | Wait | Wait until the yellow Disk-In-Use LED (Note 5 in <a href="#">Figure 3-29</a> ) light is out. |

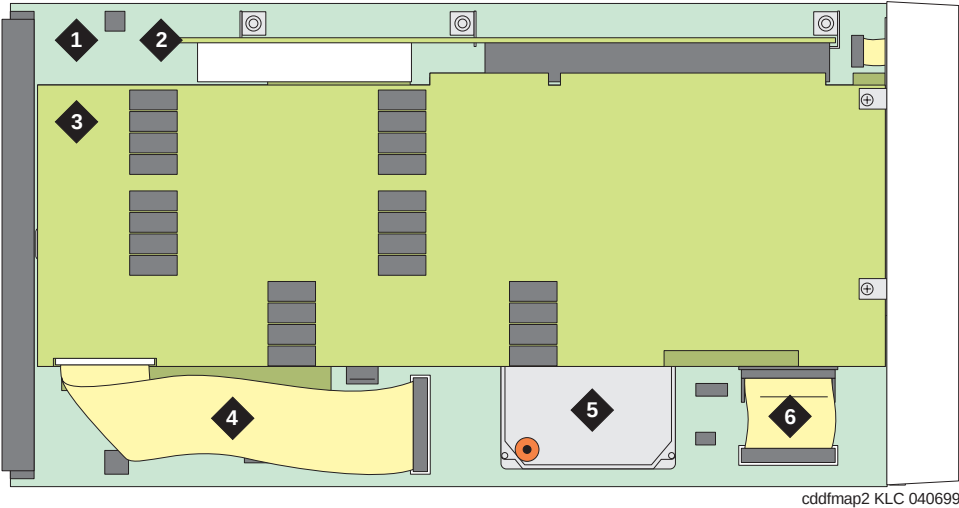
Figure 3-32 shows a side view of the thee boards and interconnecting cables that make up the TN802.

| 1. Main TN802 board | 4. SCSA (Signal Computing System Architecture) ribbon cable |

Figure 3-32. TN802 board assembly and cables (side view)

- a. Verify the IP address
  - b. Check the physical connections to and from the TN802 circuit pack.
  - c. Check the internal cables on the TN802 circuit pack (Notes 4 and 6 in [Figure 3-32](#)).
  - d. Try pinging another device on the same subnet.
  - e. Try pinging the gateway to the rest of the network from the subnet.
  - f. Try pinging a device not on the local subnet but on the network or another subnet.
5. When finished, at the command prompt type **exit** and press Enter.

- a. Check that the internal cables on the TN802 circuit pack (Notes 4 and 6 in [Figure 3-32](#)) have not worked loose.
  - b. Otherwise, replace the circuit pack.
3. At the command prompt, type **ping 10.32.64.97** (the internal IP trunk server address) and press Enter.

- a. Check that the internal cables on the TN802 circuit pack (Notes 4 and 6 in [Figure 3-32](#)) have not worked loose.
  - b. Otherwise, replace the circuit pack.
4. At the command prompt, type **ping 10.32.64.96** (the IP address of the internal Motorola MPC860 processor) and press Enter.

- a. Check that the internal cables on the TN802 circuit pack (Notes 4 and 6 in [Figure 3-32](#)) have not worked loose.
  - b. Otherwise, replace the circuit pack.
5. Ping the gateway: at the command prompt, type **ping XX.XXX.XXX.XXX** (the IP address of the gateway) and press Enter.
6. When finished, at the command prompt type **exit** and press Enter.

The TN802 hard drive (Note 5 in Figure 3-32) is field-replaceable.

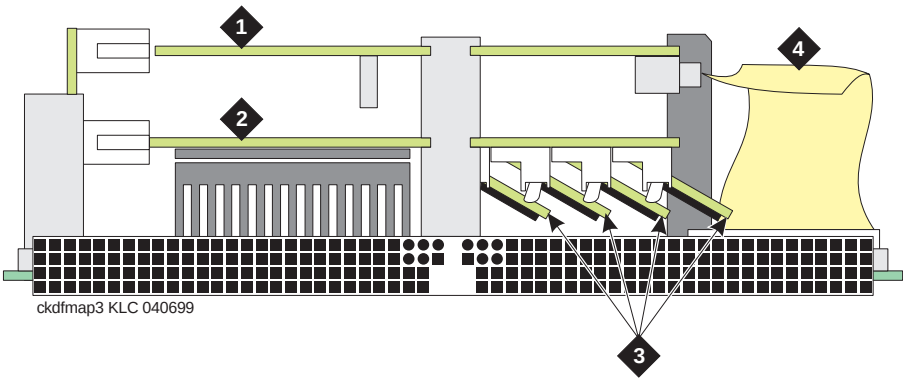
Figure 3-33. TN802 board assembly and cables (end view)

Figure 3-33 shows the end view of the thee boards and interconnecting cables on the TN802.

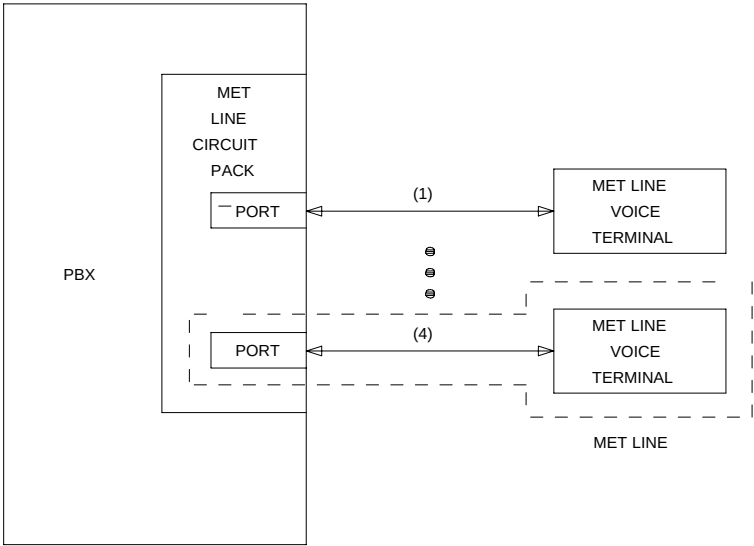
Figure 3-34. MET Line Interactions

The TN735 MET Line circuit pack supports four of these METsets. Each MET set uses three pairs of wires: an analog voice pair, a transmit pair, and a receive pair. Power is sent over the transmit and receive pairs. The MET Line circuit pack supports all 10-, 20-, and 30-button sets.

MET Line interactions are shown in [Figure 3-34](#).

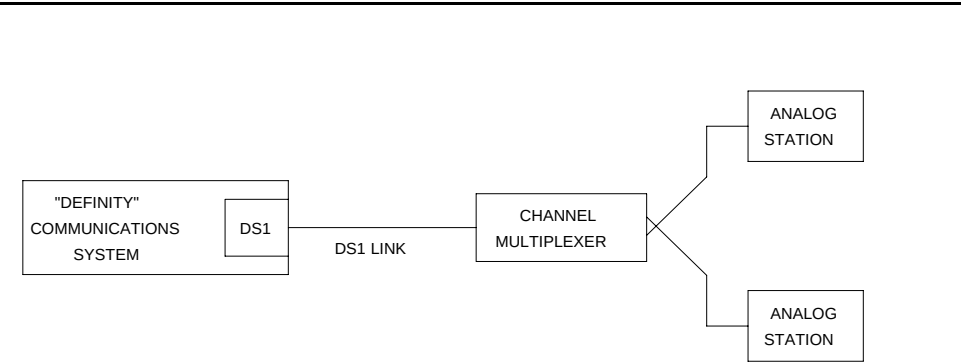
Figure 3-37. DS1 OPS Line Interactions

An analog Off-Premises Station (OPS) can be connected to the system through a DS1 link. A TN767 DS1 Interface circuit pack supports up to 24 DS1OPSs. Since the DS1OPS is an analog telephone set, a channel multiplexer is necessary as the remote DS1 endpoint that converts the digital signal of a DS1 port to the OPS Line and vice versa. See [Figure 3-37](#) for details.

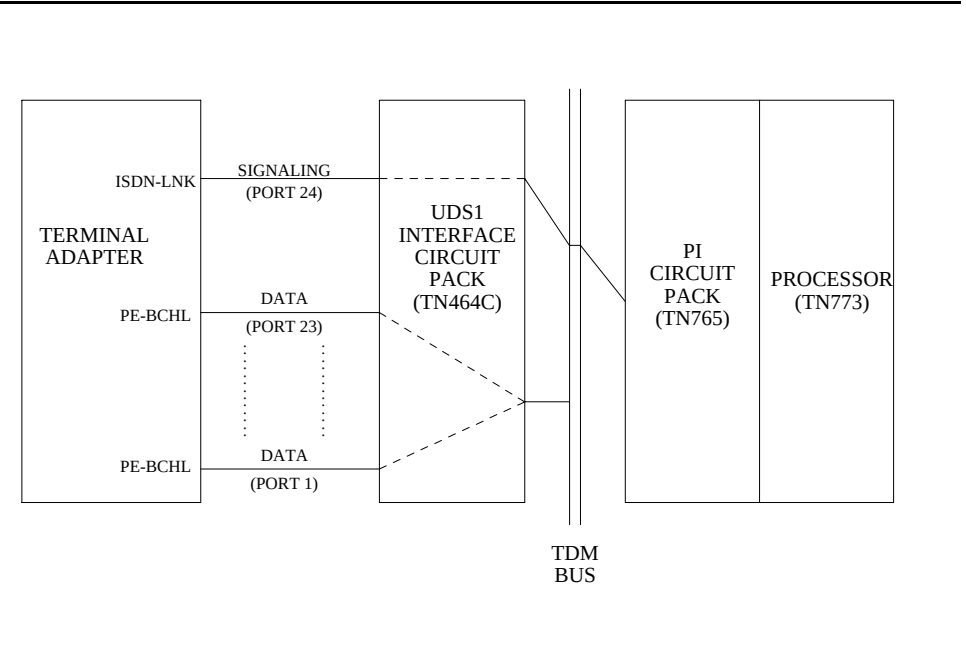
Figure 3-38. PRI Endpoint Port Interactions [INTEL]

A PRI Endpoint Port is a port on a UDS1 interface circuit pack. Therefore, this port depends on the health of the UDS1 interface circuit pack for proper operation (see [Figure 3-38](#)). As noted earlier, a PRI Endpoint Port B-channel also depends on an ISDN-PRI Signaling Link Port D-channel (ISDN-LNK) to carry the signaling traffic. If there is a problem with the ISDN-PRI Signaling Link Port, the PRI Endpoint Port is affected. The ISDN-PRI Signaling Link Port, in turn, depends on the PKT-INT (Packet Interface).

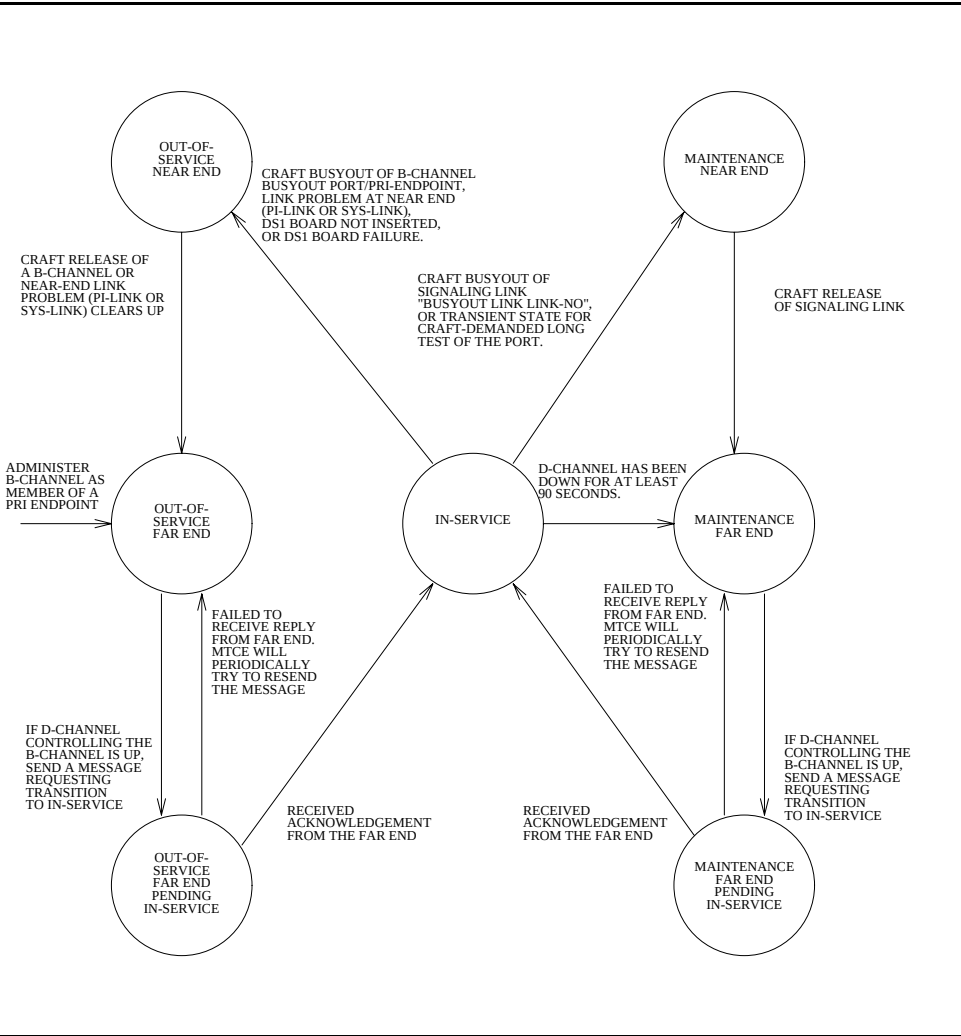
Figure 3-39. Common Progressions in Service States

The following diagram of the PRI Endpoint Port service states shows the common progression from one service state to another and the event that caused the change of state.

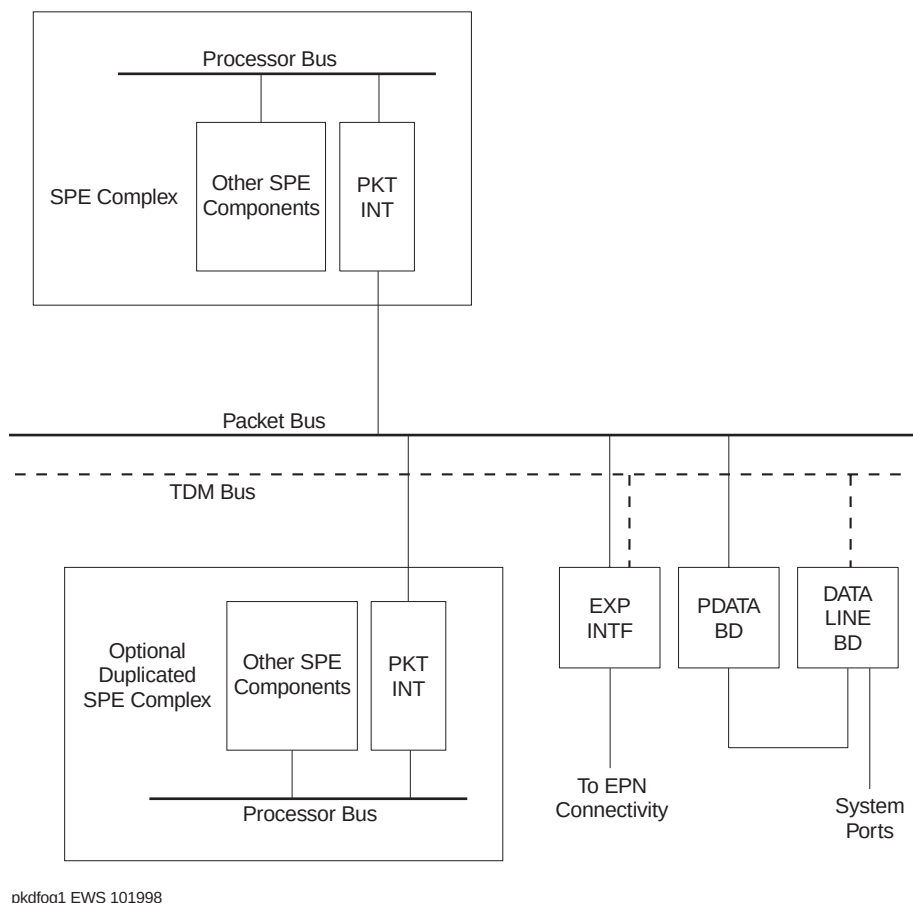
Figure 3-40. Packet Interface connections

The links that pass through the Packet Interfaces are application links or system links:

- a. Application links, such as the TCP/IP links that C-LAN include supports
  - Distributed Communication System (DCS)
  - Audio Information Exchange (AUDIX)
  - Messaging Service Adjunct (MSA)
  - Call Management System (CMS)
  - Outgoing Call Management (OCM)
  - Adjunct Switch Application Interface (ASAI)
- b. System links
  - ISDN PRI D channel signaling links
  - ISDN BRI D channel broadcast and point-to-point signaling links
  - Adjunct Switch Application Interface (ASAI) links
  - Remote Socket Links (RSL) and Remote Socket Control Links (RSCL)

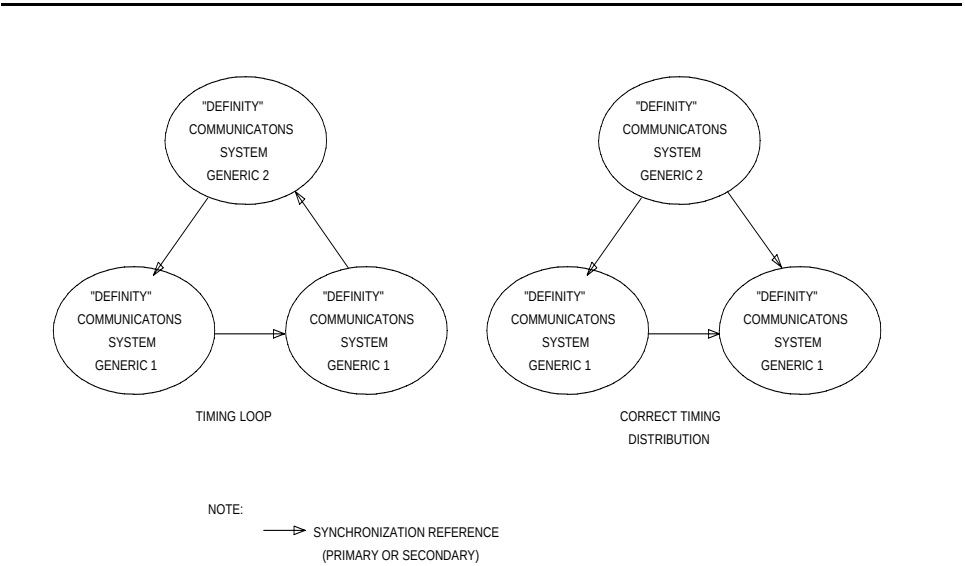
Figure 3-41. Synchronization Timing Loop

The system synchronization planner must avoid creating a *timing loop* when administering the primary and secondary synchronization references in a system. A timing loop exists whenever a system receives timing from another system whose timing reference is directly or indirectly derived from itself. Timing loops can lead to loss of digital data between systems that are exchanging data with any system within the loop. An invalid timing signal is also generated by any system within the loop, thus propagating the invalid timing signal to any system(s) using a system within the loop as a synchronization reference. [Figure 3-41](#) shows a timing loop and a correct distribution of timing between the systems.

A correctly designed network has no loops and each piece of equipment in the network is supplied by a clock of equal or lower stratum (that is, the inputs to a Stratum 3 clock should NEVER be from a Stratum 4 device). **It is strongly recommended that the network administrator be consulted before administering any synchronization changes.**

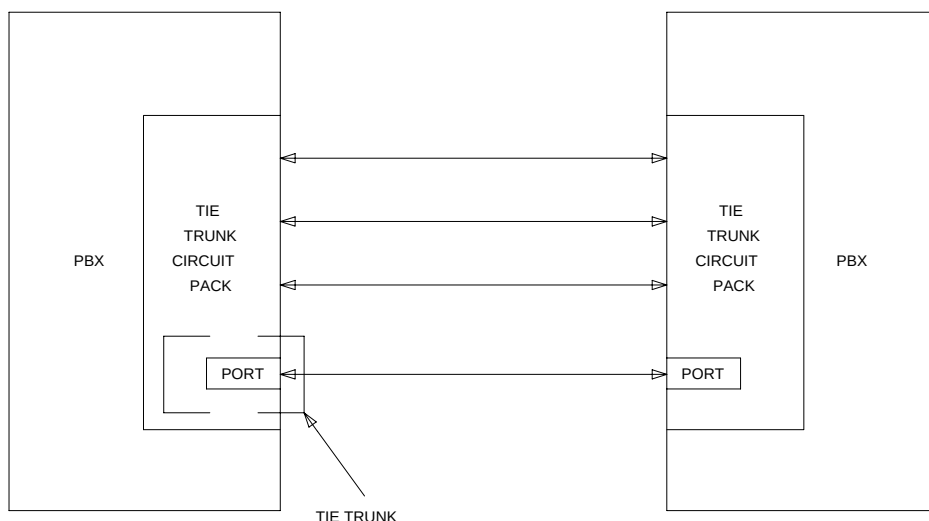
**Figure 3-44. Tie Trunk Interactions**

The Tie Trunk circuit pack fits into a port slot and contains four trunk circuits (see [Figure 3-44](#)). Each tie trunk for the TN497 circuit packs has 2-wire audio connection/signal leads (A and B).

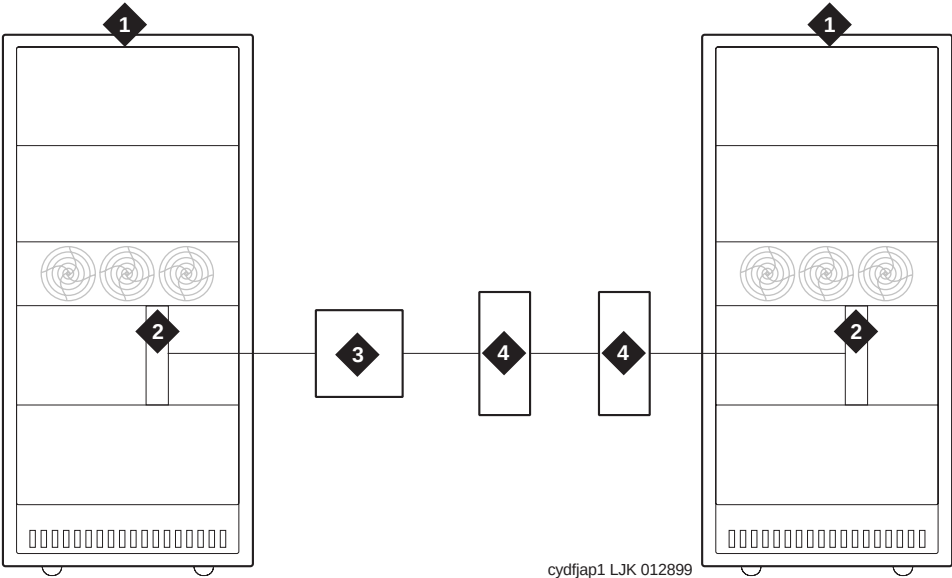
Figure 3-46. Japanese TTC public network connections

[Figure 3-46](#) shows the hardware connections for public network access in Japan. The upgrade procedure requires removing the JRC (Japan Radio Corporation) external converter in [Figure 3-46](#).

| 1. DEFINITY Release 7 | 3. JRC (Japan Radio Corporation) external converter |

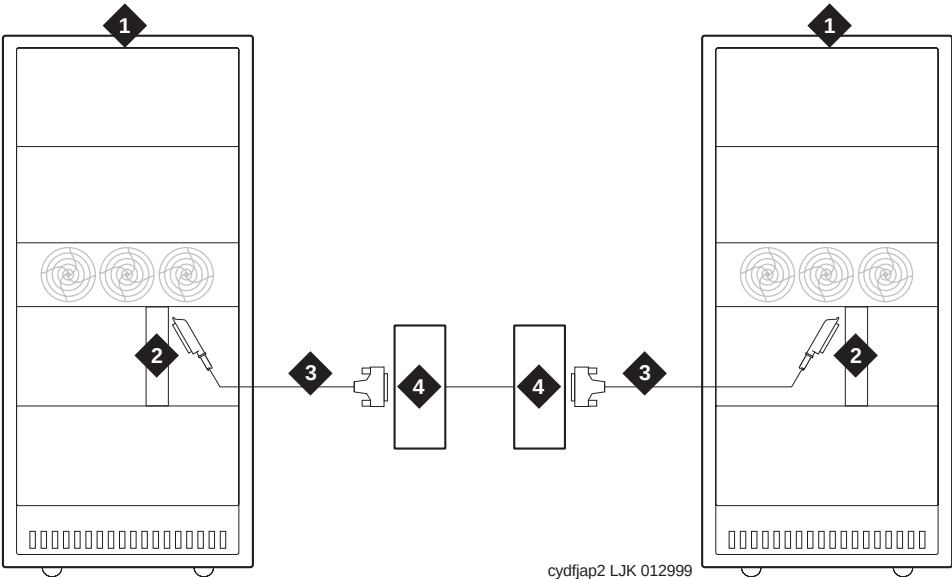
Figure 3-47. TN2242 Japan trunk TTC private network connections

Figure 3-47 shows the hardware connections for private network access using the TN2242 circuit pack.

1. DEFINITY Release 7
2. TN2242 2Mbit Japan trunk circuit pack
3. H600-513 cable assembly cable. (See [“H600-513 cable pinout”](#)).
4. TDM facilities

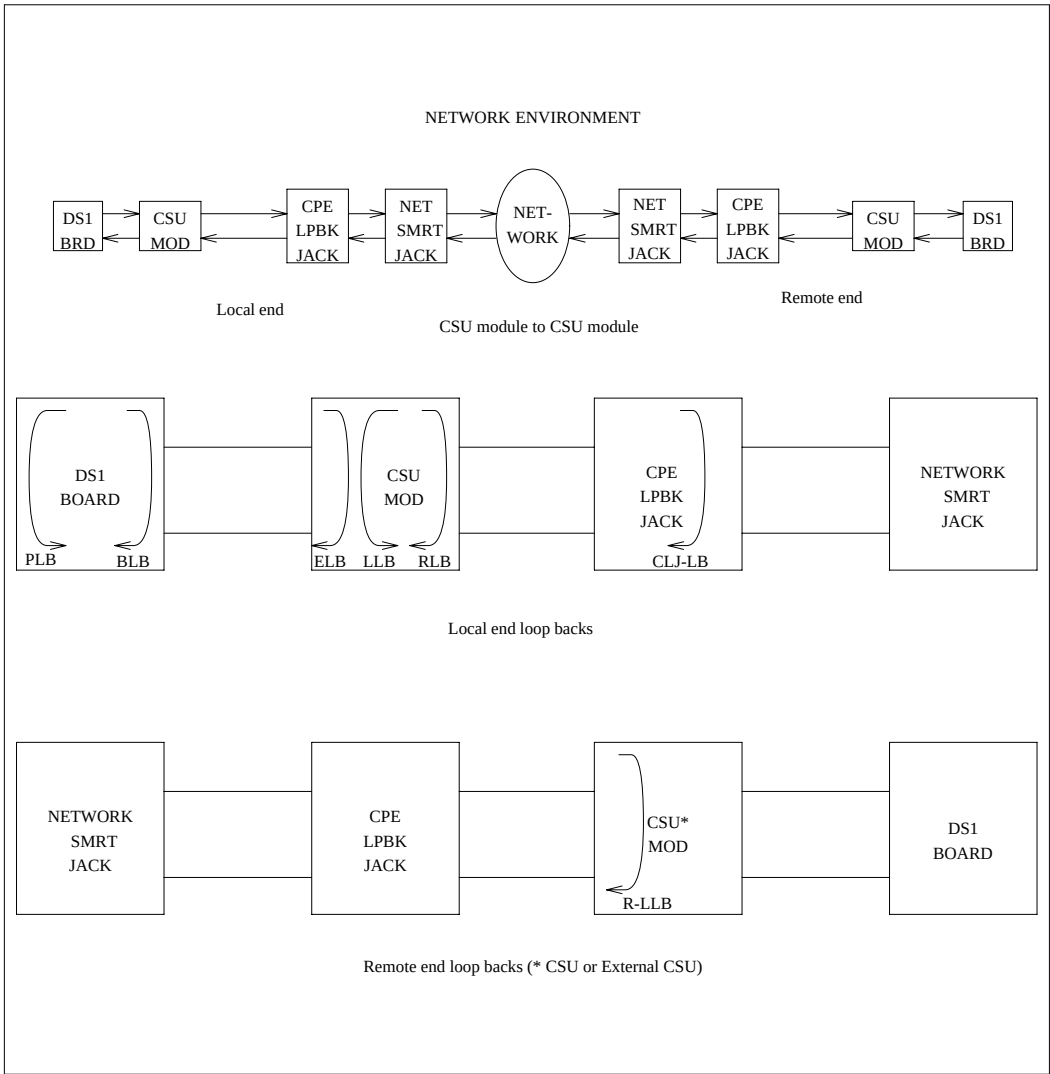
Figure 3-48. High Level Overview Of Loopback Points

The TN464F and 120A1 CSU Module support on-demand loopback tests that assist in the detection of faults between the TN464F circuit pack and the CSU Module, between the Integrated CSU and the optional Customer Premises Loopback Jack, or between the Integrated CSU and remote CSU. These loopback tests are explained in detail later in this UDS1-BD section, but [Figure 3-48](#) gives a high level overview of the loopback points.

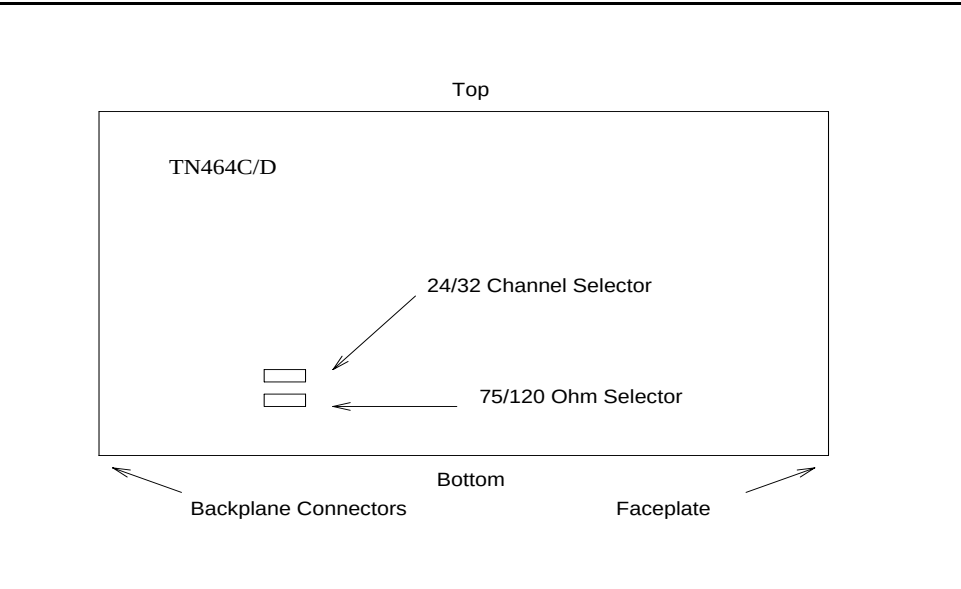
Figure 3-49. TN464C/D DS1 Option Jumpers

[Figure 3-49](#) through [Figure 3-51](#) show how to configure the circuit pack for 24-channel or 32-channel DS1. The channel selection must match the parameters administered on the corresponding DS1 Circuit Pack Form. (US applications use 24 Channels.)

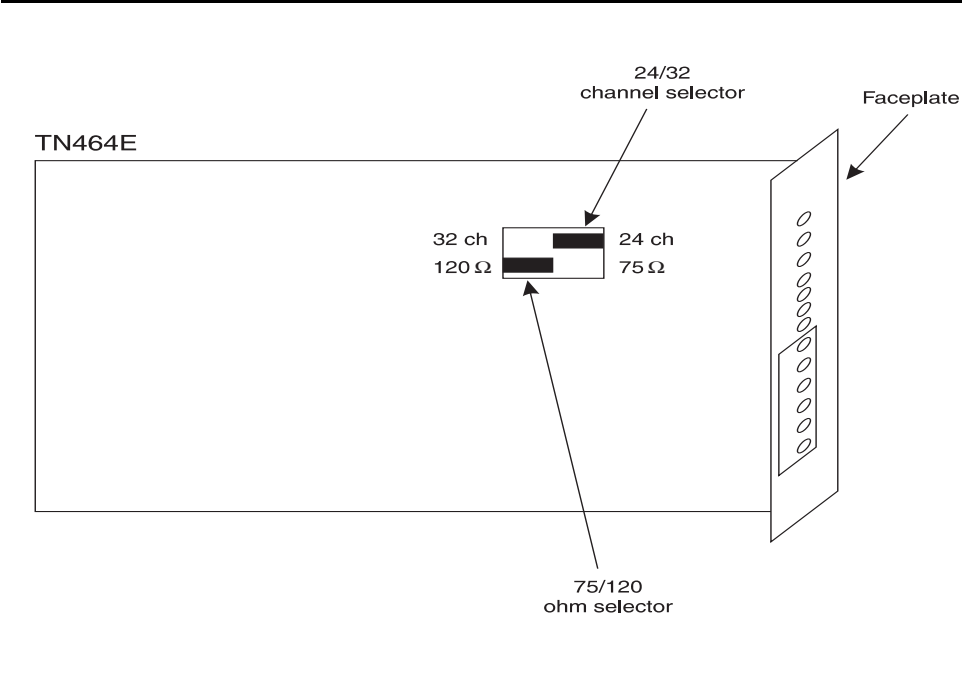
Figure 3-51. TN464E/F DS1 Option switches

The option switch located on the component side of the TN464E/F circuit pack must be set correctly. [Figure 3-51](#) shows how to configure the circuit pack for 24-channel or 32-channel DS1. The channel selection must match the parameters administered on the corresponding DS1 Circuit Pack Form. (US applications use 24 Channels.)

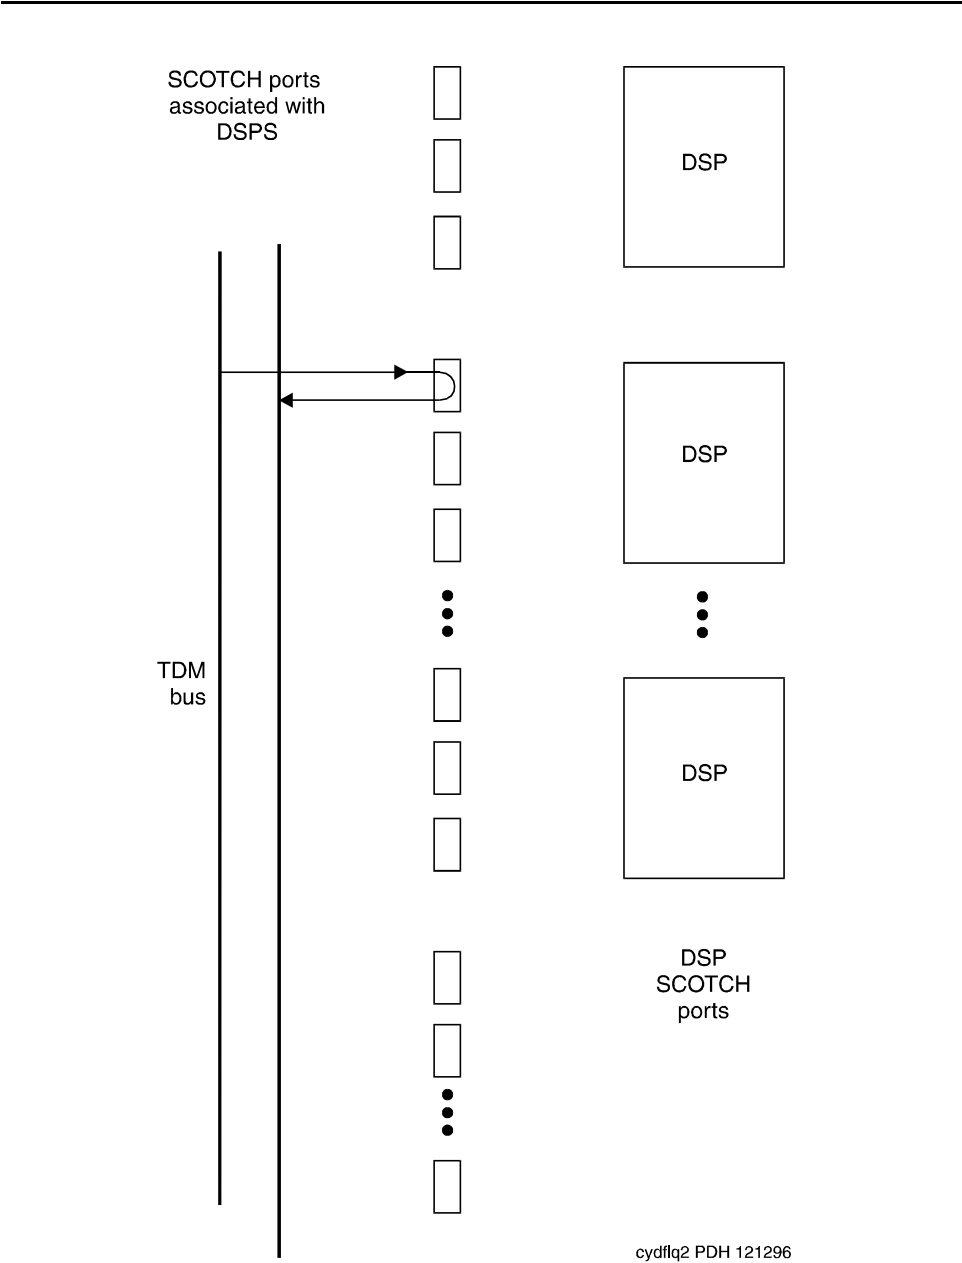
Figure 3-52. VC Circuit Pack DSP Port Local TDM Loopback Test

This test verifies the connectivity of a VC DSP Port across the TDM bus. It aborts if calls associated with the port are in progress. Failure of this test indicates an on-board fault associated with the port hardware on the circuit pack. The Loopback Test runs the following tests (refer to [Figure 3-52](#)):

- 1. A looparound test across the TDM bus.
- 2. A conference circuit test.

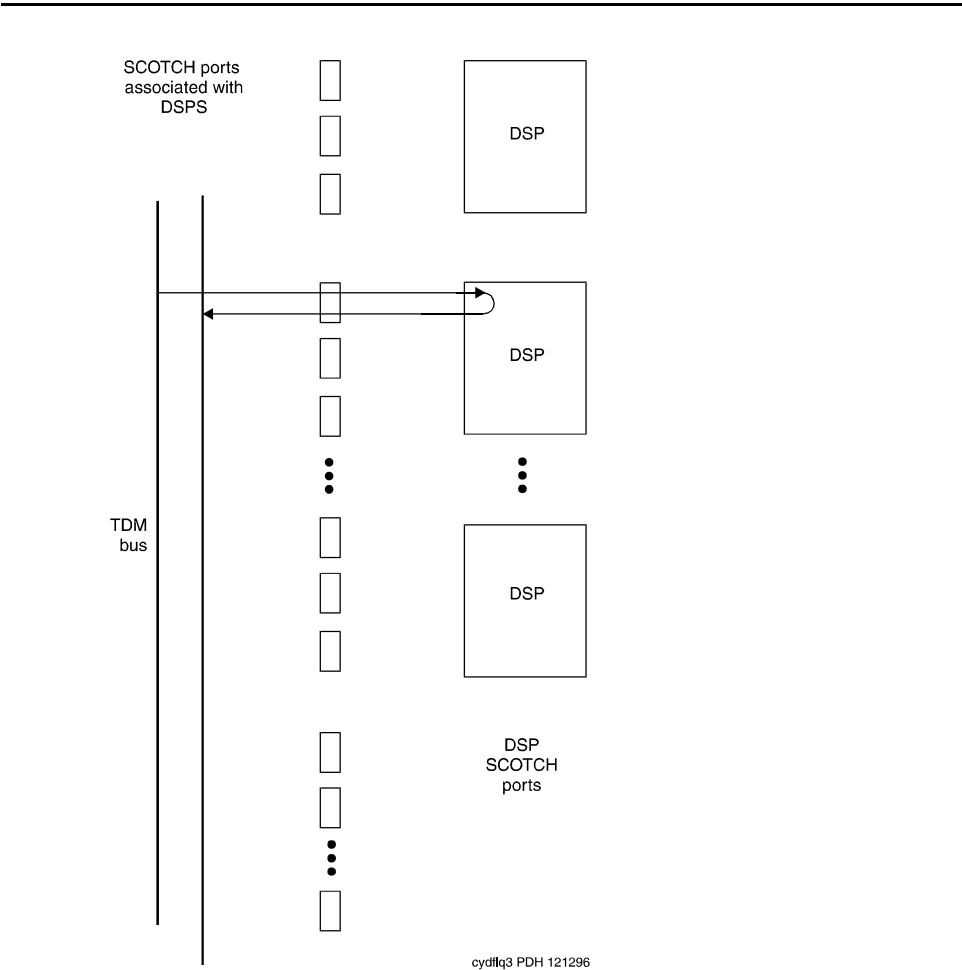
Figure 3-53. VC Circuit pack DSP Port DSP Looparound Test

This test verifies the connectivity of a VC-DSPPT across the TDM bus as shown in [Figure 3-53](#). It aborts if calls associated with the port are in progress. Failure of this test indicates an on-board fault associated with the port hardware on the circuit pack.

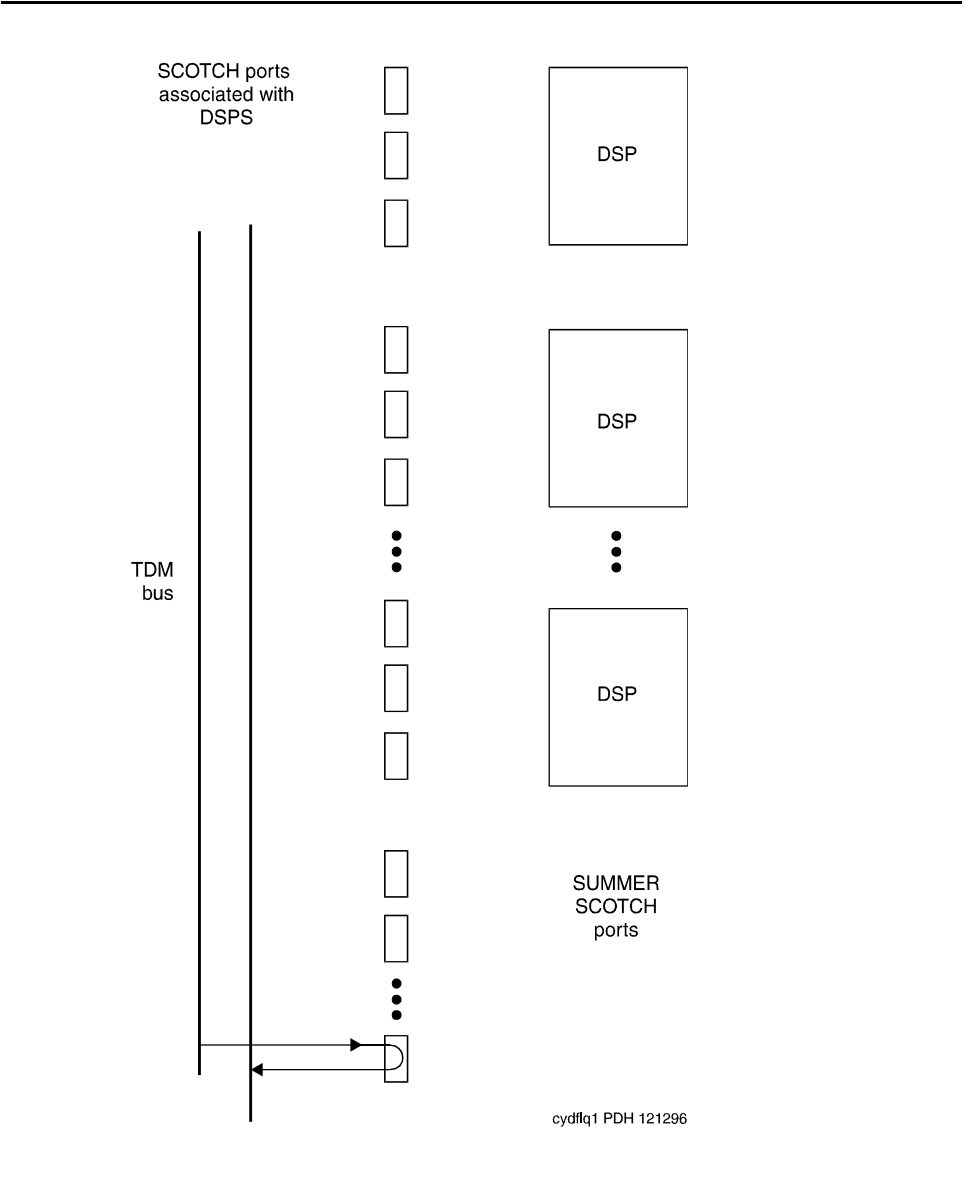
Figure 3-54. VC Circuit Pack Summer Port Loopback Test

This test verifies the connectivity of a VC Summer Port across the TDM bus. It aborts if calls associated with the port are in progress. Failure of this test indicates an on-board fault associated with the port hardware on the circuit pack. The Loopback Test runs the following tests (refer to [Figure 3-54](#)):

- A Looparound test across the TDM bus.
- A conference circuit test.
