**DEFINITY®**  
**Enterprise Communications Server**  
Release 9  
Maintenance for R9csi  
Volumes 1 and 2

555-233-119  
Issue 2  
November 2000

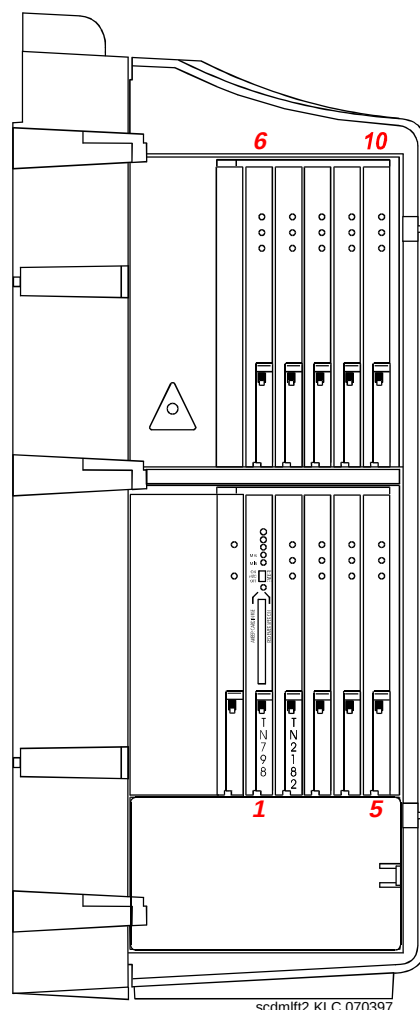
**Figure 1-1. Compact Modular Cabinet (CMC) slot configuration**

- The RISC-based TN2402/TN798 Processor circuit pack must be located slot 1. [Figure 1-1](#) also shows the Flash Memory Card slot for translations.
- TN2182 Tone-Clock must be installed in slot 2. This is the only Tone-Clock circuit pack allowed in the CMC.
- Service circuit packs the only packs allowed in the CMC. These “universal” service packs can be located in any slot numbered 3-10.
- AUDIX, if present, requires 4 slots (slots 6-9 on the top row).
- MAPD requires 2 slots if administered in slot 7, otherwise, installation requires 3 slots.

- The CMC cabinet has 2 shelves of 5 slots each (1-5, 6-10) as shown in [Figure 1-1 on page 1-14](#). This means that slots 5 and 6 are not contiguous like they are in other DEFINITY cabinet types and that Multi-Function boards such as the TN566 and the MAPD boards (TN800, TN801, and TN802) must be installed in specific slots. For example:

- The TN2402/TN798 Processor circuit pack incorporates the RISC processor complex, the TN777B NETCON (including PCM flash card interface), and TN765 Processor Interface functions and is always found in slot 1 of the A carrier. (See [Figure 1-1 on page 1-14](#))

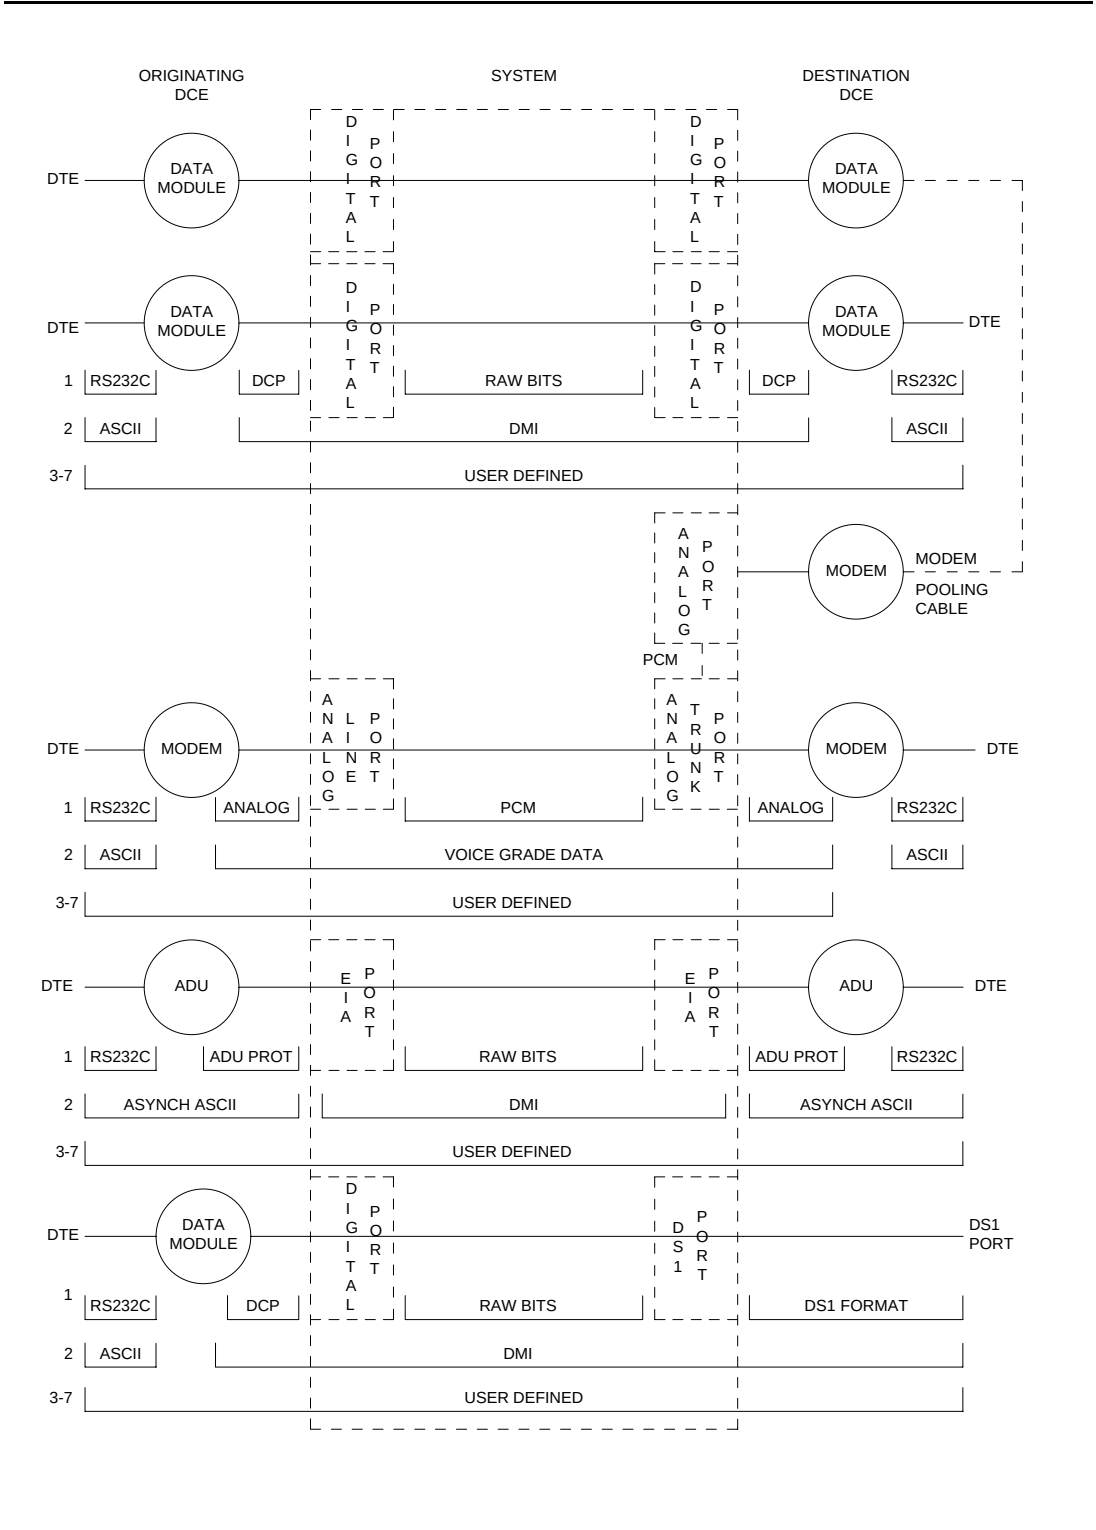
Figure 1-2. Data Transmission States

Layers 3 to 7 (and the DTE-created layer 2) are embedded in the transmission stream and are meaningful only at the destination DTE equipment. Therefore, they are shown in the figure as “user-defined,” with no state changes until the transmission stream reaches its destination.

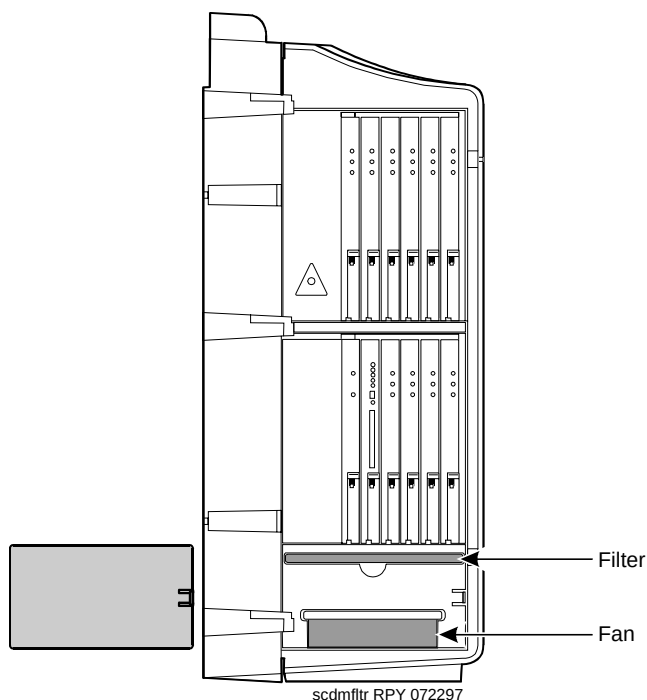
**Figure 1-3. Fan/Filter Removal**

1. Remove the left door.
2. Remove the fan/filter access panel. See [Figure 1-3 on page 1-21](#).

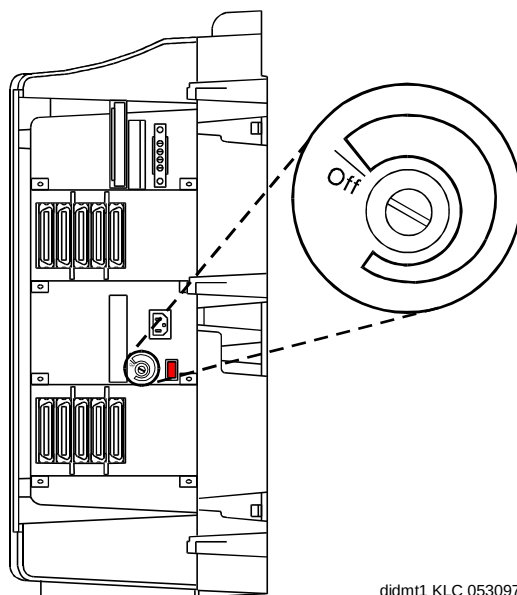
**Figure 1-4. Setting the Neon Voltage**

1. Call a telephone with a neon message indicator and leave a message.
2. Check for "ring ping" (single ring pulse) each time the lamp flashes (approximately every 3 seconds).
3. Adjust the neon voltage control clockwise in small increments until the ring ping stops. See [Figure 1-4](#). Be sure that the message lamp still lights when the adjustment is finished.
4. Enter **logoff** and press **Enter** to logoff the system and to prevent unauthorized changes to data.
5. Set the left and right doors onto the hinge pins and close the doors. The doors must be closed to prevent EMI emissions. Tighten the door screws.
6. Set the cover panel onto the right panel and secure.

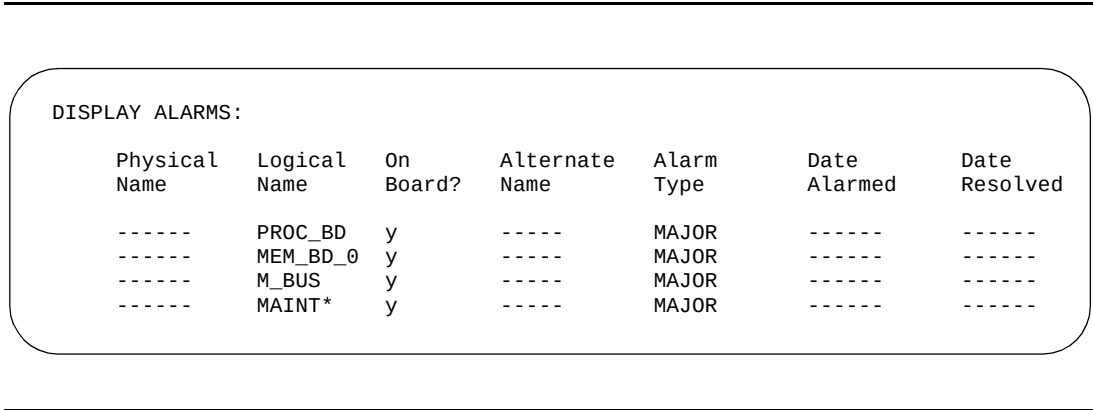
Figure 1-10. Display Alarms command

Figure 1-10 shows all possible SPE-Down alarms.

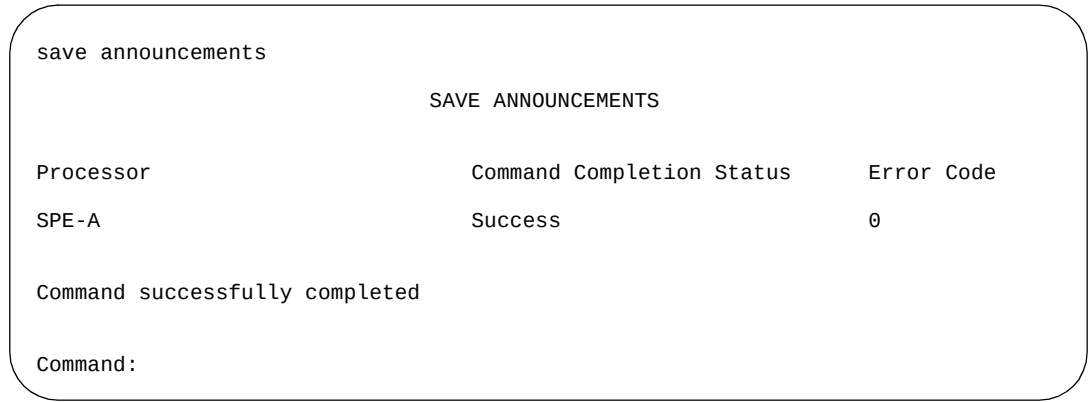
Figure 1-12. Save Announcements screen

- 4. Verify that the command successfully completes. If not, an error message appears. In such a case, refer to the “Translation Card Errors” section.
- 5. If the system is equipped with a TN750 Announcement circuit pack, the recorded announcements can be saved using the **save announcement** commands. Enter the command and press Enter. The following display appears:

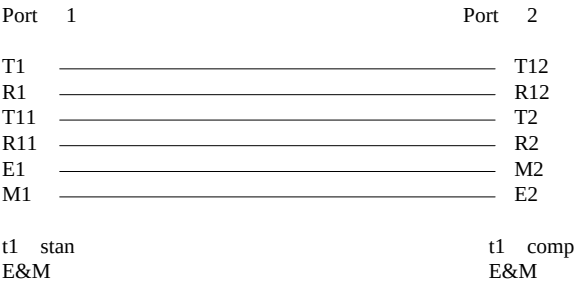
11. At the cross-connect field, disconnect outside trunk facilities from the Tie Trunk ports and mark the disconnected wires for later reconnecting the Tie Trunk ports back to normal operation. The D Impact Tool (AT-8762) is required to perform this step.
12. Use jumper wires (DT 24M-Y/BL/R/G and DT 24P-W/BRN) and the D Impact Tool to connect wiring between the two ports assigned in Step 9 at the cross-connect field. For example, if the two ports on the Analog Tie Trunk circuit pack are port 1 and 2, connect the wirings as shown below:

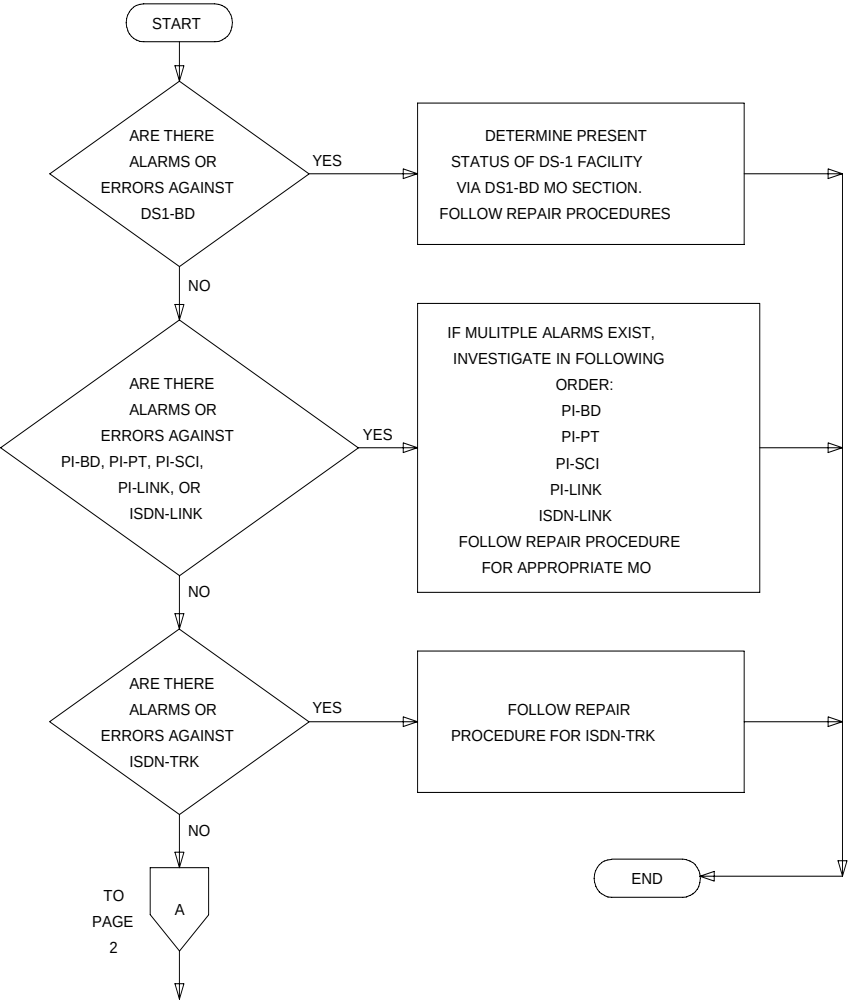
Figure 1-16. Processing of ISDN-PRI Problems (Page 1 of 2)

The following flowchart, [Figure 1-16](#) and [Figure 1-17 on page 1-67](#), defines a layered approach when troubleshooting ISDN-PRI problems. Since a problem at a lower layer affects upper layers, layers are investigated from low to high. In the flowchart, the DS1 facility is layer 1, the TN765 Processor Interface is layer 2, and the ISDN trunks are layer 3. Transient problems are diagnosed on Page 2 of the flowchart, [Figure 1-17 on page 1-67](#).

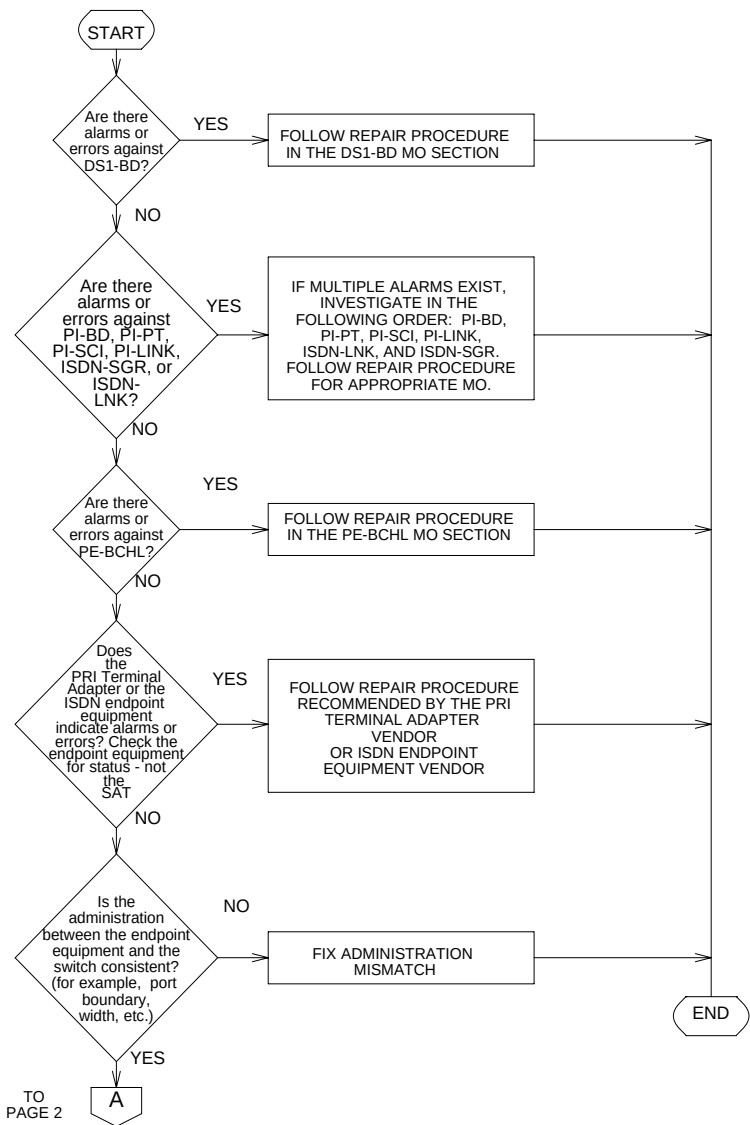
Figure 1-18. Processing of PRI Endpoint Problems (Page 1 of 2)

The following flowchart, [Figure 1-18 on page 1-68](#) and [Figure 1-19 on page 1-69](#), defines a layered approach when troubleshooting PRI endpoint problems. Since a problem at a lower layer affects upper layers, layers are investigated from low to high. In the flowchart, the DS1 facility is layer 1, the TN765 Processor Interface is layer 1, the TN765 Processor Interface is layer 1, the TN765 Processor Interface is layer 2, and the ISDN trunks are layer 3.

The troubleshooting procedure described here diagnoses faults between the switch and the line-side PRI terminal adapter/ISDN-PRI endpoint equipment. Problems encountered on the network-side of a wideband connection or problems with end-to-end equipment compatibility are outside the scope of this manual.

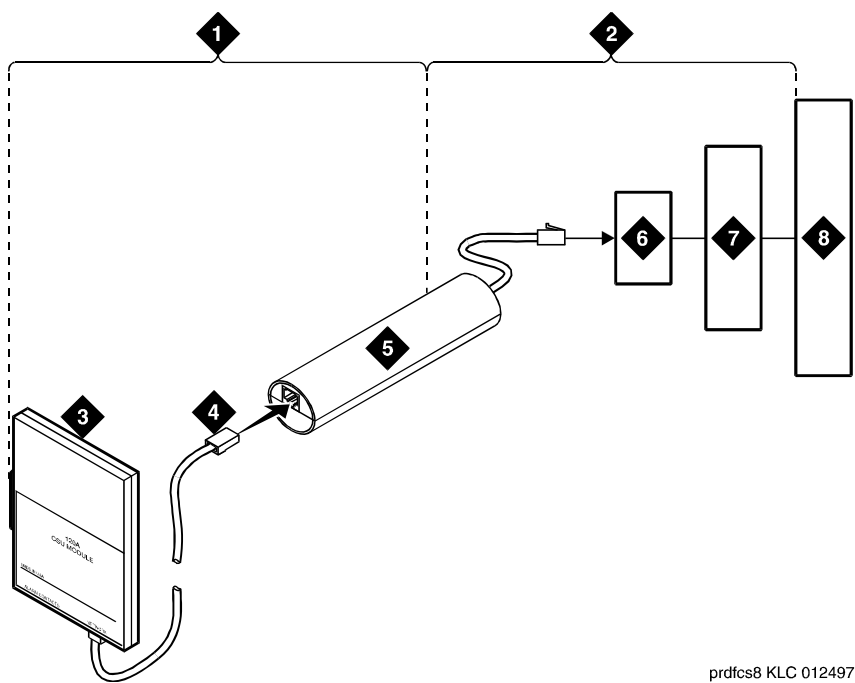
**Figure 1-24. Network Interface at "Dumb" Block**

When the loopback jack is added to a span that does not contain a Smart Jack, the span is divided into 2 sections. See [Figure 1-24](#) and [Figure 1-25 on page 1-84](#).

- 1. ICSU to the loopback jack.
- 2. Loopback jack to the Central Office (CO).

1. Install the loopback jack at the point where the cabling from the ICSU plugs into the “dumb” block. If there is more than one “dumb” block, choose the one that is closest to the Interface Termination feed or the fiber MUX. This provides maximum coverage for loopback jack tests. Refer to [Figure 1-24 on page 1-83](#) and [Figure 1-25 on page 1-84](#).

1. Test customer premises wiring (section 1 in [Figure 1-24 on page 1-83](#)) from the ICSU to the loopback jack as described in the “DS1 Span Test” section.

2. Test the loopback jack-to-“dumb” block and “dumb” block-to-CO wiring (section 2 in [Figure 1-24 on page 1-83](#)). This can be done using a loopback that “overlaps” the section of the span. Any of the following loopbacks can do this:

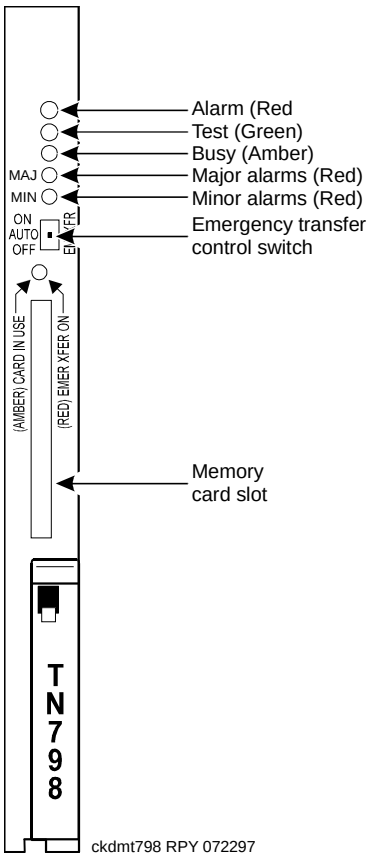
Figure 1-26. LED Indicators on the TN2402/TN798 Processor Circuit Pack

**NOTE:**  
If the LED just above the Memory Card Slot is alternating red and amber, this indicates both card in use and emergency transfer.

The front panels of the Processor circuit pack and the Maintenance circuit pack are identical. Each has two groups of LEDs. One group indicates the status of the pack, and the other group (which includes the Major, Minor, and Warning alarms described in the ["Alarm and Error Reporting"](#) section) reflects maintenance conditions in the entire system. See [Figure 1-26 on page 1-89](#).

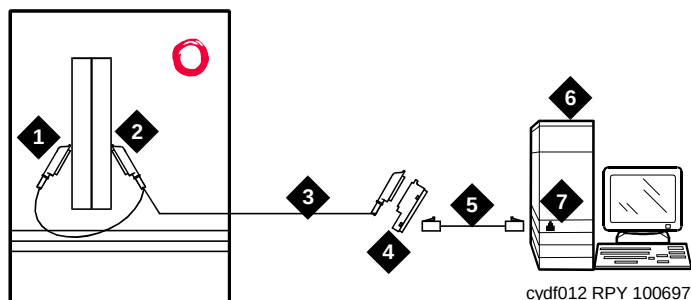
Figure 1-27. Typical ESM connections

1. Port B Y-cable connector to a TN787 Multimedia Interface (MMI) circuit pack
2. Port A Y-cable connector to a TN2207 PRI circuit pack
3. 25-pair Y-cable
4. 356A adapter
5. D8W cord connected to 356A adapter port 1
6. Expansion Service Module (ESM)
7. Port B on compatible primary rate interface (PRI) card

The Expansion Services Module (ESM) shown in [Figure 1-27 on page 1-93](#) provides T.120 data sharing capability on a MMCH multipoint H.320 video conference. Each conference participant must have endpoints administered and a personal computer with the H.320 video application installed. The DEFINITY ECS must have the expansion service module installed.

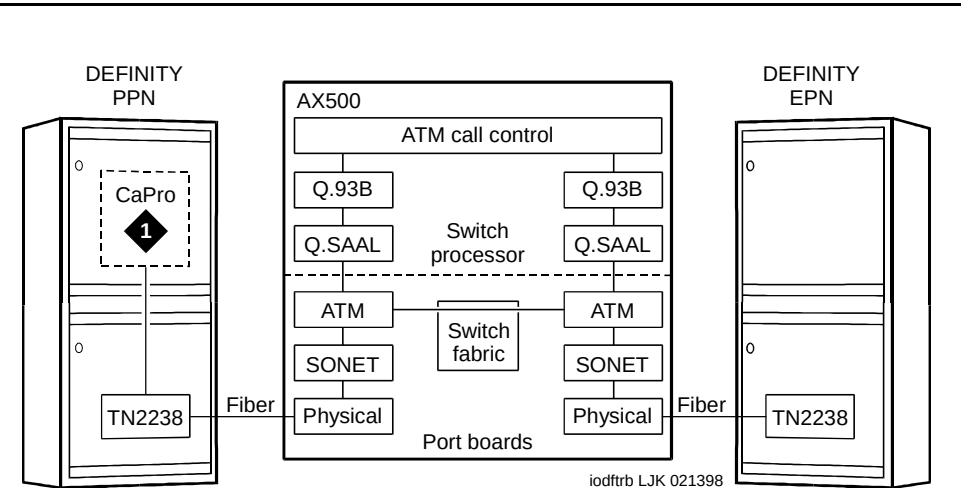
Figure 1-30. ATM troubleshooting schematic

**NOTE:**  
The CaPro element (Note 1 in [Figure 1-30](#)) is a software module within the DEFINITY PPN.

This section provides tips for DEFINITY ATM PNC when interfacing with the ATM switch. Throughout this section, refer to [Figure 1-30](#), using [TN2238](#) for [R6.3](#) systems, and [TN230X](#) for [Release 7](#) and later.

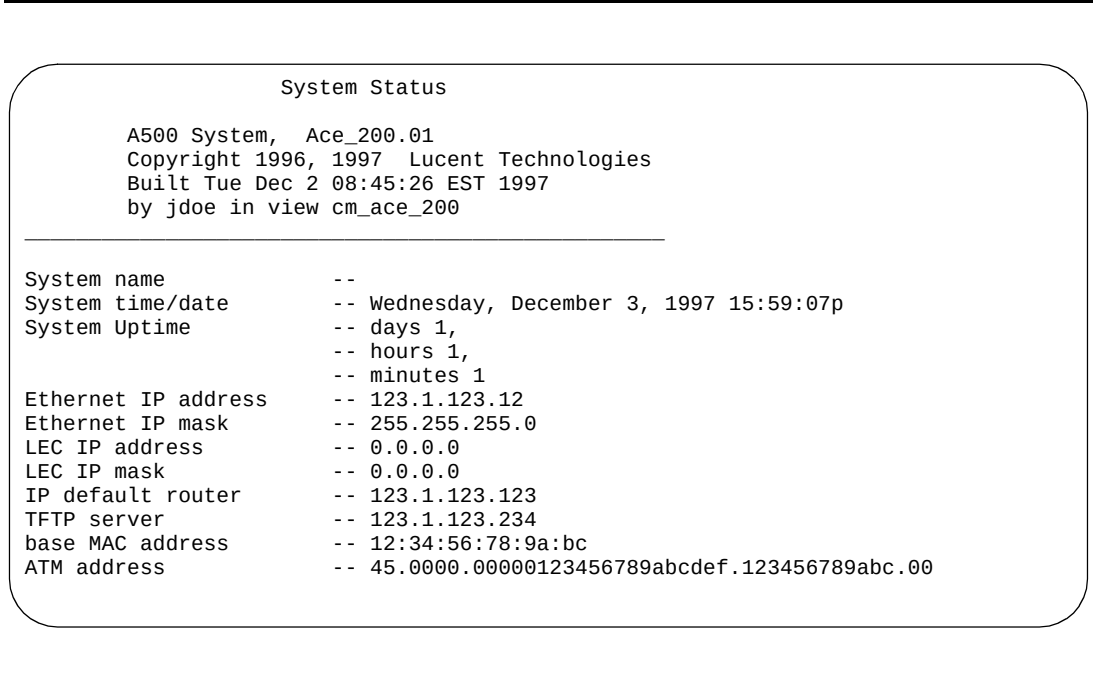
Figure 1-32. A500 screen output for status command

5. Enter **status** at the A500 : prompt. [Figure 1-32](#) shows the output from the status command.

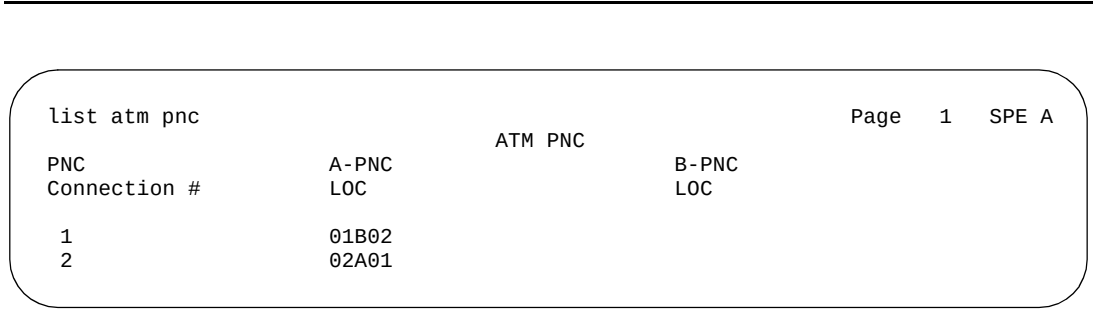
Figure 1-33. Screen output for list atm pnc command

- 1. Enter **list atm pnc** on the DEFINITY SAT. The cabinet, carrier and slot positions of each administered TN230X board display as shown in [Figure 1-33](#). Ensure that each board's physical location matches the display.

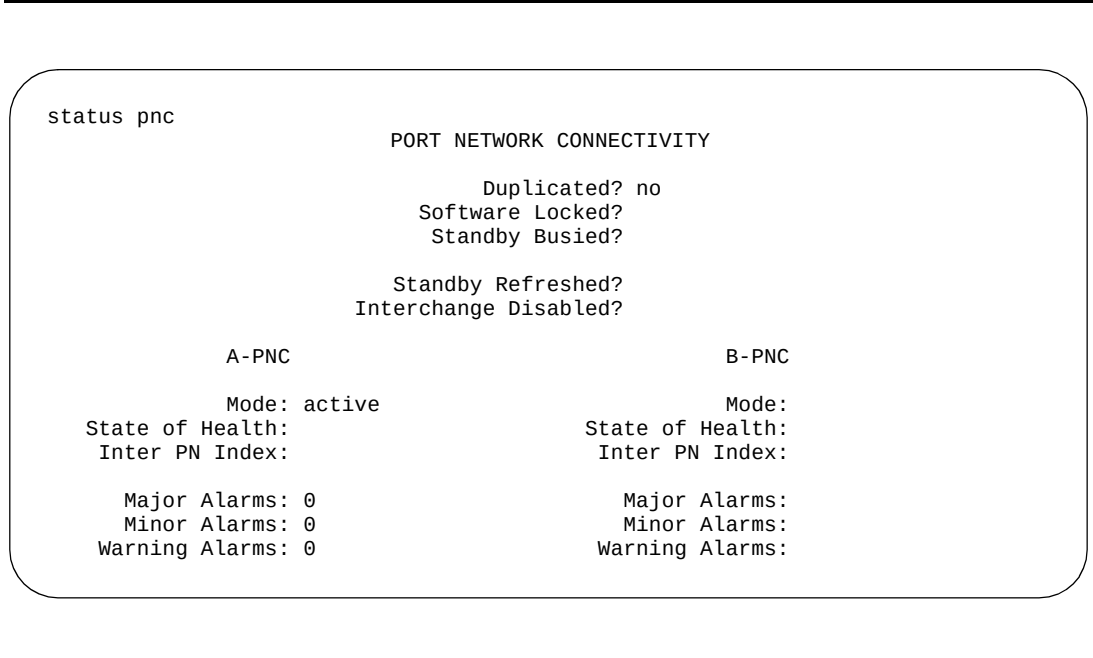
Figure 1-34. Screen output for status pnc command

- 2. Enter **status pnc** at the DEFINITY SAT. This display tells you which TN230X board is active in a duplicated system and how many alarms (if any) of each severity level have been logged for the board. [Figure 1-34](#) shows the output from this command.

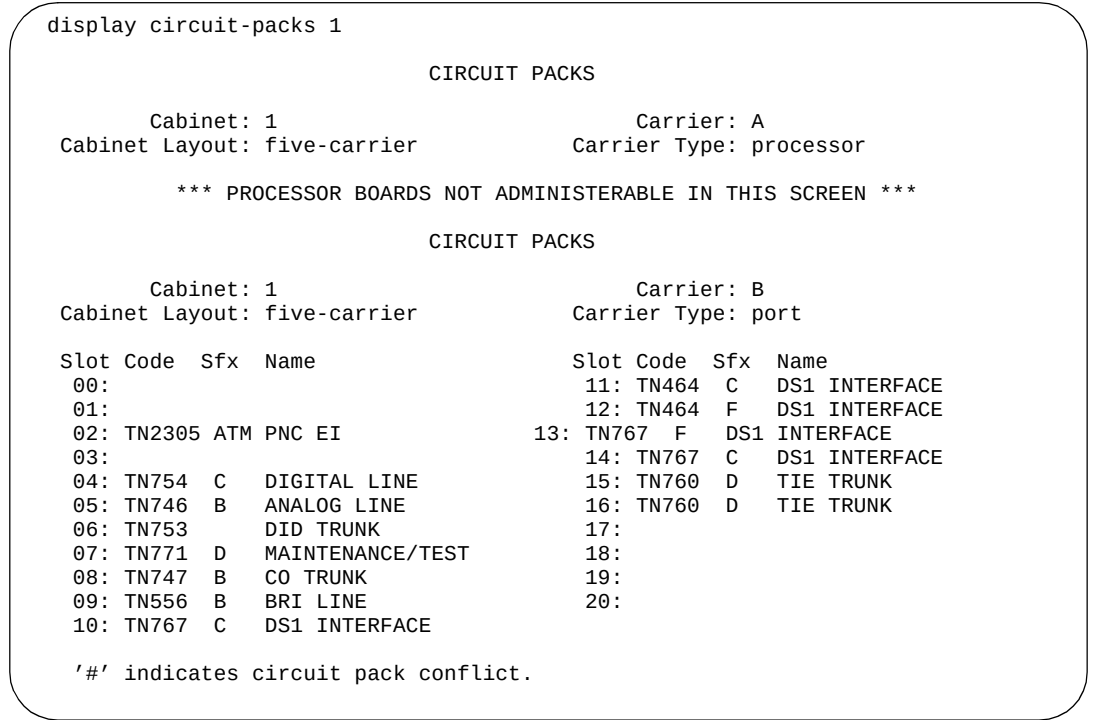
Figure 1-35. Screen output for display circuit-packs 1

- 3. Enter either **list configuration UUC** (for the carrier in which the ATM-EI packs reside) or **display circuit-packs cabinet** (non-control cabinet) at the DEFINITY SAT. This command tells you in more detail what boards are in which slots in each cabinet and carrier. Verify that the TN230Xs are physically located in the slots indicated on the display. [Figure 1-35 on page 1-111](#) shows the output for the **display circuit-packs 1** command; [Figure 1-36 on page 1-111](#) shows the output for the **display circuit-packs 2** command.

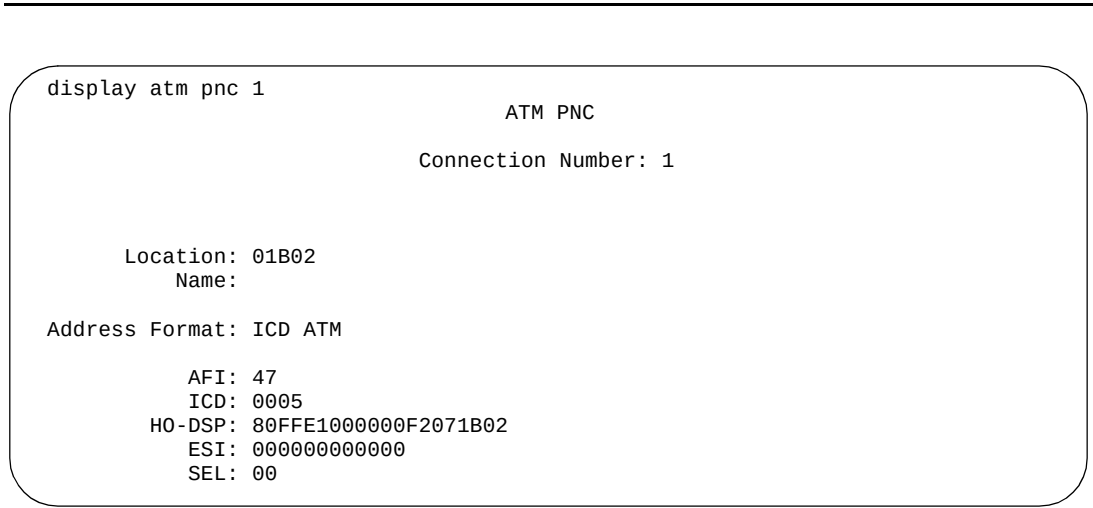
Figure 1-37. Screen output for display atm pnc 1

4. Enter **display atm pnc portnetwork** on the DEFINITY SAT.
- This display tells you the ATM addresses that have been administered for each TN230X. Verify that each ATM address (the concatenation of the five displayed hexadecimal fields) is correct and match those administered in the A500. See [“A500 Administration”](#) for more information.

If the port networks are addressed using *hard coded PNNI routes* in the A500, the display looks like [Figure 1-37](#) (pnc 1) and [Figure 1-38](#) (pnc 2).

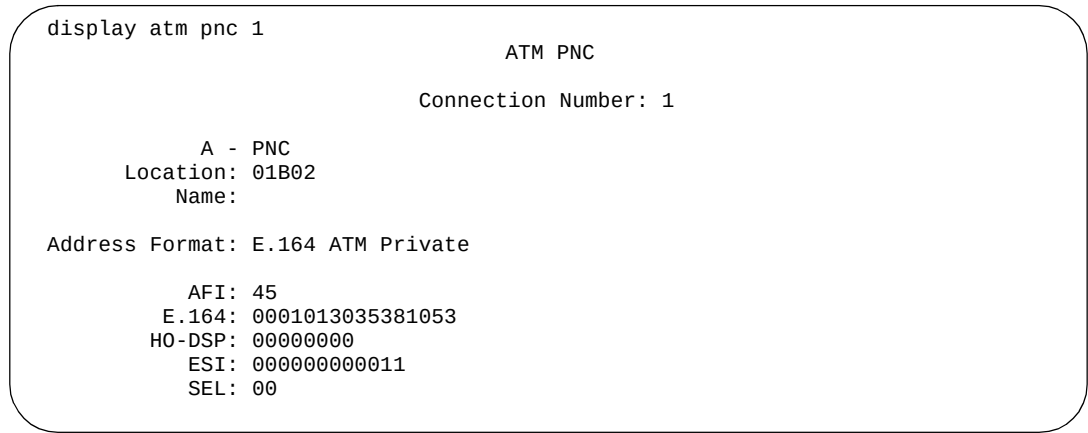
Figure 1-39. Screen output for display atm pnc 1 with End System Identifiers

If the port networks are addressed using End System Identifiers, the display looks like [Figure 1-39](#) (pnc 1) and [Figure 1-40](#) (pnc 2).

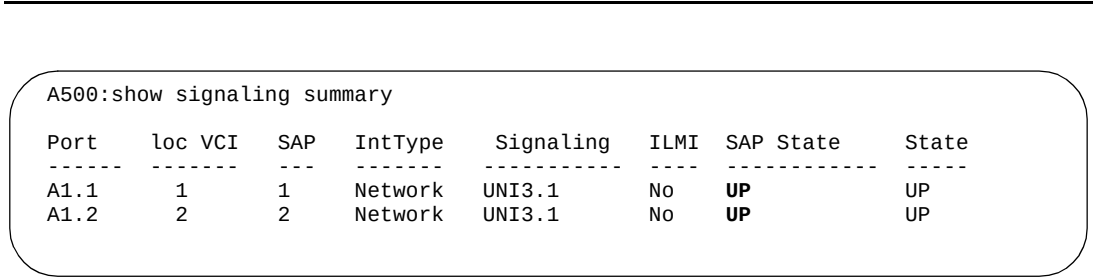
Figure 1-41. Screen output for the show signaling summary command

1. Enter **show signaling summary** on the A500 console. [Figure 1-41](#) shows the screen output.

- a. If an A500 port to which a DEFINITY port network is attached is not listed in this display, it is likely that the port was administered incorrectly as having no UNI signaling (**admin link** command).

| Field | Value |
|---|---|
| SAP State | May or may not be UP. Their values depend on more than just whether the port was marked as <b>UP</b> . (See highlighted data for SAP State in <a href="#">Figure 1-41</a> .) |

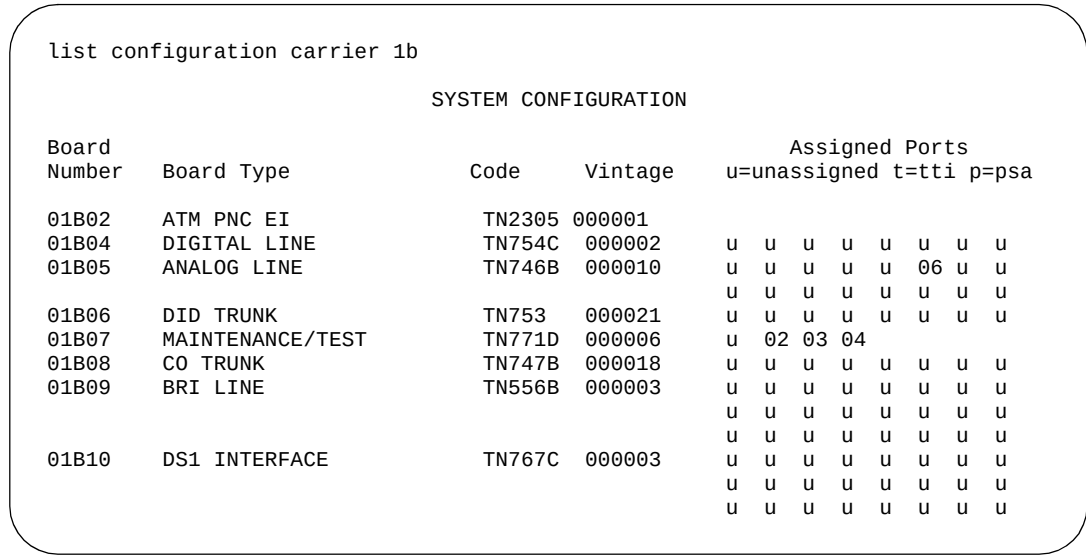
Figure 1-45. List configuration carrier 1b screen

1. Review the LED conditions for the TN230X:
  - Do the TN230X LEDs (see [Table 1-16 on page 1-104](#)) indicate a normal operational state (any of the following):
    - Active in the PPN
    - Standby in the PPN
    - Archangel mode in the EPN
    - Standby in the EPN?
2. If after board insertion or a demand reset:
  - Do the TN230X LEDs indicate that it is booting?
  - Do the TN230X LEDs indicate it is downloading its DSPs?
  - Do the TN230X LEDs indicate that board insertion has not yet occurred?
  - Do the TN230X LEDs indicate a maintenance alarm?
3. Enter **list configuration carrier *cabinetcarrier*** on the DEFINITY SAT. See [Figure 1-45 on page 1-118](#) (1b) and [Figure 1-46 on page 1-118](#) (2a) below.

- The TN230X board should be shown in the correct slot.
- Fields should have values as indicated below:

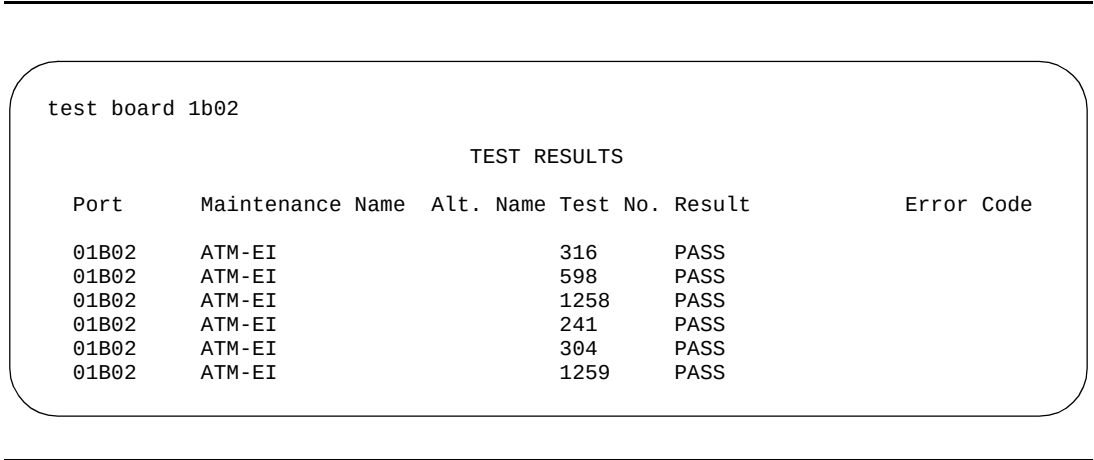
Figure 1-47. Screen output for the test board 1b02 command

4. If the TN230X is inserted and shows a vintage number, enter **test board cabinetcarrierslot** for this board on the DEFINITY SAT, as shown in [Figure 1-47](#) (1b02) and [Figure 1-48](#) (2a01).

- The Result should be PASS for each test number. If the any of the tests fail, refer to [“ATM-BCH \(ATM B-Channel Trunk\)”](#).

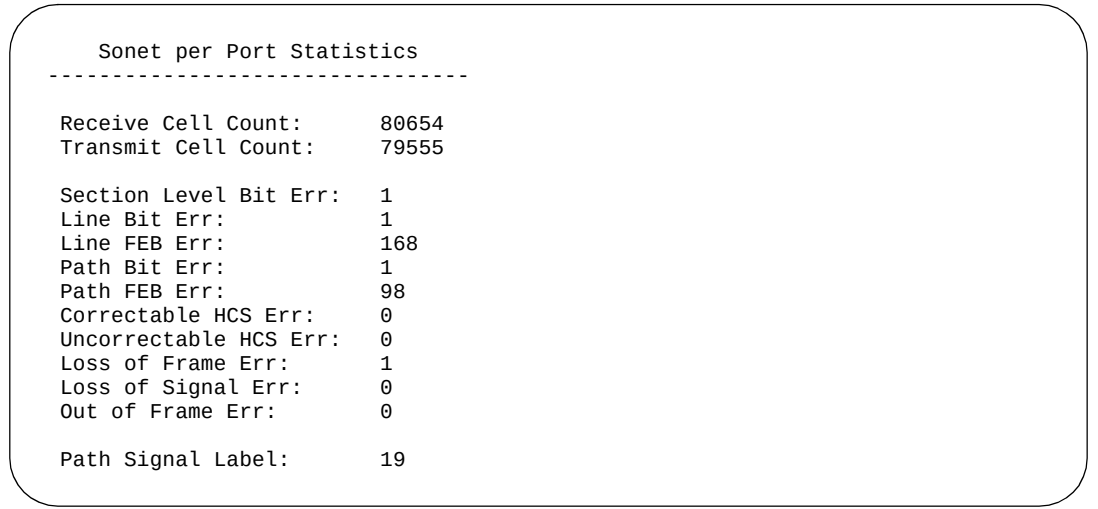
Figure 1-51. A500: show stats sonet a1.2 screen

1. Enter **show stats sonet port** on the A500 console. [Figure 1-51 on page 1-123](#) shows the screen output.

The following examples point to port A1.2 as the port of interest.

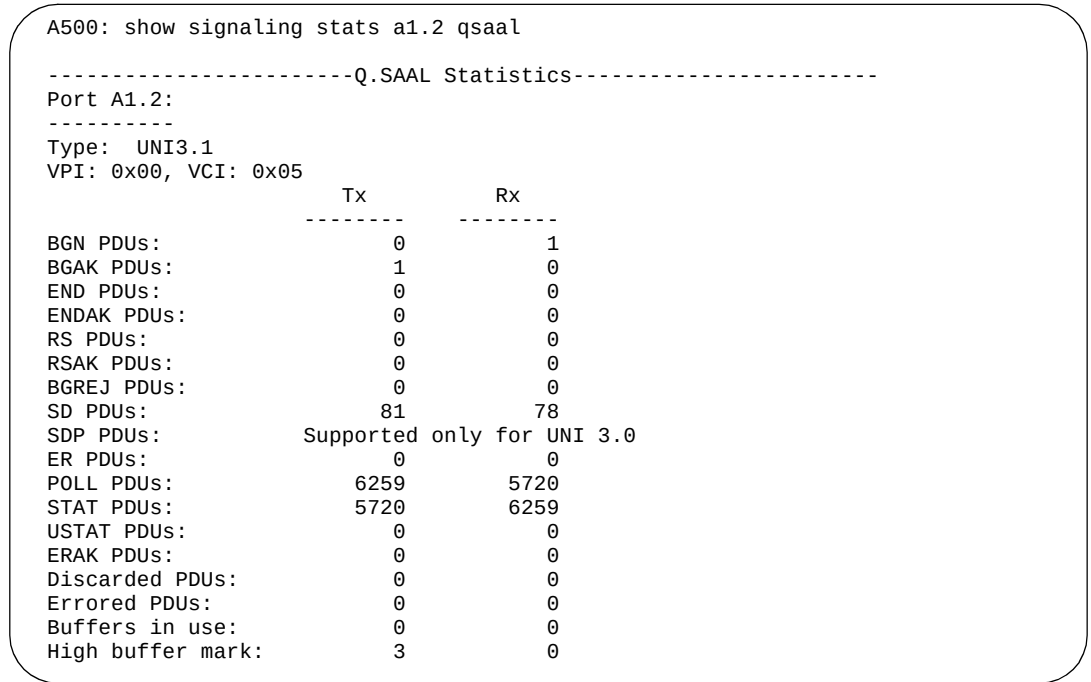
Figure 1-52. A500: show signaling stats a1.2 qsaal screen

1. Enter **show signaling stats port qsaal** on the A500 console. [Figure 1-52](#) shows the screen output.

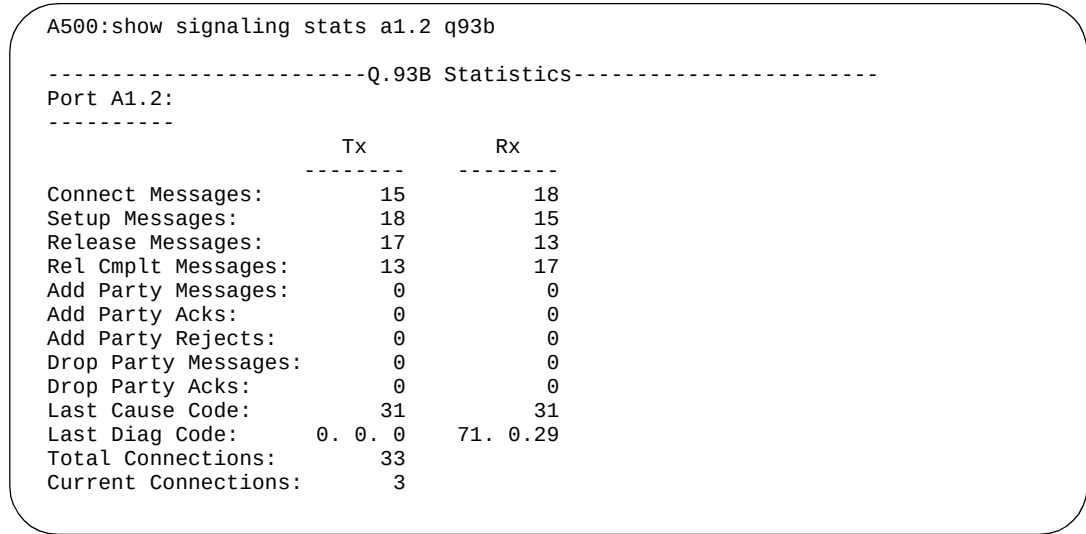
Figure 1-53. A500:show signaling stats A1.2 q93b

1. Enter **show signaling stats port q93b** (or the port of interest) on the A500 console. [Figure 1-53](#) shows the screen output.

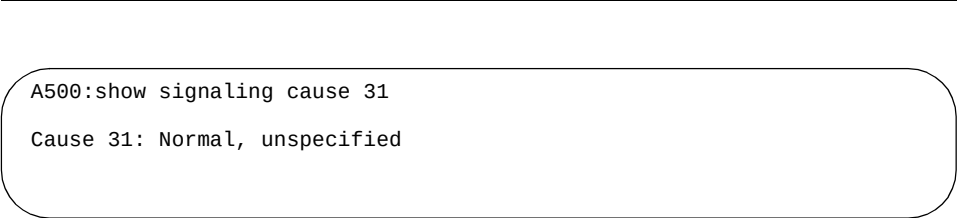
**Figure 1-54.** A500:show signaling cause 31

Enter **show signaling cause *causecode*** on the A500 console. [Figure 1-54](#) shows the screen output for this command.

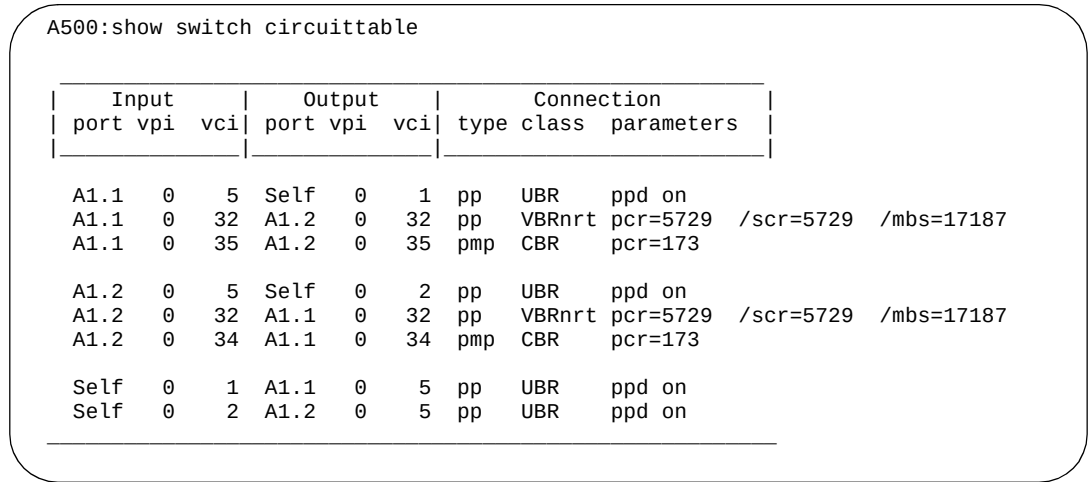
Figure 1-57. A500: show switch circuittable screen

1. Enter **show switch circuittable** on the A500 console. [Figure 1-57](#) shows the screen output.

- The pp UBR virtual circuits between A500 ports A1.1 (PPN) and Self (A500) and between A1.2 (EPN) and Self (A500) are ATM signaling channels between the port network and the A500.
- They are used to request connection setups and releases to other end points such as another port network.
- These are established by each TN230X when it comes up, independent of DEFINITY Call Processing.
- Other UBR virtual circuits may exist between A500 ports that are not associated with DEFINITY port networks and may be signaling channels for other applications (for example, data network traffic).

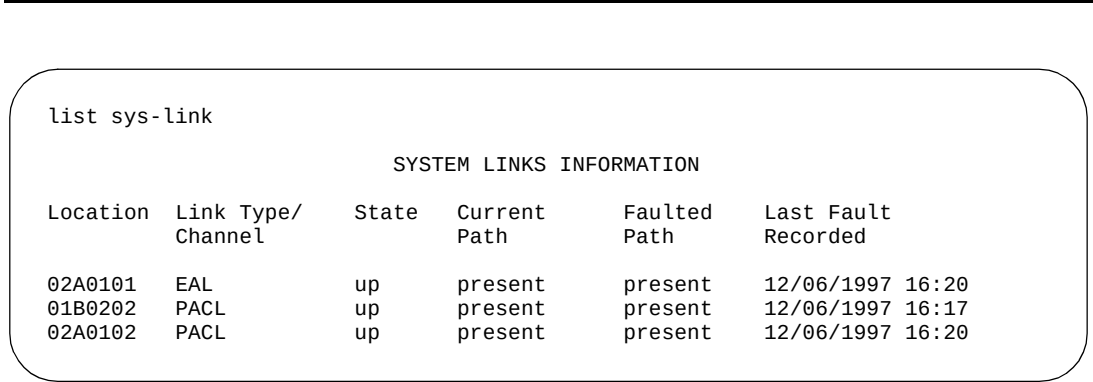
Figure 1-58. List sys-link screen

- Do you get a dial tone on a set on the port network in question?
  - Can you ring a set on the EPN dialing from the PPN and vice versa?
1. Enter **list sys-link** on the DEFINITY SAT. [Figure 1-58](#) shows the screen output.

Ensure that the fields have the values indicated below.

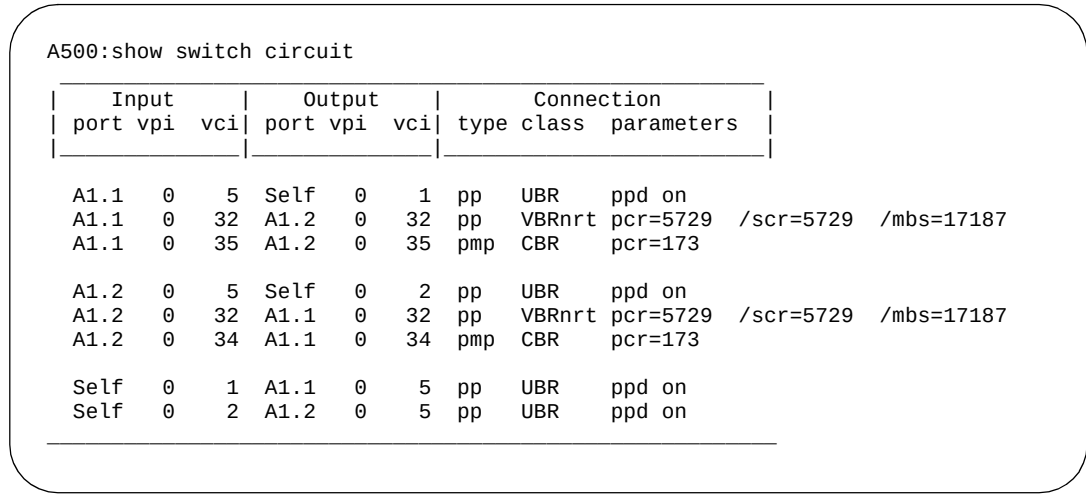
Figure 1-59. A500: show switch circuit screen

2. Enter **show switch circuittable** on the A500 console. [Figure 1-59 on page 1-131](#) shows the screen output.

- The pp VBRnrt (Variable Bit Rate) virtual circuits between A500 ports A1.1 (PPN) and A1.2 (EPN) are used for signaling between the PPN and each EPN.
- These are established once upon initialization under control of DEFINITY Call Processing. They represent the ATM Control Link (ACL) and Expansion Archangel Link (EAL).
- VBRnrt virtual circuits are also be used for ISDN channels between Definity port networks.
- Other VBRnrt virtual circuits may exist between A500 ports that are not associated with DEFINITY port networks. A common use of VBRnrt circuits is multimedia and video-conferencing systems.

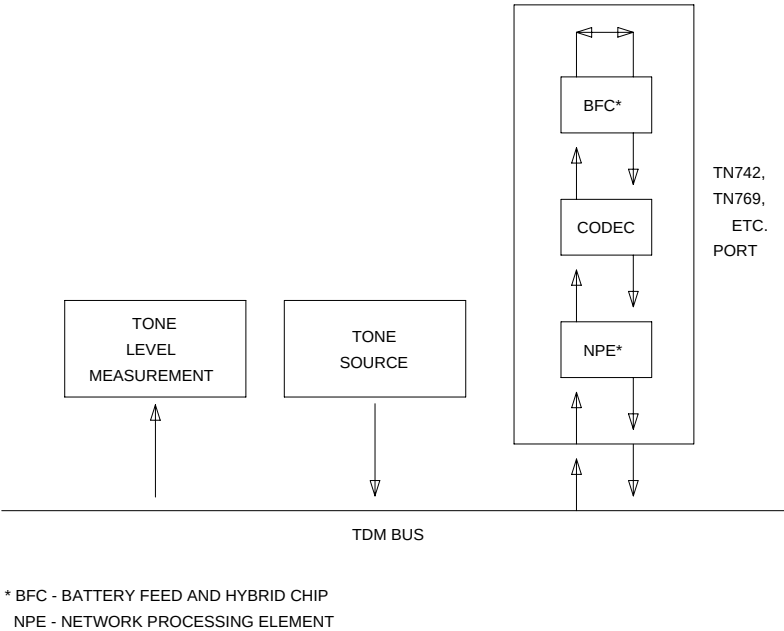
Figure 3-1. Analog Loop Around and Conference Test

This Loop Around Test is sensitive to the length of the loop, the equipment in the loop, or the equipment terminating the loop, such as off-premises stations. If this test is causing a false alarm, then disable the test by changing the Tests field to "no" using the **change station** command for this station.

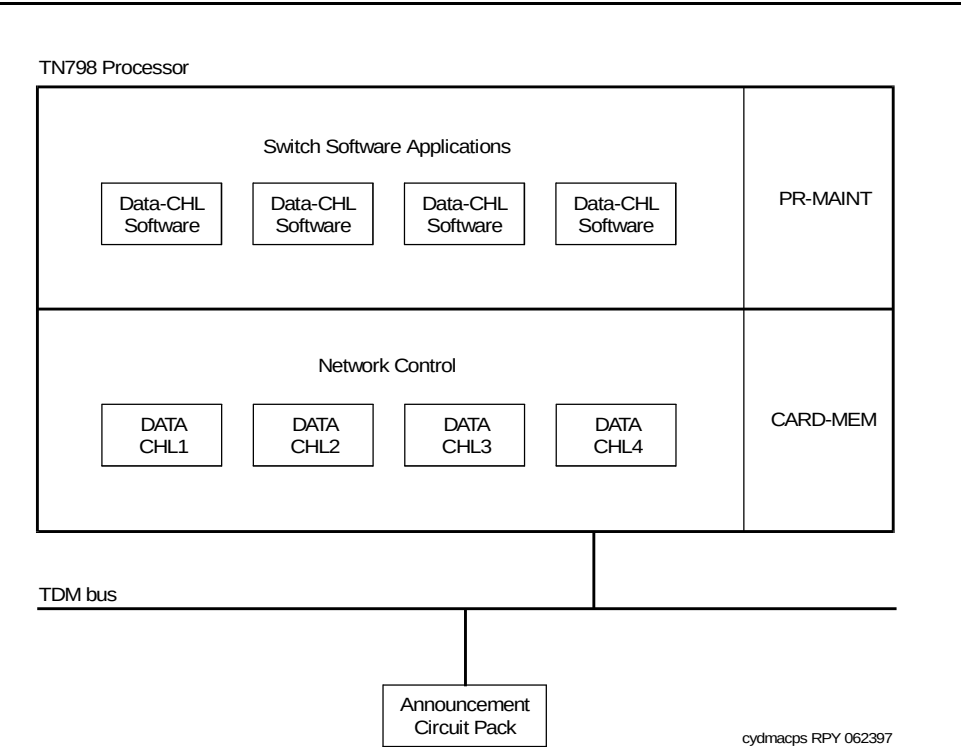
Figure 3-2. Connection of announcement circuit pack to the system

Figure 3-2 shows the connection of the Announcement Circuit Pack to the system. To save or restore announcements, an ANNOUNCEMENT Data Extension must be administered, and at least one DATA-CHL (Network Control Data Channel) must be in the in-service/idle state.

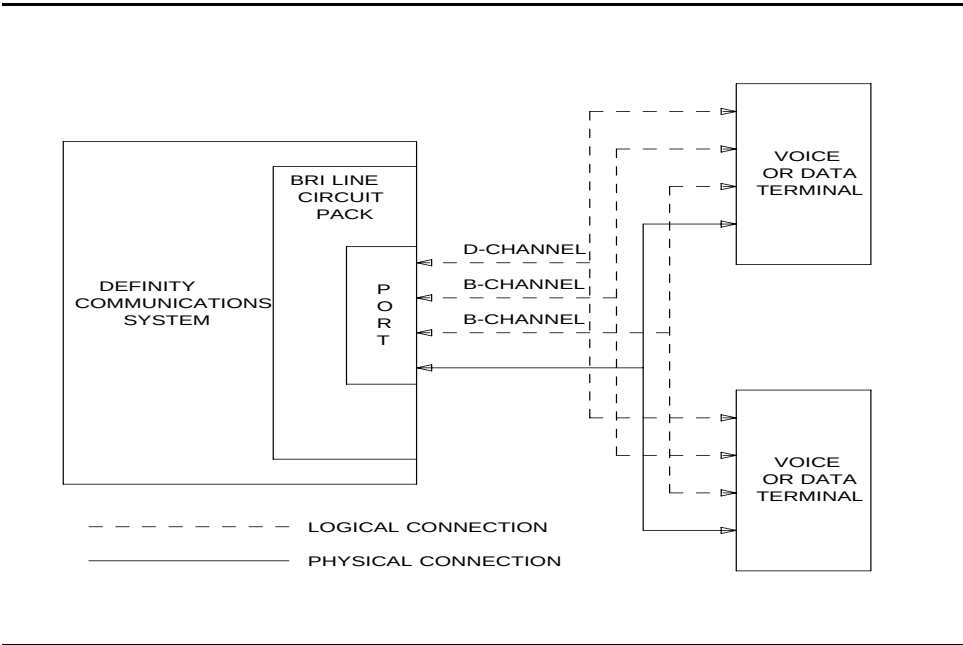
Figure 3-3. ISDN-BRI Port Interactions

[Figure 3-3 on page 3-200](#) illustrates the physical connection (solid line) between an ISDN-BRI Port and its associated ISDN-BRI set(s). Each physical connection allows for two B-channels and one D-channel. Each ISDN-BRI circuit pack can support up to 12 of these *physical* connections to different voice and voice/data sets or ASAI or Lucent adjuncts. On a TN2198 each ISDN-BRI circuit pack can support up to 12 *physical* connections to a NT1, which, in turn, connects to 2 terminals.

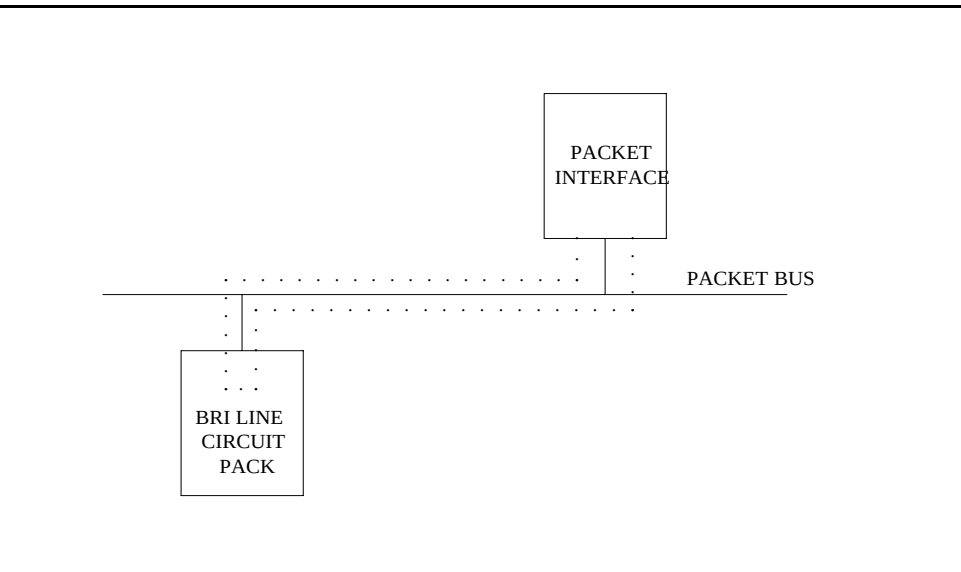
Figure 3-4. Path of the BRI Port Local LAN Loop Around

This test, which verifies the connectivity of a BRI port across the LAN Bus, executes only if the port is out-of-service. The test aborts if calls associated with the port are in-progress. Failures of this test indicate either on-board faults associated with the BRI-PORT hardware on the circuit pack or problems with the LAN Bus, which is used to form connectivity between the switch and the BRI-PORT.

The dotted lines in [Figure 3-4](#) show how a Loop Around Test is performed across the Packet Bus for the D-channel.
