**DEFINITY®**  
**Enterprise Communications Server**  
Release 9  
Maintenance for R9csi  
Volumes 1 and 2

555-233-119  
Issue 2  
November 2000

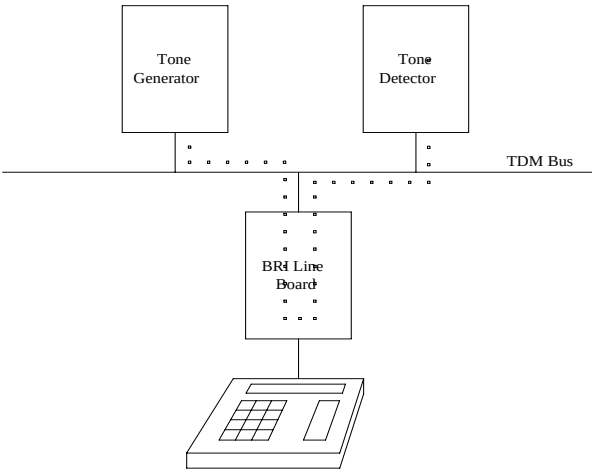
Figure 3-5. Path of the BRI Port Local TDM Loop Around

The dotted lines in [Figure 3-5 on page 3-209](#) show how a Loop Around Test is performed for the B-channels. The figure shows a terminal connected to a BRI line board using a TN556. If a TN2198 is used, the terminal would be connected to a NT1, and the NT1 to the BRI board.

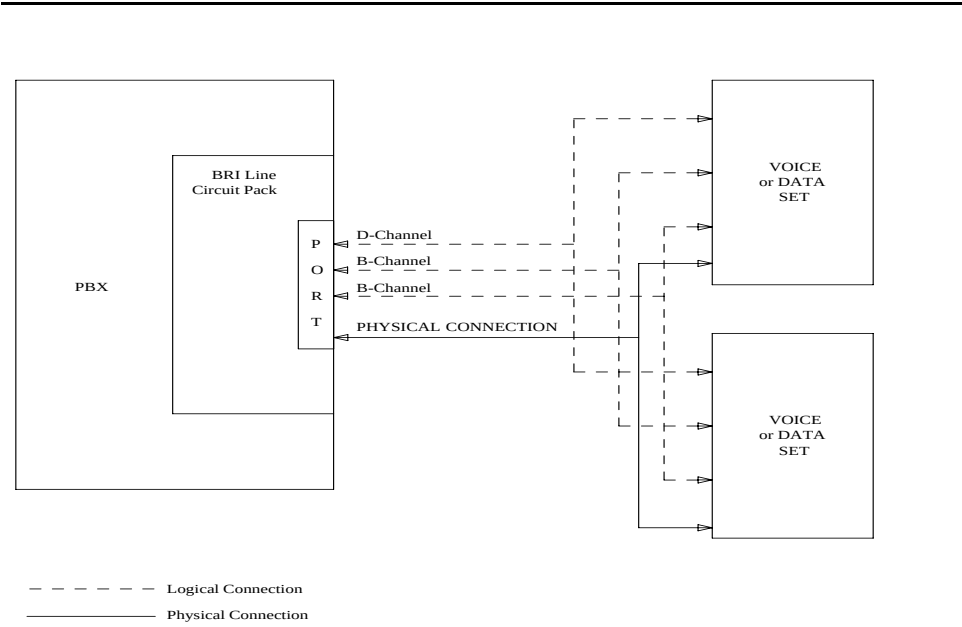
Figure 3-6. ISDN-BRI Set Interactions

Figure 3-6 illustrates the physical connection (solid line) between an ISDN-BRI Circuit Pack and a voice or voice/data set. Each physical connection allows for two B-channels, as stated above, plus one D-channel. Each ISDN-BRI circuit pack can support up to 12 of these PHYSICAL connections to different voice and voice/data sets or ASAI and Lucent adjuncts.

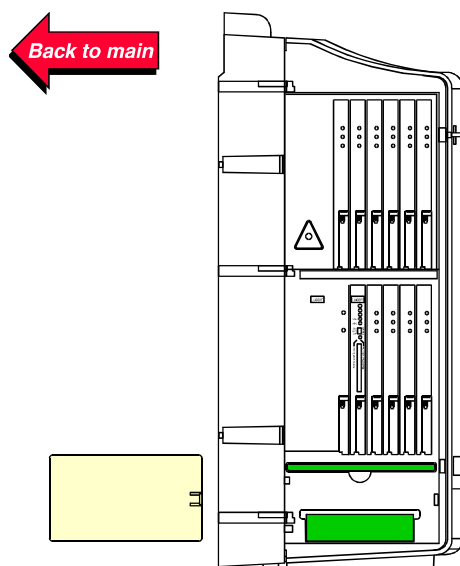
Figure 3-7. Fan/Filter Removal

1. Remove the left door.
2. Remove the fan/filter access panel. See [Figure 3-7](#).

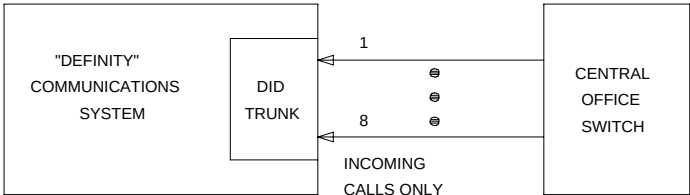
**Figure 3-8.** DID Trunk Interactions

The DID Trunk circuit packs support eight, incoming-only, ports. Each port provides an interface between the 2-wire analog line from the CO and the DEFINITY system. The DID port receives 3 to 5 digits from the CO that is used to directly connect an outside caller to the called station without assistance from an attendant. See [Figure 3-8](#).

For each call, the CO switch signals the system by opening and closing individual DID loops (one of the eight ports) and causing the starting or stopping of loop current.

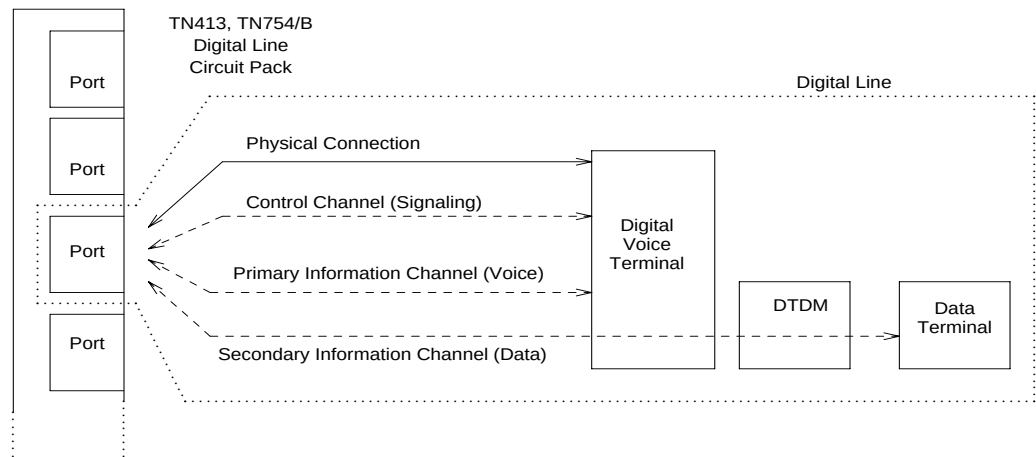
Figure 3-9. Digital Line Connectivity

It should be noted that TN2181 and TN2224 support both modes as shown in [Figure 3-9](#) and [Figure 3-10 on page 3-426](#).

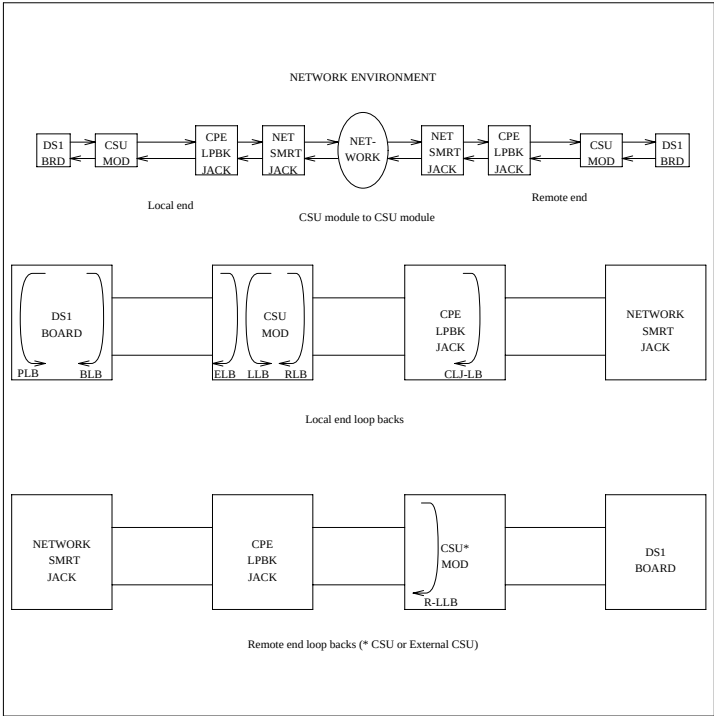
Figure 3-11. High Level Overview Of Loopback Points

The TN767E and 120A1 CSU Module support on-demand loopback tests that assist in the detection of faults between the TN767E circuit pack and the CSU Module, between the Integrated CSU and the optional Customer Premises Loopback Jack, or between the Integrated CSU and remote CSU. These loopback tests are explained in detail later in this DS1-BD section, but [Figure 3-11 on page 3-476](#) gives a high level overview of the loopback points.

- PLB = Payload Loopback
- BLB = Board Loopback
- ELB = Equipment Loopback
- LLB = Line Loopback
- RLB = Repeater Loopback
- CLJ = Loopback Jack Loopback
- R-LLB = Remote Line Loopback
- SMRT = Smart Jack
- LPBK = Loopback

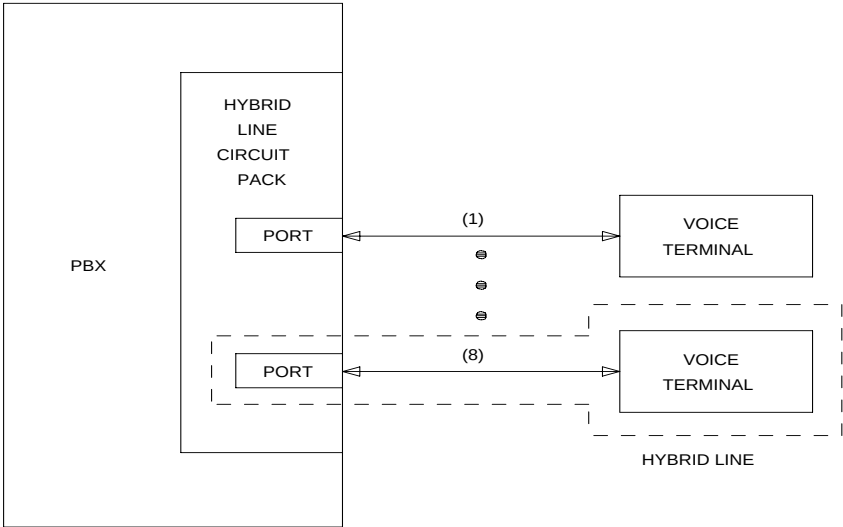
The TN762B Hybrid Line circuit pack supports eight of these multifunction analog telephone sets, as shown in the following figure. The Hybrid Line sets use three pairs of wires: an analog voice pair, a transmit/receive pair, and a power pair.

Figure 3-13. Hybrid Station Interactions

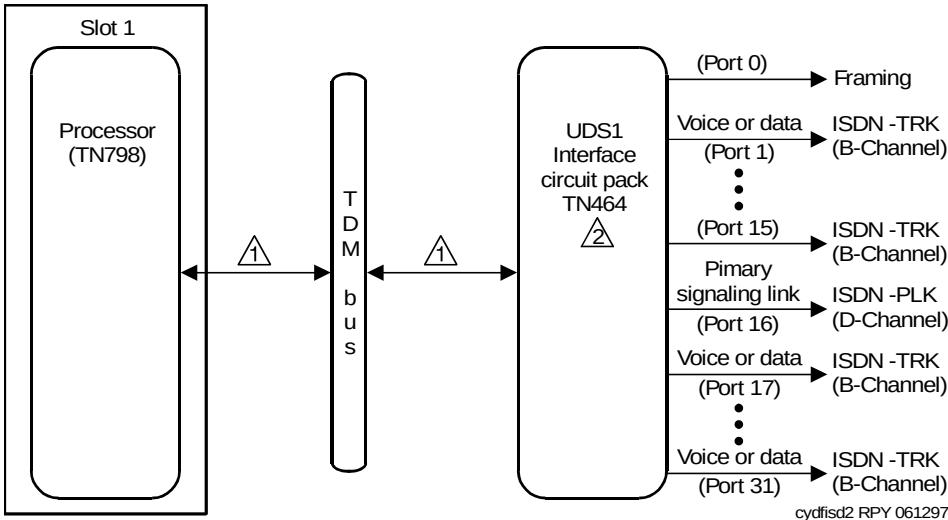
In a 32-channel system (see [Figure 3-14 on page 3-661](#)), the DS1 ISDN Trunk or PRI endpoint port (B-channels) may use any of the ports 1-15 or 17-31, but the ISDN-PRI Signaling Link Port must be the 16th port on the TN464C (or higher) circuit pack. In certain configurations (NFAS), the 16th port may be used as a B-channel. Refer to the “[ISDN-SGR \(ISDN-PRI Signaling Group\)](#)” Maintenance documentation for further details.

1. B- and D-channel messages are routed over the TDM Bus. For additional reliability, a duplex D-channel can be administered for a signaling group and located on a different TN464C (or higher) circuit pack.
2. TN464C or higher

Figure 3-14. ISDN-PRI Signaling Link Port Interactions (32-Channel - TN464)

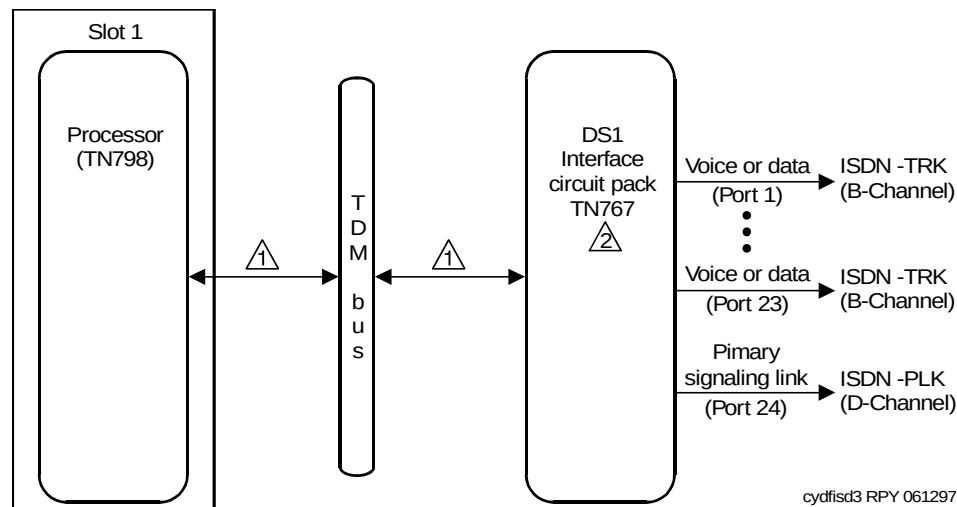
In a 24-channel system, the DS1 ISDN Trunk or PRI endpoint port (B-channels) may use any of the first 23 ports. The ISDN-PRI Signaling Link Port must be the 24th port (See [Figure 3-15 on page 3-662](#)). In certain configurations (NFAS), the 24th port may be used as a B-channel. Refer to the ISDN-PRI Signaling Group (ISDN-SGR) Maintenance documentation for further details.

1. B- and D-channel messages are routed over the TDM Bus. For additional reliability, a duplex D-channel can be administered for a signaling group and located on a different TN464C (or higher) circuit pack.
2. TN767B (or higher) or TN464C (or higher)

Figure 3-15. ISDN-PRI Signaling Link Port Interactions (24 Channel - TN767/464C)

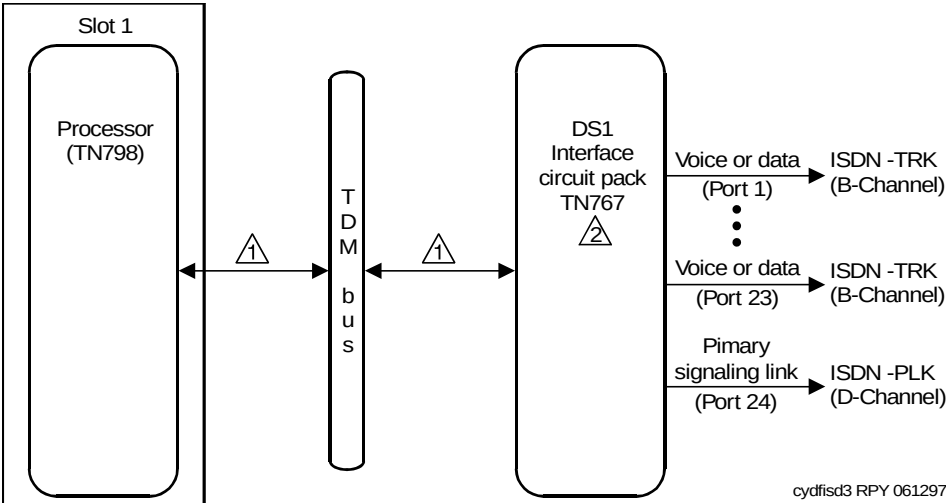
For 24-channel interfaces, the first 23 ports on the circuit pack are used as B-channels. The 24th port may be used as a B-channel or as a D-channel depending on the type of Signaling Group used (see [Figure 3-16 on page 3-667](#)).

1. B- and D-channel messages are routed over the TDM Bus. For additional reliability, a duplex D-channel can be administered for a signaling group and located on a different TN464C (or higher) circuit pack.

Figure 3-16. ISDN-PRI Signaling Link Port Interactions (24 Channel - TN767/464C)

The ISDN-PRI Signaling Link Port itself depends on the health of the DS1/UDS1 Interface circuit pack on which it resides. This test will fail if there are problems with either the ISDN-PRI Primary D-channel port or the DS1/UDS1 circuit pack. See [Figure 3-16 on page 3-667](#) for DS1 connections, [Figure 3-17 on page 3-668](#) for UDS1 connections.

See [Figure 3-16 on page 3-667](#) for DS1 connections, [Figure 3-17 on page 3-668](#) for UDS1 connections.

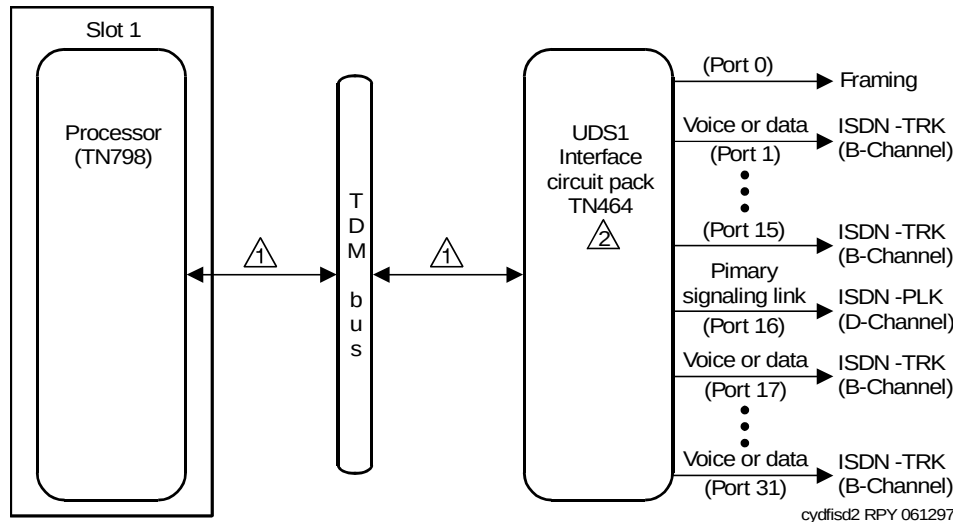
For 32-channel interfaces, ports 1-15 and 17-31 on the circuit pack are used as B-channels. The 16th port may be used as a B-channel or as a D-channel depending on the type of Signaling Group used (see [Figure 3-17 on page 3-668](#)).

1. B- and D-channel messages are routed over the TDM Bus. For additional reliability, a duplex D-channel can be administered for a signaling group and located on a different TN464C (or higher) circuit pack.
2. TN464C or higher

Figure 3-17. ISDN-PRI Signaling Link Port Interactions (32-Channel - TN464)

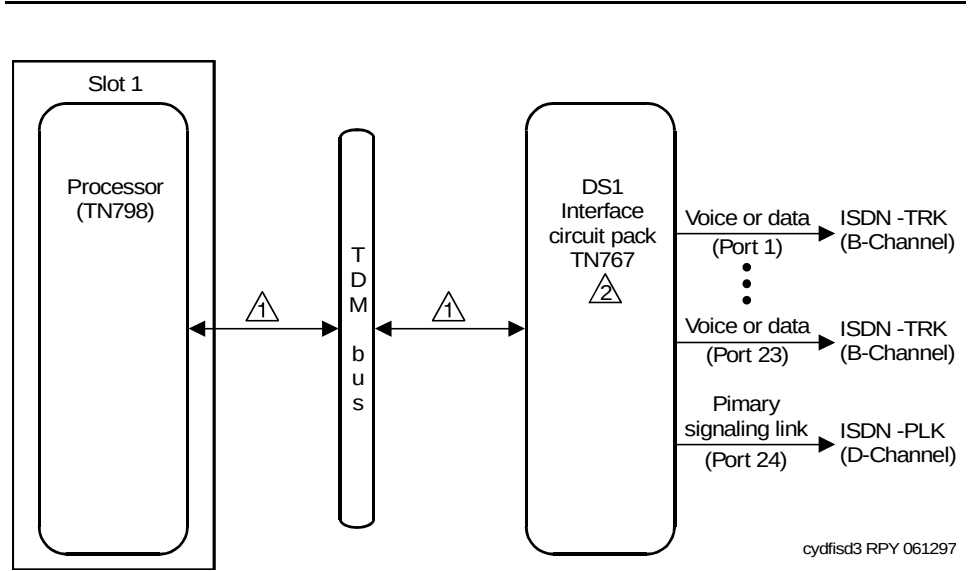
On 24-channel interfaces, any of the first 23 ports on the DS1/UDS1 interface circuit pack can be a B-channel. The 24th port may be used as a B-channel or as a D-channel depending on the type of ISDN-PRI Signaling Group (ISDN-SGR) to which it belongs.

1. B- and D-channel messages are routed over the TDM Bus. For additional reliability, a duplex D-channel can be administered for a signaling group and located on a different TN464C (or higher) circuit pack.
2. TN767B (or higher) for DS1; TN464C (or higher) for UDS1

Figure 3-18. DS1 ISDN Trunk Interactions (24 Channel - TN767/464C)

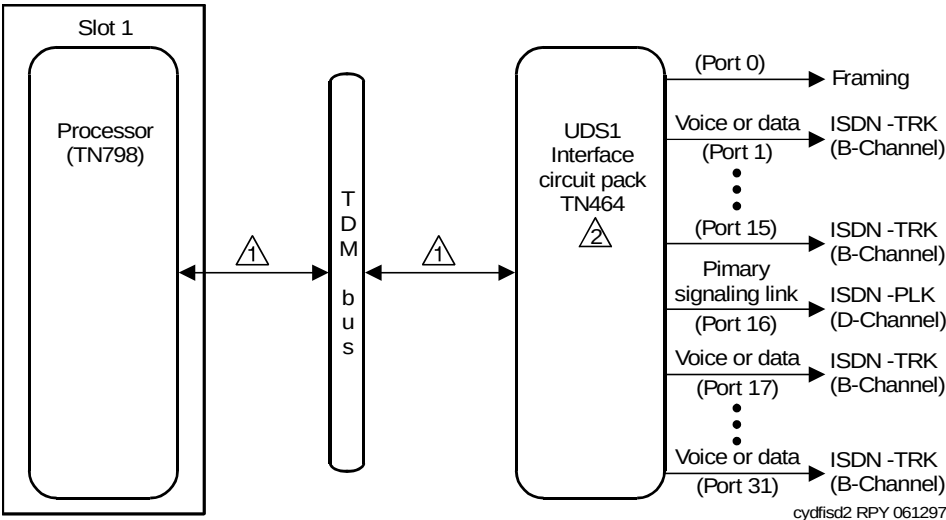
On 32 channel interfaces, any of ports 1-15 and 17-31 on the DS1 interface circuit pack can be a B-channel. The 16th port may be used as a B-channel or as a D-channel depending on the type of ISDN-PRI Signaling Group (ISDN-SGR) to which it belongs. For more details, refer to the ISDN-SGR and DS1-BD/UDS1-BD Maintenance documentation.

1. B- and D-channel messages are routed over the TDM Bus. For additional reliability, a duplex D-channel can be administered for a signaling group and located on a different TN464C (or higher) circuit pack.
2. TN464C or higher

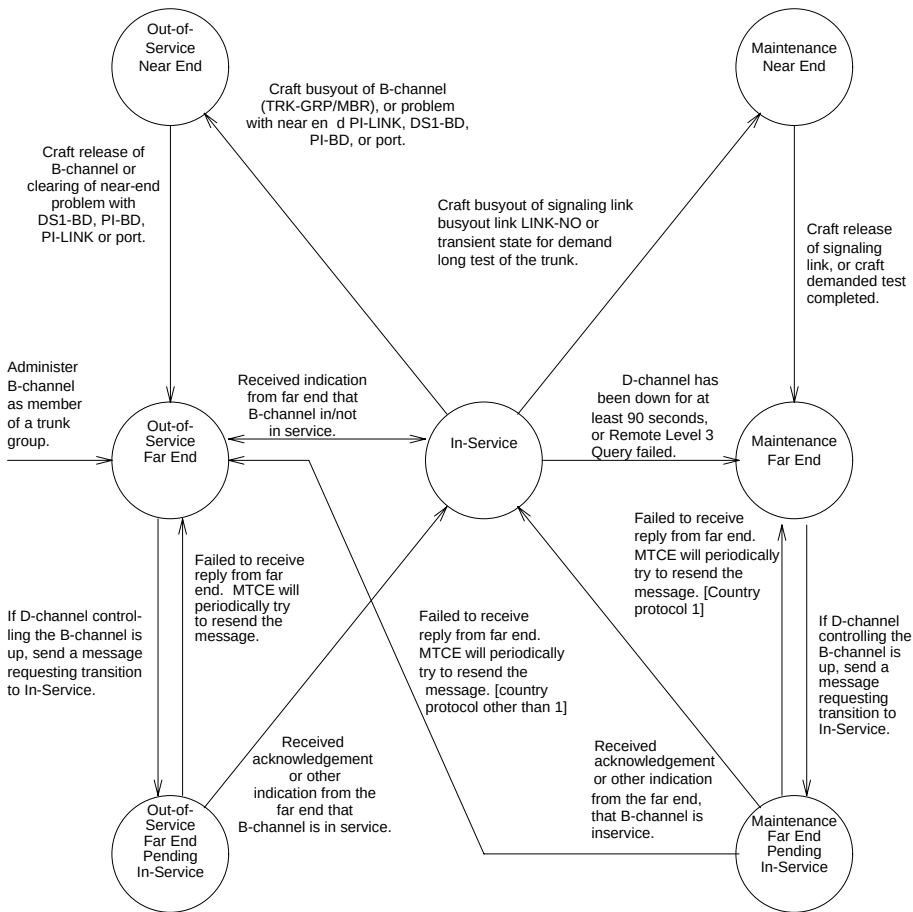
The following diagram of the DS1 ISDN Trunk service states shows the common progression from one service state to another and the event that caused the change of state.

Figure 3-20. Common Progressions in Service States

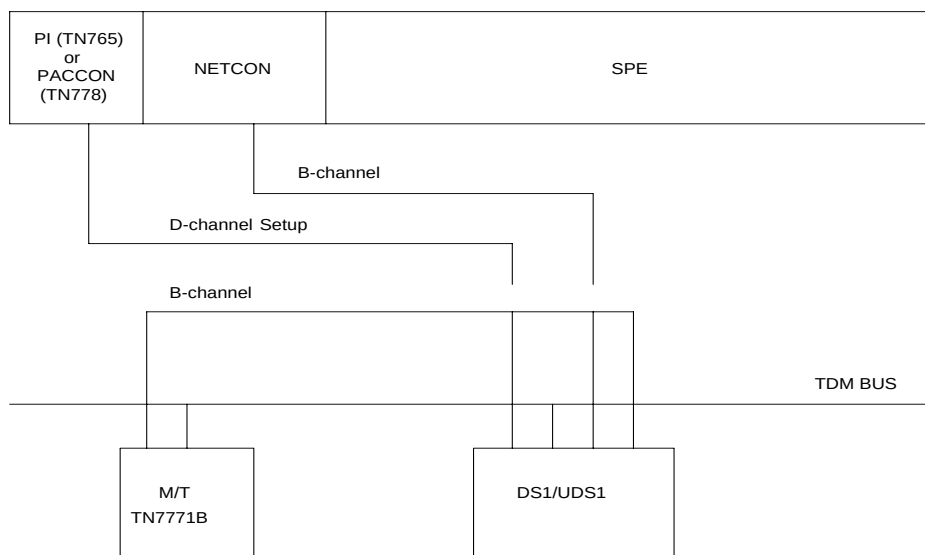
In the second method, the test call connection is established over the TDM Bus of the transmit and receive sides of the ISDN-PRI trunk to a digital trunk testing port on the Maintenance/Test circuit pack. The Maintenance/Test Digital Port generates a pseudo bit stream. A pictorial description of the outgoing ISDN-PRI test call connectivity is contained in [Figure 3-21 on page 3-703](#).

Figure 3-21. ISDN-PRI Outgoing Test Call

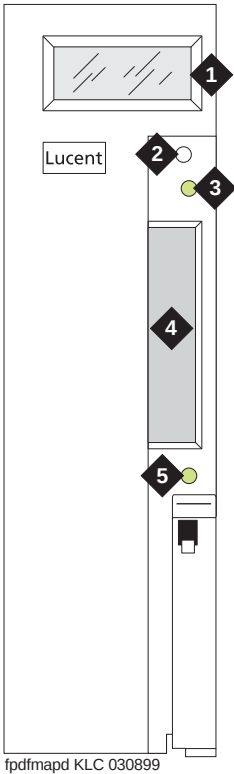
Figure 3-22 shows the TN802 faceplate.

1. LCD display (see [Table 3-307 on page 3-719](#))
2. Reset button (recessed)
3. Red board status LED
4. PCMCIA card slot
5. Yellow PCMCIA disk-in-use LED

Figure 3-22. TN802 faceplate

| Step | Description | Comments |
|---|---|---|
| 4. | Wait | Wait until the yellow Disk-In-Use LED (Note 5 in <a href="#">Figure 3-22 on page 3-718</a> ) light is out. |

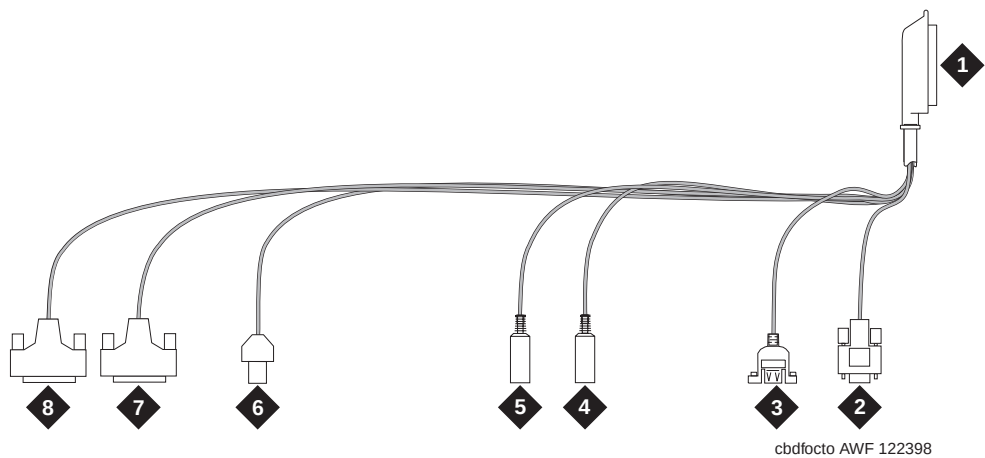
6. Click on the new item icon and the laptop connects to the host pcANYWHERE<sup>®</sup> application on the TN802 circuit pack.

1. To TN802 cabinet backplane

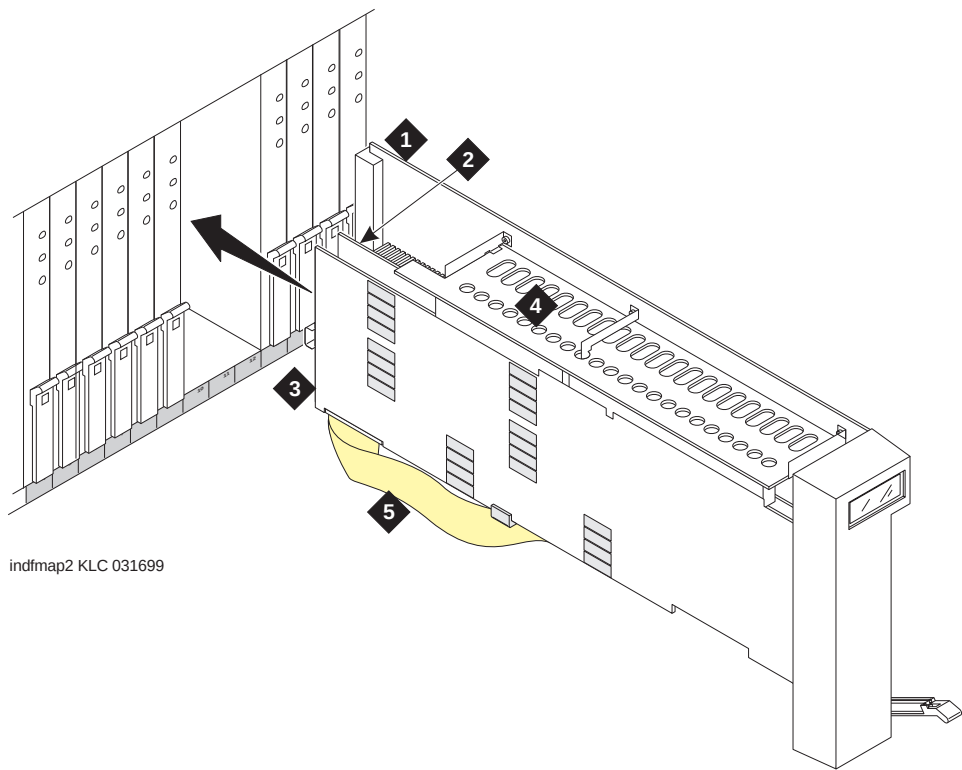
Figure 3-24 shows the circuit pack with the two additional boards connected through the side plane.

Figure 3-24. TN802 board assembly

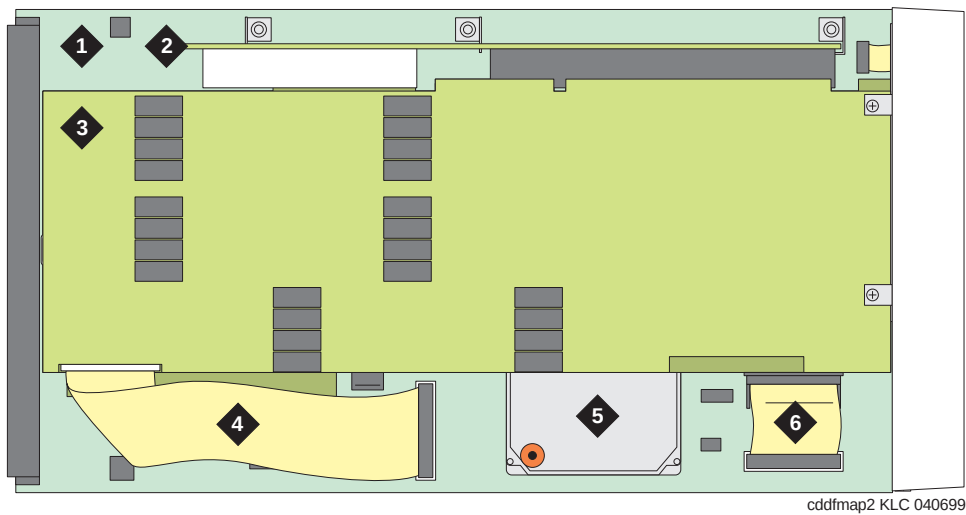
Figure 3-25 shows a side view of the three boards and interconnecting cables that make up the TN802.

Figure 3-25. TN802 board assembly and cables (side view)

- a. Verify the IP address
  - b. Check the physical connections to and from the TN802 circuit pack.
  - c. Check the internal cables on the TN802 circuit pack (Notes 4 and 6 in [Figure 3-25 on page 3-725](#)).
  - d. Try pinging another device on the same subnet.
  - e. Try pinging the gateway to the rest of the network from the subnet.
  - f. Try pinging a device not on the local subnet but on the network or another subnet.
5. When finished, at the command prompt type **exit** and press Enter.

- a. Check that the internal cables on the TN802 circuit pack (Notes 4 and 6 in [Figure 3-25 on page 3-725](#)) have not worked loose.
- b. Otherwise, replace the circuit pack.

- a. Check that the internal cables on the TN802 circuit pack (Notes 4 and 6 in [Figure 3-25 on page 3-725](#)) have not worked loose.
  - b. Otherwise, replace the circuit pack.
4. At the command prompt, type **ping 10.32.64.96** (the IP address of the internal Motorola MPC860 processor) and press Enter.

- a. Check that the internal cables on the TN802 circuit pack (Notes 4 and 6 in [Figure 3-25 on page 3-725](#)) have not worked loose.
  - b. Otherwise, replace the circuit pack.
5. Ping the gateway: at the command prompt, type **ping XX.XXX.XXX.XXX** (the IP address of the gateway) and press Enter.
6. When finished, at the command prompt type **exit** and press Enter.

The TN802 hard drive (Note 5 in [Figure 3-25 on page 3-725](#)) is field-replaceable.

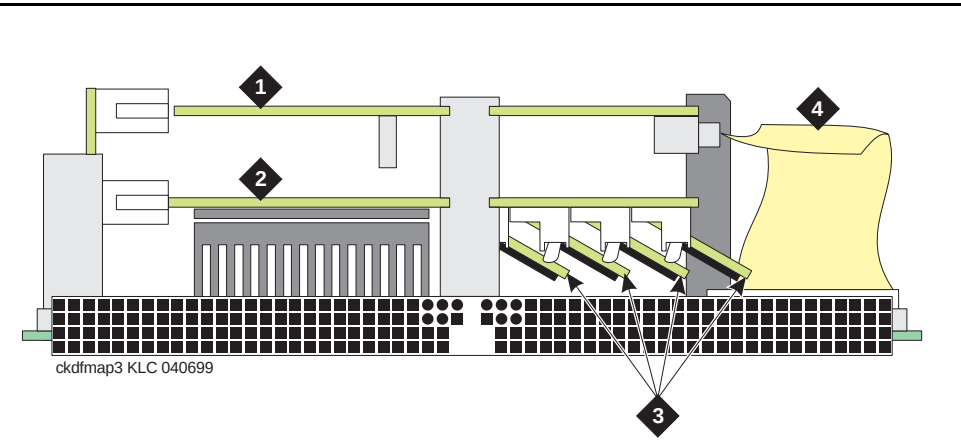
Figure 3-26 shows the end view of the three boards and interconnecting cables on the TN802.

Figure 3-26. TN802 board assembly and cables (end view)

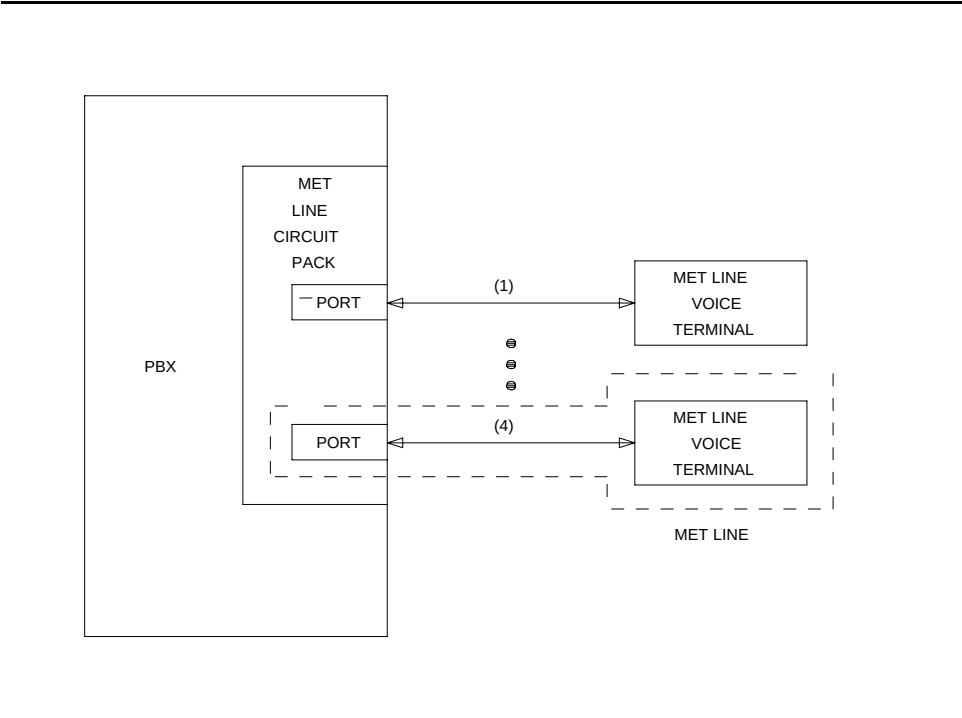
The TN735 MET Line circuit pack supports four of these METsets. Each MET set uses three pairs of wires: an analog voice pair, a transmit pair, and a receive pair. Power is sent over the transmit and receive pairs. The MET Line circuit pack supports all 10-, 20-, and 30-button sets.

Figure 3-27. MET Line Interactions

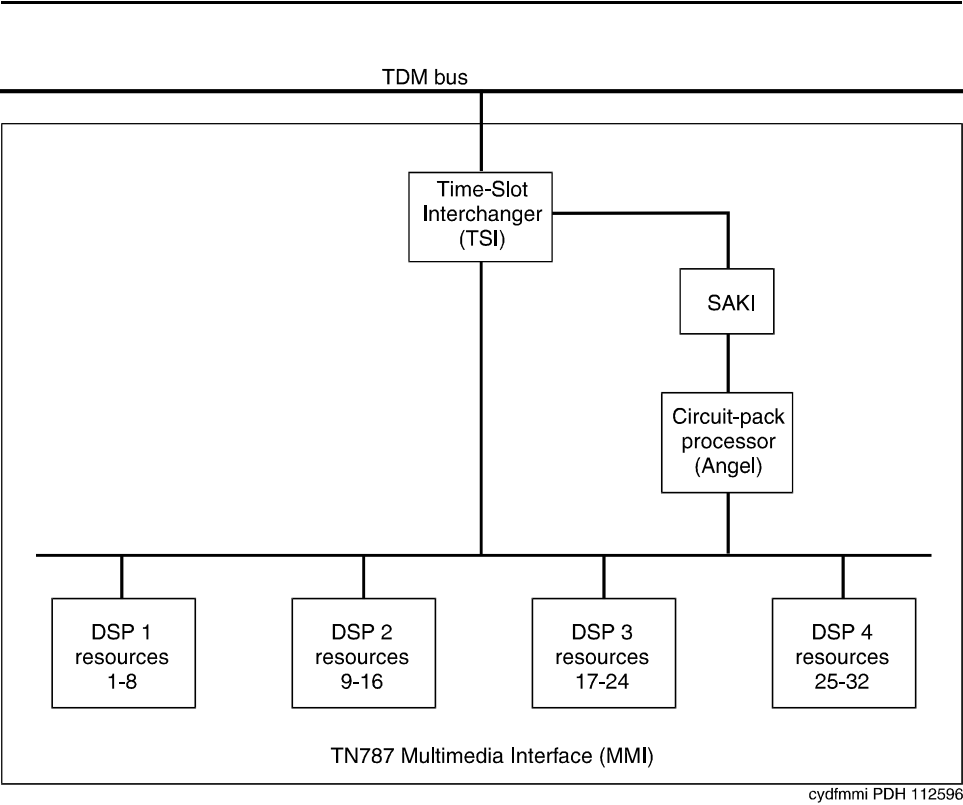
Figure 3-28. TN787 Multimedia Interface (MMI) Circuit Pack

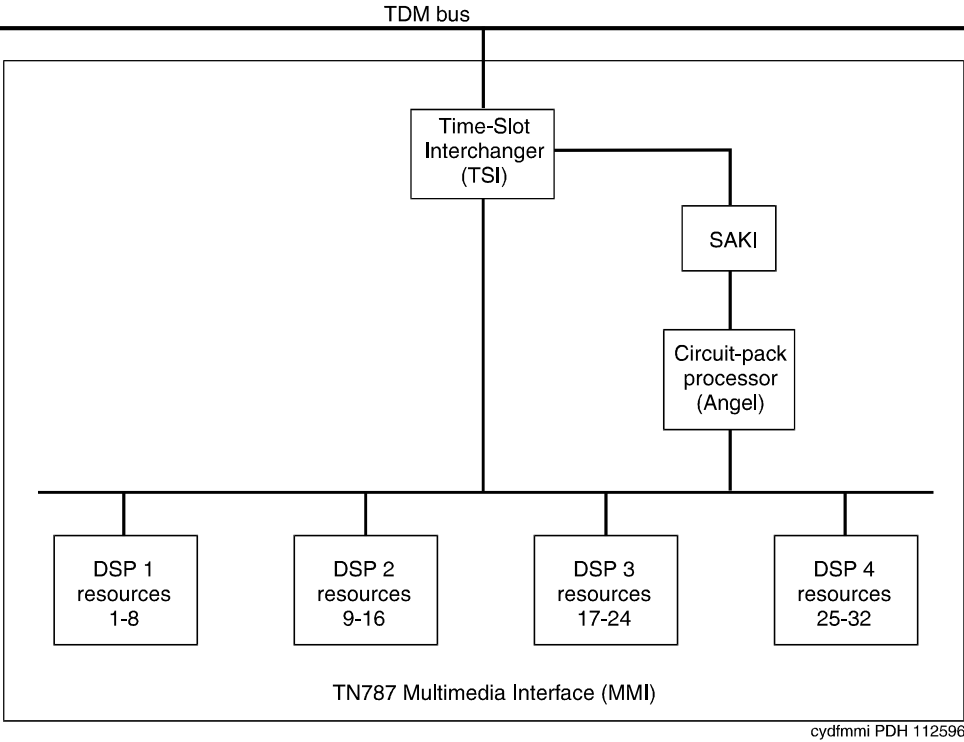
All 8 resources that the circuit pack controls may be placed out of service by the failure of one of these DSPs.

Figure 3-29. TN787 Multimedia Interface (MMI) Circuit Pack

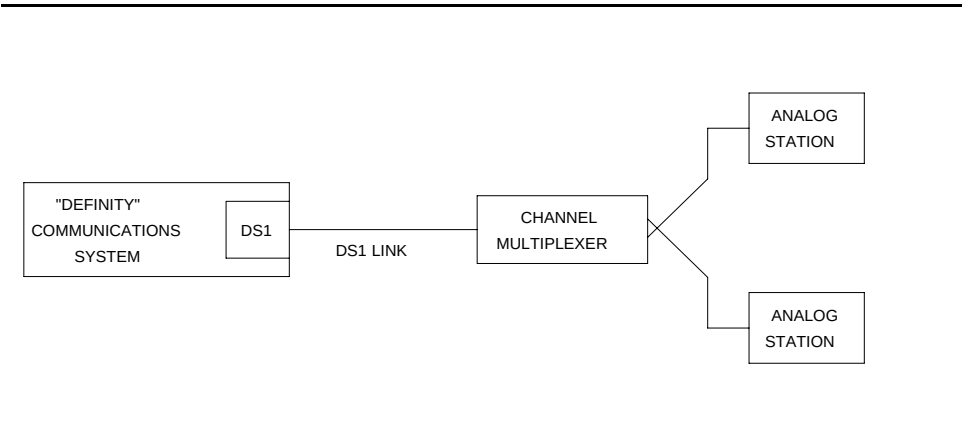
An analog Off-Premises Station (OPS) can be connected to the system through a DS1 link. A TN767 DS1 Interface circuit pack supports up to 24 DS1OPSs. Since the DS1OPS is an analog telephone set, a channel multiplexer is necessary as the remote DS1 endpoint that converts the digital signal of a DS1 port to the OPS Line and vice versa. See [Figure 3-30](#) for details.

Figure 3-30. DS1 OPS Line Interactions

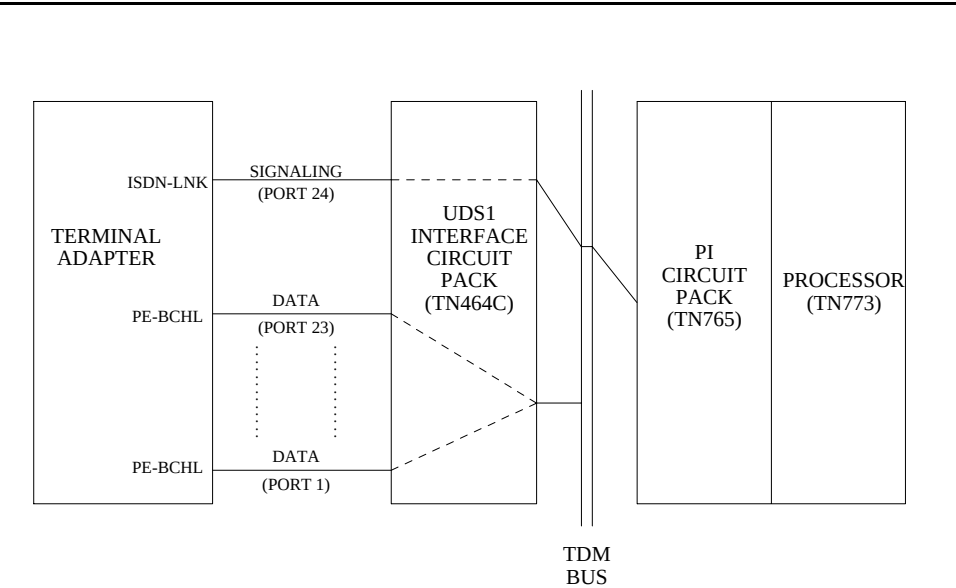
A PRI Endpoint Port is a port on a UDS1 interface circuit pack. Therefore, this port depends on the health of the UDS1 interface circuit pack for proper operation (see [Figure 3-31](#)). As noted earlier, a PRI Endpoint Port B-channel also depends on an ISDN-PRI Signaling Link Port D-channel (ISDN-LNK) to carry the signaling traffic. If there is a problem with the ISDN-PRI Signaling Link Port, the PRI Endpoint Port is affected. The ISDN-PRI Signaling Link Port, in turn, depends on the PKT-INT (Packet Interface).

Figure 3-31. PRI Endpoint Port Interactions [INTEL]

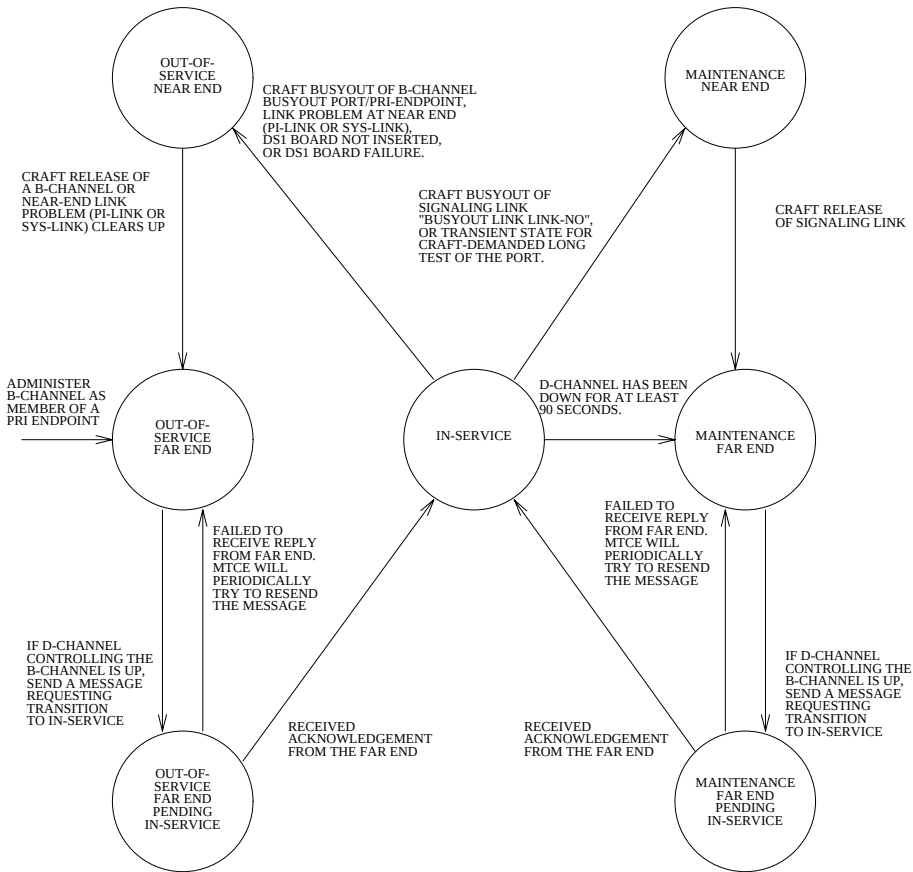
The following diagram of the PRI Endpoint Port service states shows the common progression from one service state to another and the event that caused the change of state.

Figure 3-32. Common Progressions in Service States

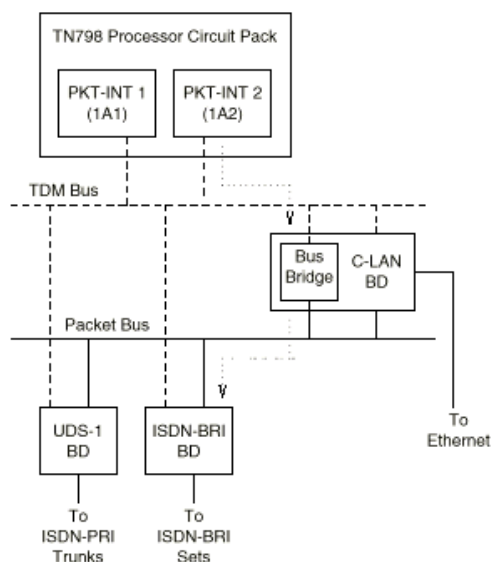
- The system contains at least one TN799 C-LAN circuit pack, and
- The *Packet Intf2?* field on the Maintenance-Related System Parameters form is set to "y".

**Figure 3-33. PKT-INT Connections**

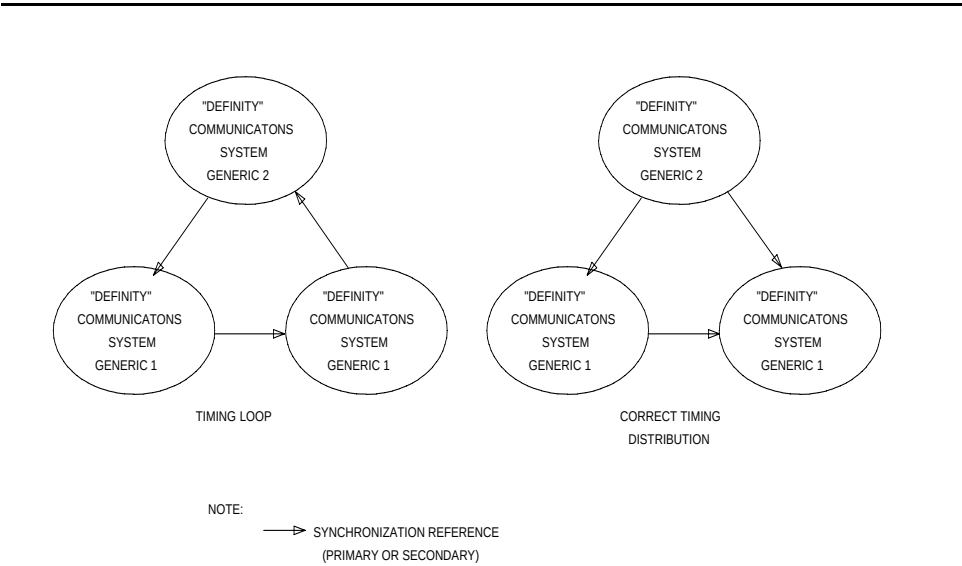
The system synchronization planner must avoid creating a *timing loop* when administering the primary and secondary synchronization references in a system. A timing loop exists whenever a system receives timing from another system whose timing reference is directly or indirectly derived from itself. Timing loops can lead to loss of digital data between systems that are exchanging data with any system within the loop. An invalid timing signal is also generated by any system within the loop, thus propagating the invalid timing signal to any system(s) using a system within the loop as a synchronization reference. [Figure 3-34 on page 3-982](#) shows a timing loop and a correct distribution of timing between the systems.

Figure 3-34. Synchronization Timing Loop

A correctly designed network has no loops and each piece of equipment in the network is supplied by a clock of equal or lower stratum (that is, the inputs to a Stratum 3 clock should NEVER be from a Stratum 4 device). **It is strongly recommended that the network administrator be consulted before administering any synchronization changes.**

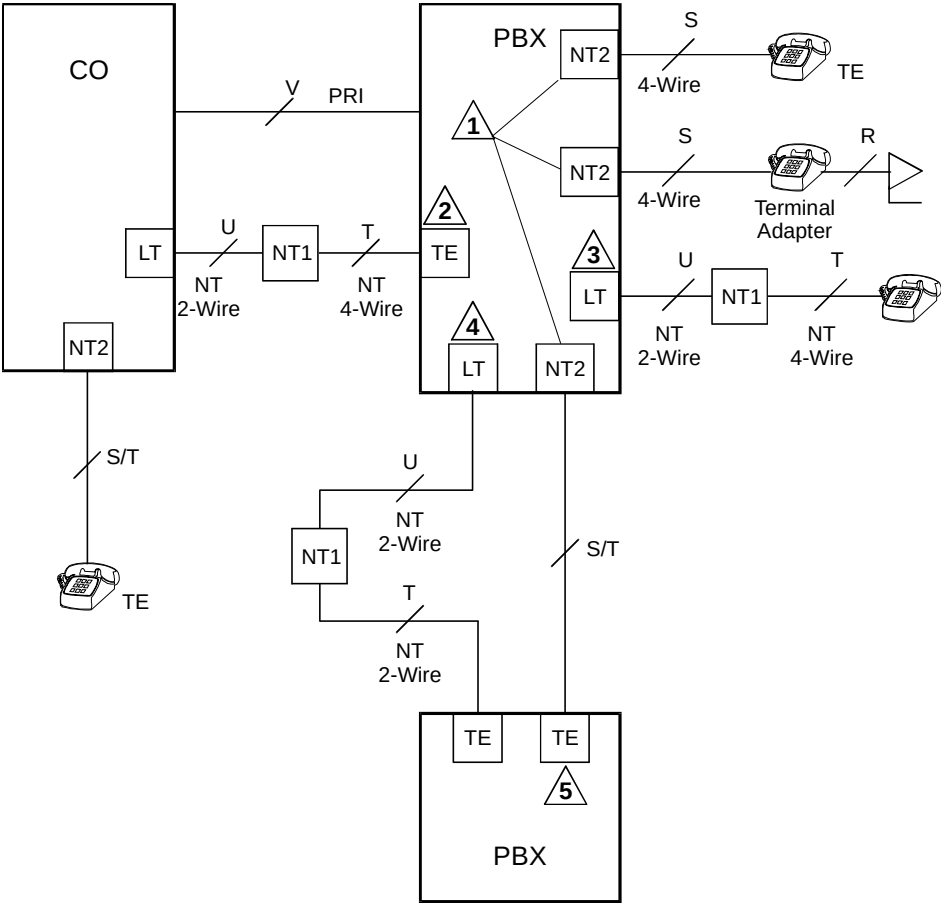
ISDN Interface Reference Points cydfisdn RPY 072397

Figure 3-36. Integrated Trunk-Side BRI, ISDN Interface Reference points

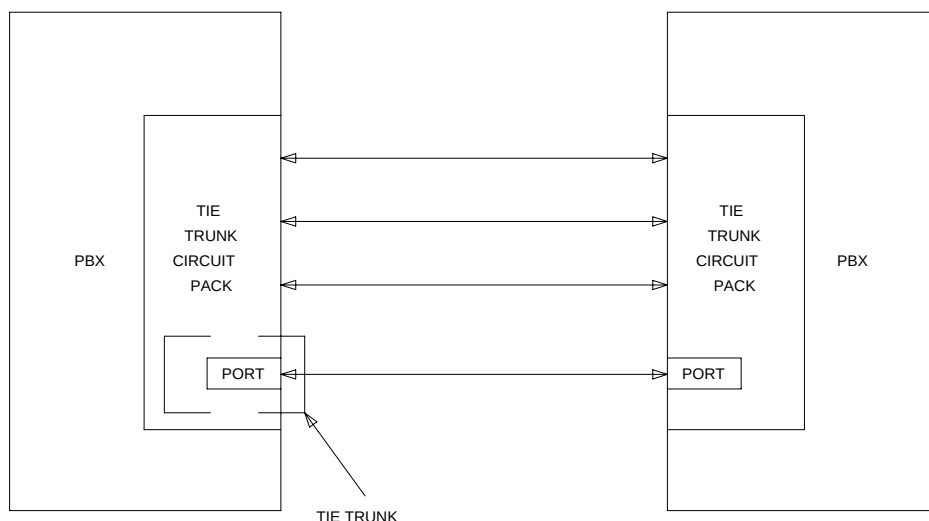
**Figure 3-37. Tie Trunk Interactions**

The Tie Trunk circuit pack fits into a port slot and contains four trunk circuits (see [Figure 3-37 on page 3-1085](#)). Each tie trunk for the TN497 circuit packs has 2-wire audio connection/signal leads (A and B).

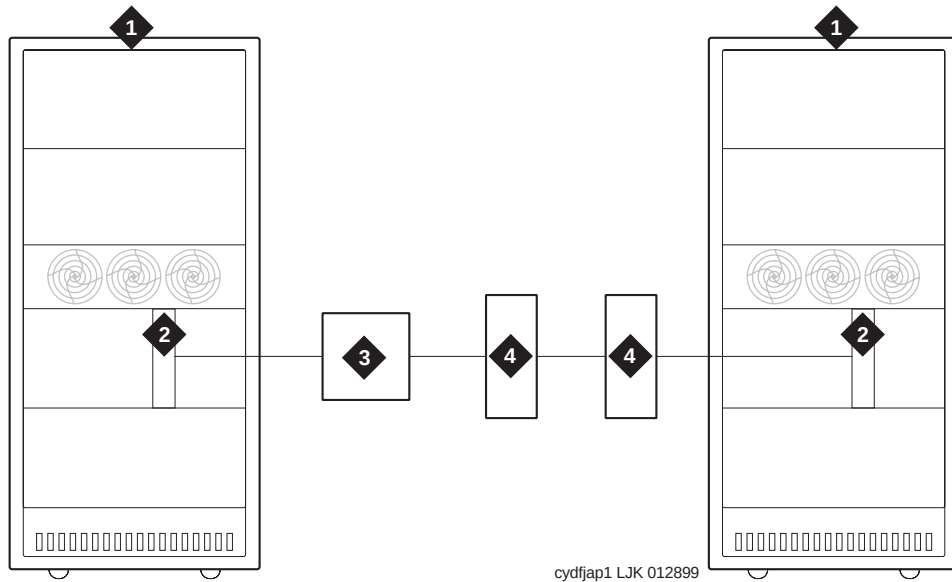
Figure 3-38 shows the hardware connections for public network access in Japan. The upgrade procedure requires removing the JRC (Japan Radio Corporation) external converter in Figure 3-38.

1. DEFINITY Release 7
2. UDS1-BD DS1-CONV circuit pack (24-trunk digital tie-trunk)
3. JRC (Japan Radio Corporation) external converter
4. TDM facilities

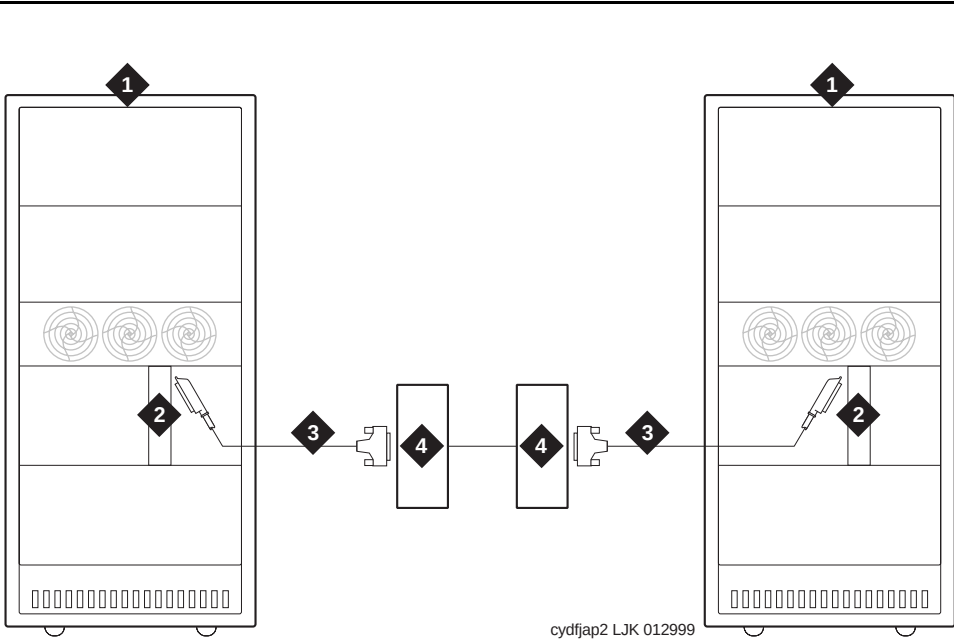
**Figure 3-39. TN2242 Japan trunk TTC private network connections**

Figure 3-39 shows the hardware connections for private network access using the TN2242 circuit pack.

1. DEFINITY Release 7

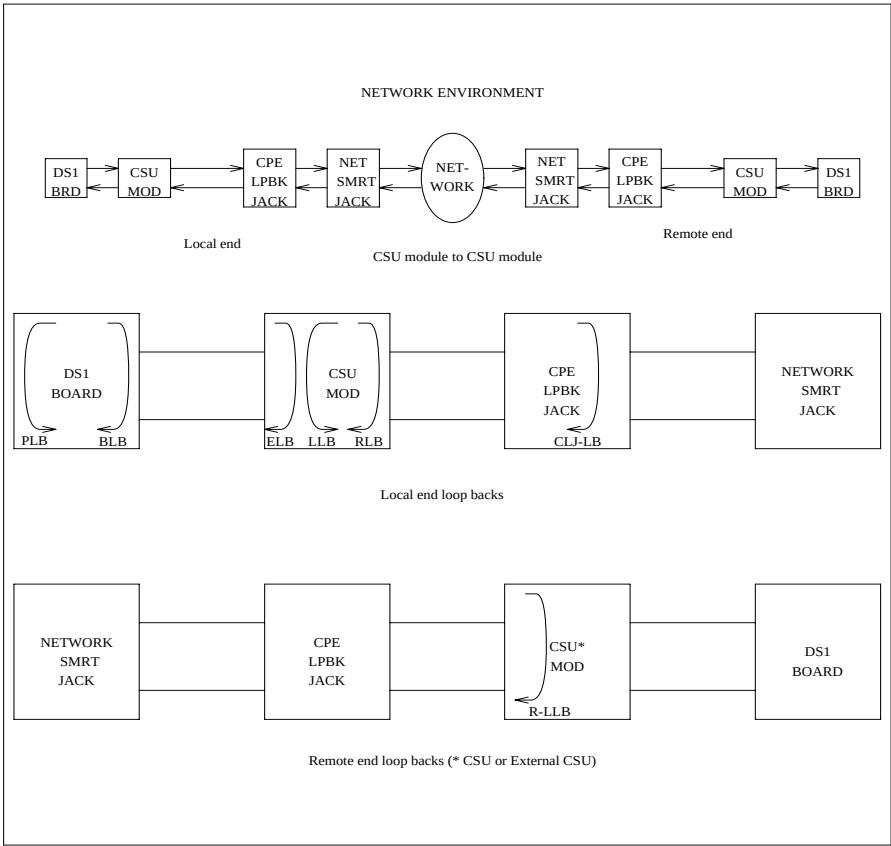
Figure 3-40. High Level Overview Of Loopback Points

The UDS1-BD and 120A1 CSU Module support on-demand loopback tests that assist in the detection of faults between the UDS1-BD circuit pack and the CSU Module, between the Integrated CSU and the optional Customer Premises Loopback Jack, or between the Integrated CSU and remote CSU. These loopback tests are explained in detail later in this UDS1-BD MO, but [Figure 3-40](#) gives a high level overview of the loopback points.

The following list of acronym definitions are for the [Figure 3-40 on page 3-1152](#):

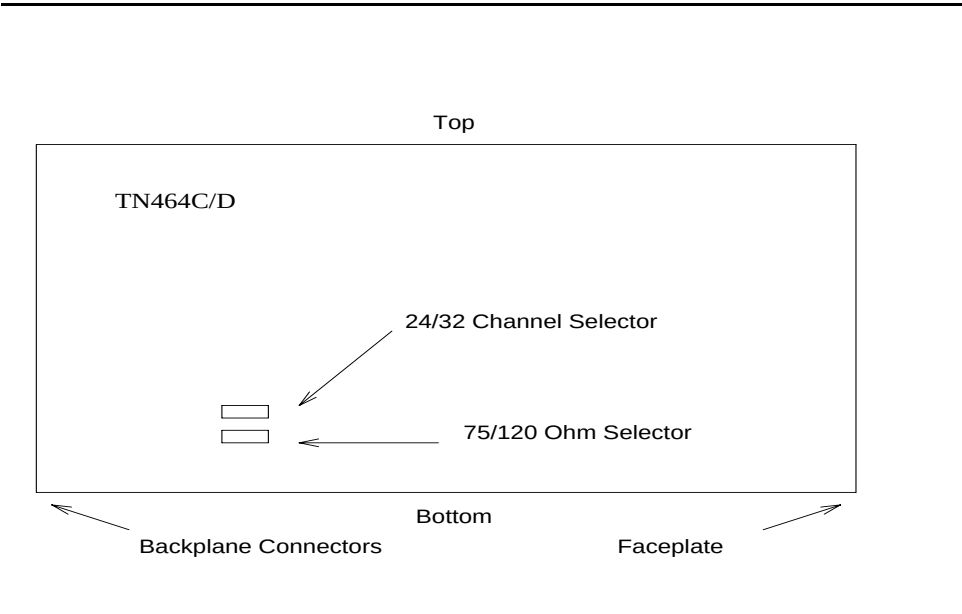
Figure 3-41. TN464C/D DS1 Option Jumpers

Two option jumpers located on the side of the TN464C/D circuit pack must be installed correctly. The figures on the following page show how to configure the circuit pack for 24-channel or 32-channel DS1, and for 75\*W (coaxial) or 120\*W trunk connections. The channel selection must match the parameters administered on the corresponding **DS1 Circuit Pack** Form. (US applications use 24 Channels.)

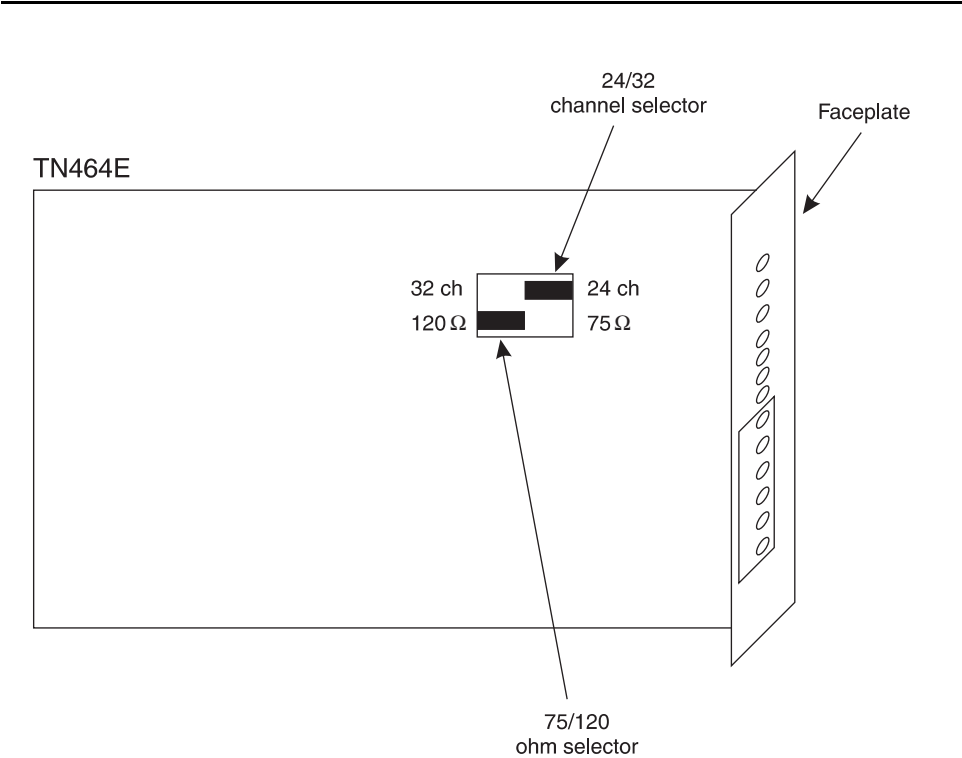
Figure 3-43. TN464E/F DS1 Option switches

The option switch located on the component side of the TN464E/F circuit pack must be set correctly. [Figure 3-43 on page 3-1155](#) shows how to configure the circuit pack for 24-channel or 32-channel DS1. The channel selection must match the parameters administered on the corresponding **DS1 Circuit Pack Form**. (US applications use 24 Channels.)
