**DEFINITY®**  
**Enterprise Communications Server**  
Release 9  
Maintenance for R9csi  
Volumes 1 and 2

555-233-119  
Issue 2  
November 2000

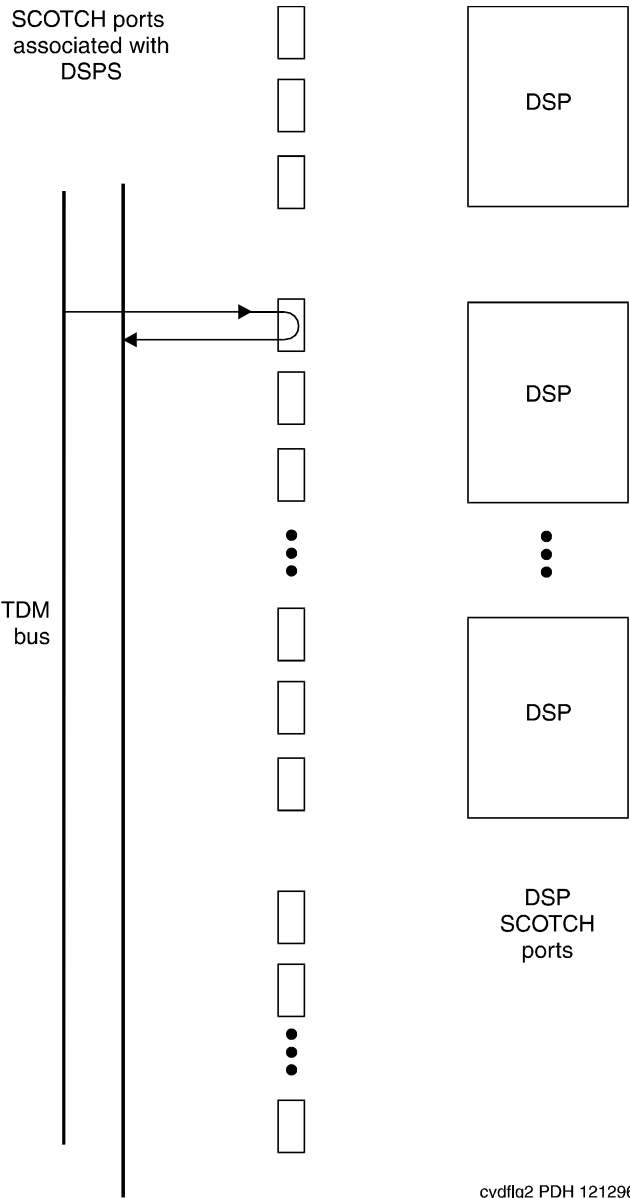
Figure 3-44. VC Circuit Pack DSP Port Local TDM Loopback Test

This test verifies the connectivity of a VC DSP Port across the TDM bus. It aborts if calls associated with the port are in progress. Failure of this test indicates an on-board fault associated with the port hardware on the circuit pack. The Loopback Test runs the following tests (refer to [Figure 3-44 on page 3-1254](#)):

1. A looparound test across the TDM bus.
2. A conference circuit test.

The tests are run in the above order; if one test fails, an error code is returned and the remaining tests in the sequence are not executed.

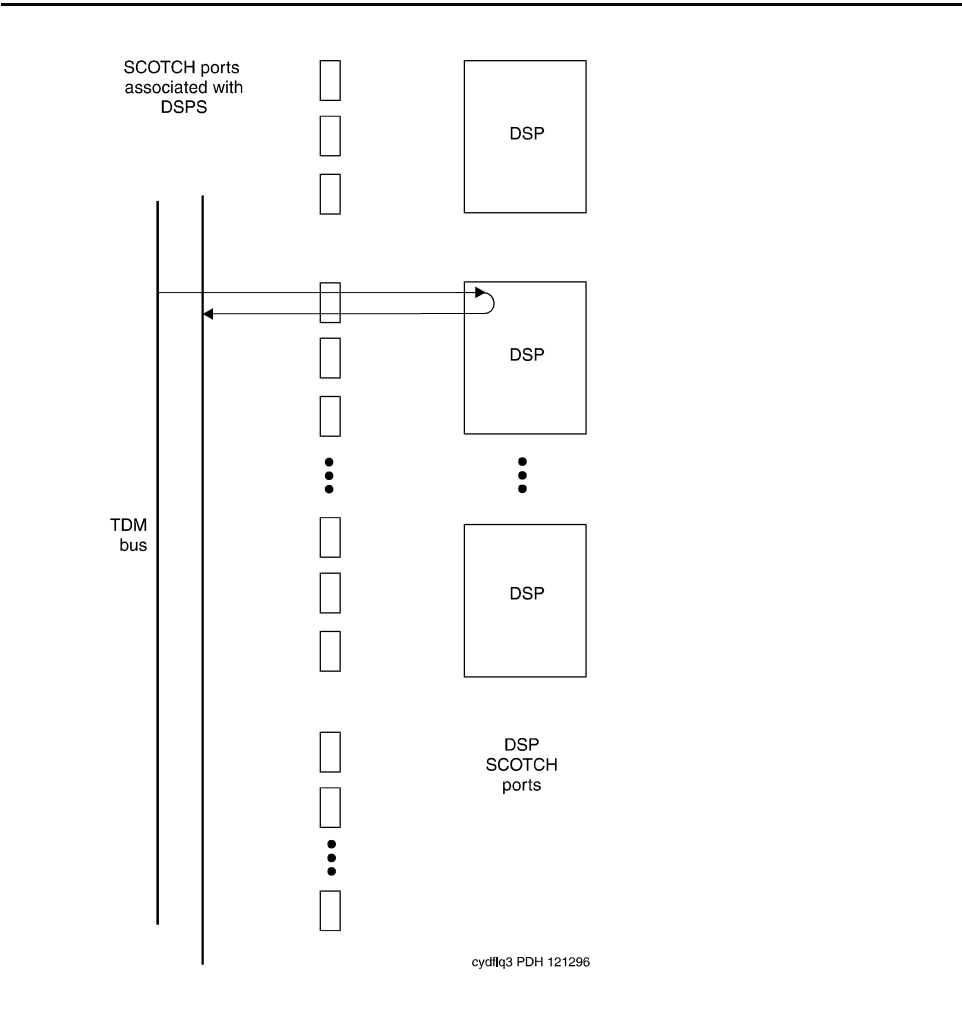
Figure 3-45. VC Circuit pack DSP Port DSP Looparound Test

This test verifies the connectivity of a VC-DSPPT across the TDM bus as shown in [Figure 3-45](#). It aborts if calls associated with the port are in progress. Failure of this test indicates an on-board fault associated with the port hardware on the circuit pack.
