# **Maintenance for Avaya DEFINITY® Server CSI**

Volumes 1 and 2

Release 1.2  
555-233-119  
Issue 5  
October 2002

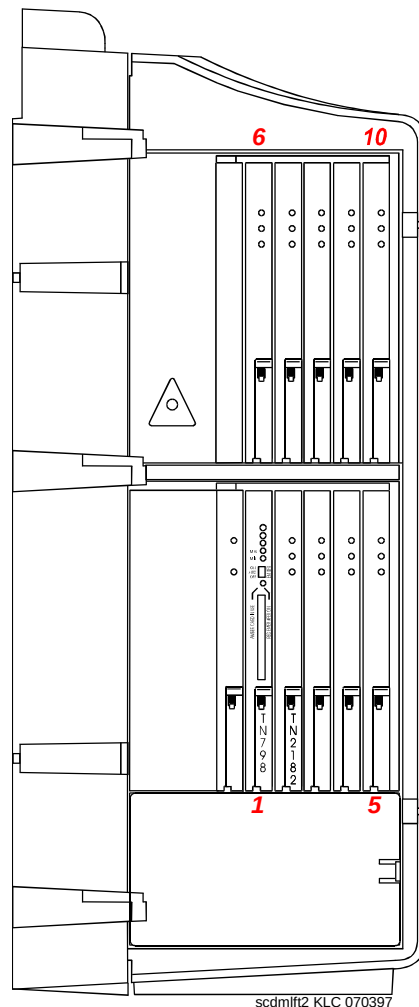
**Figure 1. Compact Modular Cabinet (CMC1) slot configuration**

- The RISC-based TN2402/TN798 Processor circuit pack must be located slot 1. [Figure 1](#) shows the Flash Memory Card slot for translations.
- TN2182 Tone-Clock must be installed in slot 2. This is the only Tone-Clock circuit pack allowed in the CMC1.
- Service circuit packs are the only packs allowed in the CMC1. These “universal” service packs can be located in any slot numbered 3-10.
- AUDIX, if present, requires 4 slots (slots 6-9 on the top row).
- MAPD requires 2 slots if administered in slot 7, otherwise, installation requires 3 slots.

All circuit pack slots in the Compact Modular Cabinet (CMC1) are “universal slots.” Any slot can contain any type of circuit pack (port, control, or service), so there is no purple and white slot coding that is found on other Avaya Definity Server products.

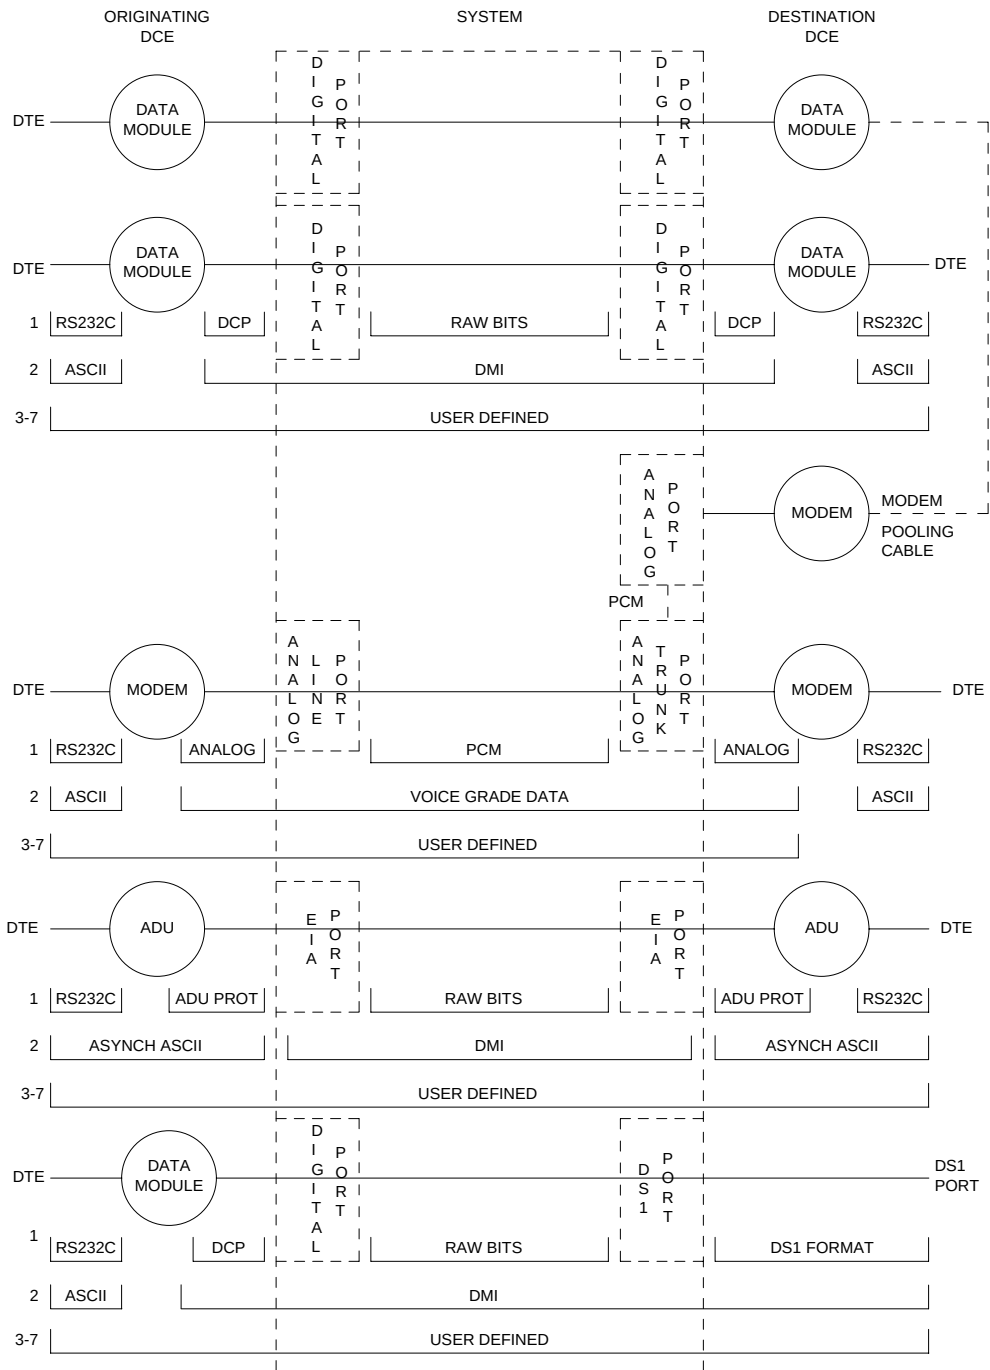
Figure 2. Data Transmission States

Layer 2, or the *data-link layer*, refers to code created and interpreted by the DCE. The originating equipment can send blocks of data with the necessary codes for synchronization, error control, or flow control. With these codes, the destination equipment checks the physical-link reliability, corrects any transmission errors, and maintains the link. When a transmission reaches the destination equipment, it strips any layer-2 information the originating equipment may have inserted. The destination equipment only passes to the destination DTE equipment the information sent by the originating DTE equipment. The originating DTE equipment can also add layer-2 code to be analyzed by the destination DTE equipment. The DCE equipment treats this layer as data and passes it along to the destination DTE equipment as it would any other binary bits.

Layers 3 to 7 (and the DTE-created layer 2) are embedded in the transmission stream and are meaningful only at the destination DTE equipment. Therefore, they are shown in the figure as “user-defined,” with no state changes until the transmission stream reaches its destination.

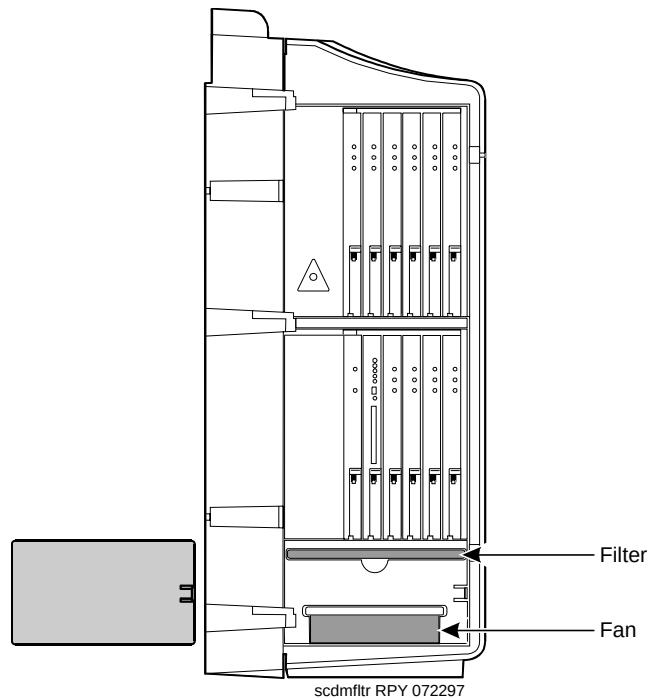
**Figure 3. Fan/Filter Removal**

1. Remove the left door.
  2. Remove the fan/filter access panel. See [Figure 3 on page 16](#).
-

1. Remove the fan access panel from the left side of the cabinet.
2. Pull the fan filter from the chassis.
3. Clean (vacuum or wash with water) or replace the filter as needed and slide the filter back into the chassis.
4. Replace the fan access panel.

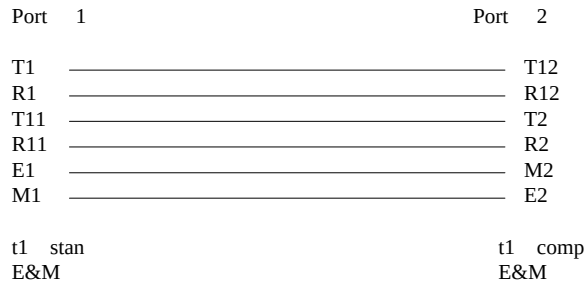
13. Use jumper wires (DT 24M-Y/BL/R/G and DT 24P-W/BRN) and the D Impact Tool to connect wiring between the two ports assigned in Step 9 at the cross-connect field. For example, if the two ports on the Analog Tie Trunk circuit pack are port 1 and 2, connect the wirings as shown below:

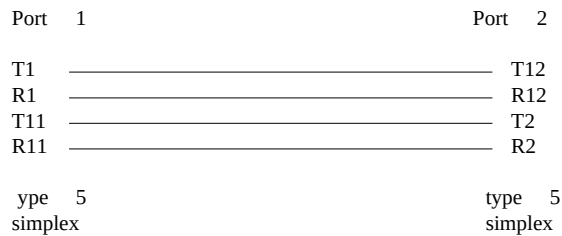
4. Locate the Tie Trunk port terminal connections at the cross-connect field. See [Table 7 on page 54](#).
5. At the cross-connect field, use the D Impact Tool (AT-8762) to disconnect outside trunk facilities from the Analog Tie Trunk ports and mark the disconnected wires for later when the Tie Trunk ports are placed back into normal operation.
6. Use jumper wires (DT 24M-Y/BL/R/G) and the D Impact Tool to connect wiring between the two ports assigned in Step 3 at the cross-connect field. For example, if the two ports on the Analog Tie Trunk circuit pack are ports 1 and 2, connect the wirings as shown below:

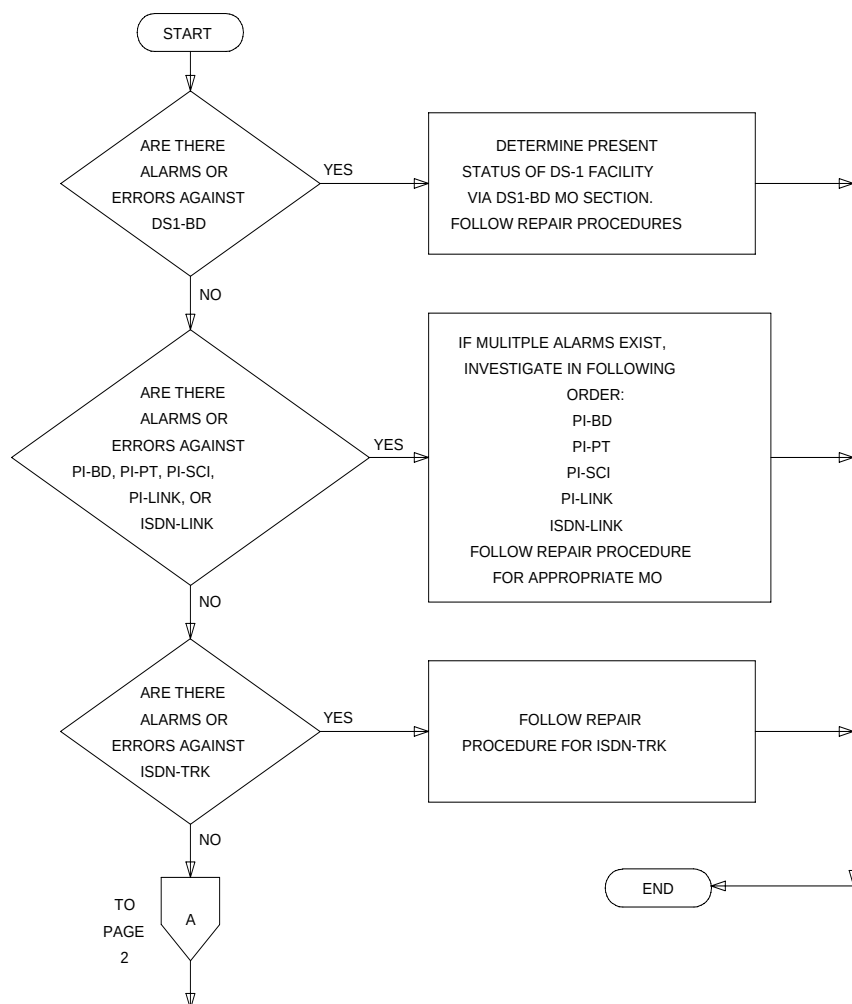
Figure 5. Processing of ISDN-PRI Problems (Page 1 of 2)

The following flowchart, [Figure 5](#) and [Figure 6 on page 60](#), defines a layered approach when troubleshooting ISDN-PRI problems. Since a problem at a lower layer affects upper layers, layers are investigated from low to high. In the flowchart, the DS1 facility is layer 1, the TN765 Processor Interface is layer 2, and the ISDN trunks are layer 3. Transient problems are diagnosed on [Page 2](#) of the flowchart, [Figure 6 on page 60](#).

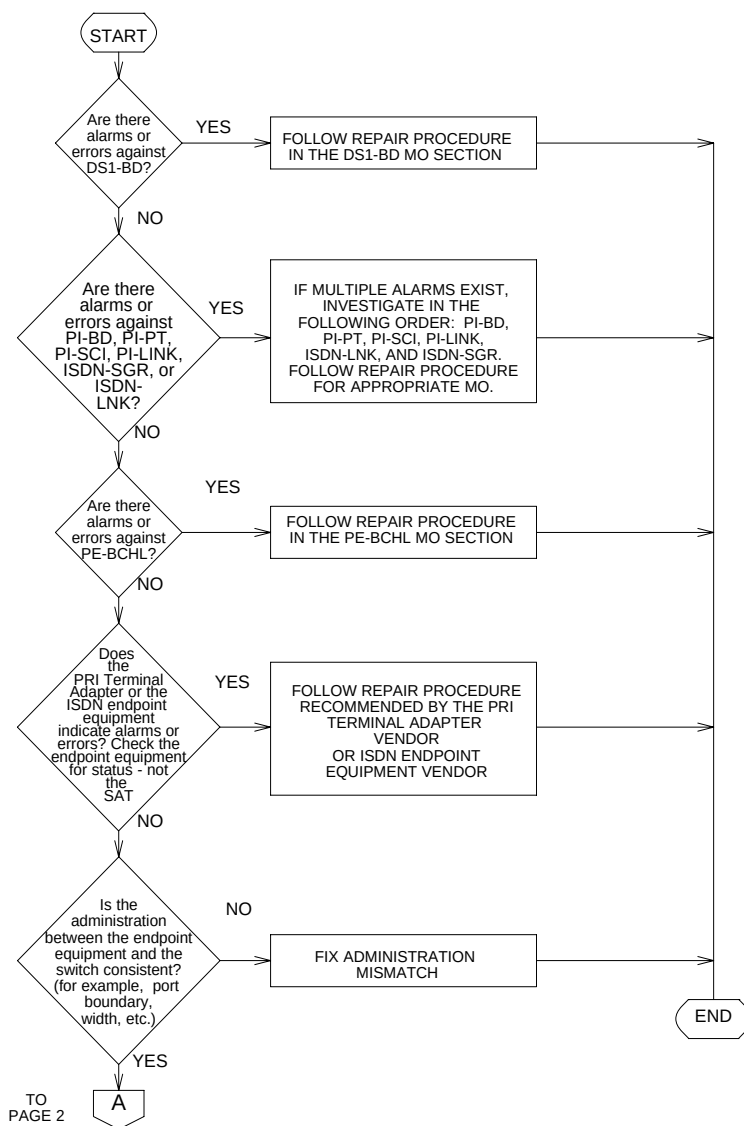
Figure 7. Processing of PRI Endpoint Problems (Page 1 of 2)

The following flowchart, [Figure 7 on page 61](#) and [Figure 8 on page 62](#), defines a layered approach when troubleshooting PRI endpoint problems. Since a problem at a lower layer affects upper layers, layers are investigated from low to high. In the flowchart, the DS1 facility is layer 1, the TN765 Processor Interface is layer 2, and the ISDN trunks are layer 3.

The troubleshooting procedure described here diagnoses faults between the switch and the line-side PRI terminal adapter/ISDN-PRI endpoint equipment. Problems encountered on the network-side of a wideband connection or problems with end-to-end equipment compatibility are outside the scope of this manual.

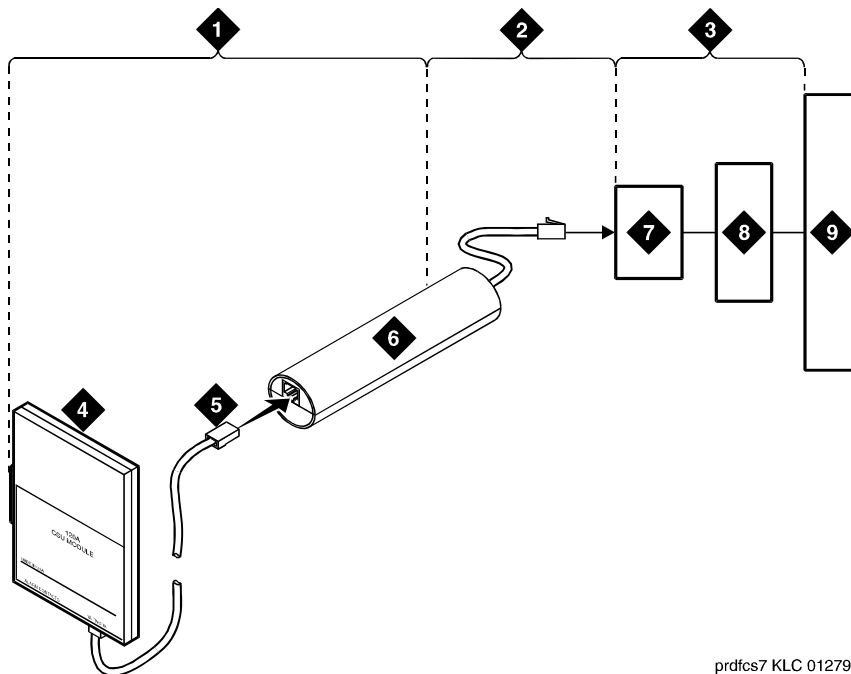
**Figure 9. Network Interface at Smart Jack**

The addition of the loopback jack and the presence of a Smart Jack divides the DS1 span into 3 separate sections for fault isolation. These sections are shown in [Figure 9 on page 73](#) through [Figure 11 on page 75](#) for the different span configurations. They are:

1. If there is no extended demarcation point, install the loopback jack directly at the network interface point as shown in [Figure 9 on page 73](#).
2. If there is an extended demarcation point and the Smart Jack is not accessible, install the loopback jack as shown in [Figure 10 on page 74](#).
3. If there is an extended demarcation point, but the Smart Jack is accessible, install the loopback jack as shown in [Figure 11 on page 75](#).

1. Test customer premises wiring (section 1 in the following 3 figures) from the ICSU to the loopback jack as described in “DS1 Span Test.”
2. Test the CO-to-network interface wiring (section 3 in [Figure 9 on page 73](#)) using the Smart Jack loopback (CO responsibility). Coordinate this test with the DS1 provider.

Fiber MUXes can take the place of Interface termination feeds as shown in [Figure 9 on page 73](#), [Figure 10 on page 74](#), [Figure 11 on page 75](#), and [Figure 12 on page 76](#). Test these spans using the same procedures as metallic spans. Note the following points:

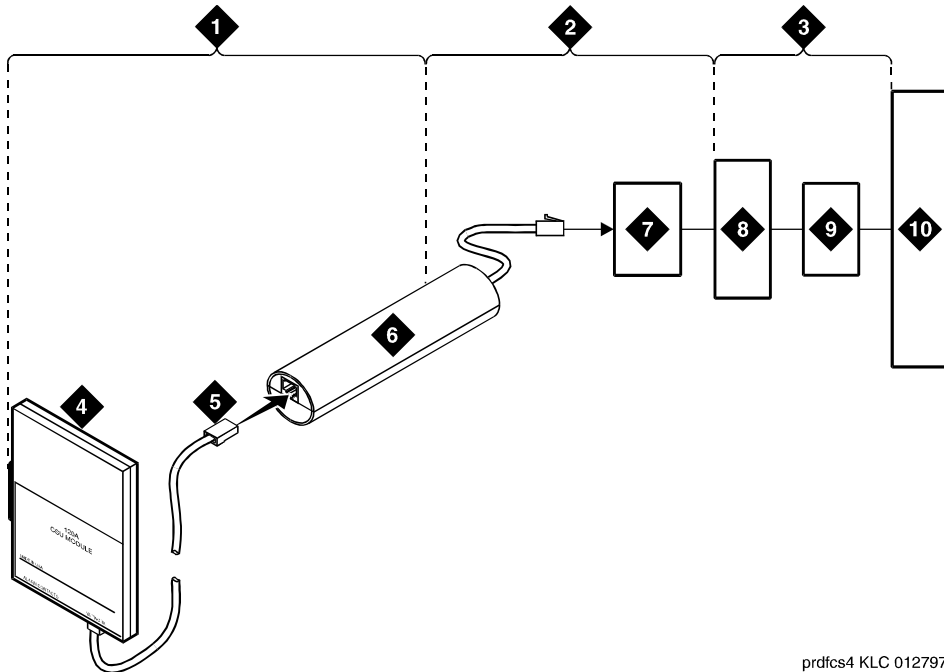
**Figure 10. Network Interface at Extended Demarcation Point (Smart Jack Inaccessible)**

| 5. RJ-48 to Network Interface (Up to 1000 Feet) (305 m) | 10. Central Office |

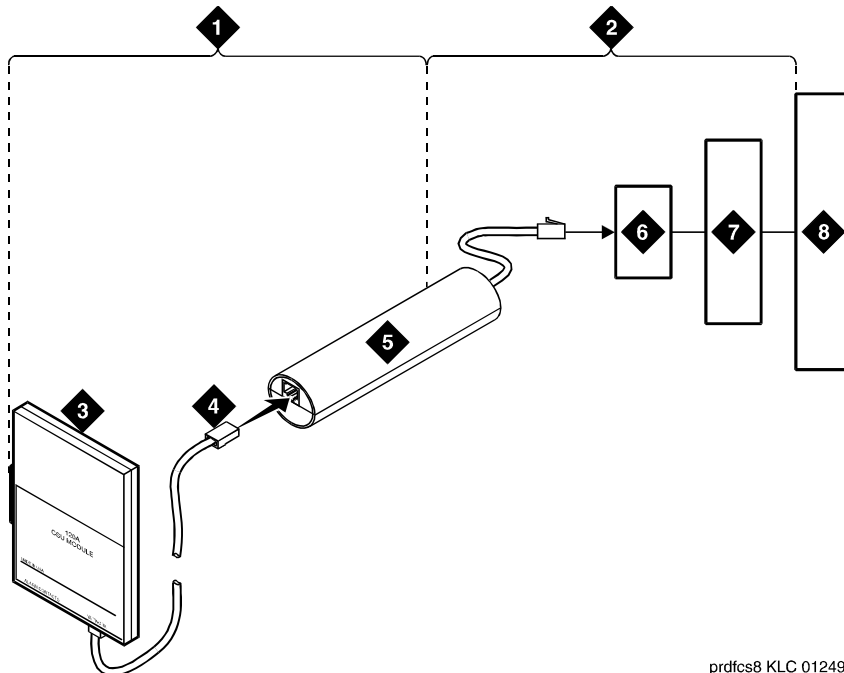
**Figure 12. Network Interface at "Dumb" Block**

When the loopback jack is added to a span that does not contain a Smart Jack, the span is divided into 2 sections. See [Figure 12](#) and [Figure 13 on page 77](#).

1. ICSU to the loopback jack.
2. Loopback jack to the Central Office (CO).

| 4. RJ-48 to Network Interface (Up to 1000 Feet) (305 m) | 8. Central Office |

1. Install the loopback jack at the point where the cabling from the ICSU plugs into the “dumb” block. If there is more than one “dumb” block, choose the one that is closest to the Interface Termination feed or the fiber MUX. This provides maximum coverage for loopback jack tests. See [Figure 12 on page 76](#) and [Figure 13 on page 77](#).

1. Test customer premises wiring (section 1 in [Figure 12 on page 76](#)) from the ICSU to the loopback jack as described in the “DS1 Span Test” section.

2. Test the loopback jack-to-“dumb” block and “dumb” block-to-CO wiring (section 2 in [Figure 12 on page 76](#)). This can be done using a loopback that “overlaps” the section of the span. Any of the following loopbacks can do this:

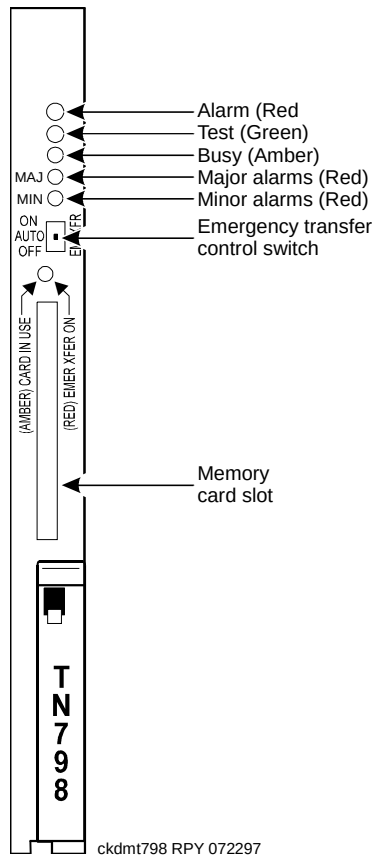
**Figure 14. LED Indicators on the TN2402/TN798 Processor Circuit Pack**

The front panels of the Processor circuit pack and the Maintenance circuit pack are identical. Each has two groups of LEDs. One group indicates the status of the pack, and the other group (which includes the Major, Minor, and Warning alarms described in the [“Alarm and Error Reporting”](#) section) reflects maintenance conditions in the entire system. See [Figure 14 on page 82](#).

If the AC power cord is unplugged, the emergency transfer feature invokes, however the EMERGENCY TRANSFER LED (red) is not lit due to loss of AC power.

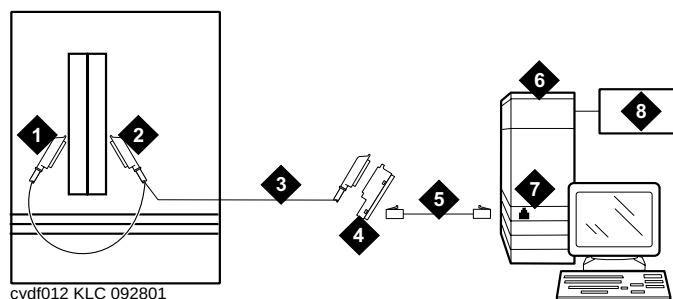
Figure 15. Typical ESM connections

The Expansion Services Module (ESM) shown in [Figure 15 on page 86](#) provides T.120 data sharing capability on a MMCH multipoint H.320 video conference. Each conference participant must have endpoints administered and a personal computer with the H.320 video application installed. The Avaya Definity Server CSI must have the expansion service module installed.

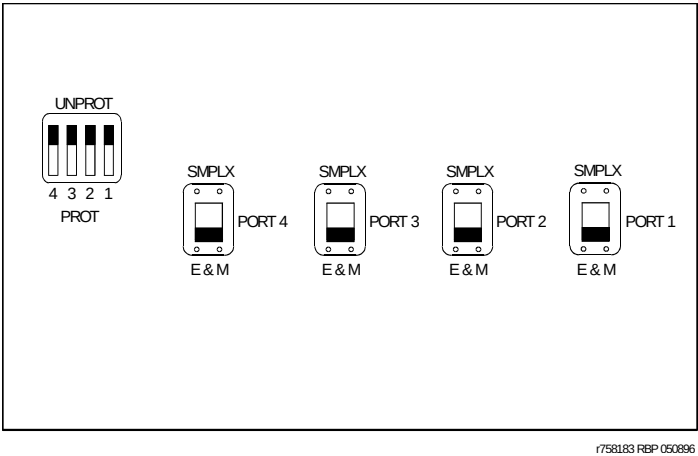
Figure 16. TN760D Tie Trunk Circuit Pack (Component Side)

To choose the preferred signaling format ([Table 11](#) and [Table 12](#)), set the switches on the TN760D and administer the port using [Figure 16 on page 95](#) and [Table 13 on page 95](#).

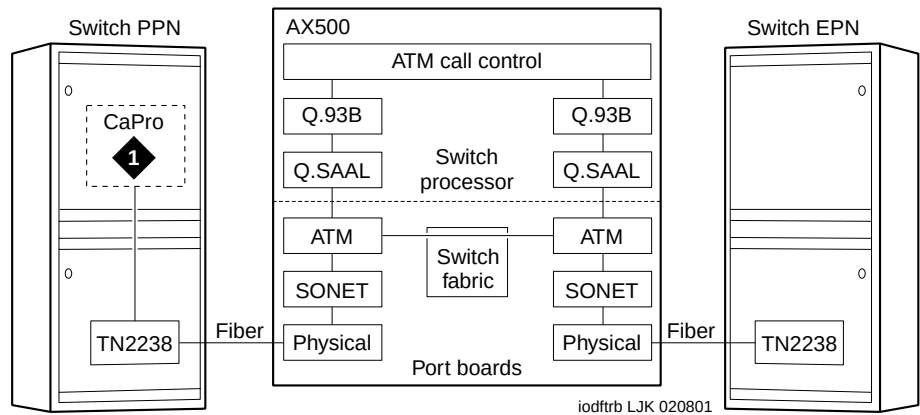
Figure 18. ATM troubleshooting schematic

This section provides tips for Avaya Definity ATM PNC when interfacing with the ATM switch. Throughout this section, see [Figure 18 on page 97](#). Use TN2238 for R6.3 systems, and TN230X for Release 7 and later.

**NOTE:**  
The CaPro element (Note 1 in [Figure 18](#)) is a software module within the Avaya Definity Server CSI PPN.

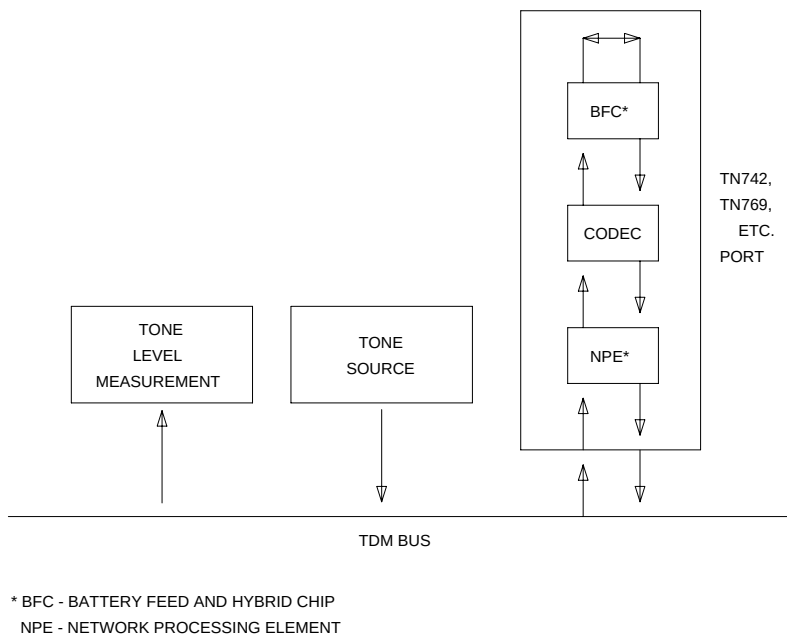
10. Enter **y** in the Facility Test Call Notification field to notify the user at logoff that the facility test call feature access code is administered. Enter **n** if you do not want the notification to appear.

This test is designed to check the on-board transmission capabilities of the NPE, the code, and the battery feed chip of the Analog Port. A Tone Detector and a Tone Generator talk and listen on the same pair of time slots as the Analog Port. The Analog Port is instructed to go into loop around mode (see [Figure 19](#)). The test passes if the signal measured by the Tone Detector is within acceptable limits.

This Loop Around Test is sensitive to the length of the loop, the equipment in the loop, or the equipment terminating the loop, such as off-premises stations. If this test is causing a false alarm, disable the test by changing the Tests field to "no" using **change station** for this station.

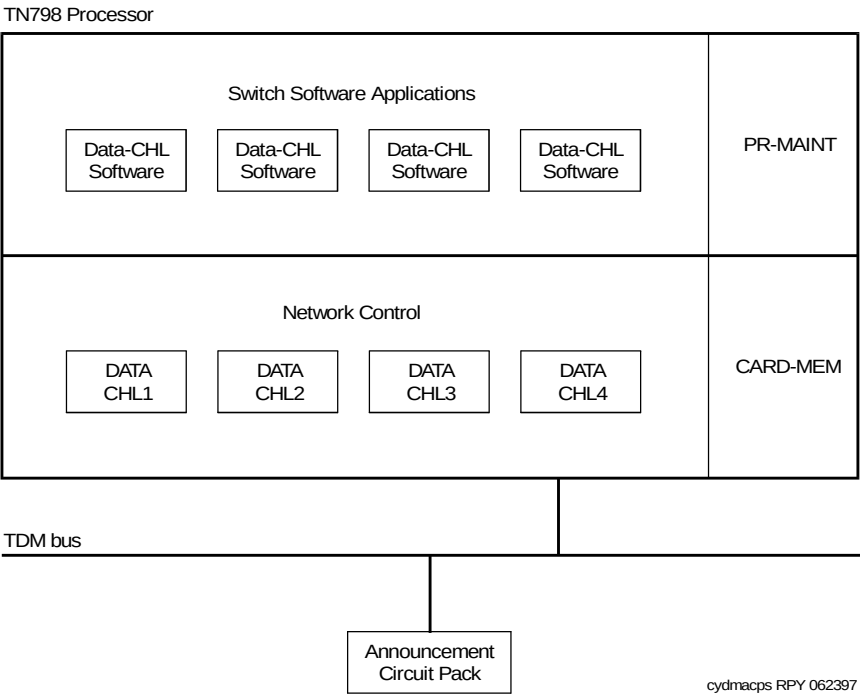
Figure 20. Connection of announcement circuit pack to the system

Figure 20 shows the connection of the Announcement Circuit Pack to the system. To save or restore announcements, an ANNOUNCEMENT Data Extension must be administered, and at least one DATA-CHL (Network Control Data Channel) must be in the in-service/idle state.

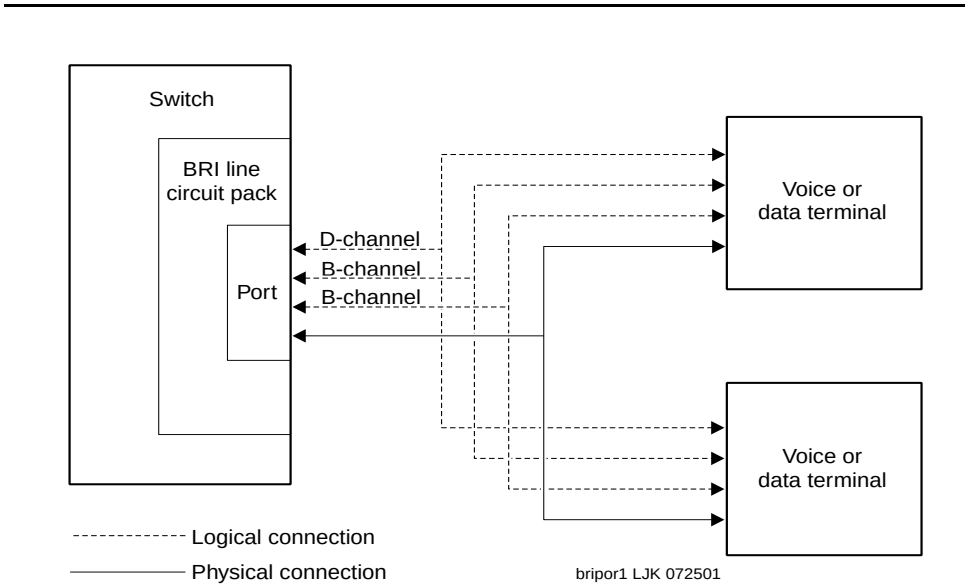
Figure 21. ISDN-BRI Port Interactions

[Figure 21 on page 769](#) illustrates the physical connection (solid line) between an ISDN-BRI Port and its associated ISDN-BRI set(s). Each physical connection allows for two B-channels and one D-channel. Each ISDN-BRI circuit pack can support up to 12 of these *physical* connections to different voice and voice/data sets or ASAI or adjuncts. On a TN2198 each ISDN-BRI circuit pack can support up to 12 *physical* connections to a NT1, which, in turn, connects to 2 terminals.

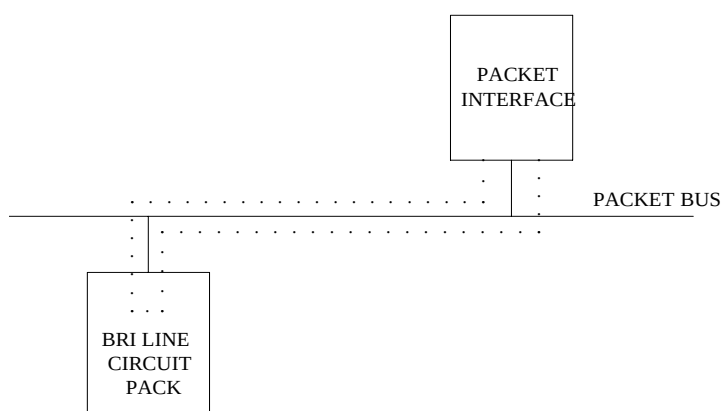
**Figure 22. Path of the BRI Port Local LAN Loop Around**

This test, which verifies the connectivity of a BRI port across the LAN Bus, executes only if the port is out-of-service. The test aborts if calls associated with the port are in-progress. Failures of this test indicate either on-board faults associated with the BRI-PORT hardware on the circuit pack or problems with the LAN Bus, which is used to form connectivity between the switch and the BRI-PORT.

The dotted lines in [Figure 22](#) show how a Loop Around Test is performed across the Packet Bus for the D-channel.

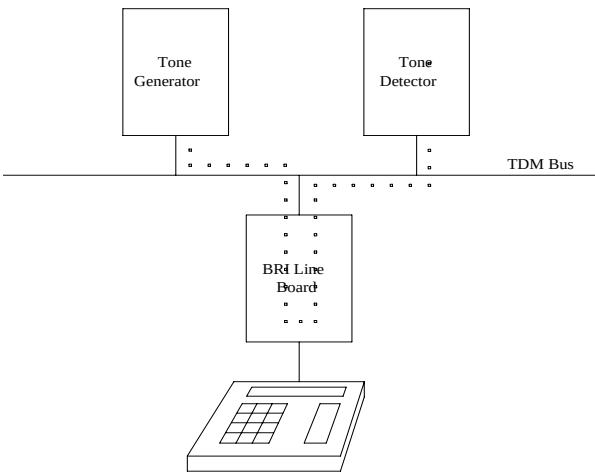
Figure 23. Path of the BRI Port Local TDM Loop Around

The dotted lines in [Figure 23 on page 778](#) show how a Loop Around Test is performed for the B-channels. The figure shows a terminal connected to a BRI line board using a TN556. If a TN2198 is used, the terminal would be connected to a NT1, and the NT1 to the BRI board.

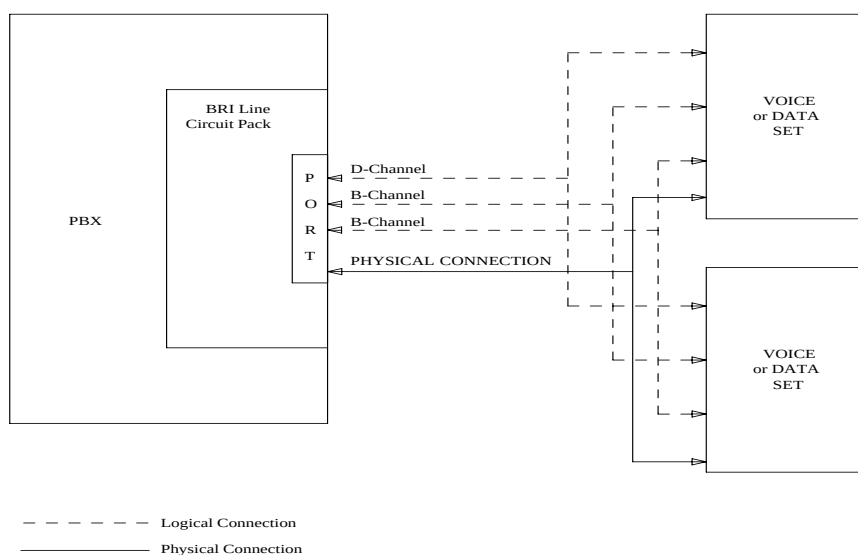
**Figure 24. ISDN-BRI Set Interactions**

ISDN-BRI endpoints come in a number of configurations. All endpoints require the D-channel to convey signaling information to the switch. A voice-only set requires only one B-channel. A voice and data-capable set requires both B-channels (one for voice and one for data). Therefore, each TN556 port can support either two voice-only sets or one voice and data-capable set. Only a single ASAI or adjunct may be connected to an ISDN-BRI port. Multiple adjuncts per line are not supported.

Figure 24 illustrates the physical connection (solid line) between an ISDN-BRI Circuit Pack and a voice or voice/data set. Each physical connection allows for two B-channels, as stated above, plus one D-channel. Each ISDN-BRI circuit pack can support up to 12 of these PHYSICAL connections to different voice and voice/data sets or ASAI and adjuncts.

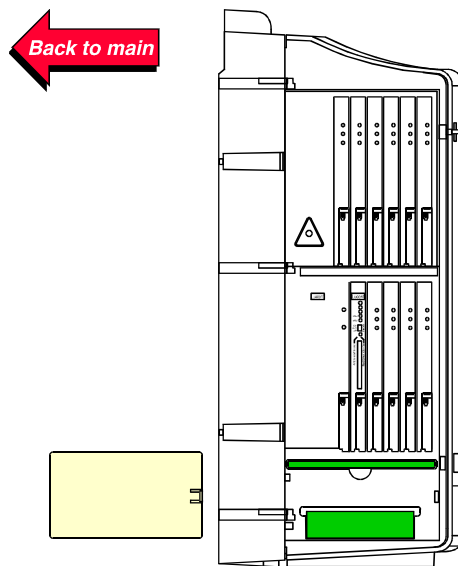
Figure 25. Fan/Filter Removal

1. Remove the left door.
2. Remove the fan/filter access panel. See [Figure 25](#).

1. Remove the fan access panel from the left side of the cabinet.
2. Pull the fan filter from the chassis.
3. Clean (vacuum or wash with water) or replace the filter as needed and slide the filter back into the chassis.
4. Replace the fan access panel.

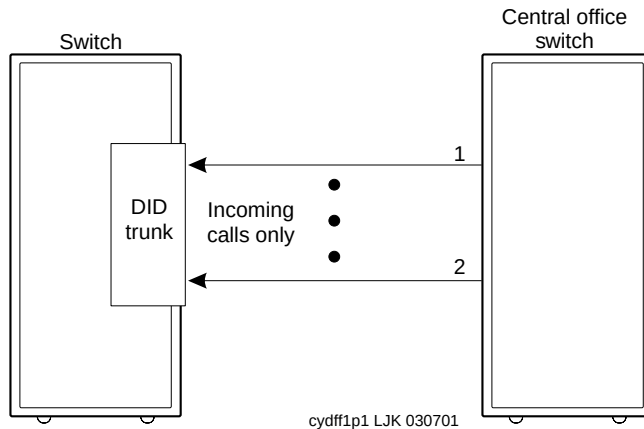
**Figure 26. DID Trunk Interactions**

The DID Trunk circuit packs support eight, incoming-only, ports. Each port provides an interface between the 2-wire analog line from the CO and the Avaya Definity Server CSI. The DID port receives 3 to 5 digits from the CO that is used to directly connect an outside caller to the called station without assistance from an attendant. See [Figure 26](#).

For each call, the CO switch signals the system by opening and closing individual DID loops (one of the eight ports) and causing the starting or stopping of loop current.

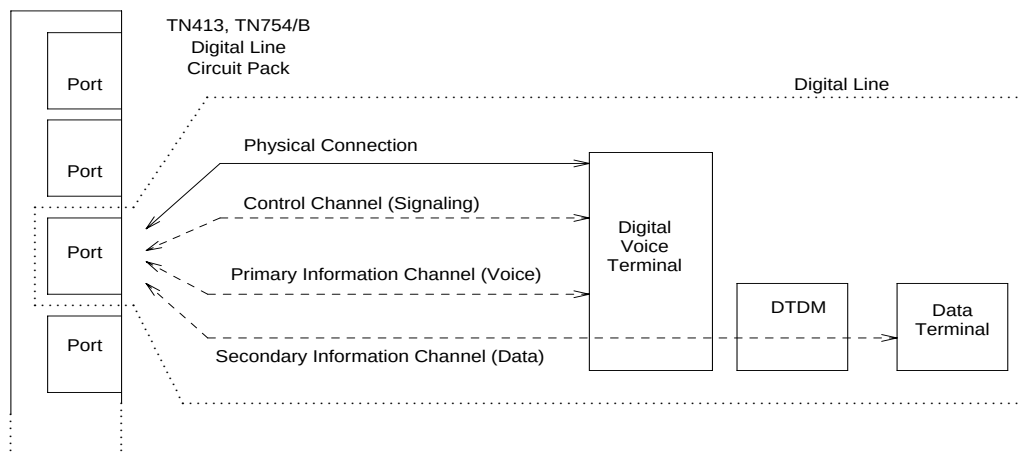
**Figure 27. Digital Line Connectivity**

It should be noted that TN2181 and TN2224 support both modes as shown in [Figure 27](#) and [Figure 28 on page 993](#).

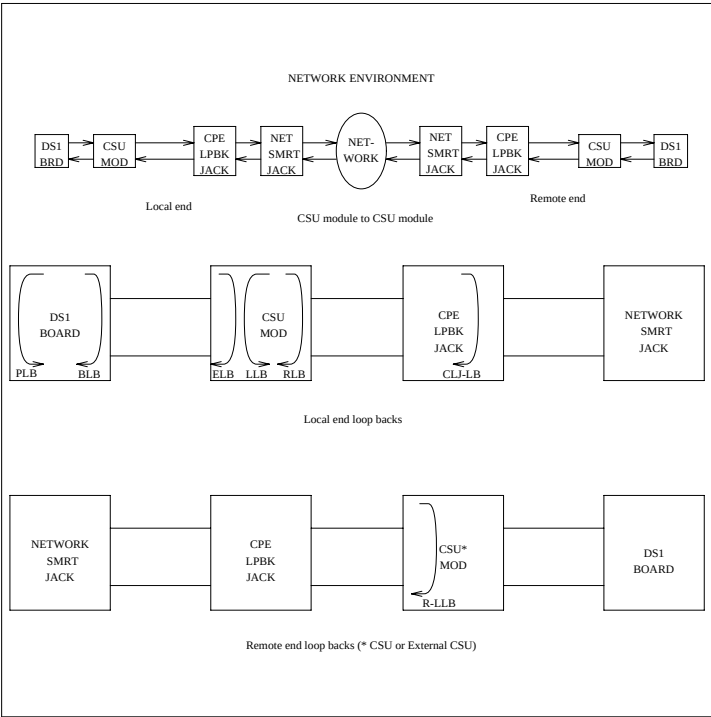
Figure 29. High Level Overview Of Loopback Points

The TN767E and 120A1 CSU Module support on-demand loopback tests that assist in the detection of faults between the TN767E circuit pack and the CSU Module, between the Integrated CSU and the optional Customer Premises Loopback Jack, or between the Integrated CSU and remote CSU. These loopback tests are explained in detail later in this DS1-BD section, but [Figure 29 on page 1041](#) gives a high level overview of the loopback points.

- PLB = Payload Loopback
- BLB = Board Loopback
- ELB = Equipment Loopback
- LLB = Line Loopback
- RLB = Repeater Loopback
- CLJ = Loopback Jack Loopback
- R-LLB = Remote Line Loopback
- SMRT = Smart Jack
- LPBK = Loopback

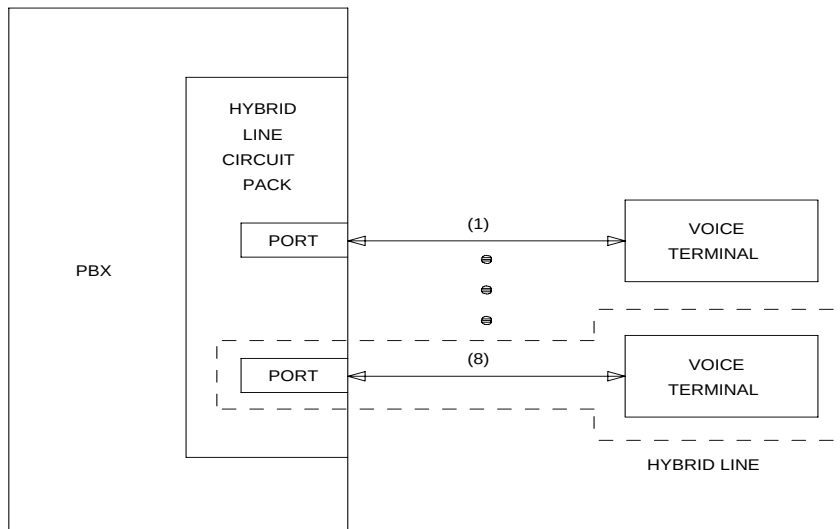
**Figure 30. Hybrid Station Interactions**

The TN762B Hybrid Line circuit pack supports eight of these multifunction analog telephone sets, as shown in the following figure. The Hybrid Line sets use three pairs of wires: an analog voice pair, a transmit/receive pair, and a power pair.

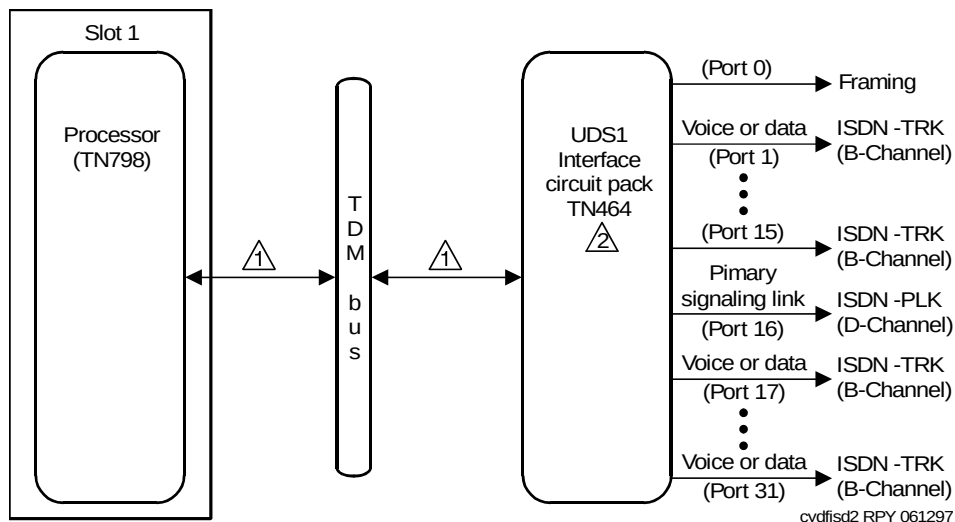
**Figure 31. ISDN-PRI Signaling Link Port Interactions (32-Channel - TN464)**

In a 32-channel system (see [Figure 31 on page 1252](#)), the DS1 ISDN Trunk or PRI endpoint port (B-channels) may use any of the ports 1-15 or 17-31, but the ISDN-PRI Signaling Link Port must be the 16th port on the TN464C (or higher) circuit pack. In certain configurations (NFAS), the 16th port may be used as a B-channel. Refer to the ["ISDN-SGR \(ISDN-PRI Signaling Group\)"](#) Maintenance documentation for further details.

1. B- and D-channel messages are routed over the TDM Bus. For additional reliability, a duplex D-channel can be administered for a signaling group and located on a different TN464C (or higher) circuit pack.
2. TN464C or higher

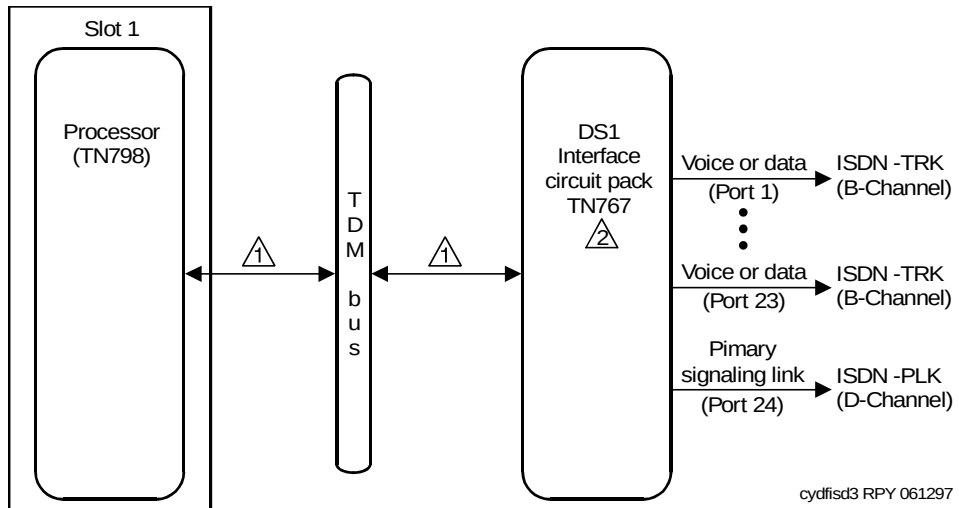
**Figure 32. ISDN-PRI Signaling Link Port Interactions (24 Channel - TN767/464C)**

In a 24-channel system, the DS1 ISDN Trunk or PRI endpoint port (B-channels) may use any of the first 23 ports. The ISDN-PRI Signaling Link Port must be the 24th port (See [Figure 32 on page 1253](#)). In certain configurations (NFAS), the 24th port may be used as a B-channel. Refer to the ISDN-PRI Signaling Group (ISDN-SGR) Maintenance documentation for further details.

1. B- and D-channel messages are routed over the TDM Bus. For additional reliability, a duplex D-channel can be administered for a signaling group and located on a different TN464C (or higher) circuit pack.
2. TN767B (or higher) or TN464C (or higher)

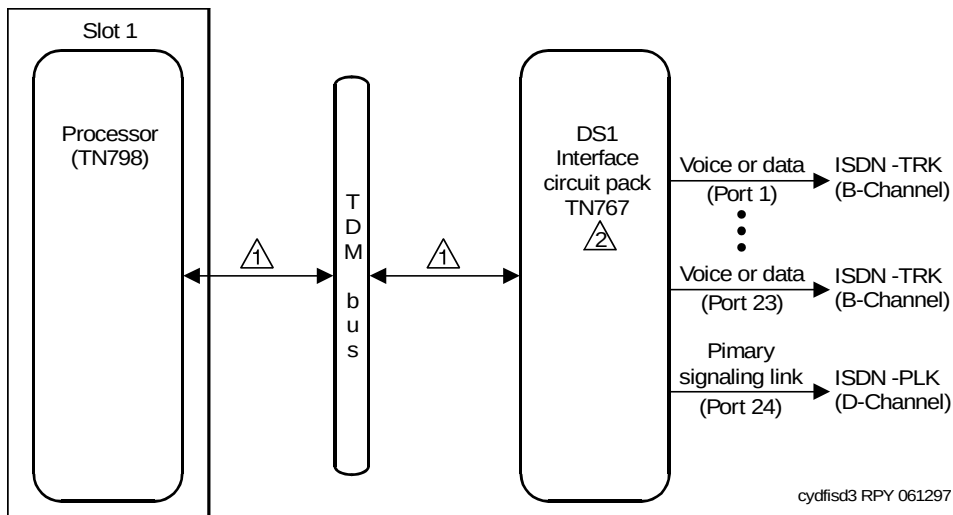
**Figure 33. ISDN-PRI Signaling Link Port Interactions (24 Channel - TN767/464C)**

For 24-channel interfaces, the first 23 ports on the circuit pack are used as B-channels. The 24th port may be used as a B-channel or as a D-channel depending on the type of Signaling Group used (see [Figure 33](#)).

1. B- and D-channel messages are routed over the TDM Bus. For additional reliability, a duplex D-channel can be administered for a signaling group and located on a different TN464C (or higher) circuit pack.
2. TN767B (or higher) or TN464C (or higher)

The ISDN-PRI Signaling Link Port itself depends on the health of the DS1/UDS1 Interface circuit pack on which it resides. This test will fail if there are problems with either the ISDN-PRI Primary D-channel port or the DS1/UDS1 circuit pack. See [Figure 33](#) for DS1 connections, [Figure 34](#) for UDS1 connections.

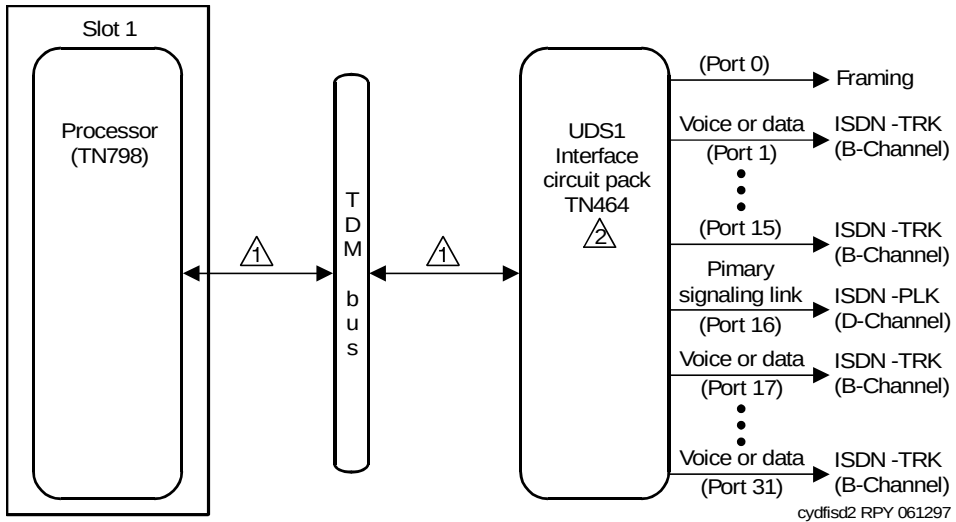
**Figure 34. ISDN-PRI Signaling Link Port Interactions (32-Channel - TN464)**

For 32-channel interfaces, ports 1-15 and 17-31 on the circuit pack are used as B-channels. The 16th port may be used as a B-channel or as a D-channel depending on the type of Signaling Group used (see [Figure 34](#)).

1. B- and D-channel messages are routed over the TDM Bus. For additional reliability, a duplex D-channel can be administered for a signaling group and located on a different TN464C (or higher) circuit pack.
2. TN464C or higher

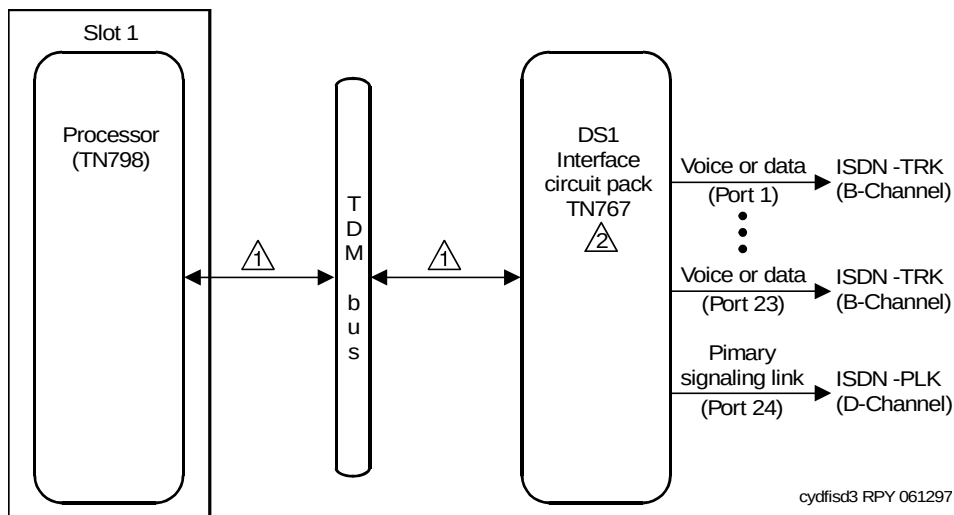
On 24-channel interfaces, any of the first 23 ports on the DS1/UDS1 interface circuit pack can be a B-channel. The 24th port may be used as a B-channel or as a D-channel depending on the type of ISDN-PRI Signaling Group (ISDN-SGR) to which it belongs.

1. B- and D-channel messages are routed over the TDM Bus. For additional reliability, a duplex D-channel can be administered for a signaling group and located on a different TN464C (or higher) circuit pack.
2. TN767B (or higher) for DS1; TN464C (or higher) for UDS1

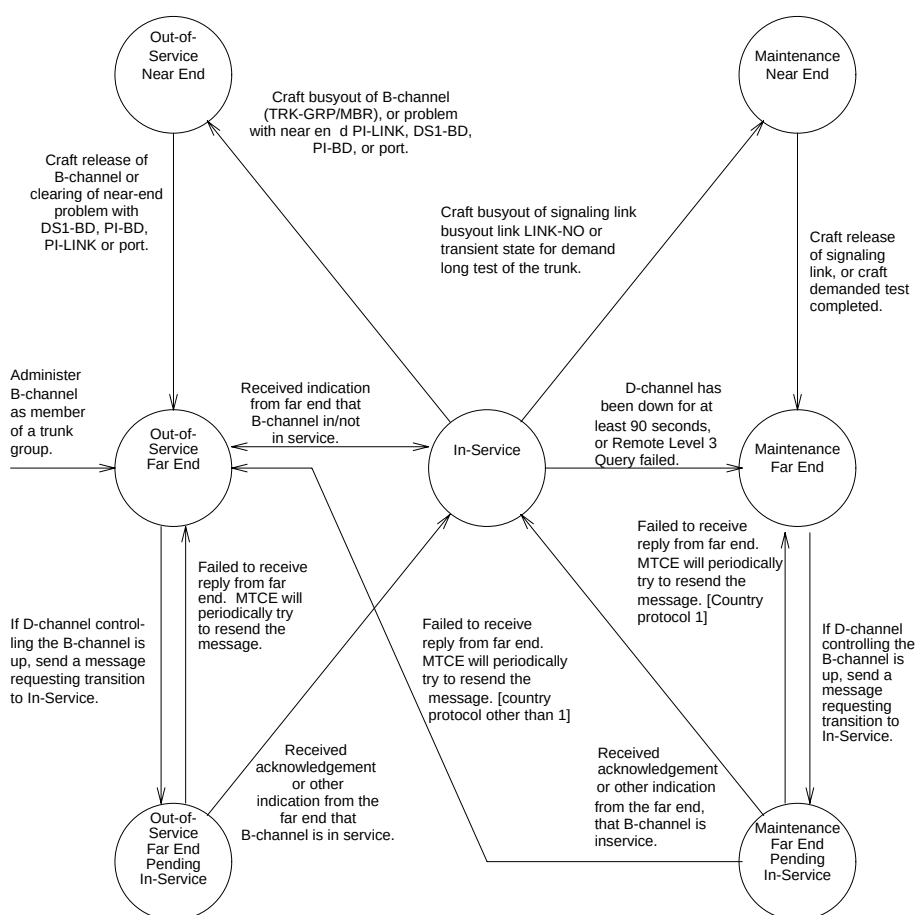
**Figure 37. Common Progressions in Service States**

The following diagram of the DS1 ISDN Trunk service states shows the common progression from one service state to another and the event that caused the change of state.

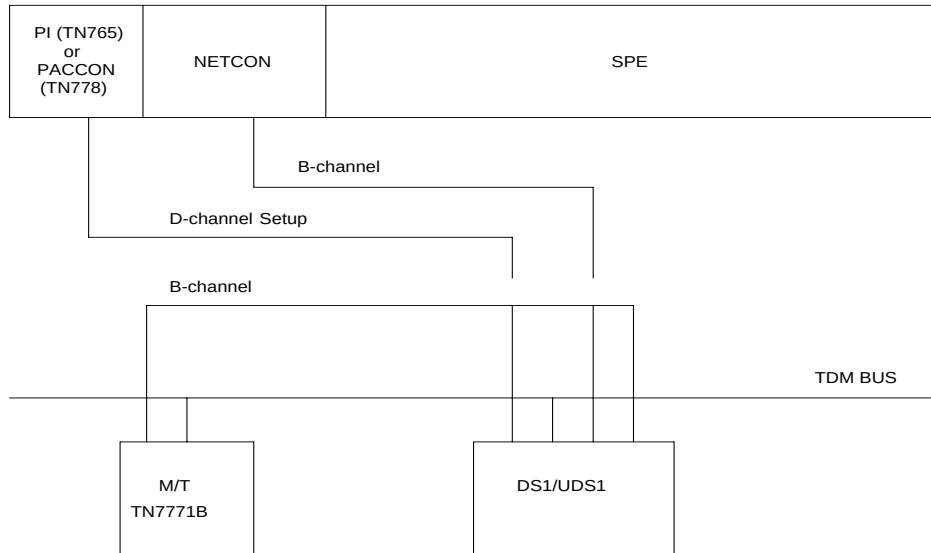
Figure 38. ISDN-PRI Outgoing Test Call

In the second method, the test call connection is established over the TDM Bus of the transmit and receive sides of the ISDN-PRI trunk to a digital trunk testing port on the Maintenance/Test circuit pack. The Maintenance/Test Digital Port generates a pseudo bit stream. A pictorial description of the outgoing ISDN-PRI test call connectivity is contained in [Figure 38 on page 1295](#).

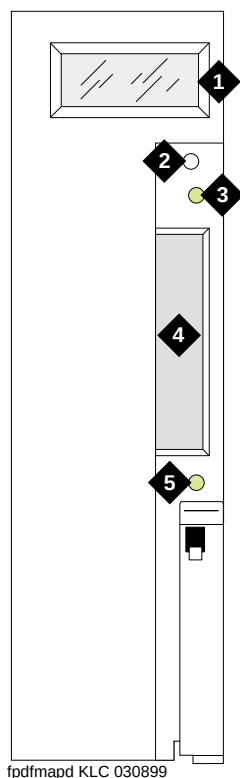
**Figure 39. TN802 faceplate**

Figure 39 shows the TN802 faceplate.

| Step | Description | Comments |
|---|---|---|
| 4. | Wait | Wait until the yellow Disk-In-Use LED (Note 5 in <a href="#">Figure 39 on page 1317</a> ) light is out. |

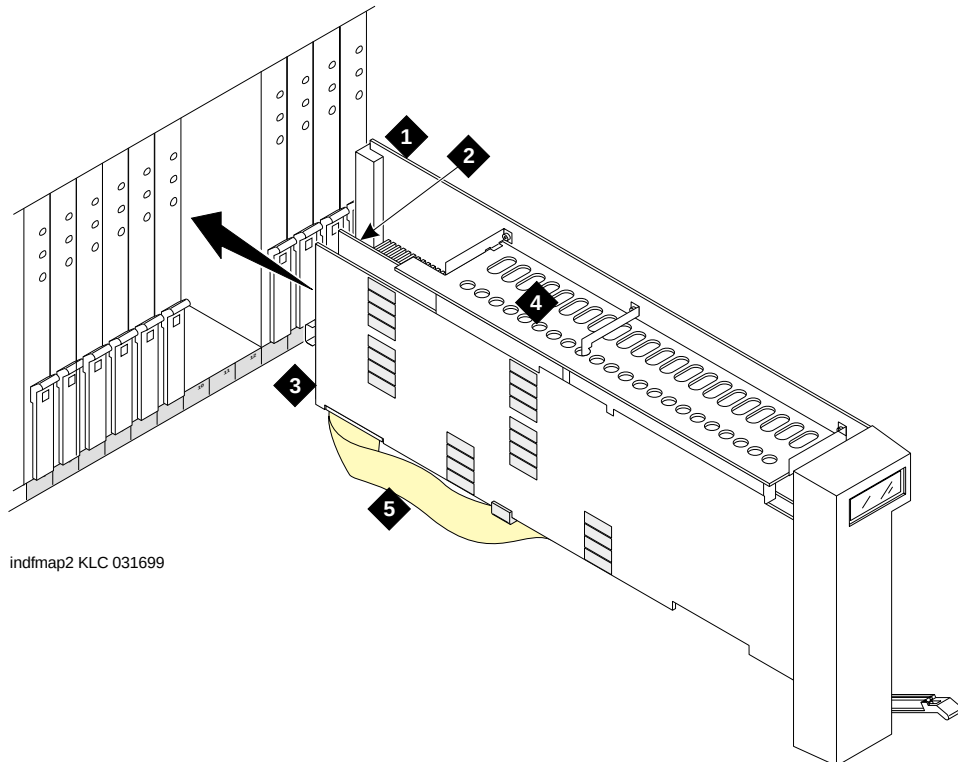
**Figure 41. TN802 board assembly**

Figure 41 shows the circuit pack with the two additional boards connected through the side plane.

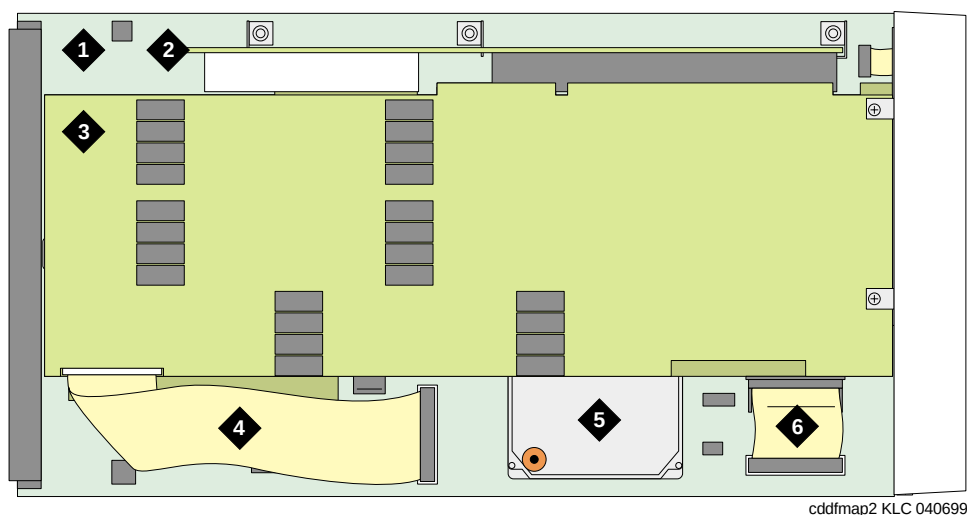
**Figure 42. TN802 board assembly and cables (side view)**

Figure 42 shows a side view of the three boards and interconnecting cables that make up the TN802.

- a. Verify the IP address
  - b. Check the physical connections to and from the TN802 circuit pack.
  - c. Check the internal cables on the TN802 circuit pack (Notes 4 and 6 in [Figure 42 on page 1324](#)).
  - d. Try pinging another device on the same subnet.
  - e. Try pinging the gateway to the rest of the network from the subnet.
  - f. Try pinging a device not on the local subnet but on the network or another subnet.
5. When finished, at the command prompt type **exit** and press Enter.

The TN802 hard drive (Note 5 in [Figure 42 on page 1324](#)) is field-replaceable.
