# **Maintenance for Avaya DEFINITY® Server CSI**

Volumes 1 and 2

Release 1.2  
555-233-119  
Issue 5  
October 2002

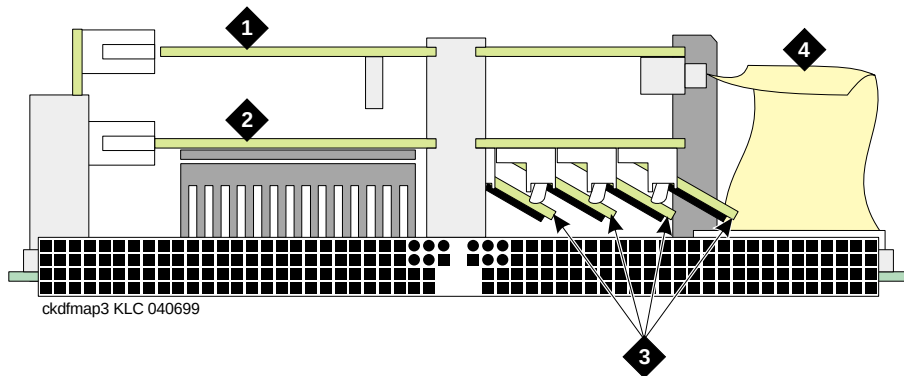
**Figure 43. TN802 board assembly and cables (end view)**

Figure 43 shows the end view of the three boards and interconnecting cables on the TN802.

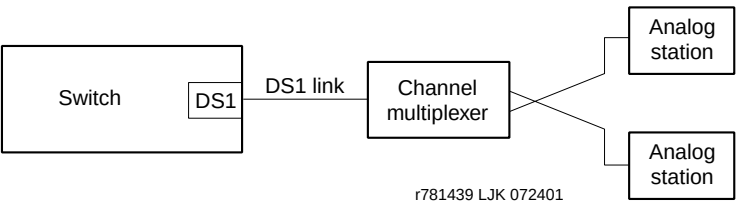
Figure 46. DS1 OPS Line Interactions

An analog Off-Premises Station (OPS) can be connected to the system through a DS1 link. A TN767 DS1 Interface circuit pack supports up to 24 DS1OPSs. Since the DS1OPS is an analog telephone set, a channel multiplexer is necessary as the remote DS1 endpoint that converts the digital signal of a DS1 port to the OPS Line and vice versa. See [Figure 46](#) for details.

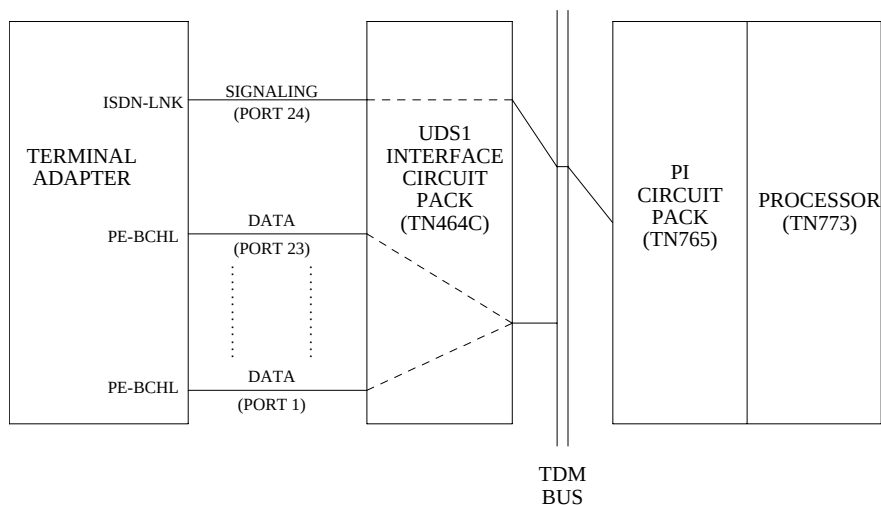
Figure 47. PRI Endpoint Port Interactions [INTEL]

A PRI Endpoint Port is a port on a UDS1 interface circuit pack. Therefore, this port depends on the health of the UDS1 interface circuit pack for proper operation (see [Figure 47](#)). As noted earlier, a PRI Endpoint Port B-channel also depends on an ISDN-PRI Signaling Link Port D-channel (ISDN-LNK) to carry the signaling traffic. If there is a problem with the ISDN-PRI Signaling Link Port, the PRI Endpoint Port is affected. The ISDN-PRI Signaling Link Port, in turn, depends on the PKT-INT (Packet Interface).

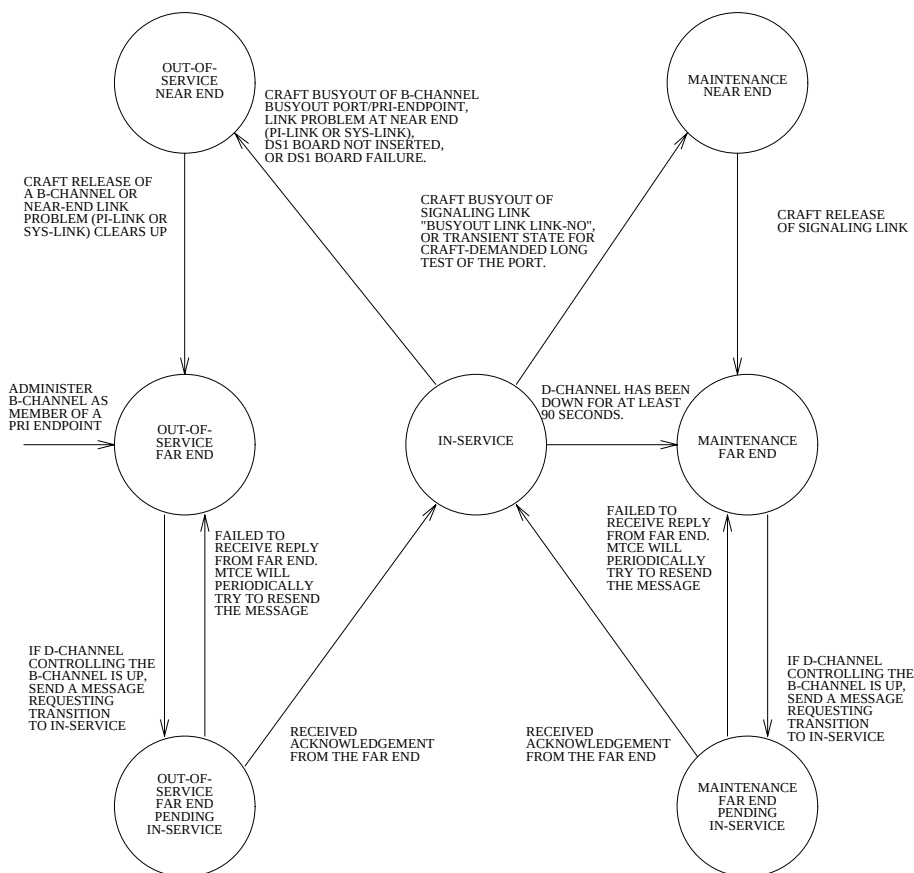
**Figure 48. Common Progressions in Service States**

The following diagram of the PRI Endpoint Port service states shows the common progression from one service state to another and the event that caused the change of state.

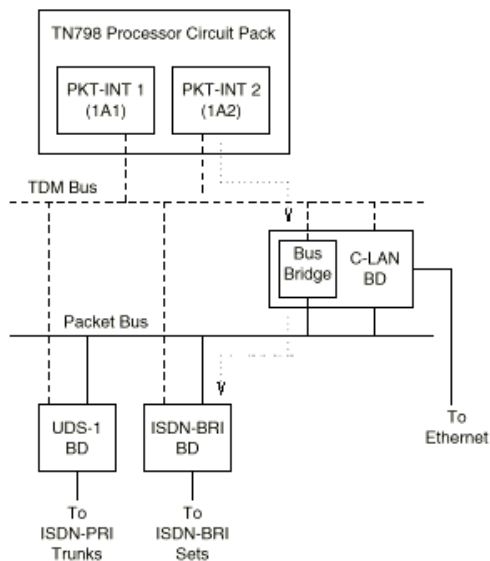
**Figure 49. PKT-INT Connections**

- The system contains at least one TN799 C-LAN circuit pack, and
- The *Packet Intf2?* field on the Maintenance-Related System Parameters form is set to "y".

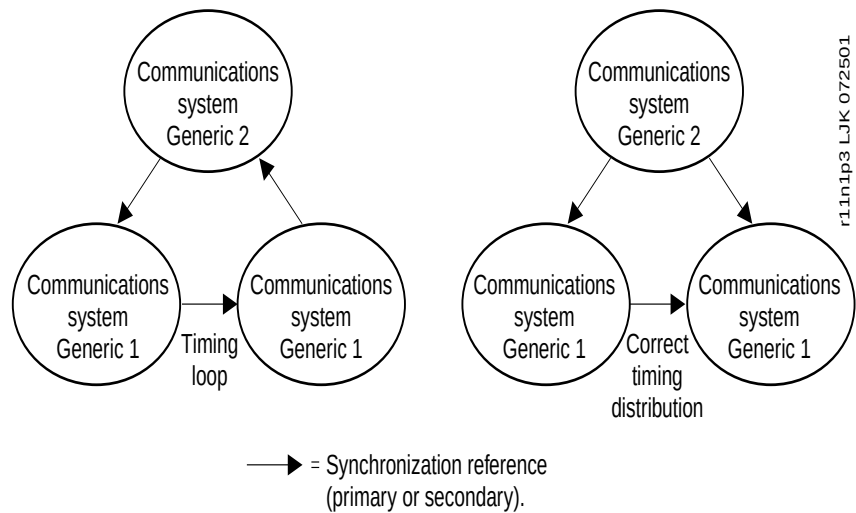
Figure 50. Synchronization Timing Loop

The system synchronization planner must avoid creating a *timing loop* when administering the primary and secondary synchronization references in a system. A timing loop exists whenever a system receives timing from another system whose timing reference is directly or indirectly derived from itself. Timing loops can lead to loss of digital data between systems that are exchanging data with any system within the loop. An invalid timing signal is also generated by any system within the loop, thus propagating the invalid timing signal to any system(s) using a system within the loop as a synchronization reference. [Figure 50 on page 1568](#) shows a timing loop and a correct distribution of timing between the systems.

A correctly designed network has no loops and each piece of equipment in the network is supplied by a clock of equal or lower stratum (that is, the inputs to a Stratum 3 clock should NEVER be from a Stratum 4 device). **It is strongly recommended that the network administrator be consulted before administering any synchronization changes.**

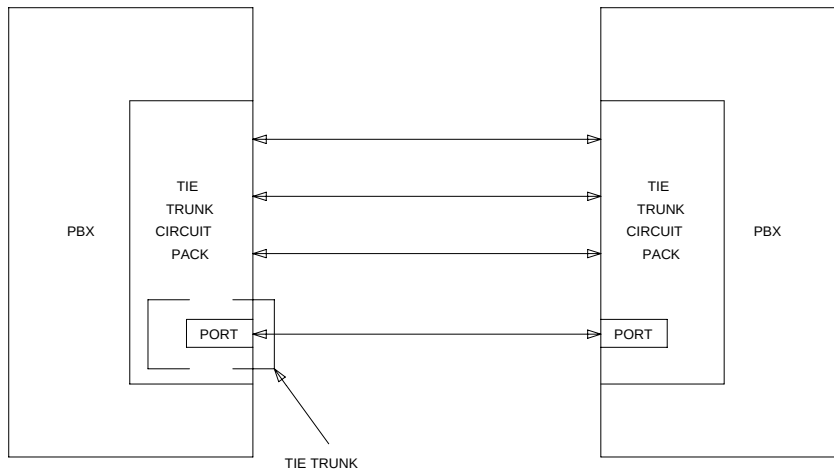
**Figure 53. Tie Trunk Interactions**

The Tie Trunk circuit pack fits into a port slot and contains four trunk circuits (see [Figure 53 on page 1665](#)). Each tie trunk for the TN497 circuit packs has 2-wire audio connection/signal leads (A and B).

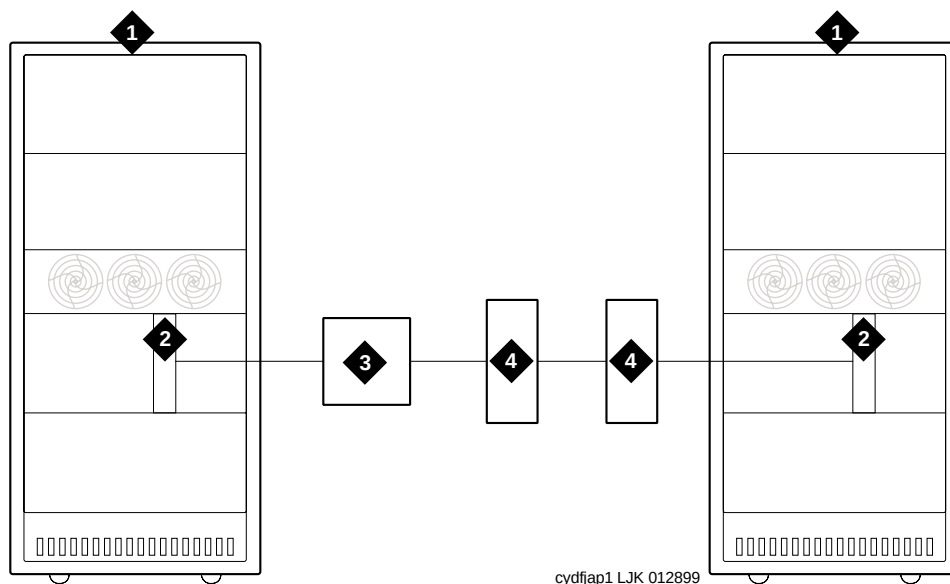
**Figure 54. Japanese TTC public network connections**

Figure 54 shows the hardware connections for public network access in Japan. The upgrade procedure requires removing the JRC (Japan Radio Corporation) external converter in Figure 54.

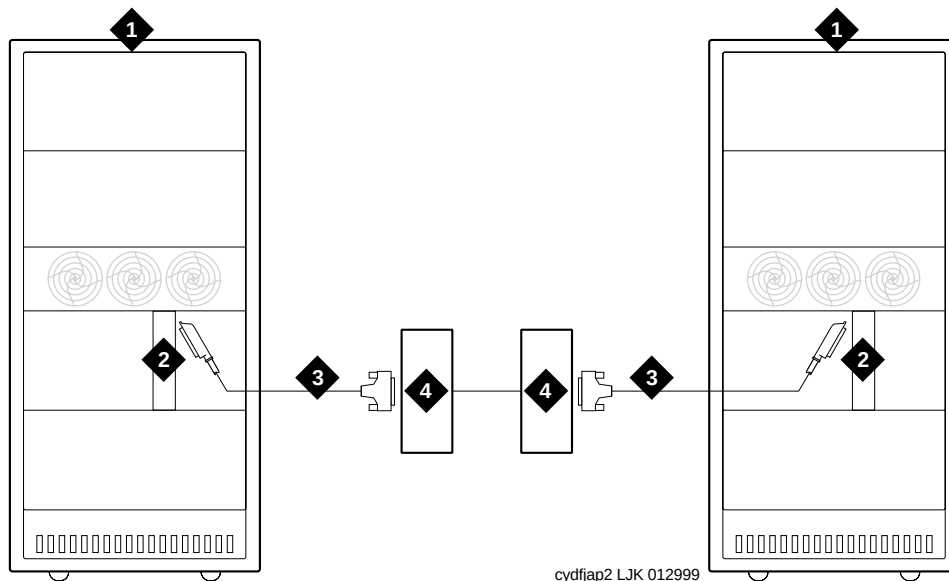
Figure 55. TN2242 Japan trunk TTC private network connections

Figure 55 shows the hardware connections for private network access using the TN2242 circuit pack.

1. Avaya DEFINITY Server
2. TN2242 2Mbit Japan trunk circuit pack
3. H600-513 cable assembly cable. (See "[H600-513 cable pinout](#)").
4. TDM facilities

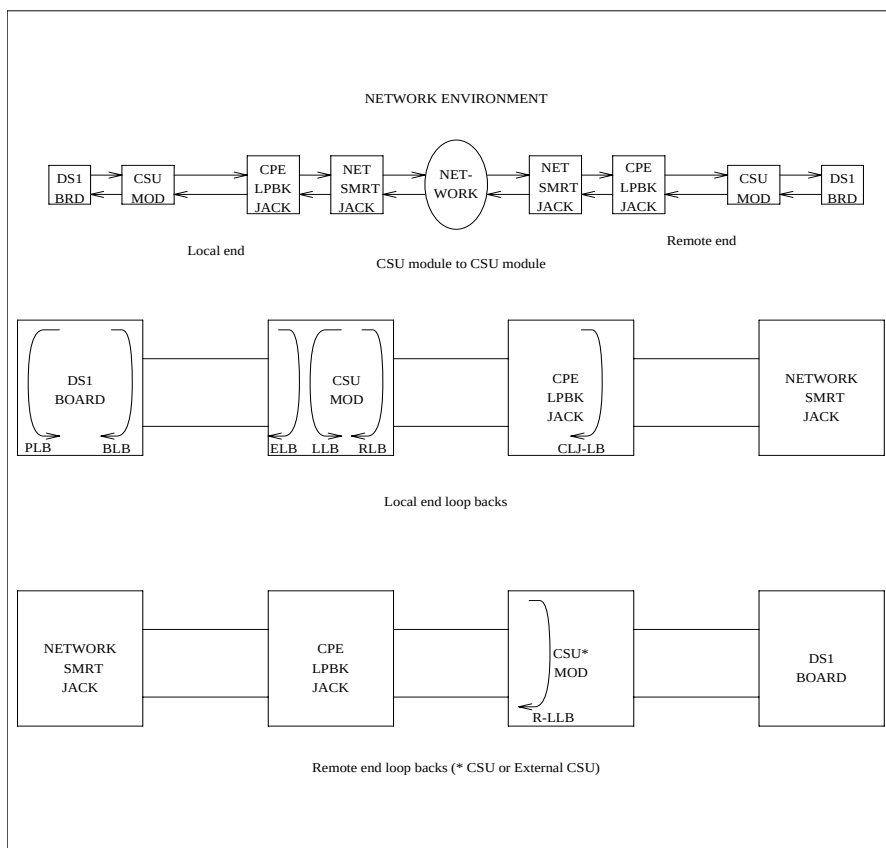
**Figure 56. High Level Overview Of Loopback Points**

The UDS1-BD and 120A1 CSU Module support on-demand loopback tests that assist in the detection of faults between the UDS1-BD circuit pack and the CSU Module, between the Integrated CSU and the optional Customer Premises Loopback Jack, or between the Integrated CSU and remote CSU. These loopback tests are explained in detail later in this UDS1-BD MO, but [Figure 56](#) gives a high level overview of the loopback points.

The following list of acronym definitions are for the [Figure 56 on page 1732](#):

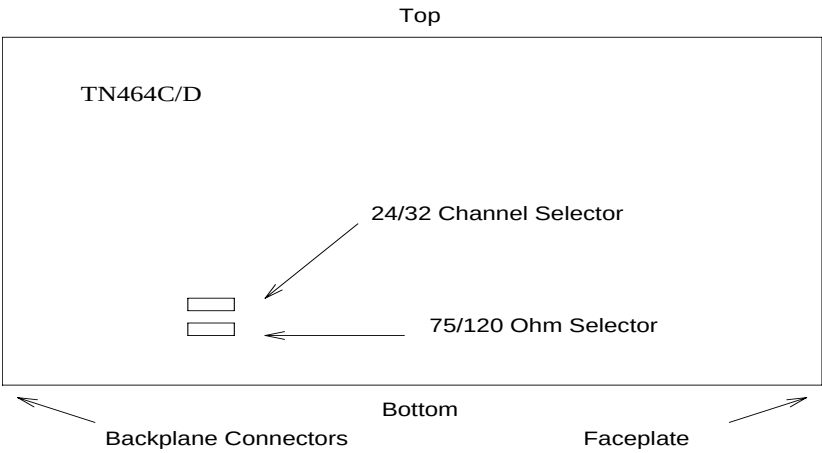
Figure 57. TN464C/D DS1 Option Jumpers

Two option jumpers located on the side of the TN464C/D circuit pack must be installed correctly. The figures on the following page show how to configure the circuit pack for 24-channel or 32-channel DS1, and for 75\*W (coaxial) or 120\*W trunk connections. The channel selection must match the parameters administered on the corresponding **DS1 Circuit Pack** Form. (US applications use 24 Channels.)

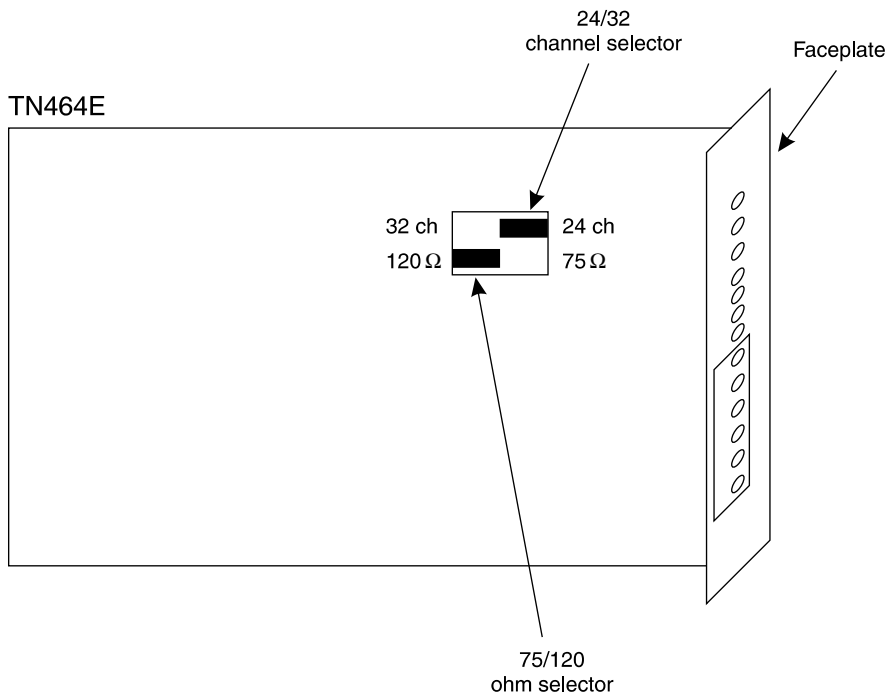
Figure 59. TN464E/F DS1 Option switches

The option switch located on the component side of the TN464E/F circuit pack must be set correctly. [Figure 59 on page 1735](#) shows how to configure the circuit pack for 24-channel or 32-channel DS1. The channel selection must match the parameters administered on the corresponding **DS1 Circuit Pack Form**. (US applications use 24 Channels.)

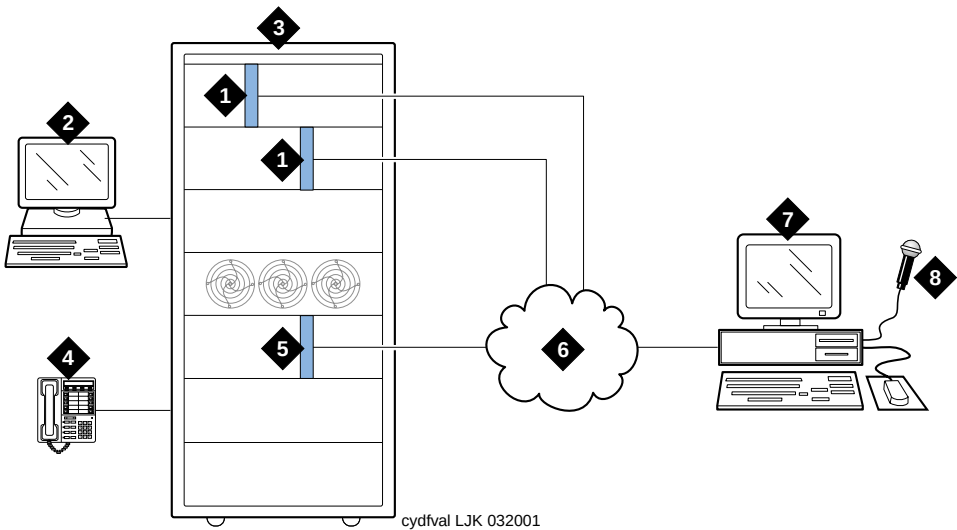
The following figure shows the configuration options for the TN2501AP (VAL) circuit pack within a system.

- 1. TN2501AP VAL announcement circuit pack
- 2. System access terminal (SAT)
- 3. Switch
- 4. Phone for recording announcements
- 5. TN799C (C-LAN) is required when using IP SAT or VAL Manager.
- 6. Your LAN (See [LAN cable](#))
- 7. computer or remote recording studio for
  - recording and storing announcements
  - FTP client application
  - VAL Manager application (PC only)
- 8. Microphone

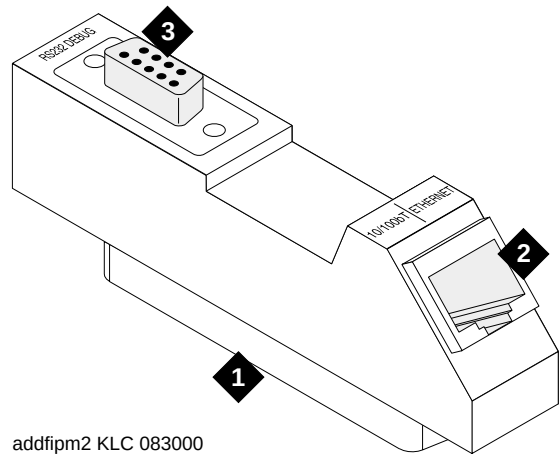
The following figure shows the Backplane Adapter (label reads IP Media Processor).

1. Amphenol connector attaches to the back of the switch cabinet, corresponding to the TN2501AP circuit pack slot.

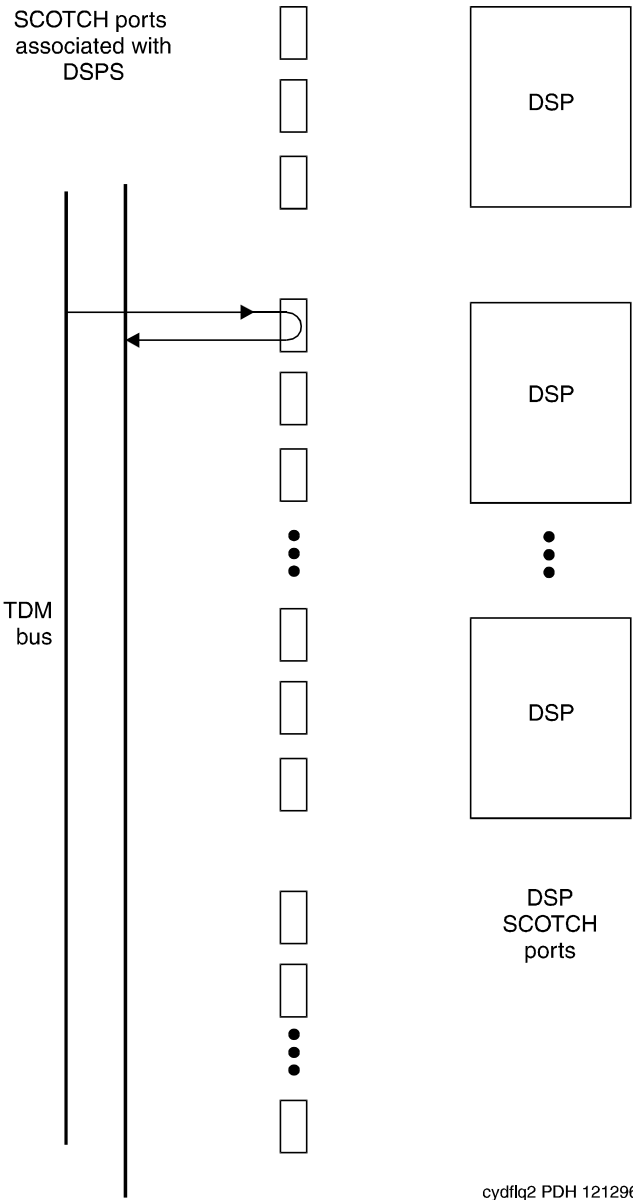
Figure 63. VC Circuit Pack DSP Port Local TDM Loopback Test

This test verifies the connectivity of a VC DSP Port across the TDM bus. It aborts if calls associated with the port are in progress. Failure of this test indicates an on-board fault associated with the port hardware on the circuit pack. The Loopback Test runs the following tests (refer to [Figure 63 on page 1861](#)):

1. A looparound test across the TDM bus.
2. A conference circuit test.

The tests are run in the above order; if one test fails, an error code is returned and the remaining tests in the sequence are not executed.

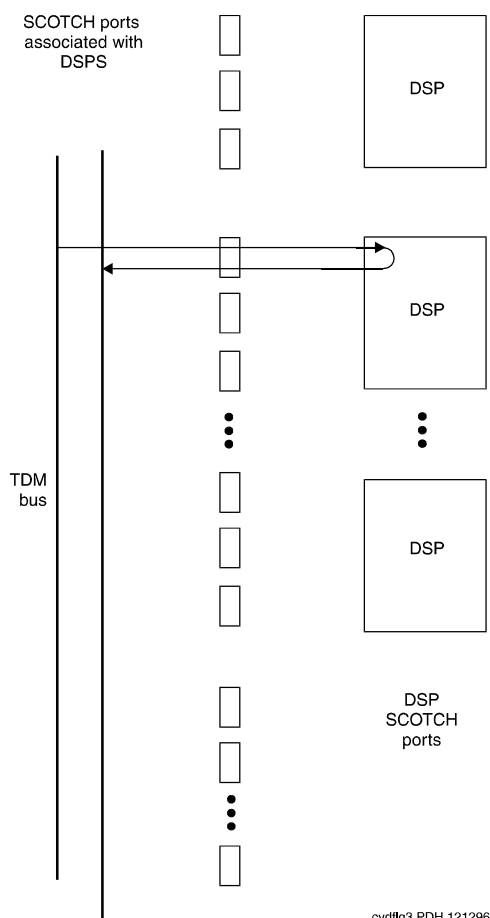
**Figure 64. VC Circuit pack DSP Port DSP Looparound Test**

This test verifies the connectivity of a VC-DSPPT across the TDM bus as shown in [Figure 64](#). It aborts if calls associated with the port are in progress. Failure of this test indicates an on-board fault associated with the port hardware on the circuit pack.

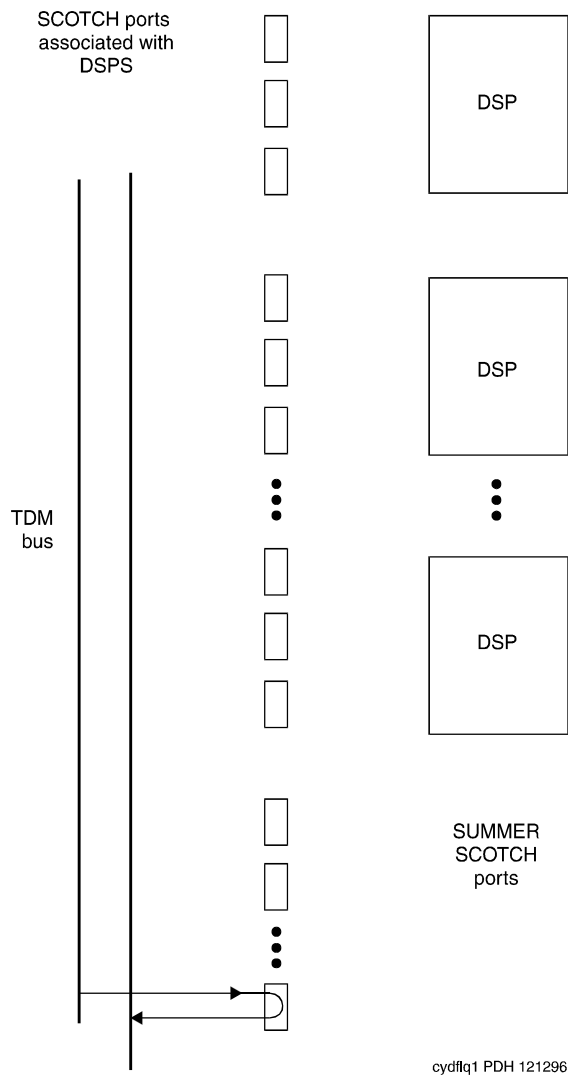
Figure 65. VC Circuit Pack Summer Port Loopback Test

This test verifies the connectivity of a VC Summer Port across the TDM bus. It aborts if calls associated with the port are in progress. Failure of this test indicates an on-board fault associated with the port hardware on the circuit pack. The Loopback Test runs the following tests (refer to [Figure 65 on page 1872](#)):

- A Looparound test across the TDM bus.
- A conference circuit test.

The tests are run in the above order. If the first test fails, the switch returns an error code, and the second test is not executed.
