Maintenance

Avaya™ G700 Media Gateway

Avaya™ S8300 Media Server or an

555-234-101
Issue 3
May 2003

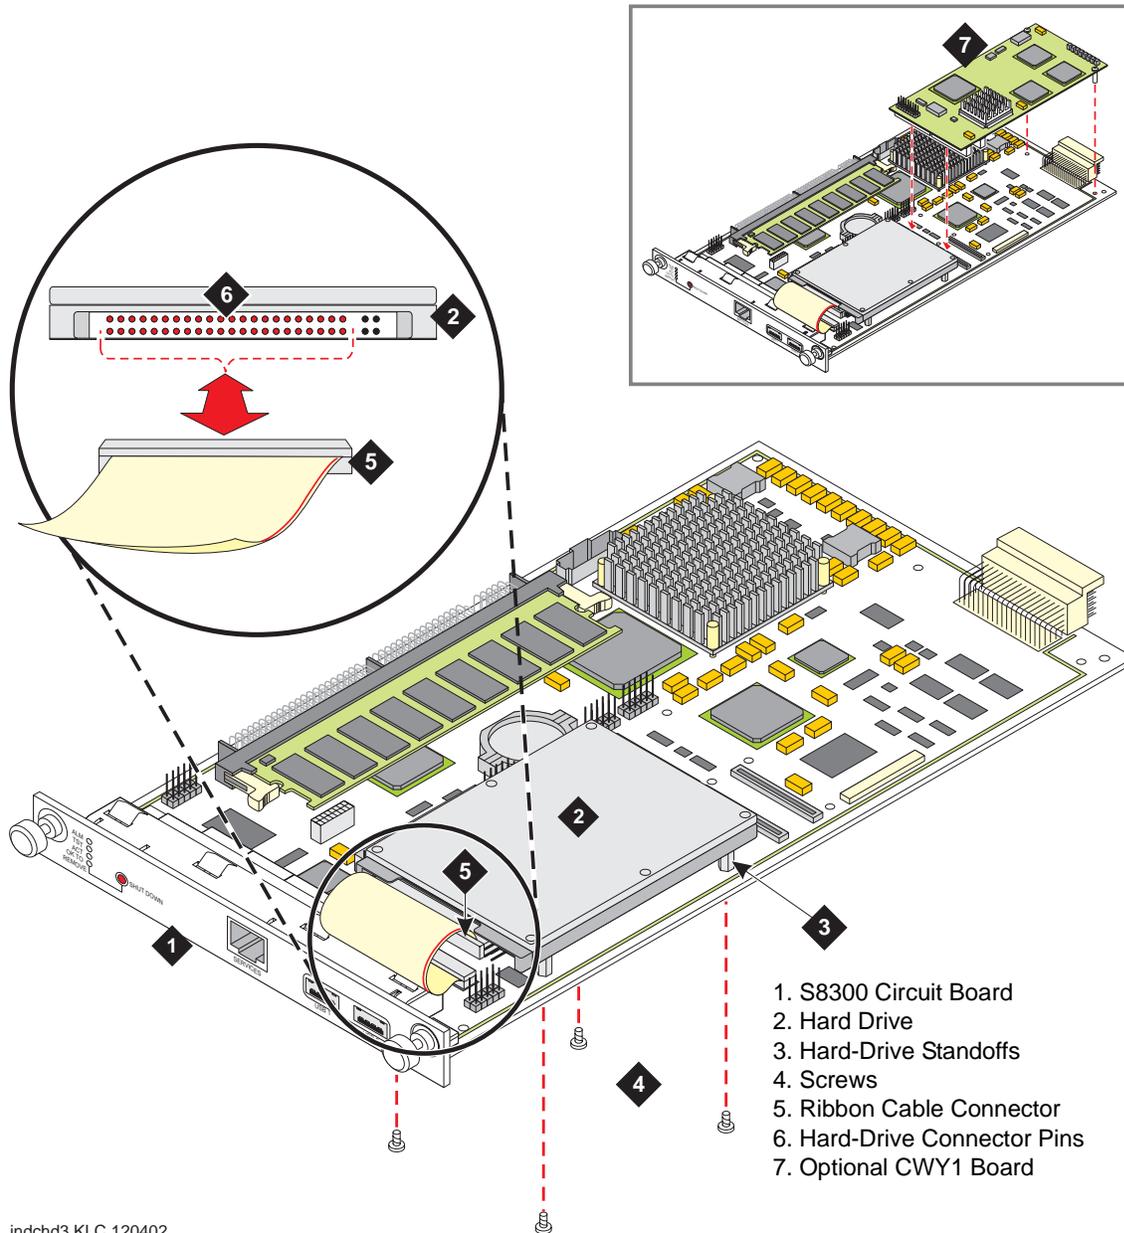
Figure 1. S8300 Hard Drive Replacement

In Step 4, be careful not to bend the pins on the hard drive. Leave the four jumper pins to the right of the ribbon cable open and unconnected, as shown in [Figure 1](#).

4. Connect the open end of the hard drive ribbon cable (which is attached to the S8300 board) to the hard drive, as shown in [Figure 1](#). Connect pin number one to the end of the ribbon connector marked with the red stripe.
5. Place the hard drive on the S8300 board with the standoffs aligned with the screw holes.
6. Hold the S8300 board on its side, with the hard drive in place, and screw the four screws through the bottom of the S8300 board into the hard drive standoffs.

To replace the S8300 hard drive, perform the following steps (Refer to [Figure 1](#)):

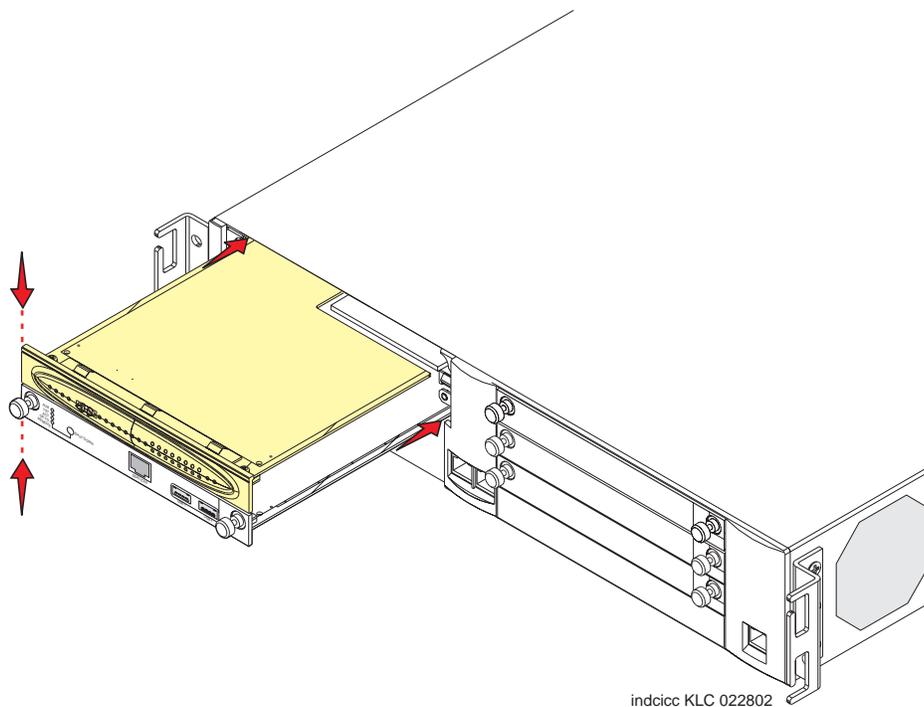
Figure 2. Align the LED module and the S8300 Media Server/LSP

1. Insert the S8300 into slot v1 of the G700 (Refer to [Figure 2](#)).
2. With the optional CWY1 and hard drive attached to the S8300 board, insert both the LED panel and S8300 board about 1/3 of the way into the guides (the guides are in slot v1 for the S8300 and above slot v1 for the LED panel).
3. Push both boards (together) back into the guides, gently and firmly, until the front of each board aligns with the front of the G700.
4. Secure the S8300 faceplate with the thumb screws (Refer to [Figure 3](#)). Tighten the thumb screws with a screw driver.

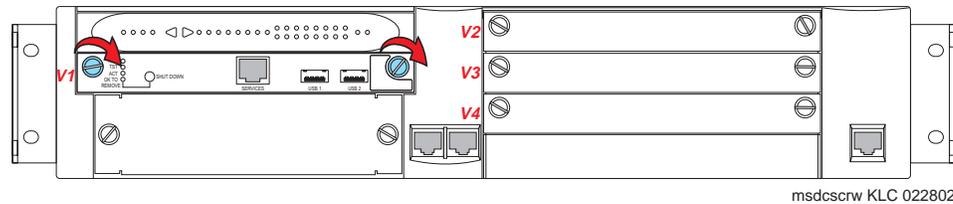
Figure 3. Tighten Screws

To prevent access to electrical hazards by unauthorized personnel and to ensure continued compliance to international radiated emissions requirements, all captive

screws must be securely tightened such that they cannot be loosened without the use of a tool.

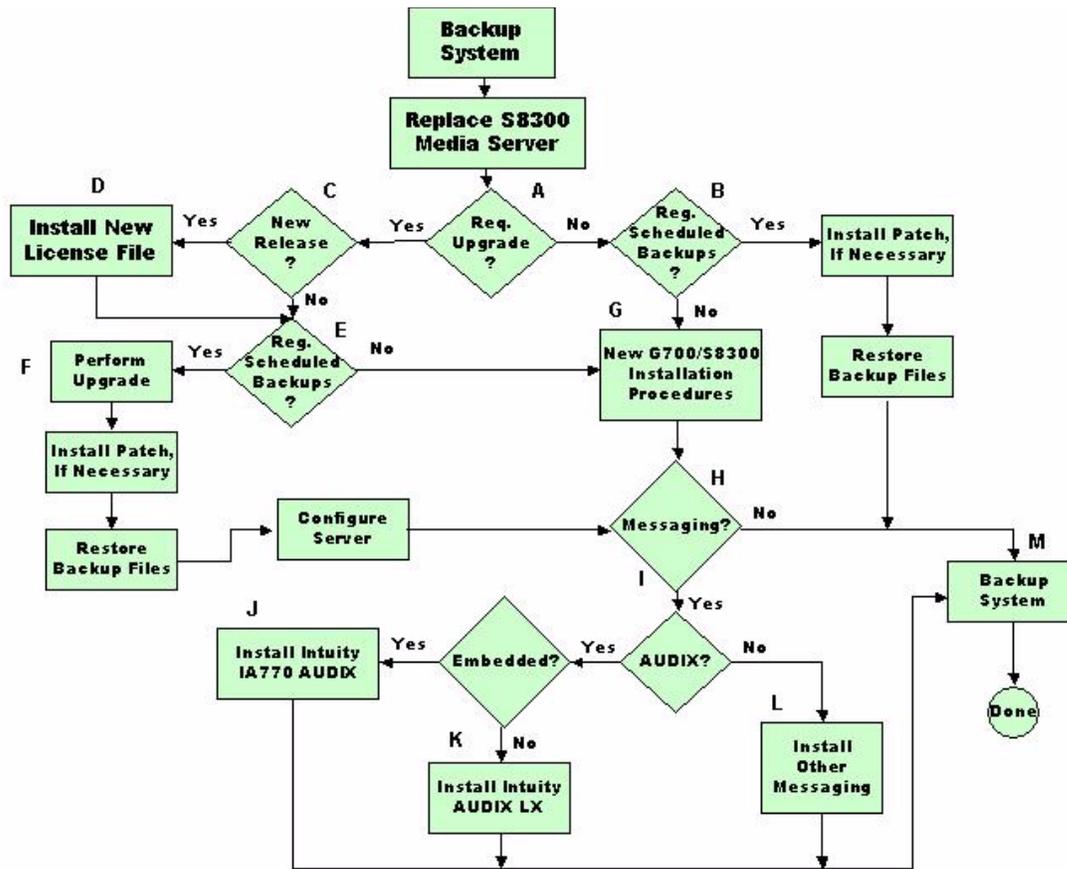
Figure 4. S8300 Media Server Replacement Flowchart

At the conclusion of the procedure for replacing the S8300 Media Server, the S8300 must be reconfigured for service. Figure 4 shows several tasks for the G700/S8300 system solution, depending on operational and configuration factors. The letters in the following list correspond to the letters in Figure 4:

A. Determine whether the replacement S8300 requires an upgrade, or whether the system software requires an upgrade. Using the Web interface, view the version of Avaya Communication Manager on the replacement S8300, and compare it to the version that the system was running before the replacement. Possible outcomes are:

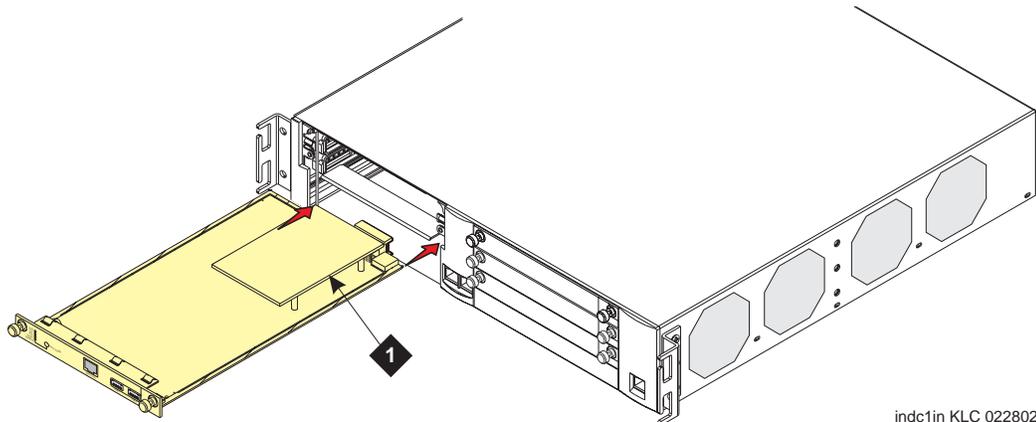
Figure 5. Inserting Media Modules

1. Identify and mark all cables.
2. Undo the cables.
3. Undo the captive screws and slide out the old Media Module.
4. Position the Media Module squarely before the selected slot on the front of the G700 chassis and engage both sides of the module in the interior guides.
5. Slide the module slowly into the chassis, maintaining an even pressure to assure that the module does not become twisted or disengage from the guides. (Figure 5)

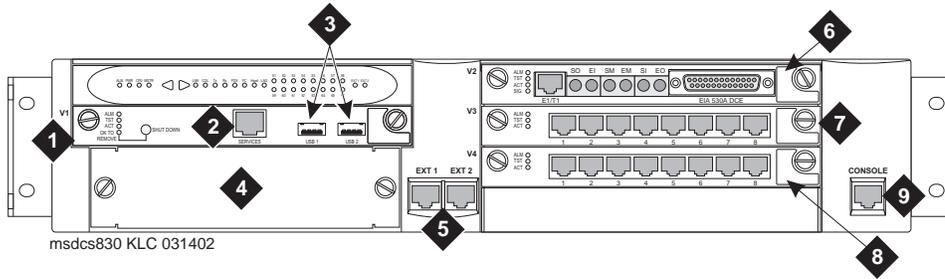
Begin

As shown in [Figure 17](#), the LED panel is located on the top left corner of the G700. Directly below the LED panel is Media Module slot V1, which can be occupied by any type of Media Module. However, the S8300 Media Server can reside only in this particular slot because of height restrictions (for a specific discussion of the S8300 LEDs, please see “[S8300 Media Server LEDs](#)” on [page 339](#)).

1. Media Module Slot #1 (V1)
2. S8300 Services Port (Used with cross-over ethernet cable)
3. S8300 USB-Series Modem connection
4. Avaya Expansion Module Slot
5. 10/100 Base-T Ethernet Ports (Ext1, Ext2)
6. Media Module Slot #2 (V2)
7. Media Module Slot #3 (V3)
8. Media Module Slot #4 (V4)
9. Console Interface (Used with serial cable)

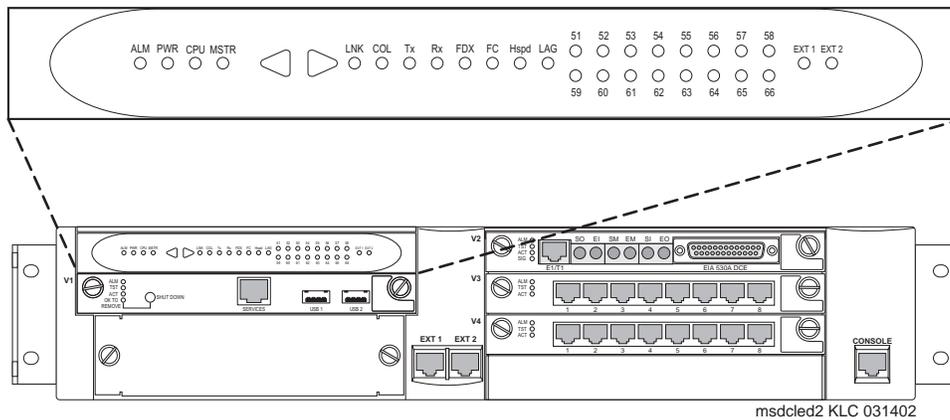
Figure 18. G700 LED Panel

Figure 18 shows an expanded view of the G700 LED panel.
