# **Maintenance of the Avaya G350 Media Gateway**

555-245-105  
Issue 1  
December 2003

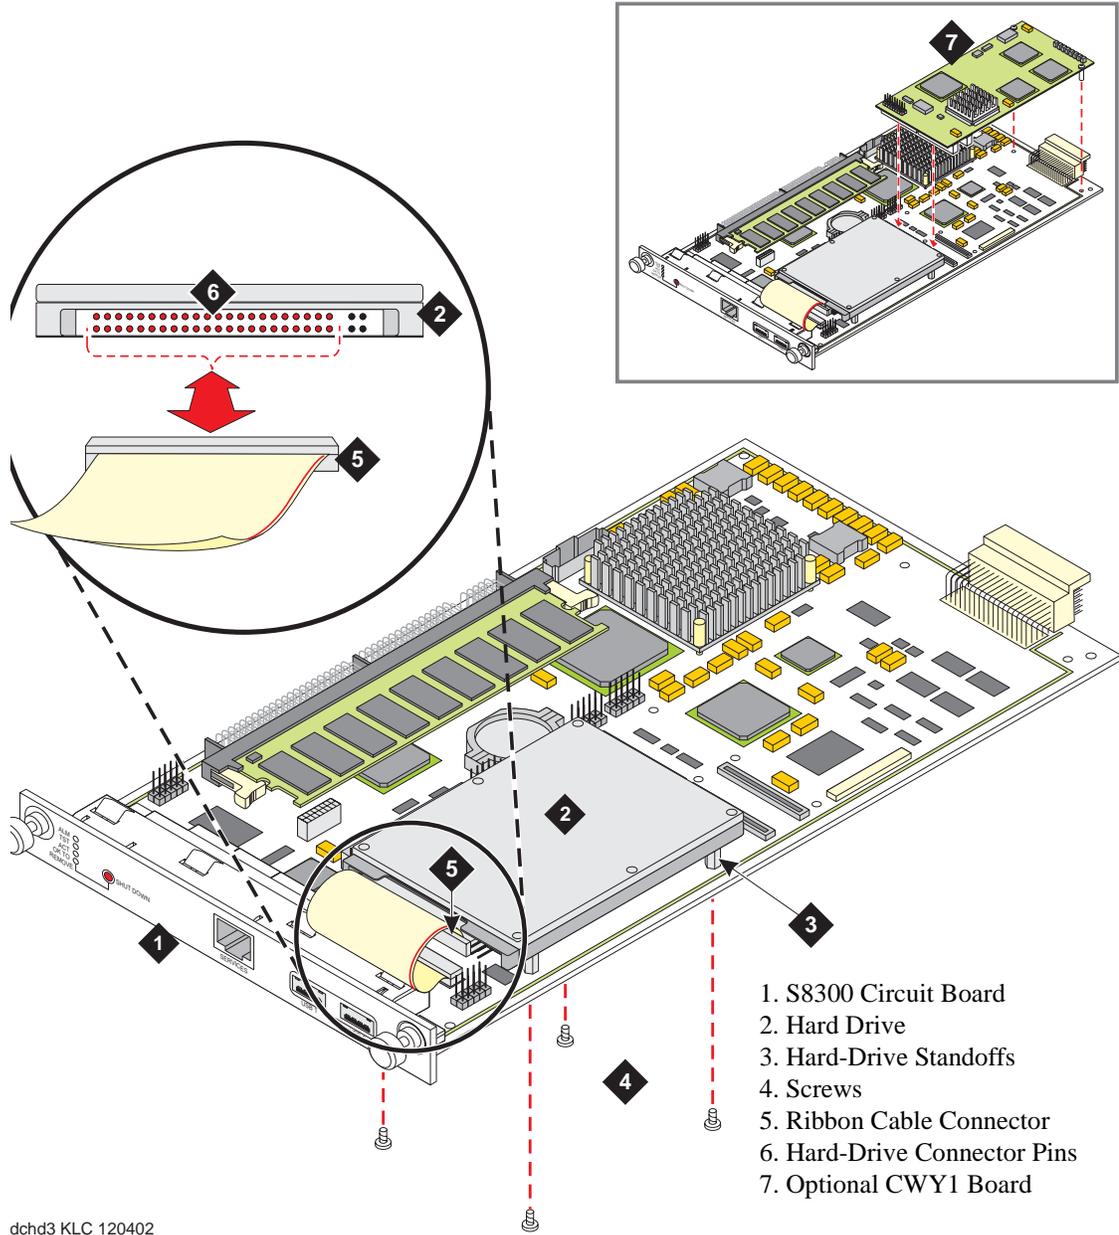
Figure 1: S8300 Hard Drive Replacement

*In Step 4, be careful not to bend the pins on the hard drive. Leave the four jumper pins to the right of the ribbon cable open and unconnected, as shown in [Figure 1, S8300 Hard Drive Replacement](#), on page 29.*

- 4 Connect the open end of the hard drive ribbon cable (which is attached to the S8300 board) to the hard drive, as shown in [Figure 1, S8300 Hard Drive Replacement](#), on page 29. Connect pin number one to the end of the ribbon connector marked with the red stripe.
- 5 Place the hard drive on the S8300 board with the standoffs aligned with the screw holes.
- 6 Hold the S8300 board on its side, with the hard drive in place, and screw the four screws through the bottom of the S8300 board into the hard drive standoffs.

**To replace the S8300 hard drive, perform the following steps (refer to [Figure 1, S8300 Hard Drive Replacement](#), on page 29):**

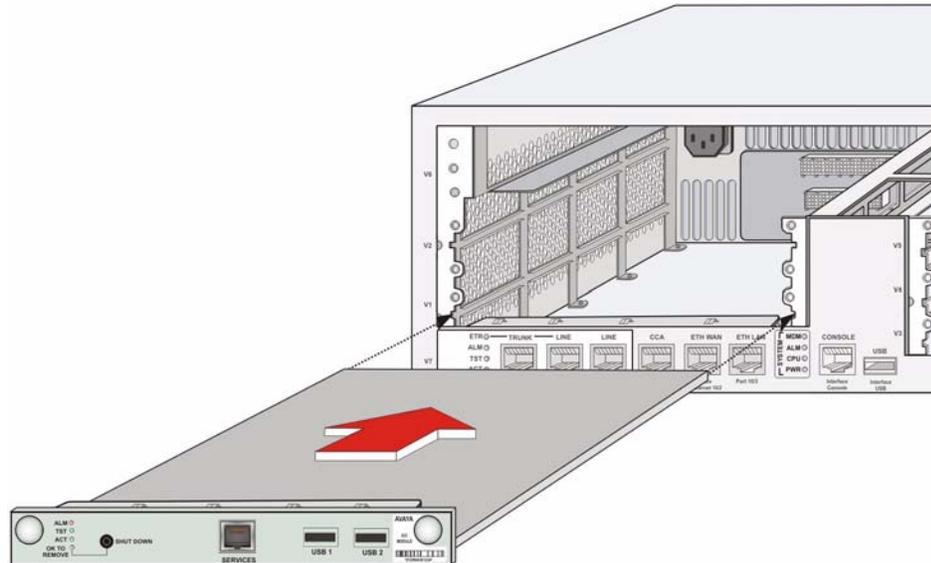
**Figure 2: Align the S8300 Media Server/LSP**

- 1 Insert the S8300 into slot v1 of the G350 (refer to [Figure 2, Align the S8300 Media Server/LSP](#), on page 30).
- 2 With the optional CWY1 and hard drive attached to the S8300 board, insert the S8300 board about 1/3 of the way into the guides (the guides are in slot v1 for the S8300).
- 3 Push both boards (together) back into the guides, gently and firmly, until the front of each board aligns with the front of the G350.
- 4 Secure the S8300 faceplate with the thumb screws. Tighten the thumb screws with a screw driver, in the clockwise direction.
- 5 Replace the plate between slots V1 and V2, labelled “Remove before removing or inserting S8300 module”.

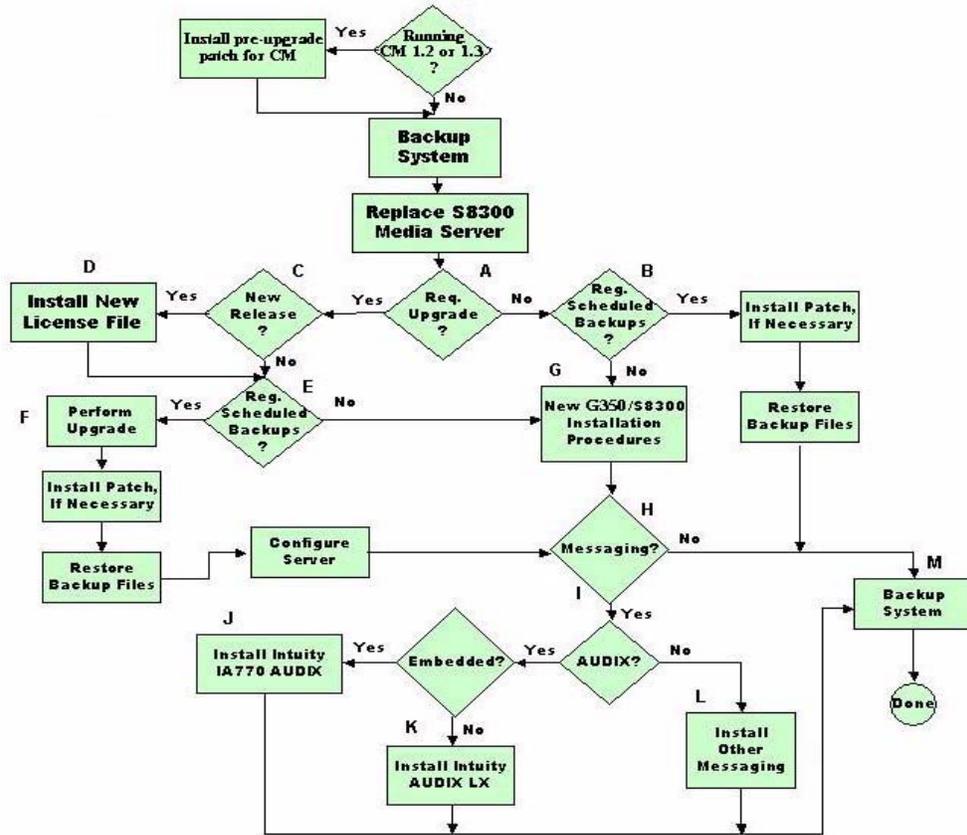
Figure 3: S8300 Media Server Replacement Flowchart

At the conclusion of the procedure for replacing the S8300 Media Server, the S8300 must be reconfigured for service. [Figure 3, S8300 Media Server Replacement Flowchart](#), on page 33 shows several tasks for the G350/S8300 system solution, depending on operational and configuration factors. The letters in the following list correspond to the letters in [Figure 3, S8300 Media Server Replacement Flowchart](#), on page 33:

**A.** Determine whether the replacement S8300 requires an upgrade, or whether the system software requires an upgrade. Using the Web interface, view the version of Avaya Communication Manager on the replacement S8300, and compare it to the version that the system was running before the replacement. Possible outcomes are ([Figure 3, S8300 Media Server Replacement Flowchart](#), on page 33):

**C.** For the case in which an upgrade is required, two possibilities exist: ([Figure 3, S8300 Media Server Replacement Flowchart](#), on page 33):

- If the server that was replaced had received regular upgrades and now has a newer version of Communication Manager, the replacement S8300 requires an upgrade. Upgrading the replacement S8300 does not require the installation of a new licence file, because the current license file reflects the newer version of Communication Manager.
- The replacement S8300 may have been upgraded to a newer version of Communication Manager. In this case, if the upgrade involves a new release of Communication Manager (for example, 1.2 to 2.0), a new license file must be obtained and installed (**D**, [Figure 3, S8300 Media Server Replacement Flowchart](#), on page 33).

**D.** If no regularly scheduled backup exists, proceed with Installation Procedures for a New S8300 Media Server (**G**, [Figure 3, S8300 Media Server Replacement Flowchart](#), on page 33). As part of those procedures, performing a necessary upgrade/patch is covered ([Figure 3, S8300 Media Server Replacement Flowchart](#), on page 33).

**G.** If the configuration has no messaging application, perform another system backup (**M**, [Figure 3, S8300 Media Server Replacement Flowchart](#), on page 33) before concluding ([Figure 3, S8300 Media Server Replacement Flowchart](#), on page 33).

**B.** For the case of no required upgrade, if regularly scheduled backups had been administered for the system ([Figure 3, S8300 Media Server Replacement Flowchart](#), on page 33):

If no backup exists, proceed with Installation Procedures for a New S8300 Media Server (**G**, [Figure 3, S8300 Media Server Replacement Flowchart](#), on page 33).

**E.** For the case in which regularly scheduled backups do exist ([Figure 3, S8300 Media Server Replacement Flowchart](#), on page 33):

**F.** Installation procedures for a new G350/S8300 are described in detail in *Installation of the Avaya G350 Media Gateway Controlled by an Avaya S8300, S8500, or S8700 Media Server*, 555-245-104. If an upgrade is necessary, these procedures are described in detail in *Upgrade and Service Guide for the Avaya G350 Media Gateway*, 555-245-106 ([Figure 3, S8300 Media Server Replacement Flowchart](#), on page 33).

**H.** If the configuration has a messaging application, install this application. Messaging can be embedded IA770 INTUITY™ AUDIX®, INTUITY™ AUDIX® LX, or another messaging application ([Figure 3, S8300 Media Server Replacement Flowchart](#), on page 33).

**I.** For information on installing the IA770 INTUITY AUDIX Messaging Application, refer to *IA770 INTUITY™ AUDIX® Messaging Application*, 555-233-825 on the Avaya S8300 and S8700 Media Server Library CD, or go to <http://www.avaya.com/support>, select **Communications Systems**, then **Product Documentation**; then, under **Enterprise Class IP Solutions**, select **Avaya G350 Media Gateway and S8300 Media Server**. Finally, search for IA770 INTUITY AUDIX documentation updates ([Figure 3, S8300 Media Server Replacement Flowchart](#), on page 33).

**J.** For information on installing the INTUITY AUDIX LX messaging application, refer to "*INTUITY™ AUDIX® LX LAN Integration with S8300 and DEFINITY® Systems*" on the Avaya S8300 and S8700 Media Server Library CD ([Figure 3, S8300 Media Server Replacement Flowchart](#), on page 33).

**K.** If another messaging application is used, follow the installation instructions applicable for that application ([Figure 3, S8300 Media Server Replacement Flowchart](#), on page 33).

**L.** Before concluding, perform another system backup ([Figure 3, S8300 Media Server Replacement Flowchart](#), on page 33).

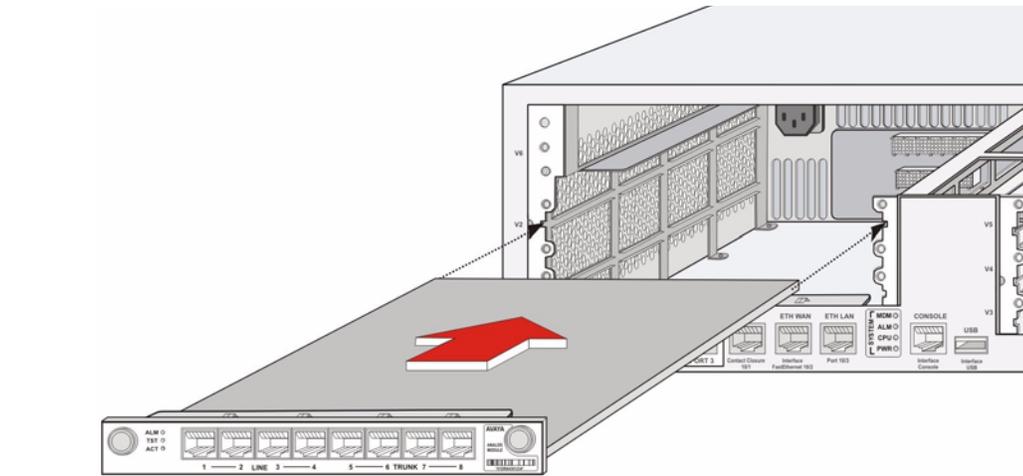
**Figure 4: Inserting Media Modules**

- 1 Identify and mark all cables.
- 2 Undo the cables. Make note of the order in which they are removed.
- 3 Undo the captive screws and slide out the Media Module currently inserted into the G350.
- 4 Position the Media Module squarely before the selected slot on the front of the G350 chassis and engage both sides of the module in the interior guides.
- 5 Slide the module slowly into the chassis, maintaining an even pressure to assure that the module does not become twisted or disengage from the guides ([Figure 4, Inserting Media Modules](#), on page 37).
- 6 Apply firm pressure to engage the connectors at the back of the chassis.

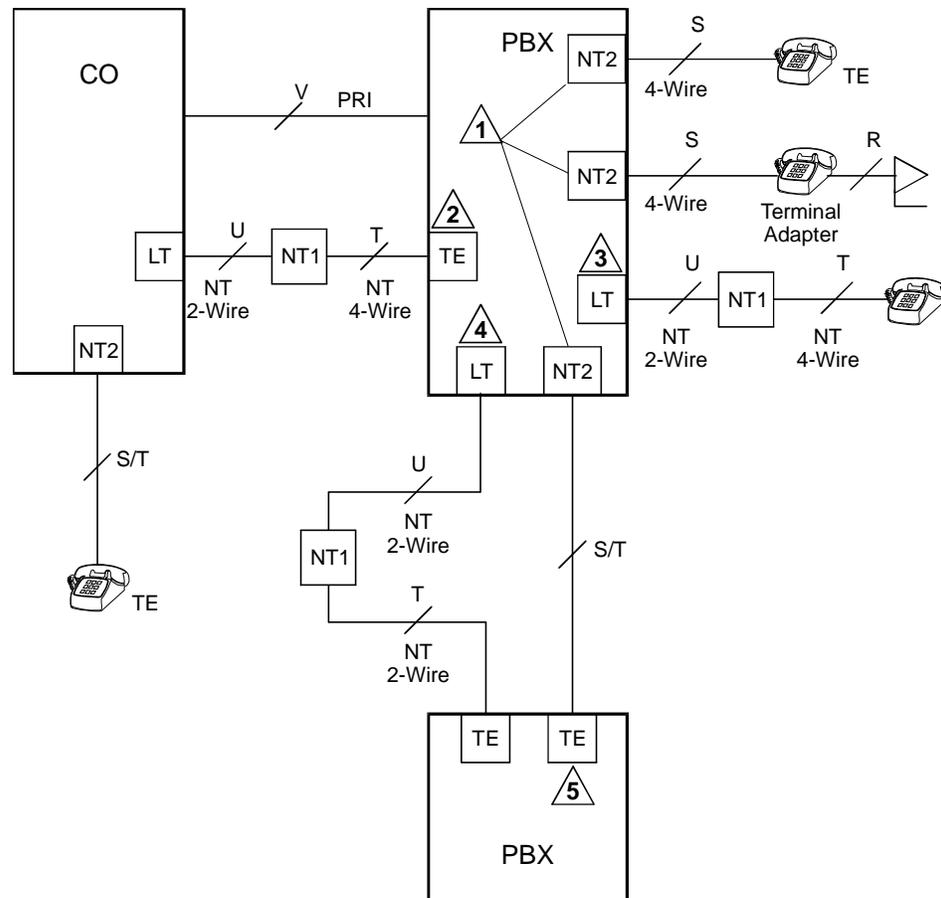
**Figure 11: Integrated Trunk-Side BRI, ISDN Interface Reference Points**

[Figure 11, Integrated Trunk-Side BRI, ISDN Interface Reference Points](#), on page 170 shows, for a generic integrated trunk-side BRI, the ISDN Interface Reference Points. [Table 100, ISDN Interface Reference Point definitions](#), on page 171 gives definitions for the generic ISDN Interface Reference Points.

ISDN Interface Reference Points

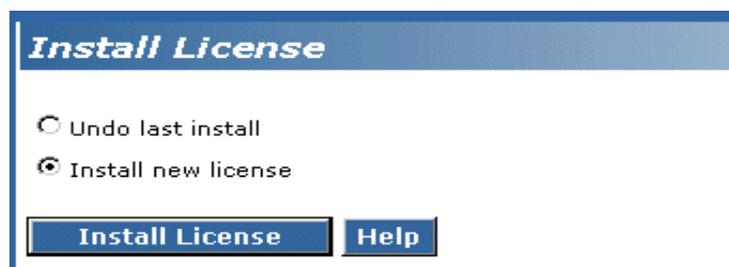
- 1 Under **Security** click **Install License**, select "Install new license," then click the Install License button to install the license files.

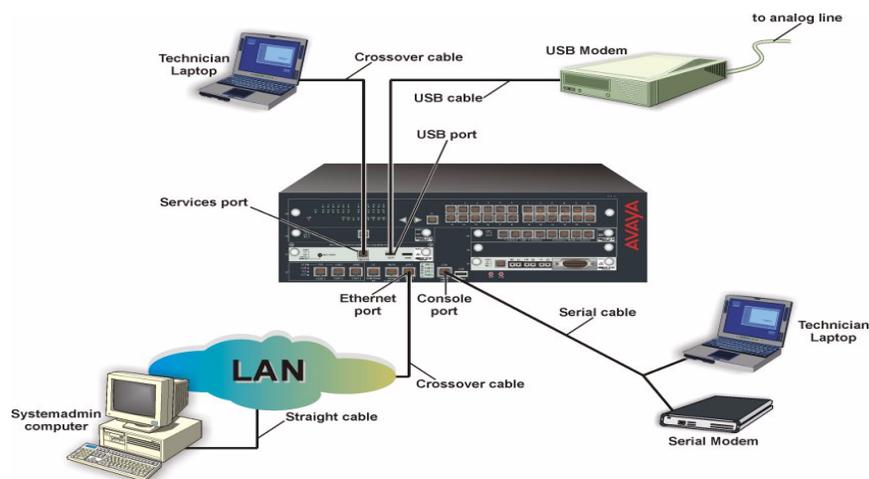
Figure 12: Summary of S8300 and G350 Access Methods and Tasks

There are several methods of connecting to the Avaya G350 Media Gateway and the S8300 Media Server, as shown in [Figure 12, Summary of S8300 and G350 Access Methods and Tasks](#), on page 247. Choose the method and tools appropriate for your maintenance task.

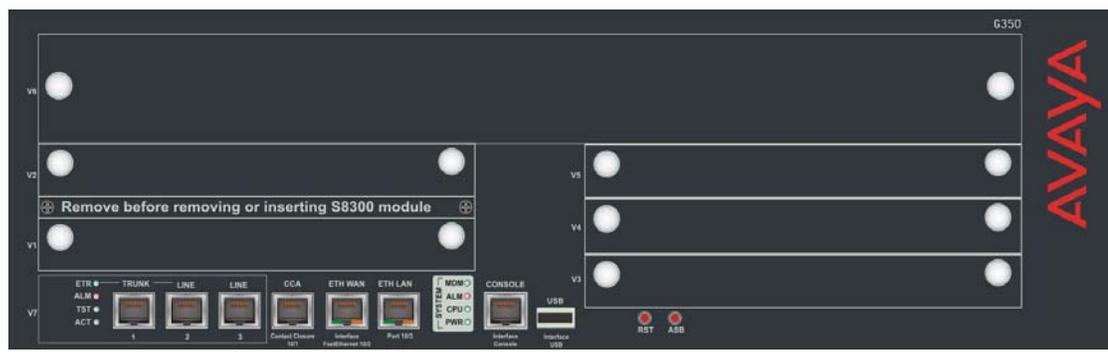
**Figure 13: G350 chassis**

The following figure shows the G350 chassis:
