**1A DATA STATION
SINGLE CHANNEL ARRANGEMENTS
BINARY MODE
MAINTENANCE**

3. MAINTENANCE PROCEDURES	4	A. Scope	
A. General	4	1.01 This section describes the trouble analysis procedures to be followed when handling service complaints of the 1A Data Station, Single Channel Arrangements (SCA), hereafter referred to as the 1A Data Station.

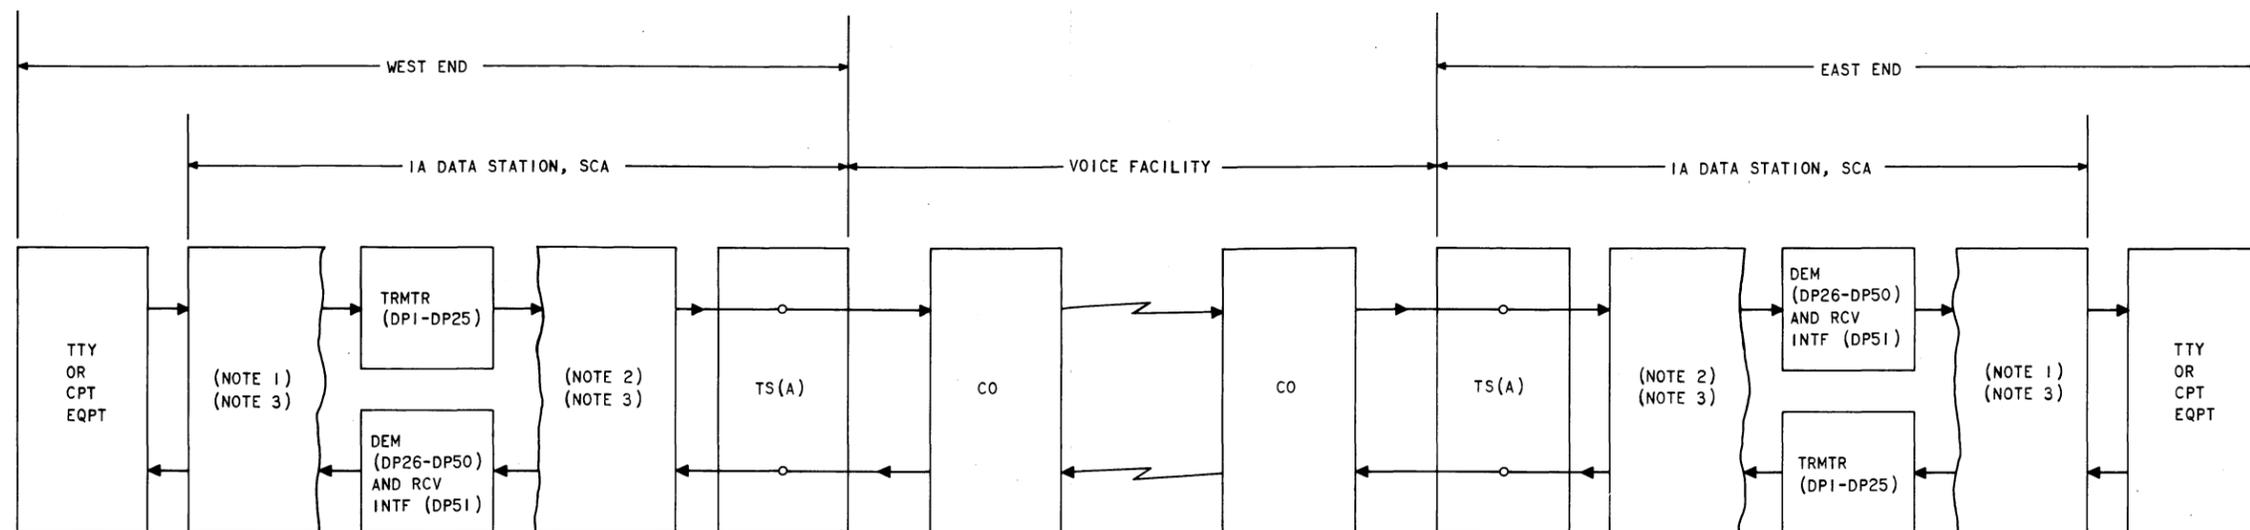
TPA 570341

Fig. 1—Orientation and Definitions—1A Data Station, SCA, Binary Mode—Block Diagram

3.01 Figure 1 is presented for orientation and definition purposes, and is intended to be used as a reference while reading the text. Maintenance of the 1A Data Station should be in accordance with the flowcharts shown in Fig. 2 through 6. The flowcharts are recommended for an organized trouble investigation with a minimum amount of time spent in locating the cause of the trouble report by the customer.

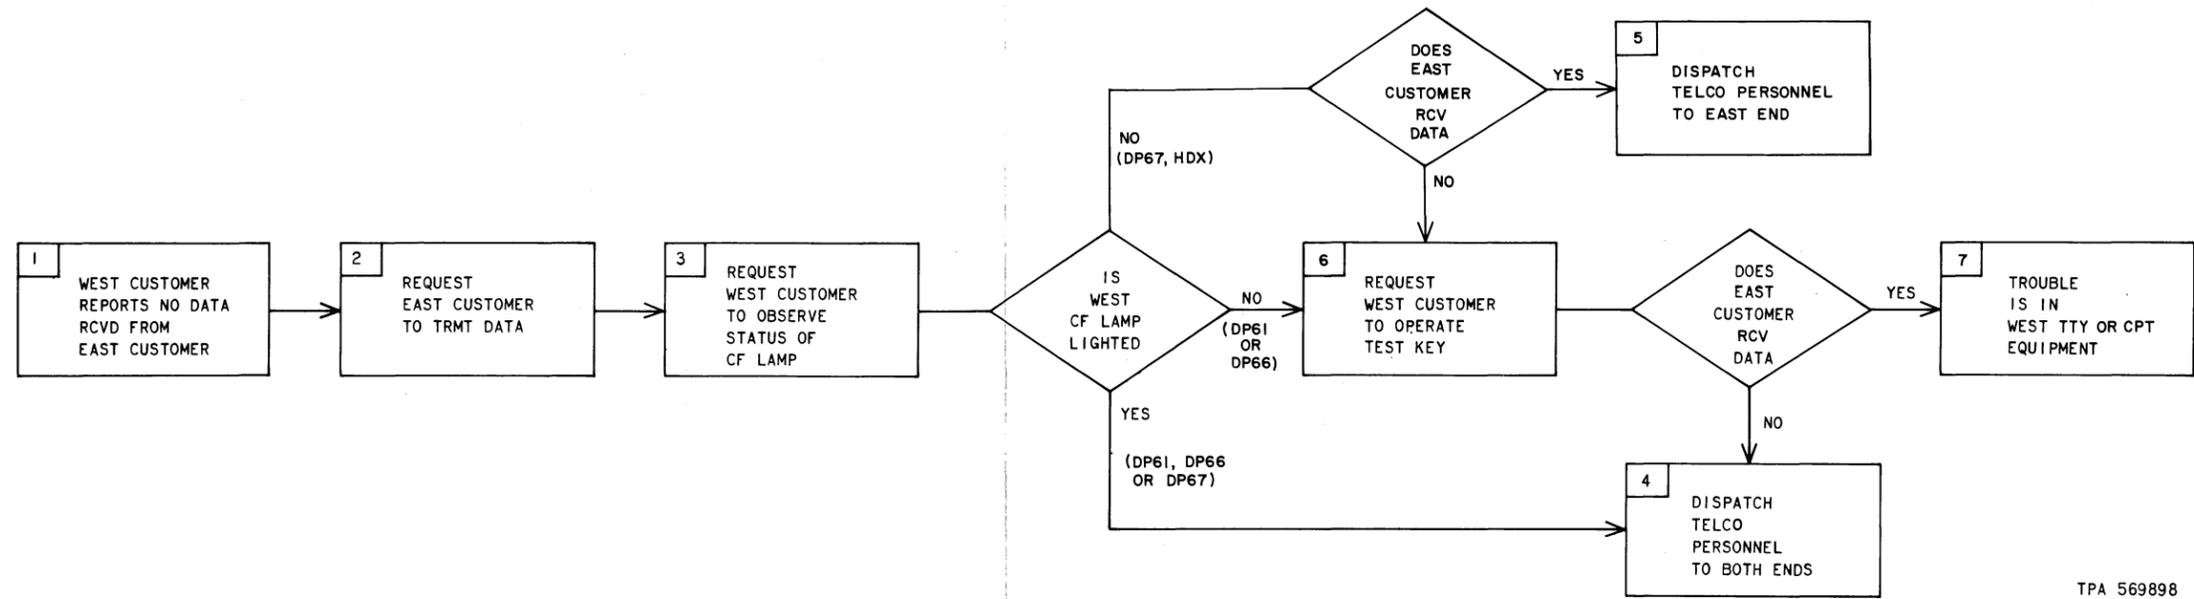
TPA 569898

Fig. 2—Trouble Isolation Prior to Dispatching Personnel—1A Data Station-to-1A Data Station, Direct (Does Not Pass Through a Central Office)

1A Data Station-to-1A Data Station Direct—(the Circuit Does NOT Pass Through a Central Office) (Fig. 2)

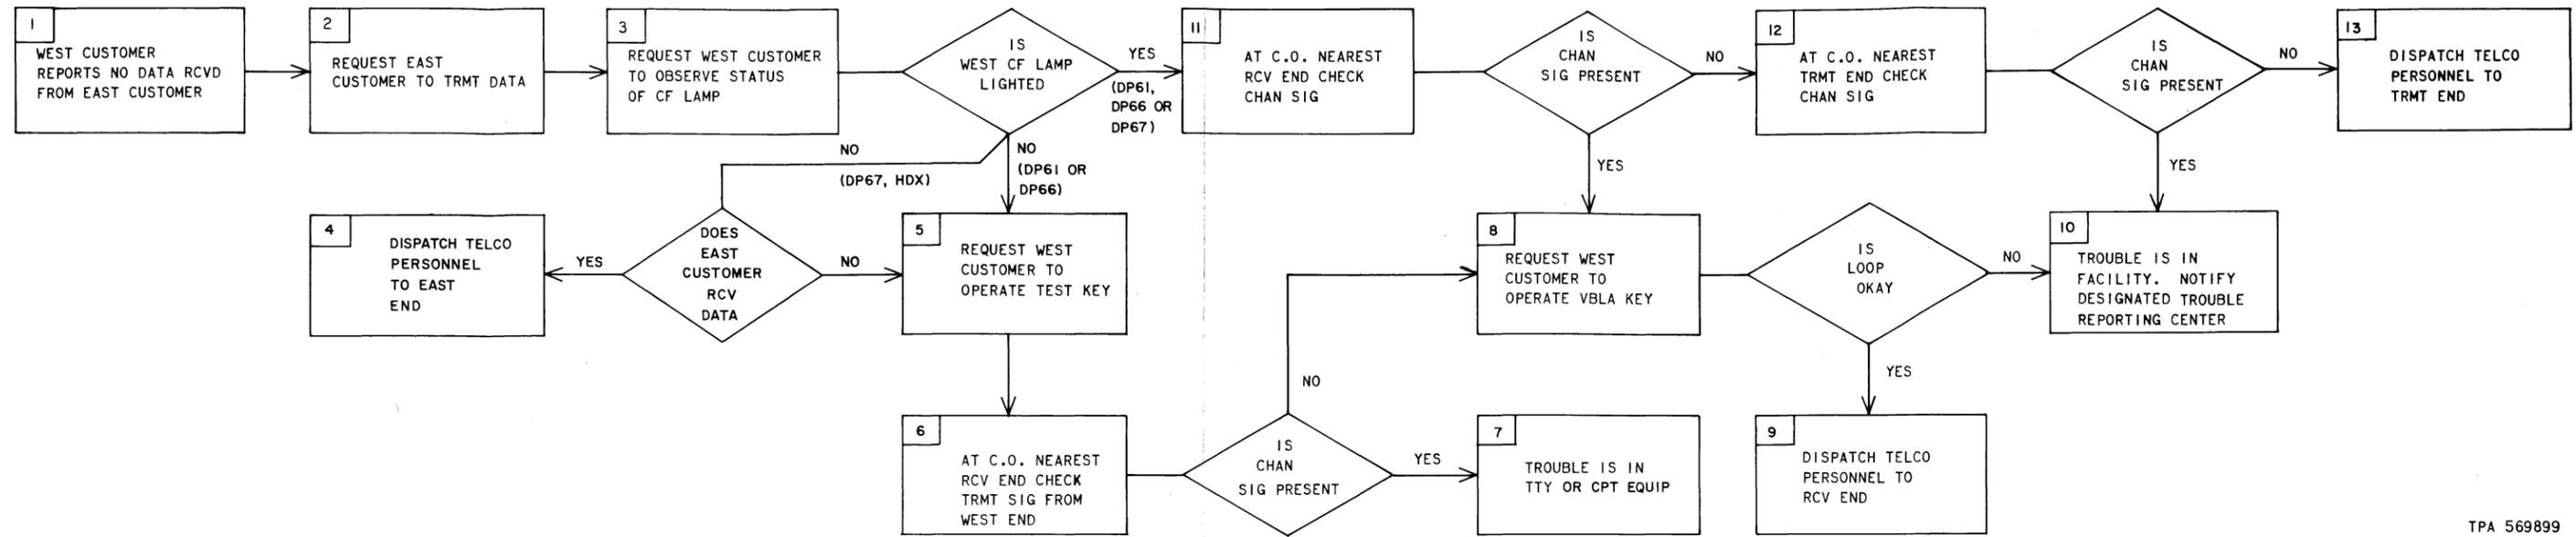
TPA 569899

Fig. 3—Trouble Isolation Prior to Dispatching Personnel—1A Data Station-to-1A Data Station Through a Central Office

1A Data Station-to-1A Data Station (the Circuit Does Pass Through a Central Office) (Fig. 3)

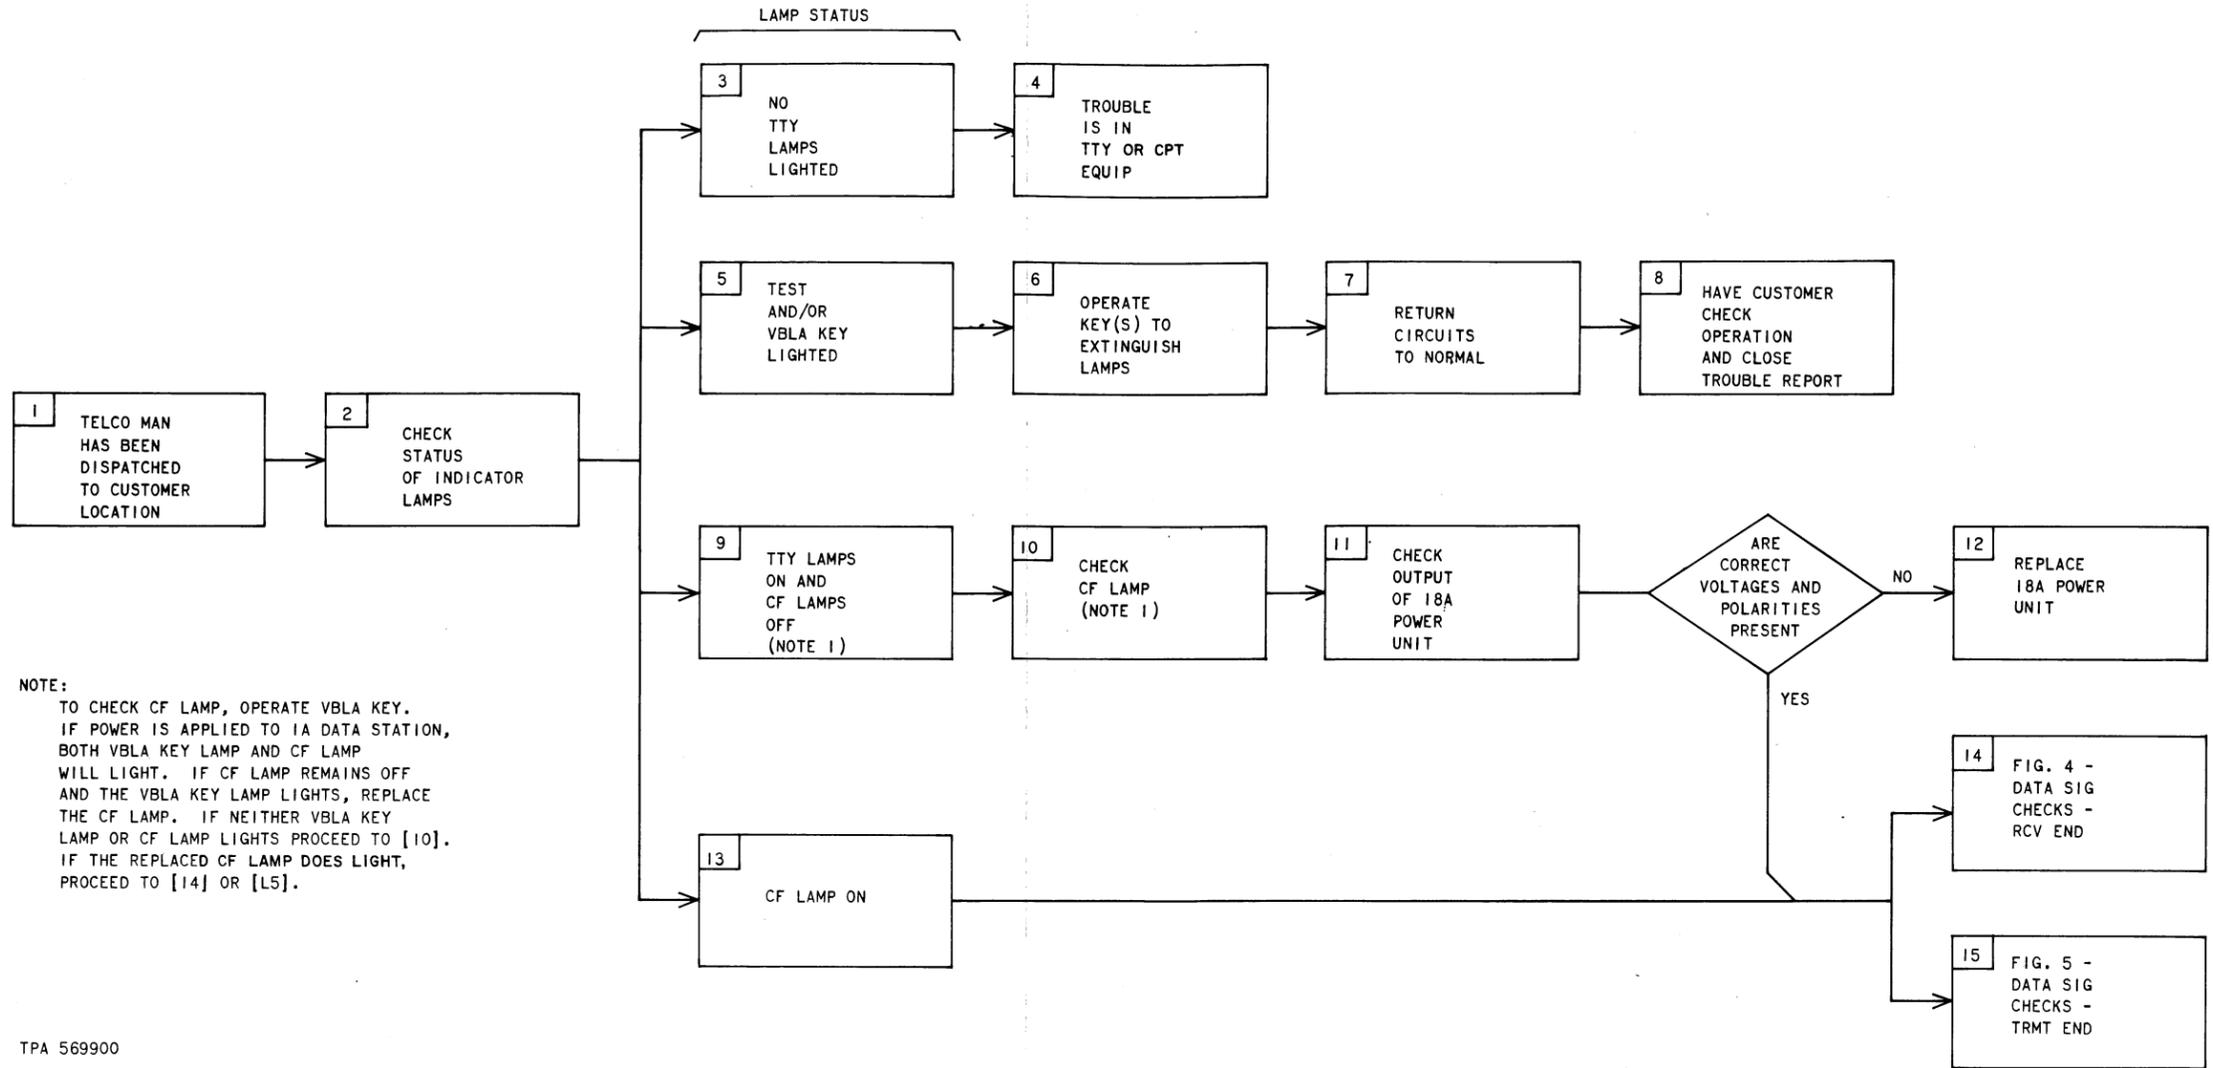
TPA 569900

Fig. 4—Trouble Isolation—Preliminary Investigation at Customer Location

C. Preliminary Trouble Isolation At The 1A Data Station, SCA (Fig. 4)

3.27 If the CF lamp is on [13], proceed to Fig. 4 if the Telco employee is at the receive end [14], or to Fig. 5 if the Telco employee is at the transmit end [15].

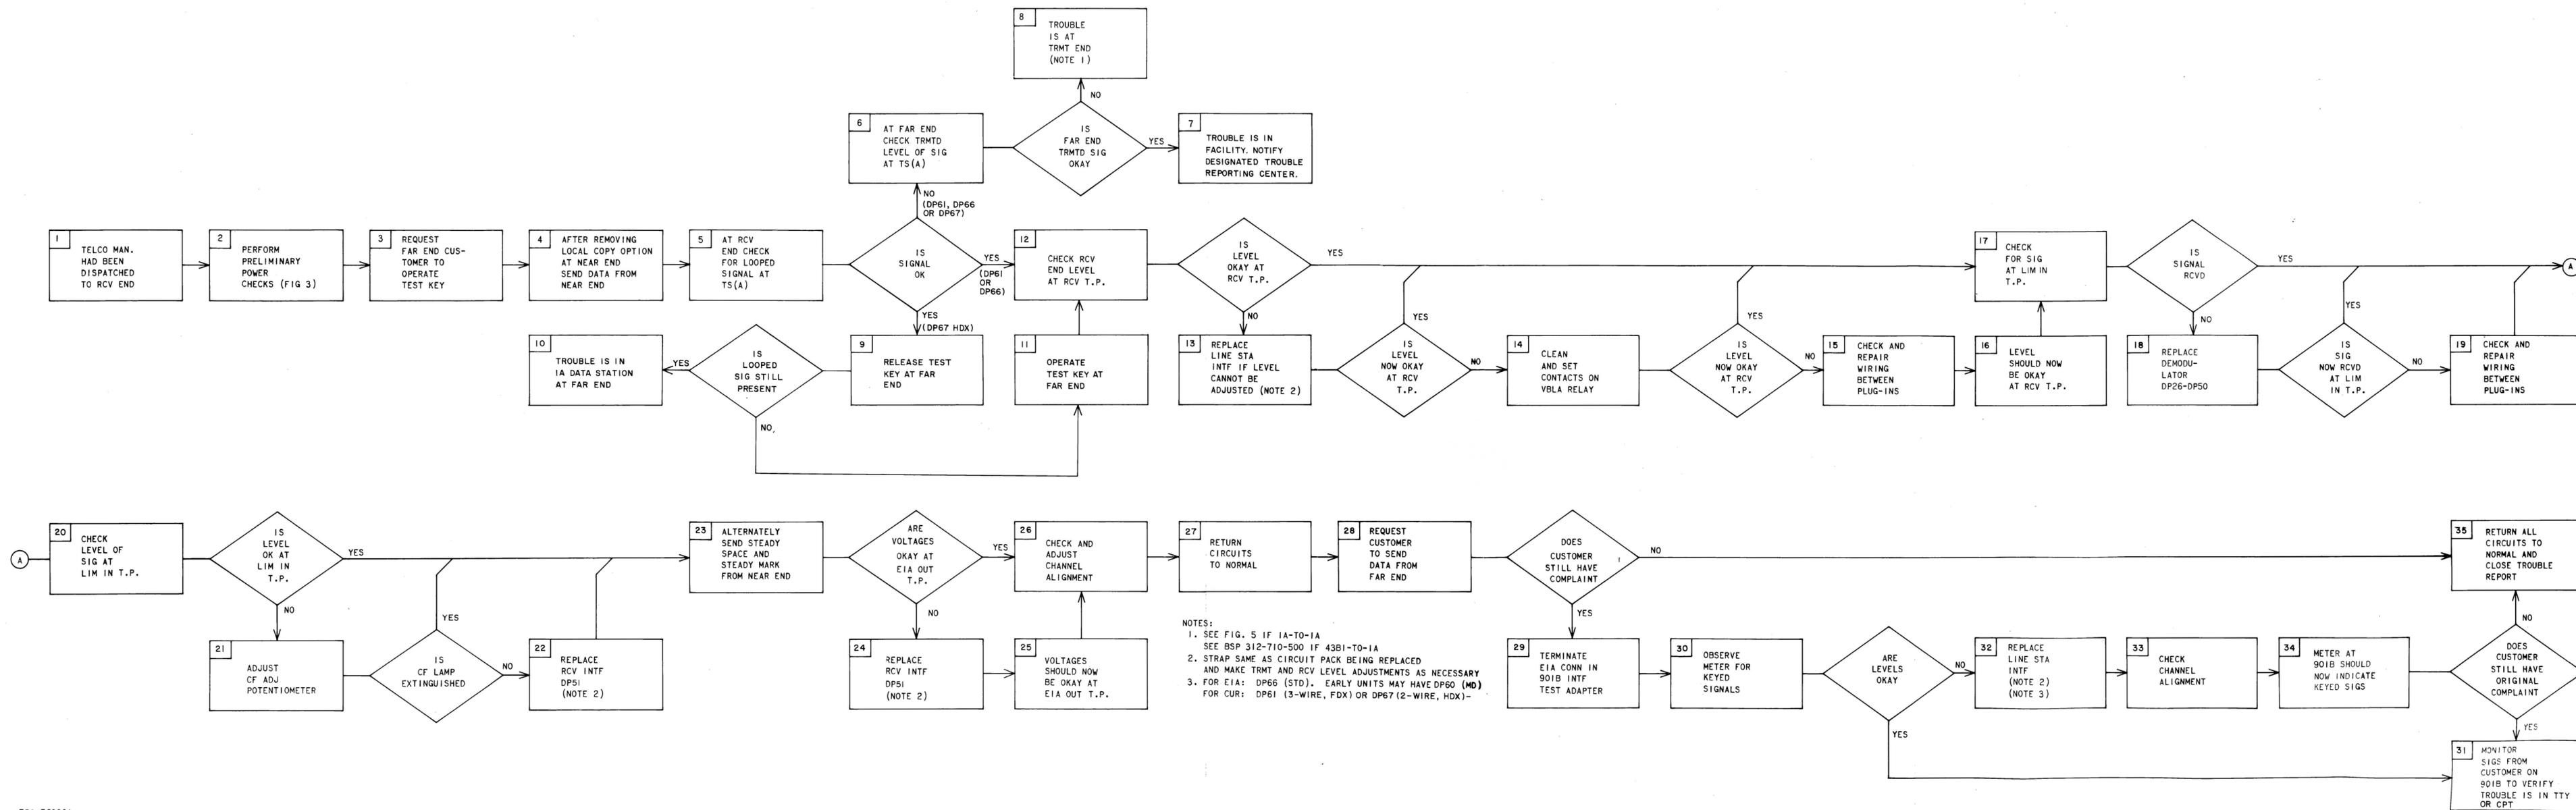
NOTES:
 1. SEE FIG. 5 IF 1A-TO-1A SEE BSP 312-710-500 IF 43B1-TO-1A
 2. STRAP SAME AS CIRCUIT PACK BEING REPLACED AND MAKE TRMT AND RCV LEVEL ADJUSTMENTS AS NECESSARY
 3. FOR EIA: DP66 (STD). EARLY UNITS MAY HAVE DP60 (MD) FOR CUR: DP61 (3-WIRE, FDX) OR DP67 (2-WIRE, HDX)-

Fig. 5—Signal Checks—Receive End—1A Data Station, SCA, Binary Mode

D. Binary Signal Checks—Receive End (Fig. 5)

3.28 The following procedure (Fig. 5) is a continuation of the 1A Data Station trouble investigation to be followed after the preliminary checks have been completed [2], and is to be used when tests or reports indicate that the malfunctioning portion of the system is at the receive end.

3.39 Should the signal not be received at the LIM IN test point after replacing the demodulator, check and repair the wiring between the plug-ins [19].

3.43 Should the voltage not be as specified at the EIA OUT test point, replace the receive interface (DP51 circuit pack) [24]. The voltage levels should now be as specified at the EIA OUT test point [25].

3.47 If the levels of the keyed receive signals on the meter at the 901B interface test adapter are not as specified, replace the line station interface (DP61, DP66, or DP67 circuit pack) after installing strapping as indicated on the circuit order or as on the removed circuit packs. Adjust

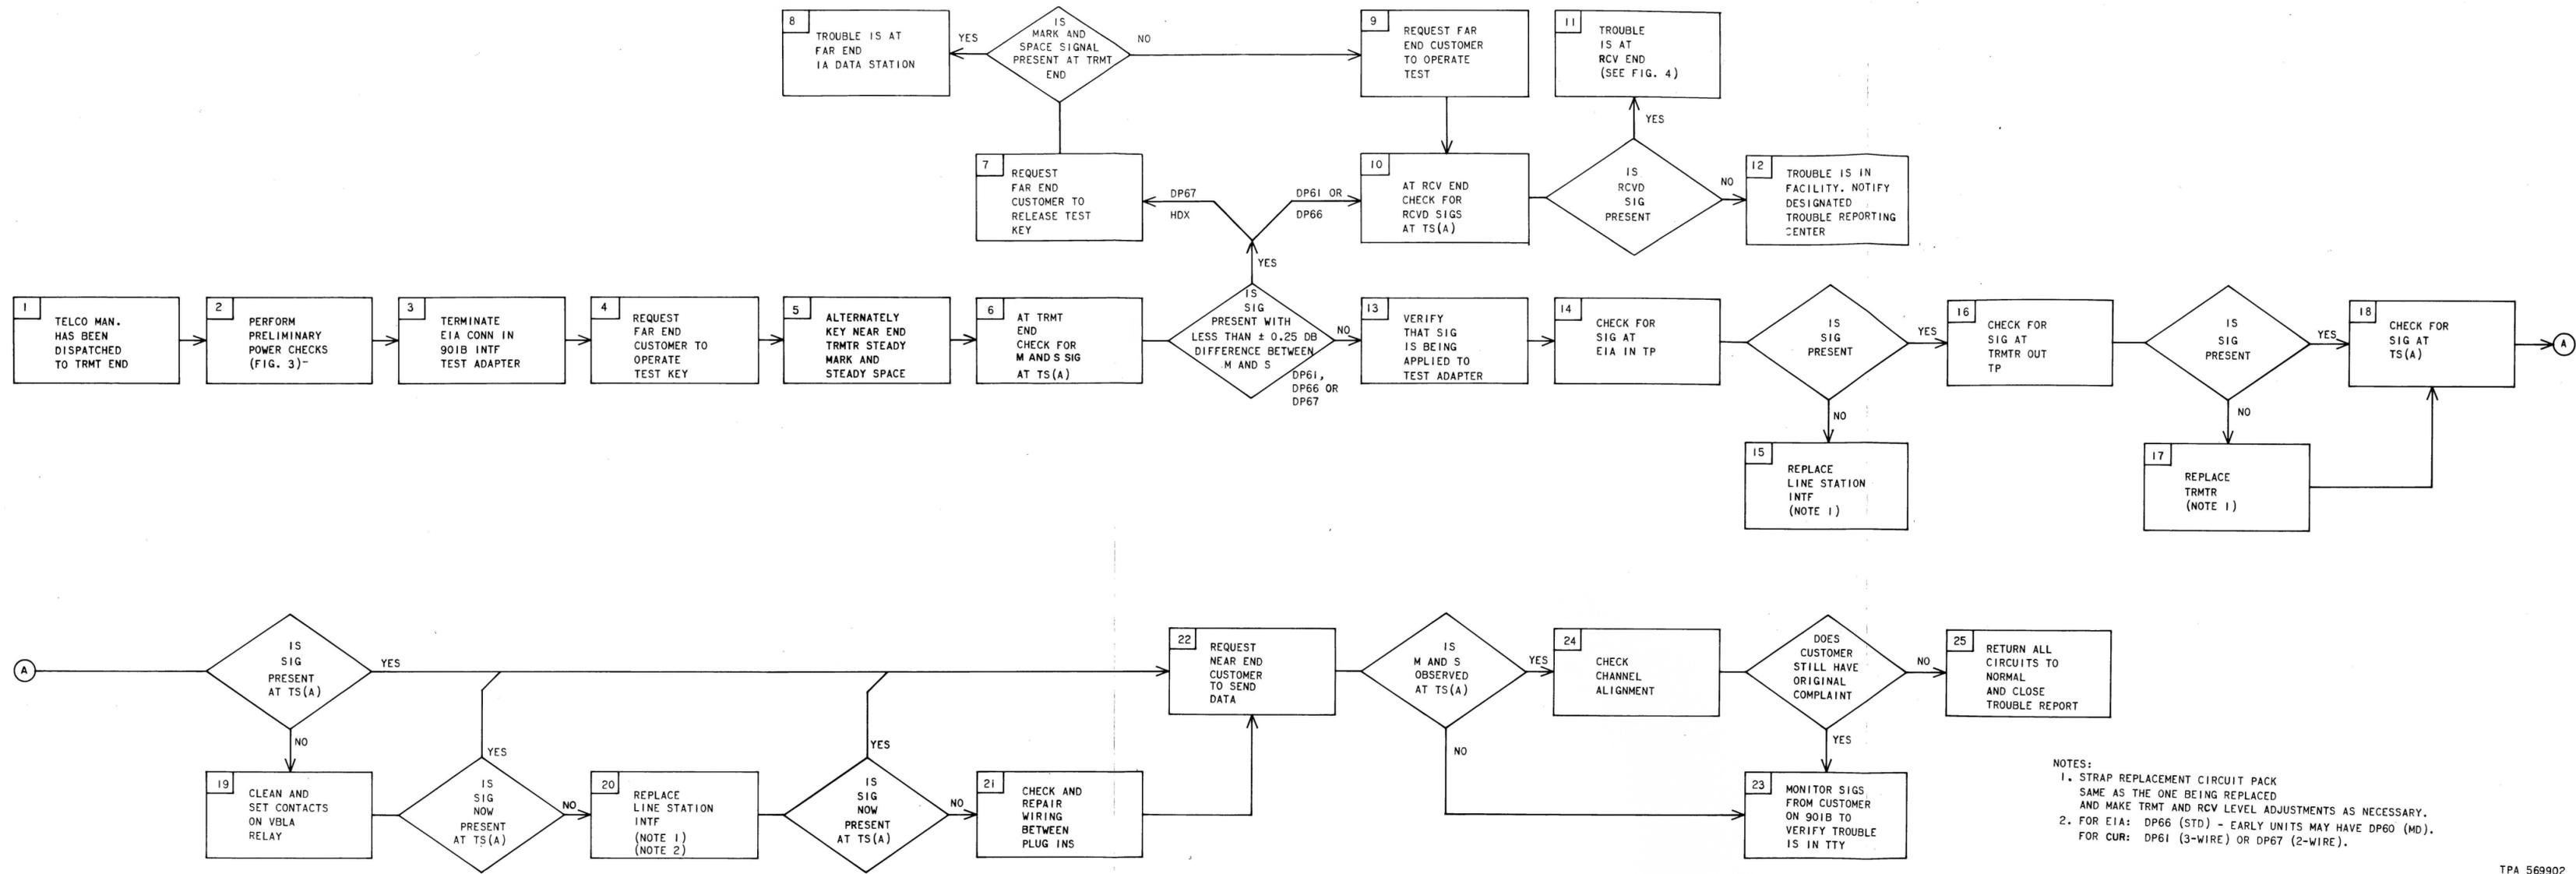
TPA 569902

NOTES:
 1. STRAP REPLACEMENT CIRCUIT PACK SAME AS THE ONE BEING REPLACED AND MAKE TRMT AND RCV LEVEL ADJUSTMENTS AS NECESSARY.
 2. FOR EIA: DP66 (STD) - EARLY UNITS MAY HAVE DP60 (MD). FOR CUR: DP61 (3-WIRE) OR DP67 (2-WIRE).

3.54 If the signal is present at the transmit end TS(A), check for the presence of the looped back signal on the receive side at the near transmit end TS(A) [10]. If the signal is received on the receive side TS(A), the trouble is at the far receive end [11] (see Fig. 4). However, should the signal not be present on the receive side TS(A), the trouble is in the facility [12].

3.56 If the signal does not appear at the EIA IN test point, replace the line station interface (DP61, DP66, or DP67 circuit pack) after applying the strapping to the new card the same as the one being replaced, or as required by the CLR [15].

3.58 If the signal is not present at the TRMTR OUT test point, replace the transmitter (DP1-DP25 circuit pack) [17].

3.61 Should the signal still not be present at TS(A), and the contacts on the VBLA relay are good, replace the line station interface after installing strapping the same as in original circuit pack. Transmit and receive levels must be adjusted [20]. If the signal now appears at TS(A), proceed to 3.63.

3.62 Should the signal still not be present at TS(A), check and repair the wiring between the plug-ins [21].

3.63 After signals have been verified at TS(A), request the near-end customer to send data [22]. If the mark and space are not observed at TS(A), monitor the signals from the customer on a 901B interface test adapter to verify that the trouble is in the TTY or CPT equipment [23].

3.64 If the data signals are present at TS(A), check the channel alignment [24]. If the

customer still has a complaint, the trouble is in the TTY or CPT equipment [23]. However, should the customer have no further complaints with respect to the original trouble, return all circuits to normal and close the trouble report [25].
