SWITCHING SYSTEMS MANAGEMENT
STEP-BY-STEP SYSTEM—ADMINISTRATION
PROBLEM ANALYSIS AND CORRECTIVE ACTION

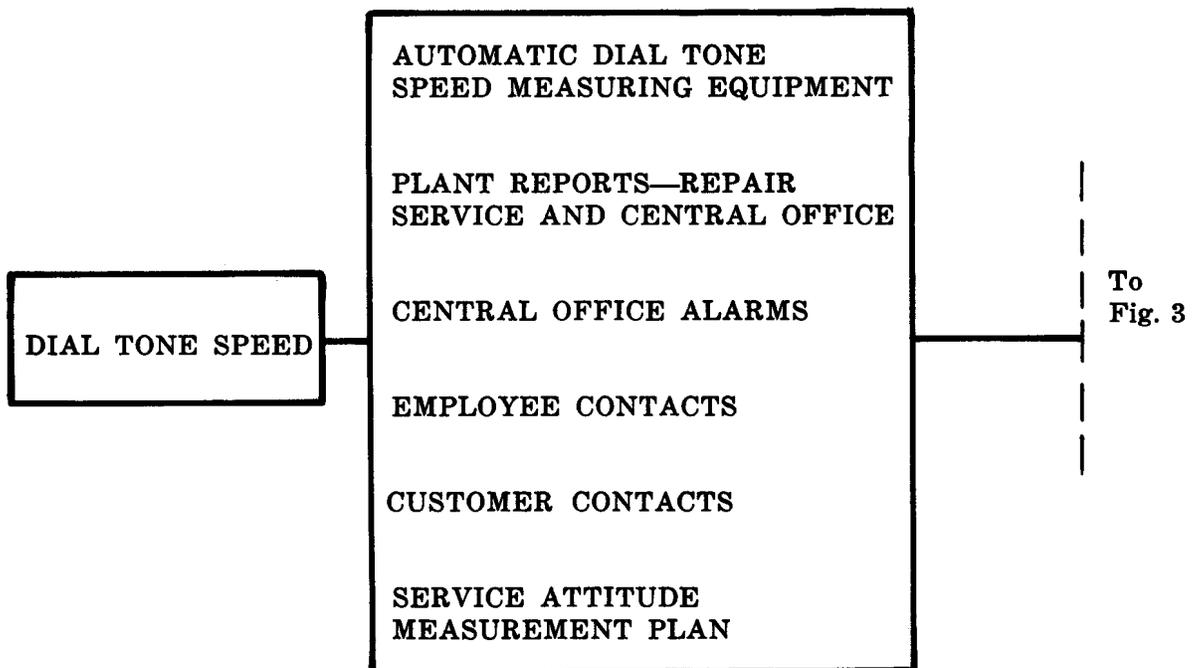
Fig. 2—Flowchart—Dial Tone Speed Indicators

3.01 Indicators (Fig. 2)

3.01.1 It is necessary to consider all the dial tone speed service indicators prior to making a judgment on, or proposing remedial action for, an apparent speed of dial tone problem. Theoretically, data from each information source should substantiate rather than conflict with its related service indicators. However, mechanical failure, human error, and subjective reporting will, at times, provide distorted or misleading information.

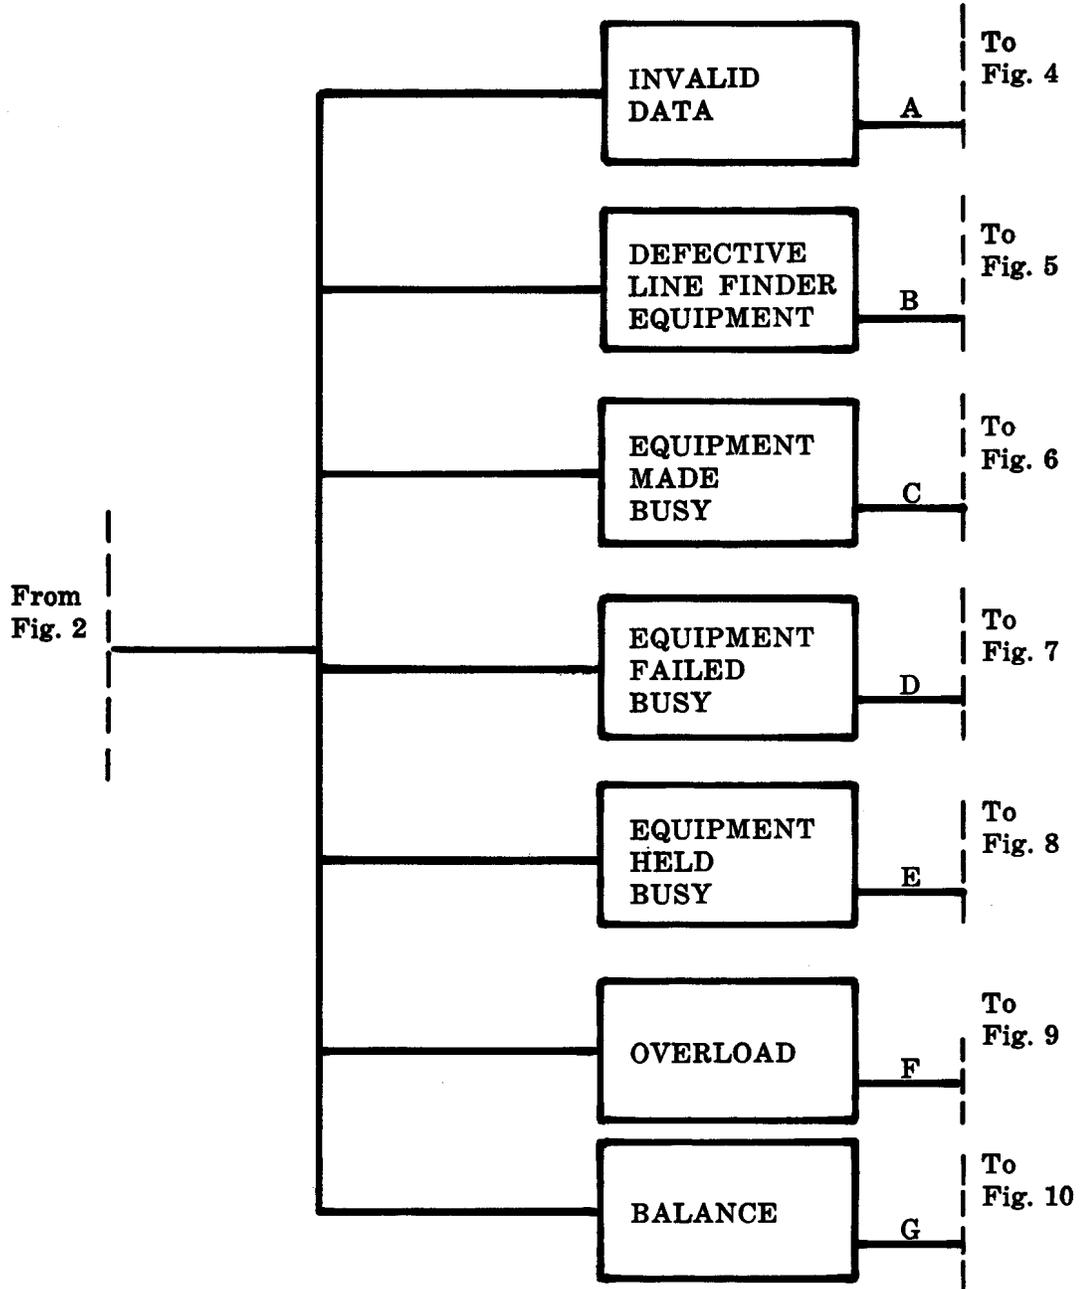
Fig. 3—Flowchart—Dial Tone Speed—Causes of Delay

3.02 Causes of Delay (Fig. 3)

3.02.3 Defective line finder equipment can directly or indirectly affect dial tone speed service when it fails to perform any of its principal functions. These functions are summarized below according to their relationship to dial tone delays.

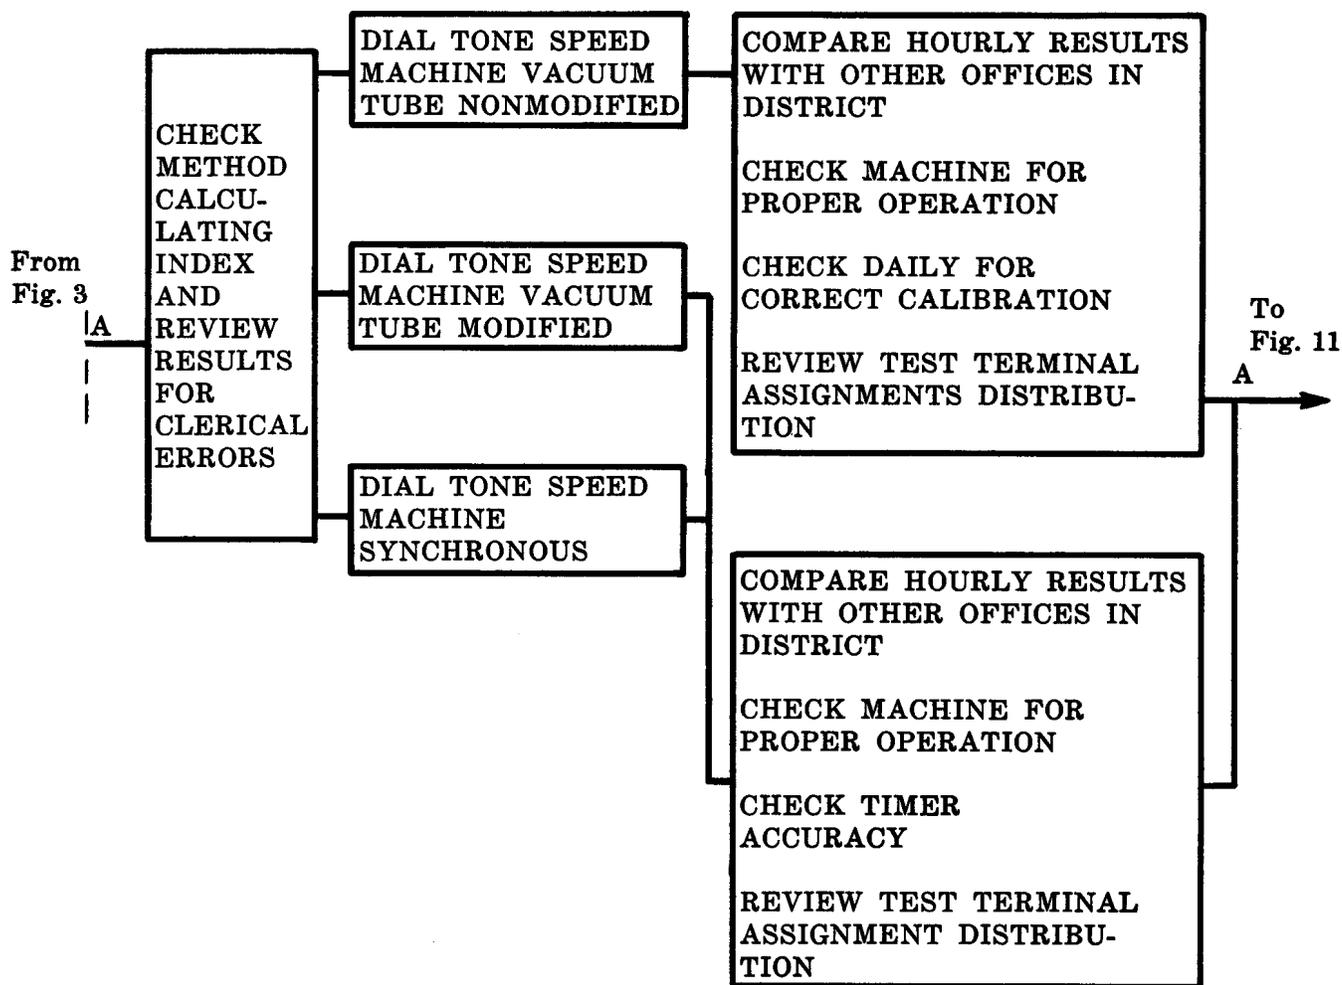
Fig. 4—Flowchart—Analysis of Dial Tone Delays—Invalid Data

3.03.1 Invalid Data (Fig. 4)

3.03.1.2 The validity of dial tone speed results become questionable when:

3.03.1.3 The first step in this analysis procedure is a detailed review of the clerical calculations, regardless of whether any of the preceding conditions exist. There can only be two reasonable consequences of this review. The calculations will be found either free from significant error, or they will not. The analysis logic branch developed from anticipating these results

must be determined if these data represent a true sample of the service offered. They may actually contain distortions caused by improper testing methods, or dial tone speed machine malfunctioning. Reference to the flowchart, Fig. 4 indicates that the next step in this analysis sequence is to establish the integrity of the testing device. The direction to advance is indicated by the following instructions for each of the three types of dial tone speed measuring equipment.

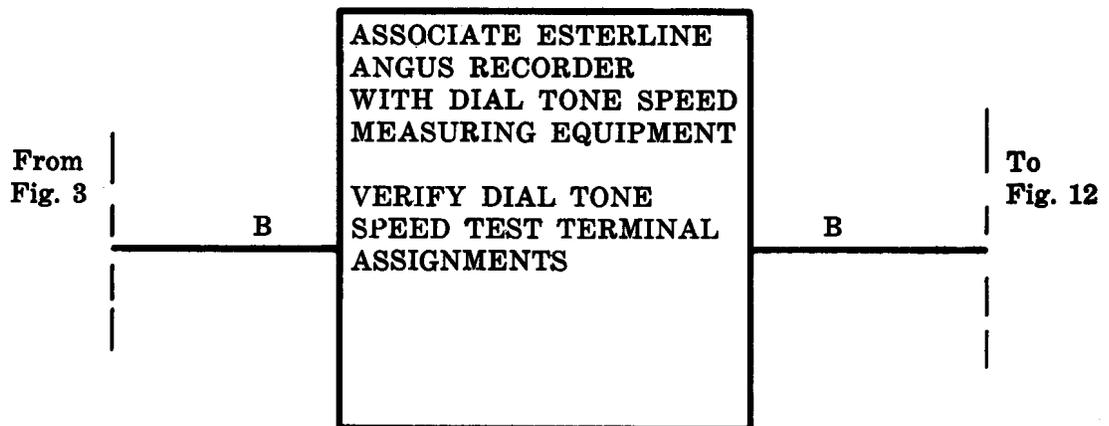
**Fig. 5—Flowchart—Analysis at Dial Tone Delays—
Defective Line Finder Equipment**

3.03.2 *Defective Line Finder Equipment* (Fig. 5):

Defective call-carrying equipment troubles cannot be overlooked as a possible source of service reaction. The Step-by-Step dial system is an electromechanical type machine which depends on good maintenance to operate at peak efficiency. A basic requirement for the analysis of dial tone speed results is the ability to locate the individual line groups which are contributing to the delays. This is essential when call carrying equipment problems or balance considerations are involved. Degraded dial tone speed results, due to other equipment problems such as ringing machine or commercial power failures, are more readily determined through Plant contacts or reports.

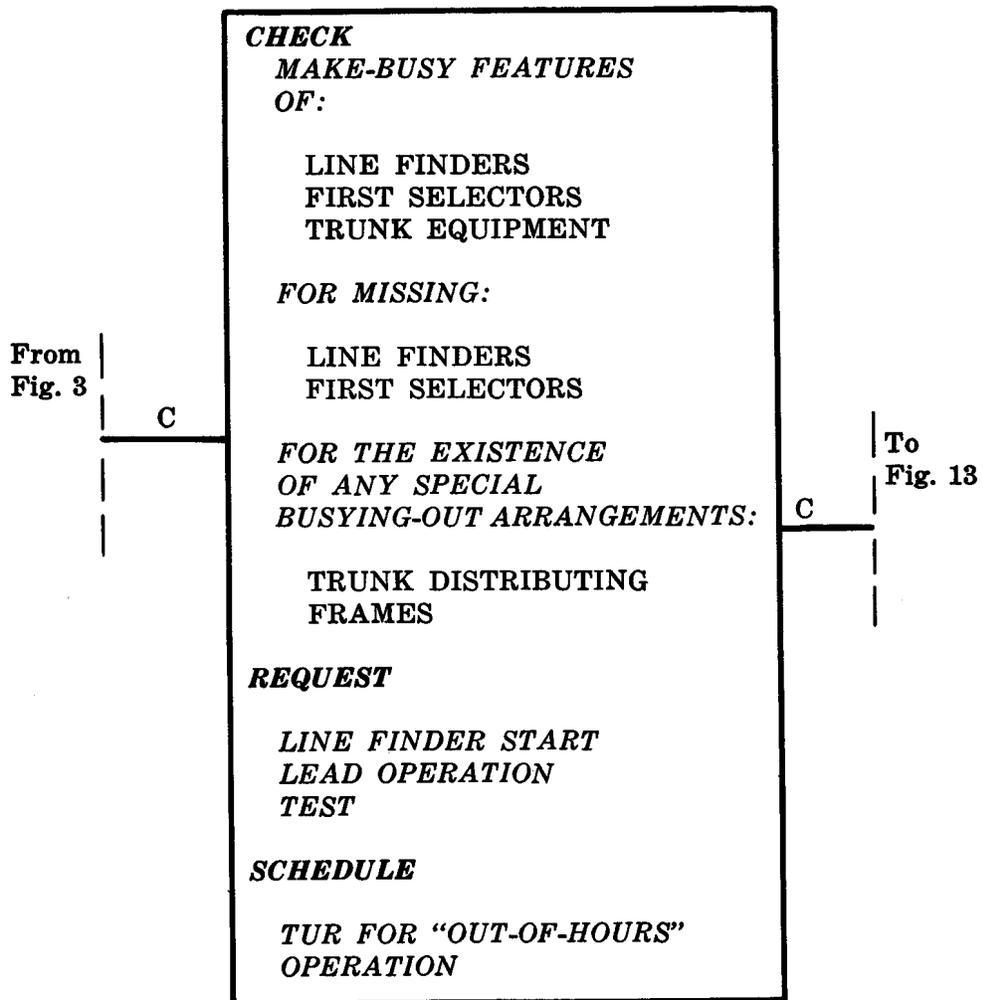
Fig. 6—Flowchart—Analysis of Dial Tone Delays—
Equipment Made Busy

3.03.3 *Equipment Made Busy* (Fig. 6)

3.03.3.2 This equipment made busy status category includes all switching and trunking facilities that are intentionally made busy for maintenance, cleaning, or for transition work. The analysis includes the following checklist for the inspection of equipment.

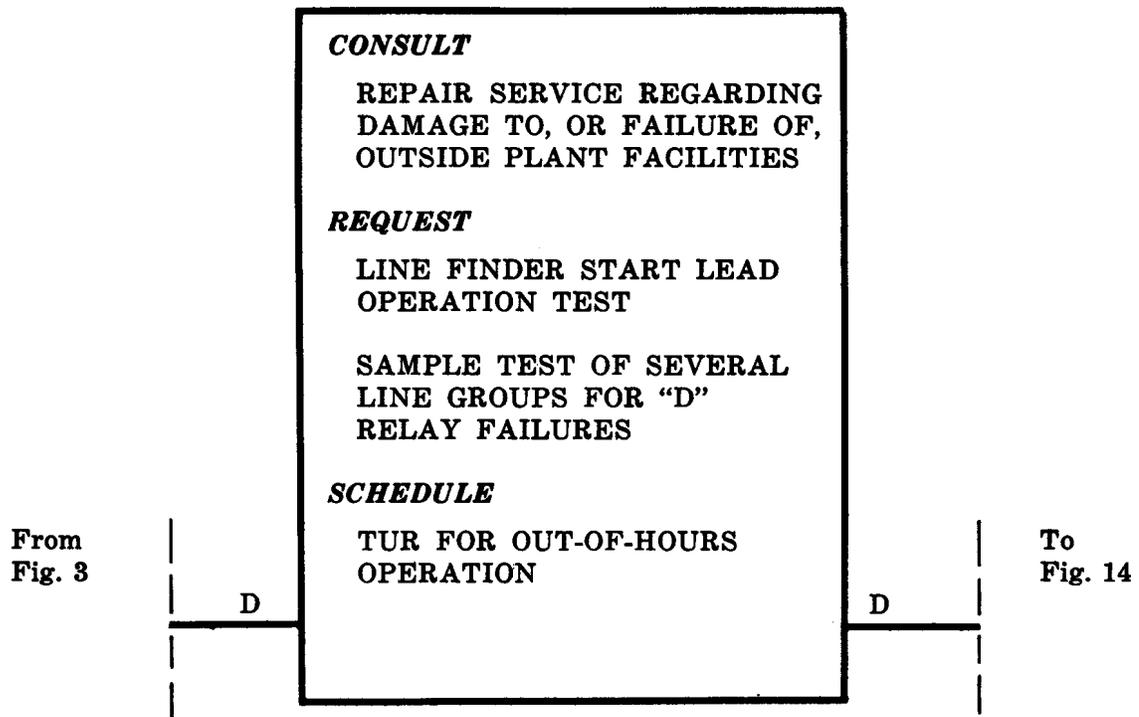
**Fig. 7—Flowchart—Analysis of Dial Tone Delays—
Equipment Failed Busy**

3.03.4 Equipment Failed Busy (Fig. 7)

3.03.4.4 Occasionally, line finder equipment may appear on TUR printouts as being made busy, yet an investigation fails to verify this indication. These intermittent and obscure failures can be due to the following line finder problems.

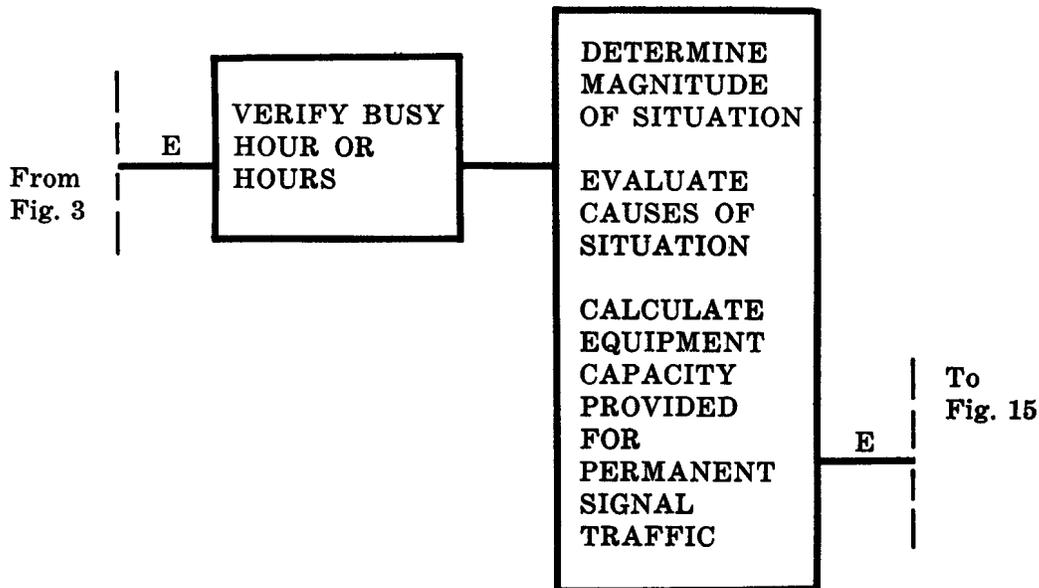
**Fig. 8—Flowchart—Analysis of Dial Tone Delays—
Equipment Held Busy**

3.03.5 Equipment Held Busy by Subscribers Leaving Their Receivers Off the Hook (Fig. 8).

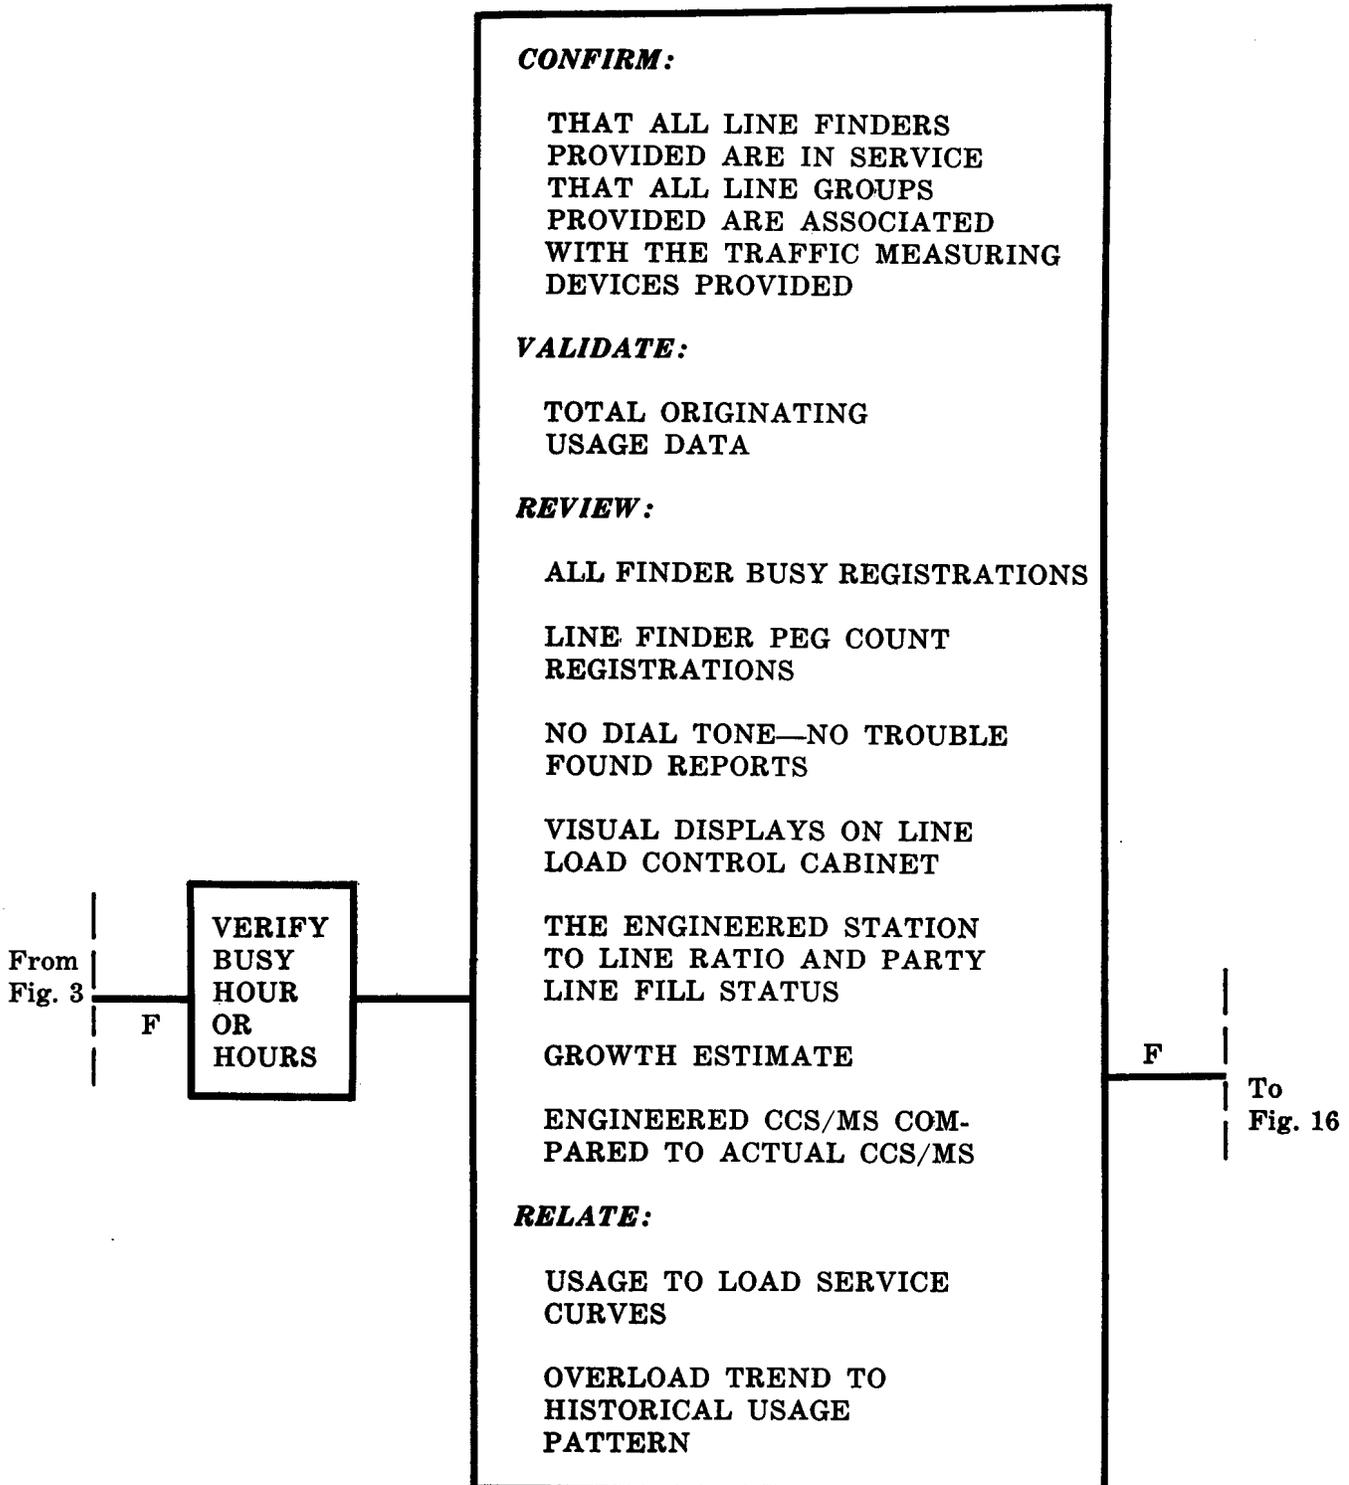
Fig. 9—Flowchart—Analysis of Dial Tone Delays—Overload

3.03.6 Overload (Fig. 9)**3.03.6.1** Items required for analysis in offices equipped with Traffic Usage Recorders:

Subsequent to the validation and review of the total originating Traffic data, the analysis should be extended to include a check of such high load indicators as:

From
Fig. 9

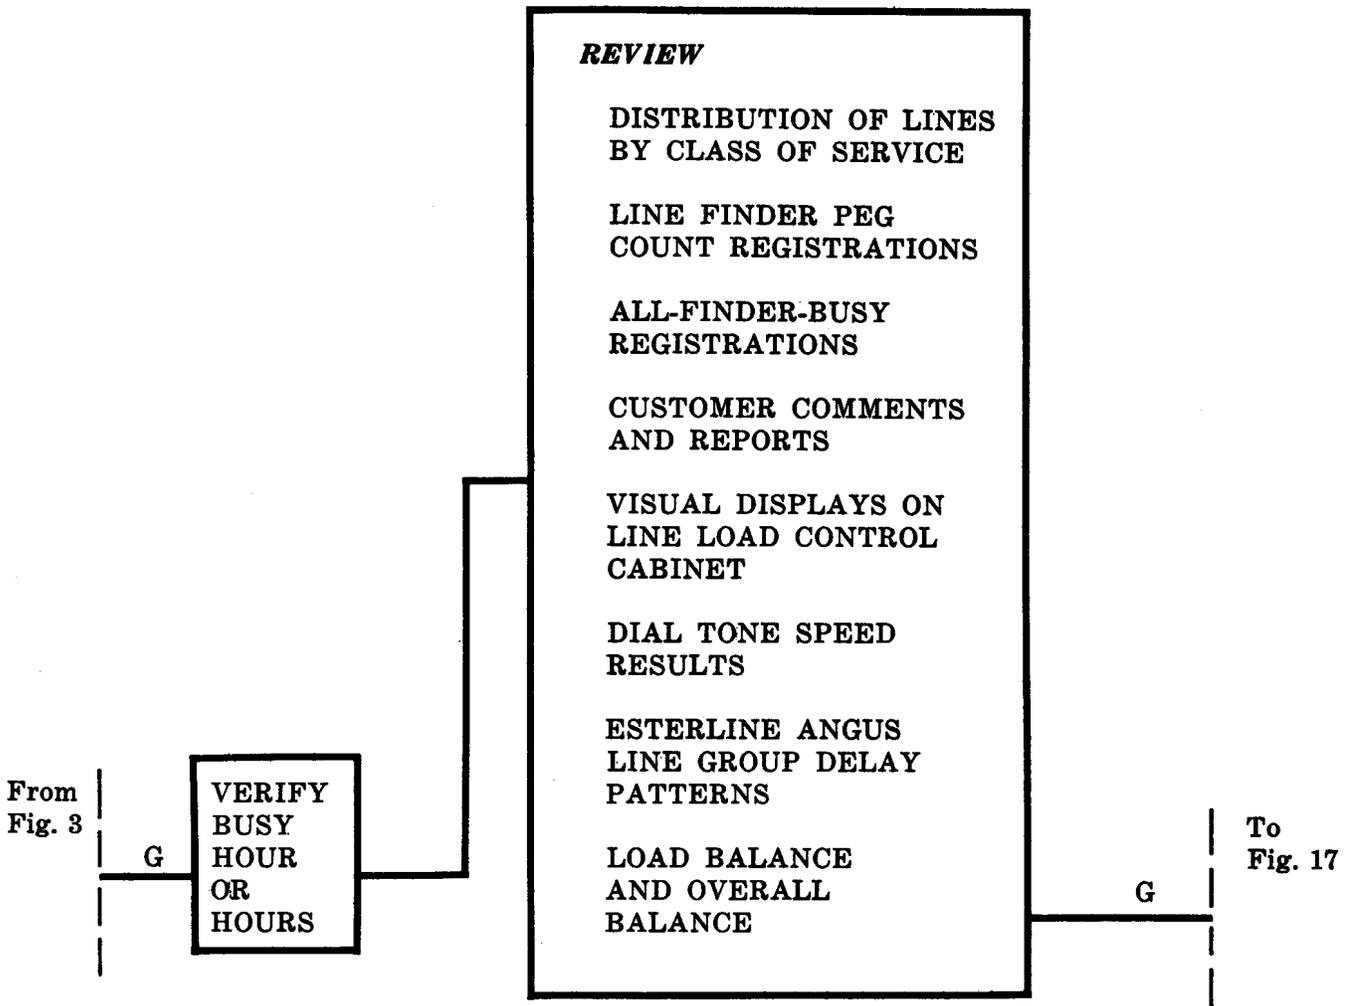
Fig. 10—Flowchart—Analysis of Dial Tone Delays—Balance

3.03.7 Balance (Fig. 10)

3.03.7.2 The indications of imbalance are varied and complex with not all symptoms being present at all times. The following are the most common indications of imbalance.

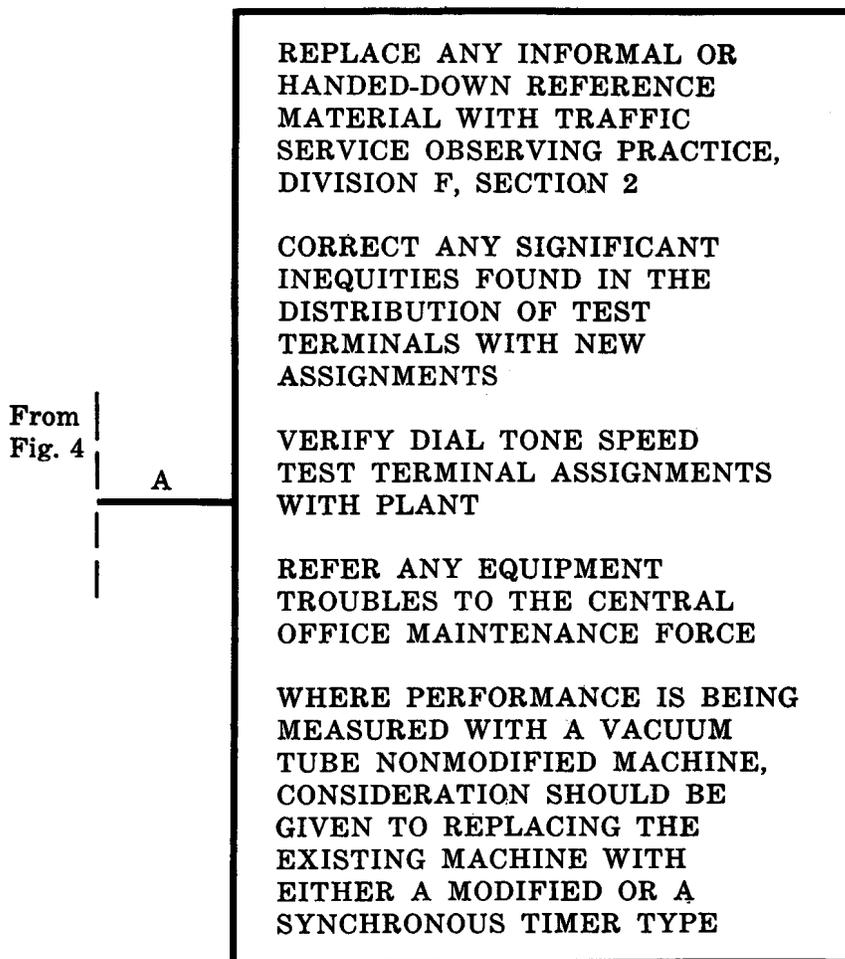
Fig. 11—Flowchart—Dial Tone Delay—Corrective Action—Invalid Data

3.04.1 Invalid Data (Fig. 11)

3.04.1.1 Replace any informal or handed-down reference material with Traffic Service Observing Practice, Division F, Section 2. The unsuitable reference material may be in the form of oral instructions, letters, or provisional prac-

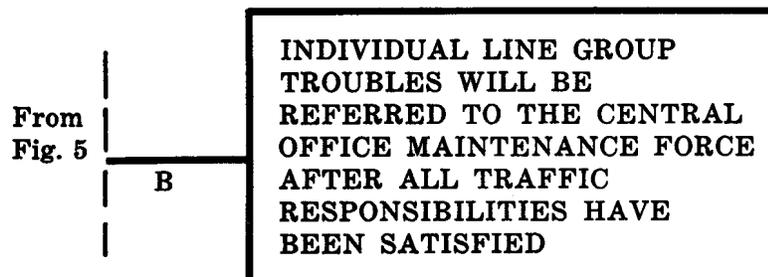
**Fig. 12—Flowchart—Dial Tone Delay—Corrective Action—
Defective Line Equipment**

The following administration guidelines should be adhered to when initiating this form:

- (a) Enter as much information as possible to assist Plant. This would include administrative data concerning usage, loading, and traffic analysis.
- (b) Arrange, if at all possible, for troubles to be cleared prior to the next busy hour.

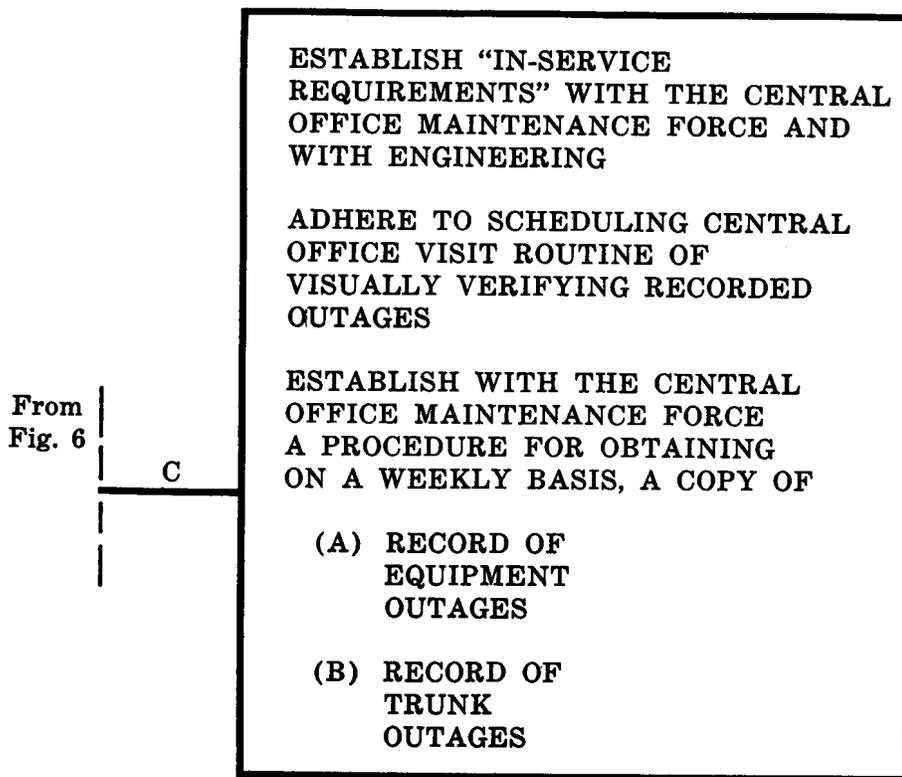
Fig. 13—Flowchart—Dial Tone Delay—Corrective Action—Equipment Made Busy

3.04.3 Equipment Made Busy (Fig. 13)

3.04.3.2 Traffic will determine the minimum number of equipment needed to maintain good service at various load conditions. These requirements will be recorded on a form similar to "In-Service Requirements," Appendix 13, and a copy given to the central office maintenance force for information and discussion. An additional copy also will be forwarded to the Engineering Department. If the central office maintenance representative does not concur with these minimum requirements, and demonstrates that maintenance requirements exceed the Traffic Department's limitations, the Engineering De-

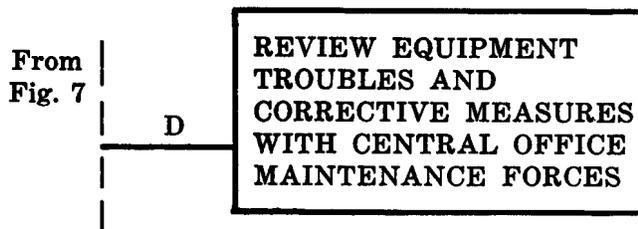
Fig. 14—Flowchart—Dial Tone Delay—Corrective Action—Equipment Failed Busy

3.04.4 Equipment Failed Busy (Fig. 14)

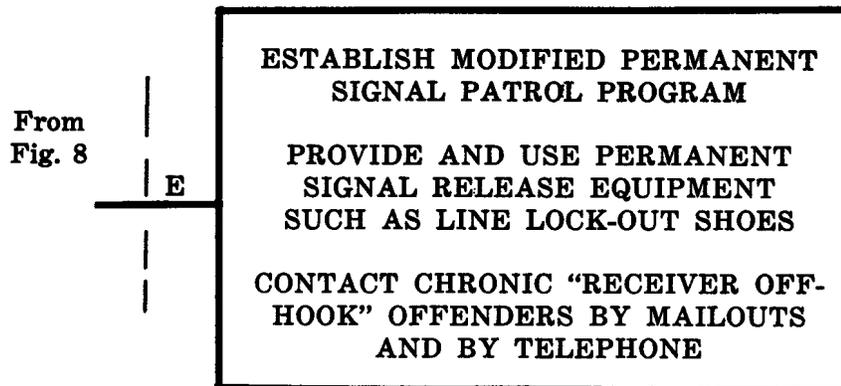
Fig. 15—Flowchart—Dial Tone Delay—Corrective Action—
Equipment Held Busy

3.04.5 Equipment Held Busy (Fig. 15)

3.04.5.2 The arrangement mentioned above assumes that maximum maintenance efforts will be made to clear all permanents during the busy hour(s). This would include the use of all available permanent signal release equipment, such as line lock-out shoes. In addition, release priority will be given to those groups indicating "All Finders Busy" on the line load control cabinet.

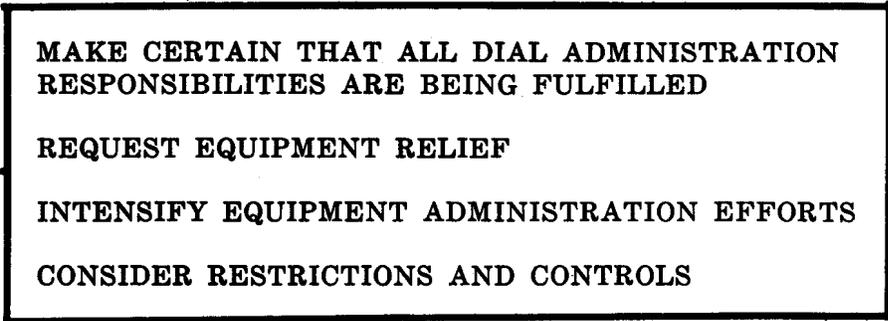
Fig. 16—Flowchart—Dial Tone Delay—Corrective Action—Overload

3.04.6 Overload (Fig. 16)

- (b) Request advance completion of next scheduled job.
- (c) Request advance completion of portions (critical components) of next scheduled job.
- (d) Request that equipment be diverted from job shipping to another office where need is not as critical.
- (e) Request area transfer of lines to another office which can accept the additional load without service reaction.

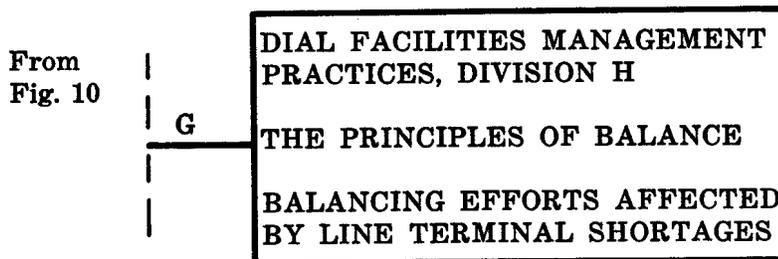
Fig. 17—Flowchart—Dial Tone Delay—Corrective Action—Balance

3.04.7 Balance (Fig. 17)

3.04.7.4 Line assignments must always be made with the thought of maintaining or improving the balance within an office. A numerical balance of lines by class of service in any loading

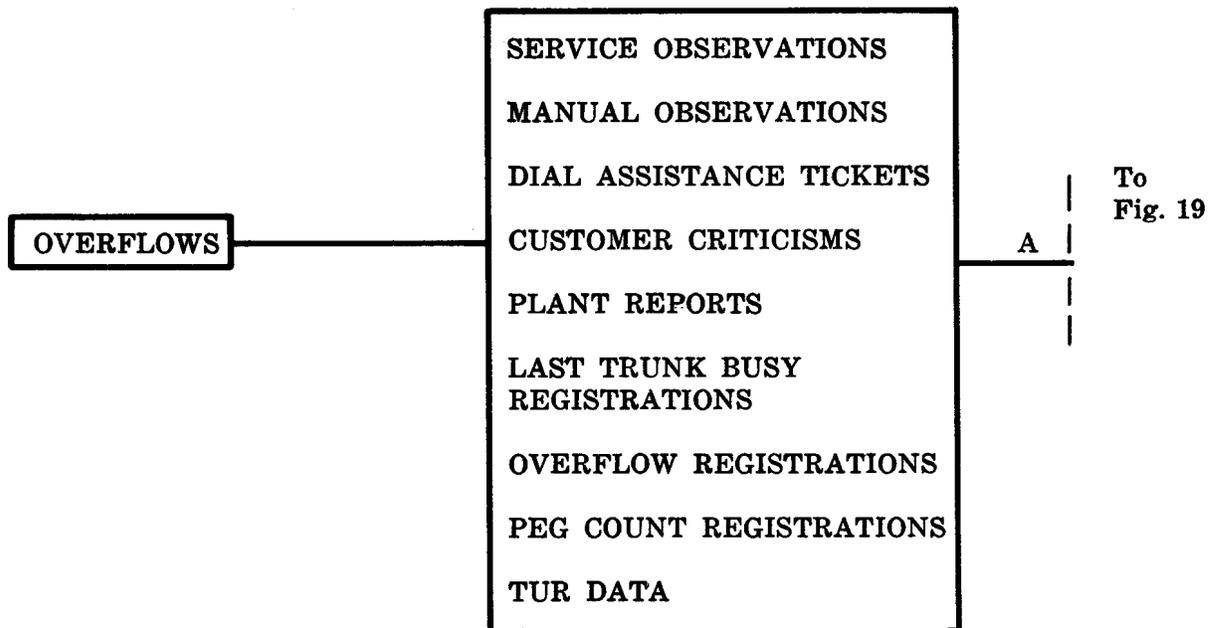
Fig. 18—Flowchart—Overflow—Indicators

4.01 *Indicators* (Fig. 18)

4.01.2 The indicators summarized below are those available for detecting Overflow conditions.

4.01.3 *Service Observations:* (Reference TSOP, Division B, Section 1C) Overflow signals, in general, are 60 or 120 IPM tone. In some Step-by-Step offices, the busy signal and the 60 IPM overflow signal are the same. If it is the overflow, the signal will usually be encountered before the end of dialing. In the case of calls to PBXs served by level hunting connectors, and in isolated instances where connection to a customer's line is made directly from a selector level, it is possible under certain conditions for either an overflow or a line busy condition to be encountered before the completion of dialing.

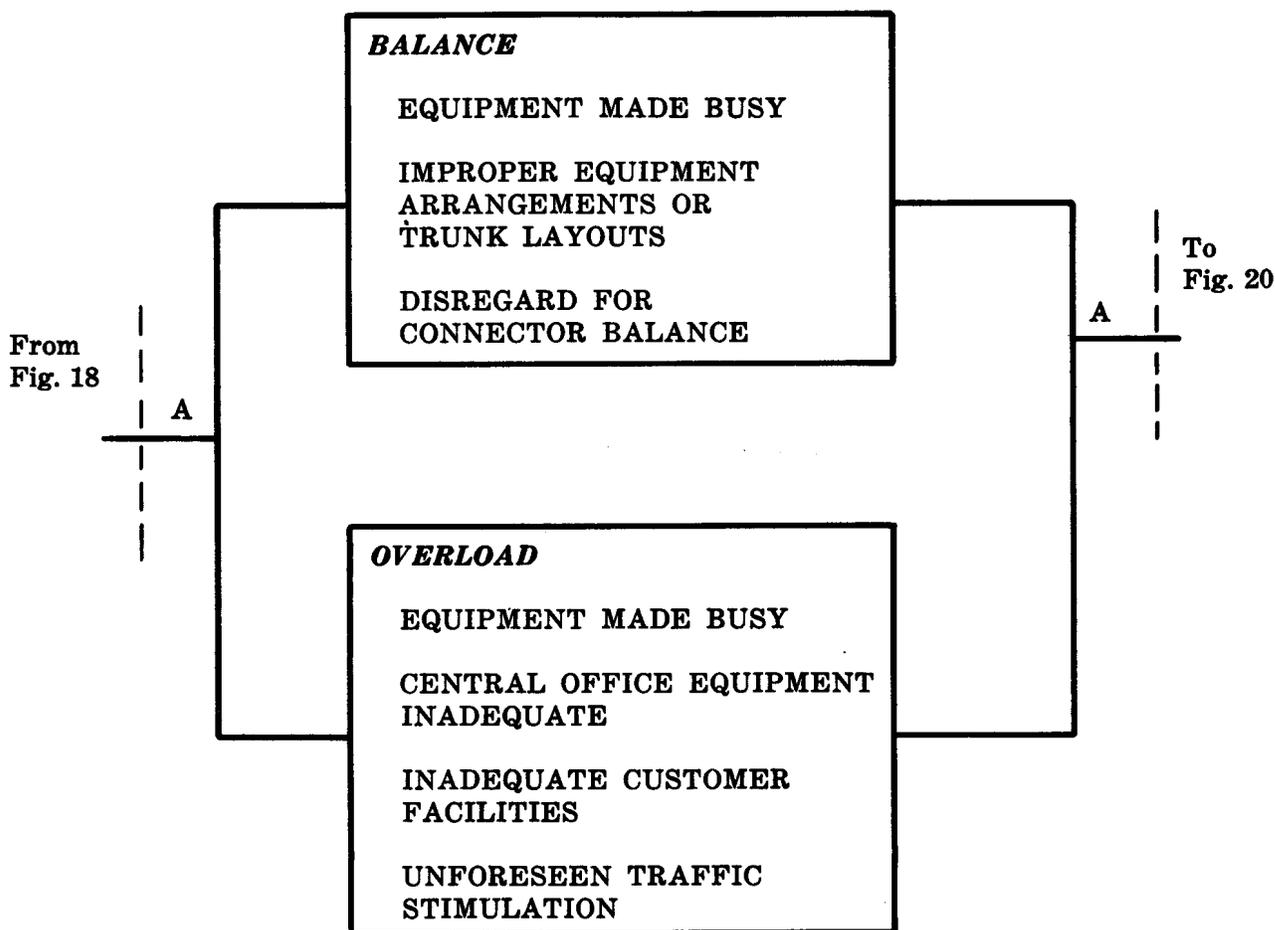
Fig. 19—Flowchart—Overflow—Causes

4.02 Causes (Fig. 19)

4.02.1.2 Improper Equipment Arrangements or Trunk Layouts: The basic reason for such undesirable situations is almost always a lack of, or invalid, dial administration data.

4.02.1.3 A Disregard for Connector Balance Considerations: This can be caused by a line assignment policy so heavily committed to the provision and reuse of telephone numbers that it completely ignores balance considerations, and imbalance indicators, at the connector switch stage.

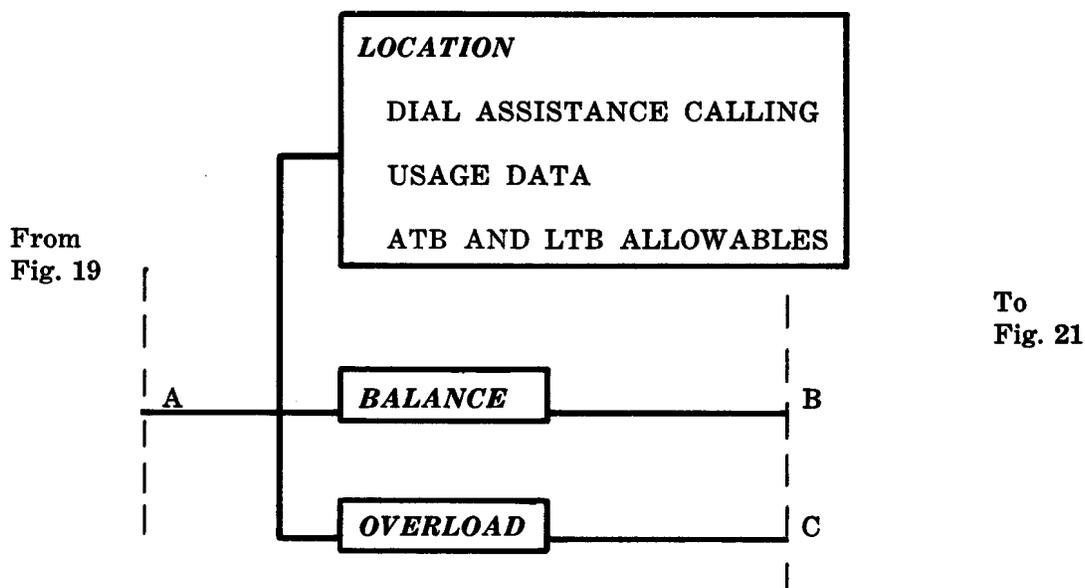
Fig. 20—Flowchart—Overflow—Analysis

4.03 Analysis (Fig. 20)

4.03.2 Analysis of Dial Assistance Tickets Requests: Dial assistance tickets indicative of overflow conditions are classified as Group 1, Busy Before Through Dialing, in the method of analysis described in 5.03, Equipment Irregularities—Analysis. The Overflow Weakspot Analysis procedure is similar and is based on:

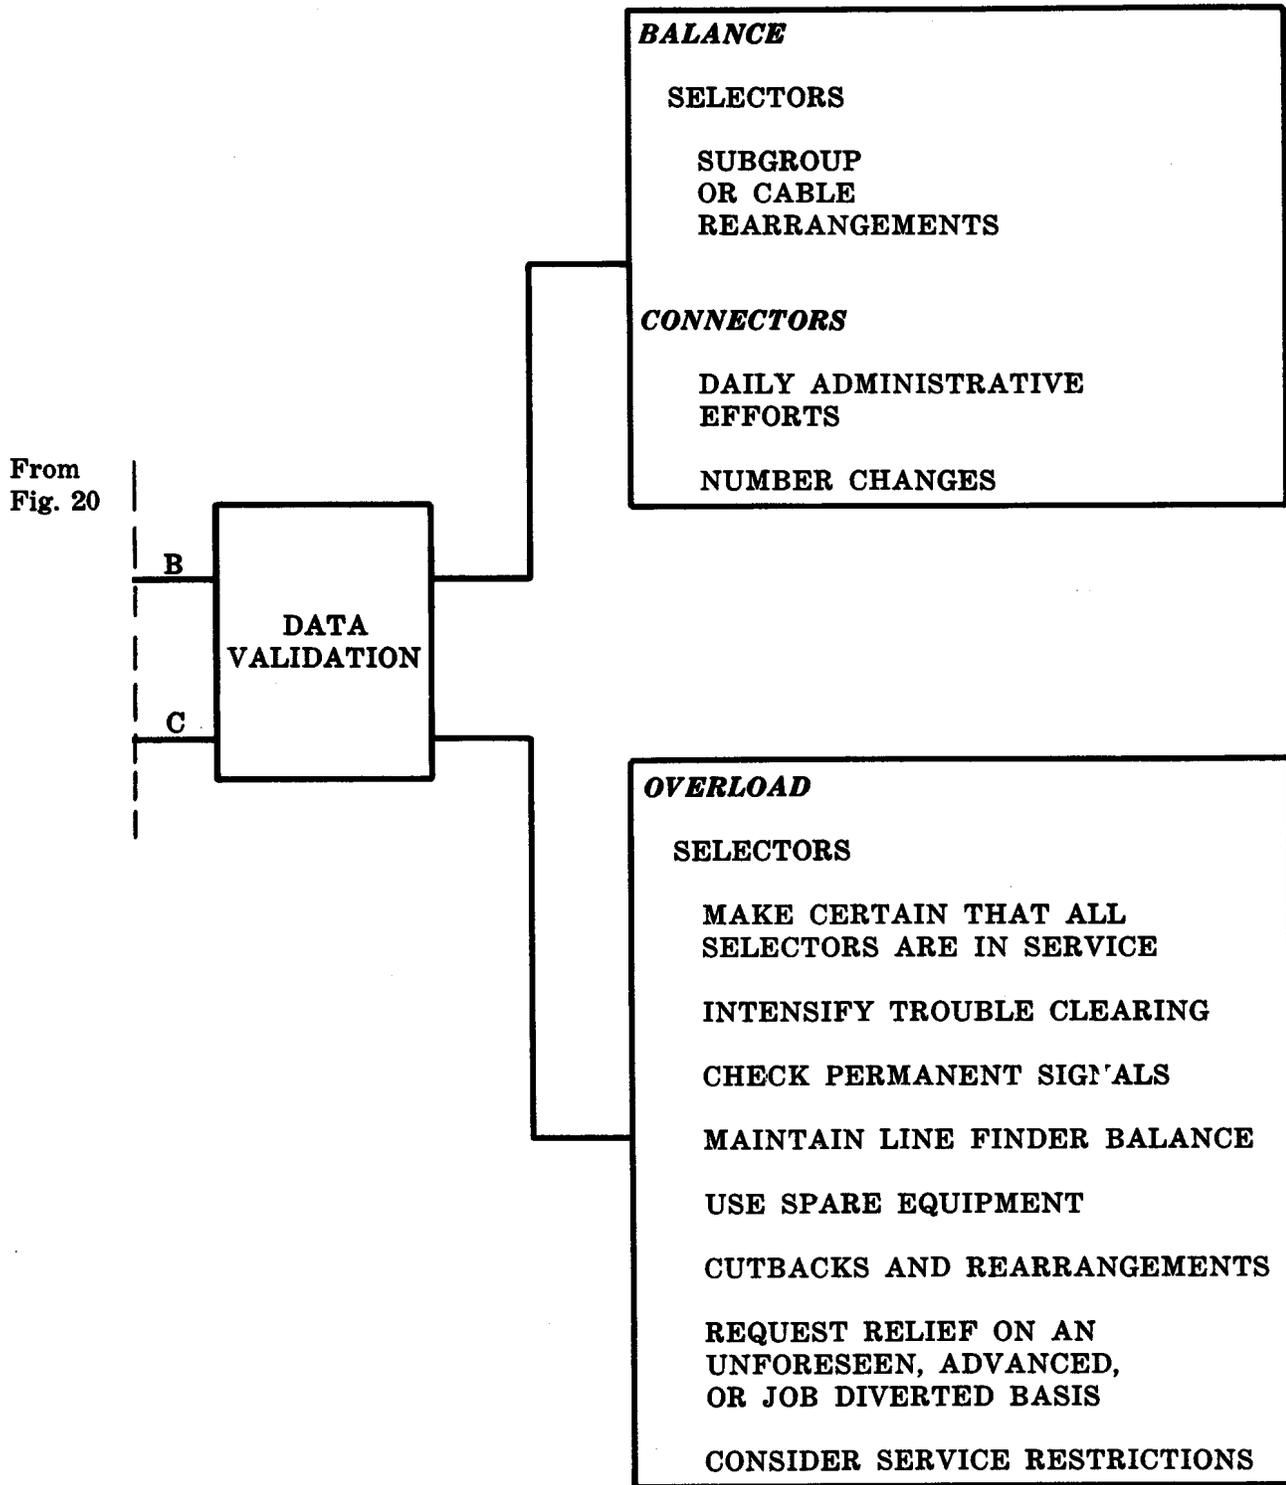
Fig. 21—Flowchart—Overflow—Corrective Action

4.04 *Corrective Action* (Fig. 21)

4.04.4.1 Imbalance in connector groups is particularly critical since number changes must be made in some instances to relieve connector group overloads, in addition to selector imbalance. This is often impossible, and always objectionable from a subscriber's viewpoint especially with PBX and other consecutive service customers in rotary and level hunting groups.

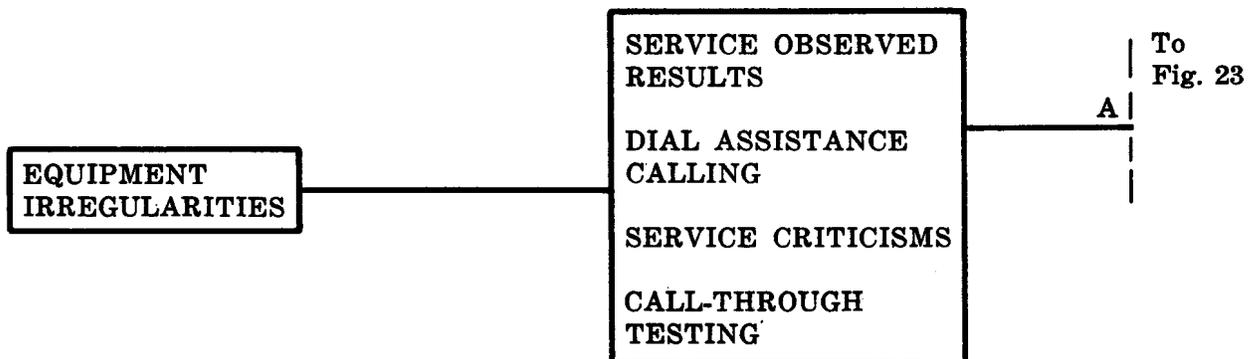
Fig. 22—Flowchart—Equipment Irregularities—Indicators

5.01 Indicators (Fig. 22)

5.01.1 This analysis and corrective action material for equipment irregularity problems is confined to traffic data sources and Traffic administrative responsibilities. The information contained in this publication is not intended to replace any existing Plant or Traffic Department routines. It supplements them by indicating central office and station trouble through the

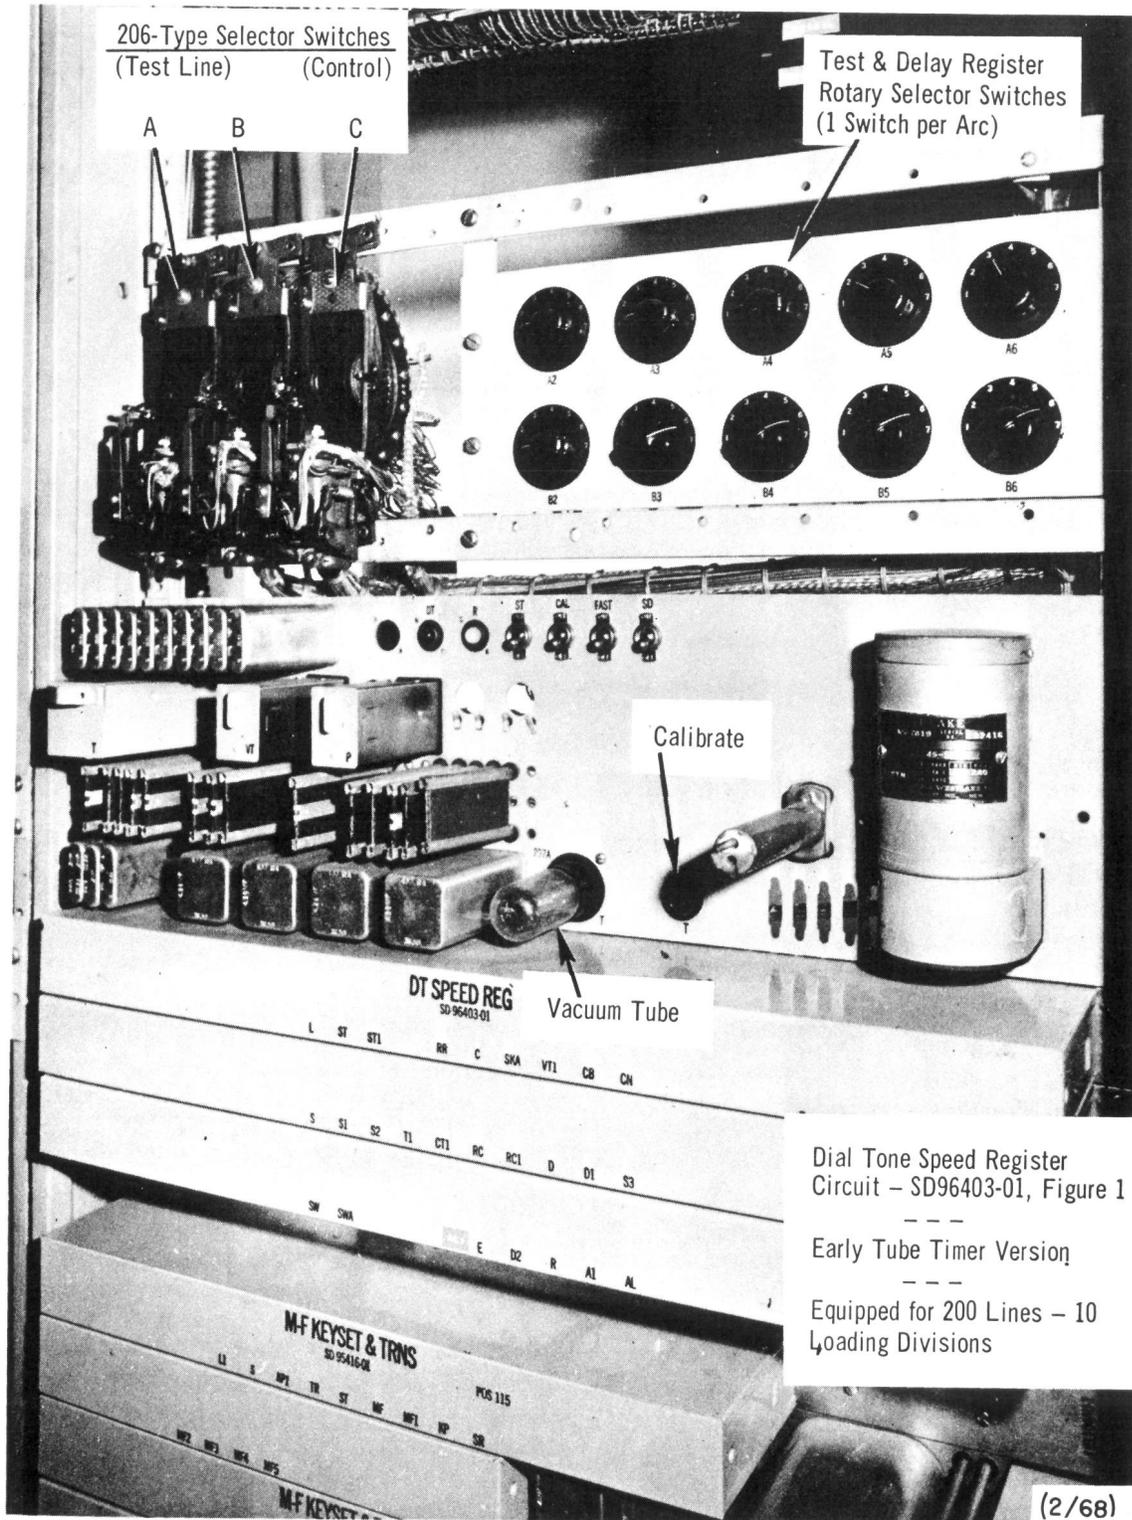
DIAL TONE SPEED REGISTER CIRCUIT—SD-96403-01, FIGURE 1
Early Tube Timer Version

206-Type Selector Switches
(Test Line) (Control)
A B C

Test & Delay Register
Rotary Selector Switches
(1 Switch per Arc)

Dial Tone Speed Register
Circuit - SD96403-01, Figure 1

3.01.2.5 *Vacuum Tube Machine SD-96403-01, Fig. 1:* This unit of dial tone speed measuring equipment (shown in Appendix 1) consists of:

3.04.1.5 Where speed of dial tone performance is being measured with the older vacuum tube timer version of the Dial Tone Speed Register Circuit (SD-96403-01, Fig. 1), it is suggested that consideration be given to replacing this equipment with either a modified machine (SD-96403-01, Fig. 12) or the synchronous timer type (SD-96403-01, Fig. 12). (See Appendixes 1 and 2.)

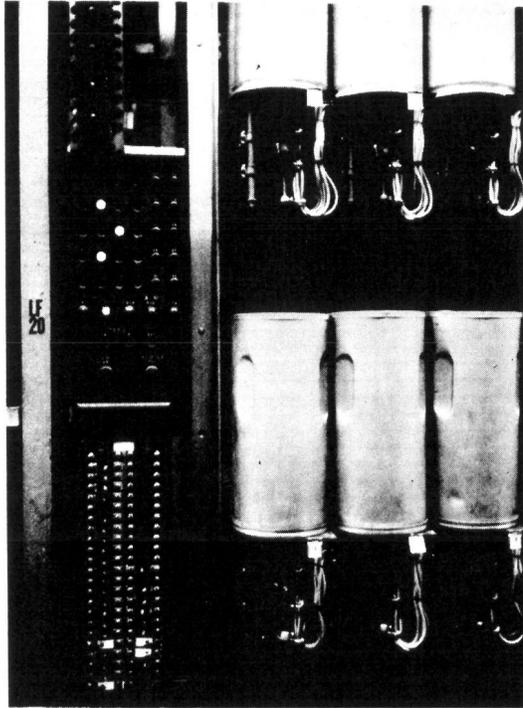
LINE FINDER MAKE-BUSY FEATURES Older Type Line Groups

Line Finders
#7, #9, and #13
Made Busy

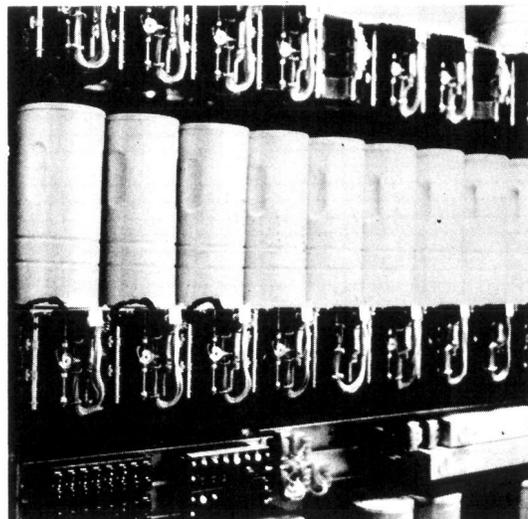
Newer Type Line Groups

Line Finders
#1, #2, and #3
Made Busy
(Note absence
of make-busy
jack field)

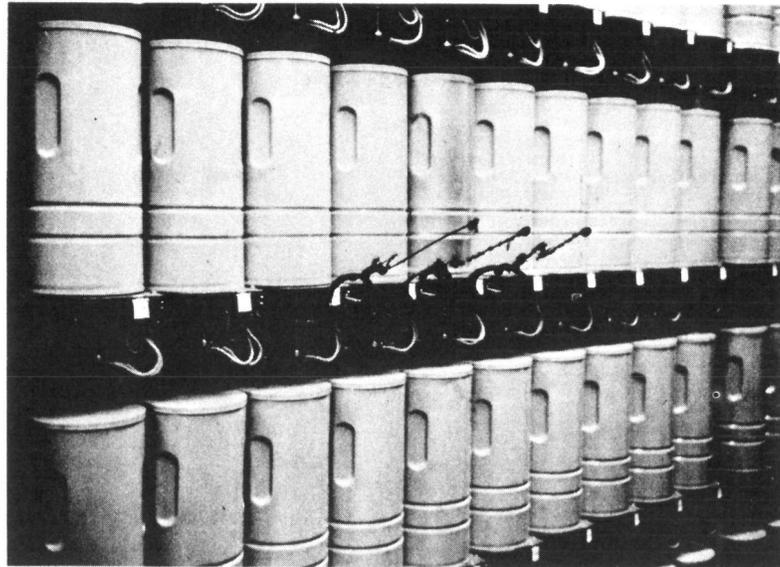
SELECTOR MAKE-BUSY FEATURES

Showing Selectors #96, #97, and #98 Made Busy
