SWITCHING SYSTEMS MANAGEMENT
STEP-BY-STEP SYSTEM—ADMINISTRATION
PROBLEM ANALYSIS AND CORRECTIVE ACTION

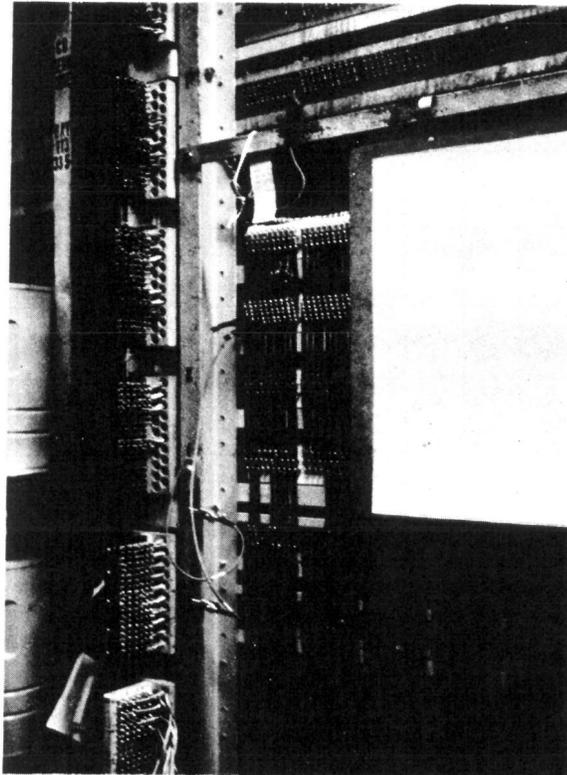
TRUNK MAKE-BUSY FEATURES

**Made Busy At
Distributing Terminal
Assembly**

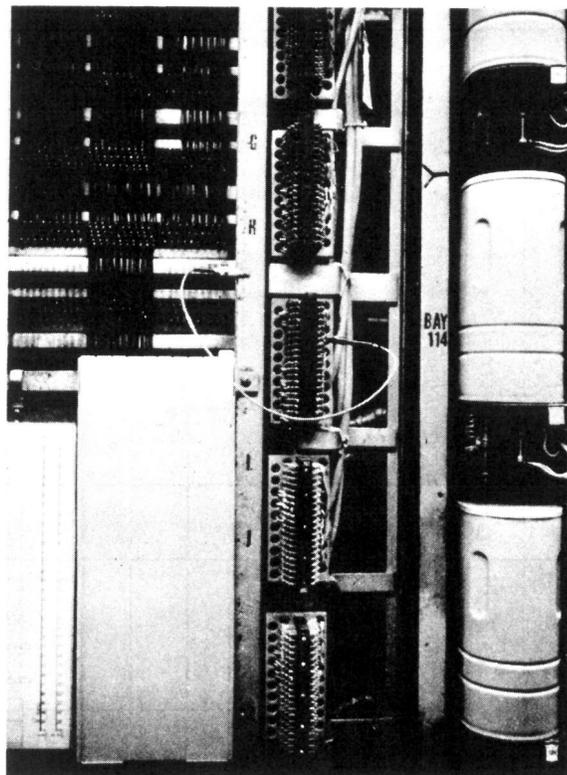
**Made Busy At
Distributing Terminal
Block**
