Electric dryer defective drive belt Replacement

Written By: Nick Ivanov

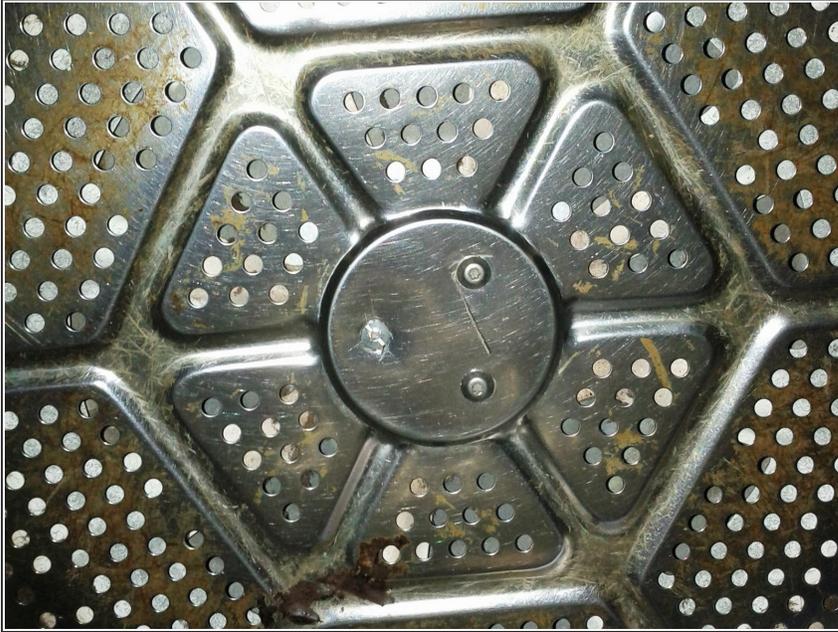
Step 1 — defective drive belt

- There are many brands of electric dryers out there, but fortunately their construction follows just a few basic designs. The one I'm describing is a 20 year old Canadian Eaton model, but some of the inexpensive models sold today have the same construction.
- A good indicator that you are dealing with a similar model is the presence of three screws at the end of the drum, which you can see after opening the appliance door. In these appliances the drum is held in place by the axis connected by the three screws you can see in the picture and the friction pads at the front panel of the dryer.
- The first thing you will want to do is reach behind the dryer and unplug it from the electric outlet.

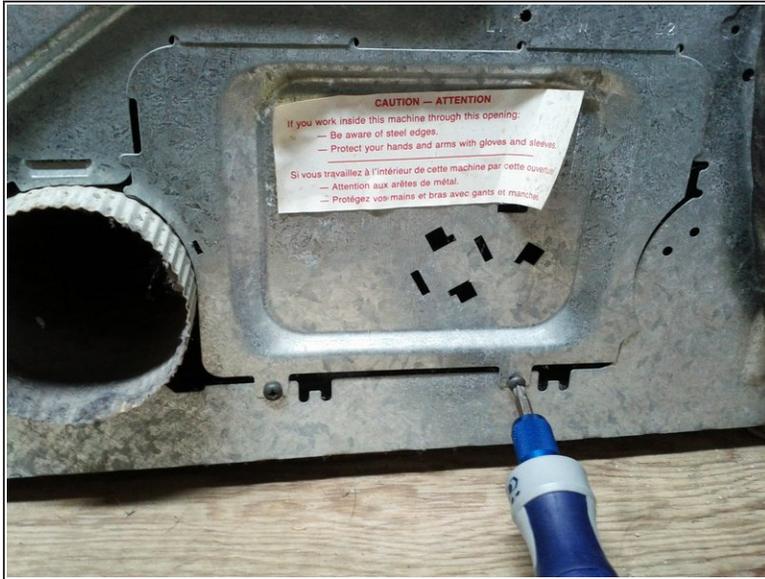
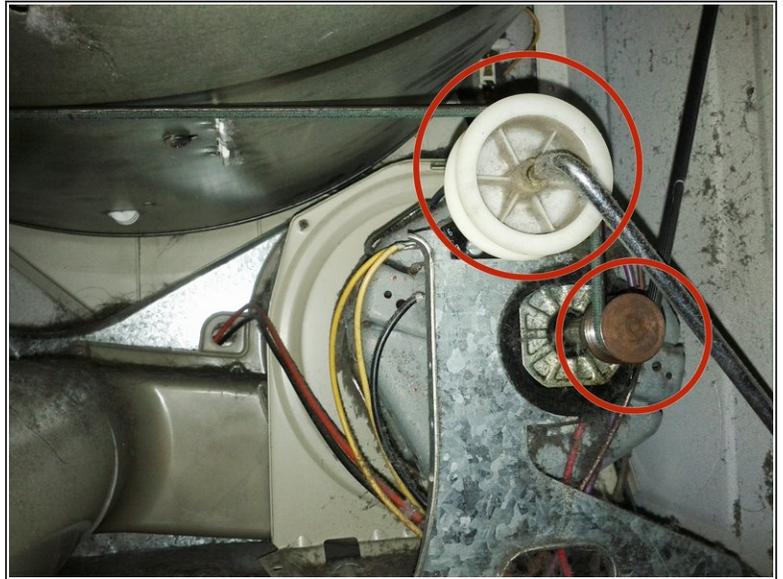
Step 2

- If the belt is not yet completely broken, you will need to disengage it from the motor and the tensioner. To do that, unscrew the service door at the back.
- Inside the door you will see the drive belt, wrapped around the motor pulley and the tensioner. Reach inside the appliance, push down on the tensioner lever, and disengage the belt. Be careful not to cut yourself: there are sharp metal edges all around.

To reassemble your device, follow these instructions in reverse order.
