Eureka Airspeed Exact Pet Bagless Upright Vacuum Power Switch Replacement

Replacement of the power switch. MAKE SURE PLUG IS DISCONNECTED FROM POWER prior to performing work. You assume all risk from any type of repair. Tutorial is for information only.

I could not get the vacuum to power on. The guide will explain how I disassembled the vacuum and repaired the power switch. I do not recommend repairing the power switch unless you are trained and qualified to repair 120VAC electrical appliances.

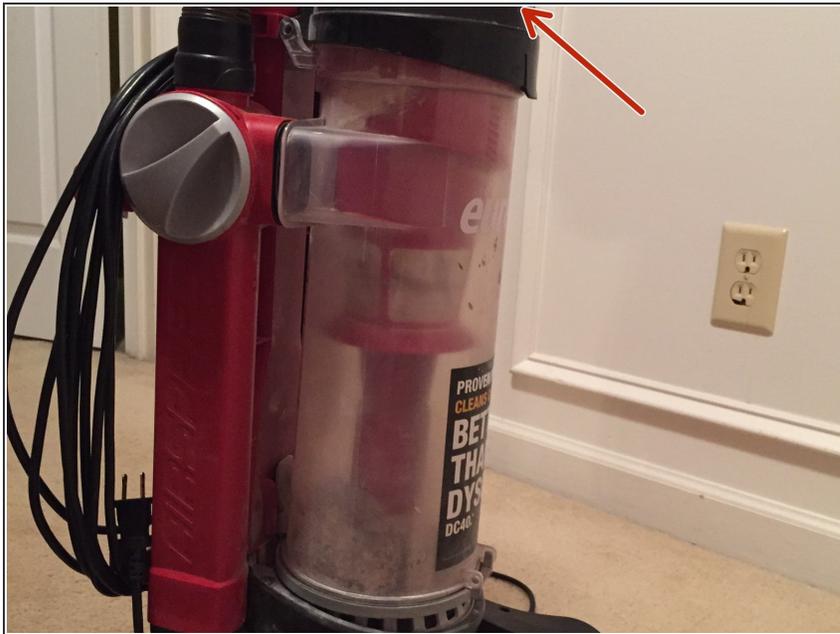
Step 1 — Remove dust canister

- Flip the black release handle and remove the dust canister from the vacuum.

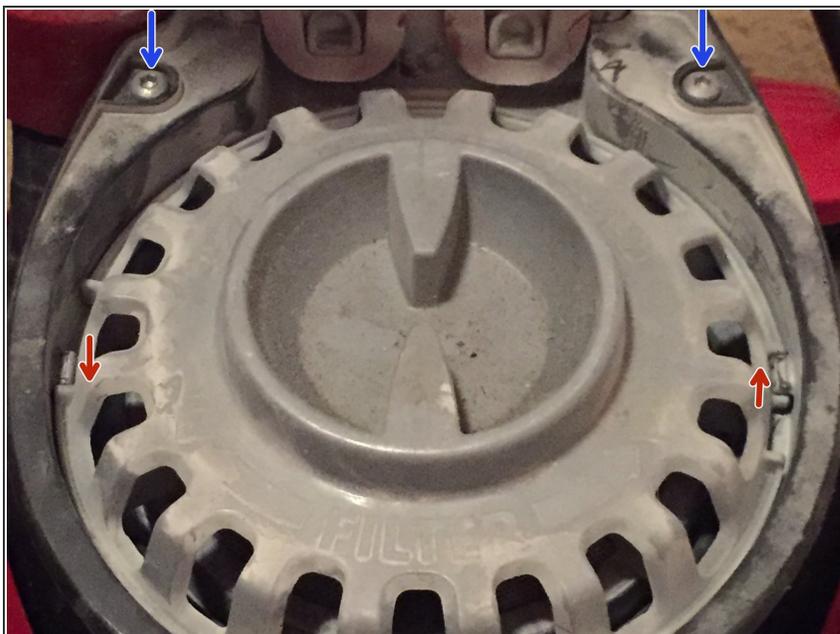
Step 2 — Remove filter and filter mount

- Rotate the grey slotted filter cover and pull the cover off.
- Remove the filter.
- Remove the black filter housing trim by unscrewing the two hex (H3.0) screws and carefully lifting the trim out. Note the power cord entry into the vacuum is partially covered by this trim.

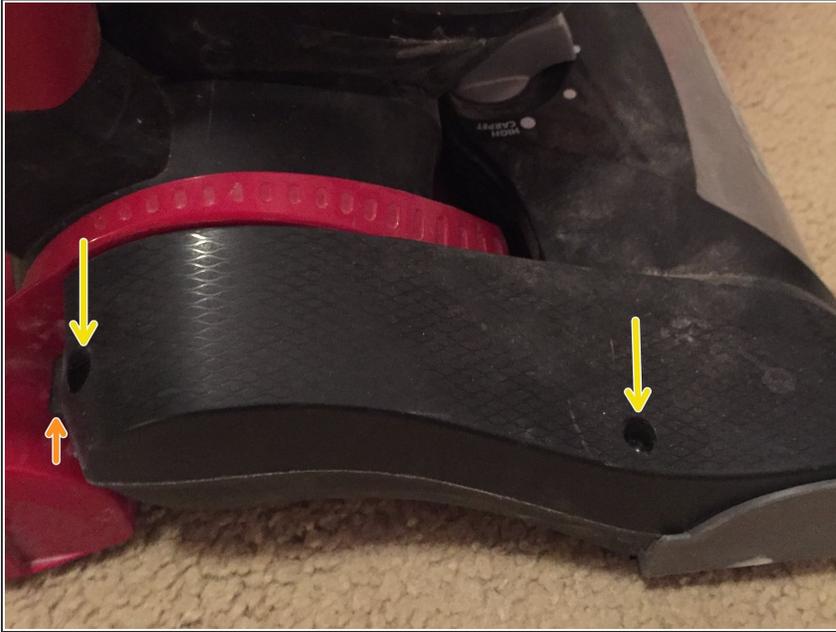
Step 3 — Remove brush and belt cover

- Using screwdriver remove two screws from each side of the vacuum brush and belt cover (four total screws). Note, there is a small flat tab toward the back of the each side of the cover which helps to lift the cover (orange arrow)
- Remove the cover from the vacuum.

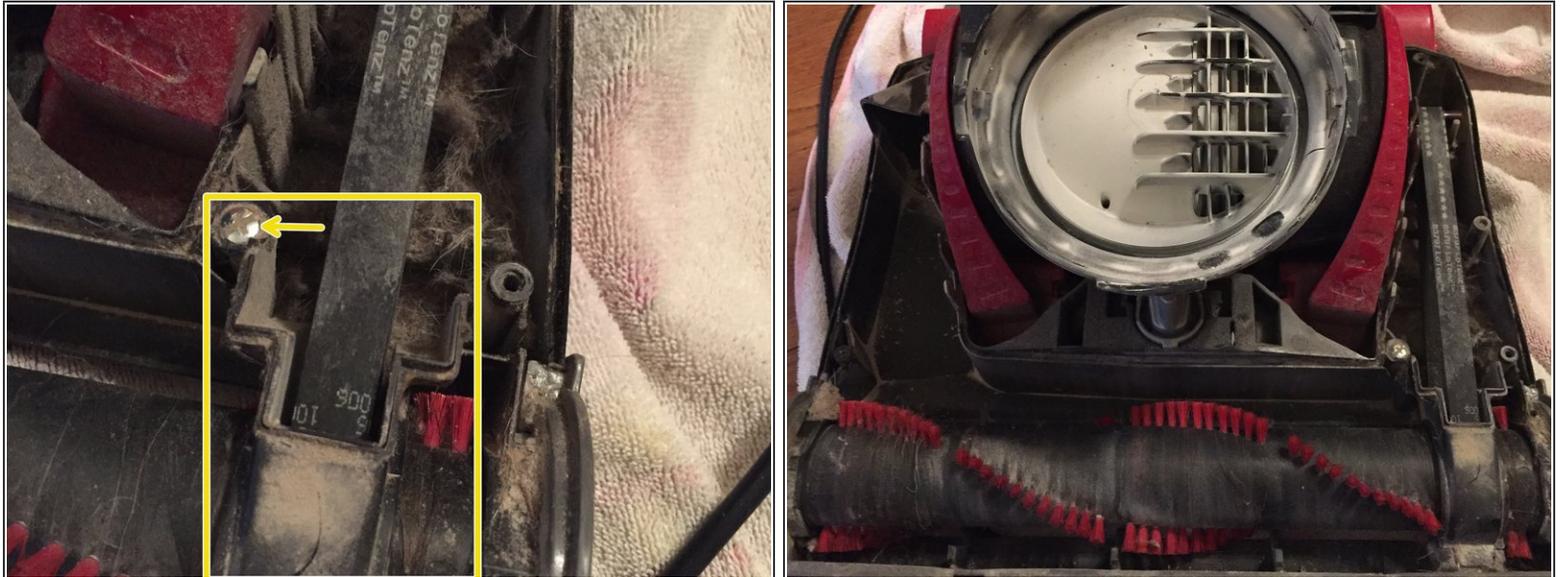
Step 4 — Remove brush and belt

- Unscrew the single screw from the belt cover over the brush and remove the belt cover.
- Remove the brush by lifting straight up on both sides and the belt can be removed at the same time.
- Remove the belt from the motor shaft by sliding the belt off of the shaft and slipping it between the end of the shaft and the adjacent plastic post.
- The cavity under the belt can apparently collect hair, dirt and debris so while we are in here, we can remove the nasty stuff and clean things up. I also remove hair from the brush as this is a common cause of brush problems.

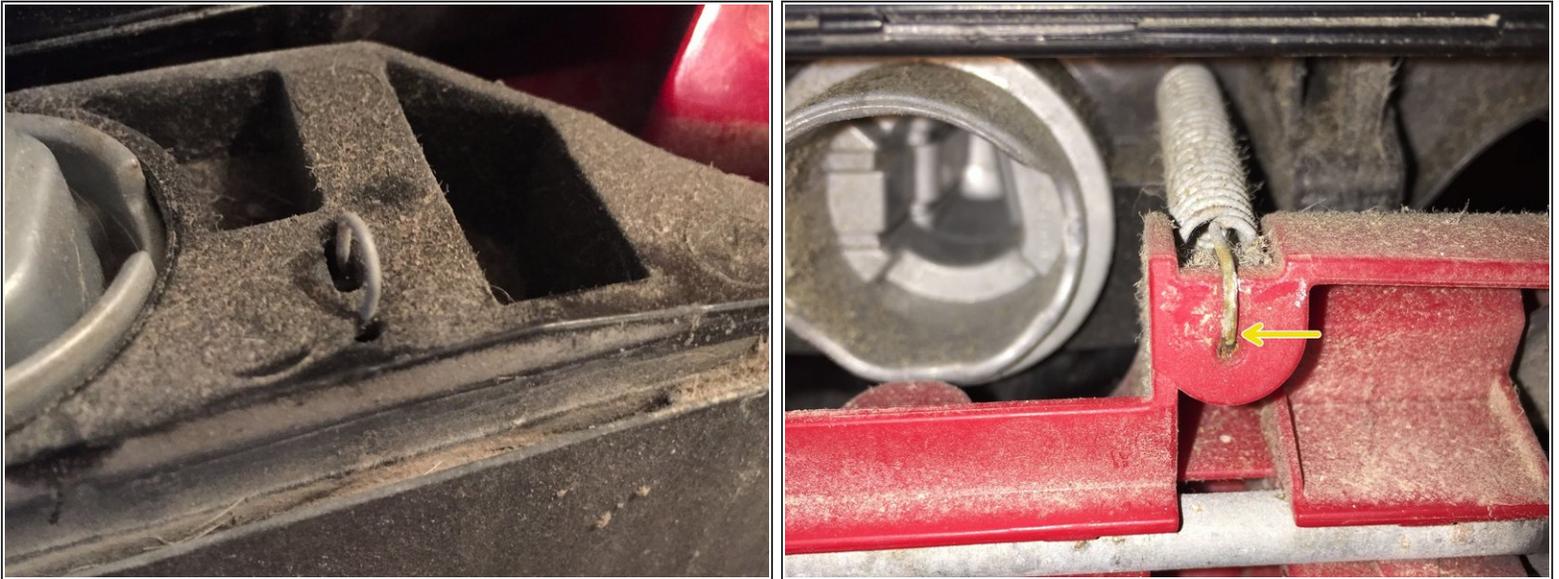
Step 5 — Disconnect spring

- Near the carpet height selector switch you'll notice the end of a spring.
- You'll be able to view this spring along its length by looking up from the bottom of the vacuum. I disconnected it from the bottom by using needle nose pliers.

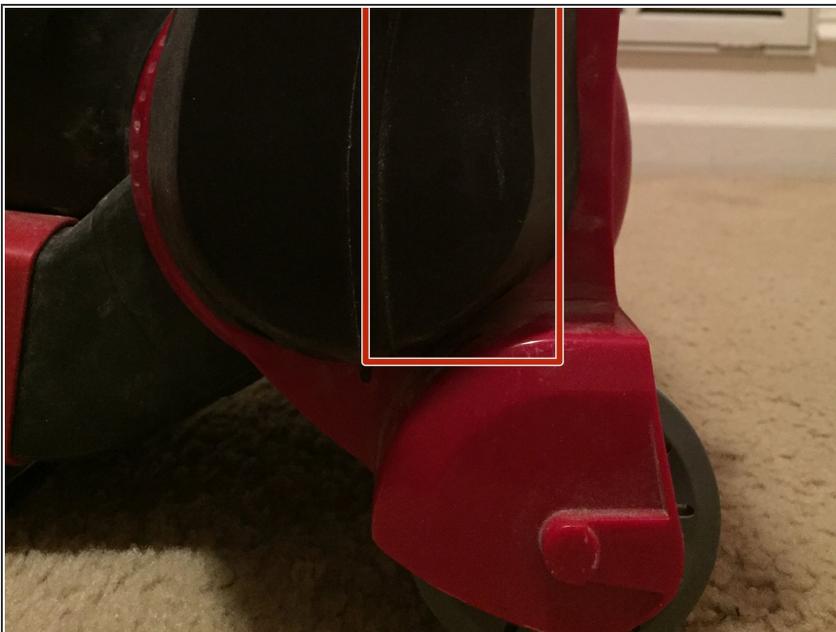
Step 6 — Remove black brush and belt housing

- At this point I did not find any more fasteners to remove and sort of jockeyed the black brush and belt housing around by pulling it outward from one side.

- I noticed that there was a "keyed" fit between the housing and the frame. By rotating the housing and holding the frame steady I was able to carefully but firmly free one side of the housing and pull it away from the

frame. Once one side was removed, the other side could be easily taken out and the whole housing removed.

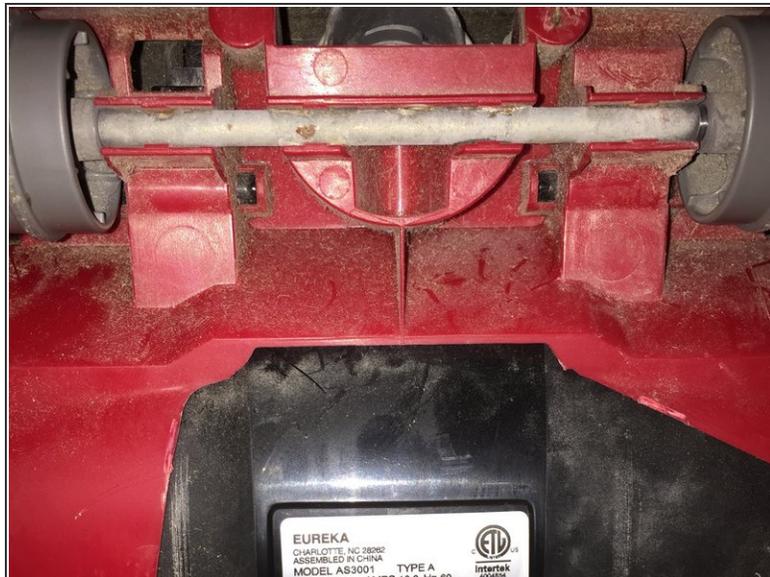
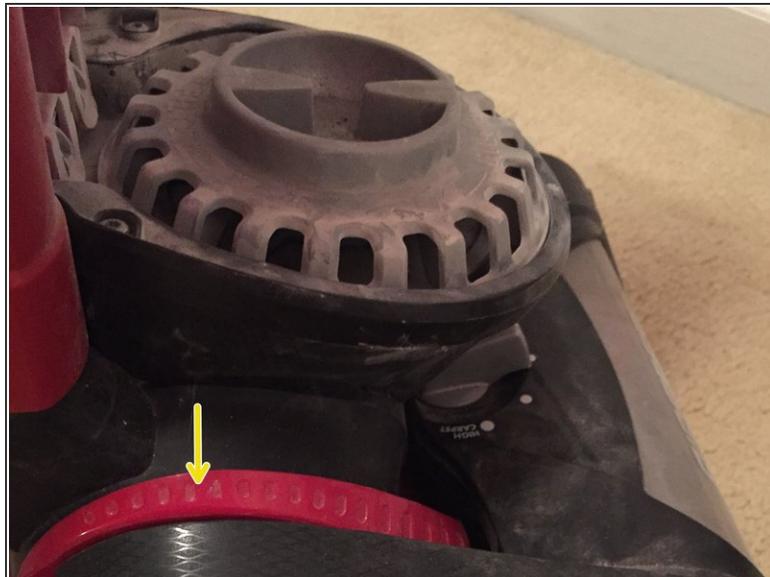
Step 7 — Remove red wheel frame

- After the brush and belt housing is removed, the red wheel frame can be removed in a similar fashion.
- The first photo is from the bottom just to show how the wheel frame is wrapped around the black motor housing.
- Carefully but firmly pull outwards on one of the wheel frame ends to free it from the motor housing and then remove the whole red wheel frame.

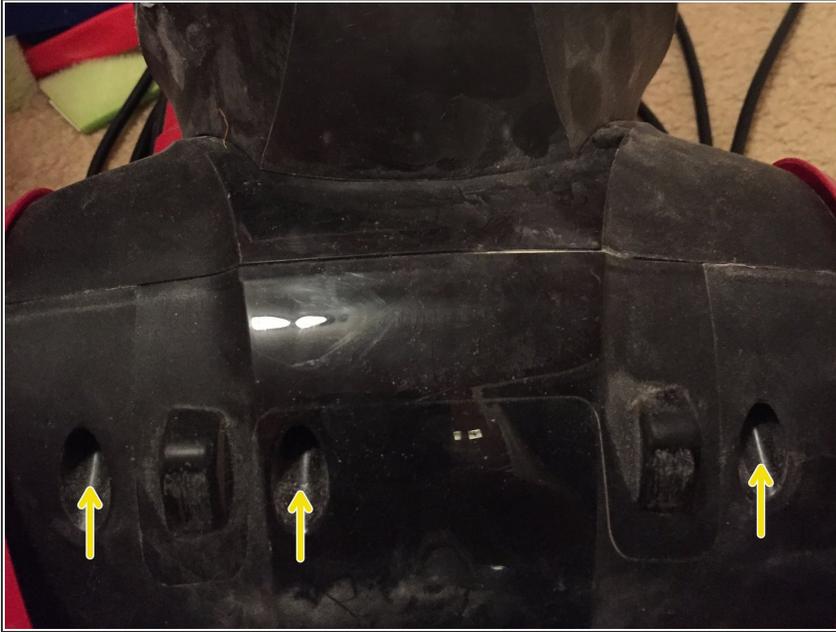
Step 8 — Open black motor housing

- Remove the five hex (H3.0) screws from the black motor housing - three on one side and two on the opposing side.
- With the screws removed, the motor housing can be opened up.

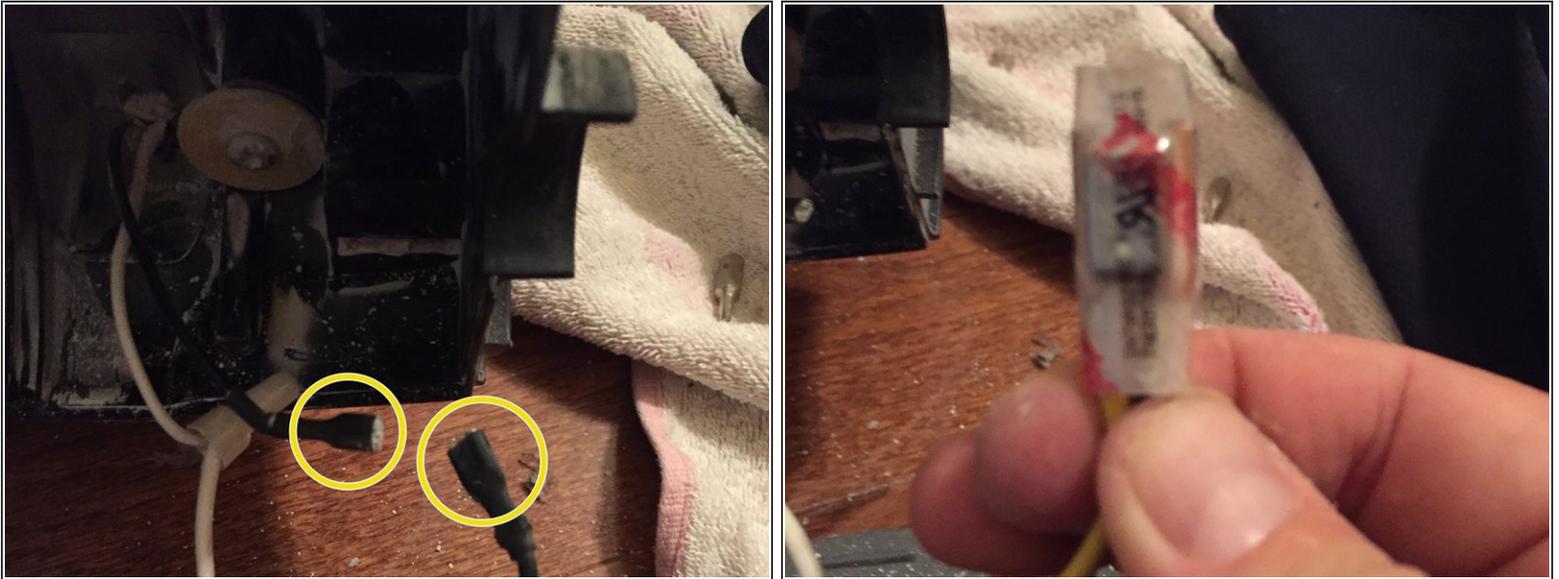
Step 9 — Disconnect leads from power switch

- With the motor housing pulled apart and using a flashlight, locate the two black wires that go into the power switch cavity.
- One black (hot) wire originates from the power cable (containing a black and white wire) and the other black wire goes to the motor via what appears to be a thermal overload or other overload device.
- Disconnect the black wire lugs from the spade connectors on the bottom of the power switch.

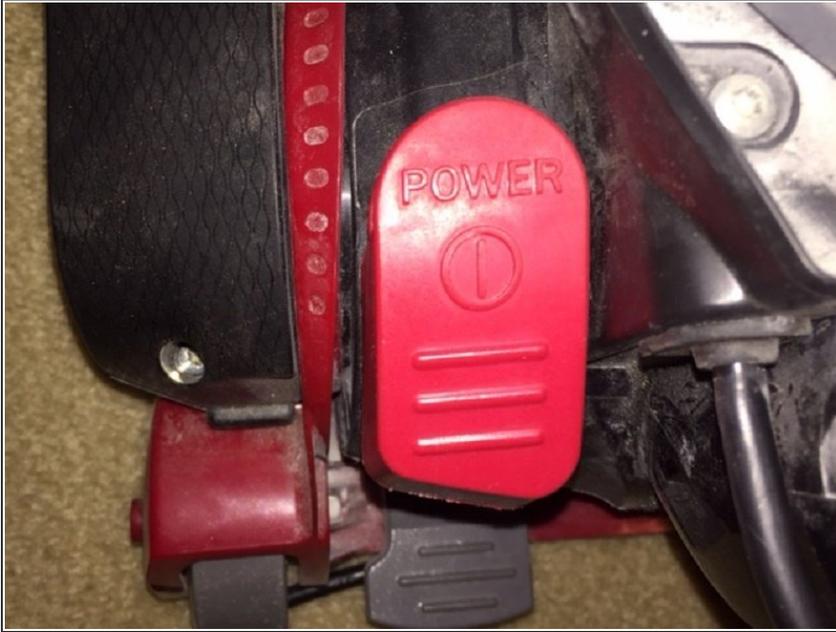
Step 10 — Remove power switch

- Remove the red plastic cover piece from the power switch cavity.
- From the motor housing side, push up on the power switch - I used my pliers to pop up the two spade connectors through the slots. The switch is held in place only by a friction fit and will come up and out through the top easily.

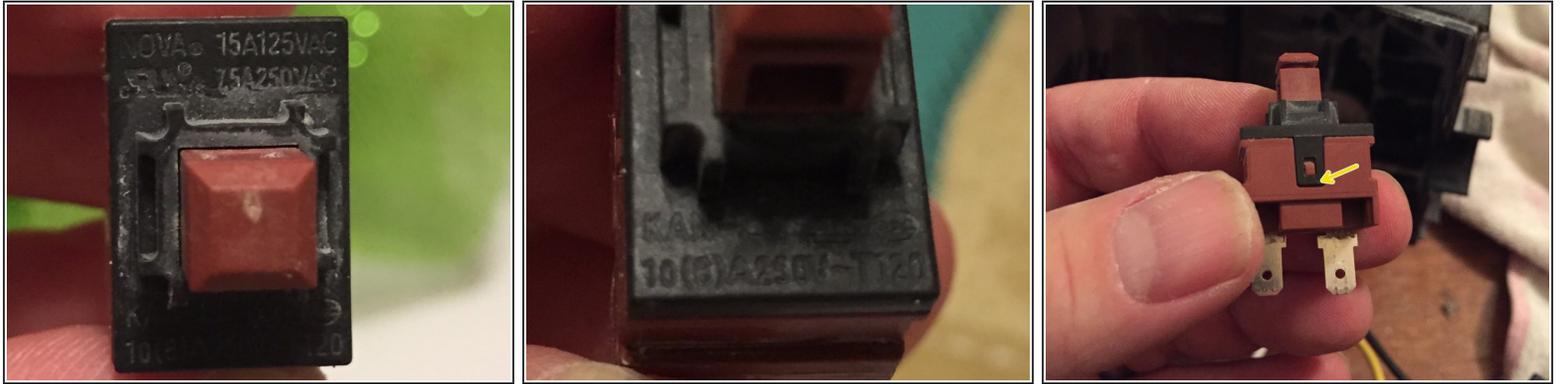
Step 11 — Replace (or possibly repair) switch

- With the switch removed, the make and model are identified. The switch is a NOVA KAN-L5 SPST pushbutton switch. This appears to be an imported component from China. I could not find much documentation on the internal details.
- Further research indicates the Eureka / Electrolux OEM part is #81142-1. Repair Clinic, an online retailer, shows that their replacement switch is a "Defond CPU-1113"
- At my house, every cleaning appliance (vacuum, clothes washer, clothes dryer, etc.) is critical and must be in working order 24 x 7 or my spouse will go out and quickly purchase a new working replacement...therefore I was under pressure to perform a repair or get out the wallet.
- It's not often that I've noticed 120VAC switches with removable components so I was intrigued to see the plastic tabs on each side of this switch.

- Using my iFixit tweezers I carefully lifted the black tabs of the switch and the top half of the switch could be lifted off.
- The switch contained two springs and a small copper pole. Upon inspection, when the switch was pressed, the main spring compressed and held the switch pole down, but the pole was not making contact with the "throw" (one of the spade connectors).
- It appeared that the pole might have been bent slightly from its original orientation. My fix was to slightly bend the pole to ensure that it would make contact with the spade connector as designed.
