Fujifilm Instax Mini 8 Infrared Blaster Replacement

This guide helps you recognize the steps to fix your IR blaster on an Instax Mini 8.

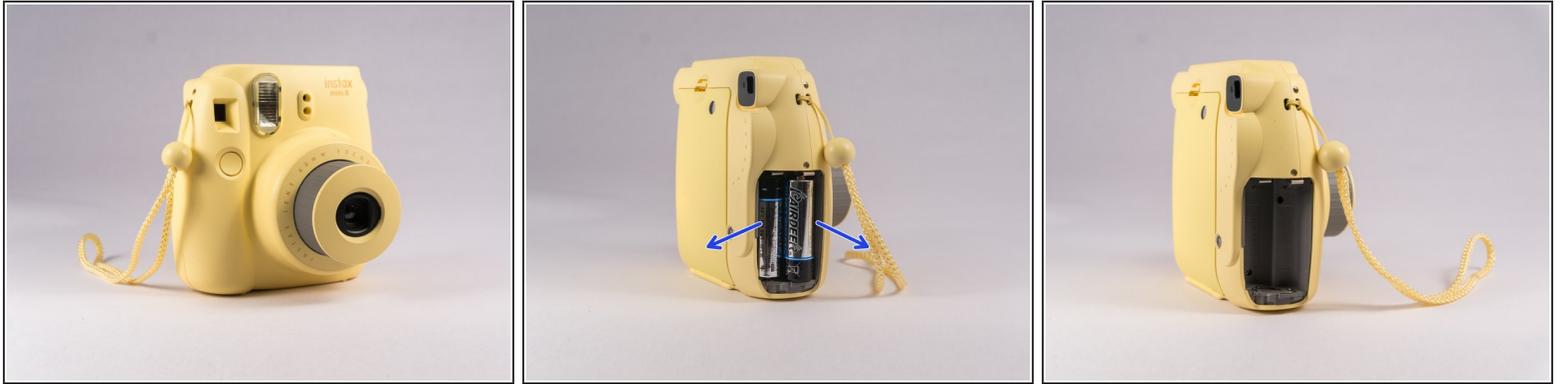
Step 1 — Infrared Blaster

- First, push in the lens and remove the two AA batteries.

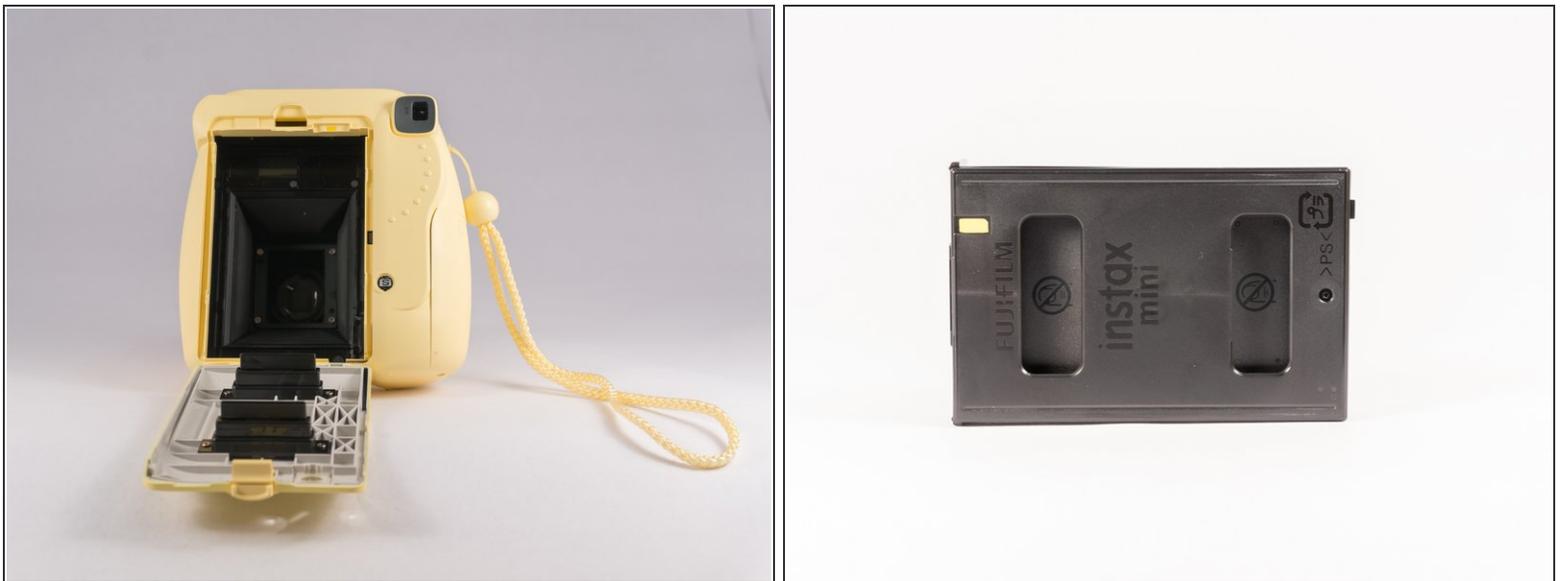
Step 2

- Open the rear compartment and remove the film cartridge.

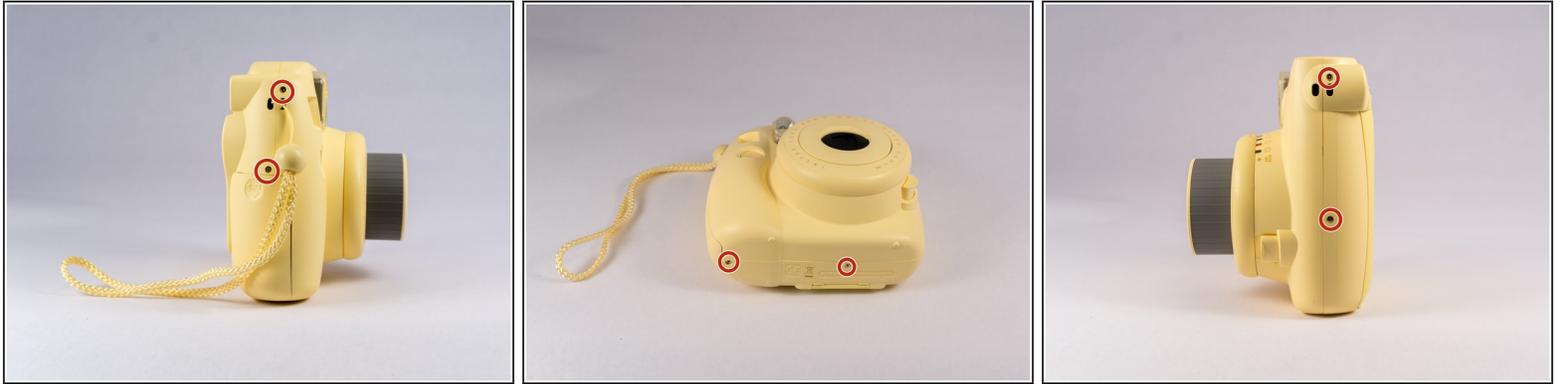
Step 3

- Remove screws from bottom of camera with a small #00 Phillips Screwdriver. Then remove screws around the camera. Additionally, there are two screws in the battery compartment which also need to be removed.
